SPECTROMETRIC OIL ANALYSIS FOR THE DETECTION OF INCIPIENT TURBOJET ENGINE FAILURES

TECHNICAL REPORT SEG-TR-65-37

JULY 1965

SYSTEMS ENGINEERING GROUP
RESEARCH AND TECHNOLOGY DIVISION
AIR FORCE SYSTEMS COMMAND
WRIGHT-PATTERSON AIR FORCE BASE, OHIO

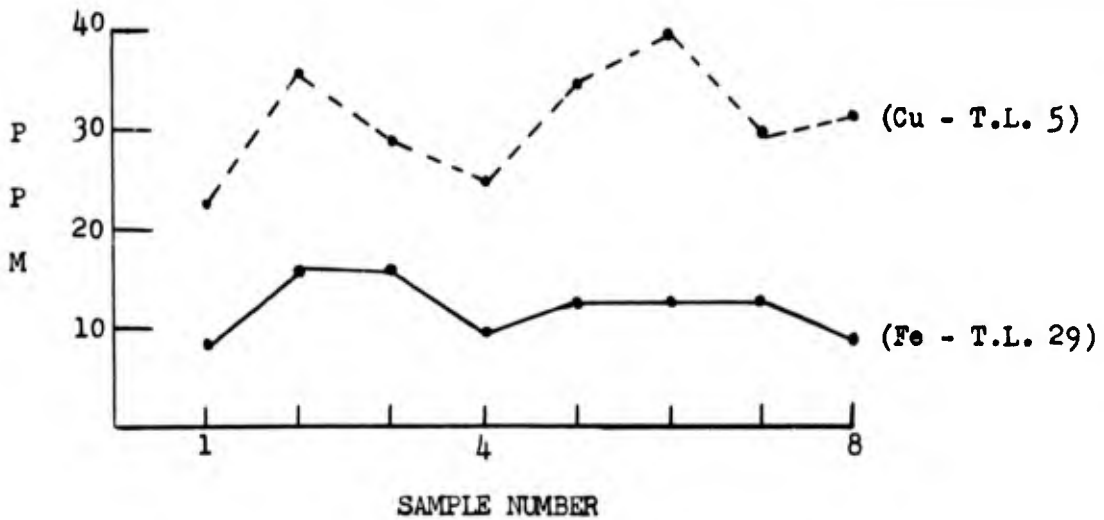
Figure 3. A1 Engine Data - Positive Correlation

On 25 March 1964 NAS Pensacola reported that copper contamination of an oil sample was high and requested that the sampling rate be increased to every five hours. By 1 April the copper content had further increased and "after every flight" sampling was recommended. By 17 April the copper reading was so high that NAS recommended the grounding of the aircraft until the discrepancy was discovered. The discrepancy was not discovered and the engine was sent for TDR. The TDR revealed wear on the Nr 4 bearing.

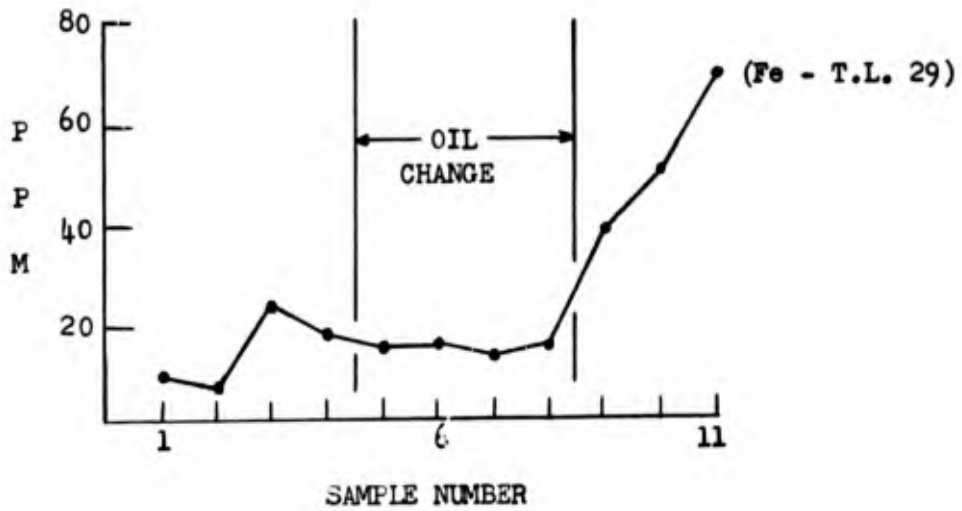
Figure 4. A2 Engine Data - Positive Correlation

On 13 December 1963 NAS Pensacola reported that a sample was iron-contaminated and recommended close supervision for two sampling intervals. The next two samples showed increasing iron (Fe) even though the oil was changed. Therefore, Pensacola recommended that the engine be sent for TDR, if the contamination source was not found. The engine was sent for TDR which revealed wear on the Nr 4 bearing, the bearing journal, and bearing spacer.

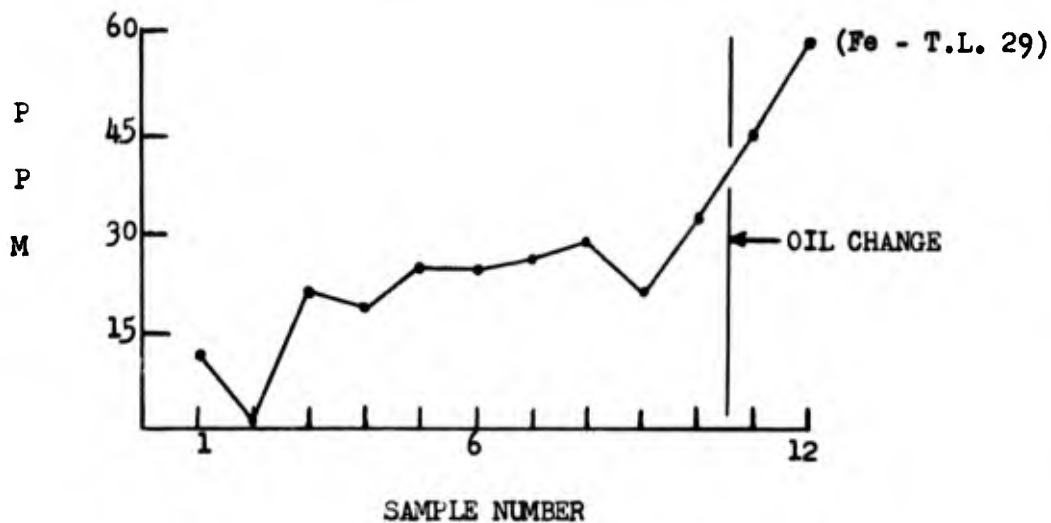
Figure 6. B2 Engine Data - Positive Correlation

On 1 November 1963 NAS Pensacola reported an increase in iron contamination from 32 to 45 ppm and recommended removal of the engine. A further sample received by Pensacola after this recommendation showed that iron content had risen to 59 ppm. Engine was removed and sent for TDR, which revealed wear in the accessory drive and also the inner walls of the pump bodies were scored, gouged, and eroded.

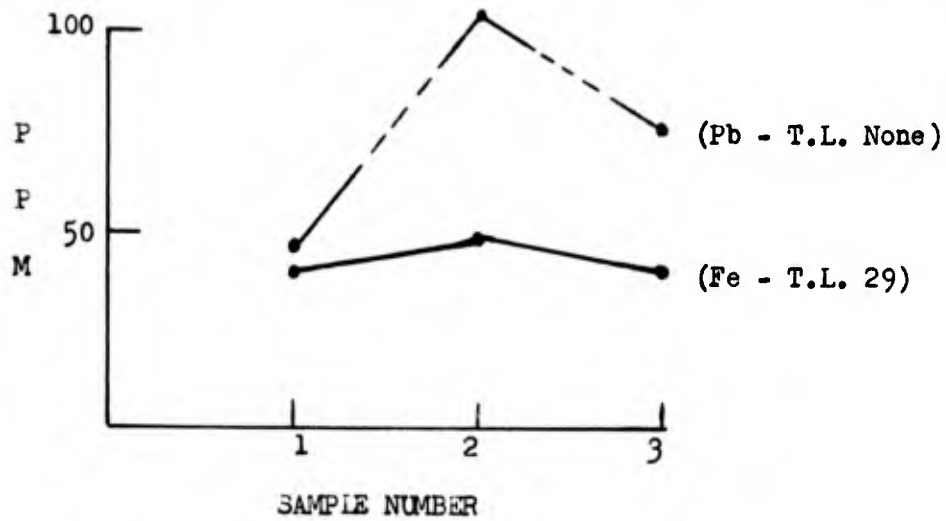
Figure 7. B3 Engine Data - Positive Correlation

On 29 May 1963 NAS Pensacola reported sample contamination of above average iron and lead. The second sample showed a continuing increase in the contamination levels of the elements. NAS recommended the removal of the engine for a TDR. The TDR results revealed that the iron wear was coming from the accessory drive and the lead from the plating on the Nr 4 bearing. It was determined from this TDR and consultations with the engine manufacturers that the loss of lead from the engine parts has no significant effect on engine integrity. For this reason a threshold limit for lead was not established for the type of jet engines being monitored under this task.

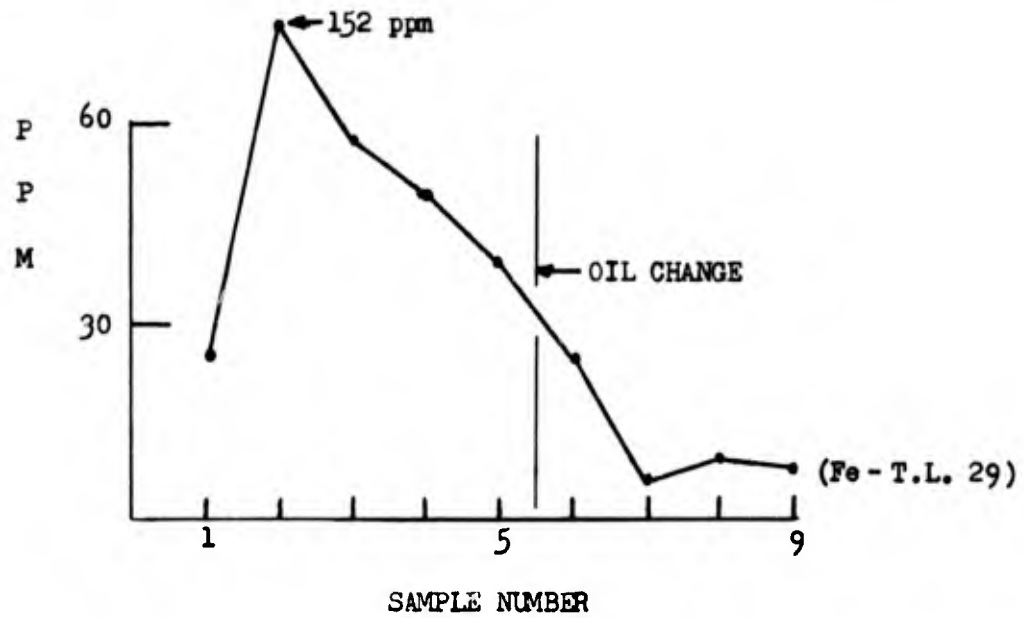
Figure 8. C1 Engine Data - Positive Correlation

On 19 May 1964 NAS Pensacola reported high iron in a routine sample and recommended grounding the aircraft pending a check sample. Further check samples of 26 May and 1 June confirmed the high iron reading and Pensacola recommended an inspection for the contamination source, suggesting auxiliary pumps and drives and gearbox. The base reported visual confirmation of wear in main lube pump and a change of this equipment. Subsequent check samples were analyzed as normal.

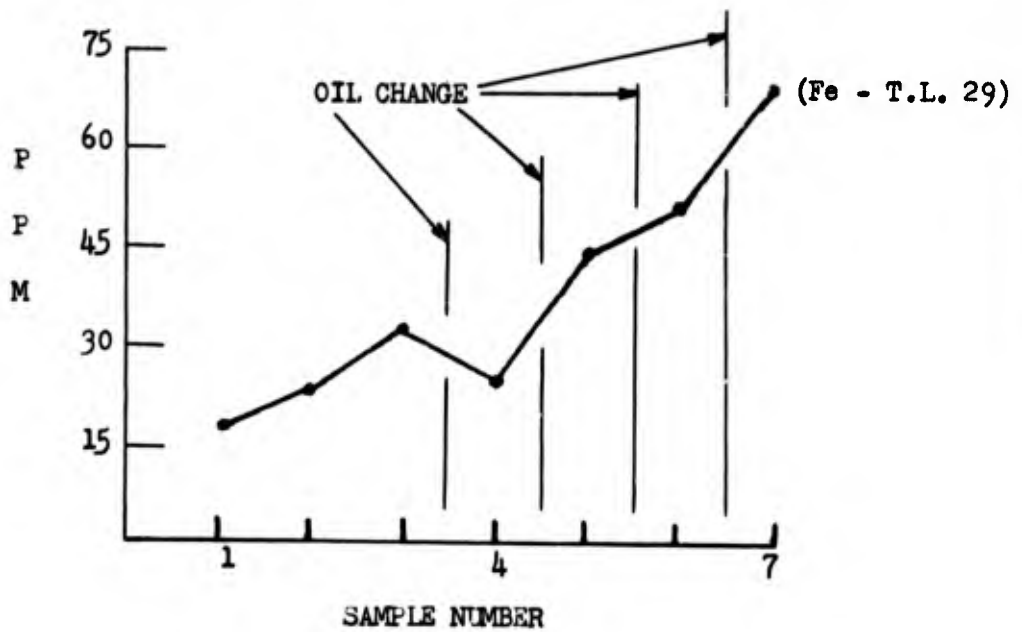
Figure 10. C3 Engine Data - Positive Correlation

As with engine C15, a sample showed high iron immediately prior to the engine being shipped for scheduled modification. The depot was requested to complete a TDR concurrently with modification, to determine the source of iron. The TDR revealed wear in the transfer gearbox.

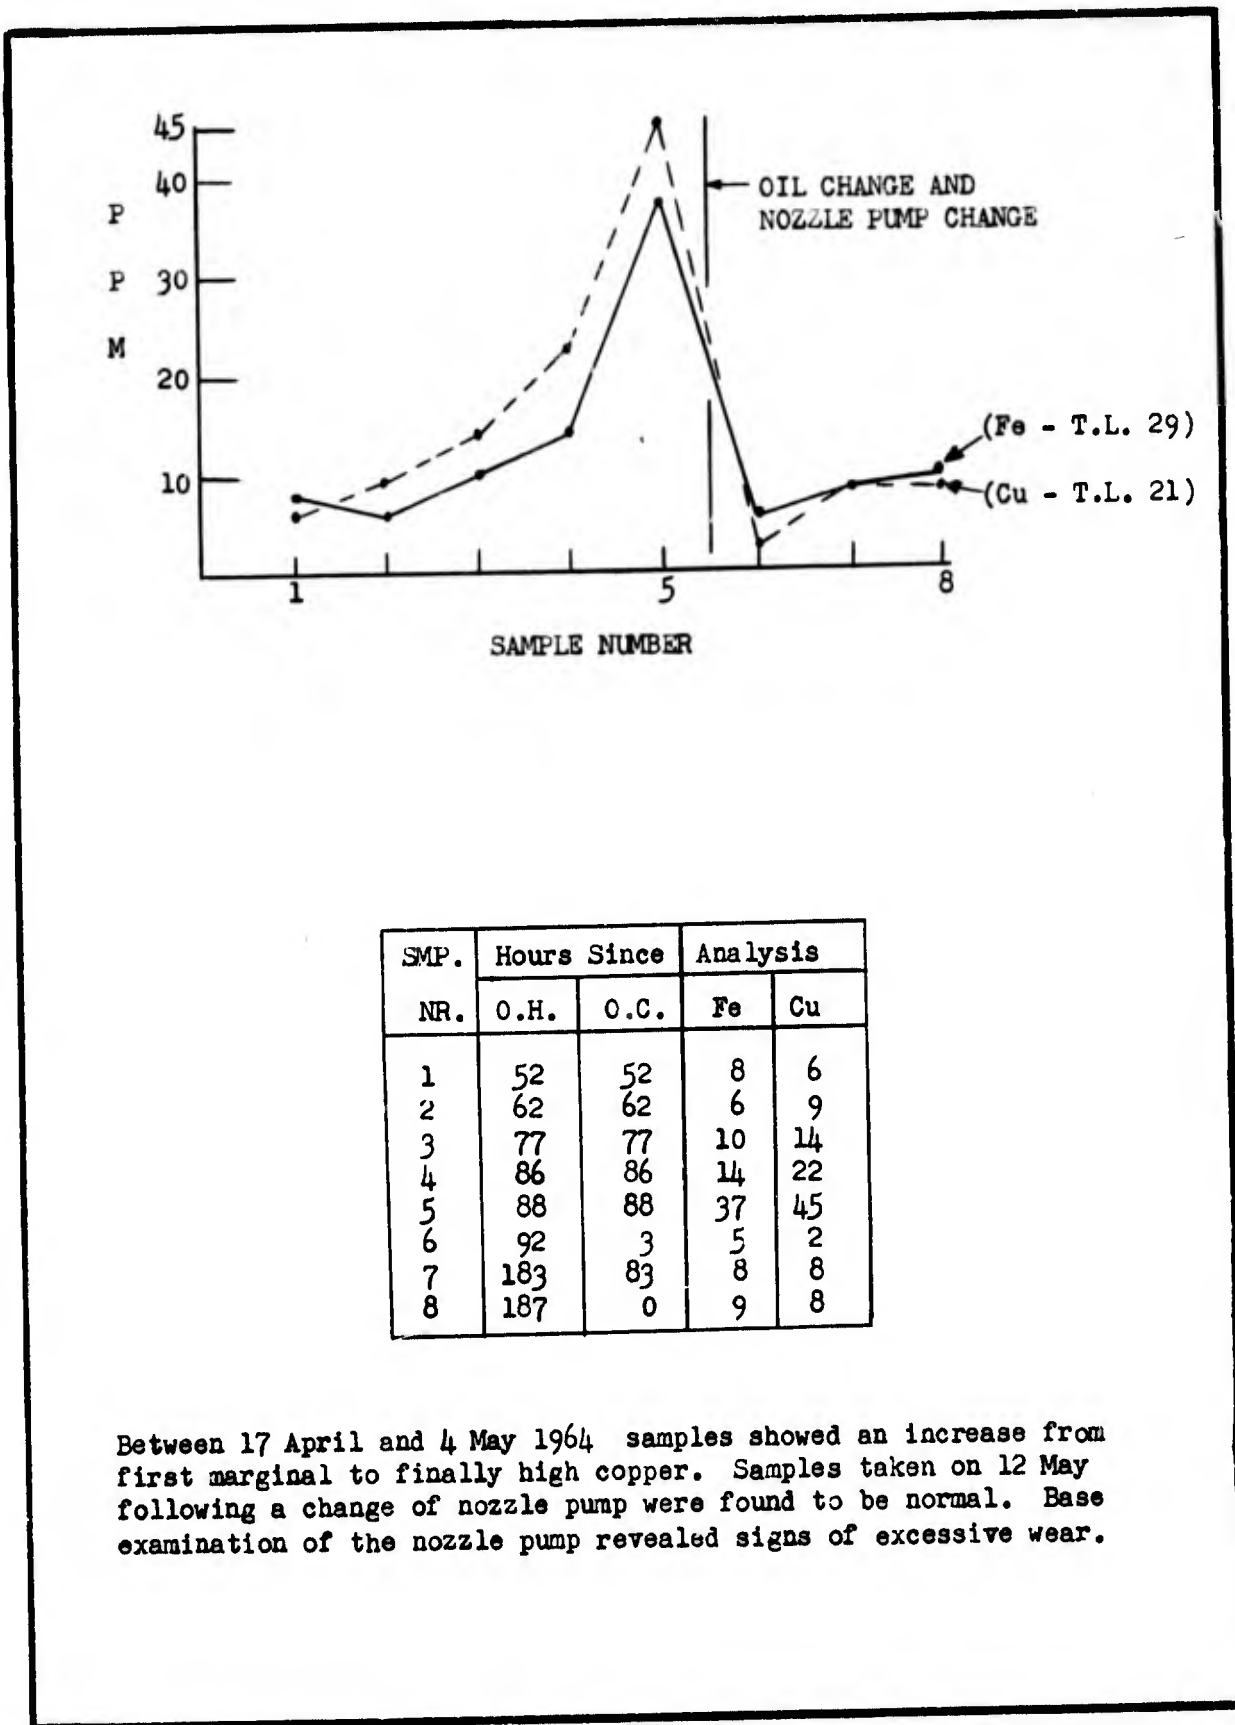
Figure 12. C5 Engine Data - Positive Correlation

Between 17 April and 4 May 1964 samples showed an increase from first marginal to finally high copper. Samples taken on 12 May following a change of nozzle pump were found to be normal. Base examination of the nozzle pump revealed signs of excessive wear.

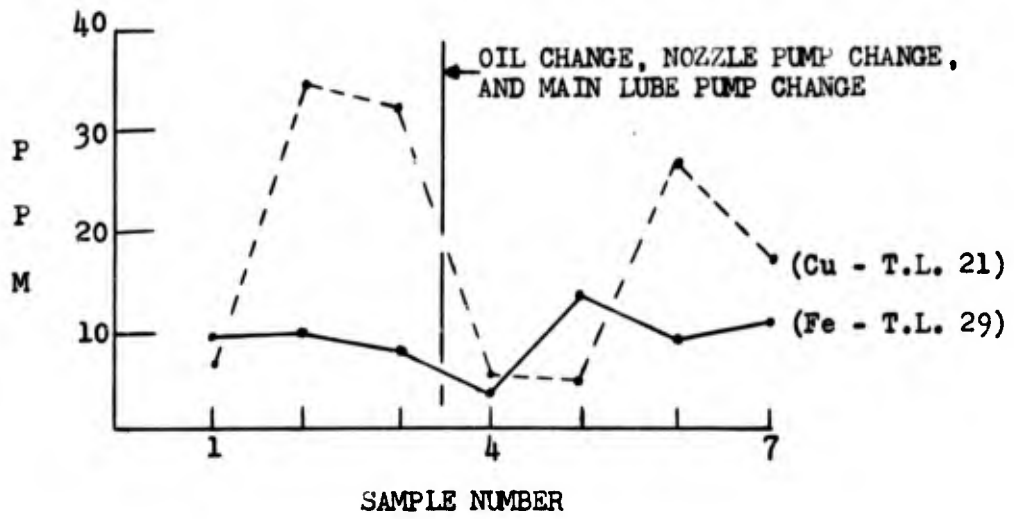
Figure 13. C6 Engine Data - Positive Correlation

After a routine oil sample showed high copper on 8 April 1964, NAS Pensacola recommended that the aircraft be grounded pending analysis of a further check sample. A sample submitted on 1 May proved satisfactory and NAS Pensacola requested details of any precautionary maintenance. Base reported that emergency nozzle pump and main lube pump had been changed because of evidence of excessive wear. Such evidence was visual.

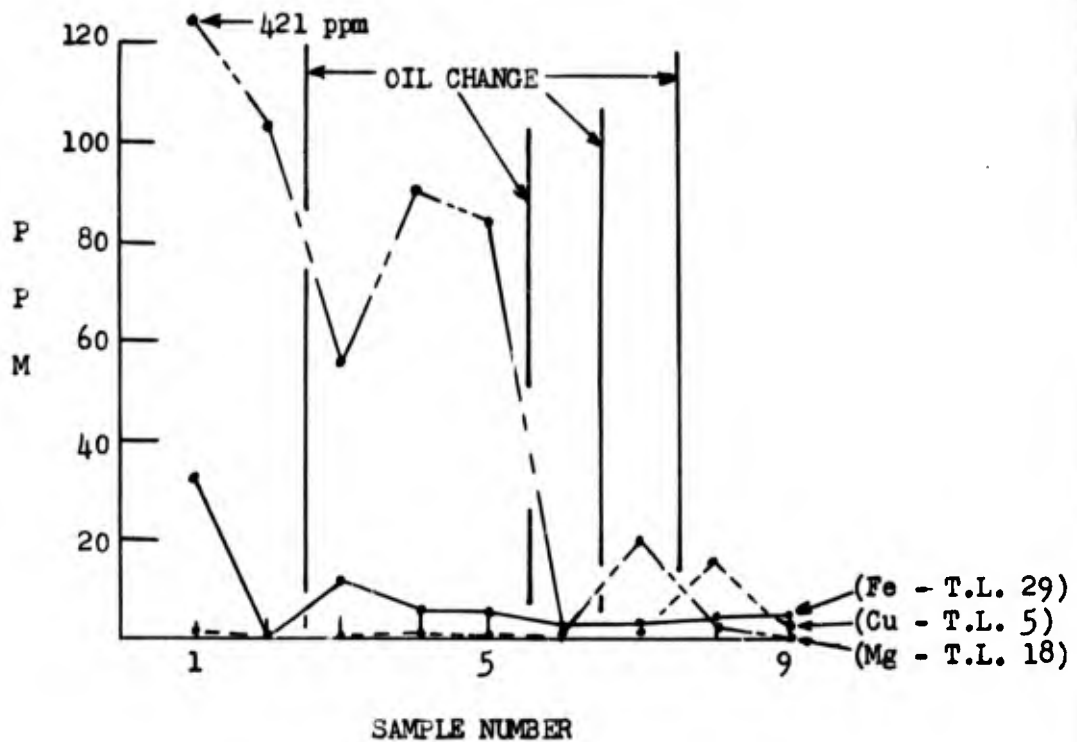
Figure 14. A3 Engine Data - Negative Correlation

On 15 August 1963 sample analysis showed high magnesium and lead and marginal iron. Since lead has not proven useful on the jet engines being monitored under this task, lead is not shown on this graph. On 19 August 1963 sample analysis only magnesium was shown high. At this time Pensacola requested further check sample to confirm conflicting data. There was then no further action until 17 January 1964 when Pensacola reported copper and recommended determination of a suspected bearing failure. After engine strip and rebuild, oil samples were satisfactory. However, the engine disassembly revealed no discrepancy and all bearings were said to be satisfactory.

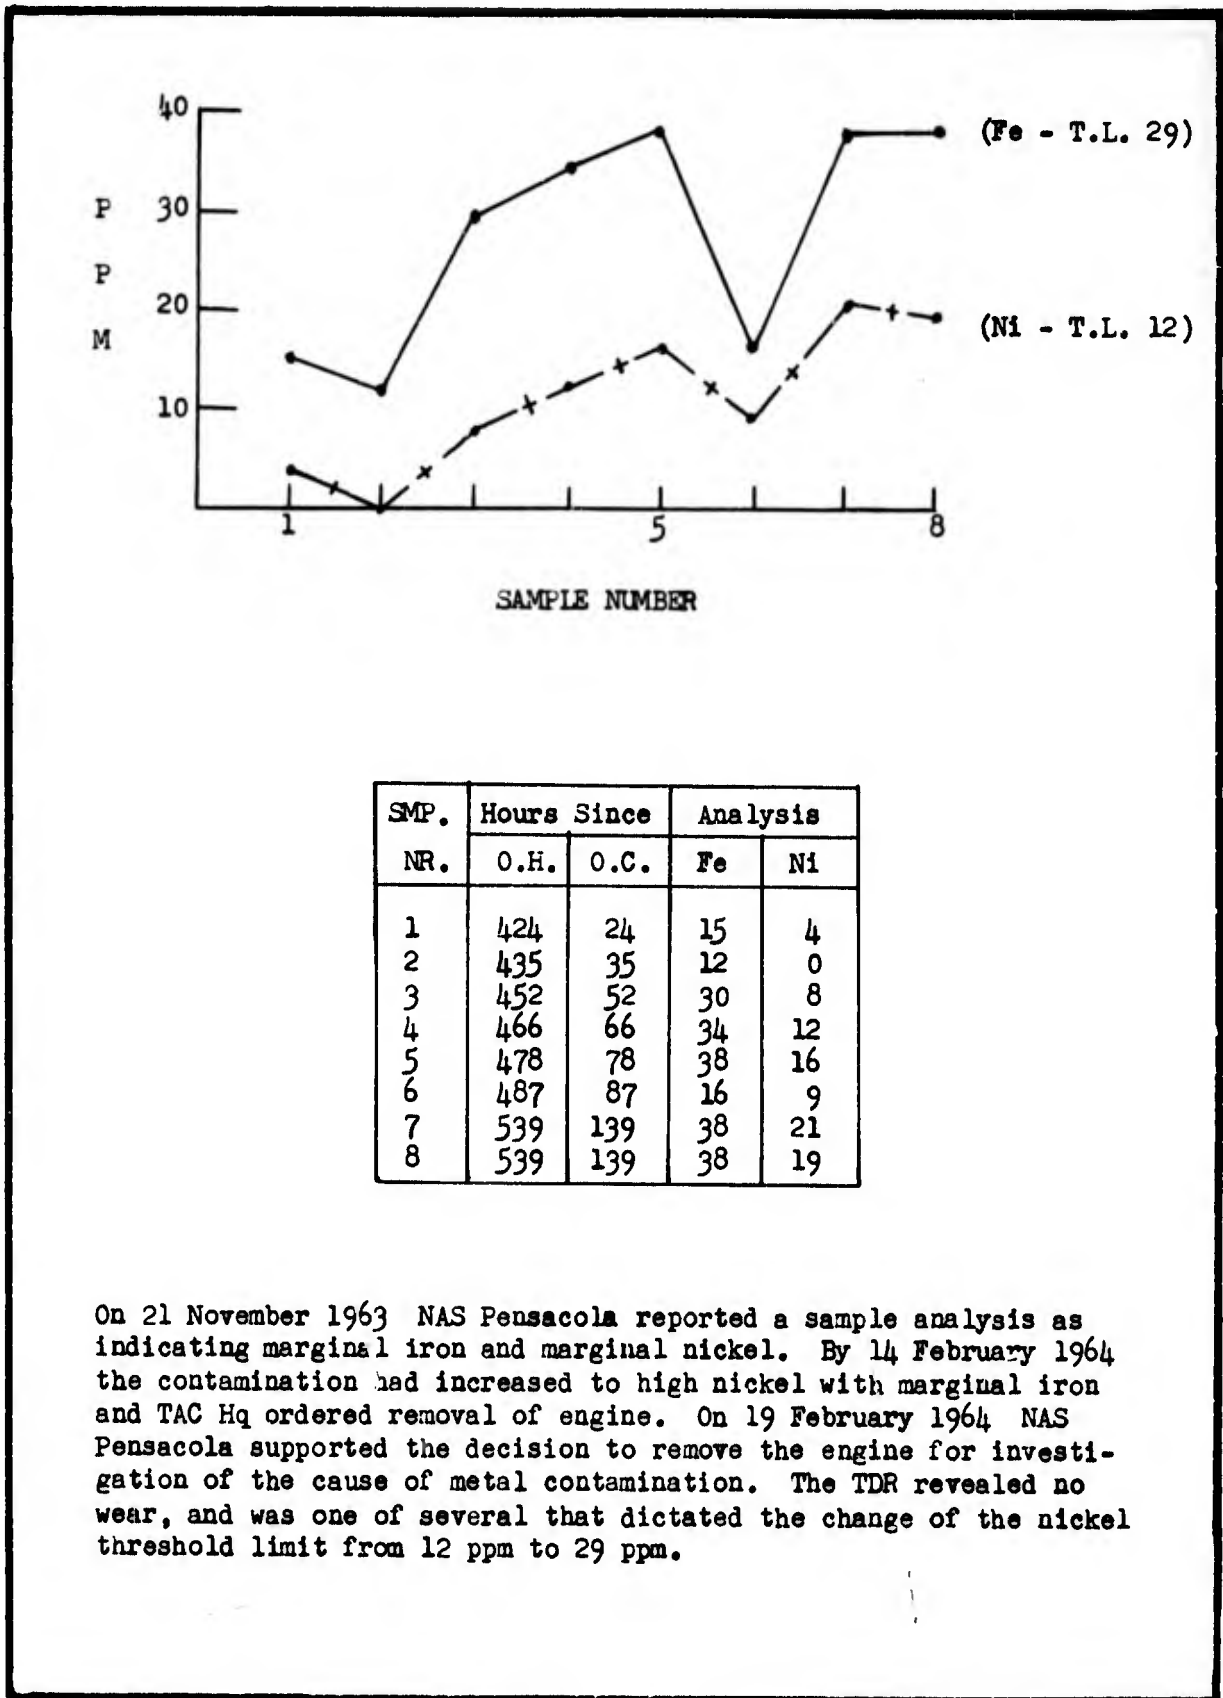
Figure 15. B4 Engine Data - Negative Correlation

On 21 November 1963 NAS Pensacola reported a sample analysis as indicating marginal iron and marginal nickel. By 14 February 1964 the contamination had increased to high nickel with marginal iron and TAC Hq ordered removal of engine. On 19 February 1964 NAS Pensacola supported the decision to remove the engine for investigation of the cause of metal contamination. The TDR revealed no wear, and was one of several that dictated the change of the nickel threshold limit from 12 ppm to 29 ppm.

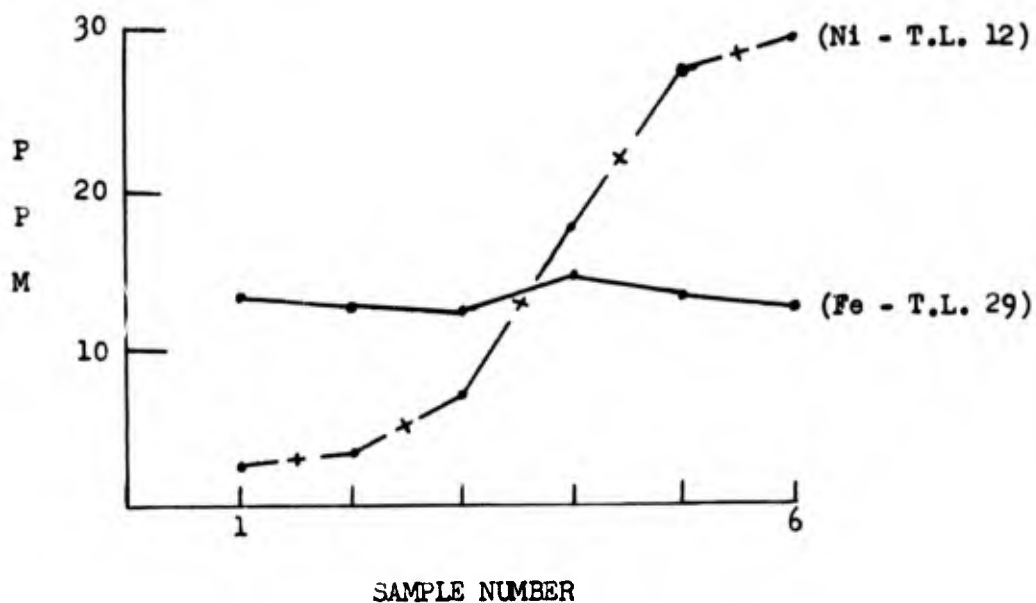
Figure 16. B5 Engine Data - Negative Correlation

On 28 February 1964 NAS Pensacola reported high nickel contamination of oil sample and later (on 10 March 1964) a very high nickel reading. At the time of the last reading NAS recommended the removal of the engine. The TDR revealed no wear, and this TDR was one of several that dictated the change of the nickel threshold limit from 12 ppm to 29 ppm.

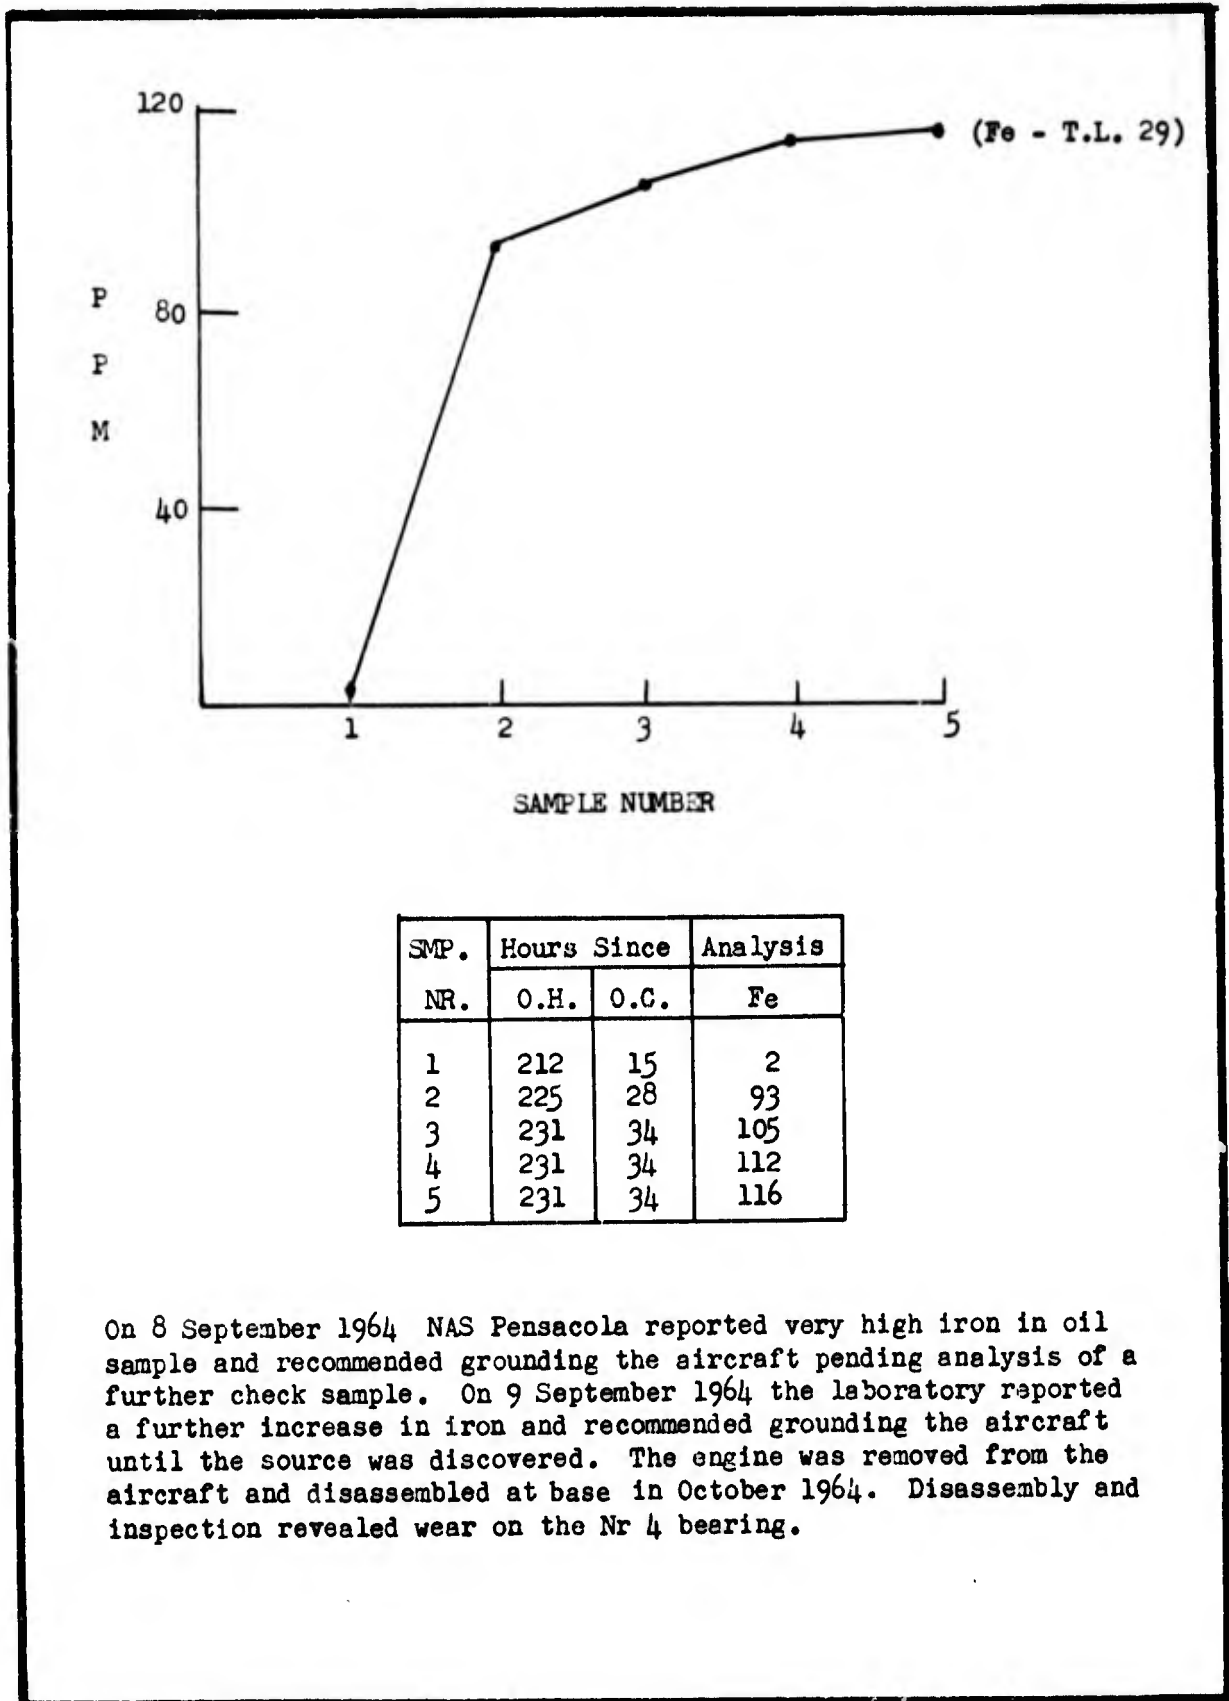
Figure 28. B14 Engine Data - Positive Correlation

On 8 September 1964 NAS Pensacola reported very high iron in oil sample and recommended grounding the aircraft pending analysis of a further check sample. On 9 September 1964 the laboratory reported a further increase in iron and recommended grounding the aircraft until the source was discovered. The engine was removed from the aircraft and disassembled at base in October 1964. Disassembly and inspection revealed wear on the Nr 4 bearing.
