INVESTIGATION OF CHANNEL SEAL  
BLOW-BY PHENOMENON

JUNE 1966

SYSTEMS ENGINEERING GROUP  
RESEARCH AND TECHNOLOGY DIVISION  
AIR FORCE SYSTEMS COMMAND  
WRIGHT-PATTERSON AIR FORCE BASE, OHIO

The purpose of this program is to investigate channel seal blow-by phenomenon in KC-135 power rudder actuators and to record the results of these investigations.

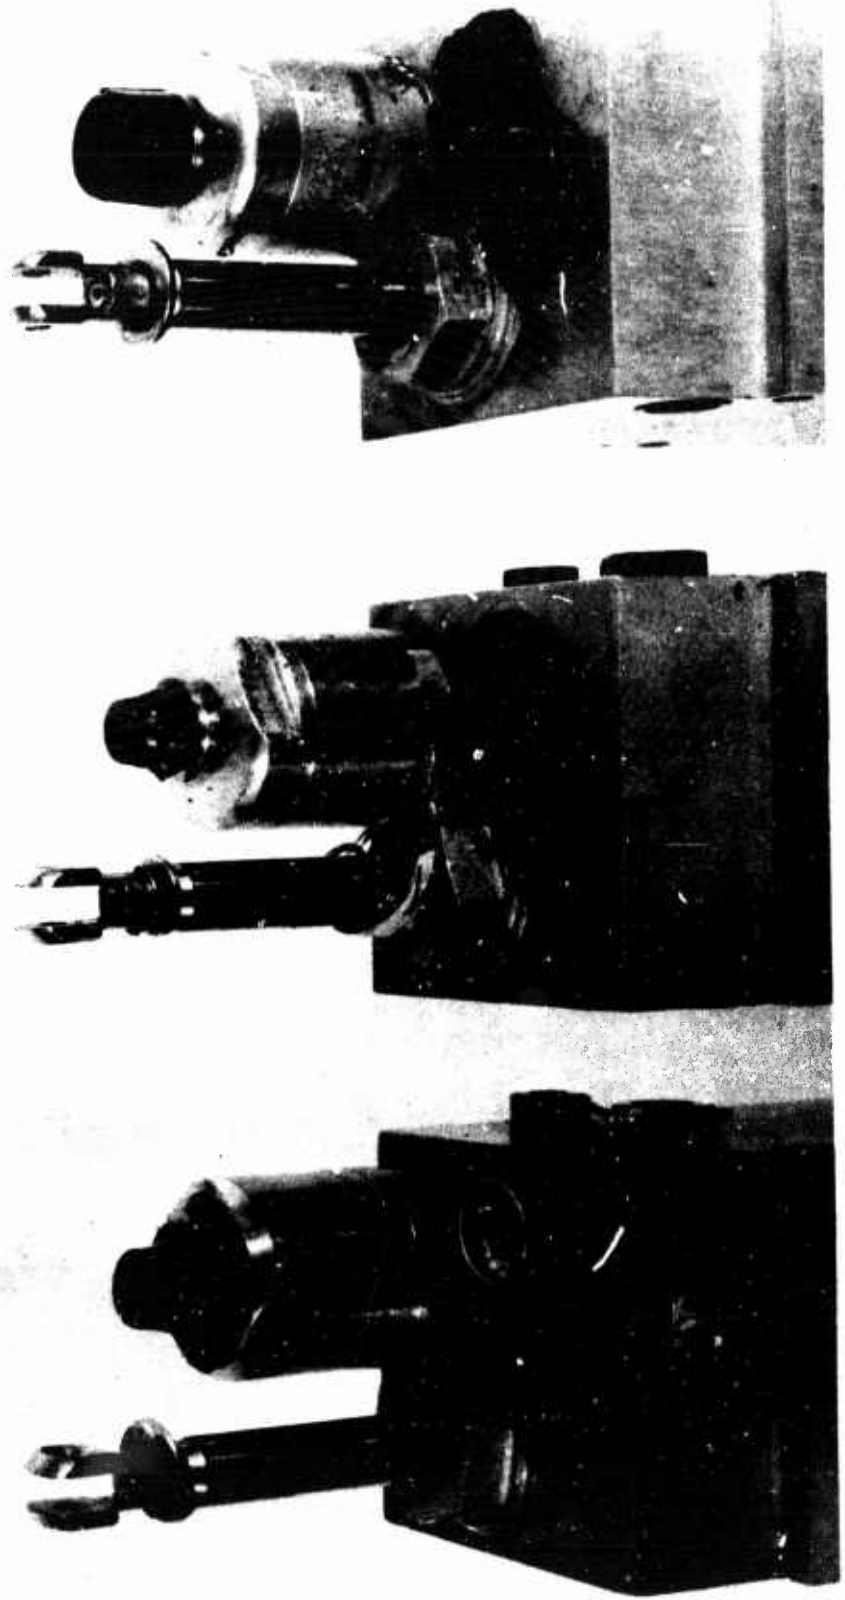
During this test program, it was noted that the test actuator valve metering control rod could be pushed far enough to permit a washer on the rod to enter the valve block a distance of approximately .125 inches. When this occurred, the actuator valve metering slide assumed a position which blocked fluid pressure and the actuator piston could not move unless the rod was retracted to approximately  $\frac{1}{4}$  inch from its neutral center position. Investigations revealed that an incorrect size washer was installed on this actuator metering control rod. This washer had a smaller diameter as compared to the MS 15795-211, which is the correct washer to use for this installation. To correct this condition, the valve block which came with the load actuator replaced the test actuator valve block which had the small washer on the metering control rod. Inadvertently, the MS 15795-211 washer on the replaced valve block metering control rod was bent when the electric motor was started with an excessive speed setting during later phases of this test program. It was found that the bent washer would also protrude into valve block causing the actuator piston to assume a locked position. Investigations were made to determine if this metering control rod bottoming could occur in the KC-135 airplane rudder control system. Discussions with Boeing engineering personnel and maintenance personnel assigned to the 17th Bombardment Wing indicate that the washer installed on the metering control rod stops approximately  $\frac{1}{4}$  inch from the valve block if the system is properly rigged. However, during the investigation procedures accomplished in regard to the UR Exhibit received from

FIGURE 5 VIEWS OF REVERSING CONTROL VALVE FACE

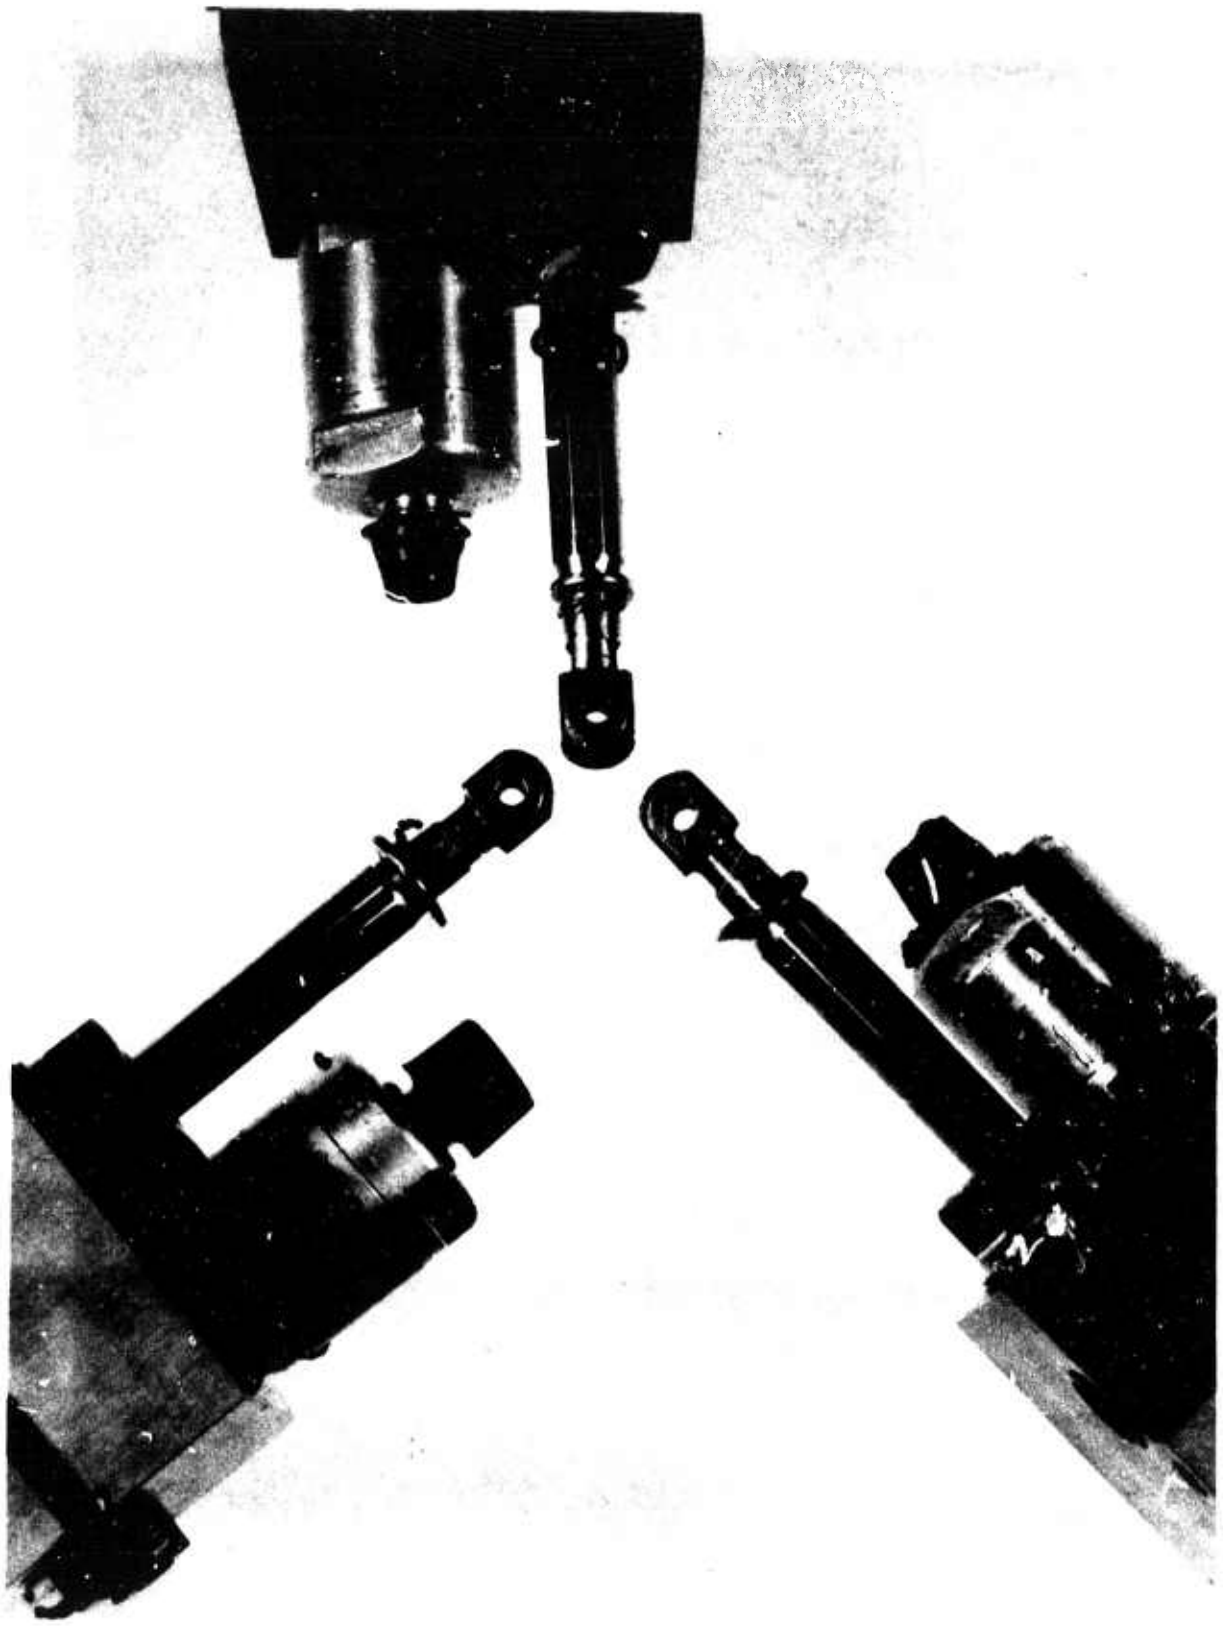
Walker AFB, it was determined that it is difficult to determine if a washer on the metering control rod is bottoming on the valve block. Also, applicable Technical Order procedures do not specify checking procedures to determine if this washer can bottom against the valve block. Photographs are included in Attachment Nr. IX which show the three metering control rods tested during this program. The bent washer and the small washer are shown in this photograph. It is noted that the washer on the opposite end of the metering control rod can also bottom against the valve block. This was demonstrated by loosening the metering control rod nut to only about one thread engagement. To further substantiate that these washers can bottom out in KC-135 airplane rudder actuators, investigations of an operational hazard number 449, BW64-KC-135-4 which occurred at Kinchloe AFB, mentions a bent washer. However, the investigation report OCNCTQ-1 "MIP OC65-7000U1" dated 27 April 1965, states that it appears the washer was bent prior to installing the actuator in the airplane or before the actuator checkout by the investigator.

Over-travel of the metering control rod experienced in this test program could cause erratic rudder responses if this condition prevailed in a KC-135 airplane. Improper washer installations and bent washers installed on the metering control rod could permit over-travel in the airplane provided the rudder control linkages are not properly rigged.

FIGURE 6 WASHER INSTALLATIONS ON METERING CONTROL ROD

It is recommended that the responsible activity at OCAMA take appropriate action to revise applicable Technical Orders to require KC-135 maintenance personnel to check both ends of the rudder metering control rod to determine if the washers bottom on the valve block body.

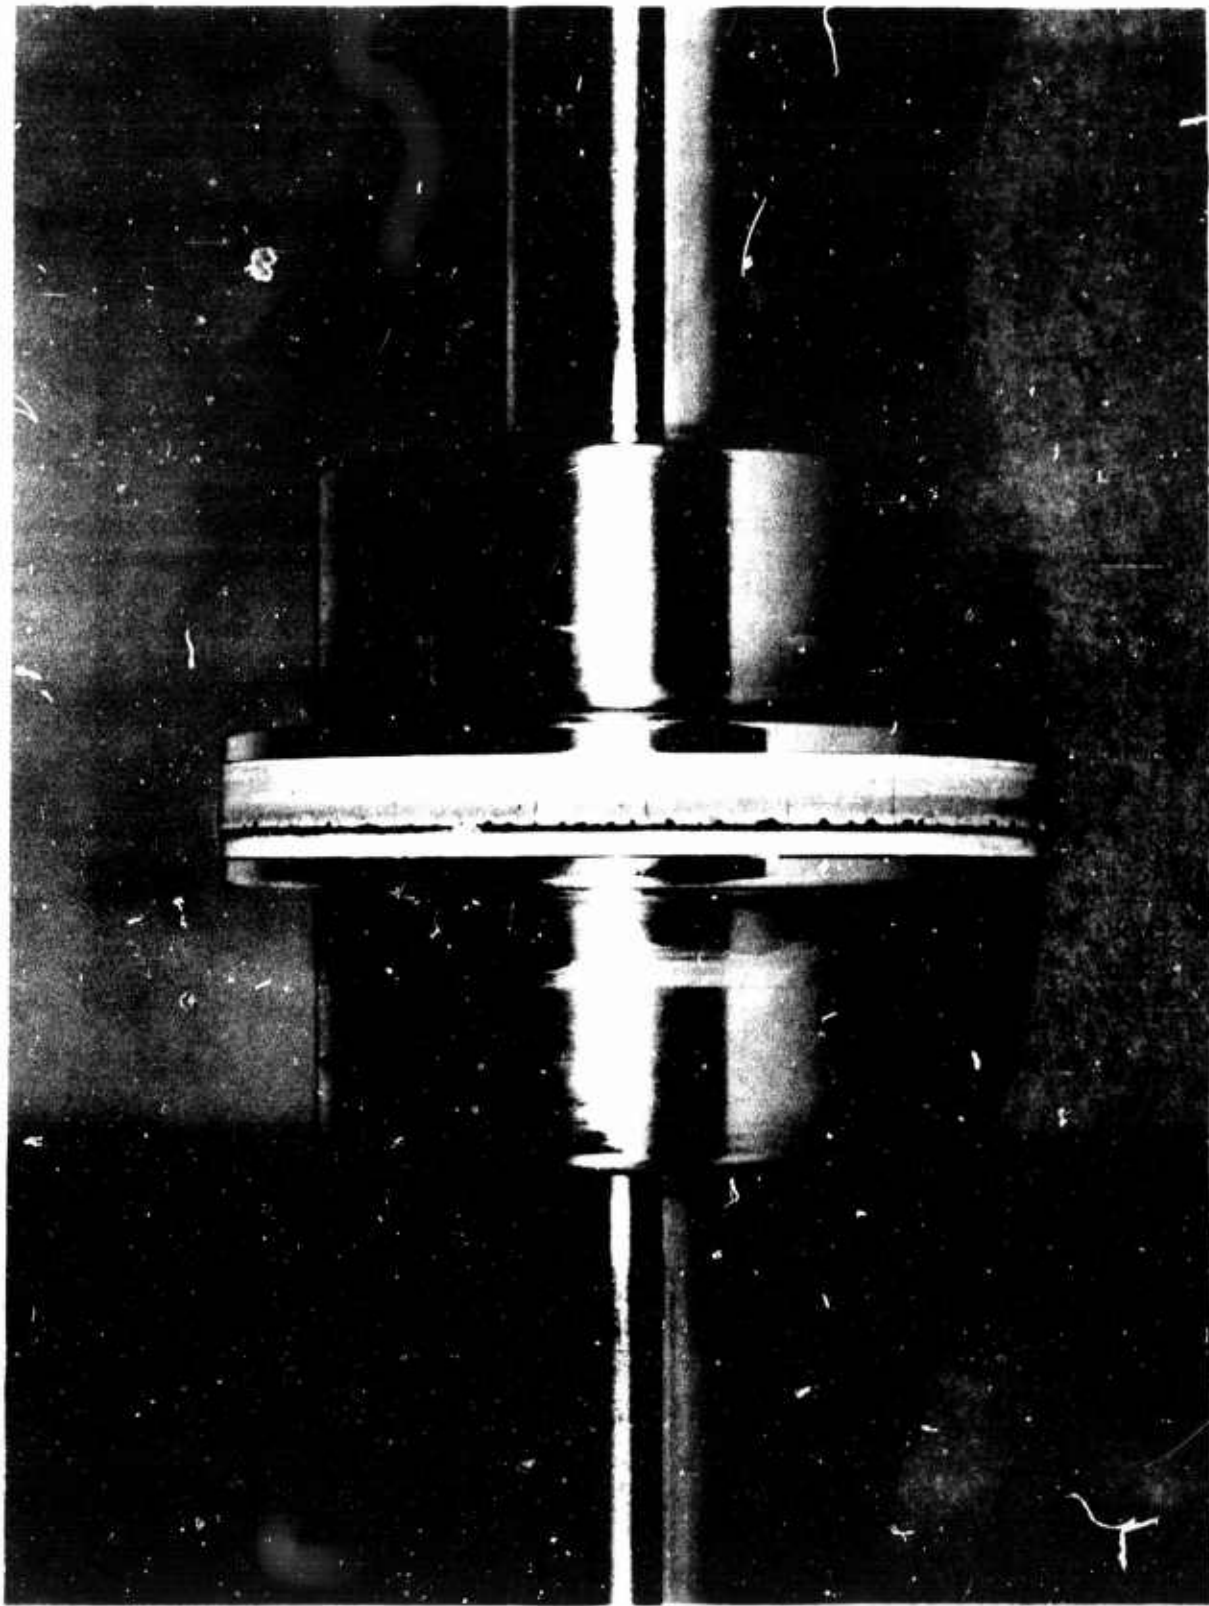
11 April 1966 Removed test actuator (S/N 151) from stand and installed actuator received from Walker AFB (S/N 332). The actuator performed satisfactorily during these tests. Actuator S/N 332 was removed from the test stand and was disassembled to inspect the channel seal. Fifteen pounds of pull were required to move piston. The channel seal was found to be split circumferentially. Photographs were taken of the damaged channel seal installed on the piston of the actuator.

**FIGURE 7** DAMAGED TEFLON CHANNEL SEAL REMOVED FROM  
UR EXHIBIT ACTUATOR

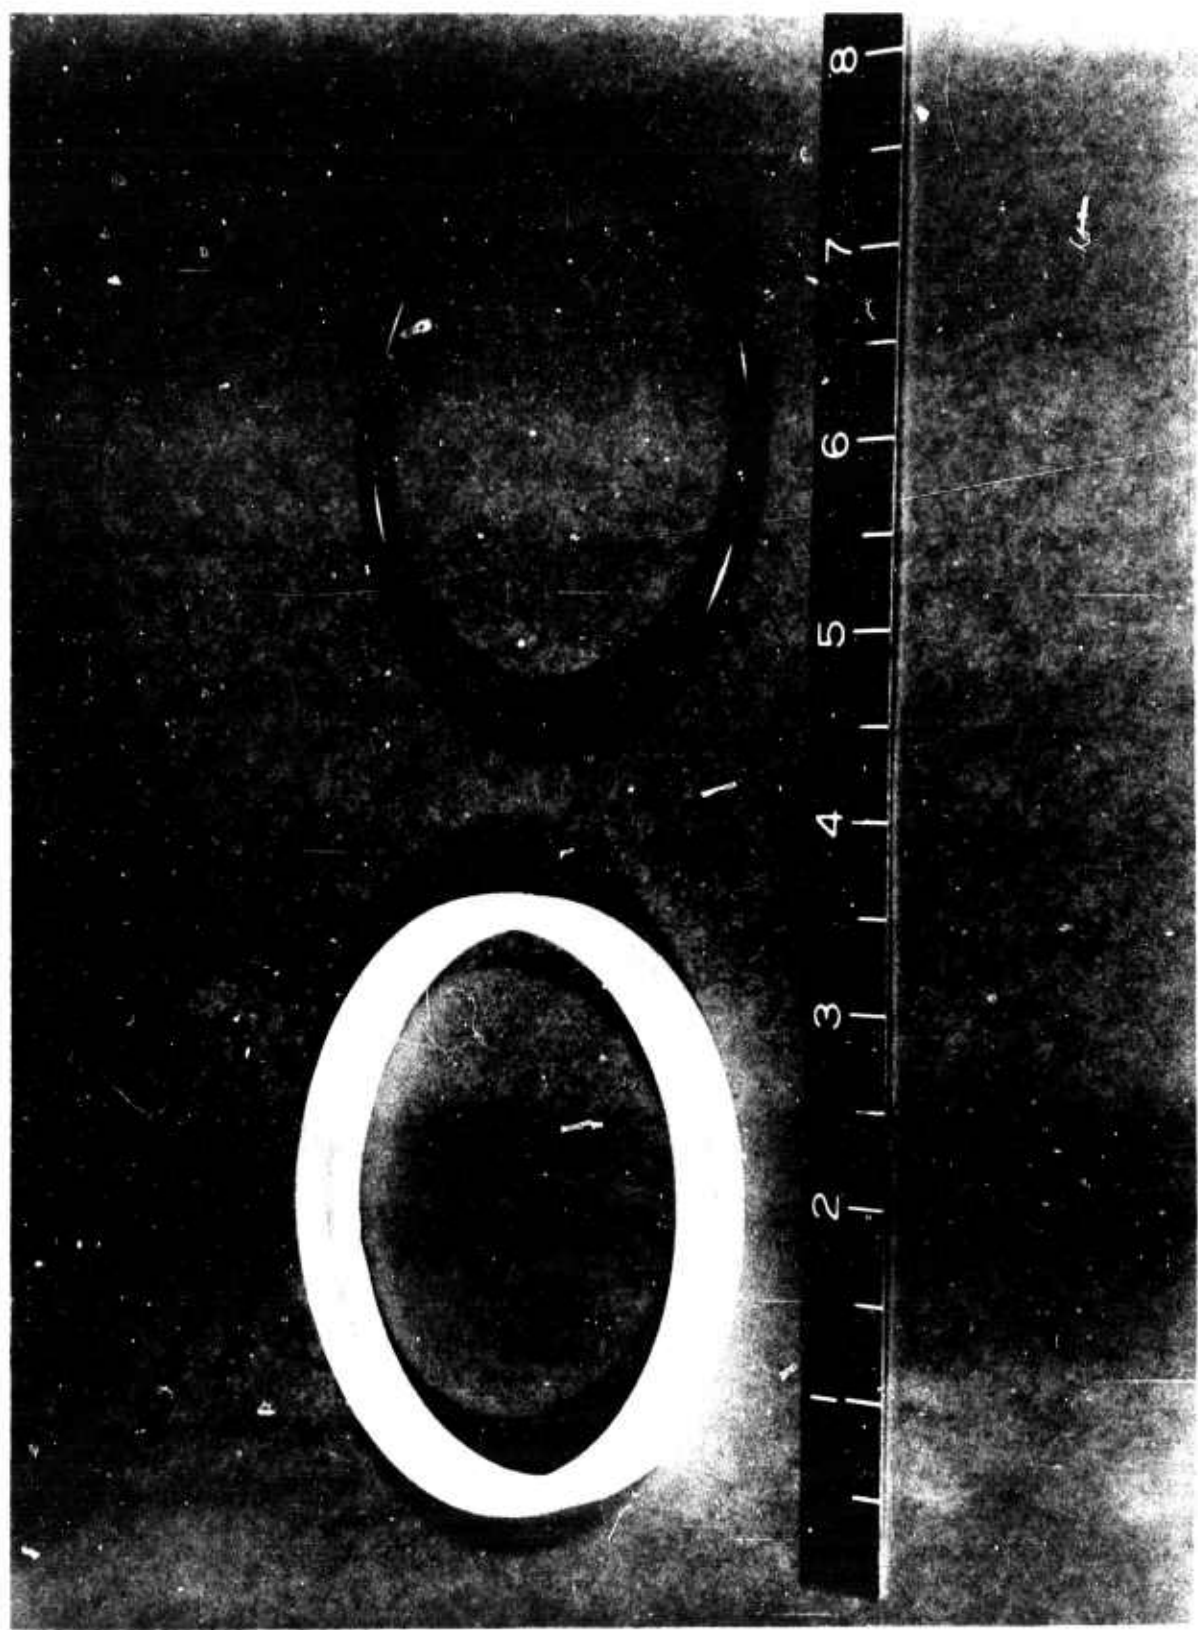
FIGURE 8 VIEWS OF THE TEFLON CHANNEL SEAL CONFIGURATION
