A TEST OF GUN, MACHINE, LIGHT,

CALIBER .30, T161E2

TWENTY SEVENTH REPORT ON PROJECT NO. TS2-2023

DATES OF TEST: 27 DECEMBER 1954 TO 25 FEBRUARY 1955

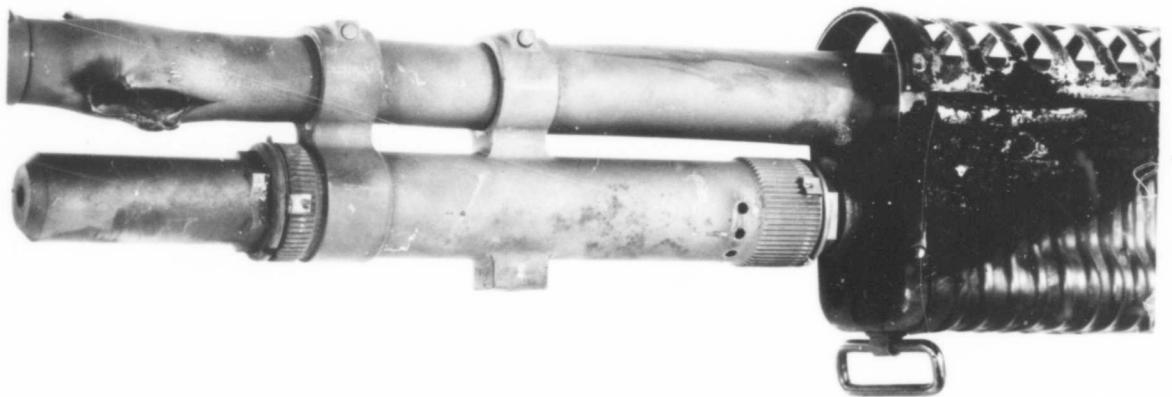
B5532 CONFIDENTIAL § ABERDEEN PROVING GROUND §

- (1) Gun serial number 17 was fired a total of 3574 rounds at a rate of 125 rounds per minute when a bullet went through the side of the barrel.
- (2) Gun serial number 19 was fired a total of 1699 rounds at a rate of 250 rounds per minute when a bullet went through the side of the barrel.

Project No. TS2-2020. Gun, Machine, Light, Caliber .30, T161E2.
Barrel damaged in firing 1699 rounds at a rate of 250 rounds per
minute.

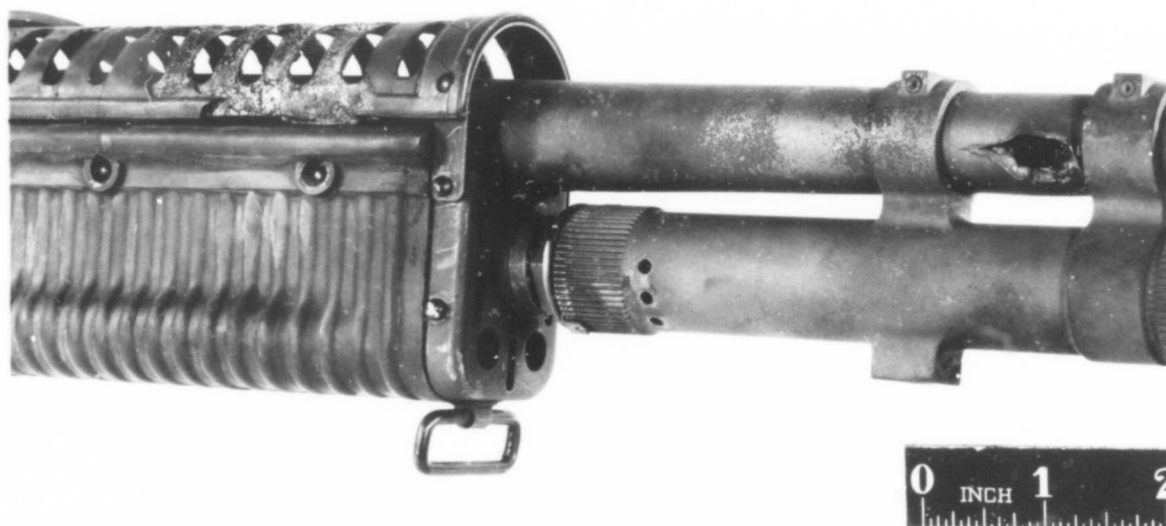
B5531 CONFIDENTIAL 8 ABERDEEN PROVING GROUND 8 5 January 1955

8. Photographs showing the barrels and other parts which failed in the barrel-performance tests are attached as Appendix C. The barrel on gun number 17 was inspected after the barrel-performance test. The barrel had a series of deformations starting in the liner a few inches forward of the chamber which indicate that the bullets were deflected from side to side as they passed down the bore. This condition apparently became worse as the test progressed until the point of a bullet dug into the left side of the barrel sufficiently to cause it to spin and pass through the right-hand side of the barrel.

Project No. TS2-2023. Gun, Machine, Light, Caliber .30, T161E2.
Barrel damaged in firing 3574 rounds at a rate of 125 rounds per
minute.

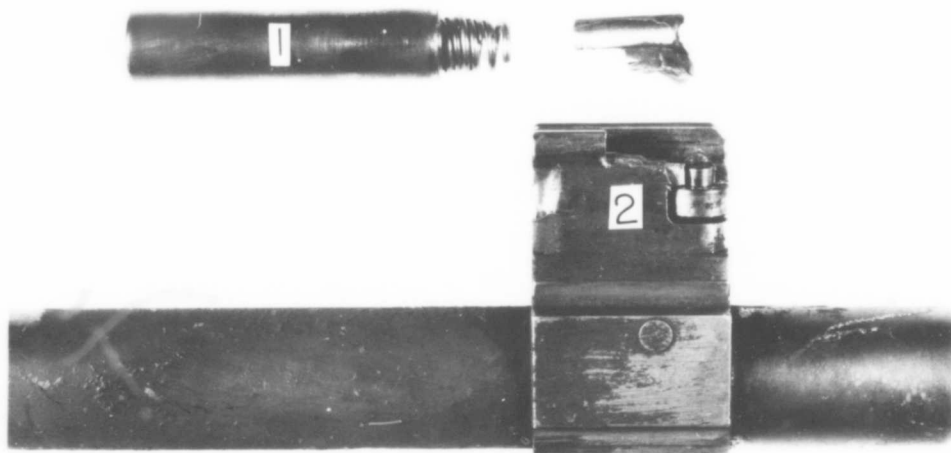
- (3) Gun serial number 17 was placed in good operating condition and fired a total of 3679 rounds at a rate of 125 rounds per minute when a stoppage occurred in which the bolt could not be retracted in a normal manner because of a broken operating rod yoke. The gun was abandoned because of the possibility of danger to the gunner. The barrel was bent downward to cause a change of 12.1 inches in the center of impact at 100 yards.

B6437 ~~CONFIDENTIAL~~ ABERDEEN PROVING GROUND 15 February 1955
Project No. TS2-2023. Gun, Machine, Light, Caliber .30, T161E2.
Parts from gun, serial number 17, which broke in firing a barrel-
performance test are (1) firing pin spring and (2) operating rod
yoke.

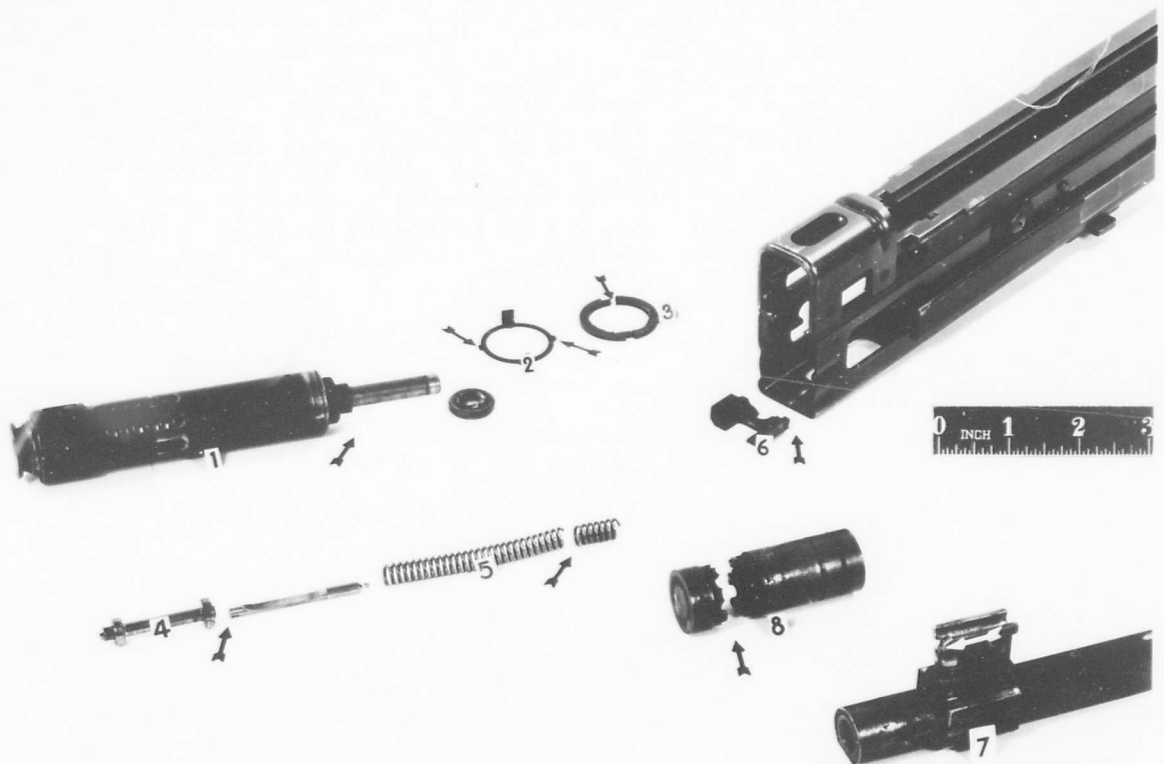
Gun disassembled and inspected.
 Bolt group very difficult to retract.
 Operating rod yoke broken.
 Firing pin broken.
 Firing pin spring broken.
 Lower rail in receiver broken.
 Front gas cylinder nut washer broken.
 Lugs on front gas cylinder nut lock broken off.
 Piston broken and was forced out.
 Barrel bent downward.
 Considerable deformation of liner.
 Free length of operating rod spring, 22.9 in.
 There was a large amount of fouling in the mechanism.
 Bore inspected with a borescope.
 Heavy deposit of metal fouling, especially in forward section of bore.
 Recess between liner and main bore filled with metal fouling.
 Bore eroded badly ahead of gas port.

B6438 ~~CONFIDENTIAL~~ 8 ABERDEEN PROVING GROUND 8 15 February 1955
Project No. TS2-2023. Gun, Machine, Light, Caliber .30, T161E2.
Parts from gun, serial number 19, which broke in firing a barrel-
performance test are (1) buffer cap, (2) gas cylinder nut lock,
(3) gas cylinder nut washer, (4) firing pin, (5) firing pin spring,
(6) lower rail, (7) operating rod yoke and (8) piston.
