HUGHES TOOL COMPANY · AIRCRAFT DAVISION: Culver City, California

BEST AVAILABLE COPY Report No. HTC-AD 64-10

#### Final Report

#### 20MM MARK 4 GUN POD 250,000 ROUND RELIABILITY IMPROVEMENT PROGRAM

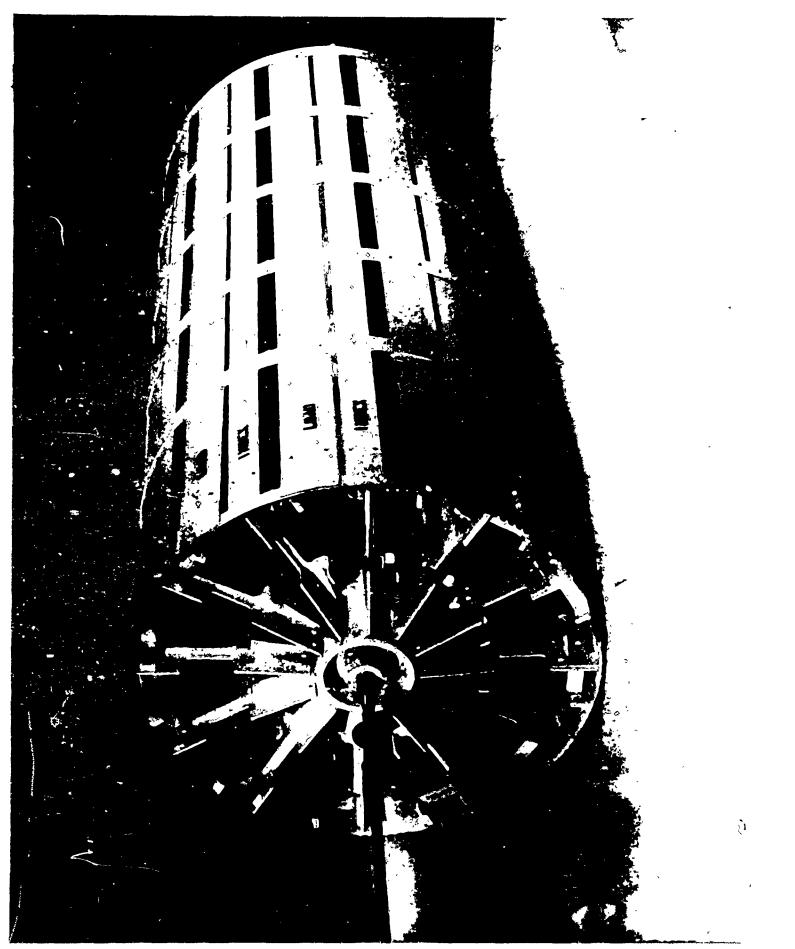
Figure 14. Ammunition Magazine Assembly

Figure 14 shows the magazine, which was simplified by using aluminum extrusions in the magazine dividers and the front end stiffened to decrease wear and improve loading characteristics.

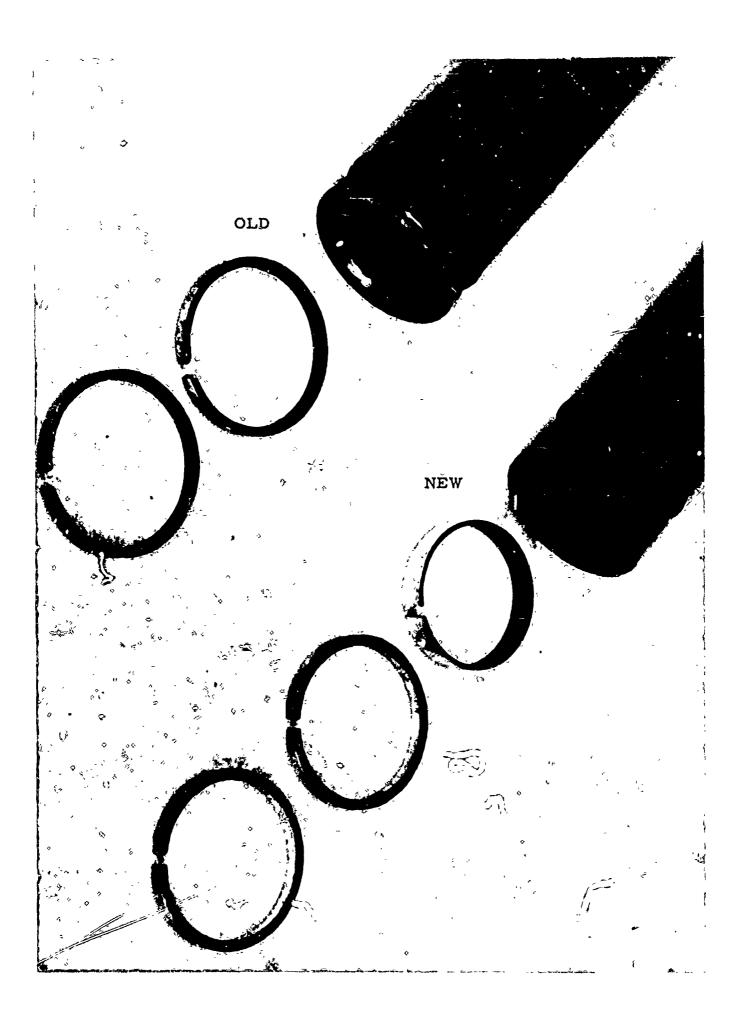
Figure 33. Rammer Piston and Ring Configuration

The increased heat in long burst firing caused the end of the ram piston to fail in both bearing and shear due to the low yield strength of the material at elevated temperatures. The end of the piston went out of round, and the piston ring groove was narrowed by bearing failure, causing the rings to stick in the grooves. A change of material to high strength maraging steel helped, but did not solve the problem. The piston ring groove was then moved back to increase

the bearing area of the piston, and also remove the groove from the point of load application. Figure 33 shows a comparison of the old and new ram piston. This change has proven satisfactory thus far and tests will continue with this configuration.
