24p-0.75⁷ - NRL Memorandum Report 1524

FRACTURE ANALYSIS OF A C-141 LANDING GEAR CYLINDER

C. D. BEACHEM

METALLURGY DIVISION

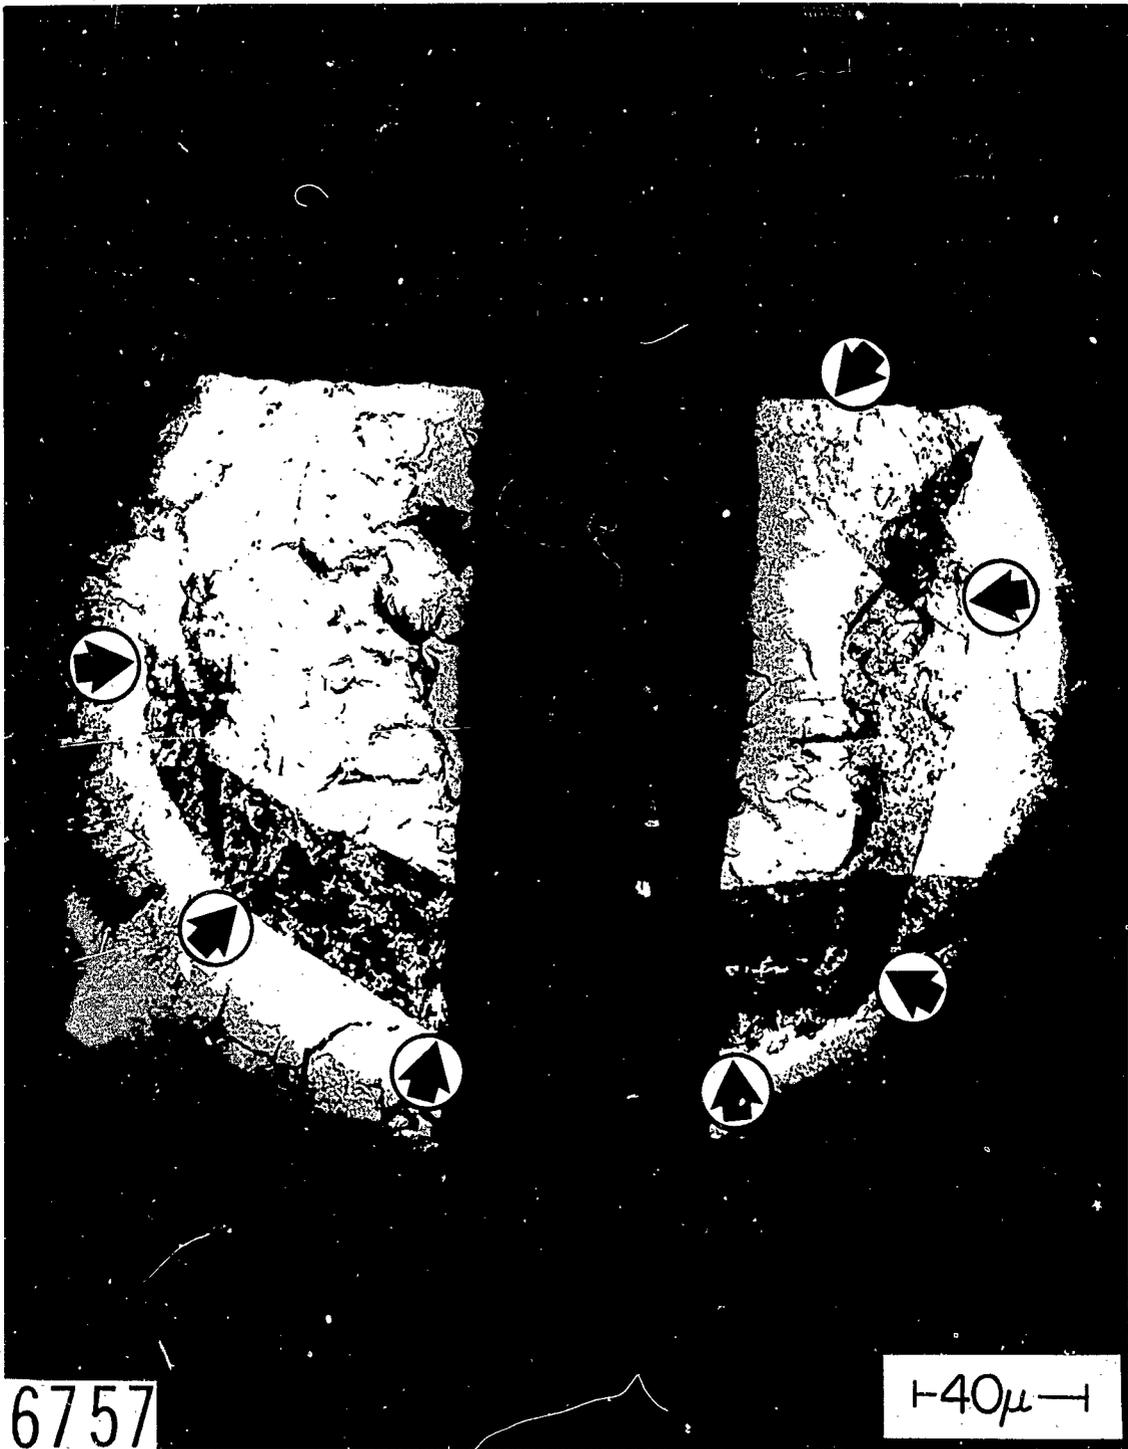
except for the small isolated patches of completely intergranular fracture in the macroscopically flat bottoms of holes and tops of "mesas" shown at low magnification in Fig. 3 and at high magnification in Fig. 11. Fig. 12 is a low magnification electron fractograph showing the collapsed sides of a "mesa". (Large elevation changes in replicas like these collapse due to the surface tension of the acetone when the replicas are placed onto grids and removed from the acetone.)

Fig. 12 - Collapsed replica (arrows) showing large and sudden elevation change between the plane of the major fracture and one of the truncated hills or one of the flat-bottomed holes. Two-stage carbon replica. 630 X.
