Technical Note N-607

EARTHQUAKE DAMAGE TO ANCHORAGE

AREA UTILITIES - MARCH 1964

26 June 1964

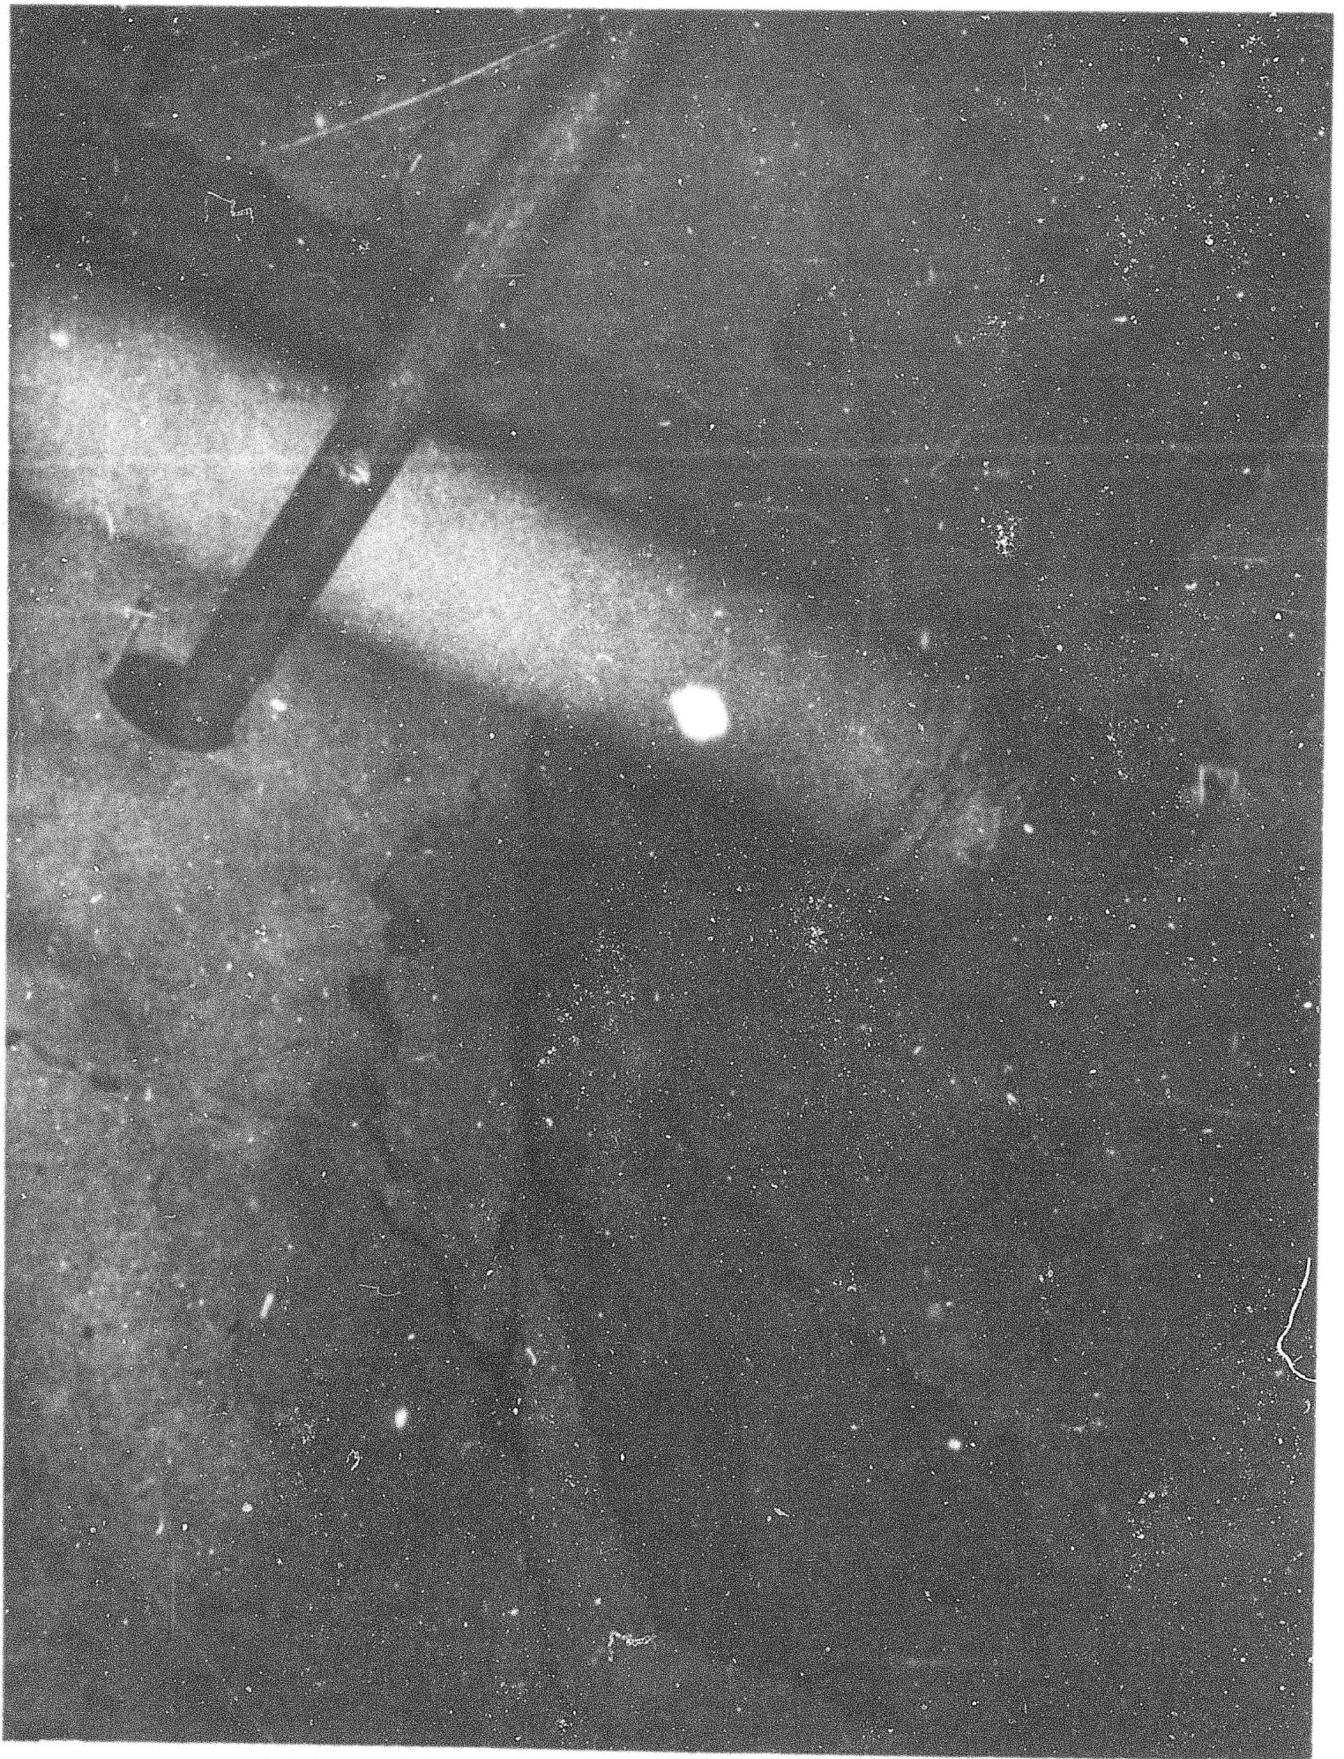
The pipes shown in Figure 24 are located in the same room as the one in Figure 23, but no breaks occurred in these pipes because they had adequate freedom of movement. As shown previously in Figure 10 a piping system designed with swing joints which allow it to move relative to the building can sustain a lot of motion without damage. Probably the most serious damage was sustained by the elevators where the counterweights pounded against their guides as they did at the Elmendorf Air Force Base Hospital.

Figure 24. Undamaged pipes in Hill Building (large displacement).

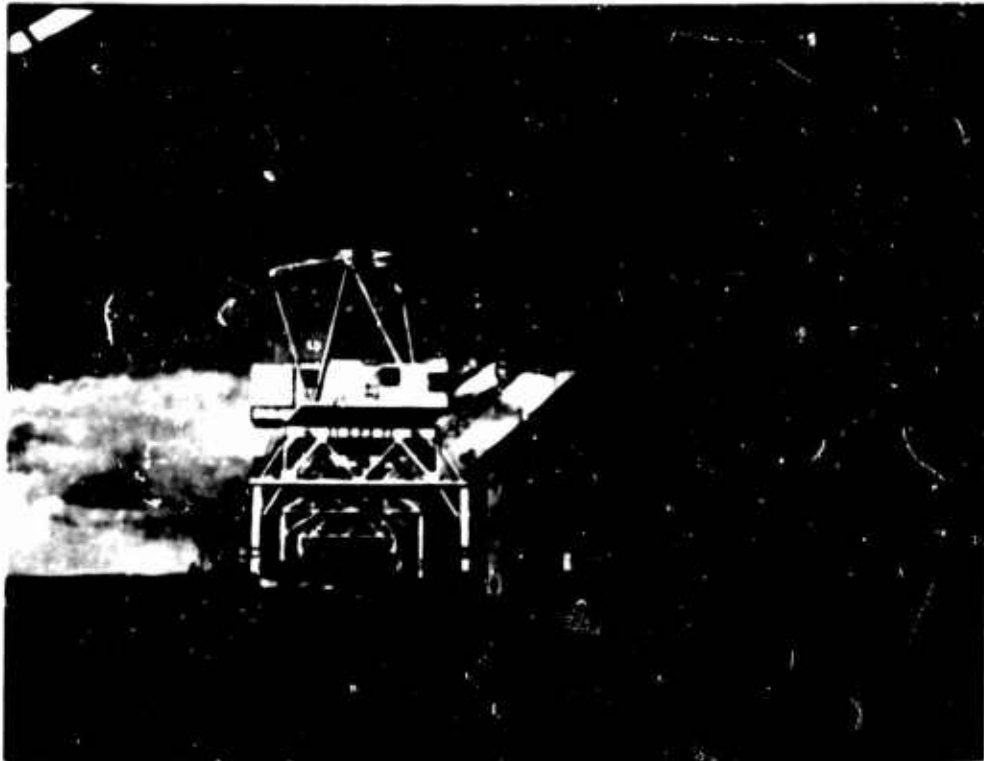
At the Port of Anchorage were five gantry cranes (Figure 37) whose counterweights were set in motion by the earthquake. As a result of this motion the counterweight arms were twisted and broken and two of the 50-ton weights fell into the water and sank in the mud. The city port dock, built with steel piles, suffered very little damage (Figure 38), however the army dock nearby built with wooden piles was put out of service (Figure 39).

Figure 37 Dock cranes at the Port of Anchorage with counterweights in place.
