UNDER-WATER CORROSION

USS FISKE (DD-842)

Lab. Project 9400-34, Technical Memorandum 3

2 SEP 1964

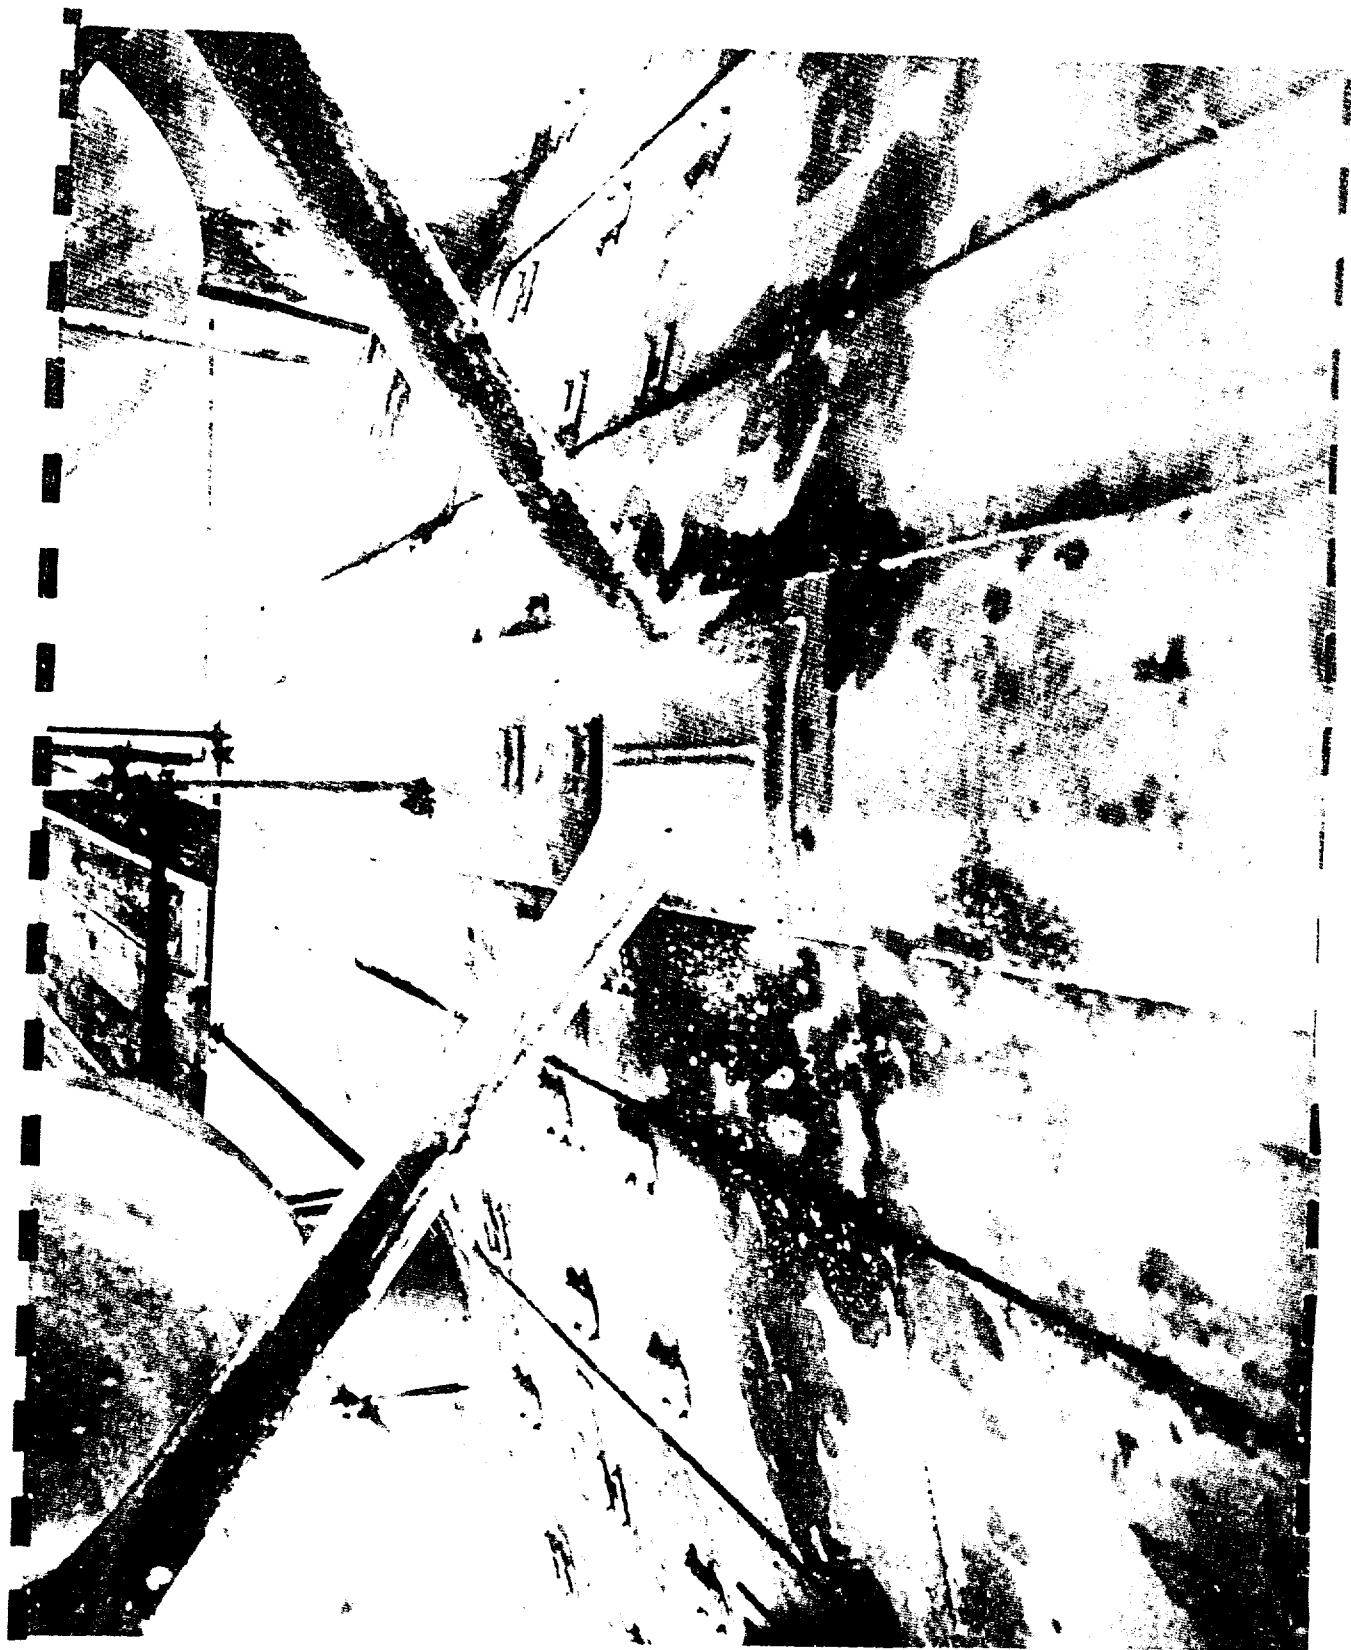
FIGURE 1

2. Principal hull corrosion was found at stern areas and bilge keel vicinity. The ship had been initially equipped with thirty-two zinc anodes at the stern. Of these, nineteen remained, but were heavily encrusted with corrosion products. Paint had stripped in areas immediately adjacent to the zincs, but in most cases rust was not evident. Figure(1) shows the distribution and appearance of the zincs; location of the missing zincs is indicated by steel straps.

USS FISKE (DD-842), Stern Area

Showing Hull Mounted Zinc Anodes

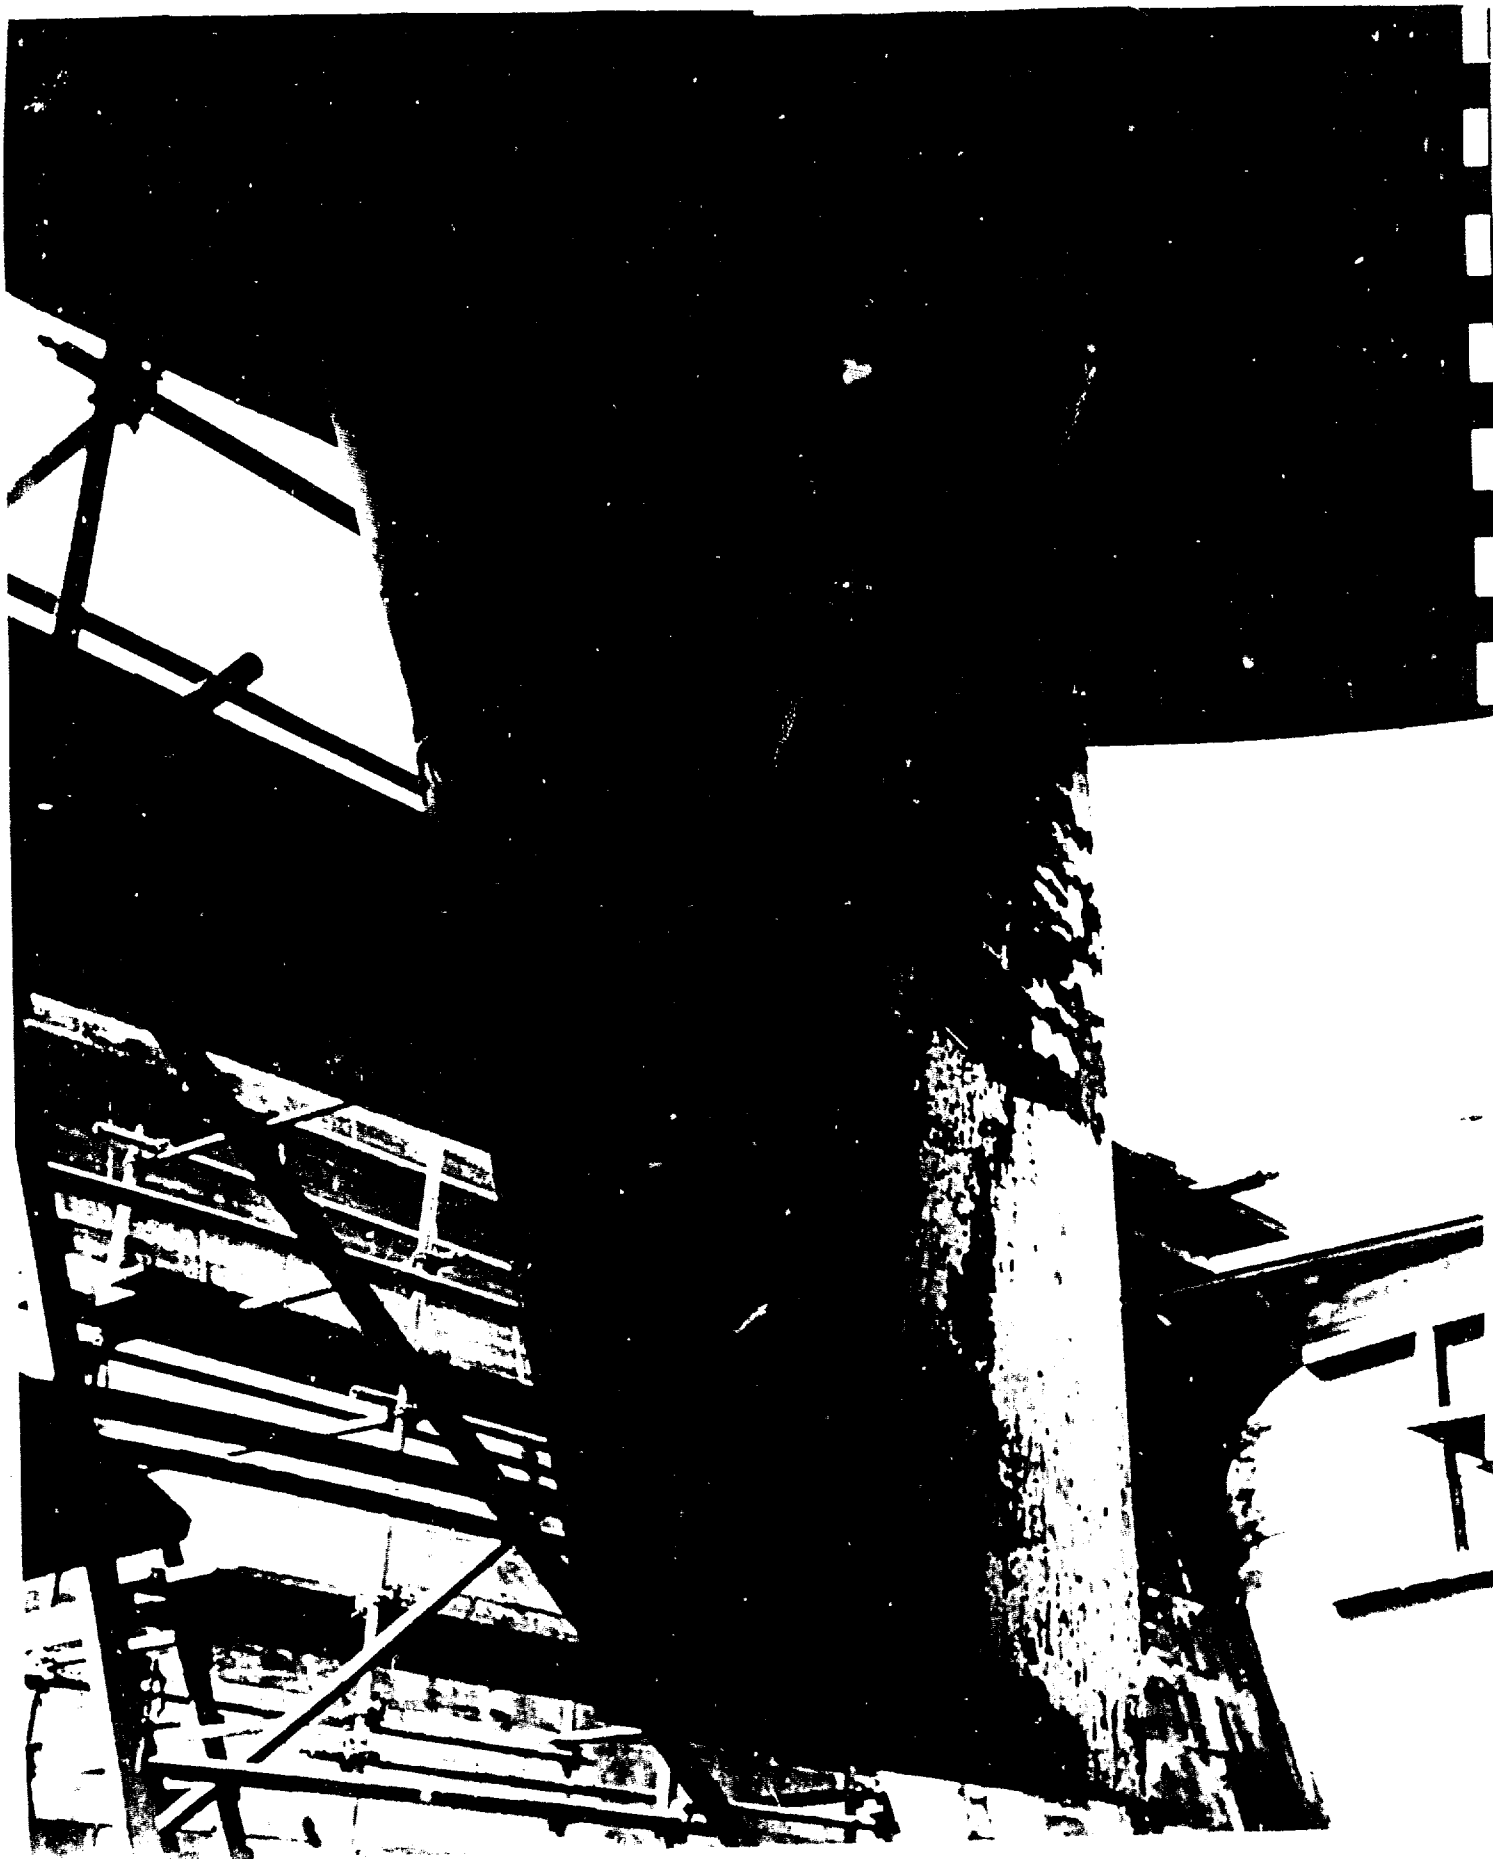
FIGURE 2

3. Rudder - Paint was not evident on about 2/3 of the rudder area, as illustrated in Figure (2). The greatest extent of rudder corrosion was found in the vicinity of the aft end of the rudder skegs (both inboard and outboard); pits and striations up to

USS FISKE (DD-842), Starboard Rudder,

Inboard

6. The following measures are recommended for minimizing corrosion of rudder skeg and adjacent rudder areas:

a. Ground rudder to the hull, preferably from the top of the rudder stock.

b. Modify reference (b) to permit attachment of faired zinc anodes to the rudder skegs, in vicinity of the pintles. Fairing may be accomplished with a suitable hull-smoothing compound.
