OPERATION PLUMBBOB

Project 30.6

TEST OF FRENCH UNDERGROUND
PERSONNEL SHELTERS

TEST OF FRENCH UNDERGROUND PERSONNEL SHELTERS

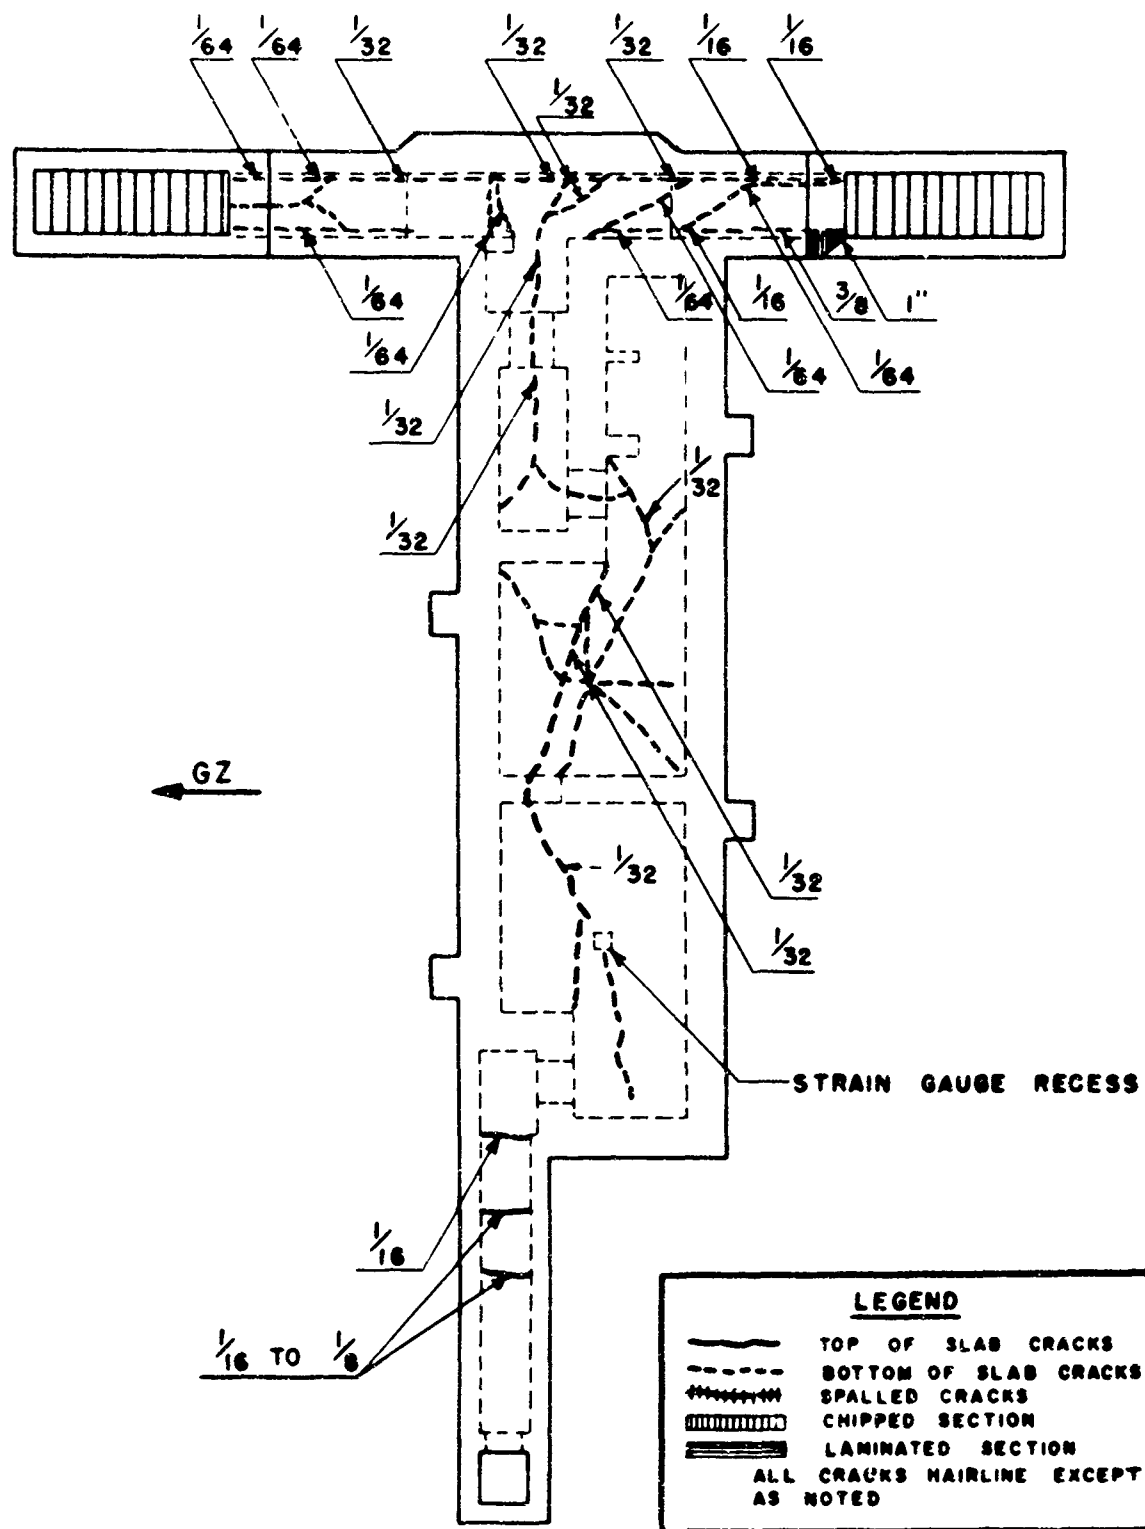
The forward room of the structure has a $\frac{1}{32}$ -in. crack in the roof slab leading from the interior corner of the antechamber to a point near the top of the center of the lintel beam over the opening in the main-chamber partition. The crack is also present in the lintel beam. Diagonal hairline cracks start at the center of the roof slab and run toward the corners of the slab. The walls of the forward room are not damaged. The floor slab has a $\frac{1}{64}$ -in. crack that starts at a point located at the front of the ventilating room and runs to the center of the room where a box-shaped crack has been formed around the survey point X-13. It then continues to the center of the opening in the main partition.

In the rear room of the main chamber, the $\frac{1}{32}$ -in. crack in the roof slab of the forward room continues past the lintel beam and ends at a strain-gauge recess located in the center of the roof slab. Hairline cracks lead from the recess and run toward the rear walls of the structure. The $\frac{1}{64}$ -in. crack in the floor slab of the forward room continues past the opening toward the center of the room. This crack intersects another $\frac{1}{64}$ -in. crack that begins at a concrete deformer gauge mount and runs toward the rear of the structure. There is a $\frac{1}{64}$ -in.-wide crack that connects the two concrete deformer mounts near the front of the rear room.

Fig. 3.1—Roof-slab crack pattern, structure II-1.

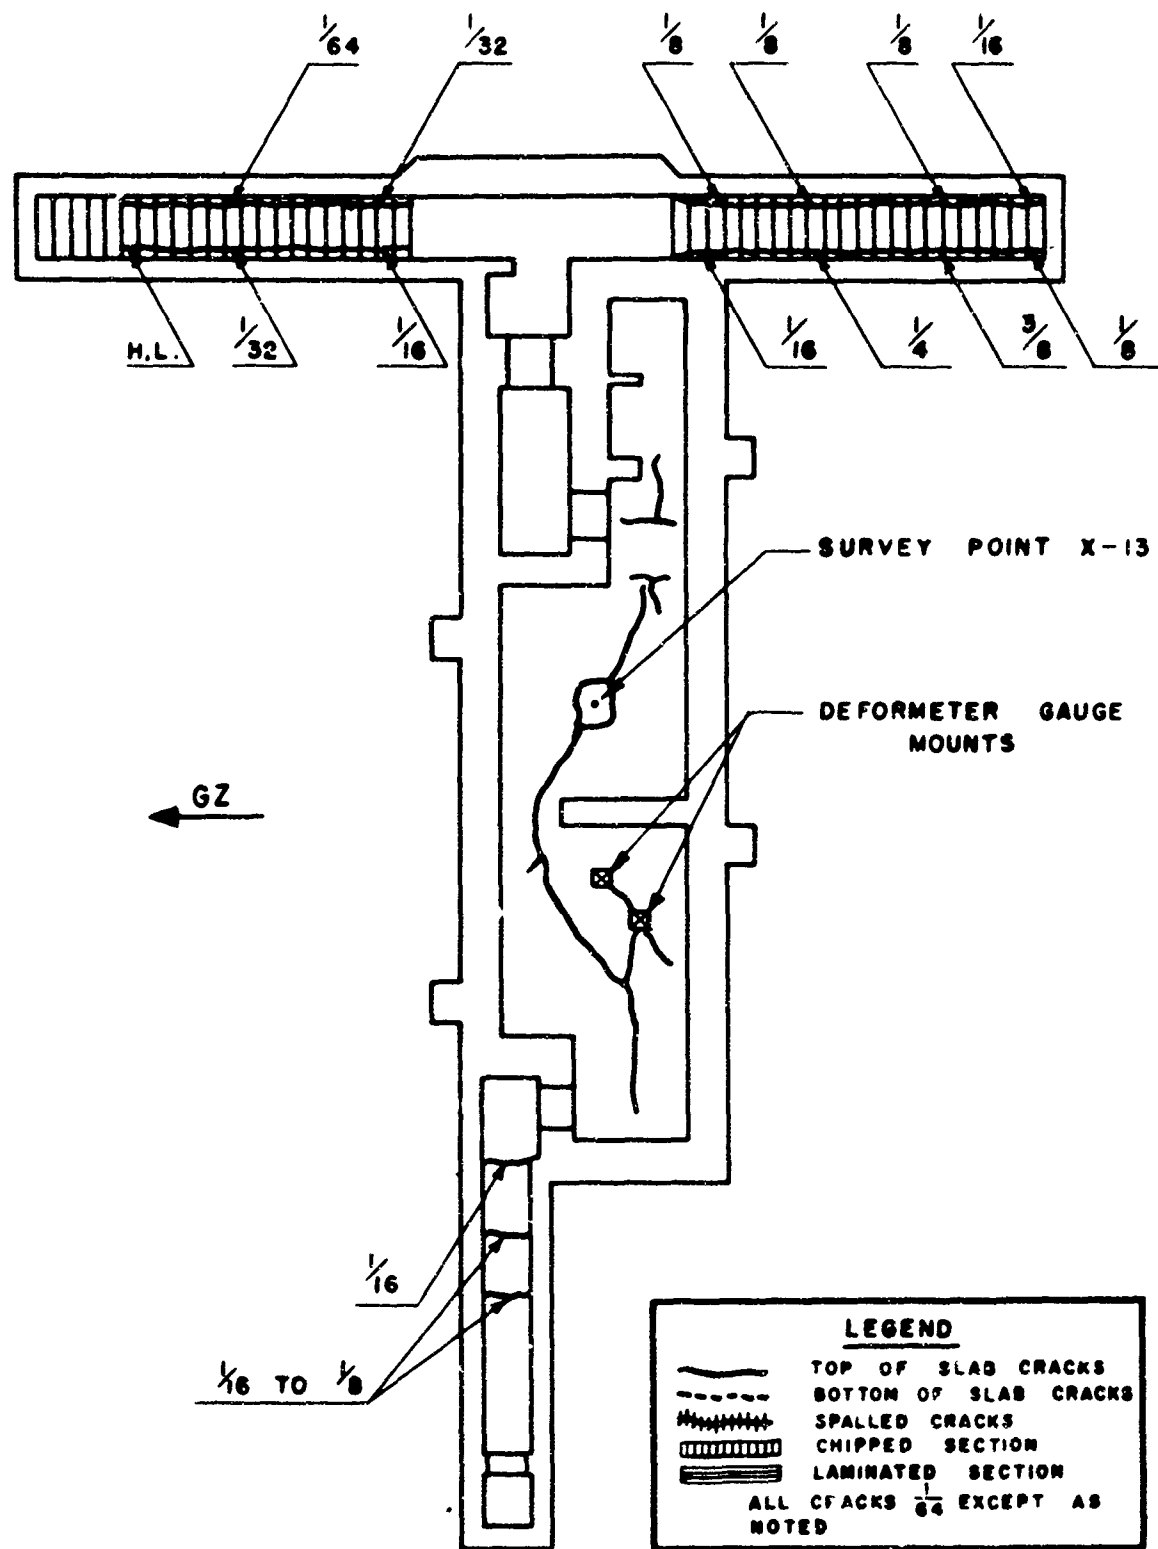
Fig. 3.2—Floor-slab crack pattern, structure II-1.

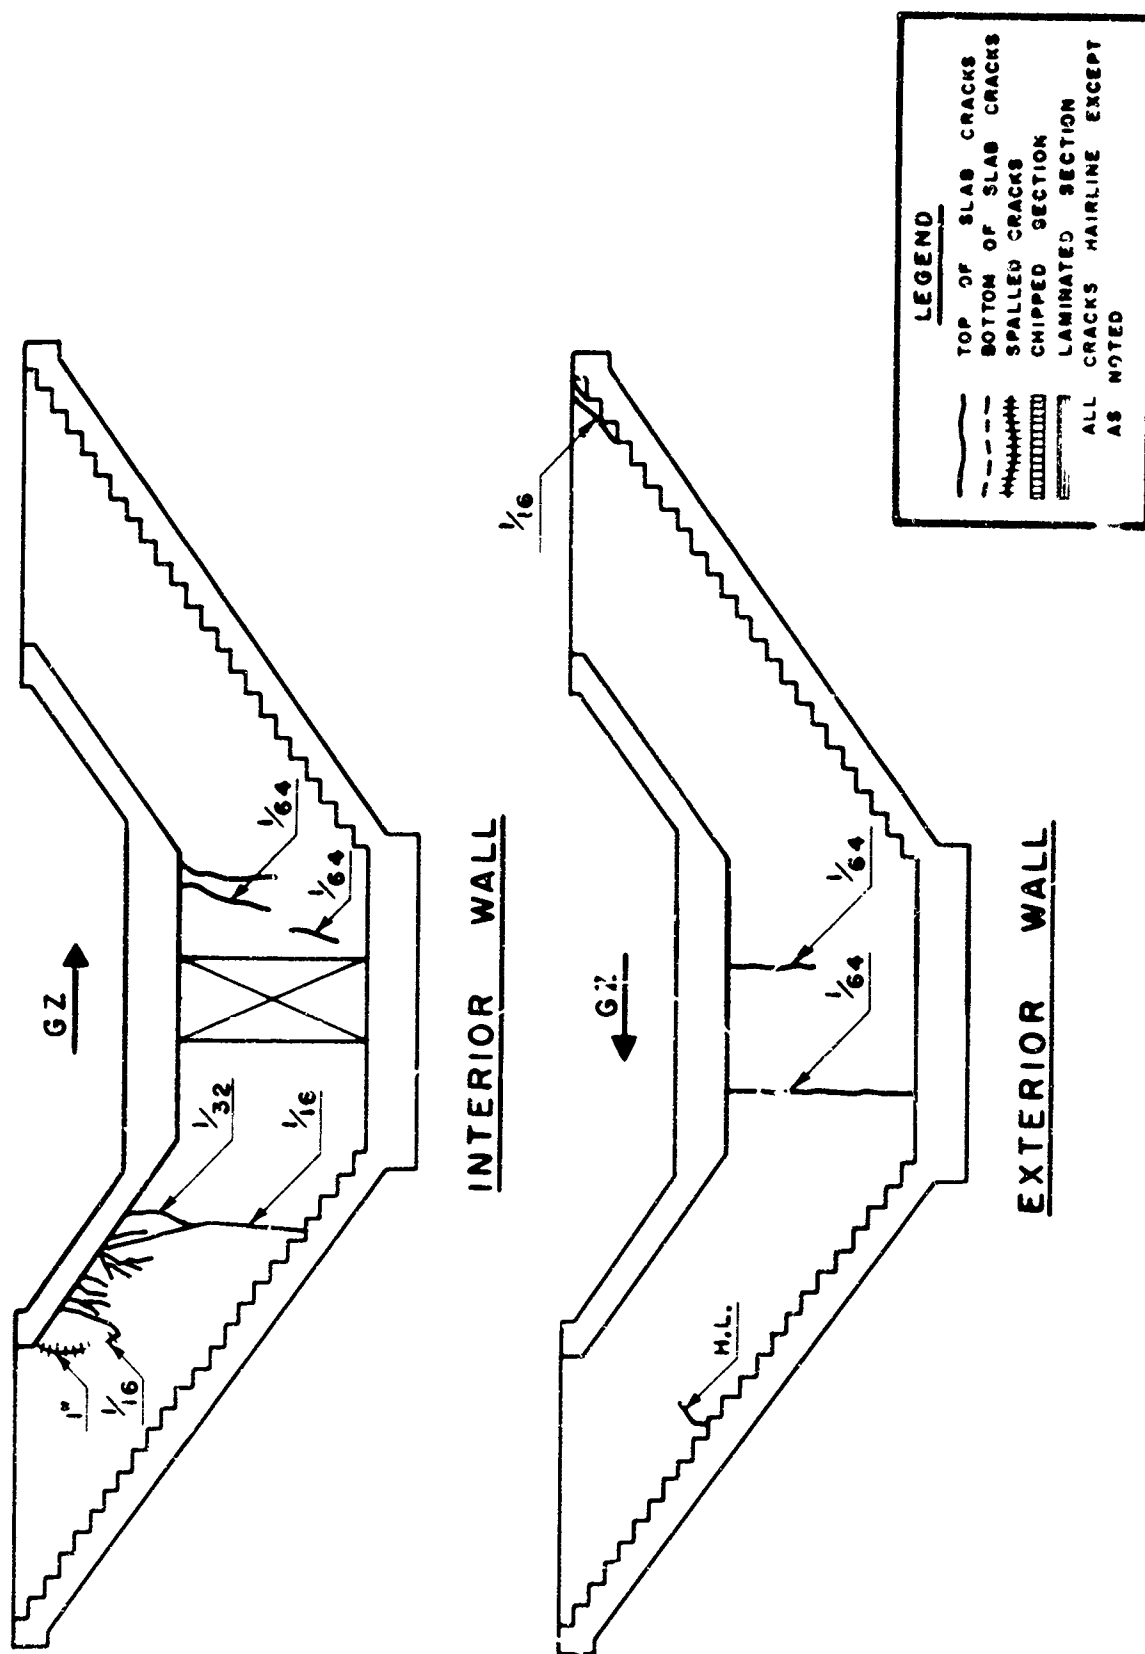
(a) *Entranceways.* In the entrance facing GZ a $\frac{1}{64}$ -in. crack occurred along the intersection of the roof slab and the interior wall. At the intersection of the exterior wall and the slab, the separation varies from $\frac{1}{64}$ in. at the top to $\frac{1}{32}$ in. at the bottom of the sloped portion of the slab. One hairline crack starts at the top of the roof slab and runs along the center line for about two-thirds of the sloped portion of the slab, at which point the crack branches off into two sections, one section leading to each wall. The stairs are separated from the interior wall by a crack that varies from hairline in size at the sixth riser from the top to $\frac{1}{16}$ in. at the bottom tread. The exterior wall is separated from the stairs by a similar crack, except that its size at the bottom tread is $\frac{1}{32}$ in. One hairline crack in the exterior wall is located at the eleventh riser from the top.

The landing roof slab has a $\frac{1}{32}$ -in. crack along its intersection with the exterior wall. A $\frac{1}{32}$ -in. transverse crack was observed to start at a point directly over the center of the blast door and continue out to a point located along the center-line of the landing; at this point the crack divides into two $\frac{1}{32}$ -in. cracks, which continue across the slab to the exterior wall. At the corner of the opening in the interior wall, a diagonal crack starts and runs to the exterior wall near the sloped portion of the roof slab over the entrance away from GZ. Two $\frac{1}{64}$ -in. transverse cracks are located at the GZ side of this opening. These cracks run the width of the landing. The interior wall has several vertical $\frac{1}{64}$ -in. cracks located on the GZ side of the door opening. Two vertical $\frac{1}{64}$ -in. cracks were observed in the exterior wall above the landing.

At the intersection of the roof slab and both walls on the side away from GZ, cracks were found varying in size from $\frac{1}{32}$ to $\frac{1}{16}$ and $\frac{1}{16}$ to 1 in. in width for the exterior and interior walls, respectively. There is a diagonal $\frac{1}{64}$ -in. separation starting at the bottom of the sloped portion of the roof near the interior wall and continuing to the top of the slab at the exterior wall. The intersection of the interior wall and the stairs has a crack that is $\frac{1}{16}$ -in. in width near the lower tread, increasing to $\frac{3}{8}$ in. at the seventh riser from the top, and decreasing again to $\frac{1}{8}$ in. near the top of the stairs. The crack along the exterior wall and the stairs is $\frac{1}{8}$ in. for three-quarters the height of the stairs; it decreases to $\frac{1}{16}$ in. at the second riser from the top. The interior wall of this entrance has a crack that starts at the intersection of the top of the roof slab and the wall and runs vertically downward toward the stairs. This crack is 1 in. in size at the roof and $\frac{1}{16}$ in. at its terminal point located approximately at the mid-height of the wall. Spalling is evident along the entire length of the crack. A $\frac{1}{16}$ -in. vertical crack was formed above the fourth tread from the bottom; it runs the full height of the wall. Several vertical hairline cracks are located near the roof slab. The exterior wall has a $\frac{1}{16}$ -in. crack located near the top four risers of the stairs.

Fig. 3.3—Entrance crack pattern, structure II-1.

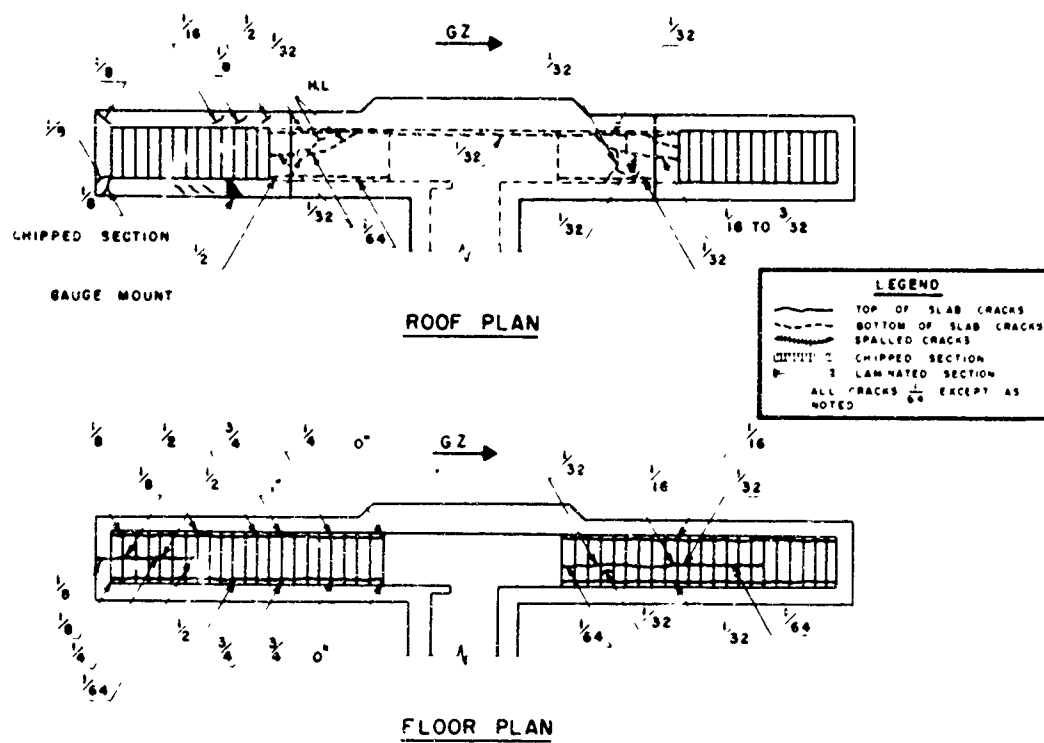
Fig. 3.46 — Entrance crack pattern, structure II-3.

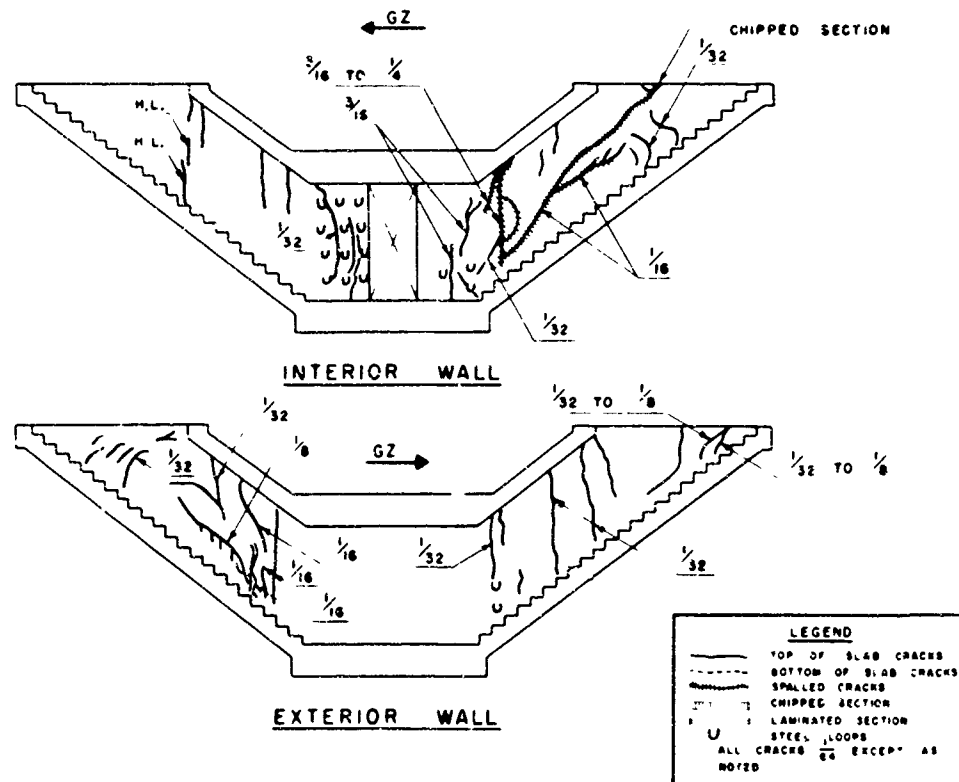
Fig. 3.47 — Entrance crack pattern, structure II-3.

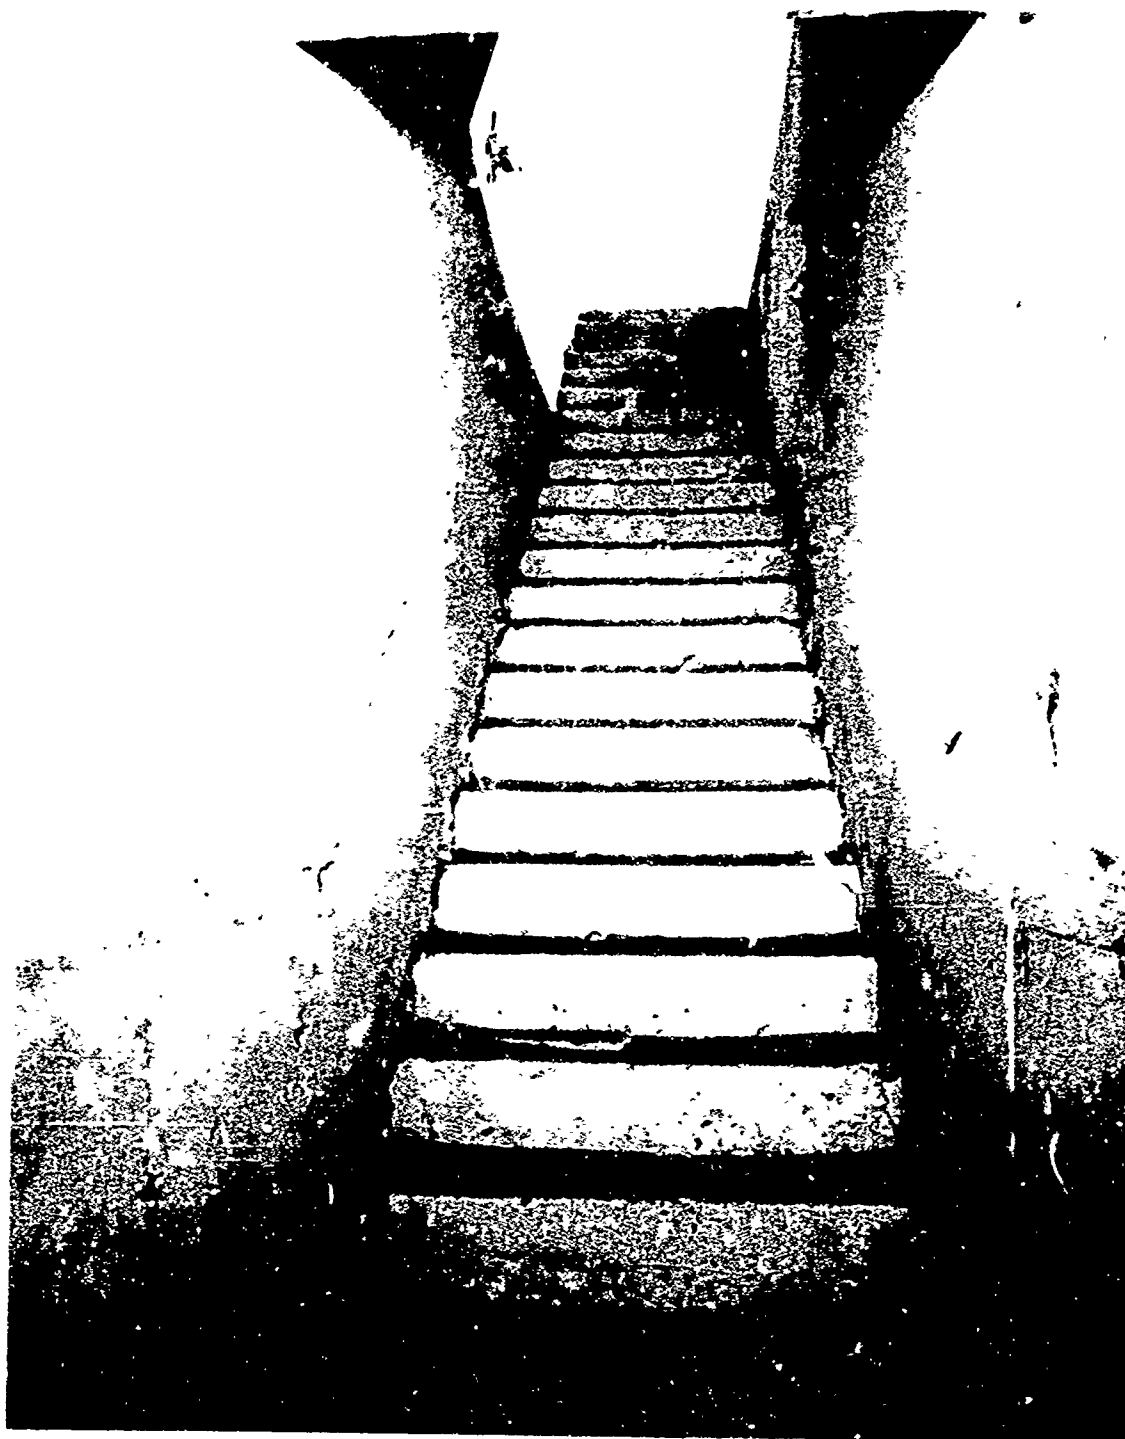
Fig. 3.56— Blast debris deposited on stairs of entrance facing away from GZ.

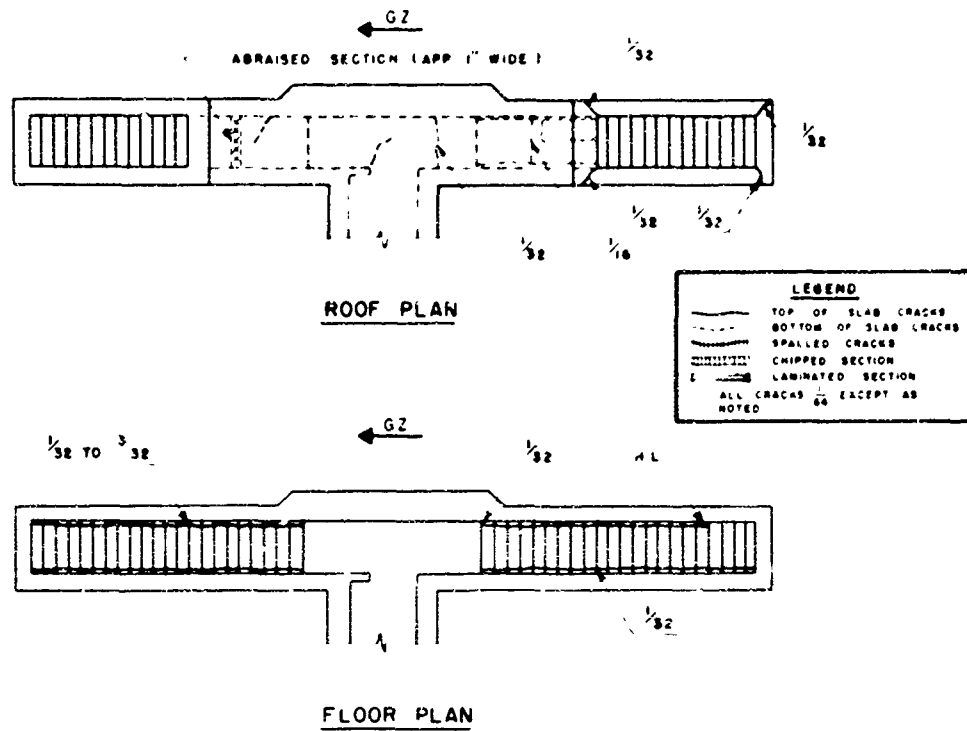
Fig. 3.57—Entrance crack pattern, structure II-4.

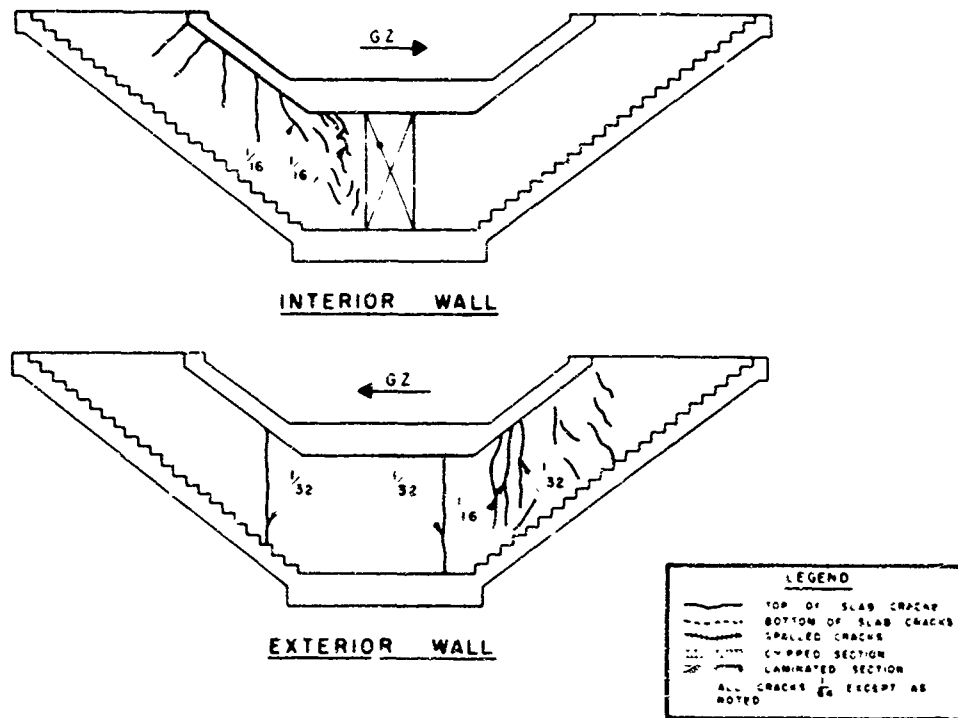
Fig. 3.53—Entrance crack pattern, structure II-4.

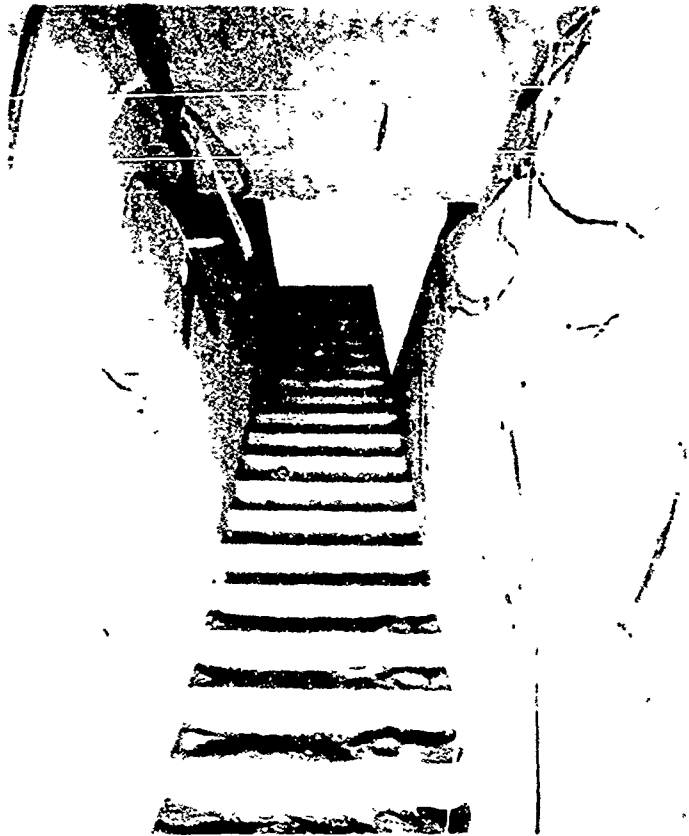
Fig. 3.65—Blast debris and damage to lower portion of entrance facing structures II-3 and II-4.
