# Operation TEAPOT

Projects 36.1 and 36.2

EXPOSURE OF MOBILE HOMES AND EMERGENCY  
VEHICLES TO NUCLEAR EXPLOSIONS

**EXPOSURE OF MOBILE HOMES  
AND EMERGENCY VEHICLES  
TO NUCLEAR EXPLOSIONS**

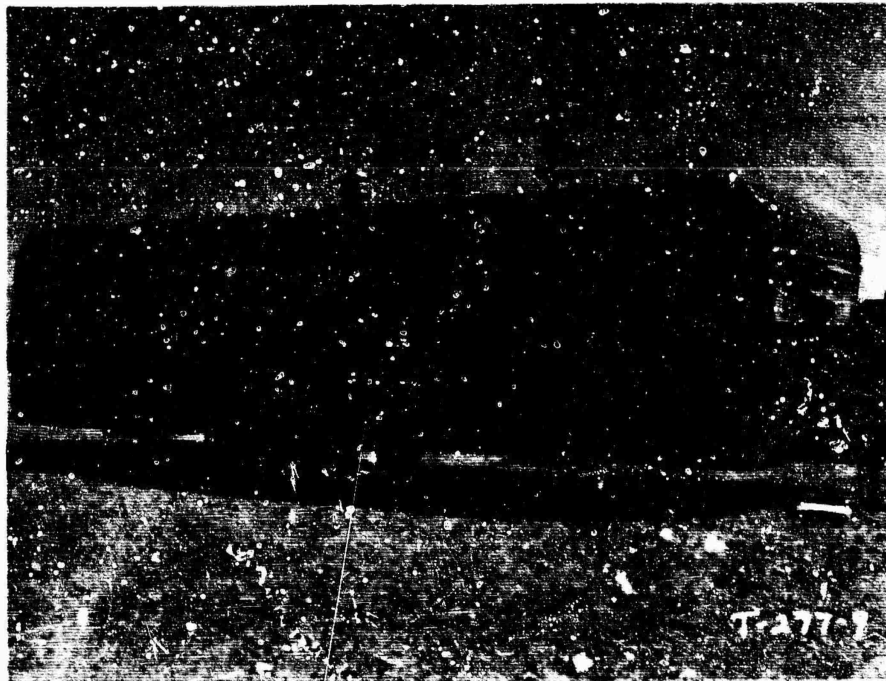
**Exterior:** Right side dished in; back end dished in; no ruptures on exterior; taillight off; trailer moved forward 12 in.; bent jack stem; front door dished in; no separation of floor and sidewalls. (See Fig. 2.6.)

Fig. 2.6—Exterior of Vagabond trailer after the blast.

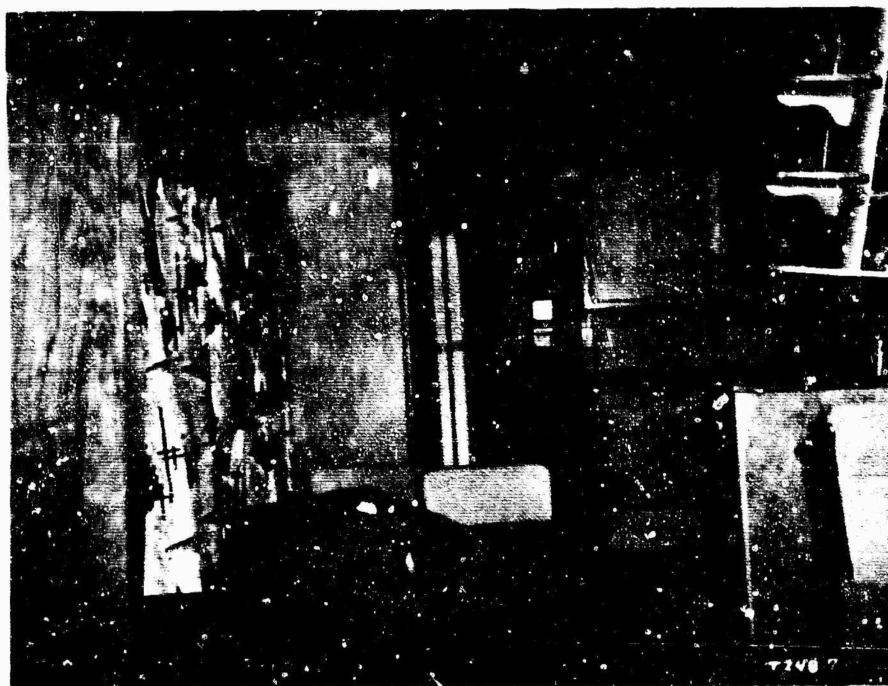
**Interior:** Ceiling bulged in slightly; front-door jamb inside torn loose; front overhead mirror broken; screen-door panel torn loose; galley overhead cabinet over stove torn loose; cornice box on left side of living room off; very little window glass inside; venetian blinds intact; no splits or ruptures in interior sidewalls; kitchen ceiling fixture hanging loose; rear windows, left front picture window, and left bedroom window broken; kitchen cabinets unhurt on both sides; sliding wardrobe door off; bathroom door off; lavatory off wall; all plumbing tight and operable; linen closet torn from bulkhead; rear bathroom bulkhead separated from floor; one tile off bathroom wall; rear wardrobe door off; rear panel molding off; light fixture in rear off; bathroom style off; light-fixture glass and mirror glass in bedroom broken; all side vents undamaged; stove, refrigerator, heater, divan, table and chairs, and beds unhurt. (See Fig. 2.7.)

Fig. 2.7—Interior of Vagabond trailer after the blast.

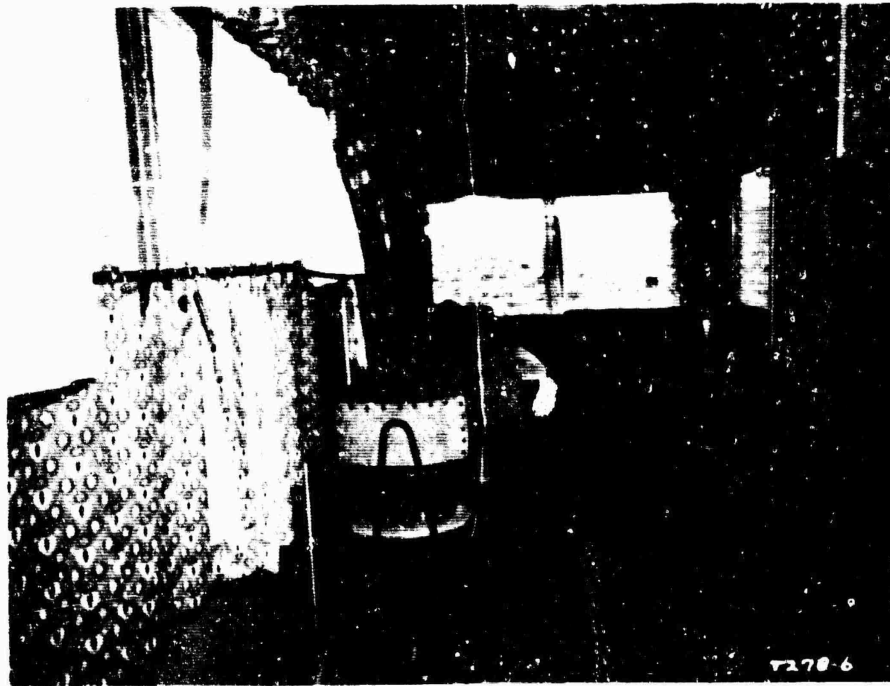
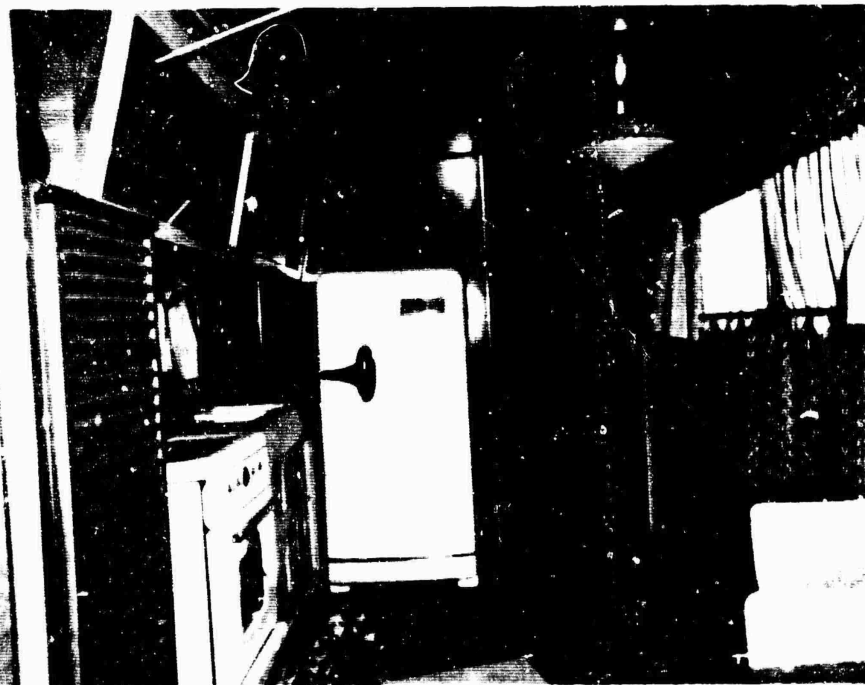
Interior: All doors of overhead cabinets in kitchen and living areas down; ceiling molding in kitchen down; kitchen overhead cabinets pulled from the ceiling and wall; front-wardrobe bulkhead dished in; fluorescent tube in kitchen broken (the only broken glass in the trailer); panel doors of sink cabinet out; thermostat loose on the wall; lavatory torn loose from wall in bathroom; toilet tank broken; all plumbing intact; front-bedroom bulkhead dished in; overhead cabinet upstairs loose from the ceiling; venetian blinds off; both upstairs and downstairs window frames pulled loose; three pieces of glass broken in jalousie windows and glass outside trailer; entrance-hall light hanging loose. (See Figs. 2.10 and 2.11.)

Fig. 2.10—Interior of Southwestern trailer after the blast.

Fig. 2.11—Interior of Southwestern trailer after the blast.

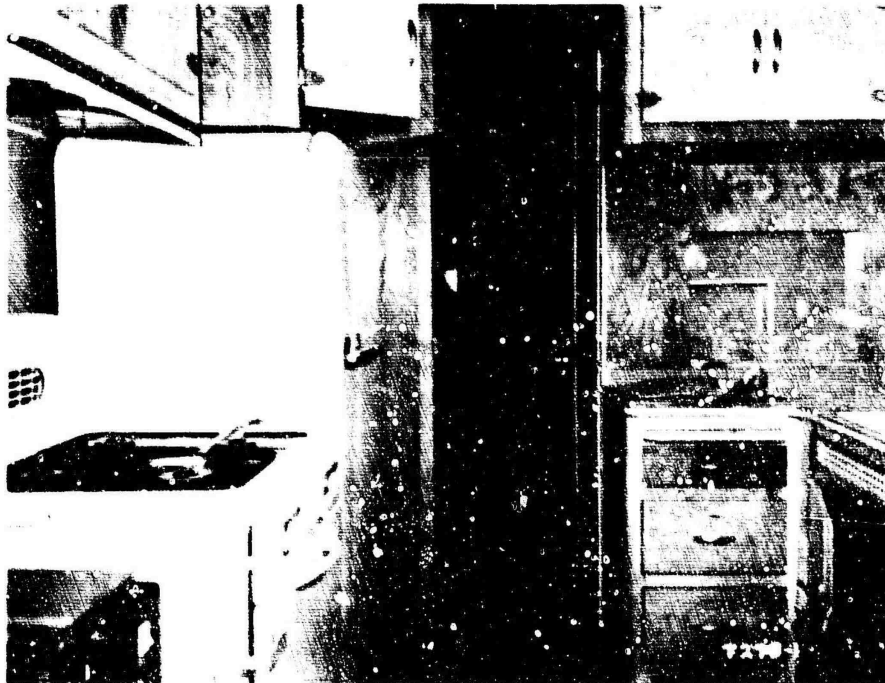
Interior: Style in center wardrobe broken; one piece of molding in living room bulged; heater door off; kitchen venetian blind off; left-side rear panel by window in bedroom split; lower right front window, lower kitchen window, and bedroom left-side window broken; no glass inside trailer. (See Figs. 2.14 and 2.15.)

Fig. 2.14—interior of Columbia trailer after the blast.

Fig. 2.15—Interior of Columbia trailer after the blast.

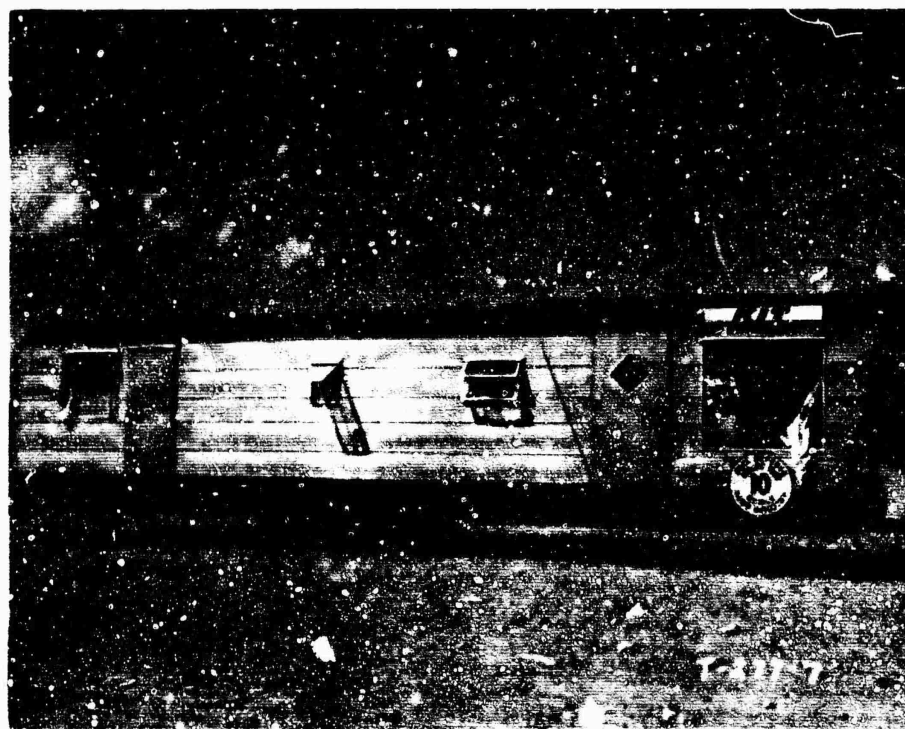
**Exterior:** Left lower panel partially out of channel; two panels on left lower side out of channel approximately 3 ft; overhang in front dished in; no rupture in roof; panel over left front window out of channel the length of the window; panels below taillight and below roof curve in rear out of channel. These panels out of channel could be easily and quickly repaired without tools. (See Fig. 2.17.)

Fig. 2.17—Exterior of Kit trailer at 10,500 ft after the blast.

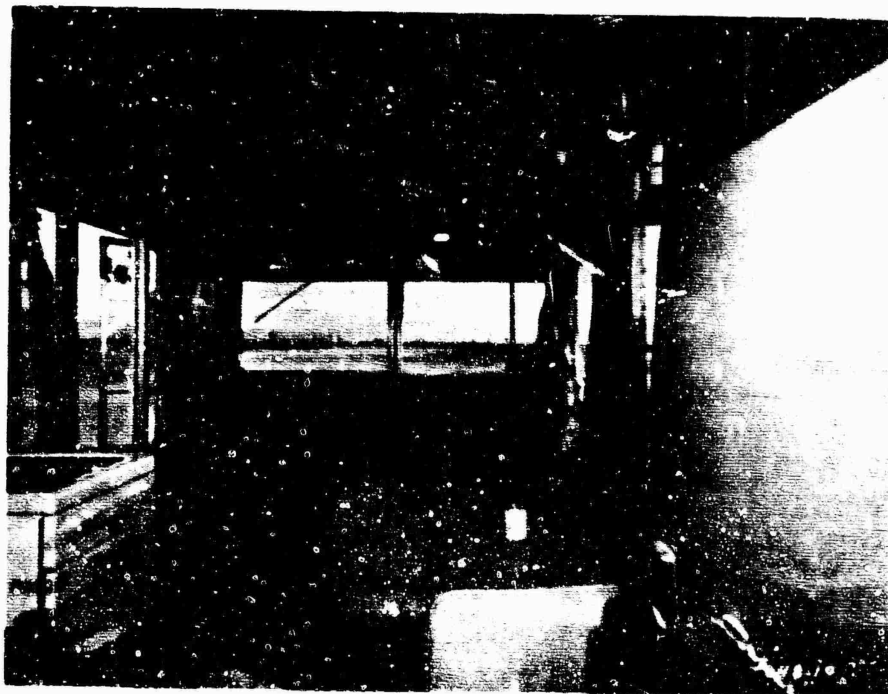
**Interior:** Interior ceiling panels by the front door split; front shelf above davenport torn loose; front panel bulged; mirror and cabinet separated; furniture disarranged; bathroom bulkhead bulged in; toilet tank broken; wardrobe bulkheads torn loose slightly; all light fixtures intact; stove moved about 2 in.; refrigerator, heater, divan, table and chairs, beds, and stove undamaged; 2 front picture windows, right front side picture window, left front side casement window, left kitchen picture window, center left lower and left rear windows, right rear lower window, and right dinette lower window were broken; mirror in bedroom off the wall, not broken. (See Figs. 2.18 and 2.19.)

Fig. 2.18—Interior of Kit trailer after the blast.

Fig. 2.19—Interior of Kit trailer after the blast.

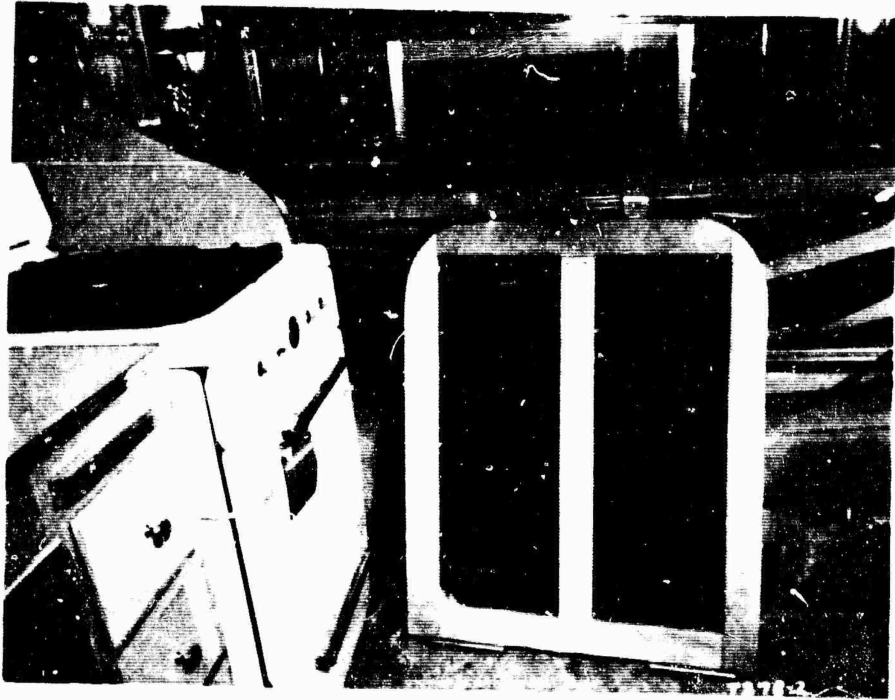
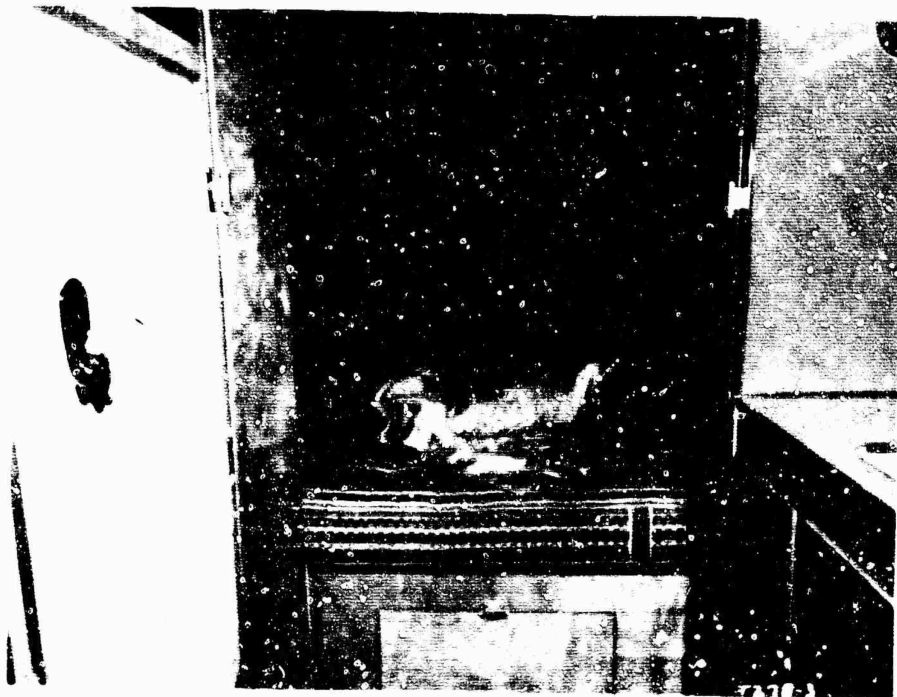
**Interior:** Dinette table down, with leg broken off; ceiling molding bulged down left front side; rear left bedroom venetian blind down; front left lower window cracked. (See Figs. 2.22 and 2.23.)

Fig. 2.22—Interior of Aljoa trailer after the blast.

Fig. 2.23—Interior of Aljoa trailer after the blast.

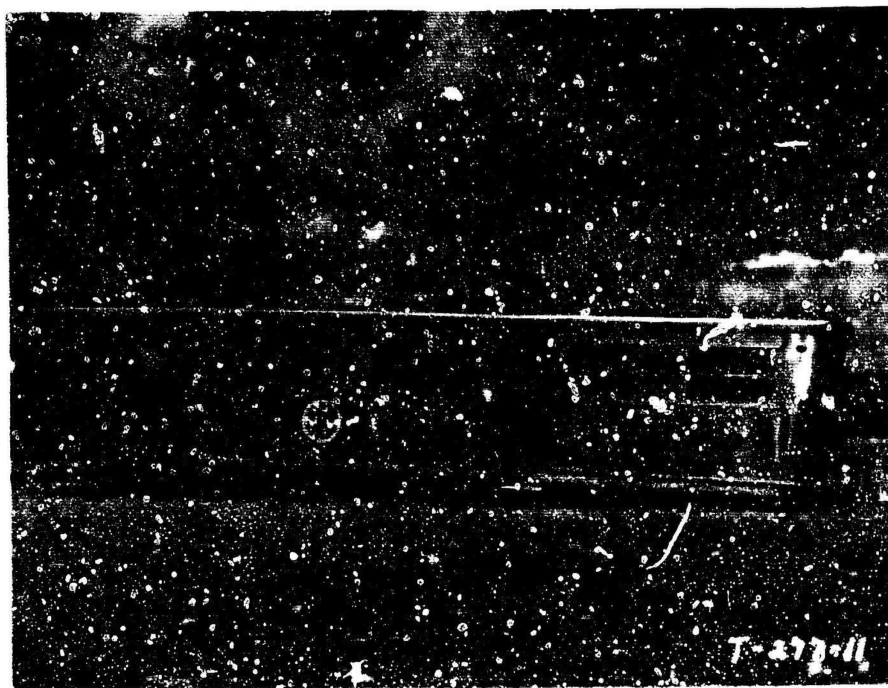
Fig. 2.25—Exterior of Spartan trailer at 10,500 ft after the blast.

Exterior: Front end dished in about 8 in.; left side dished in about 8 in. at living-room window; entire length of left side of trailer distorted; minor rupture of front roof, dented about 4 in.; no distortion of back and right side. (See Fig. 2.25.)

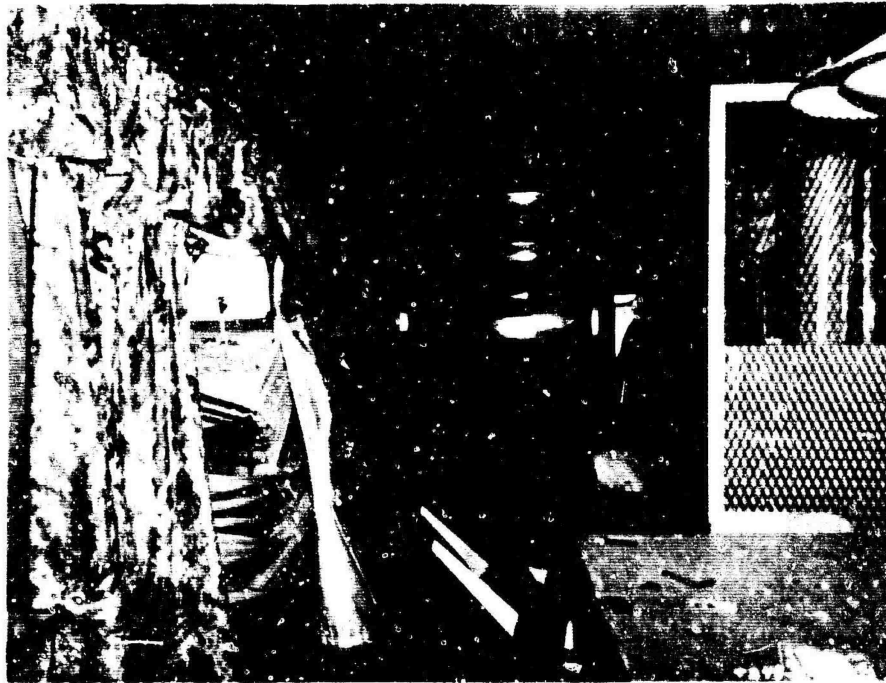
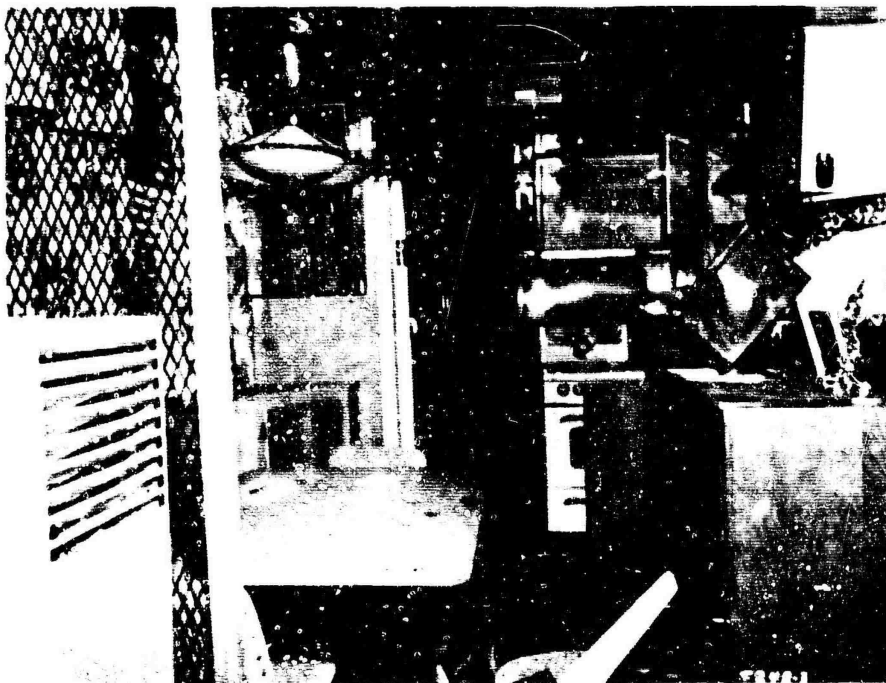
Interior: Front-bedroom left-side panel bulged in; front panels bulged in, some separation; living-room panels on left side bulged in; living-room window frame on left side torn loose; ceiling panels bulged down, no rupture; living-room end of galley ruptured on wall; galley overhead door styles broken; bottom of overhead cabinet broken; no damage to cabinets on right side; back-bedroom chest of drawers broken; left-side panel in bedroom bulged; window frame broken; all front windows and all windows on left side except kitchen window broken; right-side rear window broken; plumbing undamaged; light fixture in living room broken, glass in living room; divan, table and chairs, stove, refrigerator, and heater undamaged; all vent plates on left side down. (See Figs. 2.26 and 2.27.)

Fig. 2.26—Interior of Spartan trailer after the blast.

Fig. 2.27—Interior of Spartan trailer after the blast.

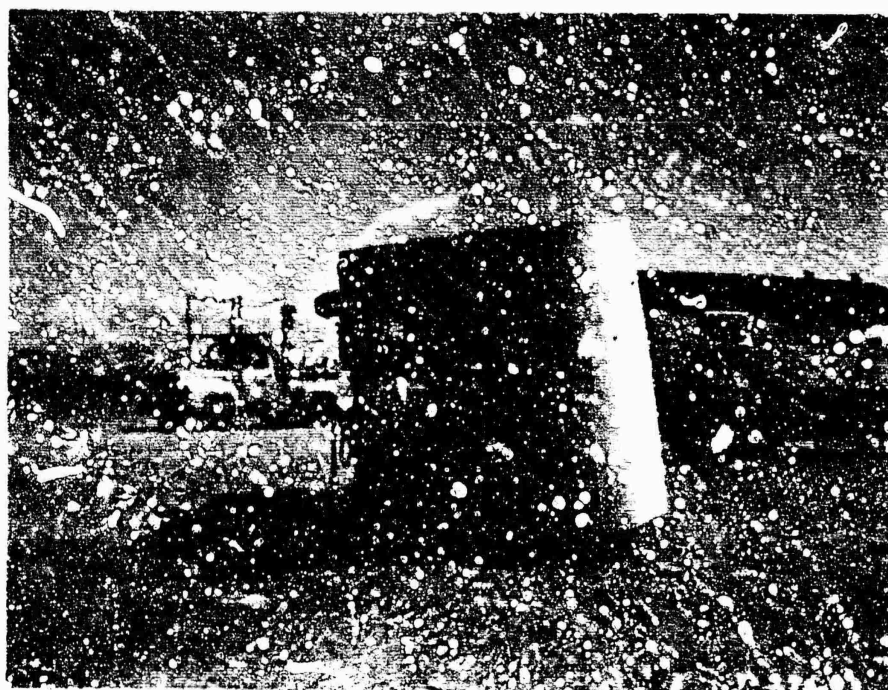
Exterior: Some distortion of left side; dents in rear roof, no ruptures. (See Fig. 2.29.)

Fig. 2.29—Exterior of used trailer at 10,500 ft after the blast.

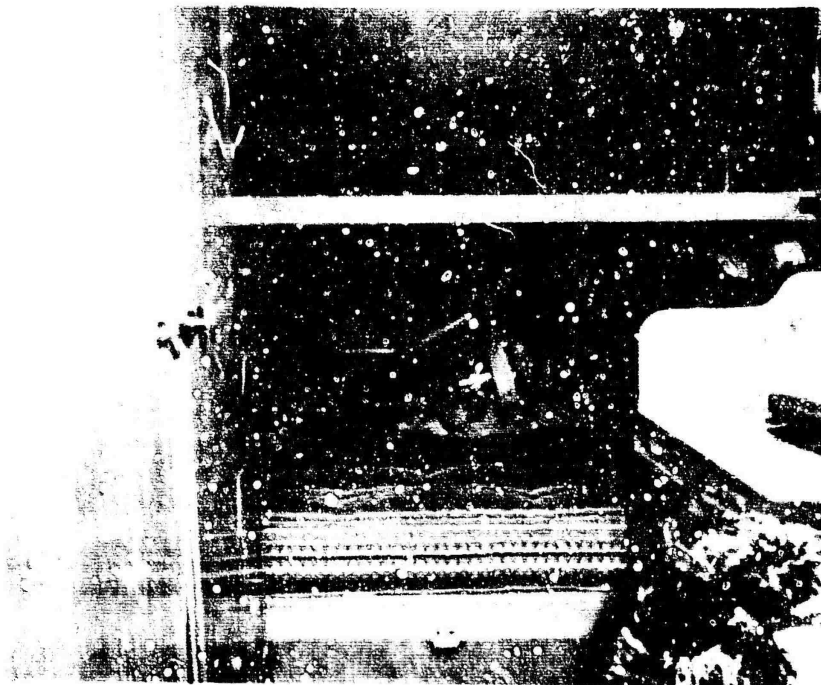
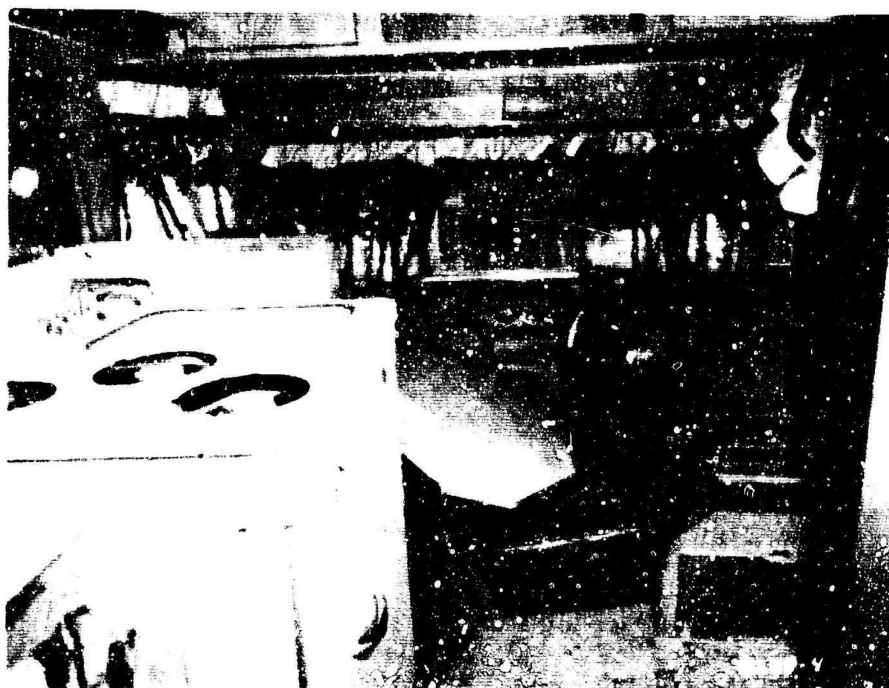
Interior: Ceiling molding off; ruptured panel above back window; butane light globe broken; wardrobe and overhead cabinet split slightly; table off wall; dinette cushion-wood assembly torn from wall and floor; all windows except front and right front side broken. (See Figs. 2.30 and 2.31.)

Fig. 2.30—Interior of used trailer at 10,500 ft after the blast.

Fig. 2.31—Interior of used trailer at 10,500 ft after the blast.

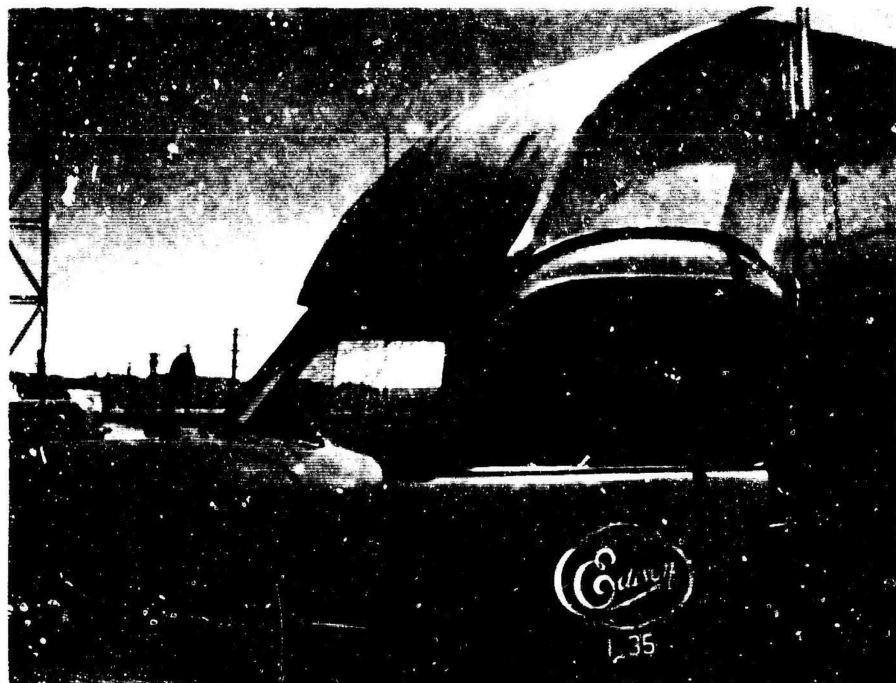
Test Results: The windshield was shattered. The rear window of the cab and two side windows on the truck were cracked; one side panel was dished in. Tools and equipment were not damaged. This vehicle would have been available for emergency operations. (See Fig. 3.10.)

Fig. 3.10—Shattered glass in light-duty electrical service truck.

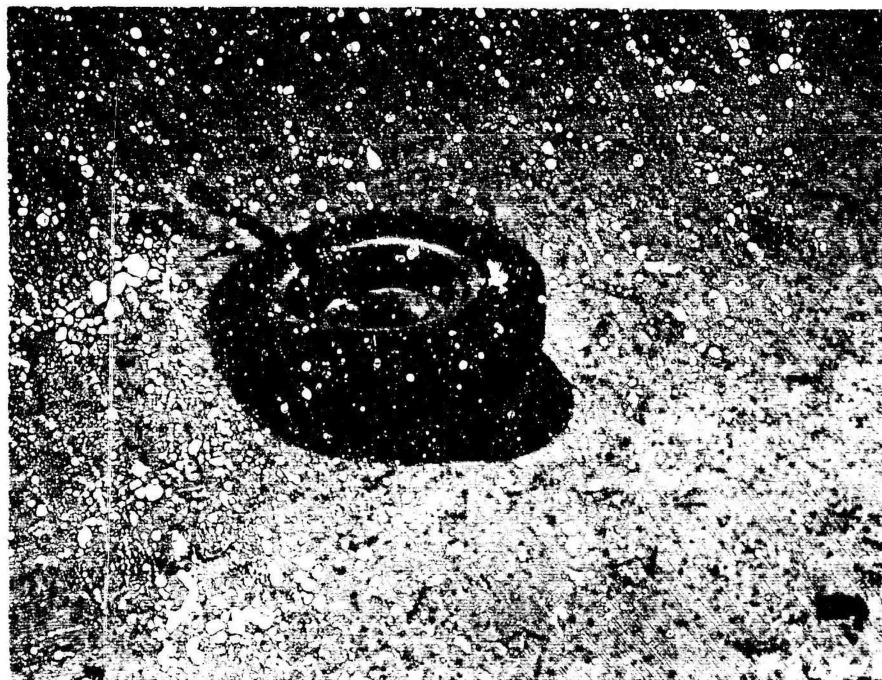
**Test Results:** Only one wheel and part of an axle were found after the blast. (See Fig. 3.17.)

Fig. 3.17—Remains of rescue truck after the blast.
