Technical Report

PROTECTION OF MOORING
 BUOYS - PART V. FOURTH
 RATING INSPECTION

4 January 1965

U. S. NAVAL CIVIL ENGINEERING LABORATORY
 Port Hueneme, California

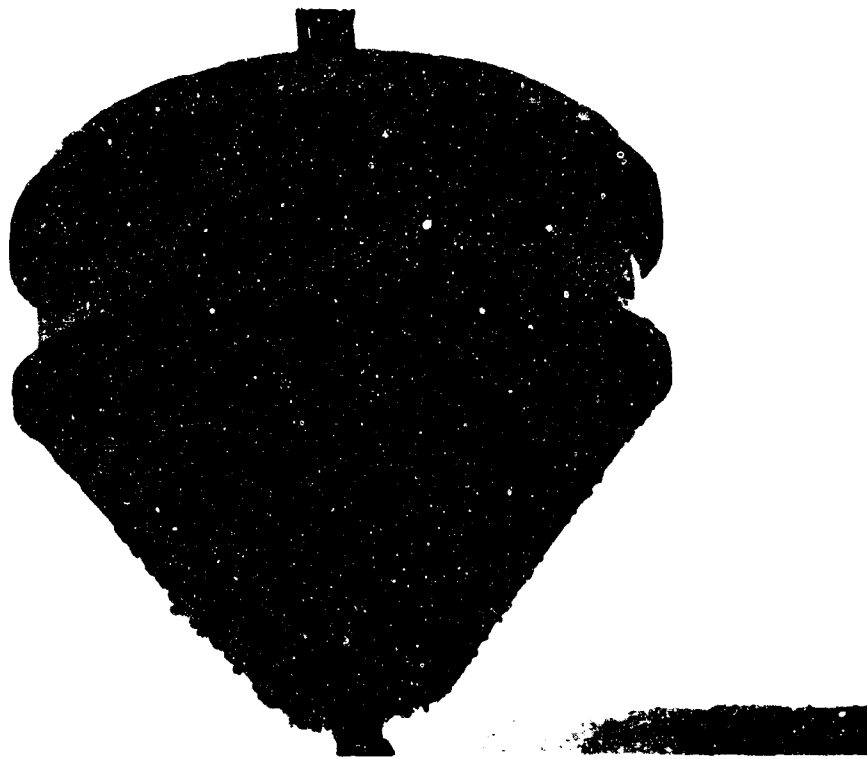
The buoy with Coating System 4 was in essentially the same condition (Figure 5) as at the previous inspection. The delamination of the topcoat and seal coat (Figure 6) had increased only slightly, and the underlying epoxy primer and coal tar epoxy were providing good protection to the steel.

Figure 5. System 4 buoy after removal of fouling.

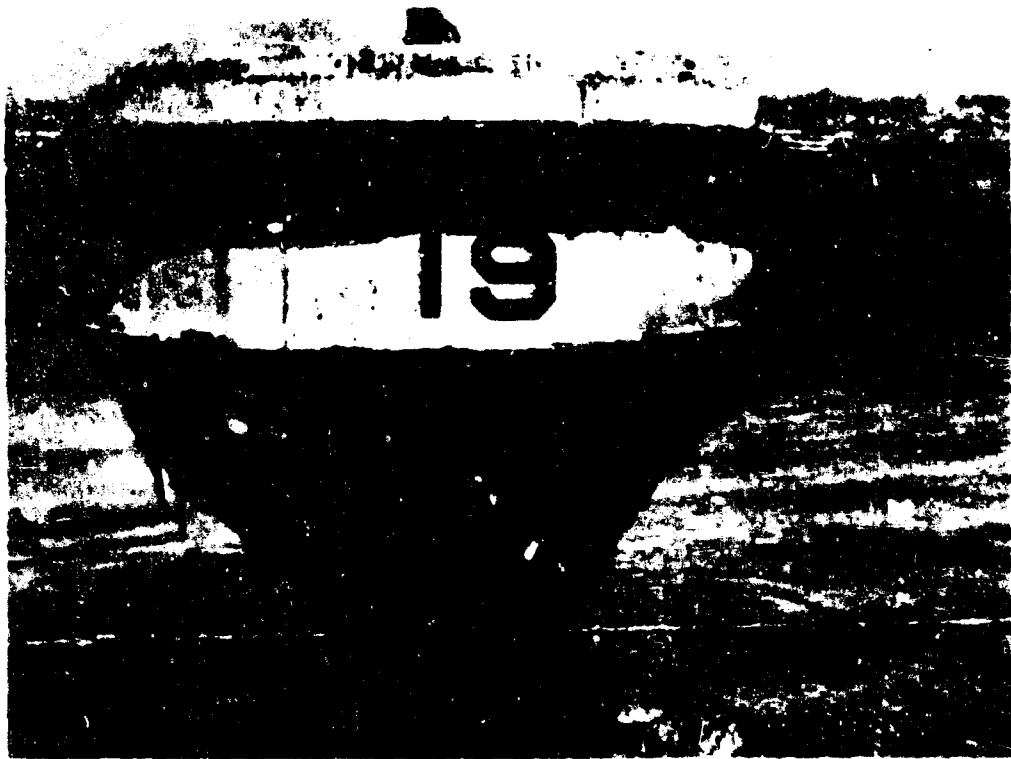
The fouling on the Coating System 7C buoy (Figure 10) was of a type and intensity similar to that on test buoys without antifouling paint. Growths of barnacles and tunicates were relatively heavy, and there were mussels, hydroids, green algae, and tube worms to a lesser degree. The yellow primer had been exposed in many places on the submerged portion of the buoy where the antifouling paint had eroded, but this had not permitted any rusting. The pin-point rusting previously noted⁴ in the atmospheric and splash zones had not advanced significantly since the previous inspection.

Figure 10. System 7C buoy before removal of fouling.

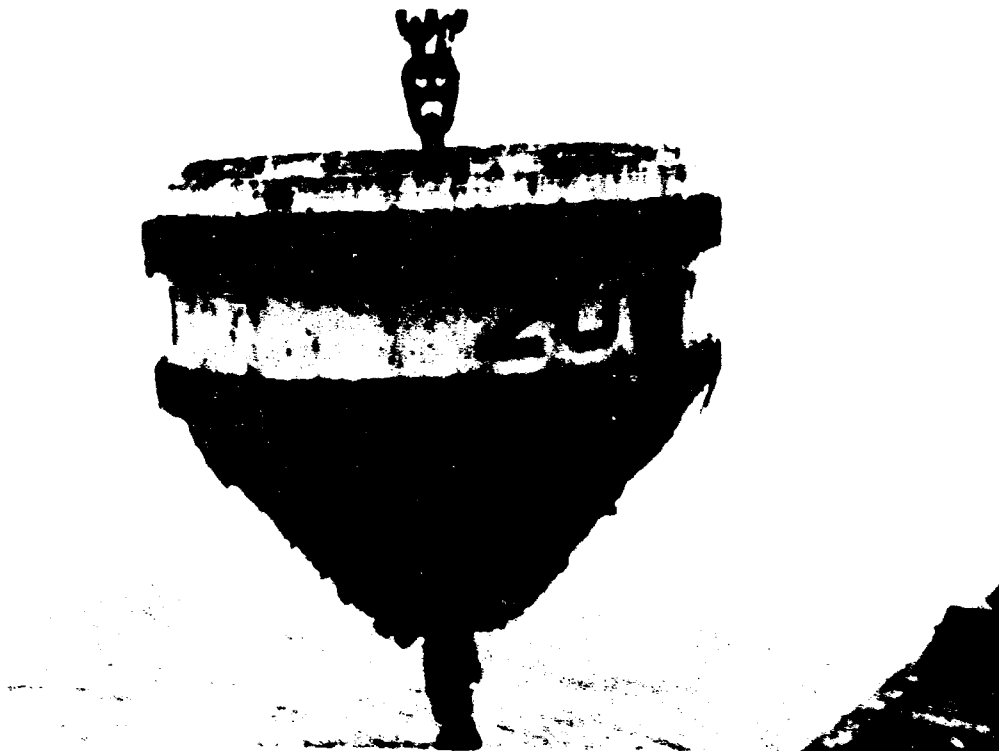
The coating system on the submerged portion of the System 8 buoy (Figure 11) was identical to that of the System 7C buoy. Consequently, the fouling on both buoys was similar. The System 8 buoy, however, had lost less antifouling coat, so less yellow primer was exposed. The pin-point rusting and abraded areas previously noted on the buoy^{3,4} showed no further significant corrosion since the previous inspection.

Figure 11. System 8 buoy before removal of fouling.

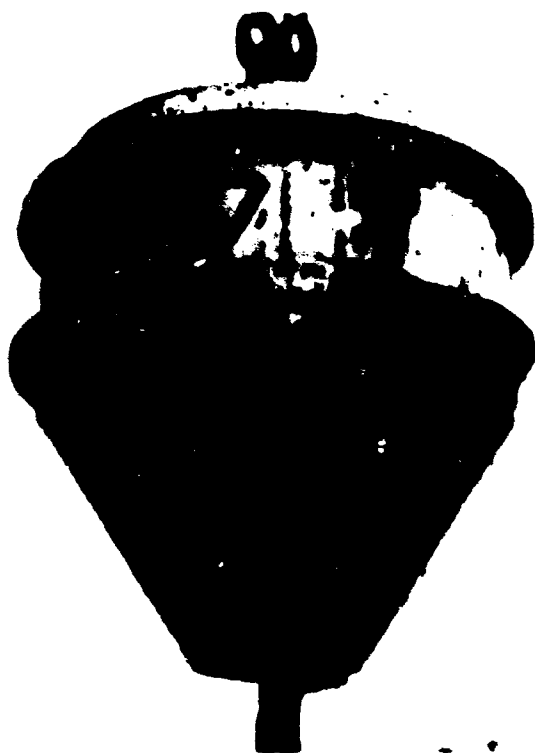
The blistering and rusting in all three zones of the System 10 buoy had not deteriorated appreciably further (Figure 13) since the previous inspection. Many of the blisters were broken by the high-pressure hosing, exposing bare metal. Both fenders on the side of the buoy had been broken by the impact of a naval vessel.

Figure 13. System 10 buoy after removal of fouling.

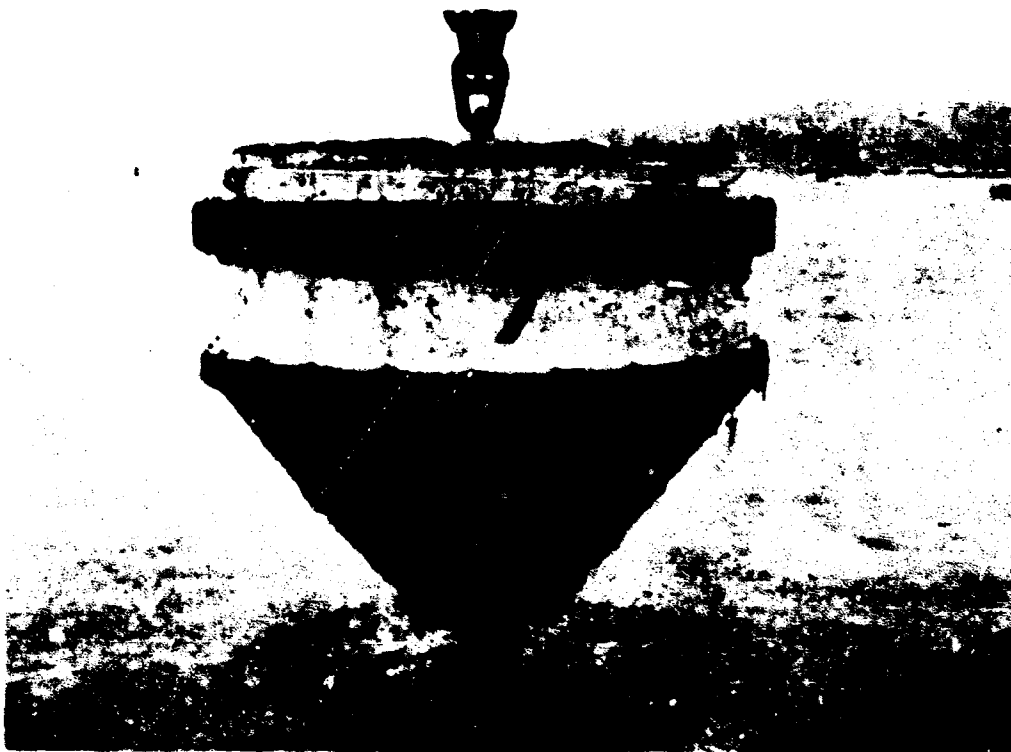
The Coating System 12 buoy was essentially free of corrosion in all three zones (Figure 14). The only corrosion noted was where portions of the top edge had been abraded by mooring lines. Although approximately half of the primer and topcoat had been lost from the submerged portion of the buoy after 6 months of service, the underlying inorganic zinc silicate was still preventing corrosion 18 months later (Figure 15).

Figure 14. System 12 buoy before removal of fouling.

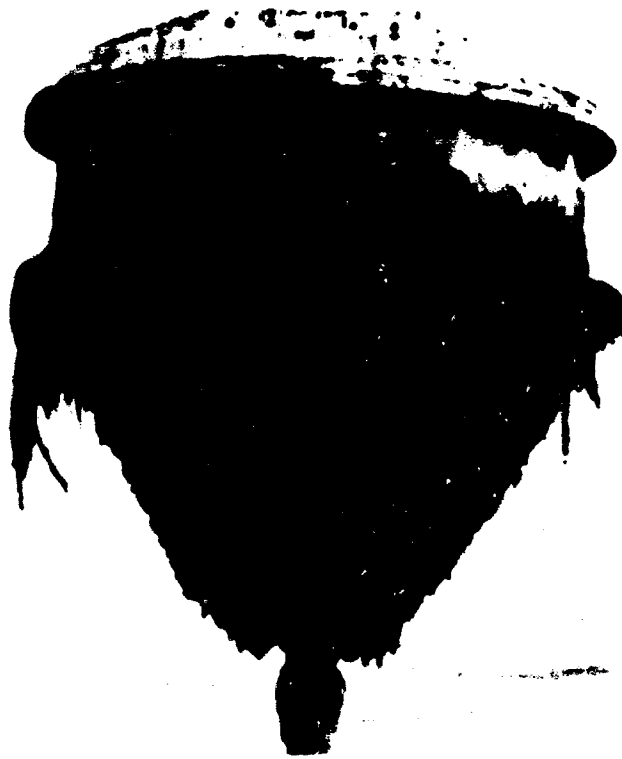
Coating Systems 13 and 13C were identical, but System 13C was applied to a cathodically protected buoy. There was rust on both buoys (Figures 16 and 17) in the atmospheric and splash zones, either pin-point rusting or rusting initiated by coating abrasion. The System 13 buoy also had rust in the submerged zone, but in this portion of the System 13C buoy rust occurred only on the square of steel exposed by wire brushing to test the cathodic protection system. The 13C buoy had been struck by a ship that bent the cathodic protection unit, but this damaged neither the coating nor the cathodic protection system.

Figure 16. System 13 buoy before removal of fouling.

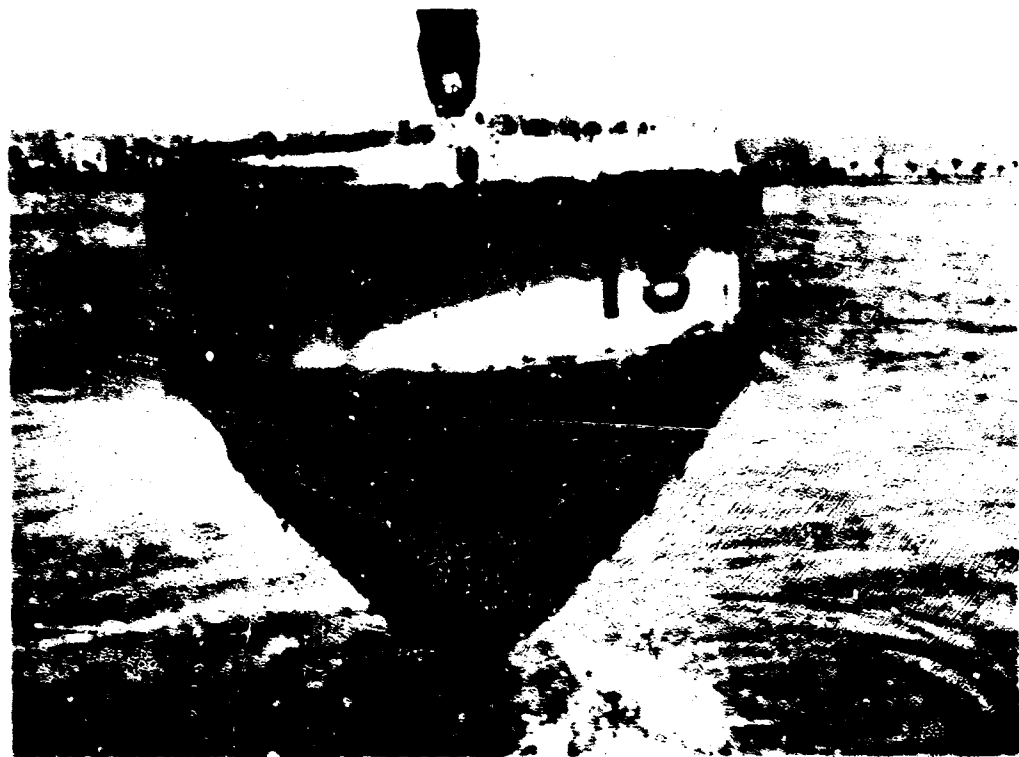
Figure 17. System 13C buoy before removal of fouling.

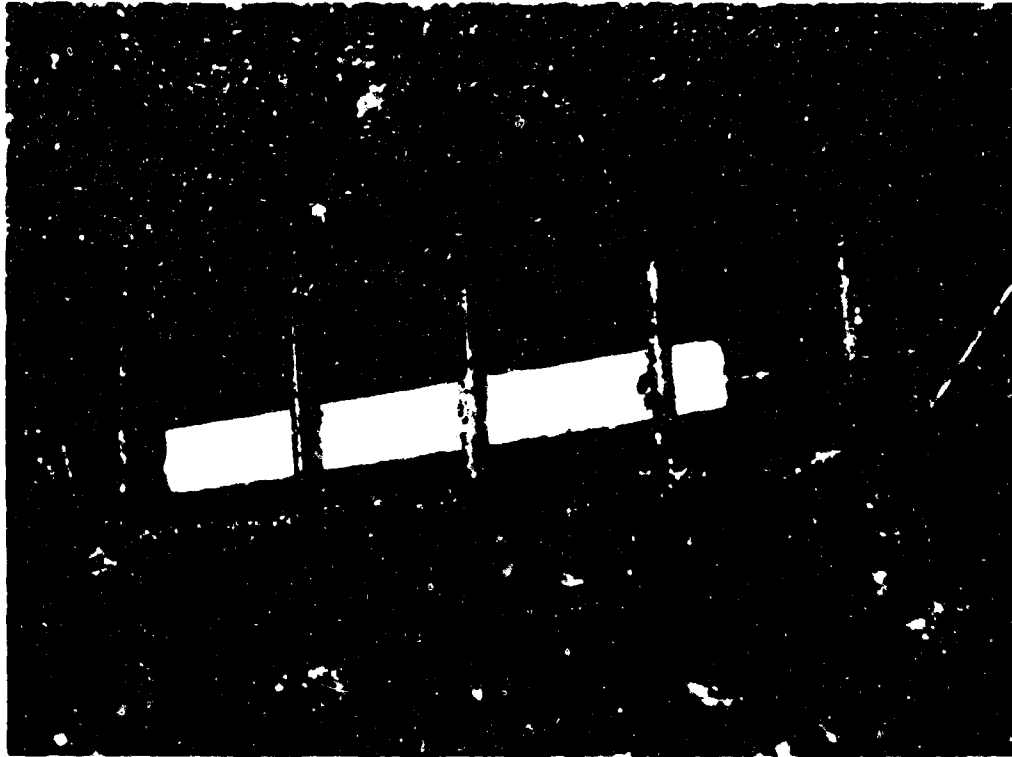
Figure 18. Zinc anode of System 7C after 132 days.

Consequently, the cathodic protection system on the System 7C buoy was again modified. The magnesium anode was replaced with a zinc anode, and the remote ground cable was joined directly to the steel pipe supporting the zinc anode. With this arrangement, current does not pass through the control head, which now serves only as a securing bracket. Although both anodes were of the same general size, the zinc anodes weigh about 145 pounds — approximately double that of the magnesium anodes. Immediately after the modified buoy was returned to the water, its potential was -840 mv. When checked 29 days later, buoy potential was -980 mv. After 51 days, it was -900 mv with a naval vessel secured to the buoy. At the time of the present inspection (132 days after the modification), buoy potential was -930 mv. The condition of the anode at this time is shown in Figure 18.
