**USATRECOM TECHNICAL REPORT 65-6**

**CRASHWORTHINESS EVALUATION OF AN  
ENERGY-ABSORPTION EXPERIMENTAL  
TROOP SEAT CONCEPT**

**Langston W. T. Weinberg**

February 1965

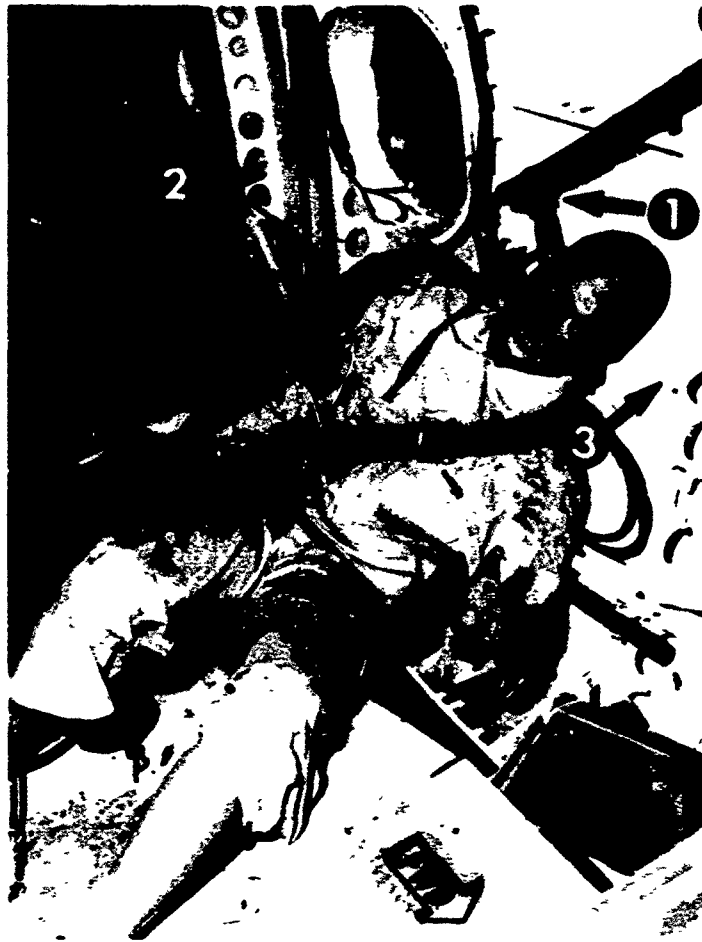
Figure 13. Postcrash View of Experimental Troop Seat.

Figure 13 shows the position of the seat and dummy immediately after the crash. The metal seat-pan portion of the seat remained relatively intact. The upper torso support value of the wraparound-type nylon seat back was lost; however, due to failure of the upper support tube to which it was attached. The outboard nylon straps remained attached to the broken ends of the support tube. The diagonal chest strap and lap belt remained fastened and prevented the dummy from being thrown from the seat after collapse of the nylon back support. There was sufficient play in the chest strap after the support failure to allow the dummy's head to contact the fuselage frame forcibly at station 219.5.

In Figure 13, arrow 1 shows broken tube and left nylon strap tie point. Arrow 2 shows right nylon strap. Note that strap tore away from rest of seat back for approximately 12 inches. Arrow 3 shows where head of dummy contacted bulkhead.

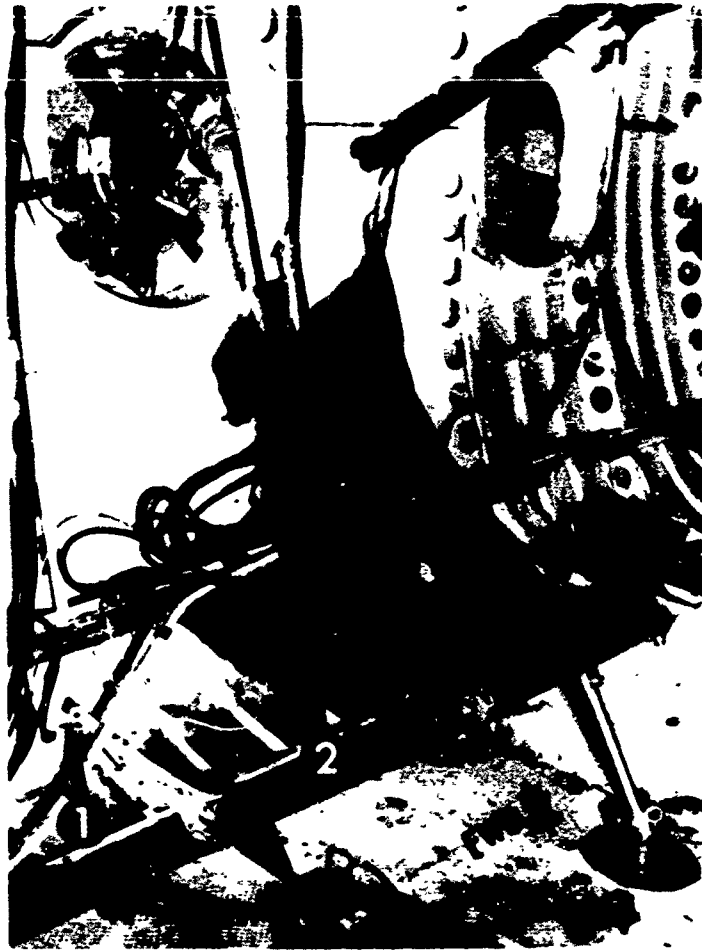
Figure 15. Postcrash View of Experimental Troop Seat - Dummy Removed. (Tensiometer link installation is shown by Arrow 1. Arrow 2 shows typical collapsed bulkhead in left side of passenger compartment.)

Figure 15 is another postcrash view of the seat after the dummy had been removed. Again, note that the seat pan and the bulkhead are nearly parallel.

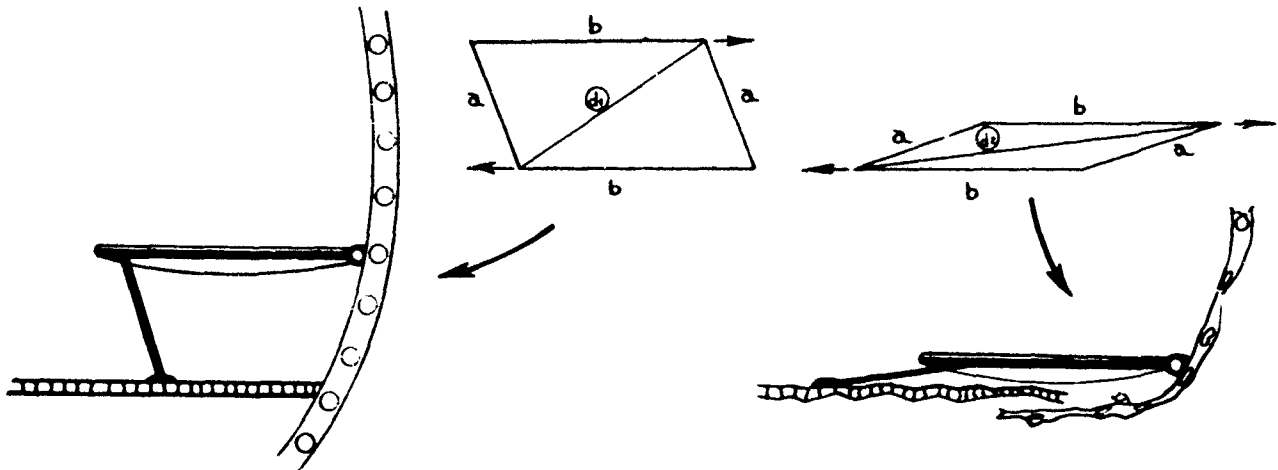
Figure 20. Relation of Seat Collapse to Aircraft Structure Failure.

The evidence of the previous two paragraphs led to the conclusion that the seat itself did not collapse when the upper support failed. The sharp impact when the seat and floor contacted was due to failure of aircraft basic structure rather than failure of the seat. The impact was the result of an action analogous to pulling the opposite corners of a parallelogram as shown in Figure 20.

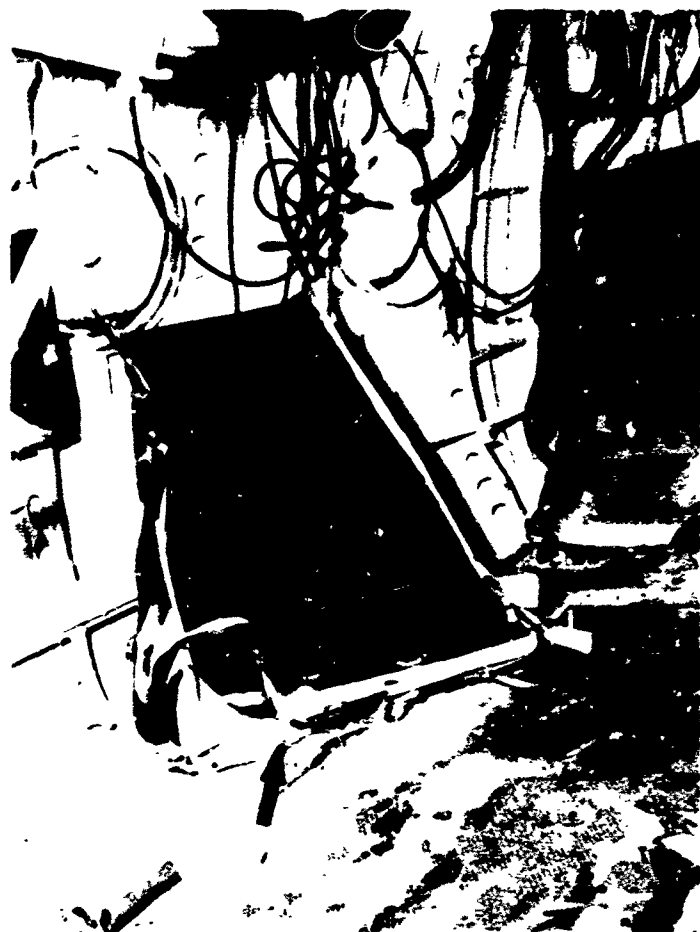
Figure 30. Postcrash View of Seat 2 With Dummy Removed.  
(Arrow shows point of failure of nylon seat back attachment strap retainer.)

Note in Figure 30, which shows seat 2 after the dummy had been removed, that the nylon seat back is intact. The only failure in the seat back assembly was the broken strap retainer. This failure would not in itself have caused a failure of the seat; it probably occurred when the seat corner came in contact with the floor during the final phases of the crash.

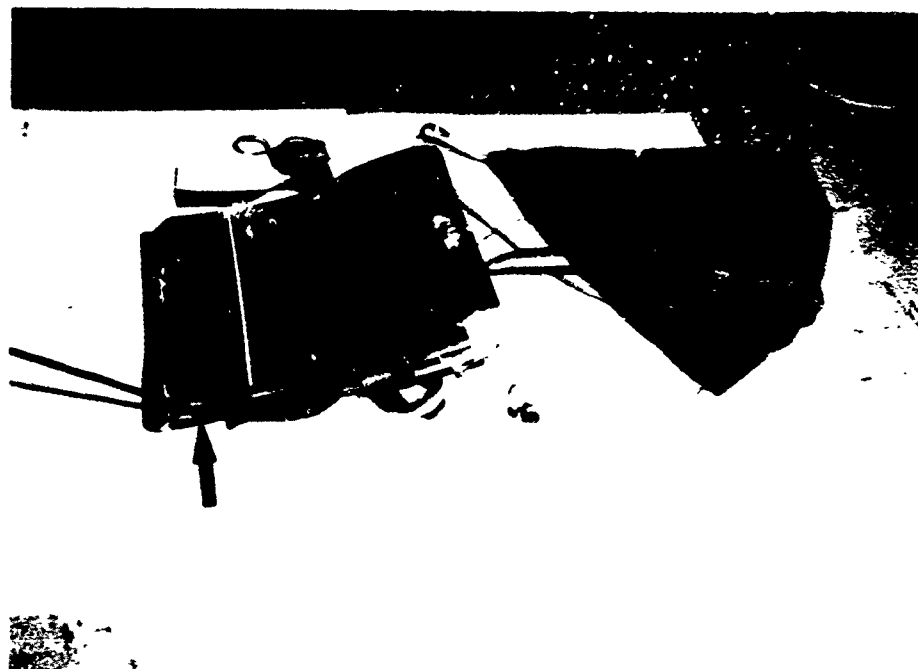
The seat pan was intact after the crash; however, extensive cracking of the fiber glass skin was evidence of the high stresses on the seat during the crash sequence. The designed "weak line", shown by the white line in Figure 36, showed no evidence of failure. The following series of photographs shows the effect of the crash forces on the seat pan. All of these photographs were taken after the seat had been removed from the test vehicle.

Figure 35. View of Right Side of Seat Pan.  
(White line indicates "weakened" portion of seat pan. Arrow indicates crack in fiber glass cover of seat pan.)

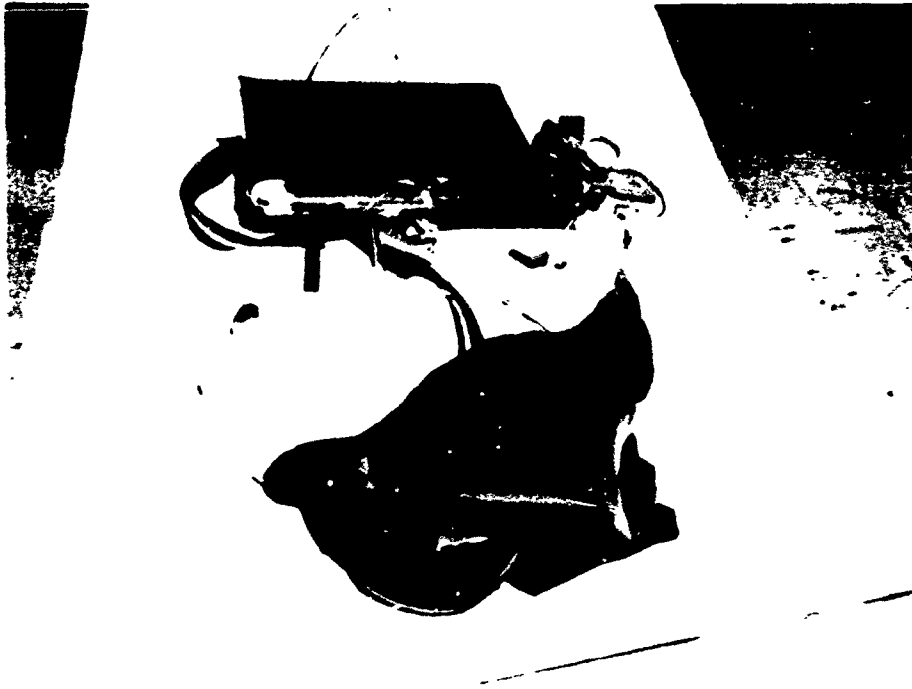
Figure 36. Front View of Seat Pan. (Arrow indicates crack in front of fiber glass cover.)

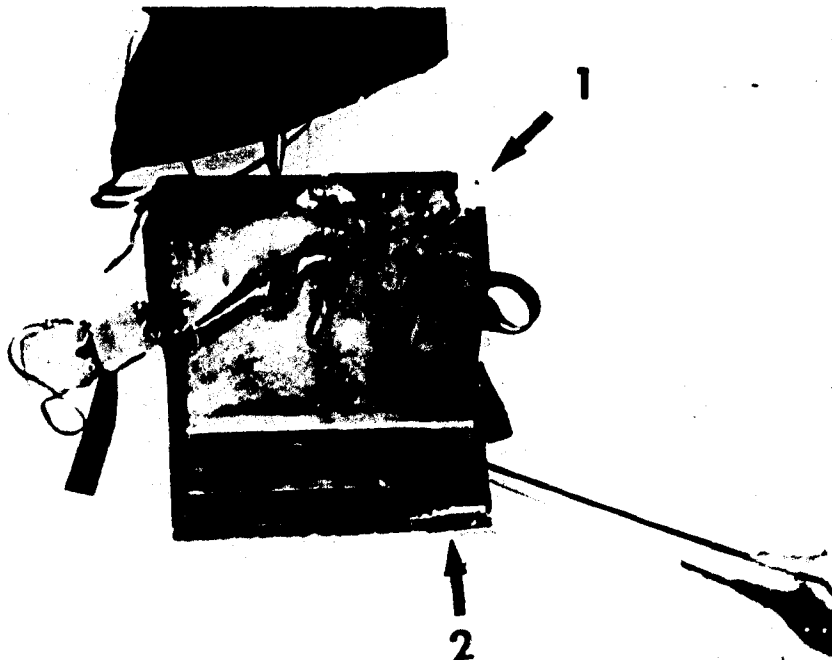
Along the line of the hinge connection, the right-hand 4 inches of the seat pan showed shattered fiber glass. There was evident cracking of the paint along the remainder of the hinge connection.

Figure 38. Top View of Seat Pan. (Pointer indicates "weak line". Arrow 2 shows shattered fiber glass at right side of hinge connection. Arrow 1 shows failed seat pan retainer.)

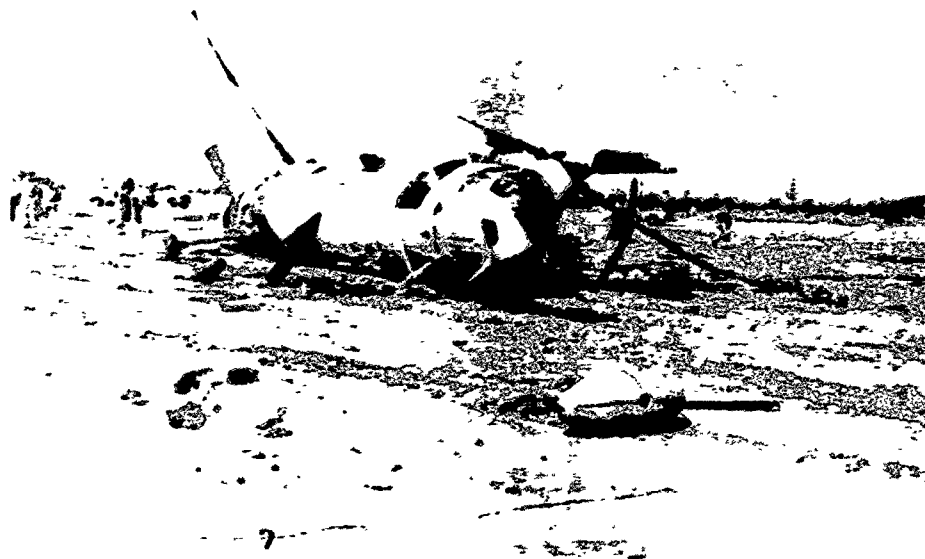
**Figure 45. Postcrash View of CH-21A Test Vehicle Used in Third Test.  
(General location of experimental troop seat is shown by  
arrow.)**

The impact conditions of the third drone test were very mild as far as fuselage structural deformation was concerned (see Figure 45). The landing gear broke free on impact, allowing the center of the fuselage to contact the ground. The major damage to the aircraft was aft of the passenger compartment, where the impact was sufficient to break the helicopter fuselage just forward of the engine and to deform the understructure inward approximately 16 inches directly below the fuel tank.

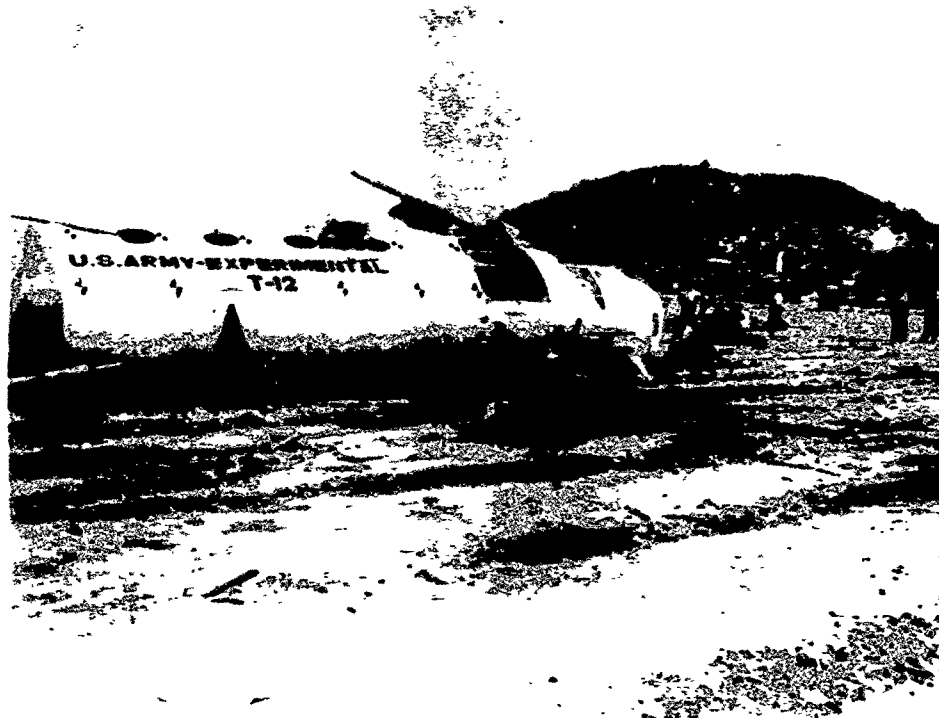
The underside of the passenger compartment was only slightly damaged, as shown in Figure 46.

**Figure 46. Postcrash View of Underside of Passenger Compartment.  
(Arrow shows location of seat 3.)**

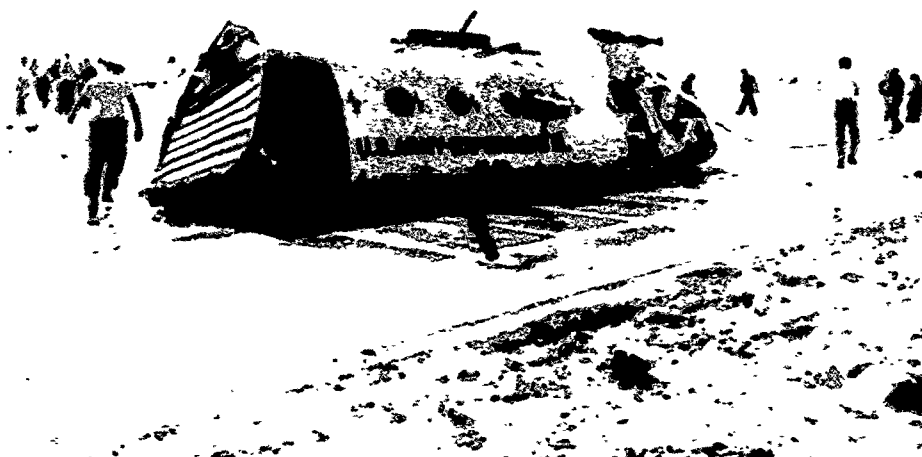
The crash conditions of the crane drop very closely duplicated the acceleration environment of the first drone crash, T-7, and the deformation of the fuselage was similar (see Figure 54). The crushing of the floor and the body frame collapse showed no significant difference between drone tests and crane drops of similar impact conditions.

Figure 54. Postcrash View of Crane Drop (T-13).  
(Arrow shows area of seat 4 installation.)
