METALLURGICAL EVALUATION OF FAILED AIRCRAFT STAINLESS STEEL EXHAUST SYSTEM COMPONENTS

TECHNICAL REPORT

by
 T. H. McCunn
 Allegheny Ludlum Steel Corporation
 Research Center
 Brackenridge, Pennsylvania
 Under Contract FA NAF-176

FEDERAL AVIATION AGENCY
AIRCRAFT DEVELOPMENT SERVICE

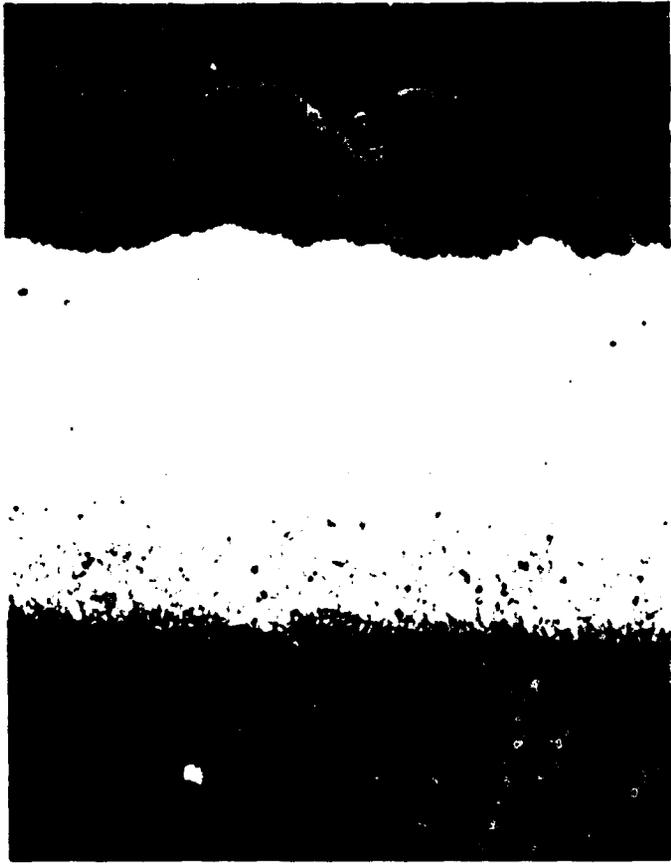
Photomicrographs in the unetched condition in the two areas are shown in Figure 11. The material in the bulged area was more heavily oxidized. In some areas the thickness of the metal remaining in the bulged area was even less than that shown in Figure 11A. Cracks were heavily oxidized so that no information could be obtained with respect to the type of cracking. The structure of the material at the scale-metal interface of the bulged area is shown at higher magnification in Figure 12.

FIG. 11 SAMPLE NO. 5 SHELL CROSS-SECTION,
SHOWING EXTENT OF OXIDATION

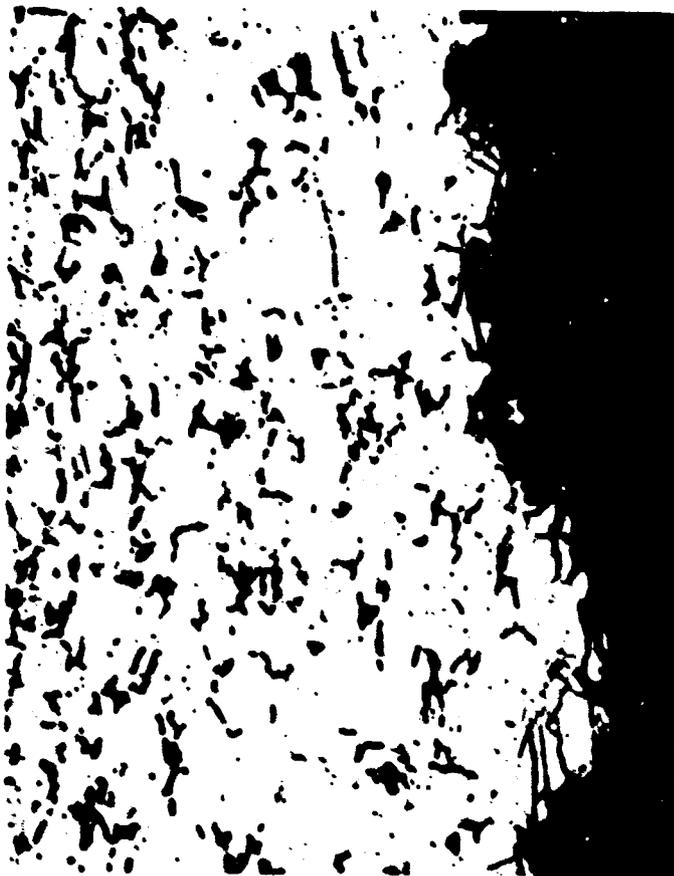
INSIDE SURFACE SHOWING
CARBIDES AND SIGMA PHASE

OUTSIDE SURFACE SHOWING
SIGMA PHASE

FIG. 14 STRUCTURE OF SAMPLE NO. 5 SHELL

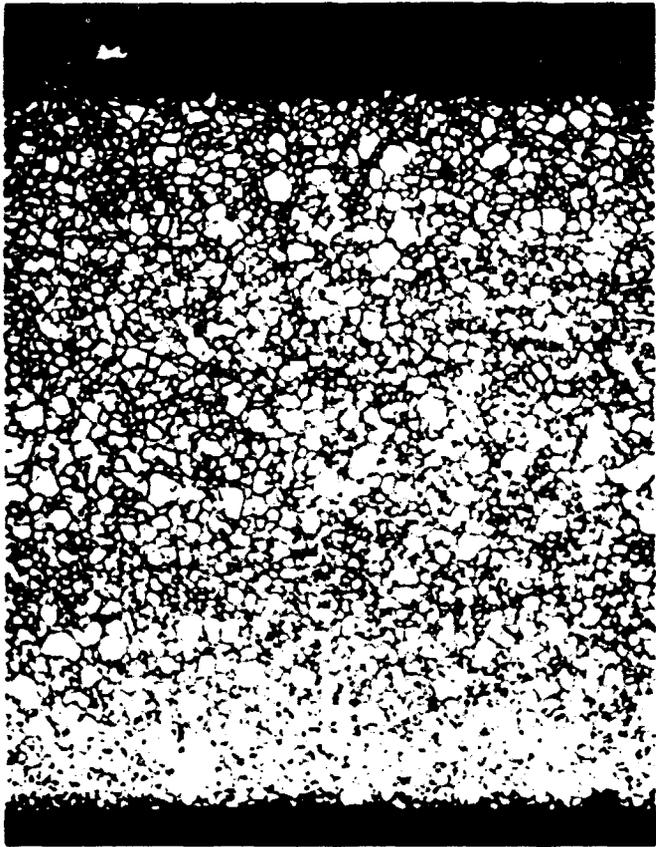
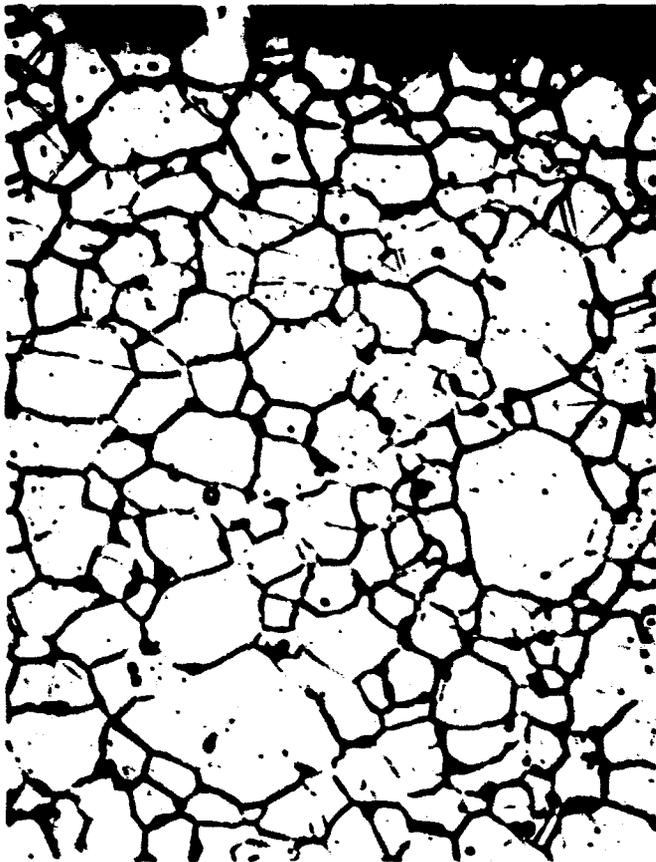
FIG. 15 STRUCTURE OF SAMPLE NO. 5 SHELL AWAY FROM BULGED AREA, SHOWING SIGMA PHASE IN GRAIN BOUNDARIES

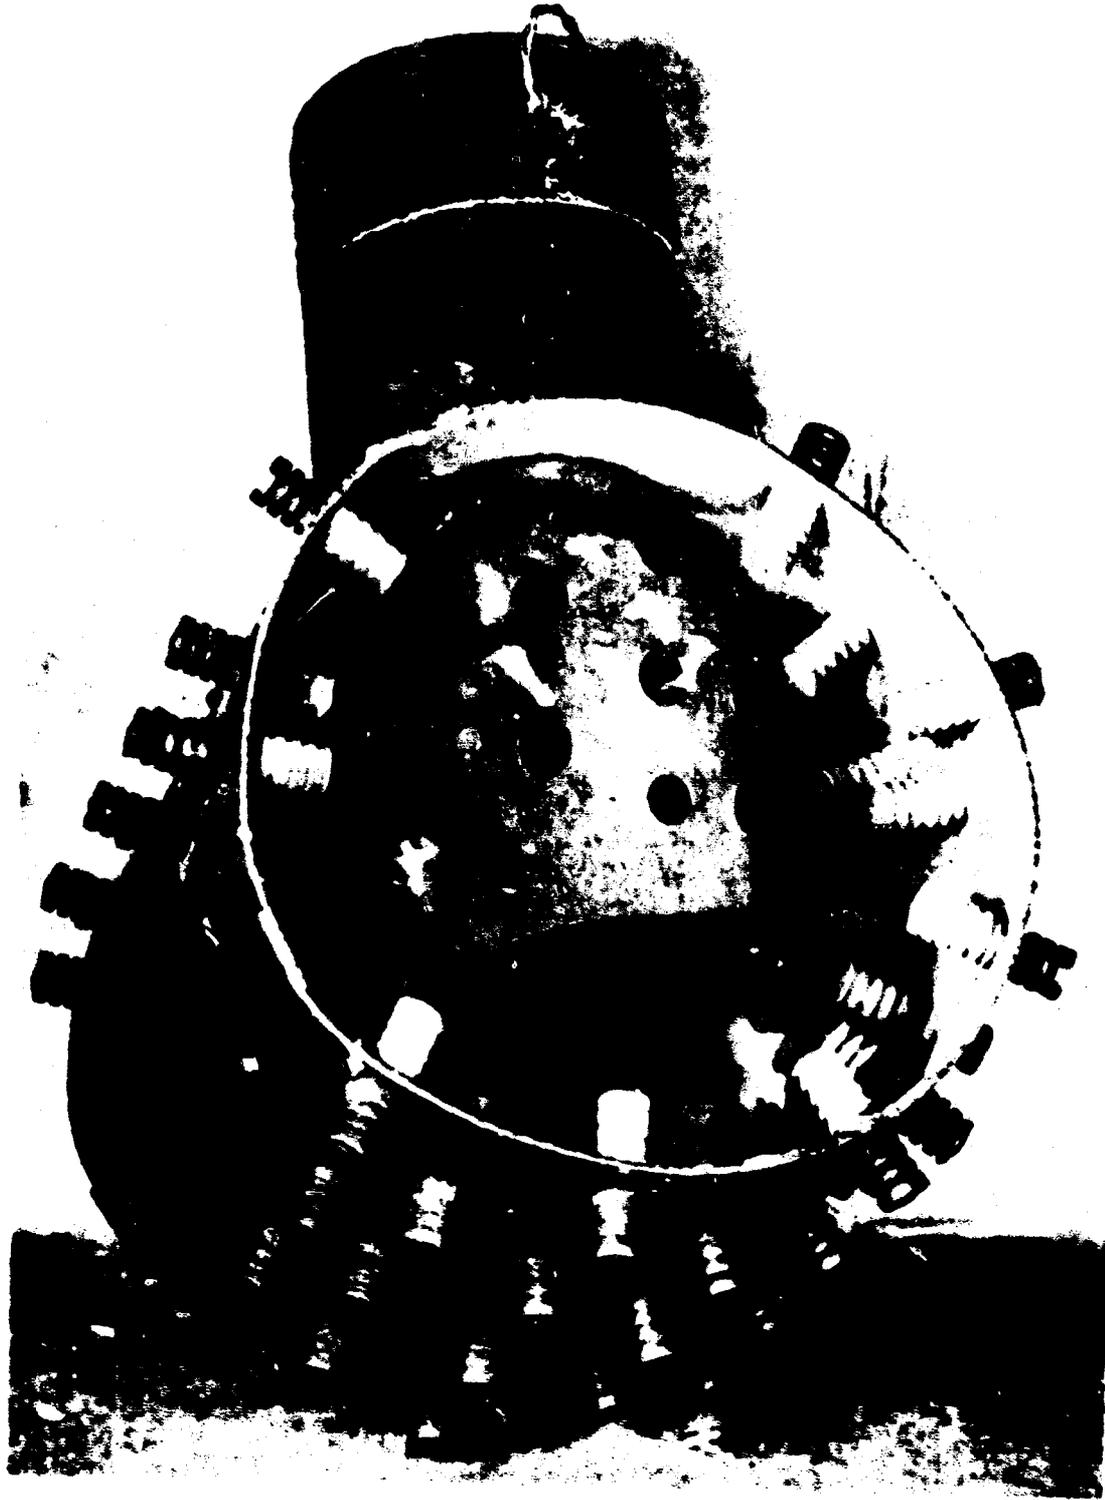
Sample No. 6 was a section of a muffler in which the internal baffle had failed as shown in Figure 16. Specimens for metallographic examination and

FIG. 16 SAMPLE NO. 6 - SECTION OF MUFFLER SHOWING
FAILURE OF INTERNAL BAFFLE

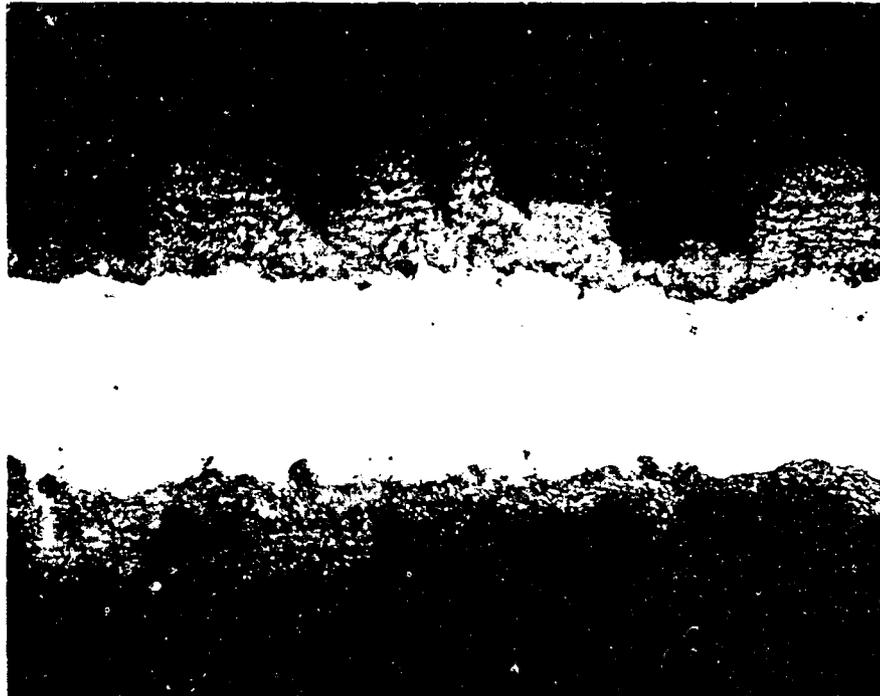
Figure 17 shows that the material was heavily oxidized. Etching revealed a microstructure through the entire cross-section of many carbides and grain boundary sigma similar to the structure shown in Figure 14A at the surface.

Corrosion product was scraped from the baffle. An X-ray analysis showed $\text{FeO} \cdot \text{Cr}_2\text{O}_3$ spinel and $\text{Pb}(\text{Fe, Mn, Al, Ti})_{12}\text{O}_{19}$.

FIG. 17 SAMPLE NO. 6 - INTERNAL BAFFLE, SHOWING HEAVY OXIDATION

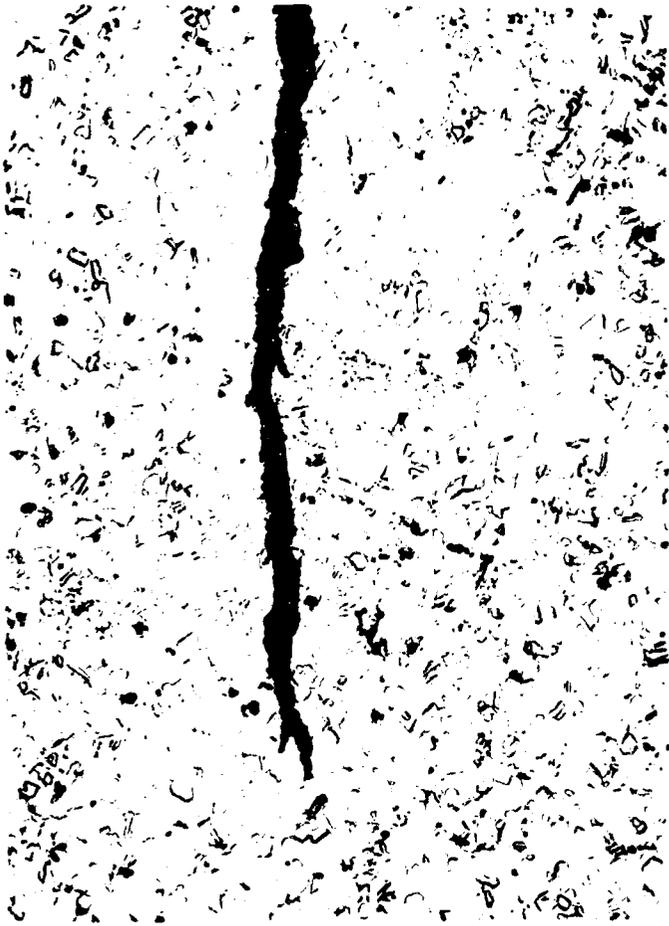
FIG. 20

One specimen for metallographic examination was taken at the end of the crack through the hole of the support. Figure 20 indicates the crack to be the result of fatigue. The presence of titanium carbonitrides indicates that this support section was Type 321 also. The microstructure was essentially free of finer carbides.

SAMPLE NO. 7 - SHOWING
END OF CRACK THROUGH
HOLE IN SUPPORT PIECE

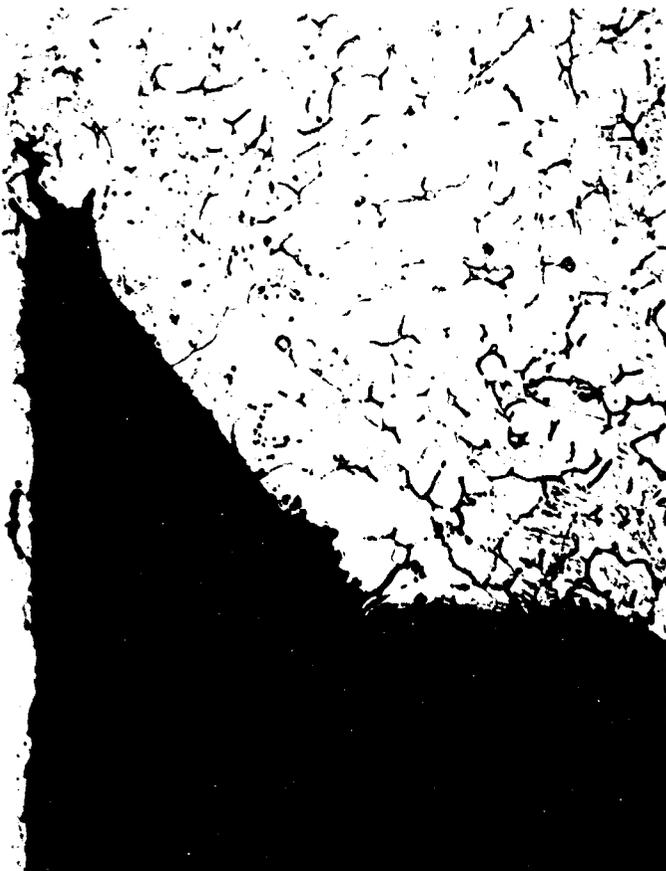
FIG. 21

Another specimen was cut through the crack at the weld. The pieces fell apart so that the specimen examined metallographically essentially consisted of a piece of the tubing and the fusion weld. Figure 21 shows where the shell had been joined by welding to the tubing. It is believed that the straight edge is part of the crack through the heat-affected zone. Note that the amount of delta ferrite along this edge of crack surface is somewhat less than that in the weld, thus suggesting that this is the heat-affected zone. The straightness and the transgranular course of the crack in addition to little evidence of deformation indicate failure by fatigue. While not shown by a photomicrograph, the tube had a normal microstructure where it was not exposed to the hot gases. The portion of the tube within the shell showed a continuous grain boundary precipitate, starting somewhat beyond the heat-affected zone. Within the heat-affected zone, the grain size was large due to the fusion welding, but there was no grain boundary precipitate. The difference here is believed to be due to the temperatures attained during operation rather than to effects of the fusion welding. The crack between the weld and the support also appeared to be caused by fatigue as it was relatively straight and transgranular. The crack was for the most part in the heat-affected zone.

SAMPLE NO. 7 - SHOWING
FUSION WELD WHERE SHELL
WAS JOINED TO THE TUBE.
A SMALL PORTION OF THE
TUBE IS ON THE LEFT

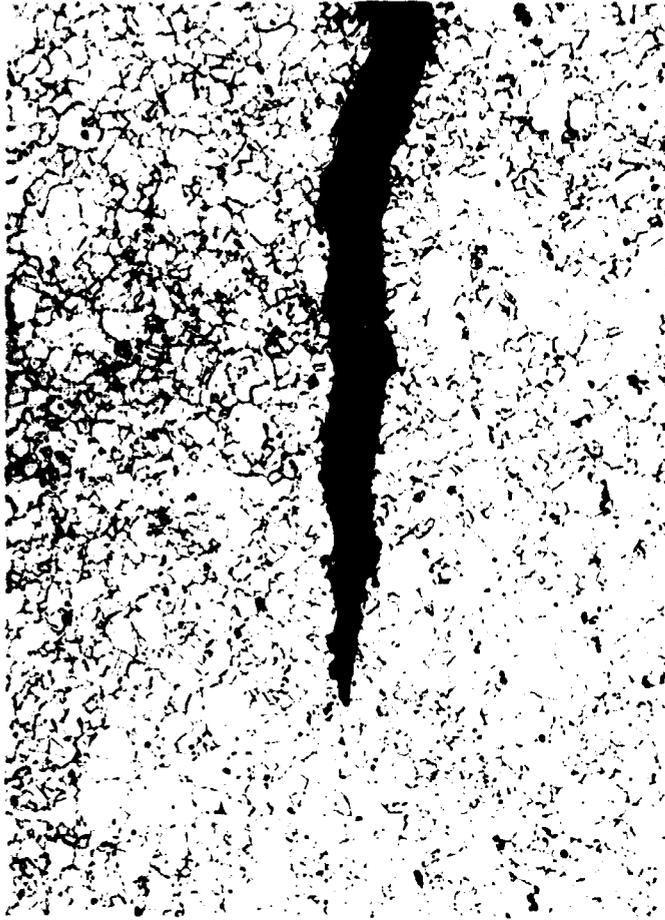
Another specimen was taken at the end of the crack in the shell which can be seen in Figure 19 just above the tube. The crack is shown in Figure 22. It also appears to be a fatigue crack. The microstructure shows a continuous grain boundary precipitate similar to that observed in the portion of the tube which was inside the shell and exposed to the hot gases.

FIG. 22 SAMPLE NO. 7 - SHOWING END OF CRACK IN SHELL WHICH CAN BE SEEN IN FIGURE 19 JUST ABOVE THE TUBE.

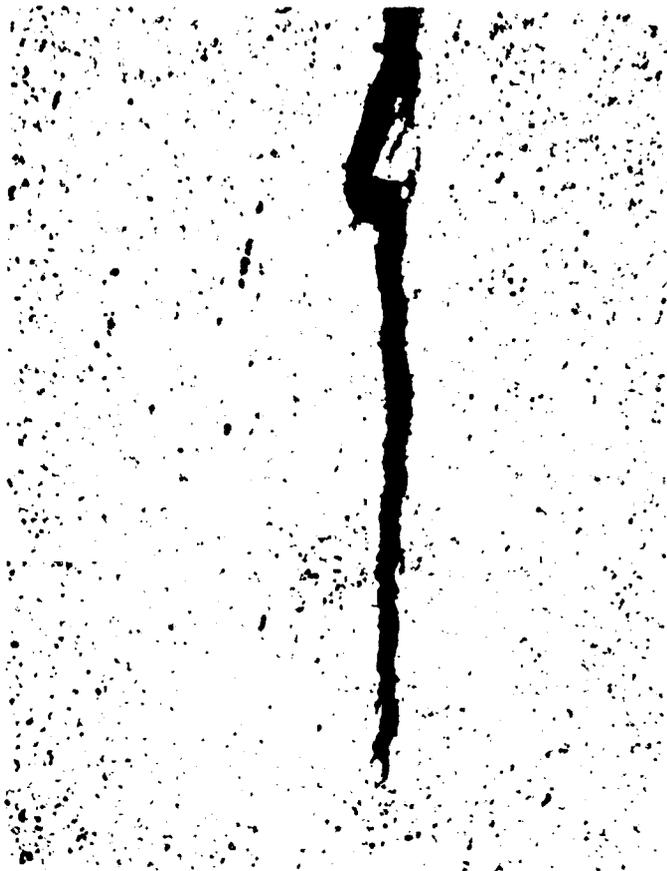
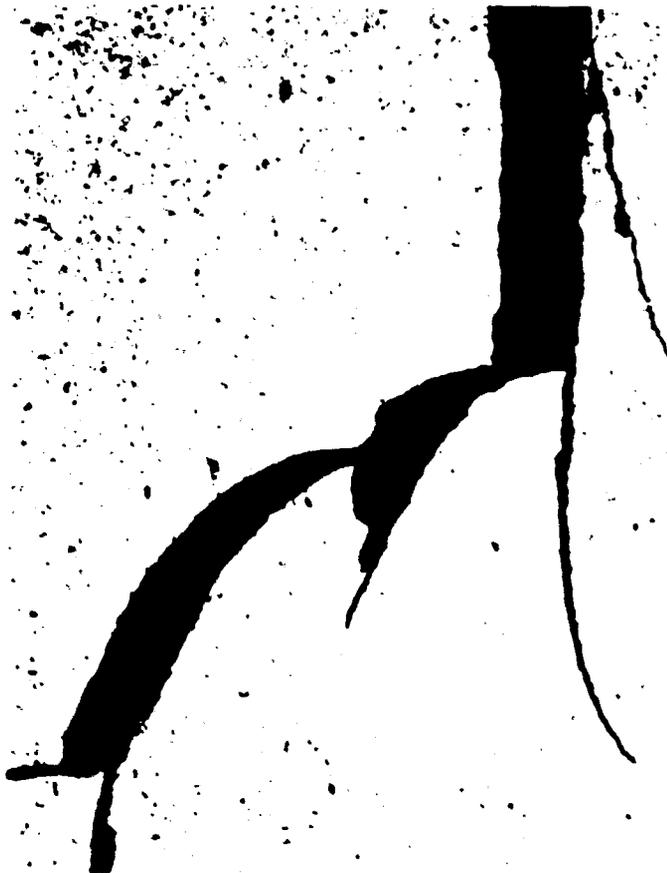
A specimen for metallographic examination was taken at the end of the crack extending in the shell at four o'clock from the tube. Figure 25 shows the end of the crack and another location of the crack where it seems to have been changing direction. The crack appears to be a fatigue failure. A specimen taken to show the cross-section of the shell confirmed that the microstructure of the shell of this muffler, unlike that of Sample No. 7, did not have a grain boundary precipitate, indicating that this muffler operated at a lower temperature or for a shorter time than that from which Sample No. 7 was taken.

FIG. 25 SAMPLE NO. 8 - SHOWING (A) END AND (B) ANOTHER LOCATION OF CRACK IN SHELL

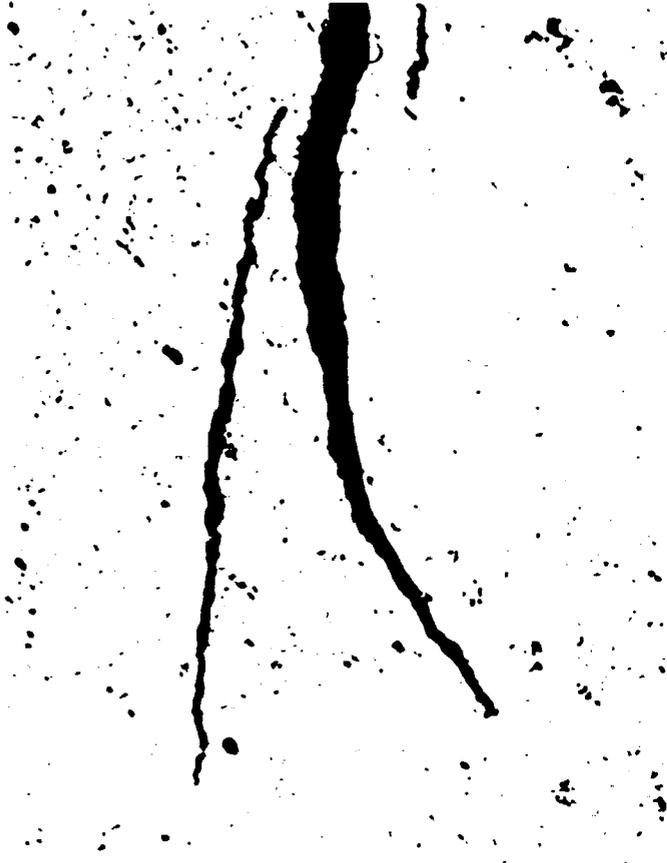
FIG. 27

A specimen for metallographic examination was taken at the end of the crack in the shell. An adjacent specimen was taken to view the cross-section. Figure 27 shows the end of the crack. While this crack had a few branches, it still appears to be a fatigue failure. As Figure 28 shows, the microstructure contained sigma phase and carbides. This material also had a few stringers of delta ferrite which had transformed to sigma phase. The indication is that this muffler operated at higher temperatures or for a longer time than Sample Nos. 7 or 8.

SAMPLE NC, 9 - SHOWING
END OF CRACK IN SHELL

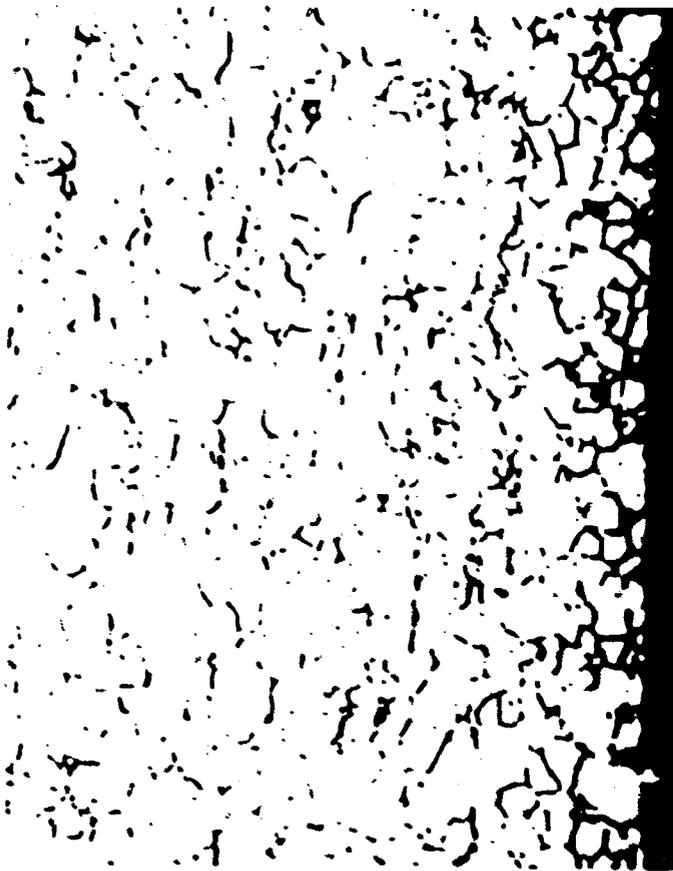
FIG. 28

SAMPLE NO. 9 - SHOWING
STRUCTURE OF SHELL

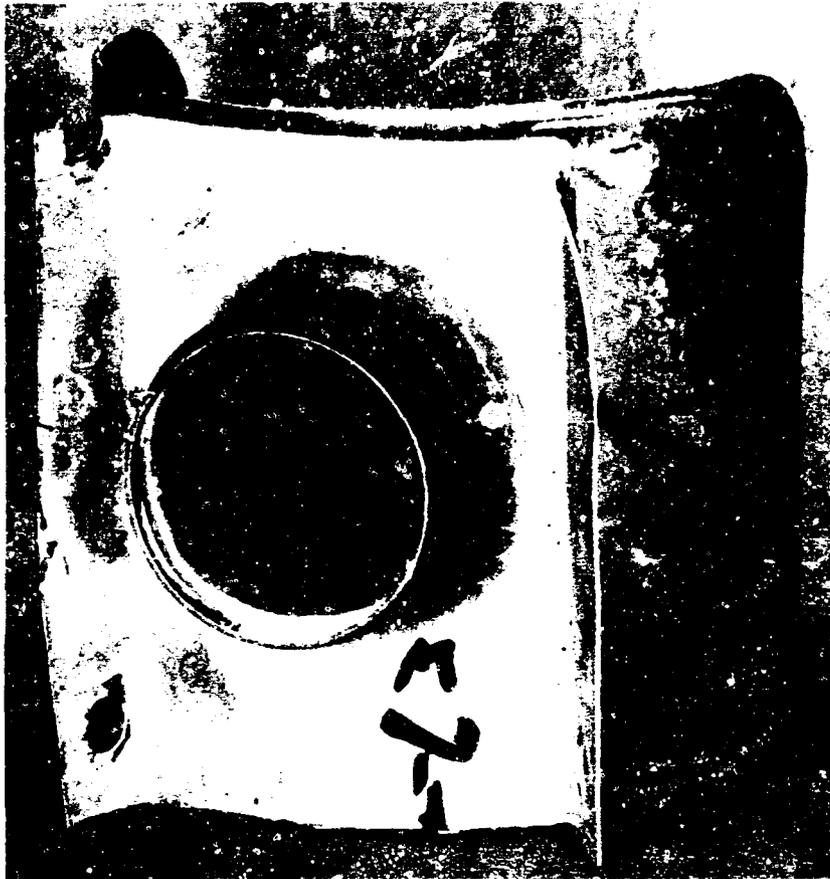
Sample No. 10 was a portion of another muffler similar in design to Sample Nos. 7, 8 and 9. As Figure 29 shows, this part had a crack through one of the holes of the support piece and a crack at the fusion weld in the support piece. The crack extended into the shell portion as shown in Figure 30. The piece for chemical analysis was taken from the shell. The material was Type 321.

FIG. 29 SAMPLE NO. 10 - SECTION OF MUFFLER SHOWING CRACK THROUGH HOLE OF SUPPORT PIECE (LOWER LEFT) AND CRACK AT FUSION WELD

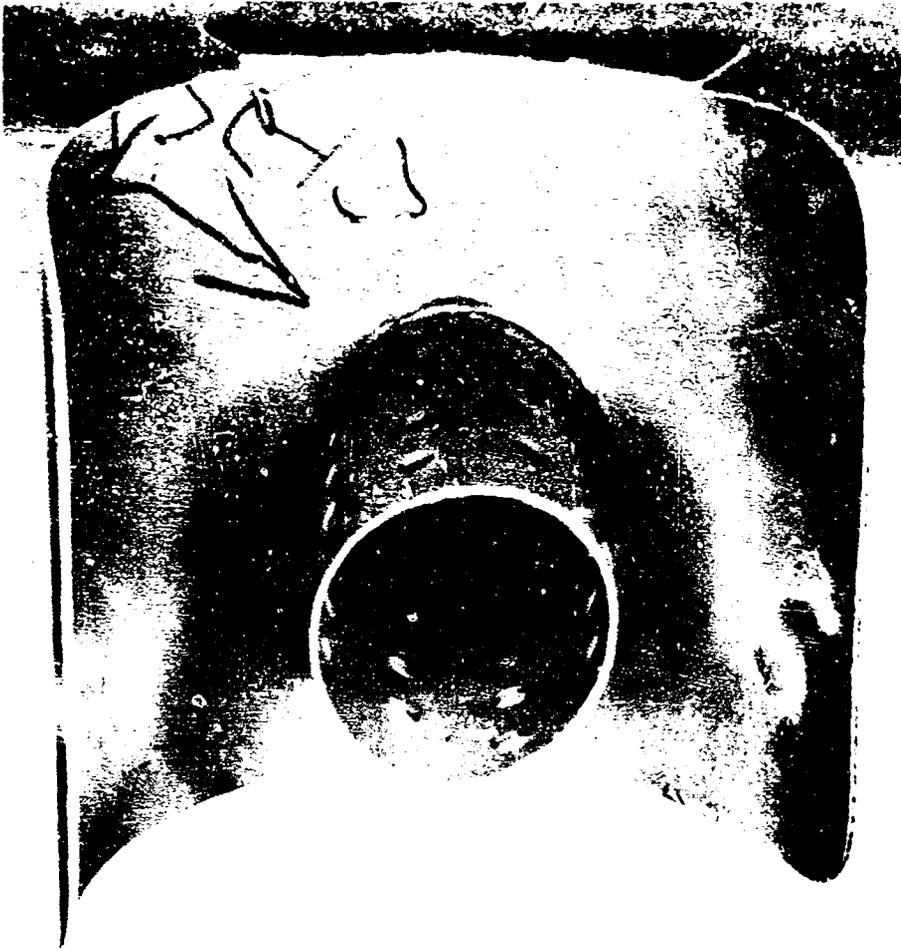
FIG. 30 SAMPLE NO. 10 - VIEW SHOWING CRACK IN SHELL

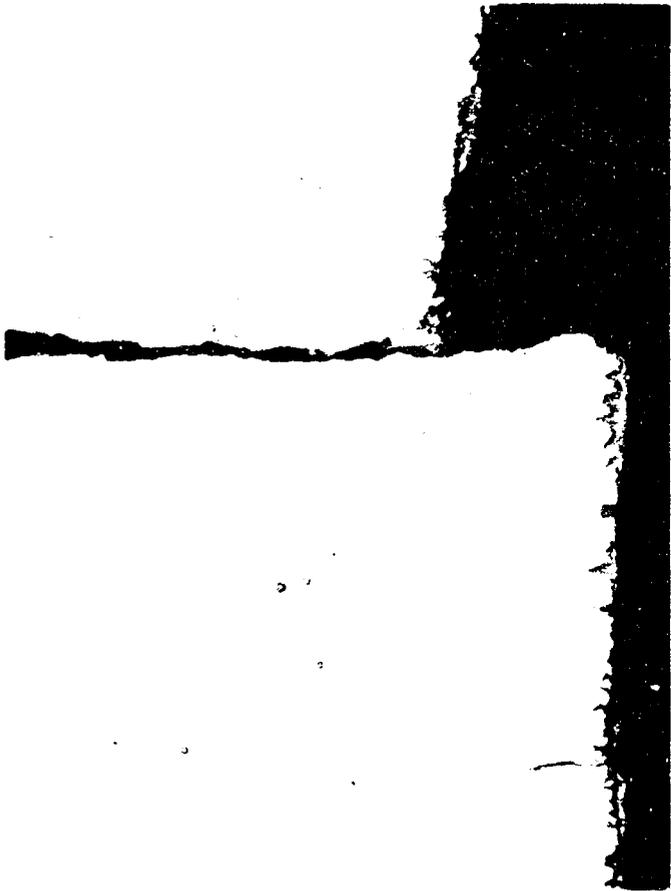
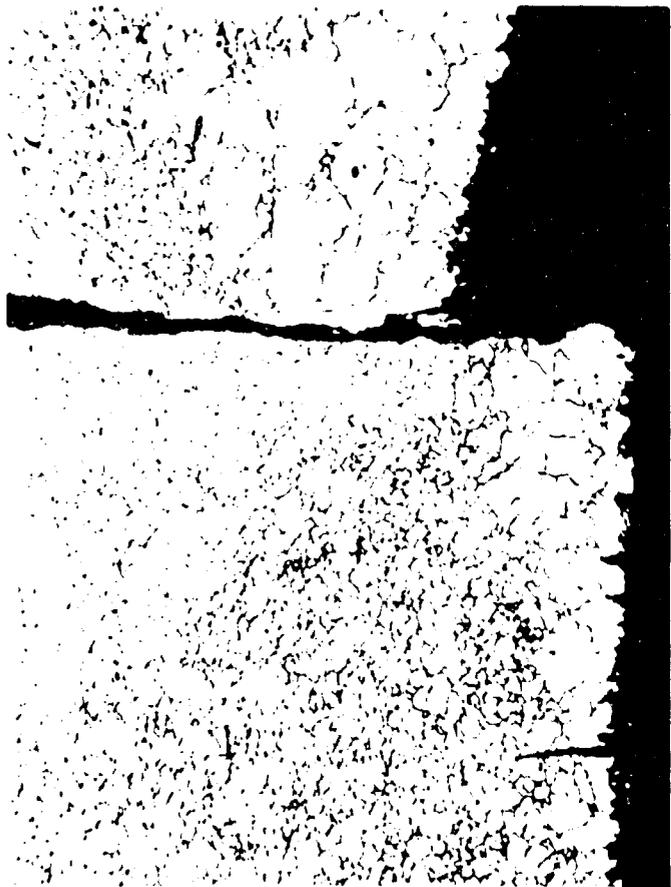
Since a specimen for metallographic examination to view the end of the crack was difficult to obtain because of the curved surfaces, a specimen was taken through the weld perpendicular to the plane of the crack in the shell. This specimen included portions of the tube, the support piece, and the shell. After the sample was polished, the crack through the shell extended all the way through the cross-section in the plane being viewed. This is shown in Figure 31 by the relative displacement of the two pieces.

FIG. 31 SAMPLE NO. 10 - SHOWING CRACK IN SHELL

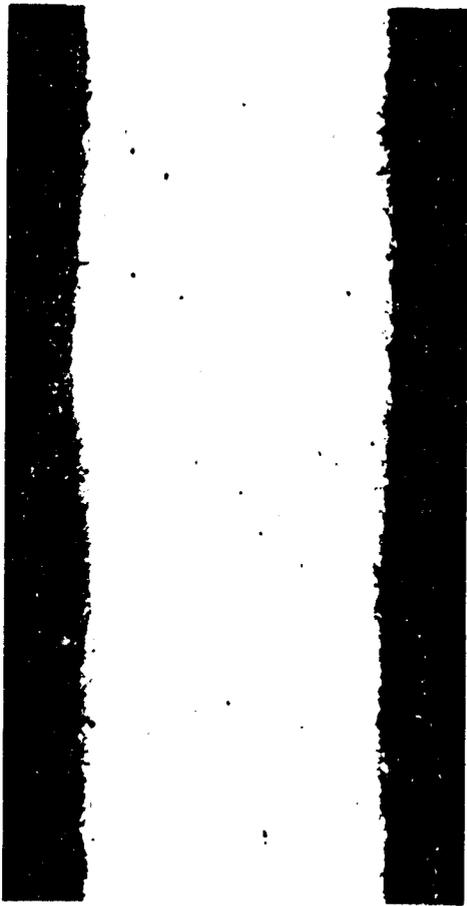
FIG. 33

Specimens for metallographic examination were taken in areas of various amounts of distortion. Figure 33 shows heavy oxidation and a tendency towards intergranular oxidation at the metal-heavy scale interface. Thicknesses of the specimens varied considerably due to the amount of oxidation involved. Figure 34 shows the microstructure at one surface. The structure contains many carbides and sigma phase. The sigma phase was present throughout the cross-section of all specimens examined. The carbides were present at both surfaces of all specimens. Where material was thinned considerably many carbides were present throughout the cross-section.

SAMPLE NO. 11 - SHOWING
HEAVY OXIDATION OF
BAFFLE

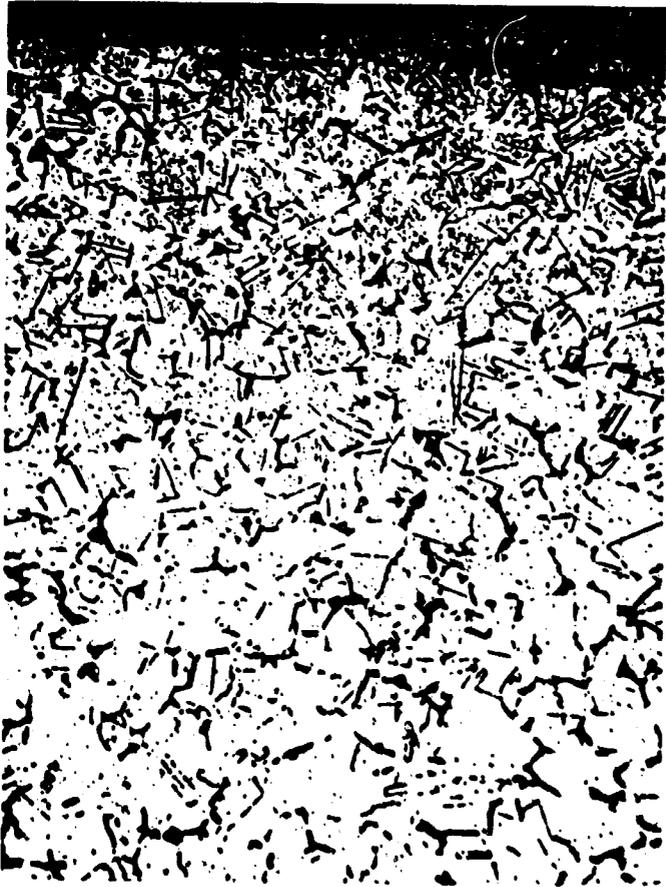
FIG. 34

SAMPLE NO. 11 - SHOWING
CARBIDES AT INSIDE SURFACE
OF BAFFLE (TOP) AND SIGMA
PHASE IN GRAIN BOUNDARIES

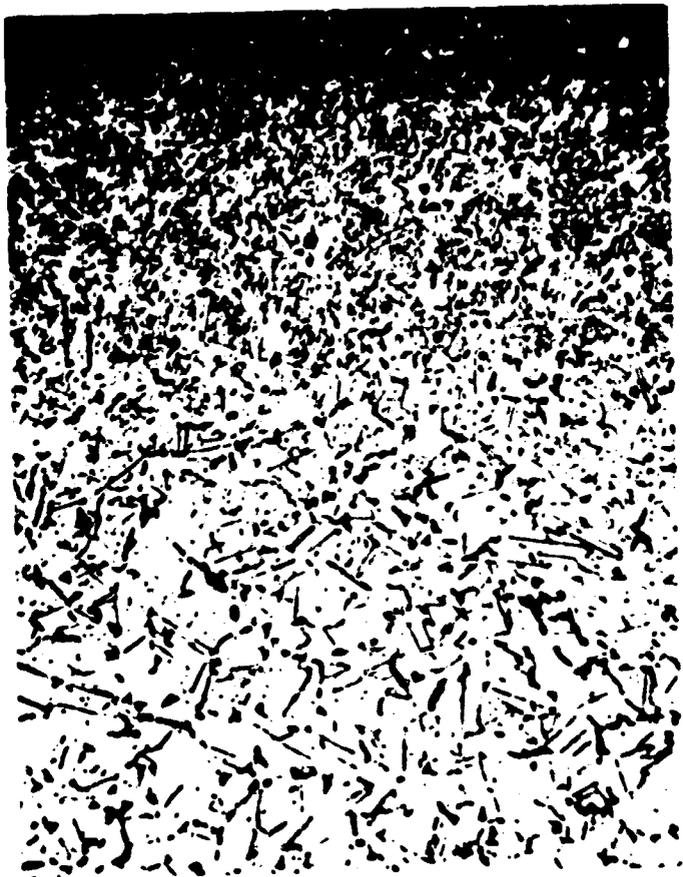
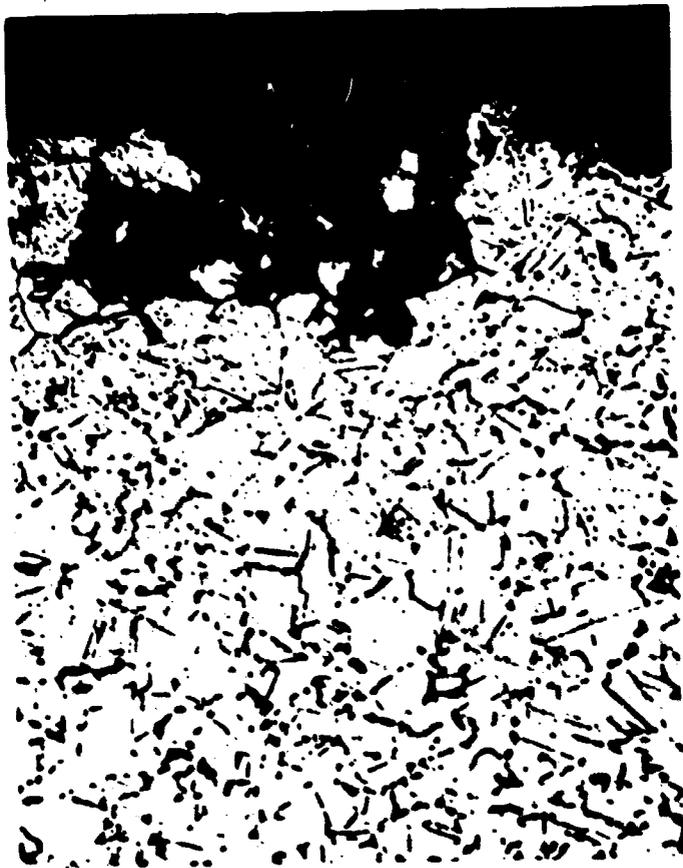
FIG. 38 SAMPLE NO. 12 - SHOWING (A) SIGMA PHASE AND CARBIDES AT THE OUTSIDE SURFACE AND (B) SIGMA PHASE WITH MUCH LESS CARBURIZATION AT THE INSIDE SURFACE

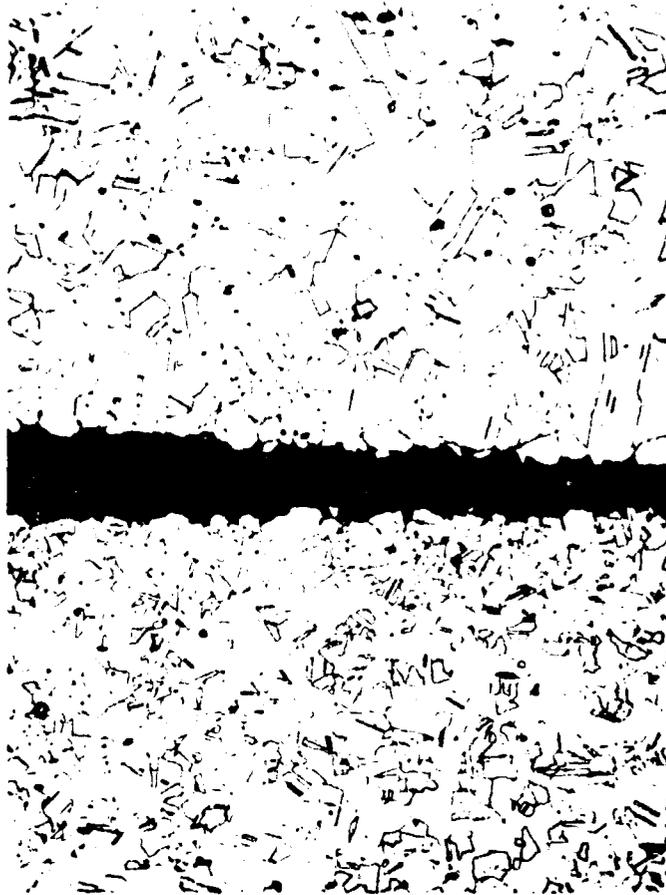
FIG. 40

Two specimens for metallographic examination were taken through the spot welds, one specimen being from the side that cracked and the other being on the opposite side of the stack. The grain size of the piece which cracked was larger than that of the collar. The two specimens allowed examination of four spot welds. All four of these showed the weld nugget to be located more in the collar than in the cracked piece. The microstructures of the spot welds and base metal appeared normal in the specimen taken on the opposite side of the crack. The microstructures of the two materials are shown in Figure 40 at a section between the two spot welds.

SAMPLE NO. 14 - SHOWING
STRUCTURE AT A LOCATION
ON SIDE OF TAILPIPE
OPPOSITE TO THAT WHICH
CRACKED

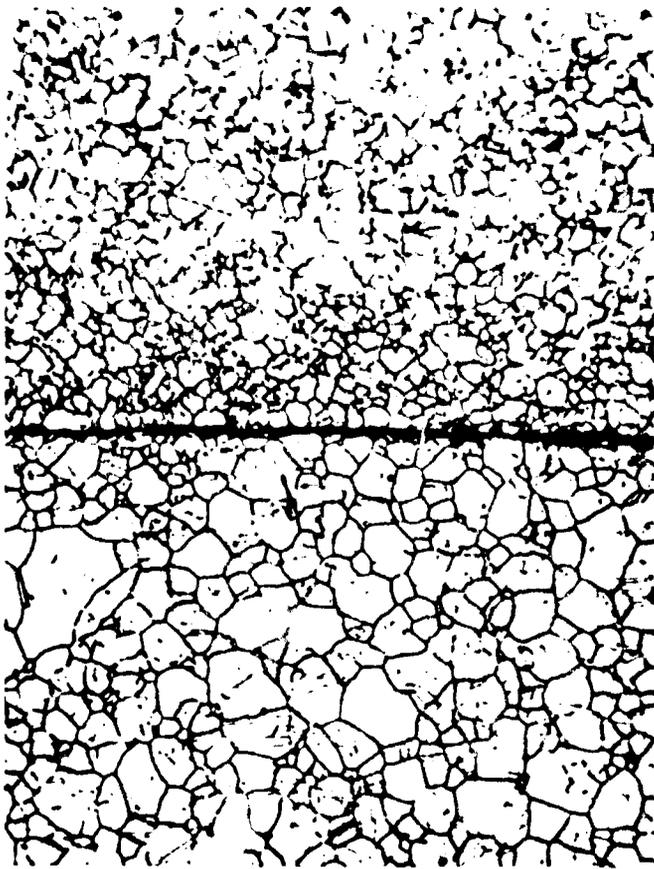
FIG. 42

SAMPLE NO. 14 - SHOWING GRAIN BOUNDARY PRECIPITATE AT A LOCATION NEAR THE SPOT WELD AND THE CRACK.

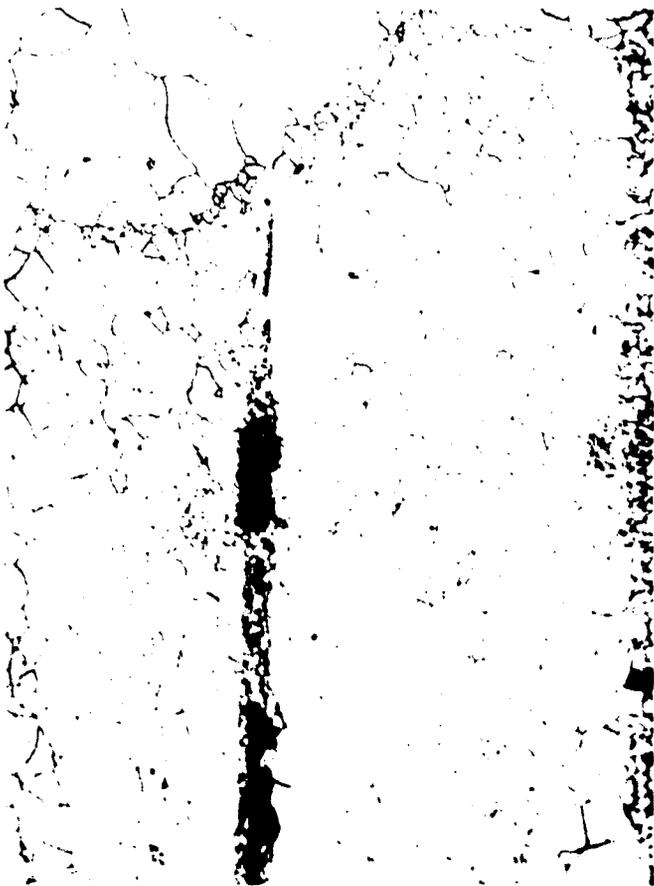
FIG. 43

SAMPLE NO. 14 - SHOWING THE STRUCTURE OF A PORTION OF THE SPOT WELD AND THE BASE METAL NEAR THE FUSION WELD. THE GRAIN SIZE IS LARGER THAN AT OTHER LOCATIONS EXAMINED. THE STRUCTURE SHOWS A GRAIN BOUNDARY PRECIPITATE.

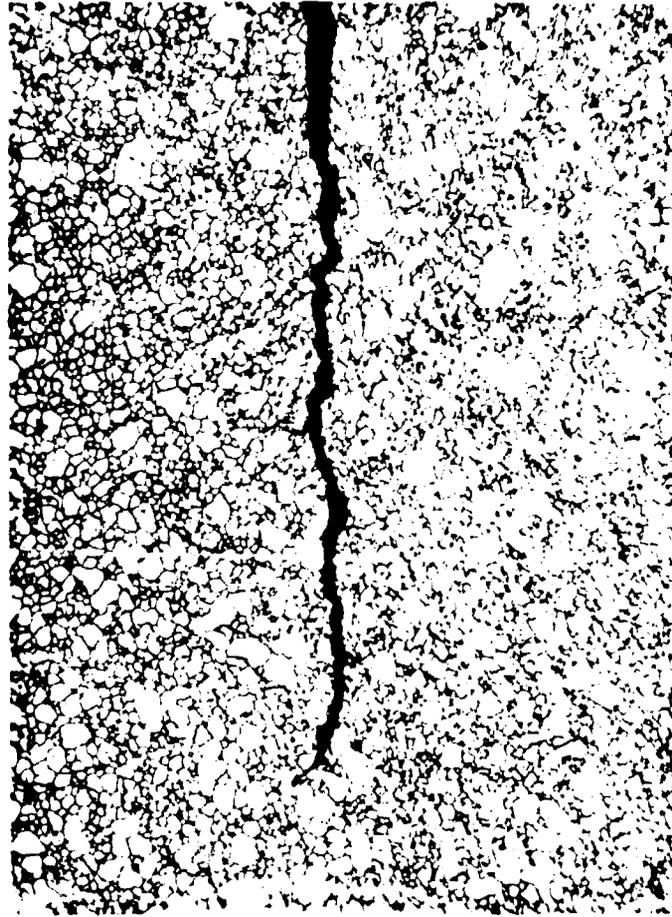
FIG. 44 SAMPLE NO. 14 - SHOWING A BRANCH OFF THE MAIN CRACK
