Technical Report

CORROSION OF MILD STEEL  
IN CONCRETE

U. S. NAVAL CIVIL ENGINEERING LABORATORY  
Port Hueneme, California

Type C Final Report

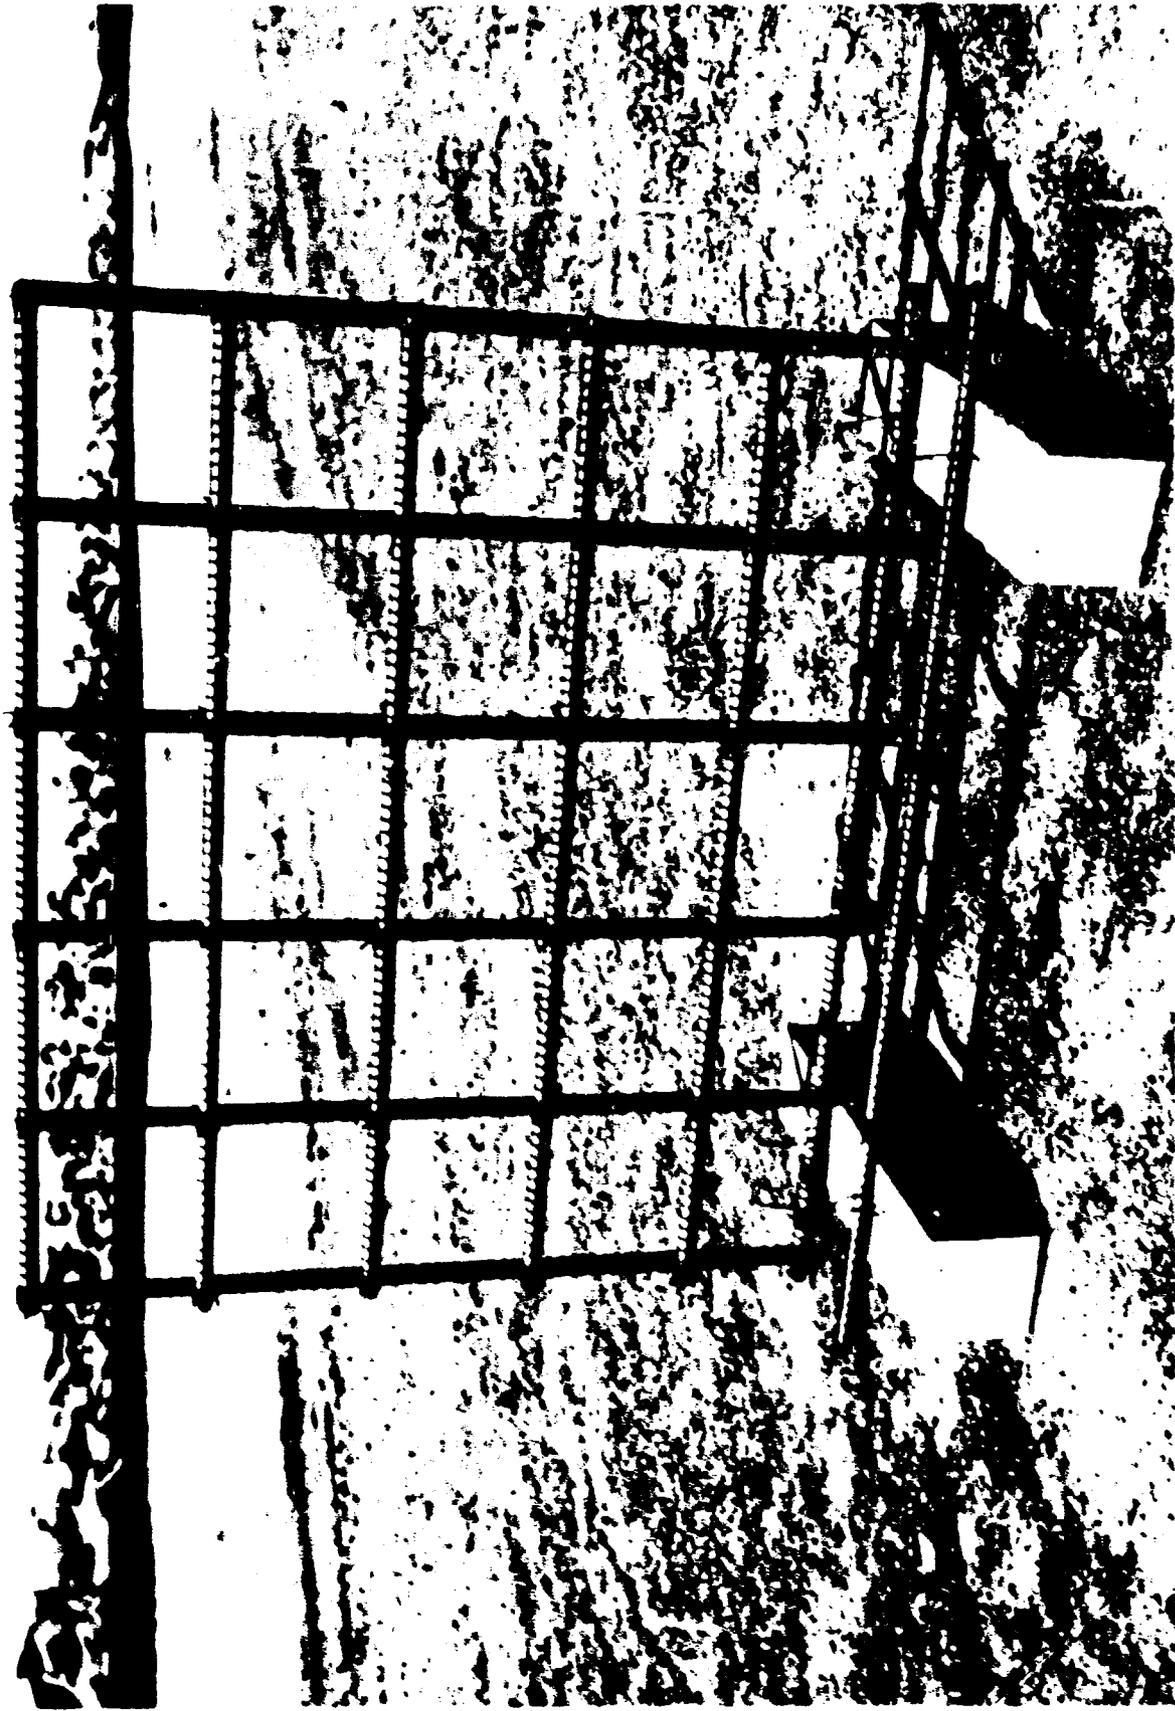
Figure 1. Grid of No. 5 reinforcing bars. This grid is held together with nylon cord. The points of contact are insulated with plastic tape.

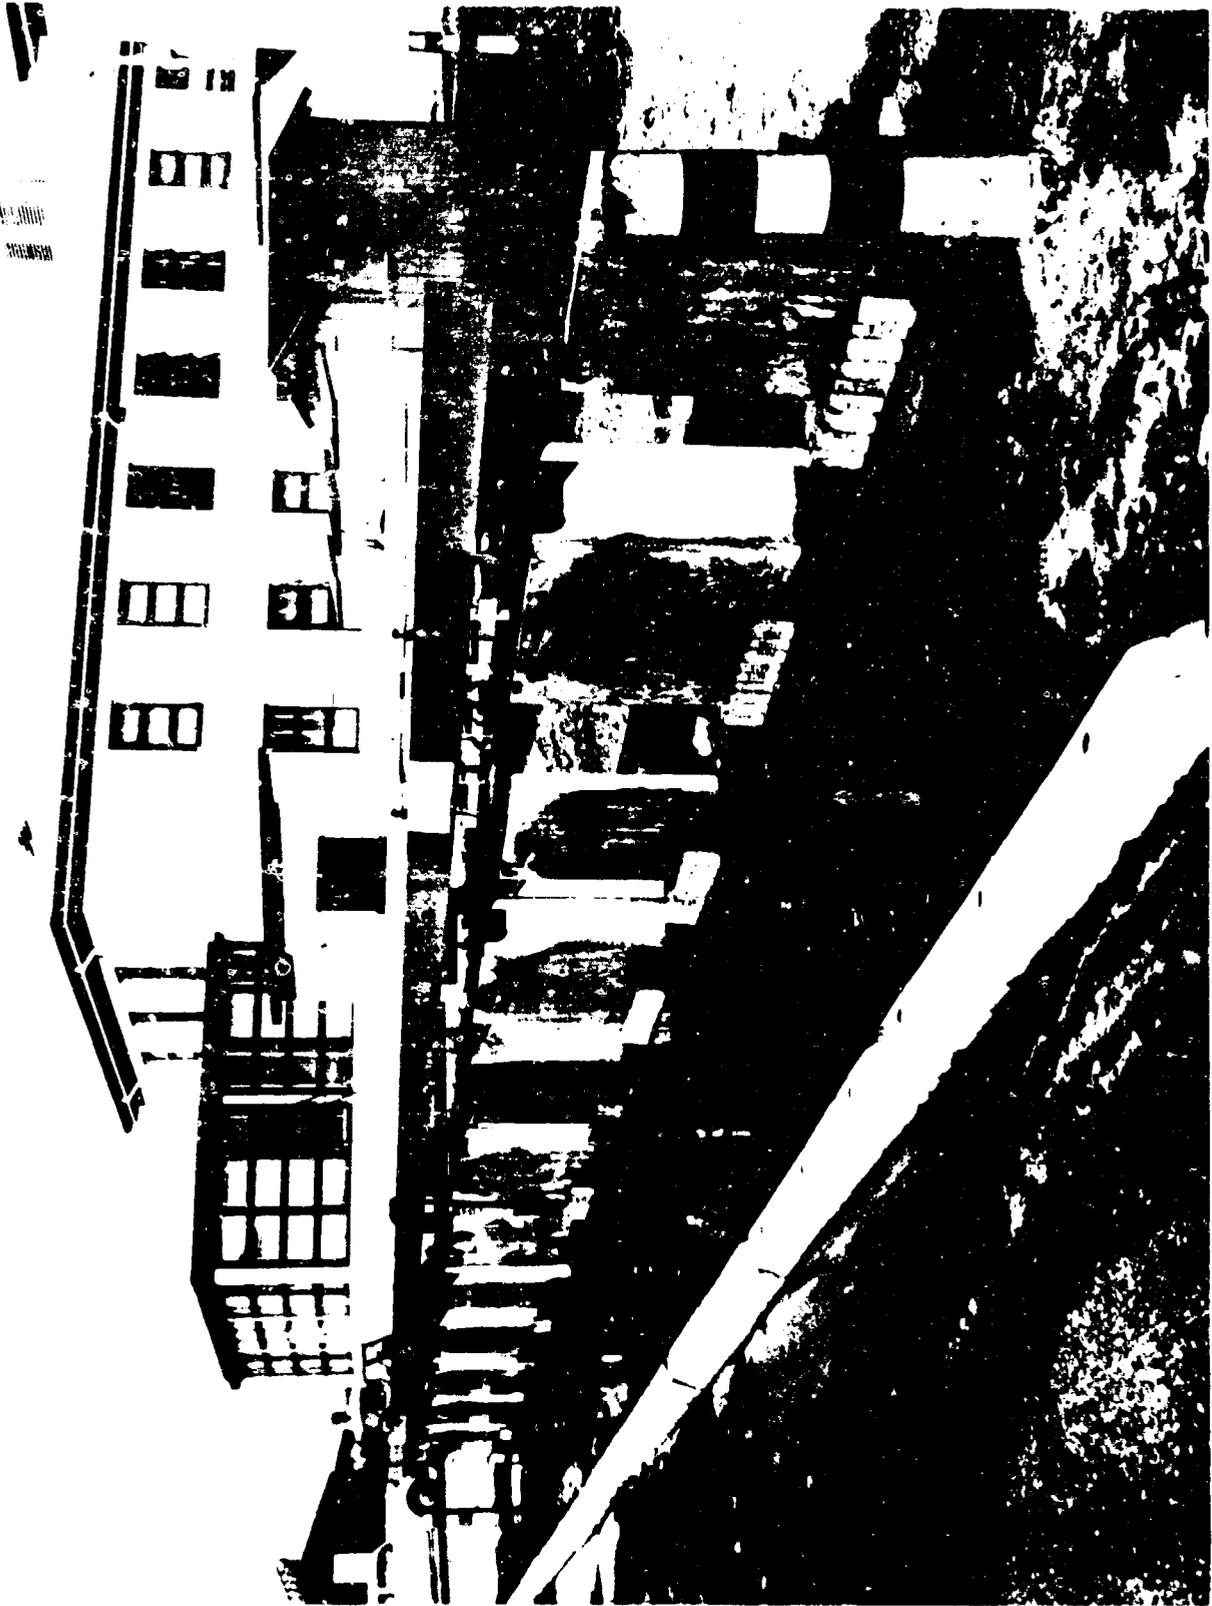
Figure 2. Overall view of experimental walls. Line of walls is west to east from left to right.

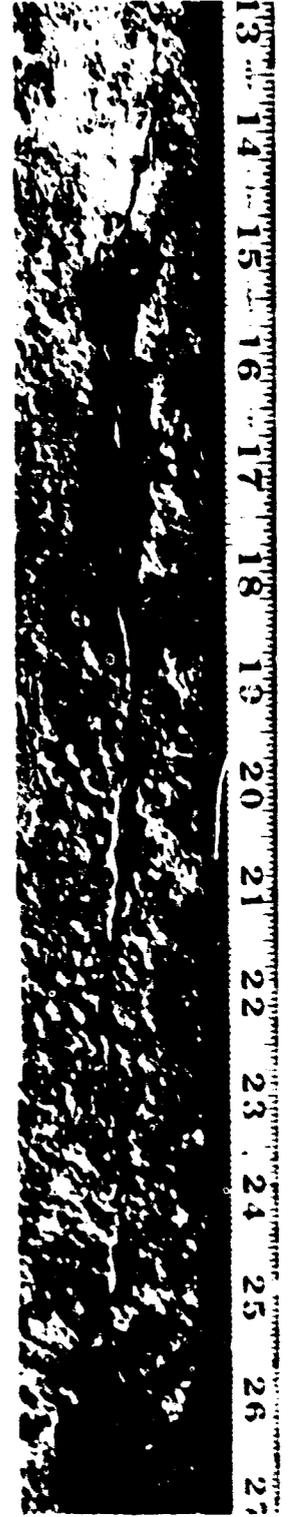
1961 - May 15	Casting date.
1962 - Sept 5	Brown stains (spots) apparent on east end face and on upper left of north face.
1963 - Feb 20	Crack on west end face was noticeable. See Figure 3.
1963 - Mar 5	Brown stains (spots) apparent on south face.
1963 - Sept 23	Vertical crack apparent on lower left corner of south face. See Figure 4.
1965 - Feb 23	Crack on east end face. See Figure 5.

(a) 20 Feb 1963  
First observed

Figure 3. Wall No. 1, west end face. Progression of cracking.

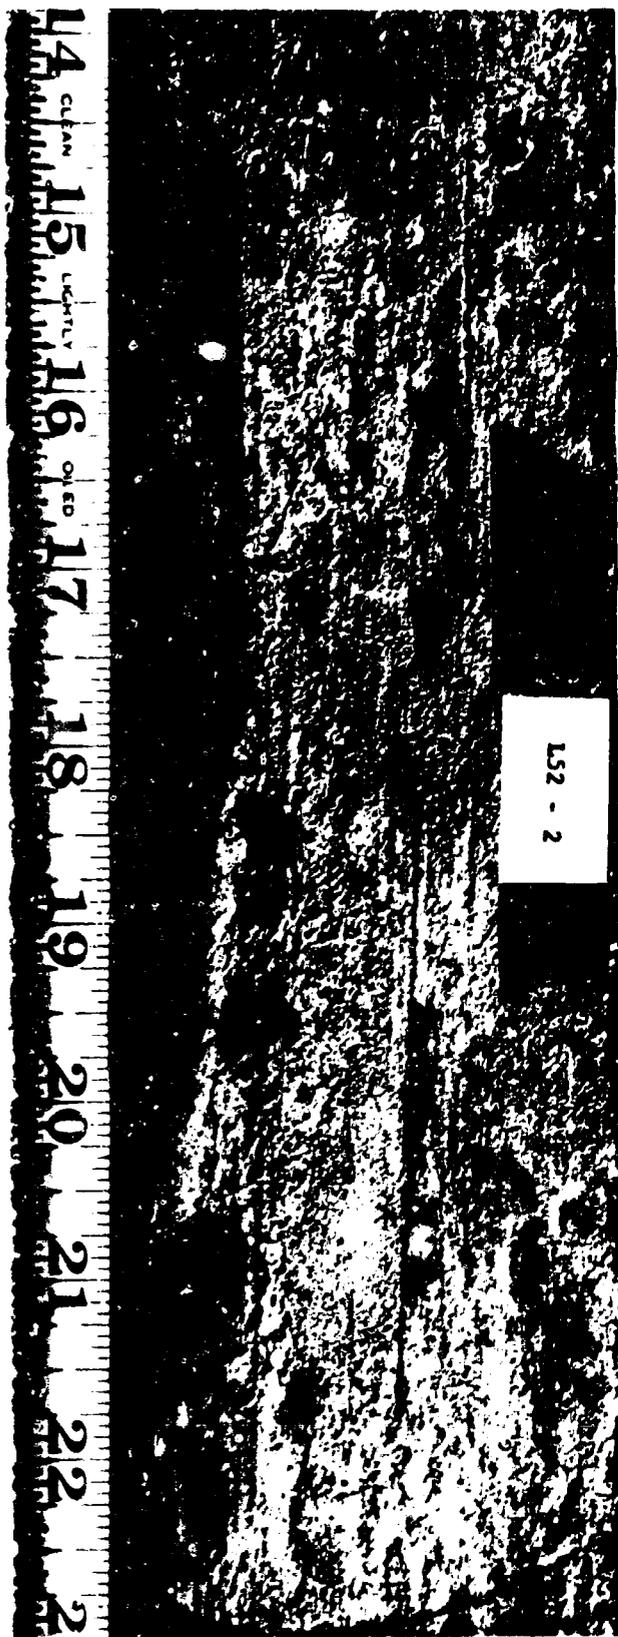
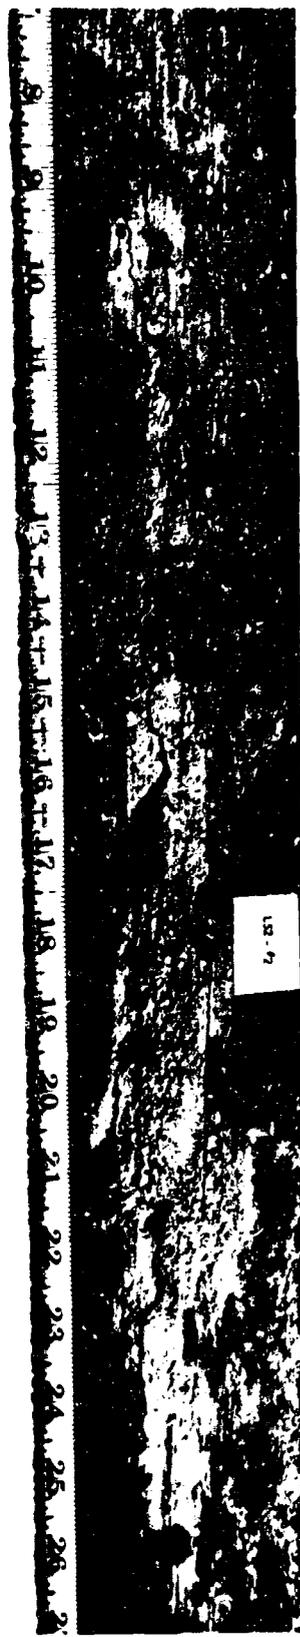
1961 - May 8	Casting date.
1962 - Sept 5	Brown stains (spots) on both end faces and on upper middle of north face (6 inches from top). Hairline cracks (vertical) apparent on both end faces.
1963 - Feb 20	Cracks on end faces more noticeable. See Figures 6 and 7.
1963 - Mar 5	Cracks on end faces more extensive. Brown stains (spots) on all faces except top. Small curved crack in upper left-hand corner of south face. See Figure 8.
1964 - Sept 18	Two horizontal cracks apparent on north face. See Figure 9.

Figure c. Wall No. 2, east end face. Progression of cracking first observed 5 Sept 1962.

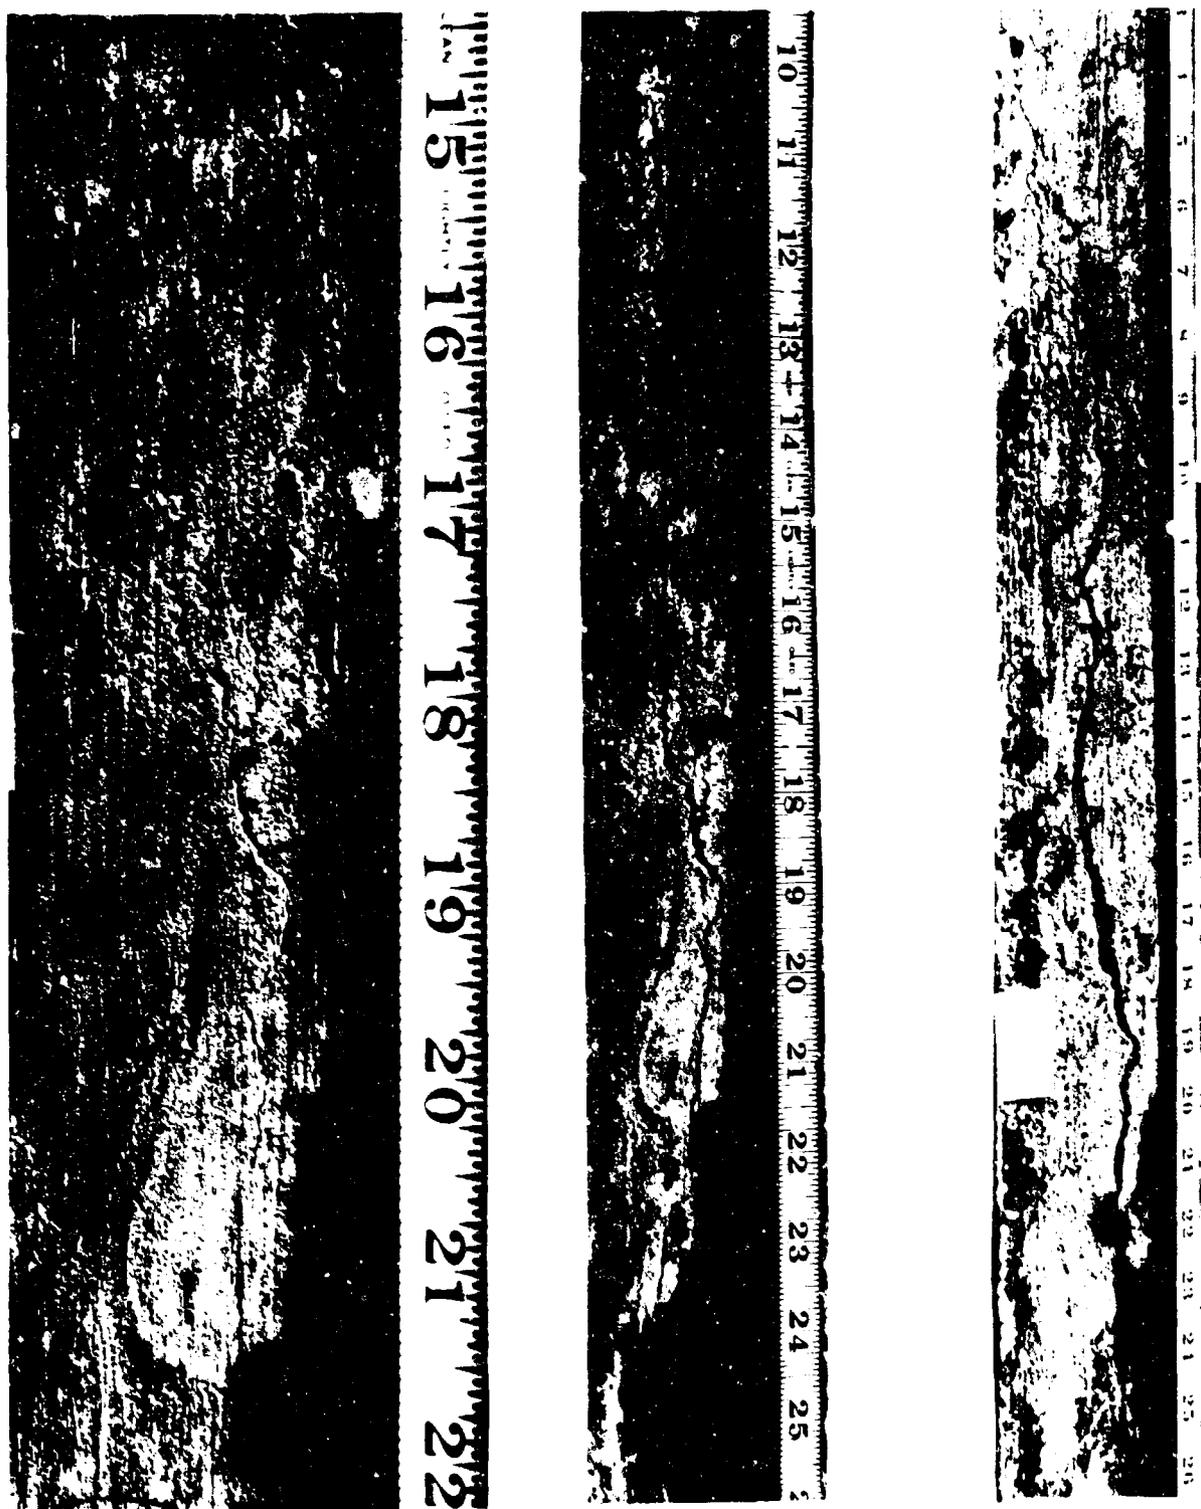
Figure 7. Wall No. 2, west end face. Progression of cracking first observed 5 Sept 1962.
