DEEP-OCEAN BIODETERIORATION  
OF MATERIALS - PART II. SIX  
MONTHS AT 2,340 FEET

August 1965

U. S. NAVAL CIVIL ENGINEERING LABORATORY  
Port Hueneme, California

James S. Muracka

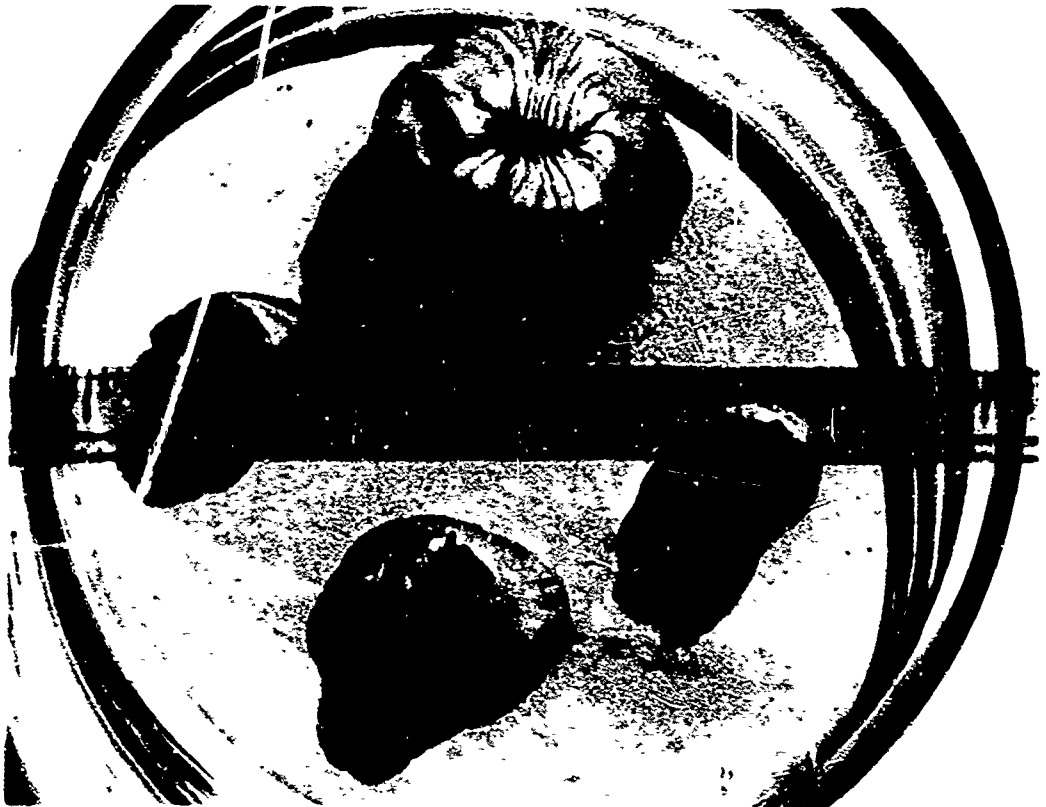
A large number of pink sea anemones, up to 3 inches in diameter at the base, were found securely attached over the entire 6,000-foot length of polyethylene-jacketed 1/2-inch-diameter wire rope (Figures B-3 and B-4). The jacketed wire rope was attached to the STU frame and stretched across the ocean floor to serve as an alternate method of retrieving the STU by means of grappling.

Figure B-4. Close-up view of deep-sea anemones.

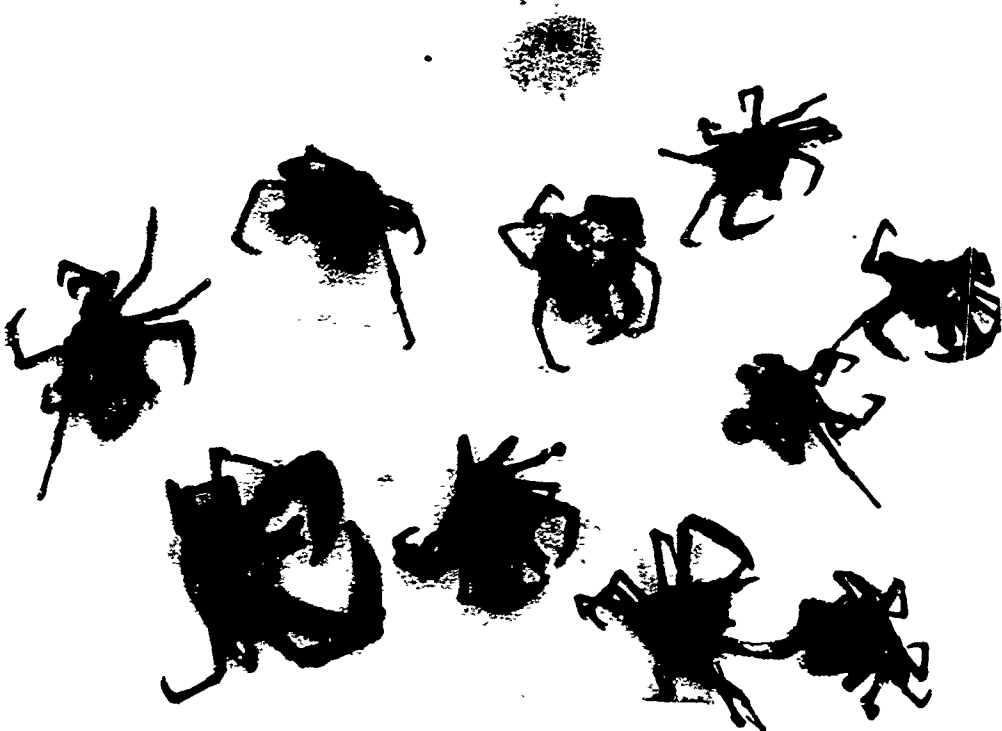
There were several hundred amphipods (Figure B-7) about 3/8 inch long swarming over the materials on the bio-rack. It is possible that several thousand other amphipods may have been washed off during recovery of the STU. In addition to the amphipods, about two dozen small crabs were also found crawling over the materials on the bio-rack (Figure B-8). One was found wedged in between metal test specimens.

Figure B-8. Deep-sea crabs found crawling over STU test specimens.

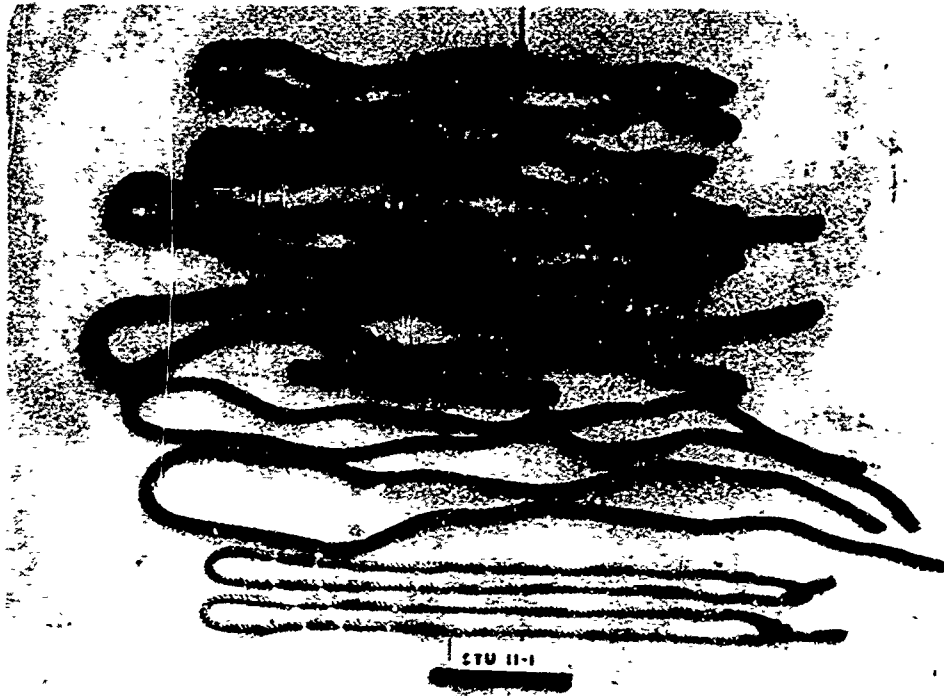
A heavy growth of slime bacteria was present on the surface of nylon, polypropylene, cotton, and Manila ropes (Figure B-12). The fibers of cotton rope were decayed considerably by bacterial action. The cotton fibers were easily pulled apart by tweezers or one's fingers. Because of the damaged fibers, considerable difficulty was experienced attempting to place a splice at each end of the cotton rope for a breaking-strength test (Figure B-13). Only a few marine borers were found on the cotton, resulting in little damage to the fibers by borers.

Figure B-12. Cotton, Manila, polypropylene, and nylon rope specimens after recovery.

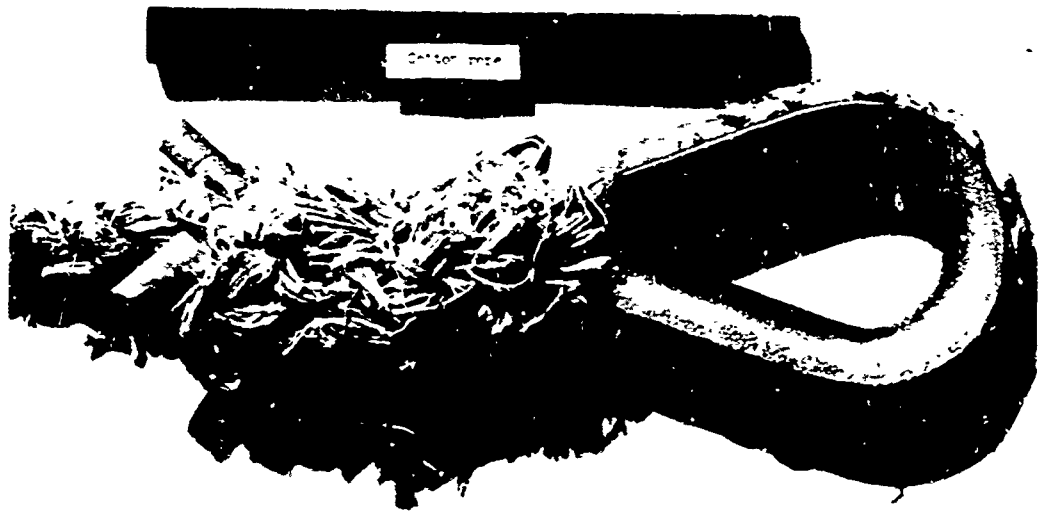
Figure B-13. Fibers of cotton rope decayed by microorganisms.

Because of severe biological deterioration of untreated wood panels (including redwood), jute fiber materials, and cotton and Manila ropes, the use of these materials for deep-ocean applications is not recommended. Electrical cables covered with silicone rubber insulation is not recommended for use on the sea floor in the vicinity of Test Site II, where large deep-sea crabs exist and presumably attack this material.

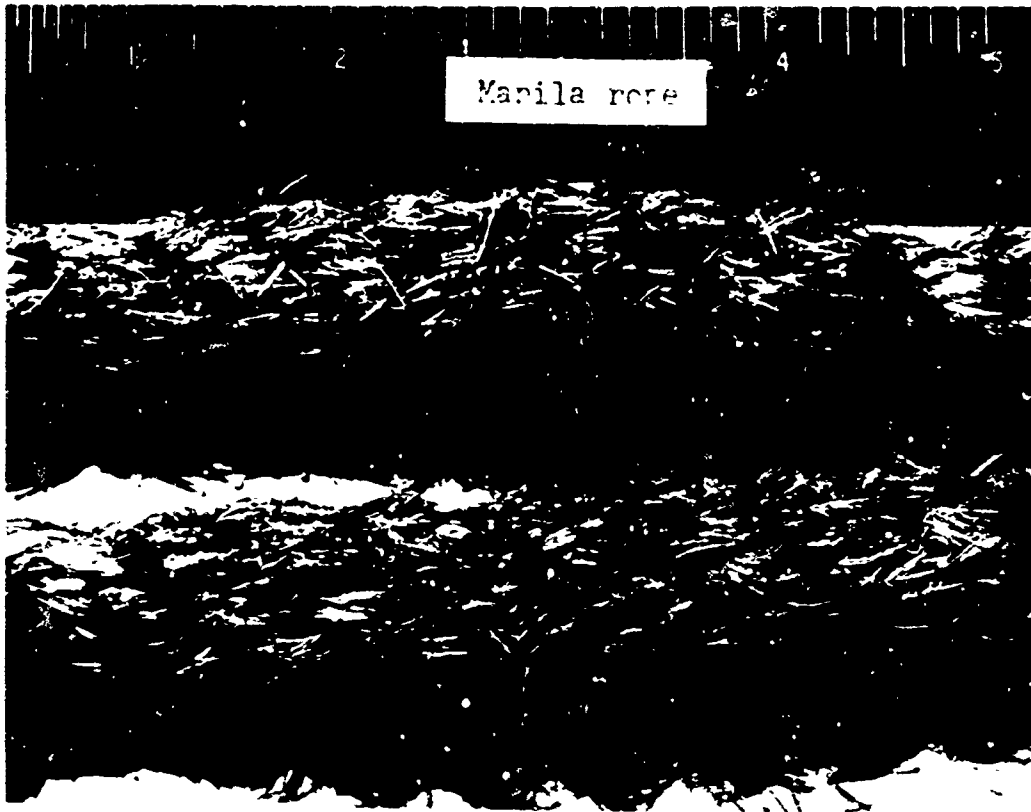
Manila rope specimens were severely damaged by marine borers. The fibers were severed completely by the boring action of small borers. The 1/2-inch-diameter Manila rope was so heavily infested with borers deep inside the rope that it was impossible to count the numbers present. It was estimated that there were several hundred per lineal inch of the entire length of two 5-foot rope specimens (Figure B-14). In addition to the borers, slime bacteria were responsible for the decay of fiber materials.

A splice could not be placed on the Manila rope specimen for a breaking-strength test because of the deteriorated condition of the rope. However, by examining the damage to the hemp fibers, it was estimated that 75 percent of the tensile strength of the rope was destroyed. The deterioration of fishing nets and ropes made of natural fibers has always been a serious problem. It has been recognized that microorganisms are the primary cause of decay of fibers, resulting in loss of tensile strength. The microorganisms responsible are chiefly cellulose-decomposing bacteria.

Figure B-14. Fibers of Manila rope destroyed by marine borers. Hundreds of borers are visible on the rope.

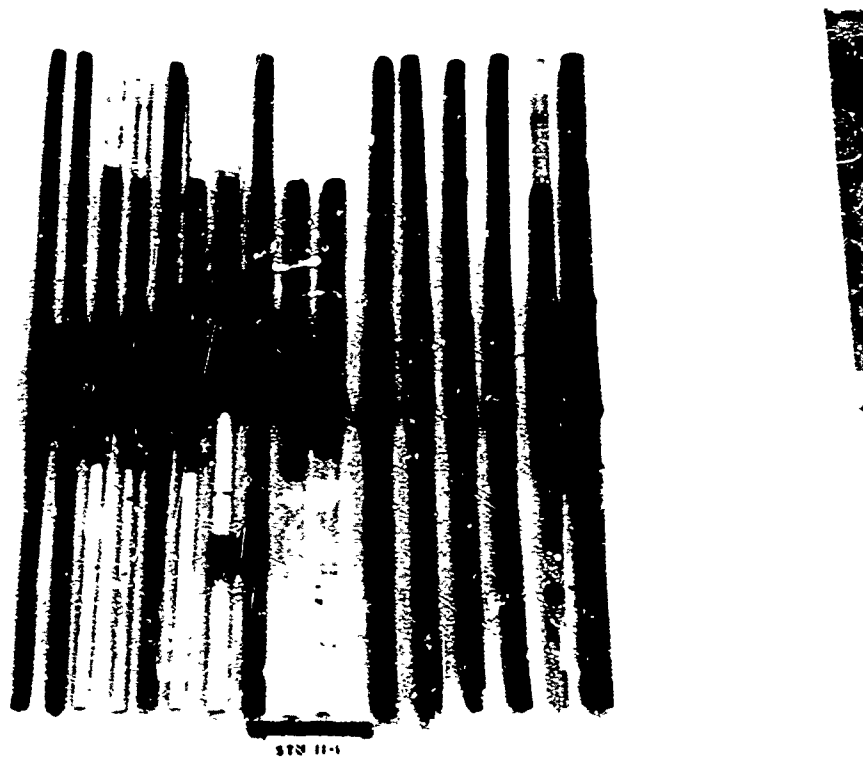
The 3-foot-long solid plastic rods and flexible tubes after 6 months of exposure are shown in Figure B-15. Plastics not deteriorated by marine organisms are noted later under the heading Unaffected Materials.

Figure B-15. Three-foot-long plastic rods and tubes after 6 months on the ocean floor.

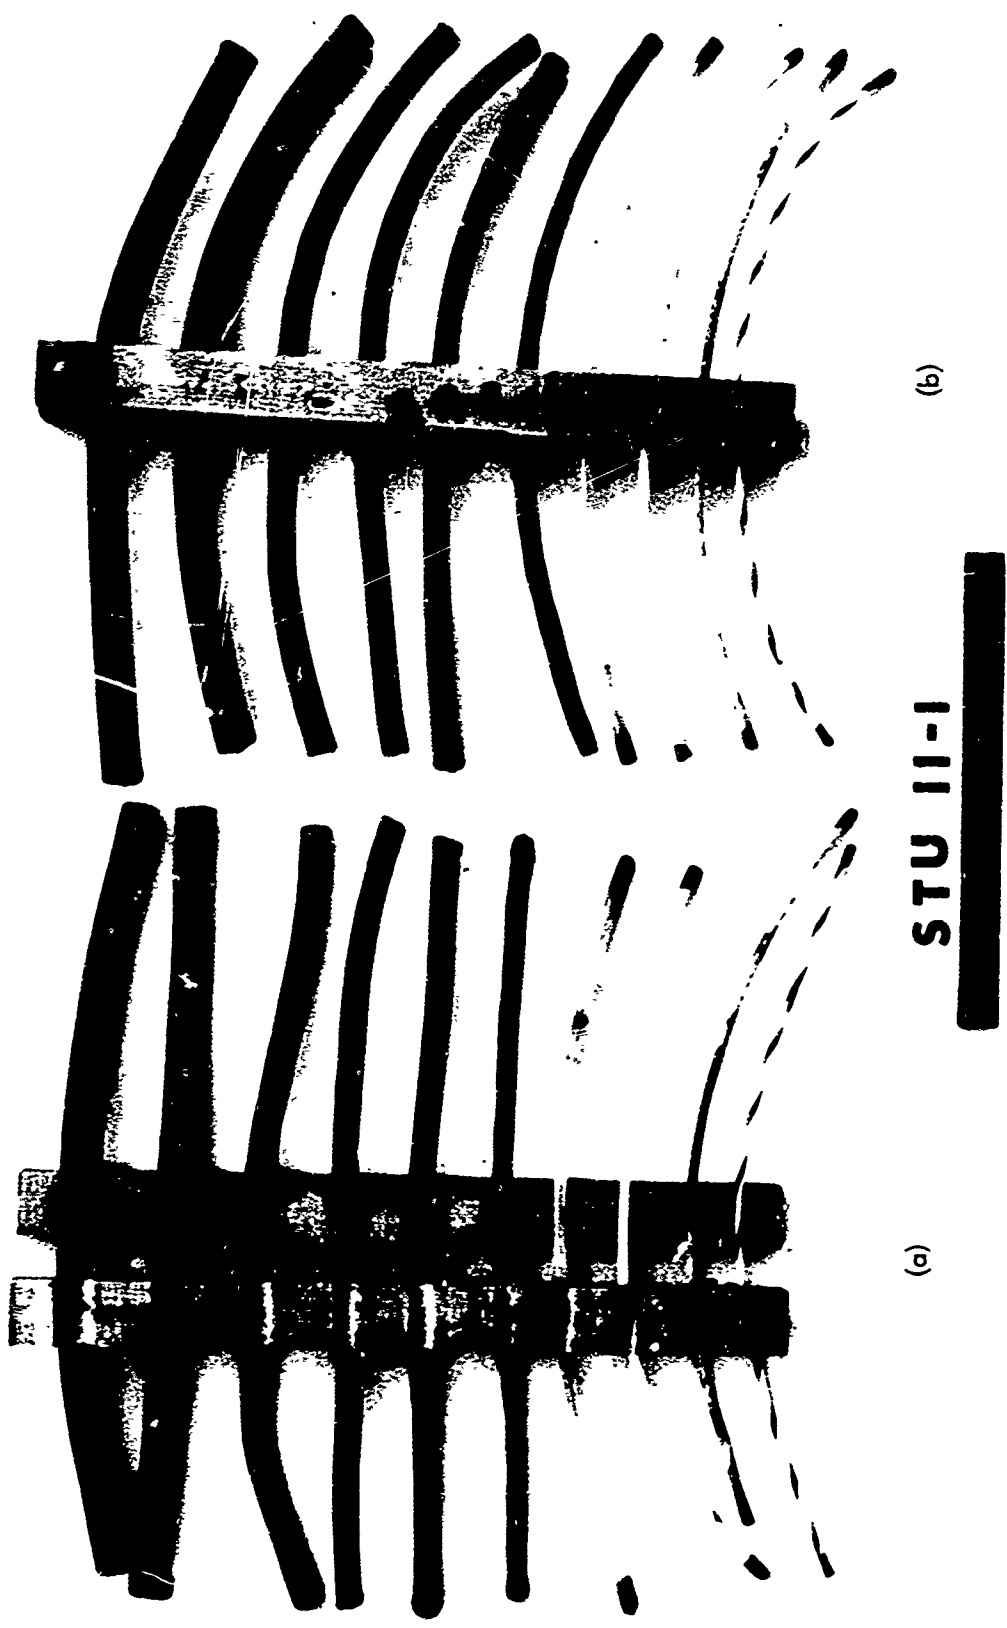
A few borers had penetrated slightly into the silicone rubber (Figure B-19) and nylon insulating materials. The borer holes found on the silicone rubber were exposed to the sea-water environment. The borer holes found on the nylon, however, were exposed in an area underneath the wooden bait piece. The bait piece exposed near the sediment was severely damaged compared to the piece exposed about 3 feet above the sediment (Figure B-20).

Figure B-20. Electrical cable test specimens showing: (a) numerous borer penetrations of wooden bait piece on specimens exposed near the sediment; (b) slight attack on specimens exposed about 3 feet above the sediment.

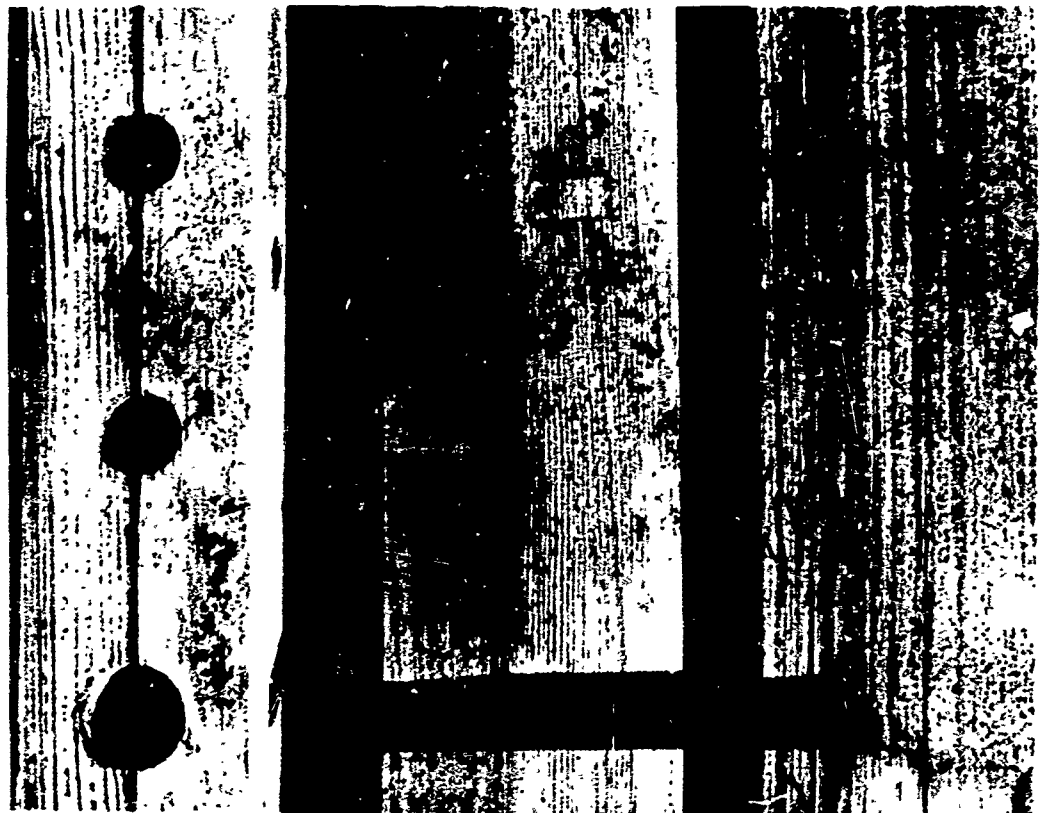
Figure B-24. Borers in pine wood bait piece. They are concentrated in an area where the rope specimens were resting against the wood.

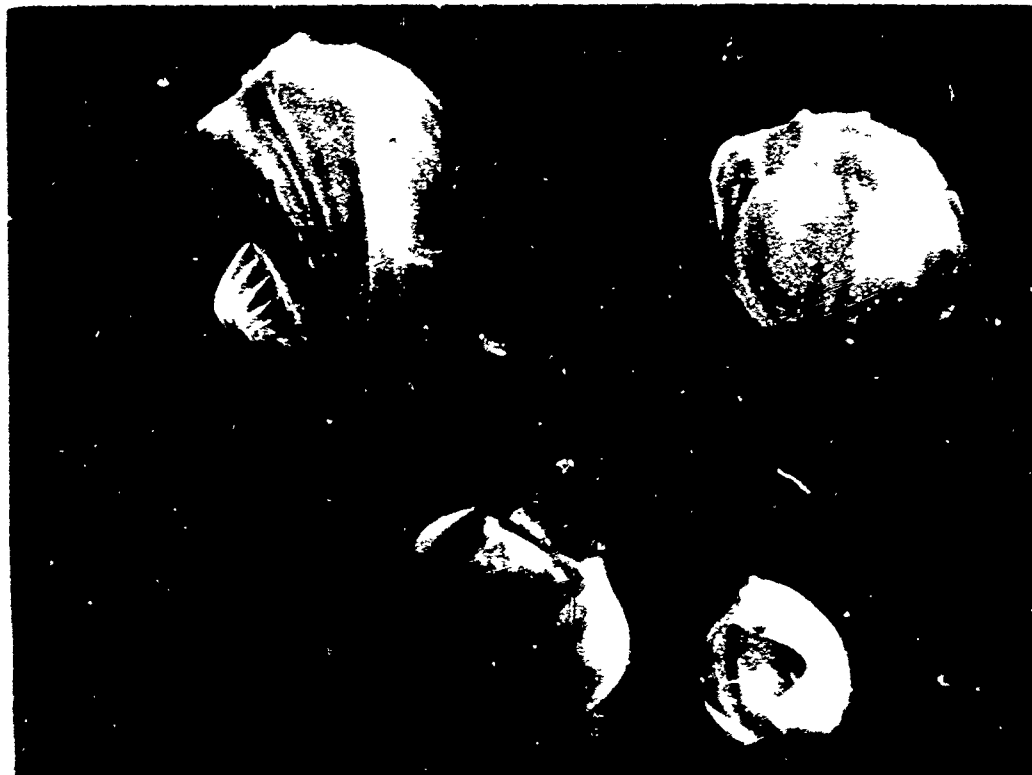
Figure B-26. Photomicrograph of borers, *Xylophaga washingtona*. These specimens were about 1/8 inch in diameter. (magnified)
