USAAVLABS TECHNICAL REPORT 65-64

TEST PROGRAM FOR AUTOMATIC LIGHT AIRCRAFT READINESS MONITOR

(Project ALARM)
FINAL REPORT

August 1965

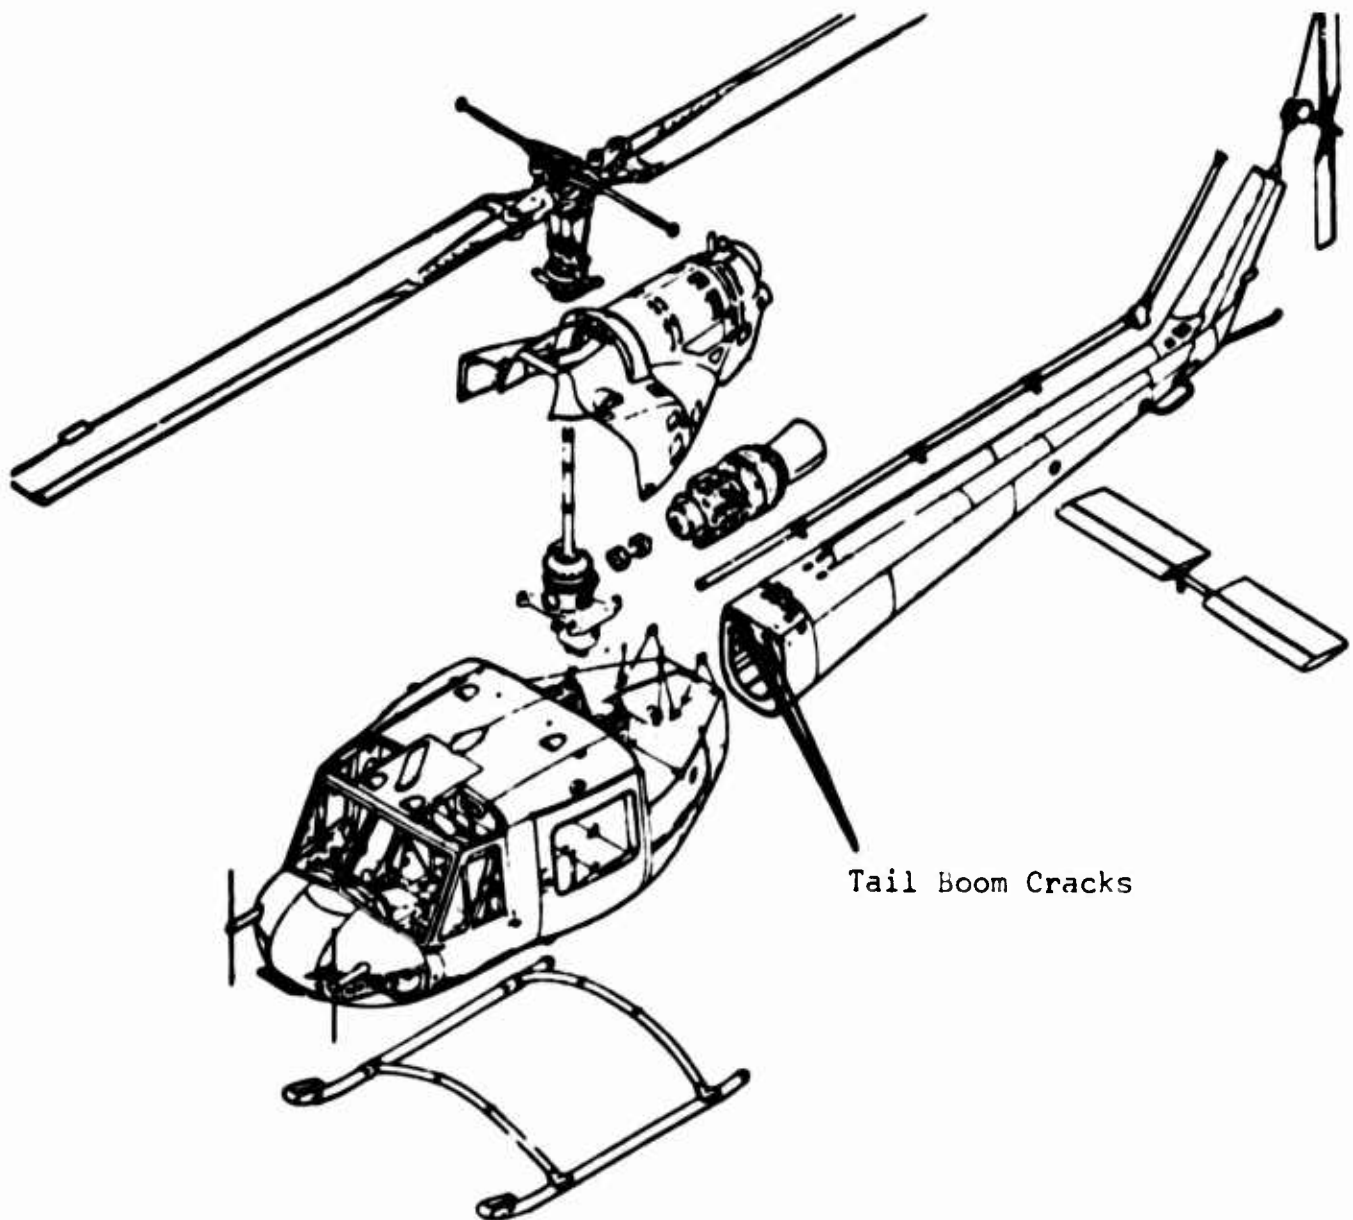
The cracks in the tail boom were discovered during a detailed inspection that was initiated because of the unusually high ALARM tail vibration readings. The locations of these cracks are shown in Figure 3. These cracks were not detected by conventional maintenance methods, and, had the unusually high ALARM vibration indications not occurred, the detailed inspection would not have been made.

Figure 3. Tail Boom Cracks From Vibration.

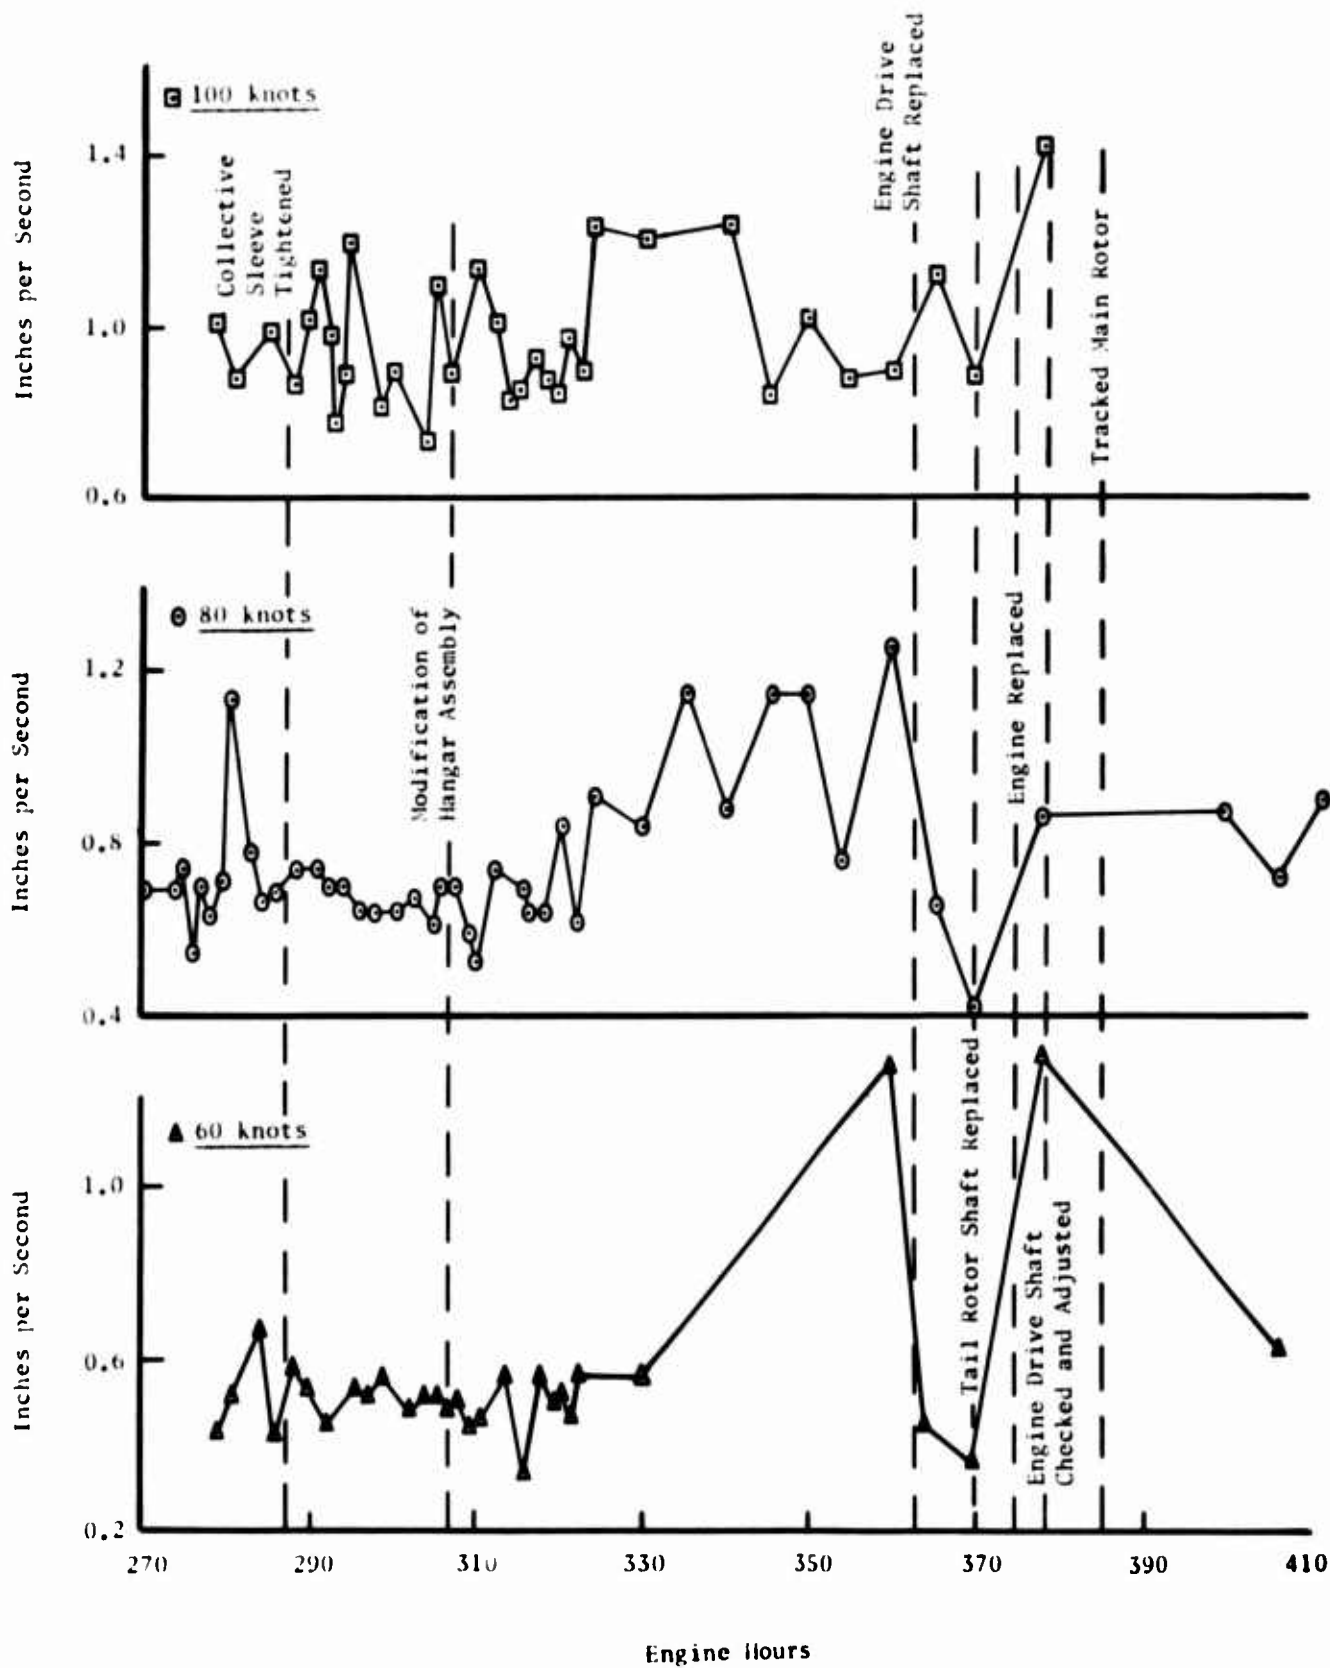
Figure 4. Low Frequency Vibration (3 to 100 cps).

During some test flights, many readings were omitted because of lack of time; thus, large gaps were left between some readings. An example of this can be seen in Figure 4 (page 18) for the 60-knot plot between engine hours 330 and 370. In such cases, the line joining the two points cannot be considered as representative of the actual vibration level and is only included for continuity.

The low frequency plots (Figure 4) for 80 knots and 60 knots indicate that there was a steady increase in the vibration level until the engine drive shaft was replaced at 363 engine hours, at which point the vibration level decreased sharply. Upon replacement of the engine, at 375 engine hours, the vibration level increased sharply. At 377 engine hours, the main rotor was tracked and the drive shaft was adjusted; the vibration level then dropped to the normal operation level.

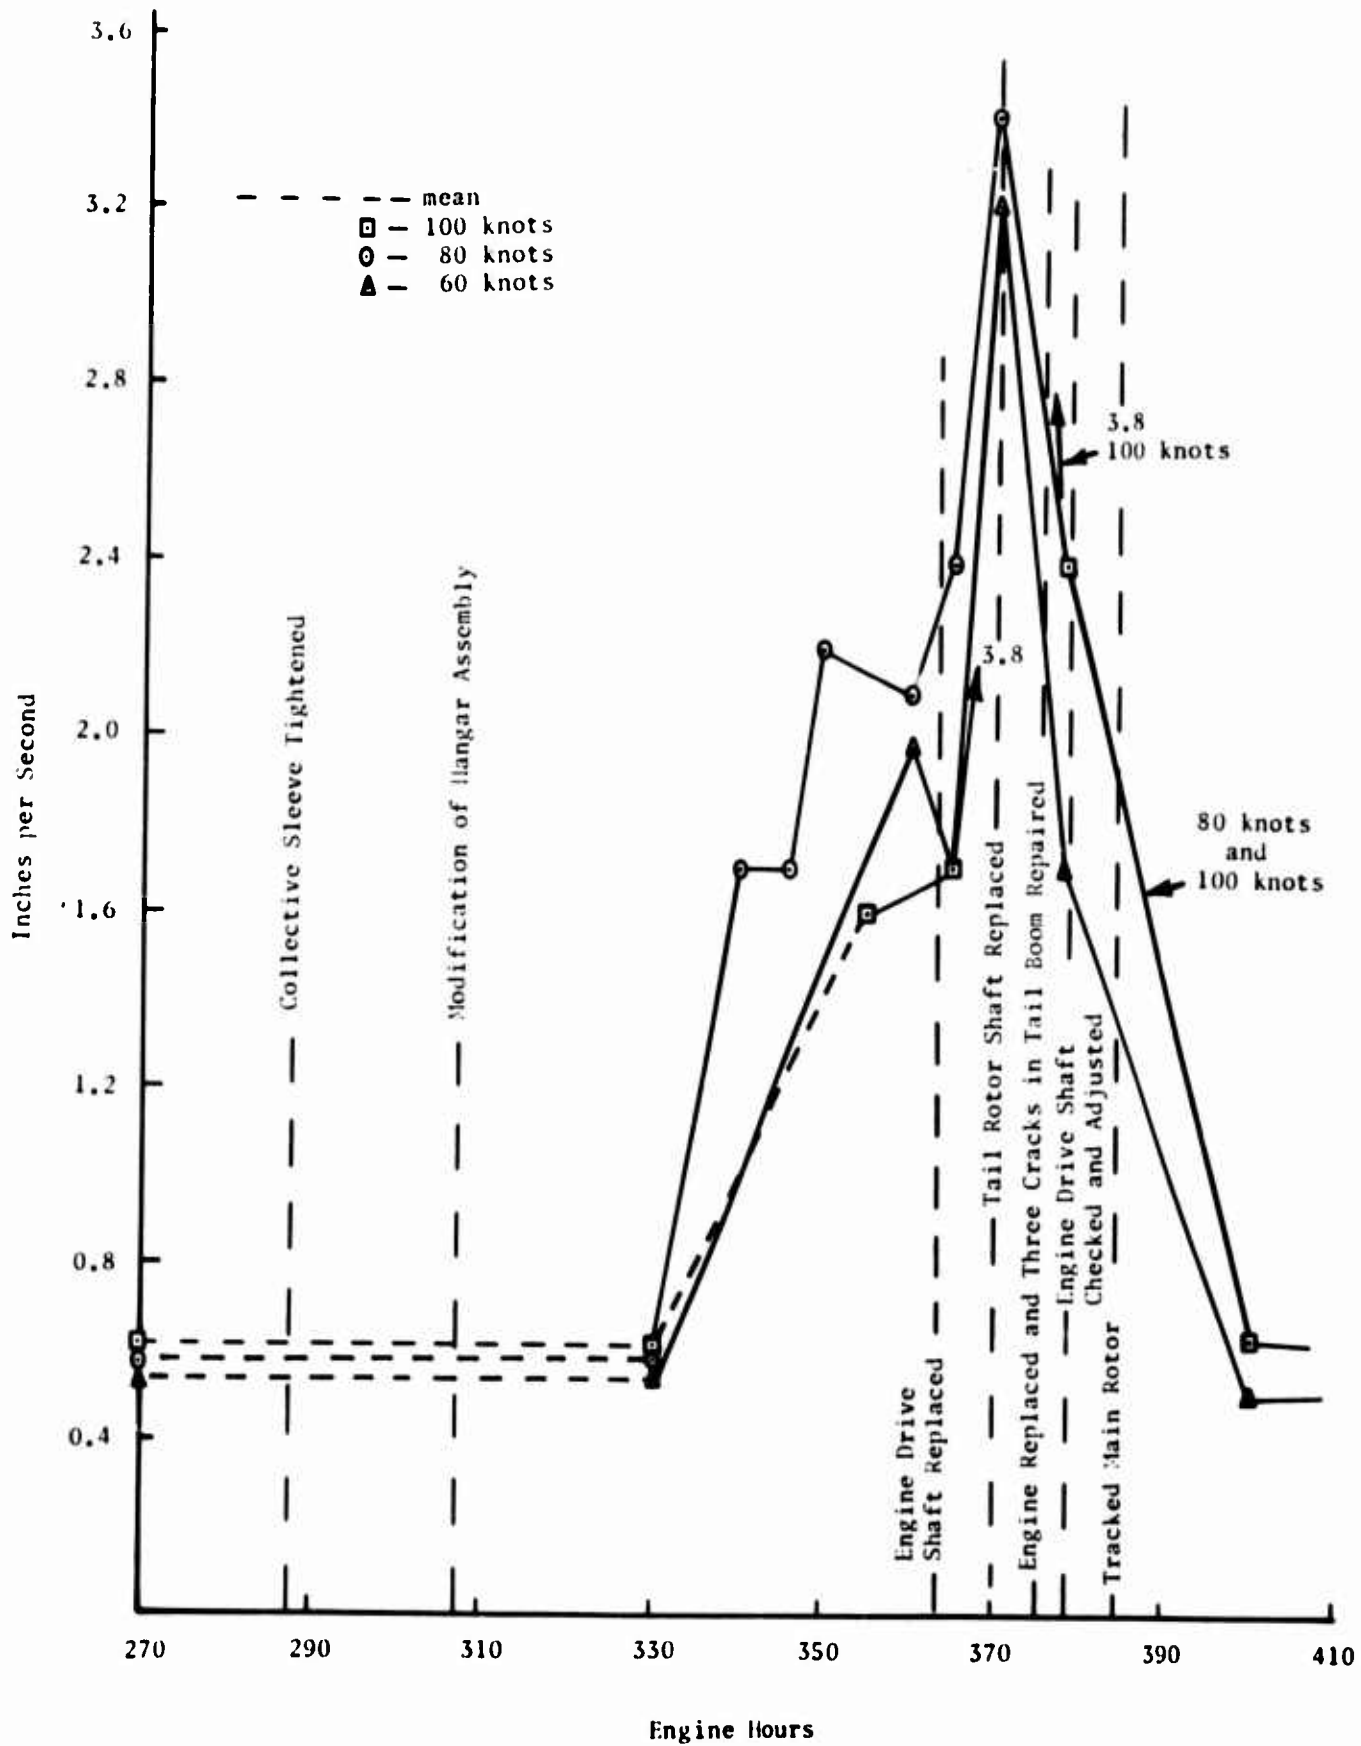
Figure 5. Tail Vibration (20 to 2,000 cps).

Figures 5 through 9 display the vibration levels of various components of the aircraft versus engine hours. Superimposed on each of these graphs are descriptions of the major repairs performed on the aircraft during the test period. Each of the vibration levels recorded was taken through a frequency band wide enough to include all significant vibrations of the respective component. Most noteworthy of the vibration plots is that of the tail vibration, Figure 5, which displays a climb in the vibration level beginning at 330 engine hours. The climb continued to the 370-engine-hour reading; then, a bent tail rotor shaft and three cracks in the tail boom were repaired and the engine was replaced. The vibration level took a substantial drop immediately following these repairs; however, it did not drop to the normal operating level until the engine drive shaft was adjusted at 377 engine hours and the main rotor was tracked at 385 engine hours.

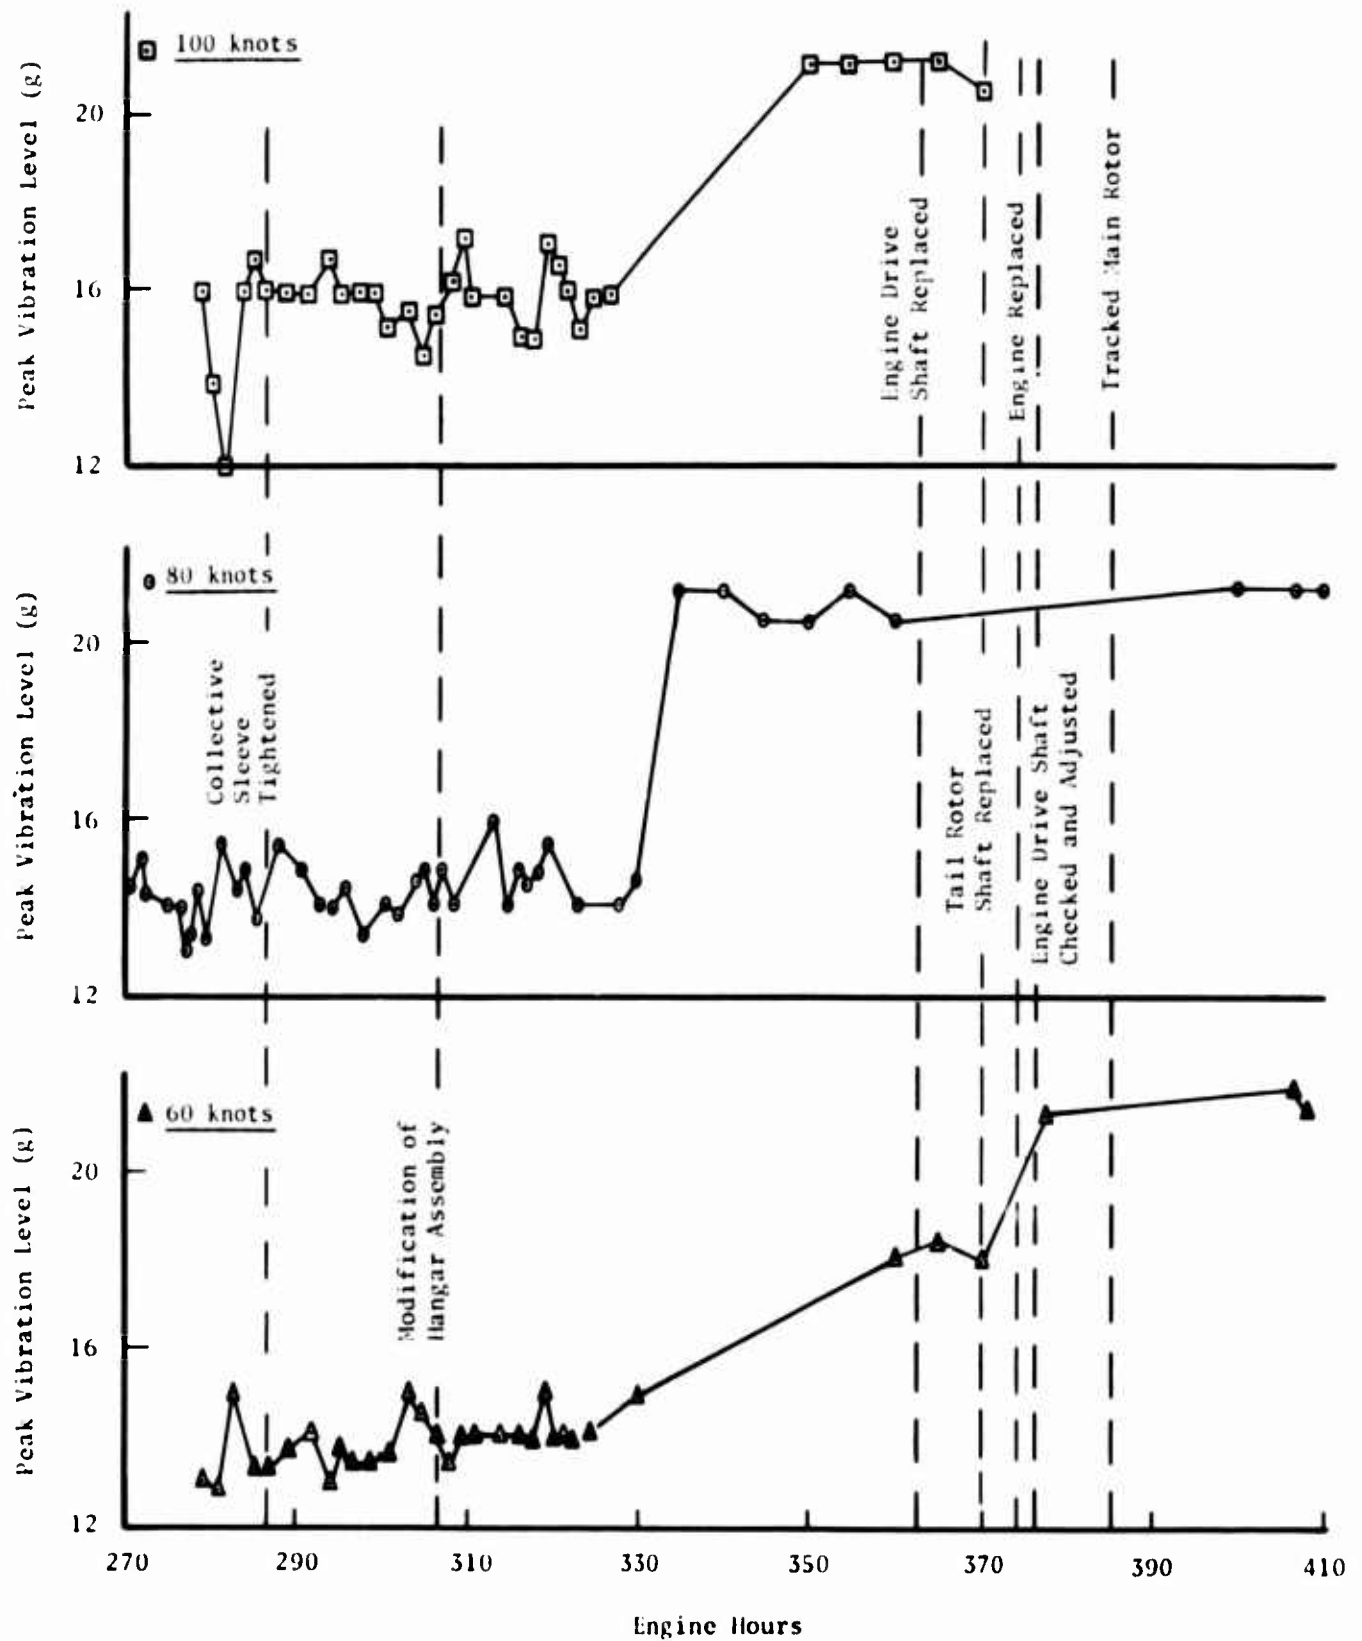
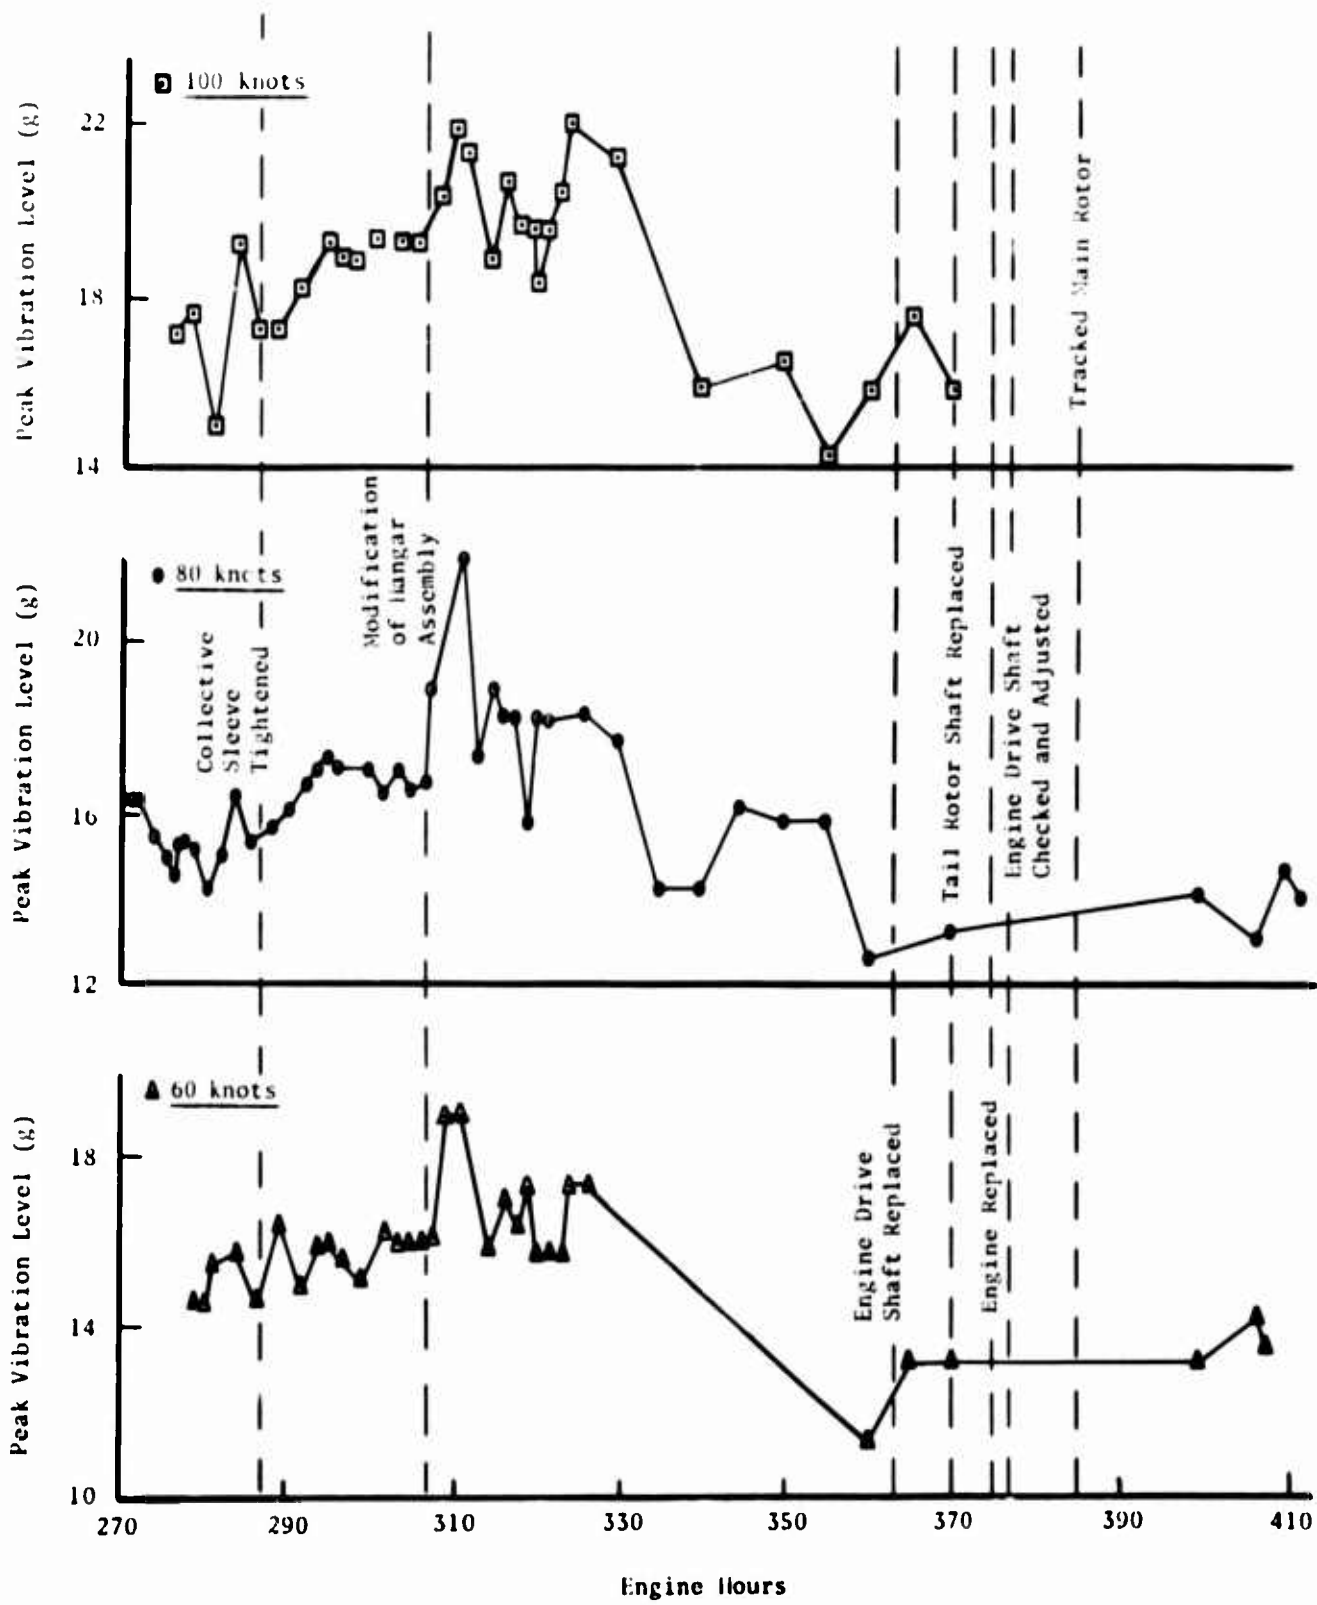
An interesting feature displayed by the transmission plots, Figures 6 and 7, is that at 330 engine hours the vibration level of the transmission top began to decrease and that of the transmission base to increase. These trends continued until the end of the test period, although no explanation presented itself for these phenomena.

Figure 6. Transmission Base Vibration (500 to 20,000 cps).

Figure 7. Transmission Top Vibration (500 to 20,000 cps).

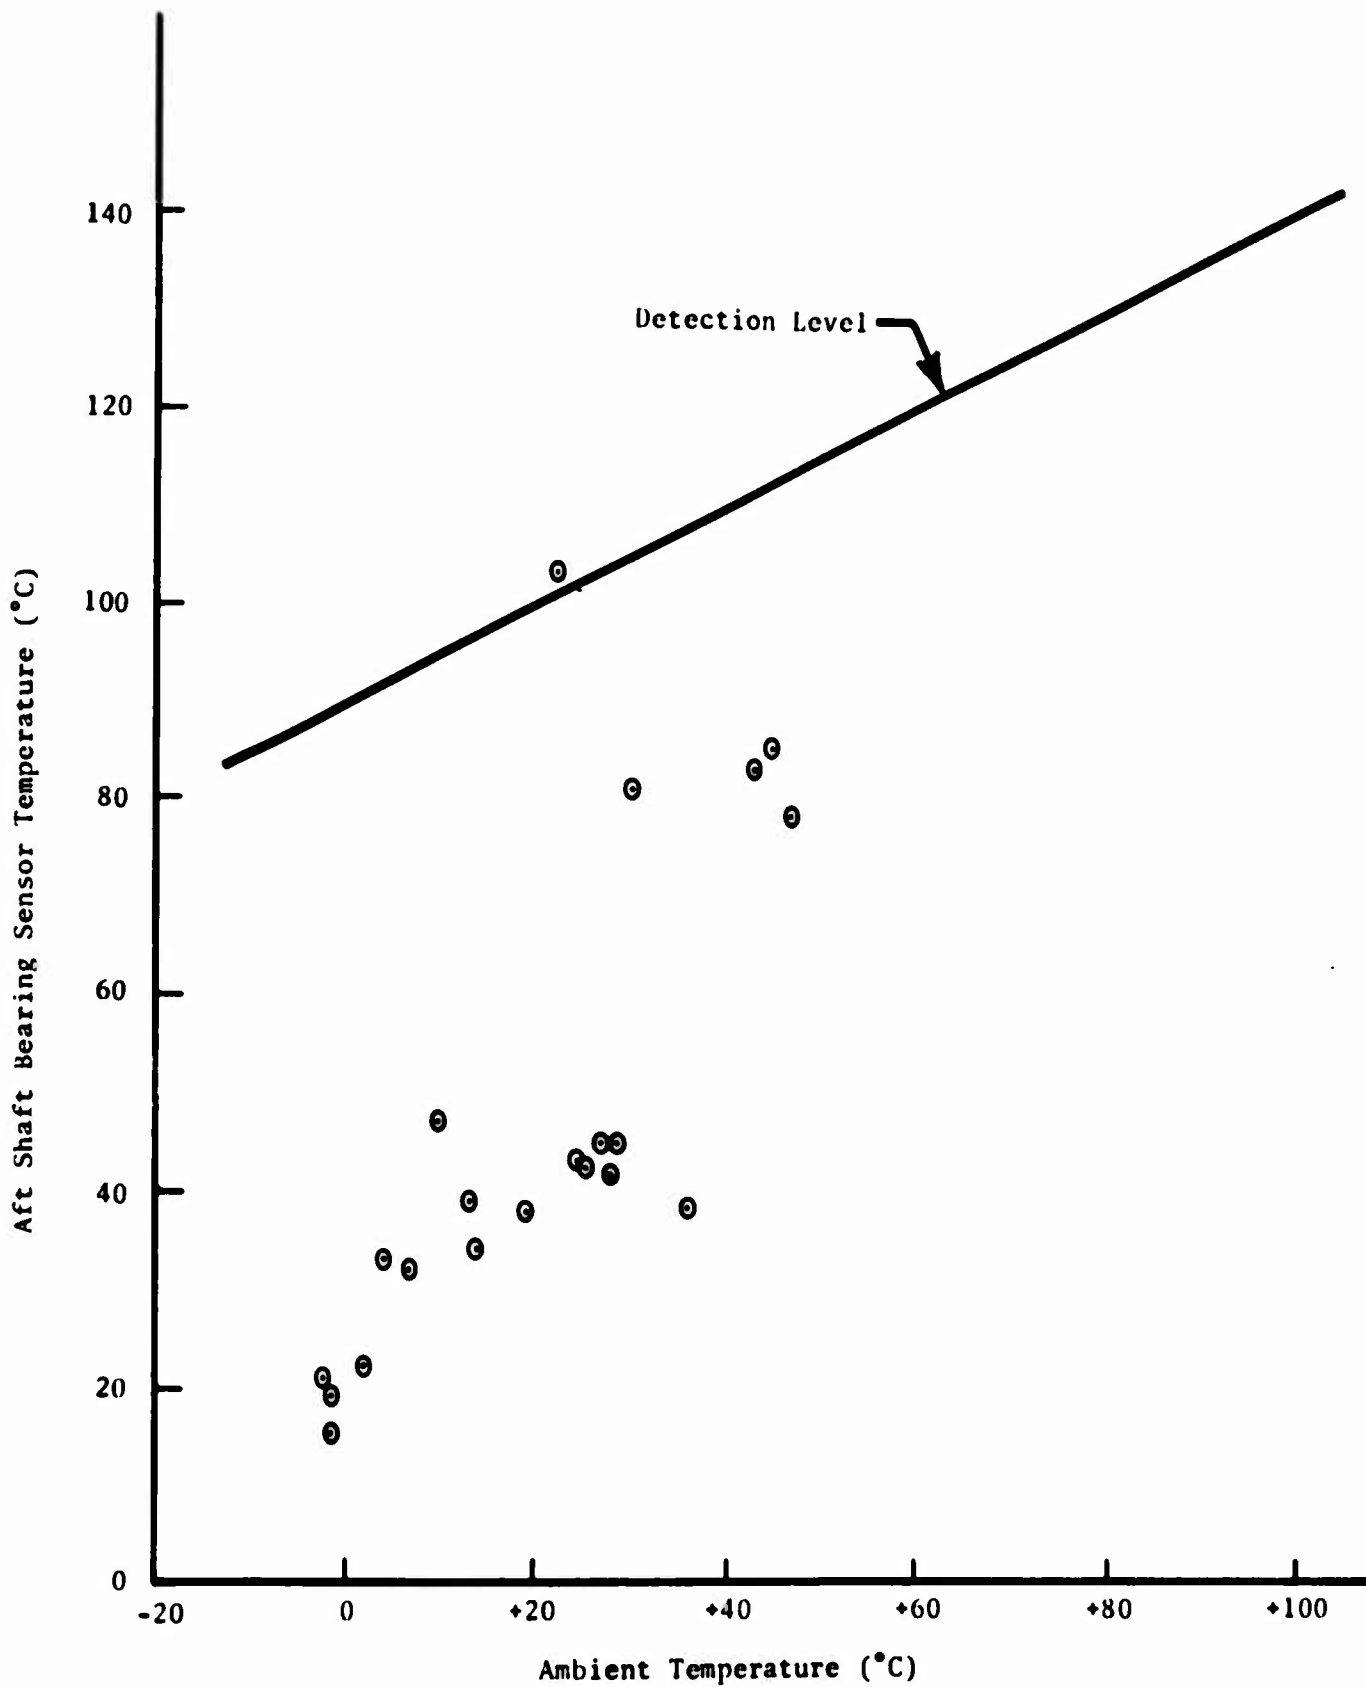
Figure 12. Aft Shaft Bearing Sensor Temperature Versus Ambient Temperature.

Three no-go indications were obtained during the dynamic and flight tests. One was sensed by the aft shaft bearing sensor (see Figure 12) and two were sensed by the swash plate bearing sensor (see Figure 13).

In all three of these instances, it was determined that the bearings yielding the no-go readings were contaminated. Upon removing, purging, and re-installing the bearings, the respective sensors gave normal operating readings.
