**FULL-SCALE DYNAMIC CRASH TEST
OF A
DOUGLAS DC-7 AIRCRAFT**

TECHNICAL REPORT

APRIL 1965

**Aviation Safety Engineering and Research
Division of Flight Safety Foundation, Inc.
Phoenix, Arizona**

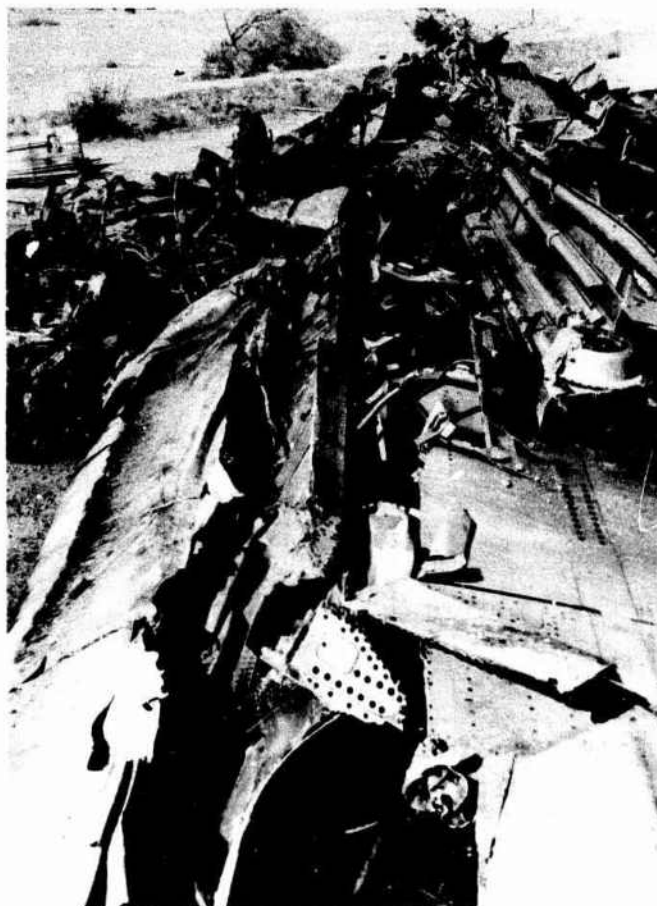
FIG. 34 CLOSEUP VIEW OF FRONT OF LEFT MID-WING
AREA (ALTERNATE TANK NO. 1) WHERE GELLED
FUEL WAS CARRIED

The bottom of No. 1 alternate tank had no visible punctures and was only slightly deformed. The top was in good condition with practically no deformation. The spar leading edge area separated for 28 inches, outboard to inboard, on the bottom and completely separated on top. This is shown in Figure 33. Just outboard from the No. 1 engine, the forward spar was bulged outward (forward). The arc formed in the spar between the top and the bottom edges had a radius of approximately 30 to 35 inches. This is shown in Figure 34.

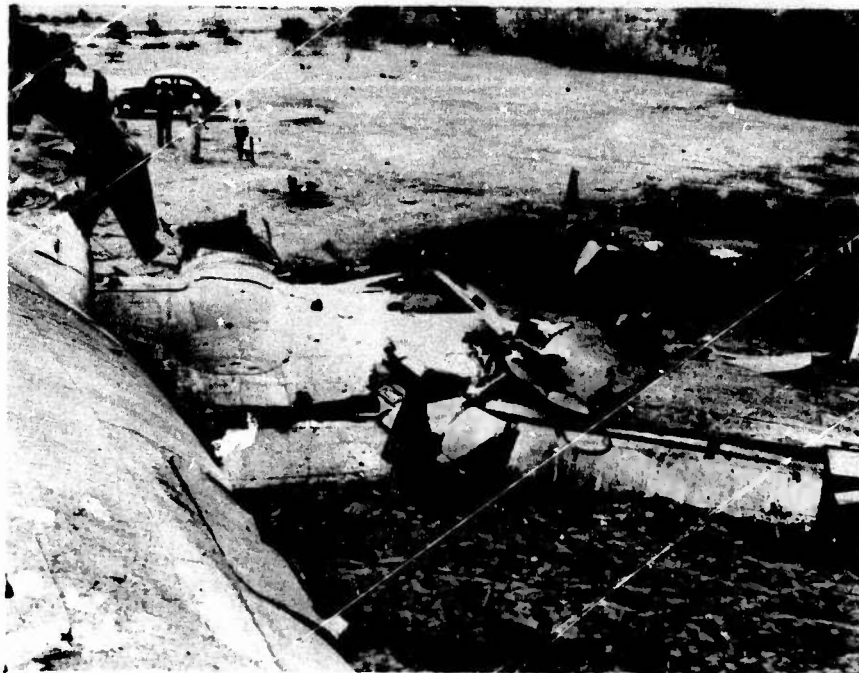
FIG. 38 POSTCRASH VIEW, RIGHT WING

Jagged and torn metal was all that remained of the inboard wing section. Torn material from the bladder tank and laminated nylon chafing board were exposed along the line of separation from the fuselage. The top and bottom of the tank were practically all destroyed. The damage to this section is shown in Figure 38.

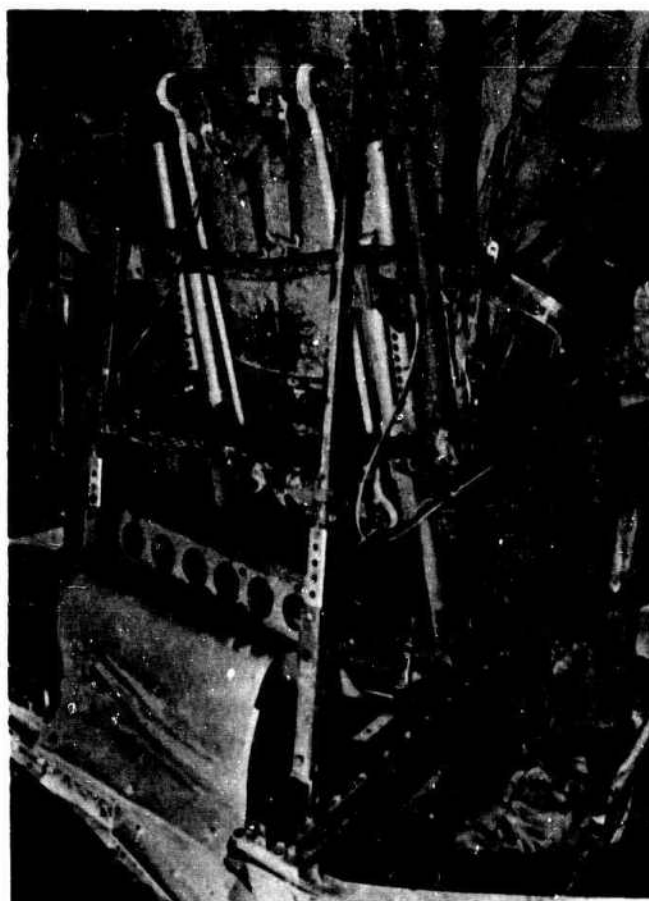
FIG. 48 RIGHT SIDE VIEW
OF COPILOT SEAT
SHOWING ANGLE
OF SEAT PAN
WITH RESPECT
TO SEAT BACK

The copilot's seat remained attached to the aircraft structure, as shown in Figure 47. The seat track attachments remained intact, but the surrounding structure was badly damaged. The entire seat pan was bent upward with respect to the seat back, due to contact with forward and lower cockpit structure. The copilot dummy remained in the seat. The inertia reel was locked and the shoulder harness was still attached to the right side of the lap belt, which was still connected to the seat. The lap belt was broken on the left side of the adjustment fitting as shown in Figure 50. Neither of the vertical energy absorbers used in the seat extended. The postcrash condition of this seat is shown in Figures 48, 49, 50, and 51.

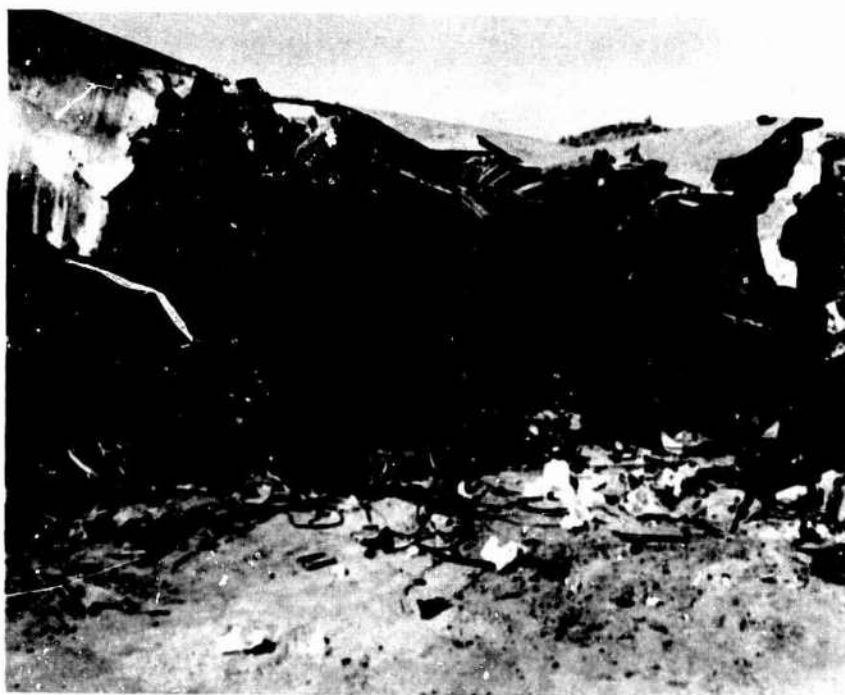
FIG. 57 POSTCRASH ENVIRONMENT OF CARGO EXPERIMENT

Neither pallet or cargo load completely separated from its original tiedown. Several failures did occur to each net and the pallet tiedown links, but the bulk of the cargo was effectively restrained by both systems. Figure 57 is a postcrash view of the cargo experiment section of the aircraft.

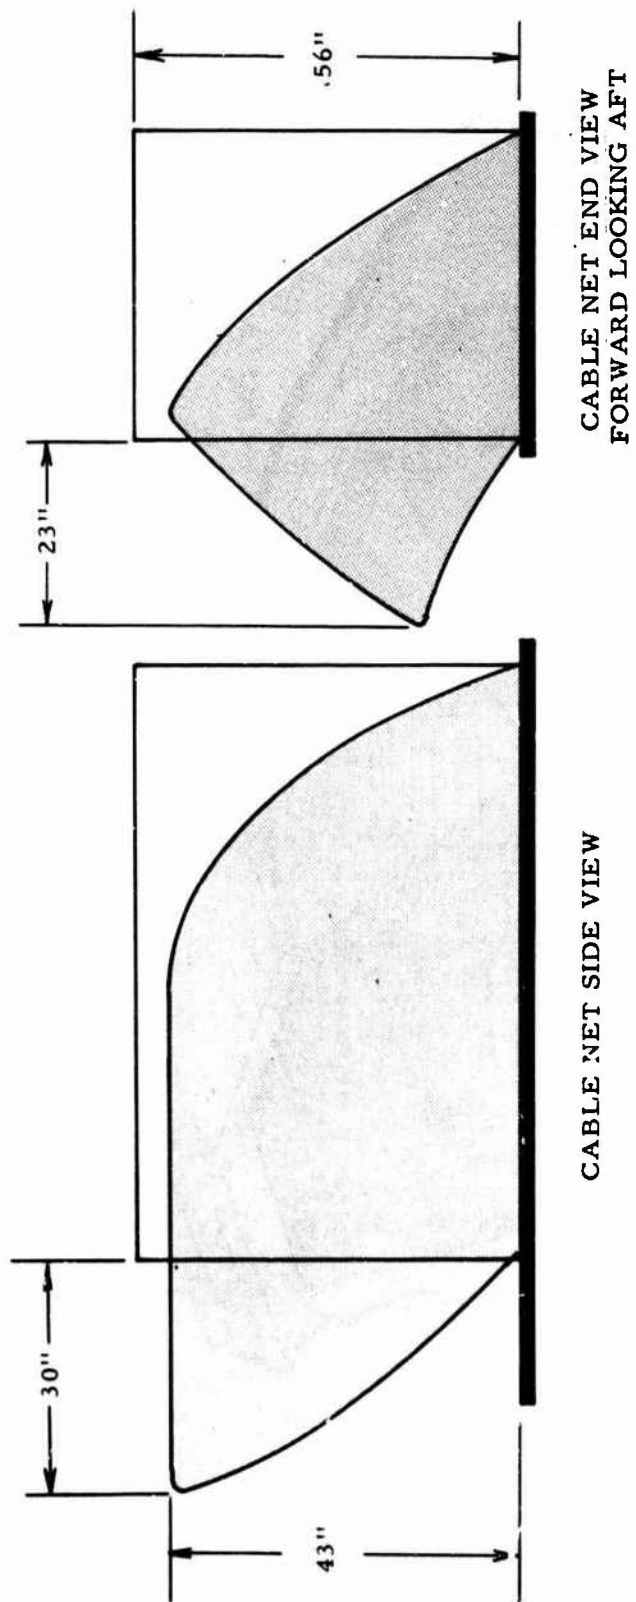
FIG. 60 POSTCRASH POSITION OF SHIFTED CARGO

net failures were found where the engine impacted the cargo. However, the cargo was "chewed up" where the engine climbed the stack. Figure 60 is a sketch of the postcrash position of the shifted forward cargo. Nearly all of the boxes of simulated cargo on the forward cargo pallet were torn apart. Of the two cargo experiments, this cargo definitely sustained the most damage.

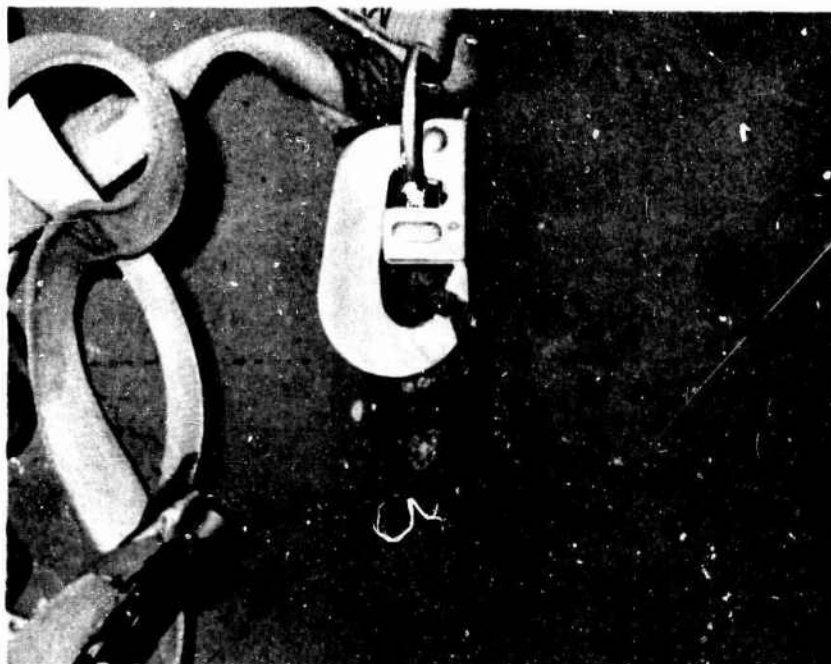
FIG. 63 FORWARD DEFORMATION OF PALLET CARGO NET
TIEDOWN RING SHOWN WITH NET HOOK STILL
ATTACHED

There was no evidence to indicate that any loads were applied to the cargo, cargo pallet or nylon net of the aft cargo experiment except the inertia loads of the cargo and pallet. The postcrash configuration of this cargo installation is shown in the sketch of Figure 61. Approximately one-fourth of the boxes of cargo used for this load suffered no damage whatsoever, while approximately one-half were torn but not destroyed. Only four boxes of cargo were completely ripped apart. One buckle on a load carrying strap, Figure 62, failed. Figure 63 shows the forward tiedown ring on the pallet which was deformed forward by the load applied to this strap.

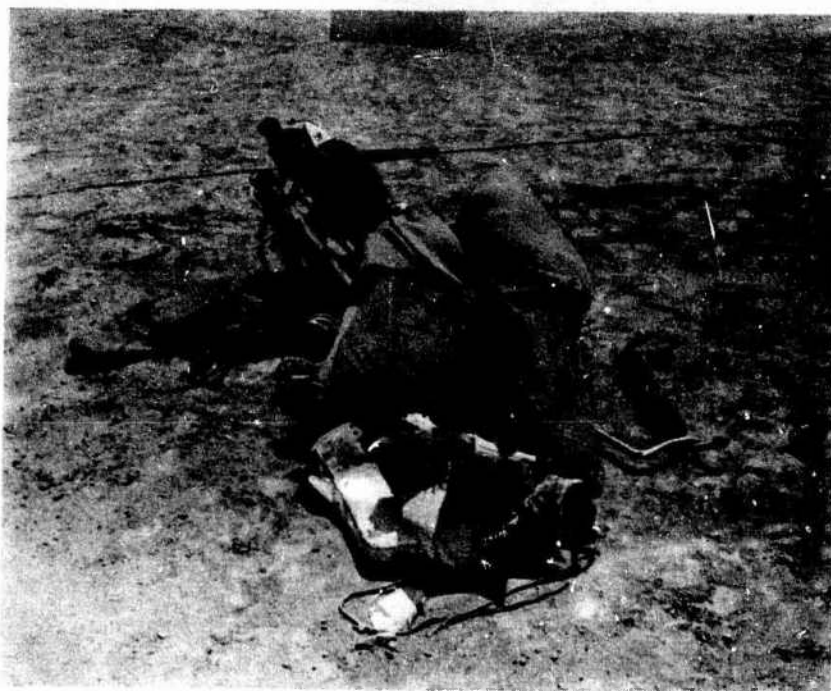
FIG. 66 FORWARD SEAT OF FORWARD CABIN DC-7
PASSENGER SEAT EXPERIMENT

The two forward seats of this group of three were torn loose from their mountings and were found entangled in the wreckage of the forward fuselage section. The postcrash conditions of these seats is shown in Figures 66 and 67. The first seat was struck by the propeller blade from No. 3 engine. In addition, the fuselage broke just forward of the seat location and the walls of the fuselage, next to the seats, were buckled outward and crushed. The wall attachment for the forward seat pulled out of the wall fitting. The second seat ripped out the fitting and the intercostal to which it was attached.

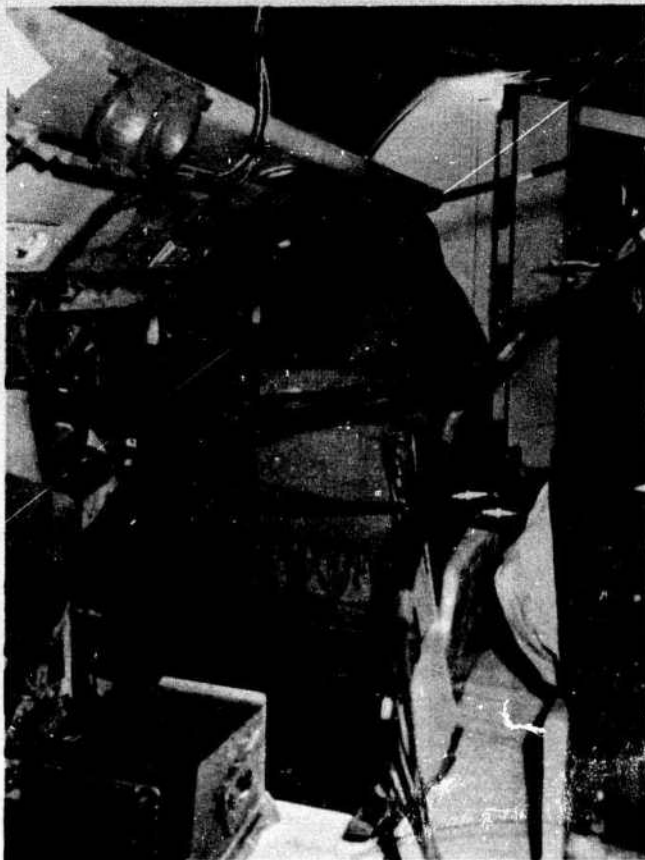
FIG. 88 POSTCRASH REAR
VIEW OF AIRBAG
EXPERIMENT
(PICTURE ROTA-
TED 90° CLOCK-
WISE)

Figure 88 is a postcrash rear view of the airbag experiment, showing the rotated bag lodged against the aft galley partition. The plastic airbag installed in front of the dummy next to the wall split along the inboard aft seam during impact. This 15-inch tear allowed rapid deflation and allowed the dummy's head to strike the back of the seat ahead. Figure 85 shows the dummy after the crash with his head positioned against the fitting box for the clear plastic bag. The occupied seat remained attached to the floor. The aft wall attachment held; but the forward wall fitting failed, allowing the forward seat structure next to the wall to deflect downward.
