DEEP-OCEAN BIODETERIORATION
OF MATERIALS — PART III. THREE
YEARS AT 5,300 FEET

U. S. NAVAL CIVIL ENGINEERING LABORATORY
PORT HUENEME, CALIFORNIA

Technical Report R-428

James S. Muraoka

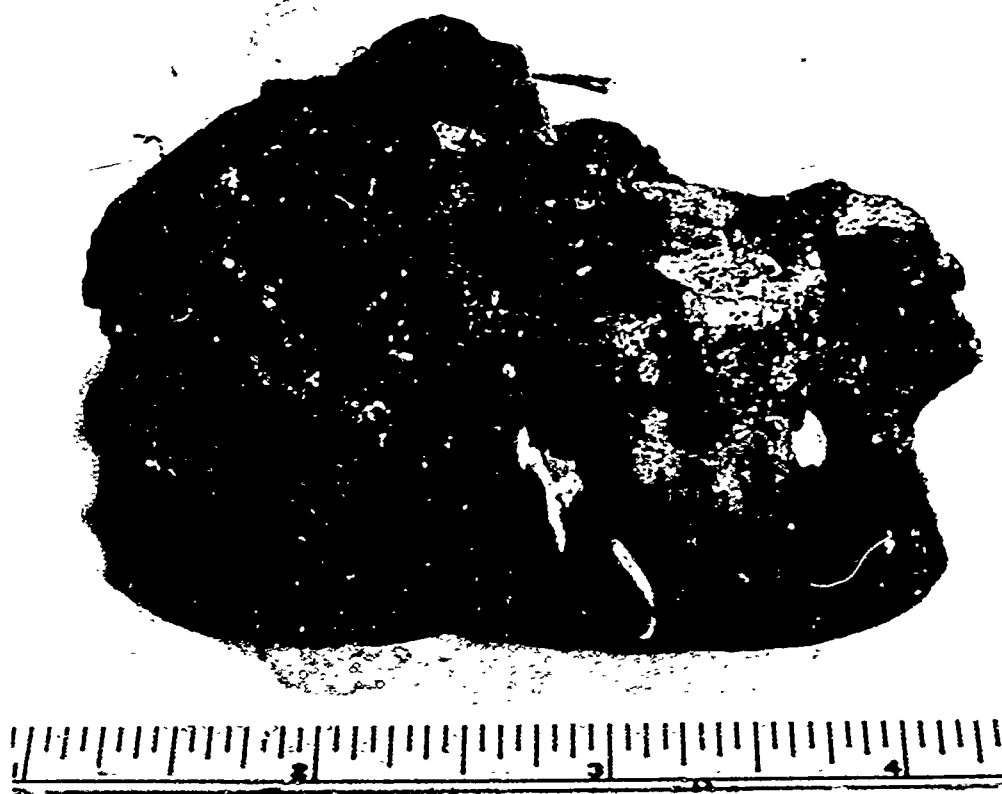
Several rocks had deep holes bored by pholads (Figure 5); neither live pholads nor their empty shells were found in the holes, so it is not known whether these rock borers are active at this depth. There was a thick deposit (as much as 1/4 inch) of manganese oxide on the rock specimens. There is a report of finding and isolating 36 pure bacterial species from inside surface-sterilized manganese nodules. It is thought that bacteria play a major role in the formation of nodules.⁵

Figure 5. Rock sample from 6,000-foot depth showing numerous holes made by rock-boring animals. Bryozoa (erect type), tube worms, and legs of a brittle star are visible.

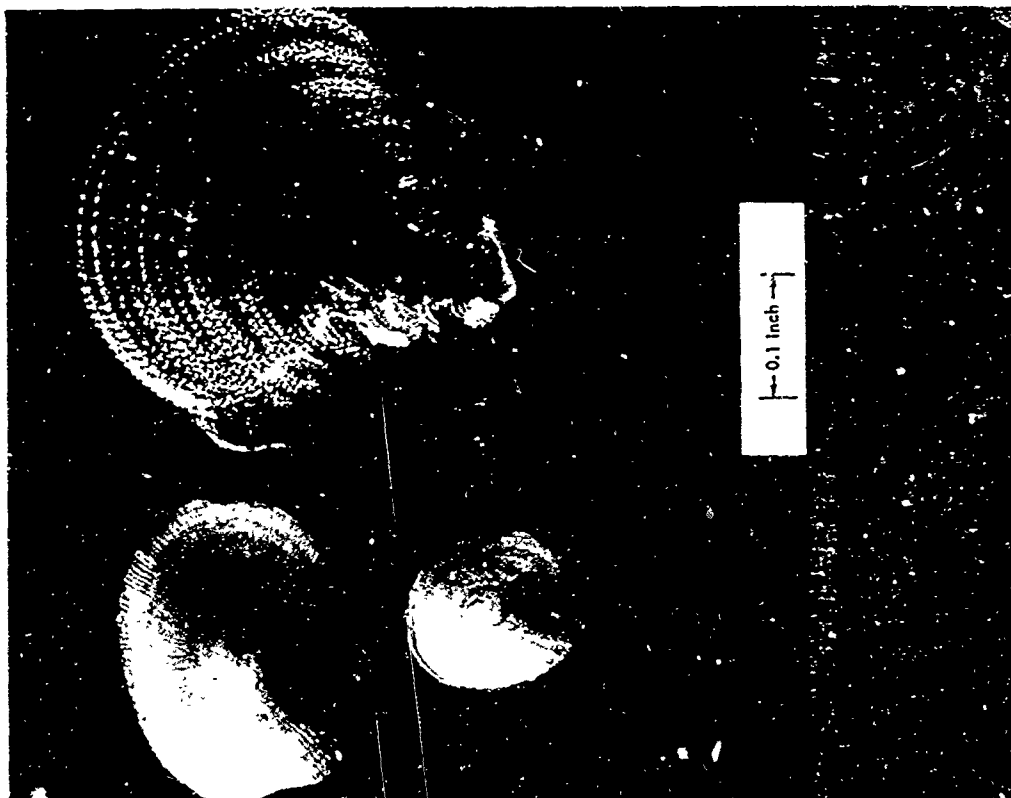
When the vinyl-painted biological test specimen holders were examined in the laboratory, it was found that the lower section of the "U" channel iron exposed near the sediment, especially the area in contact with the rope specimens, had turned black (Figure 23). This was probably the result of hydrogen sulfide produced by the sulfate-reducing bacteria combining with the lead in the paint to form lead sulfide, which is black. The area under the decaying rope specimen where slime bacteria were active could have produced an anaerobic environment suitable for the growth of sulfate-reducing microorganisms. Except for the change in color, neither the paint nor the metal underneath the painted surface was damaged. Species of pectens and limpets were found on the painted surface exposed near the sediment (Figure 24).

Figure 24. Species of deep-sea pecten and limpets found attached to STU materials.
