USAAVLABS TECHNICAL REPORT 66-24

AIRCRAFT FUEL TANK DESIGN CRITERIA

March 1966

U. S. ARMY AVIATION MATERIEL LABORATORIES
 FORT EUSTIS, VIRGINIA
 CONTRACT DA 44-177-AMC-254(T)
 AVIATION SAFETY ENGINEERING AND RESEARCH
 A DIVISION OF
 FLIGHT SAFETY FOUNDATION, INC.
 PHOENIX, ARIZONA

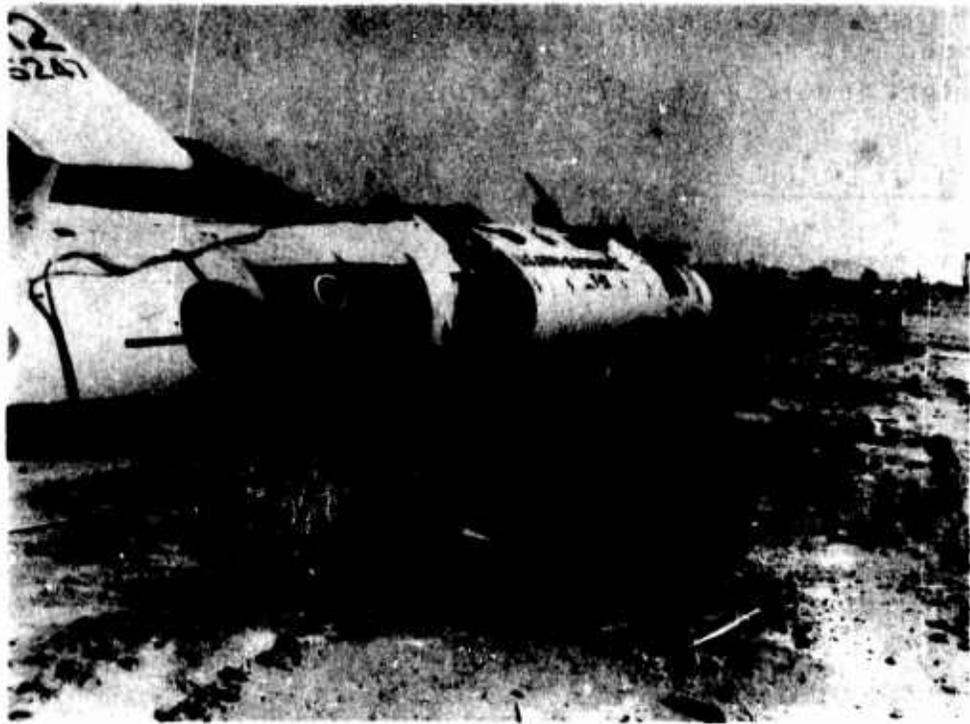
A relatively mild impact resulted from T-12. Overall structural damage to the fuselage was minor, as shown in Figure 11.

Figure 11. Condition of Helicopter After T-12 Crash.

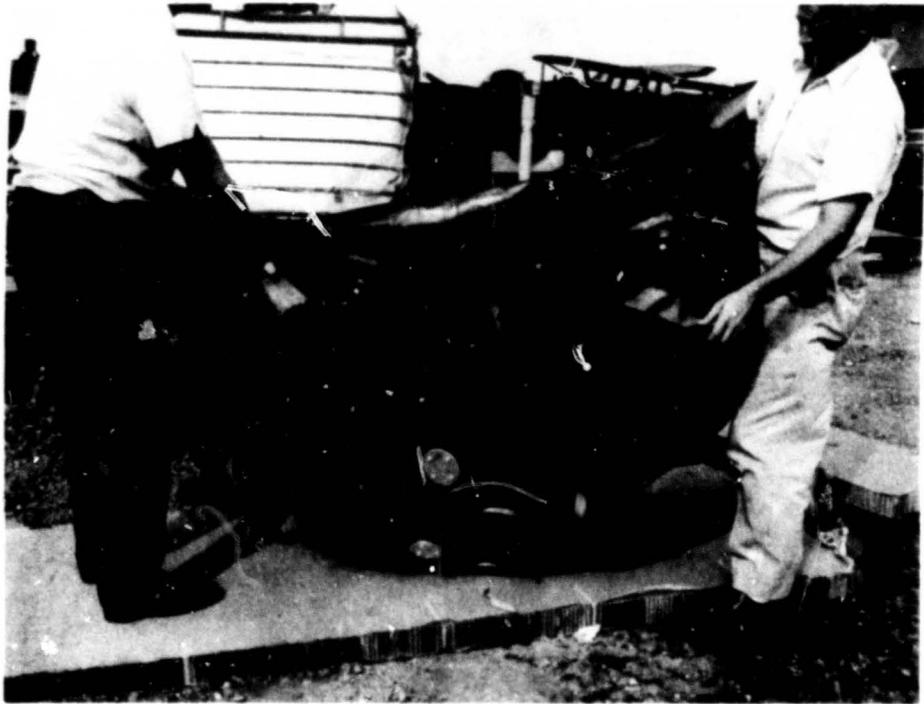
The fuel cell sustained only two small slit-like perforations, 6 inches apart on the bottom, 1 foot from the instrumentation housing. These are shown in Figures 18 and 19. The perforations measured 1/2 and 1 inch, respectively, and occurred when the longitudinals, shown exposed in Figure 20, sheared upward. Figure 21 depicts the jagged metal that punctured the fuel cell bottom.

Figure 18. Fuel Cell After T-12 Crash (Perforations Outlined in Tape).

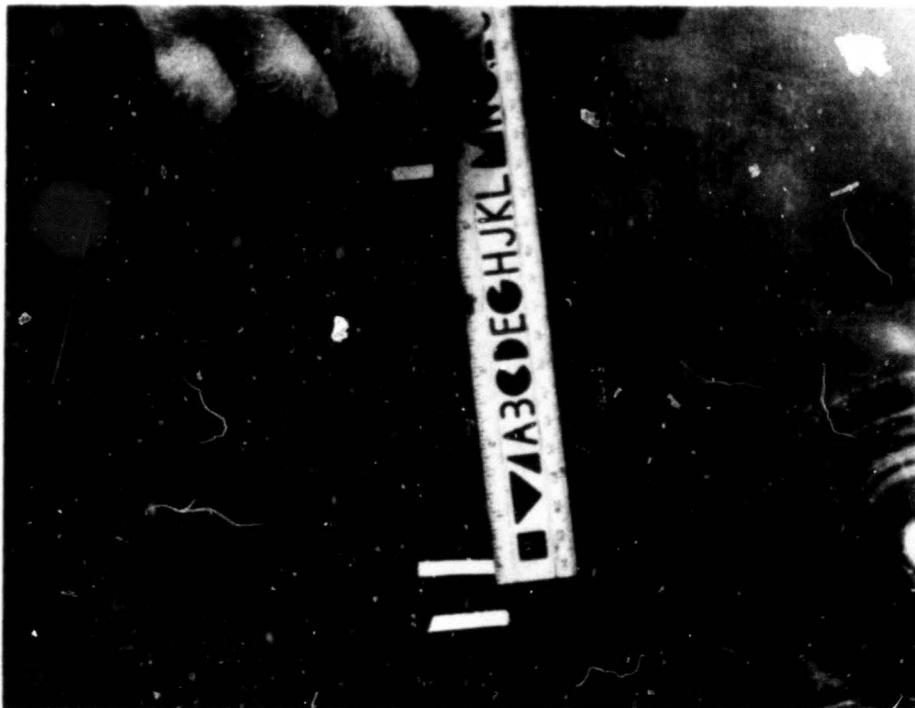
Figure 19. Close-up of T-12 Perforations.

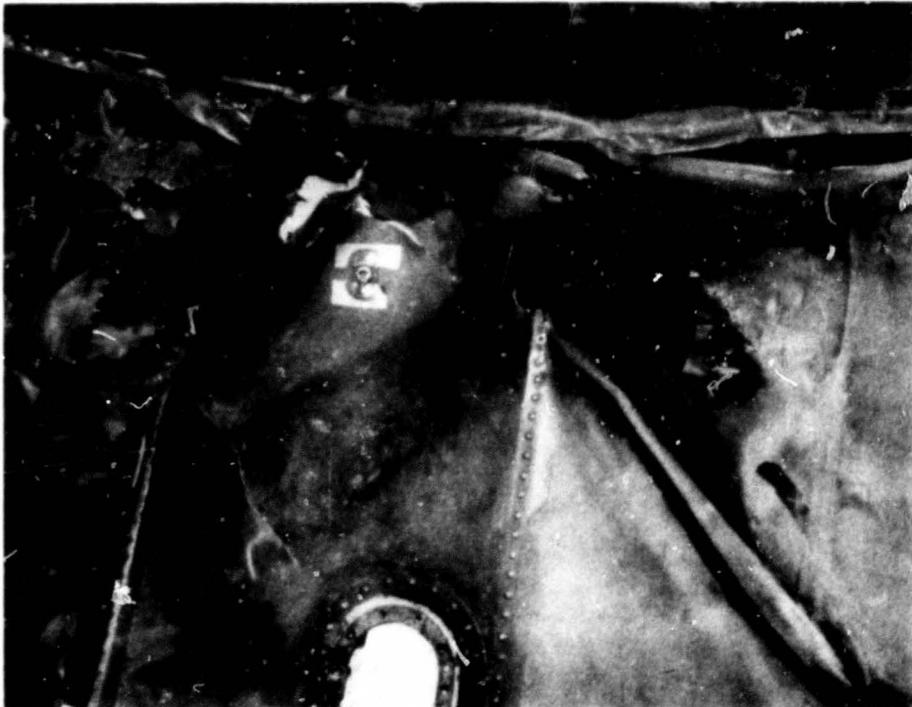
Figure 21. Interior View of Cell Chamber Showing Area Where Fuel Cell Was Punctured.

The crash forces recorded in this test were well below survivable limits as presently known. The cell puncture caused by the jagged metal shown in Figure 21 started leakage of sufficient rate for ignition by the oil fire, through abraded sparks, contact with heated metals, or any of the ignition potentials present in an aircraft crash, had actual fuel been carried in the tank. The fact that the crash forces were well within

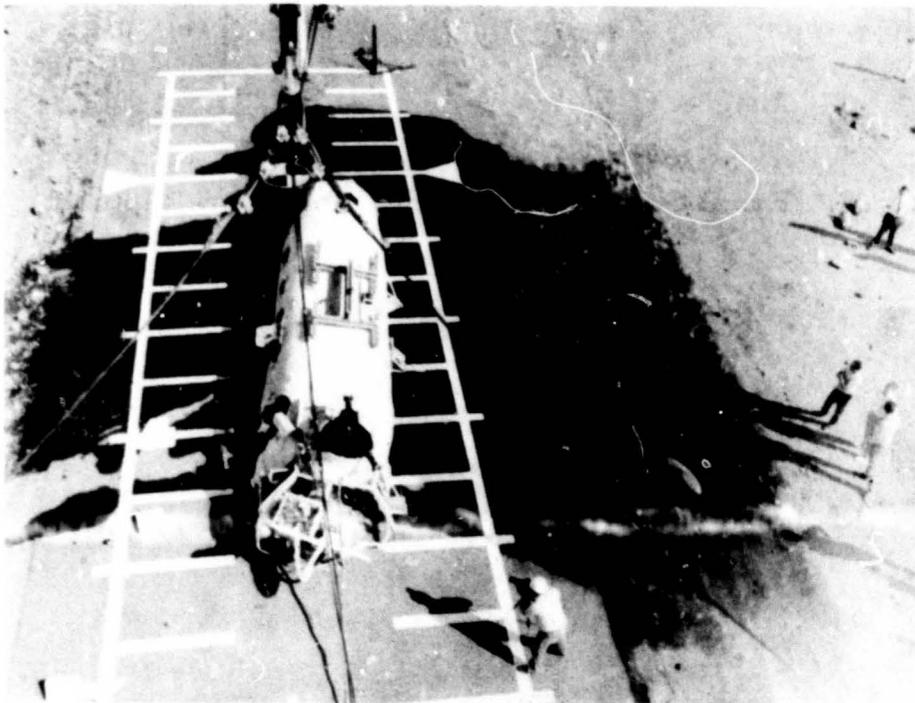
Figure 26. T-13 Exterior Fuel Spillage Pattern.

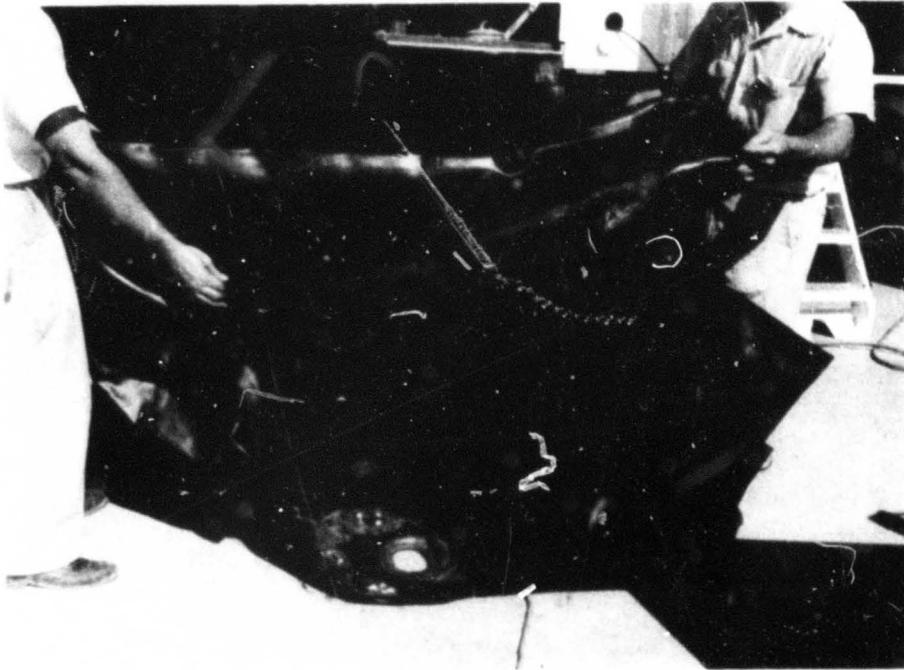
Figure 27. Front Side Showing Length of Seam Rupture.

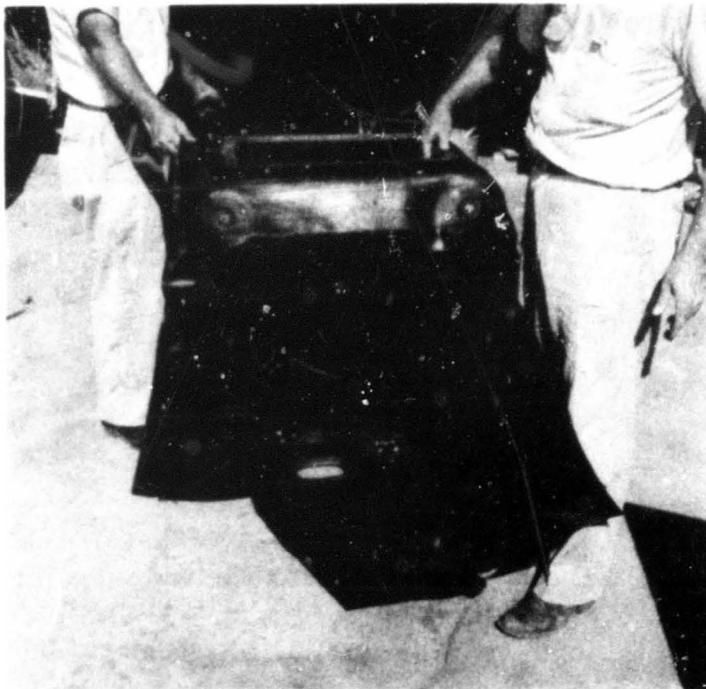
Figure 28. Left Side of Ruptured Fuel Cell.

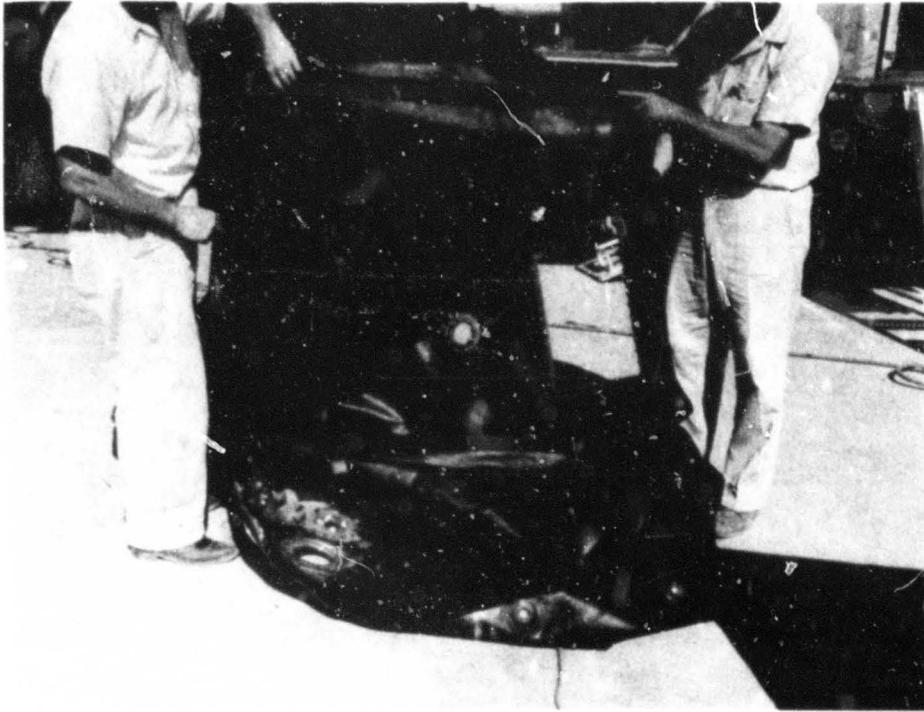
Figure 29. Size of Opening Demonstrated.

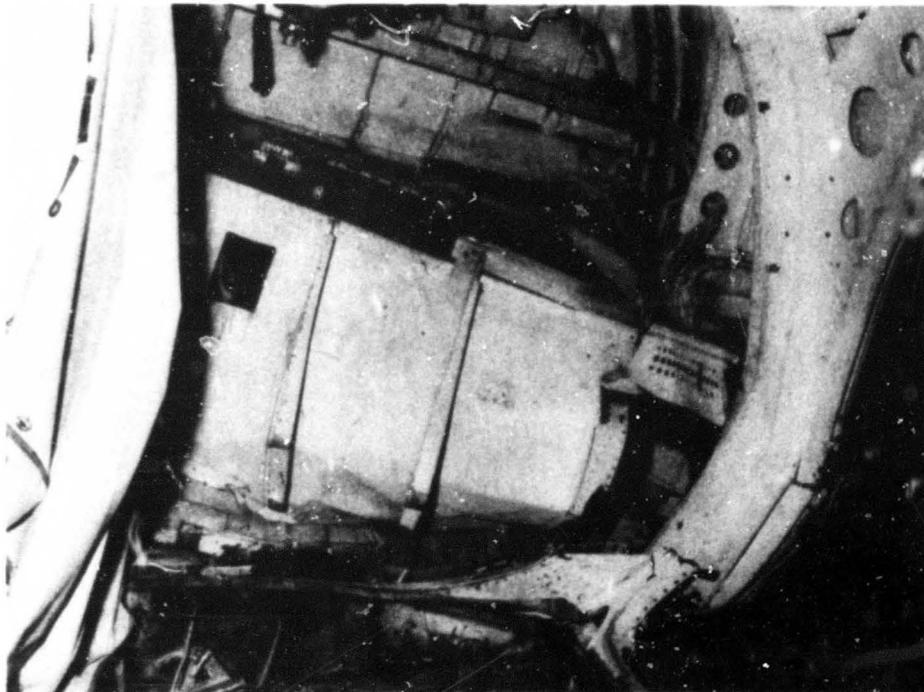
Figure 30. Forward View of Fuel Chamber Damage.

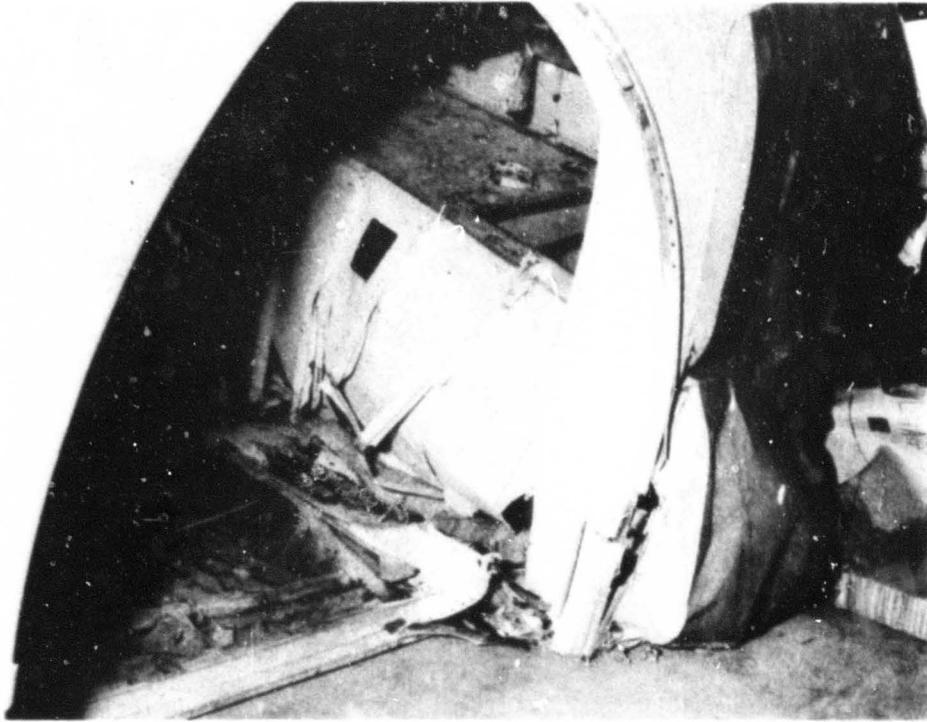
Figure 31. View Showing Forward Deformation of Front of Fuel Chamber Structure.

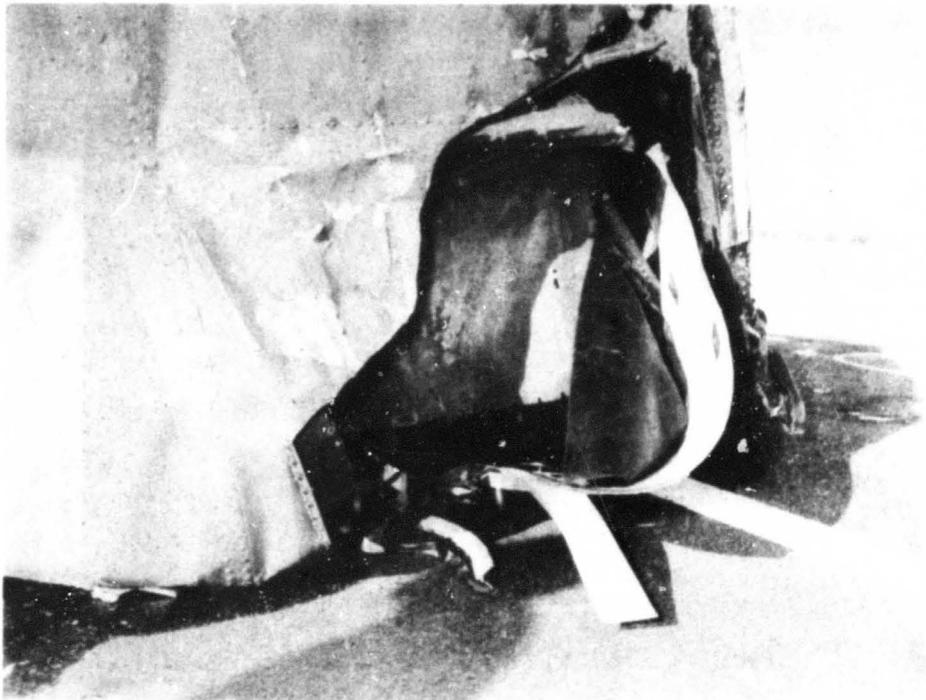
and 32. These pictures also indicate that the pressure surge was primarily in a forward and left direction.

Figure 32. Opening Created in Left Side of Fuel Chamber.

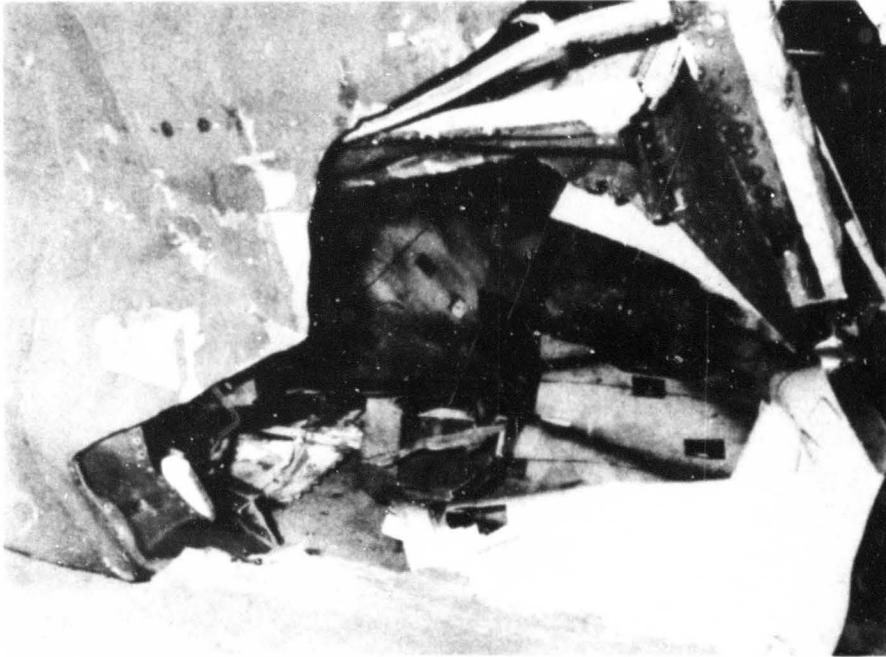
The nylon liner sustained no rips or perforations. Figures 33 and 34 show the position and condition of the liner with the fuel cell removed. Upon impact and during the chamber deformation, the liner followed the metal to which it was fastened. Where separation occurred between the liner and the chamber wall, the rivets pulled through the metal and remained with the liner. The corner taping offered only minor resistance to seam separation and tore or ripped indiscriminately.

Figure 33. Liner Position After Test.

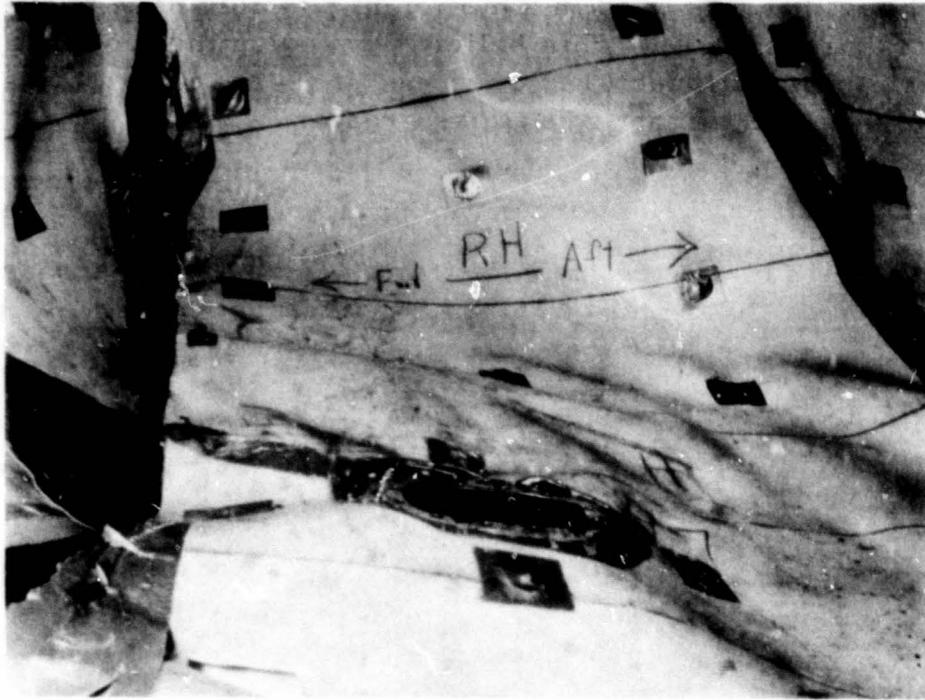
Figure 34. Postcrash Condition of Liner and Edge Taping.

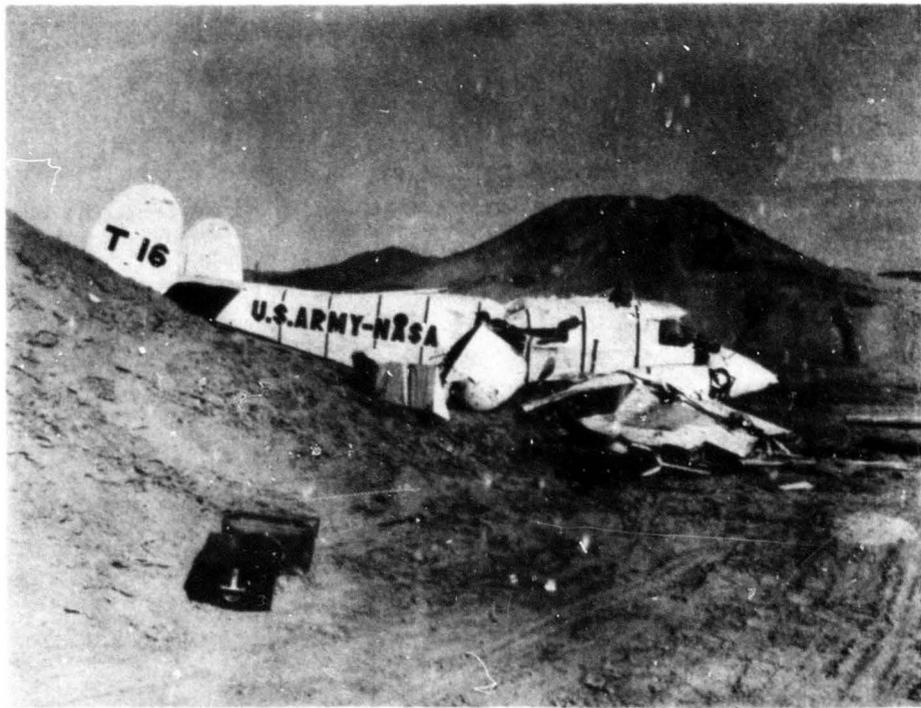
Figure 39. Damage to Aircraft Right Side, T-16.

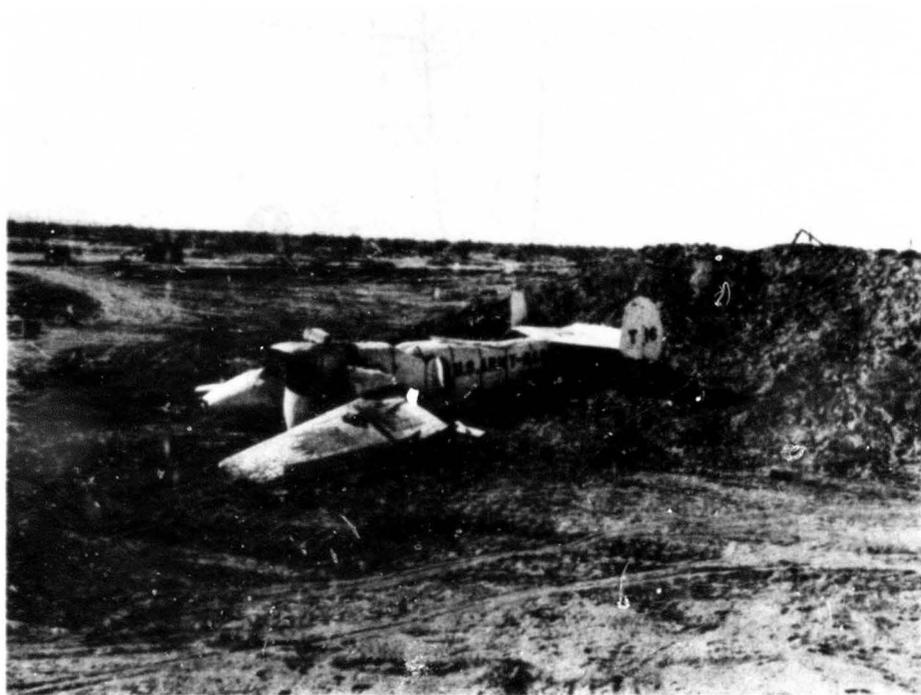
Figure 40. Damage to Aircraft Left Side, T-16. (Note That the Left Wing Nearly Severed By Hill Impact Continued Forward, Coming to Final Rest in a Swept-Forward Position.)

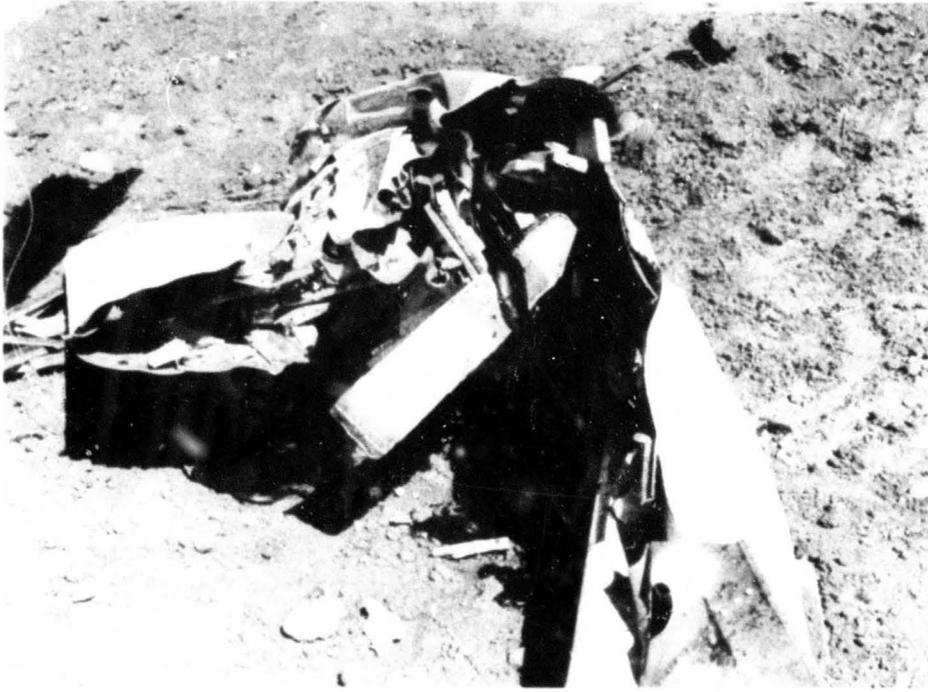
Figure 41. Right Wing Tank, T-16. (At Impact With the Pole, These Tanks Were "Accordioned" Rearward into the Structure.)

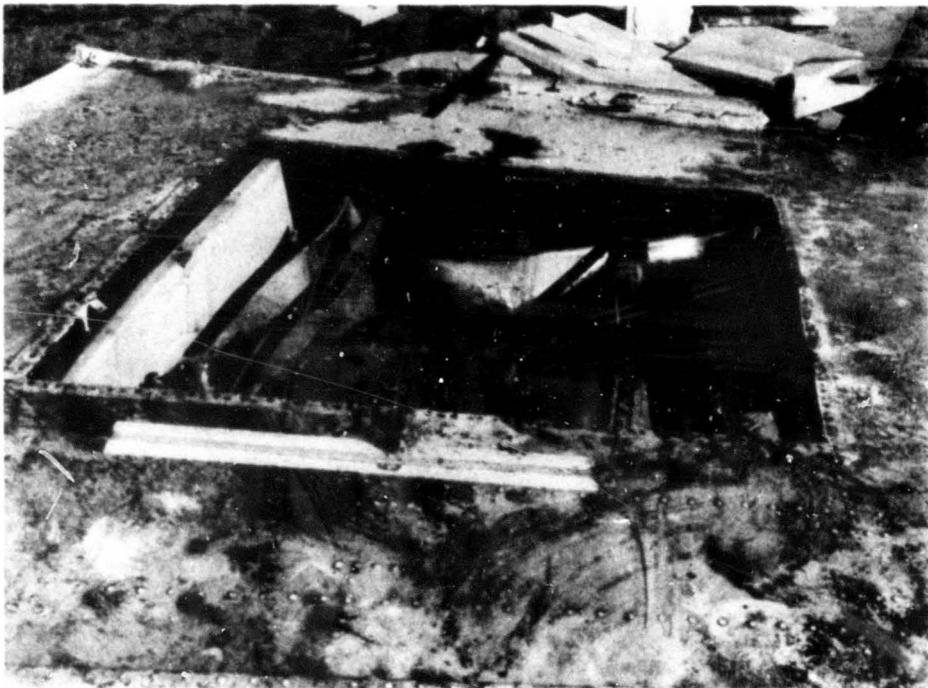
Figure 42. Left Wing Root Tank, T-16. (At Hill Impact, These Tanks Expanded in the Forward Half and Collapsed in the Aft Half.)

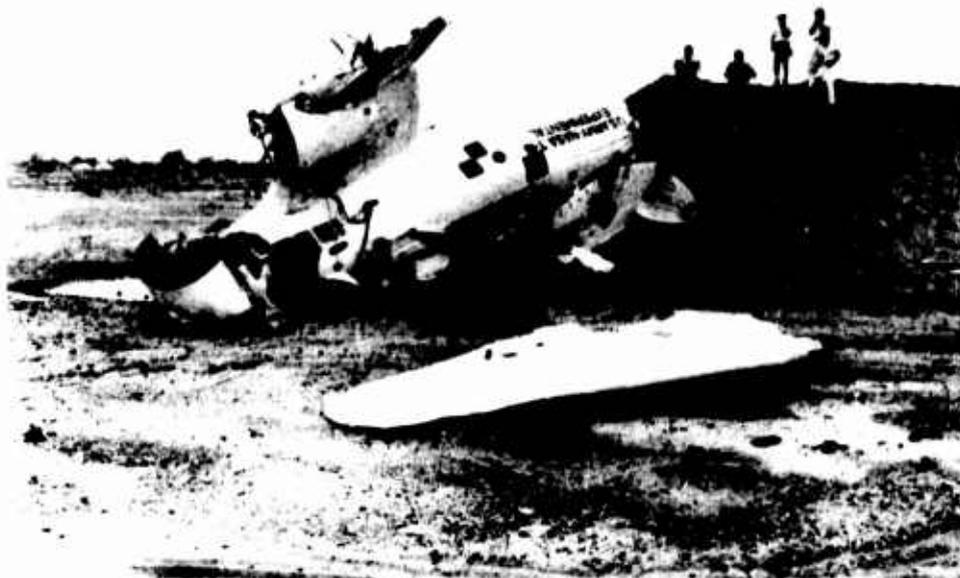
Figure 46. Postcrash View of Aircraft, T-19. (The Left Wing Was Torn Free at Hill Impact and Came to Rest Ahead of the Main Wreckage.)

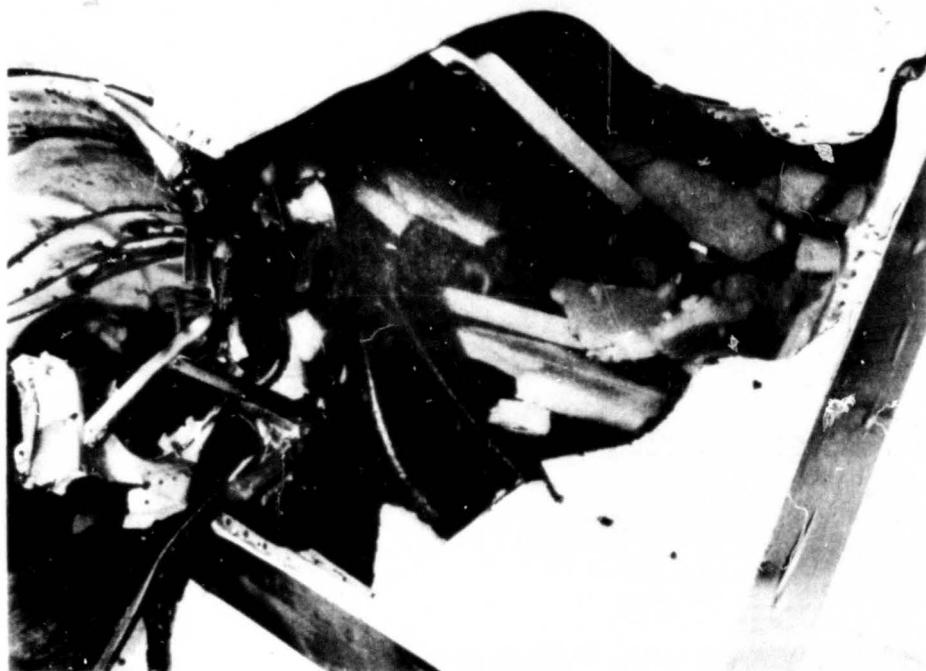
Figure 50. Right Wing Outboard Tank - In Place, T-19.
(The Tank Was Displaced Rearward by the Caved-in Leading Edge of the Wing.)

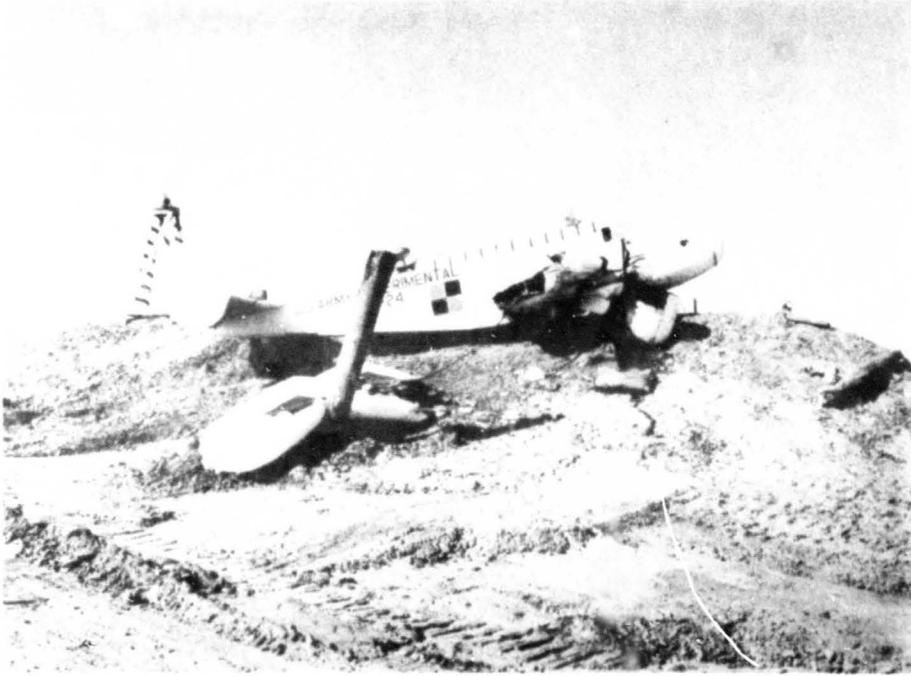
Figure 53. Postcrash View, T-24. (The Right Wing Was Torn Free at Pole Impact, and Remained Wrapped Around the Outboard Pole.)

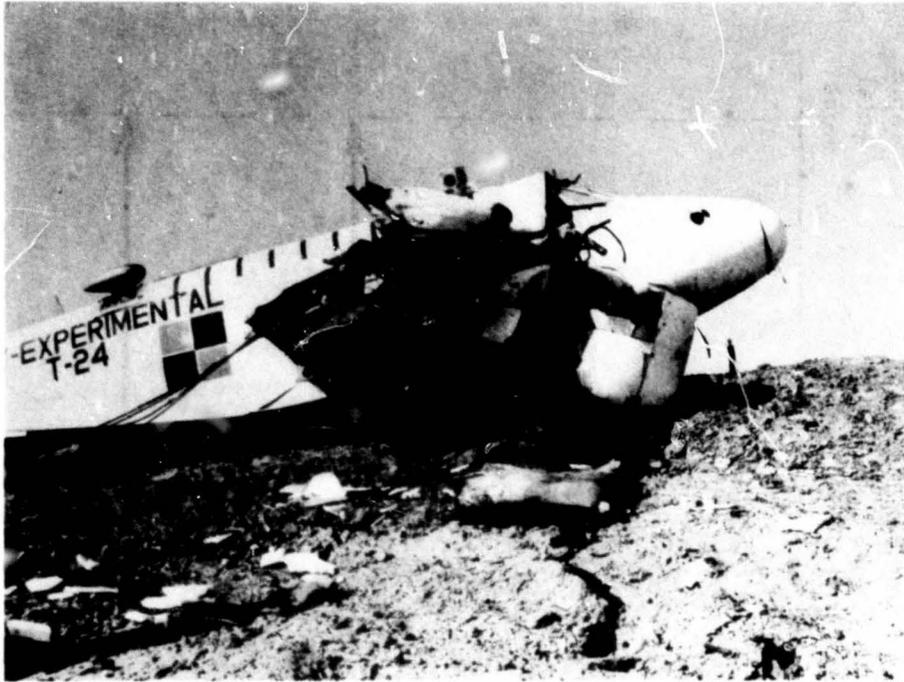
Figure 55. Right-Hand Inboard Tank, T-24. (After the Pole Impact Severed the Wing Through the Fuel Tank Location, the Experimental "Fuzzy Wall" Tank Dropped to the Ground. The Leakage Evident in Figure 55 Is Oil from the Engine, Not Simulated Fuel.)

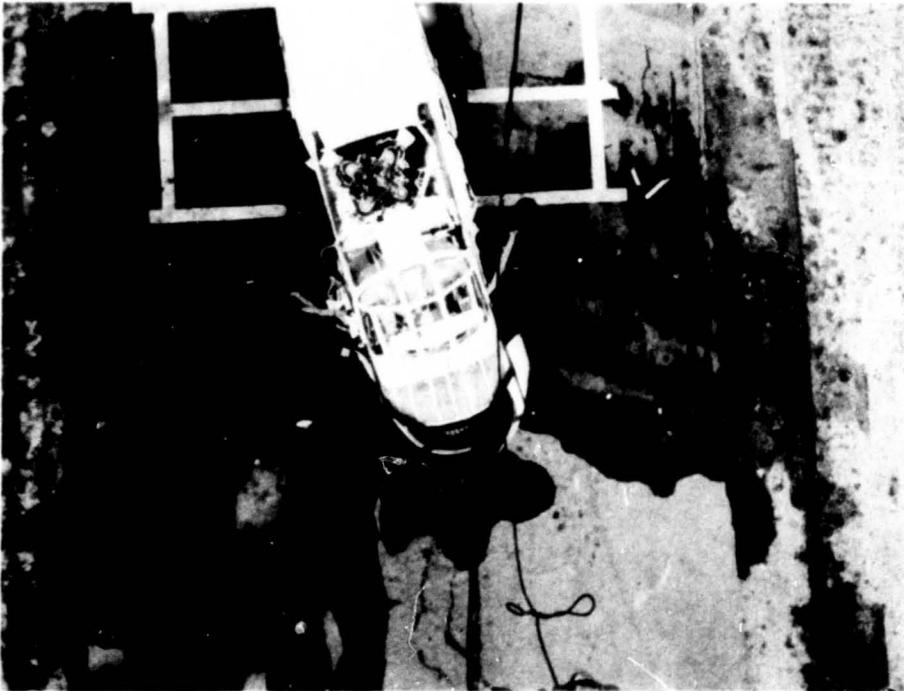
Figure 62. Fluid Spillage, T-17. (Extensive Fluid Spillage Resulted from Failure of Standard Fuel Tanks.)

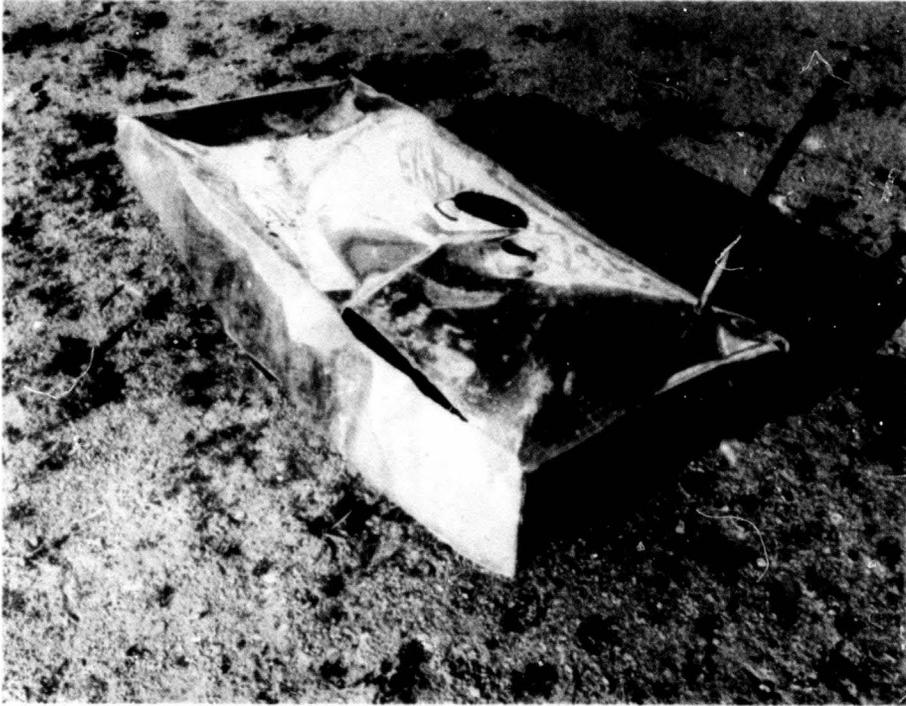
Figure 63. The Ruptured Experimental Aluminum Tank, T-17.

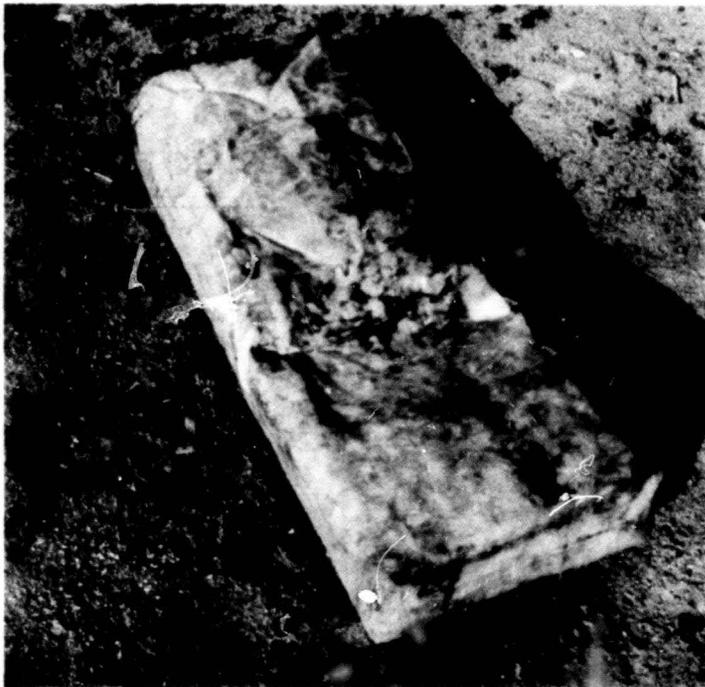
Figure 64. Honeycomb-Cored "Tough Wall" Tank, T-17. (The Only Leakage Occurring in Either Honeycomb-Filled "Tough Wall" Tank Was the Pinhole Seepage Apparent at the Tank Midsection.)

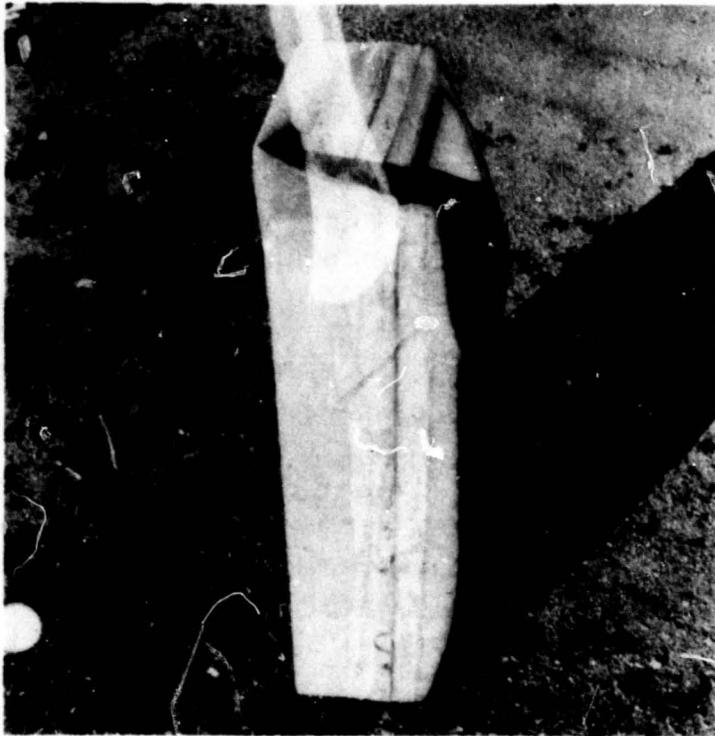
Figure 65. The Hollow "Tough Wall" Tank. (This Tank, Filled to Capacity with Water, Received a Direct Rock Impact and Did Not Fail.)

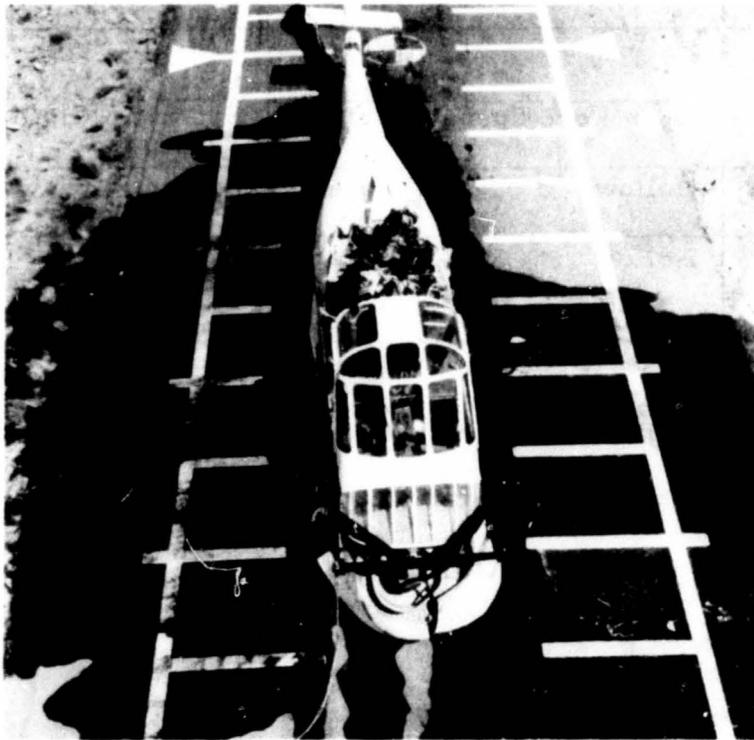
Figure 70. Fluid Spillage, T-23. (Extensive Liquid Dispersion Resulting from Ruptured Fuel Tanks.)

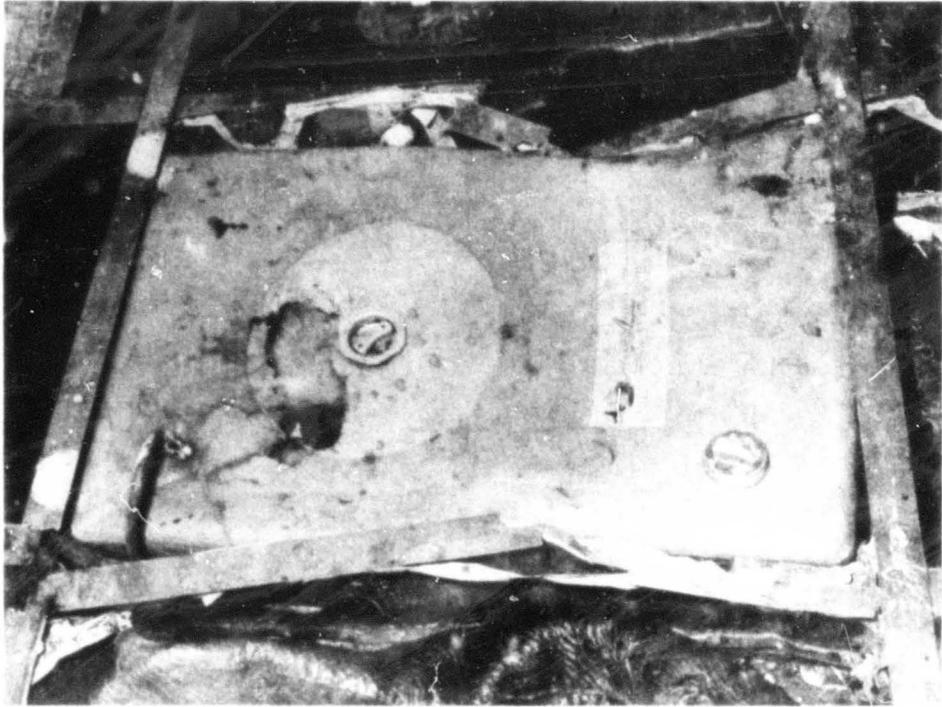
Figure 77. The Hollow "Tough Wall" Tank, T-23. (The Ruptured Tank in Location After Floor Removal.)

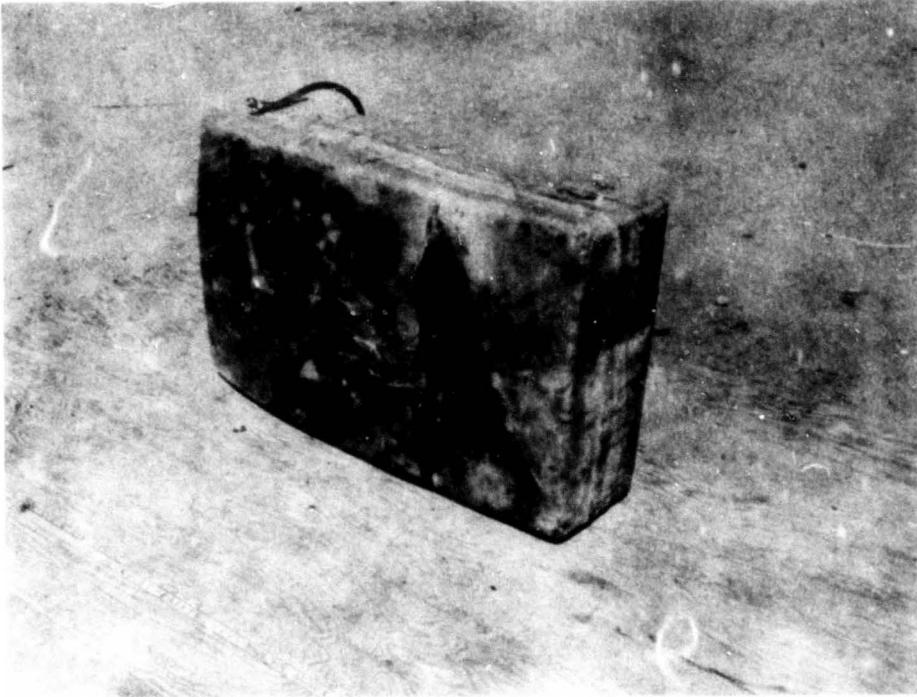
Figure 78. "Tough Wall" Tank Failure, T-23. (The Failure in the Bottom of the Hollow "Tough Wall" Tank Was Due to Rock Impact. The Tank Was Unable To Expand Upward Because of the Modification Made to the Floor To Restrain the Cargo Vertically.)

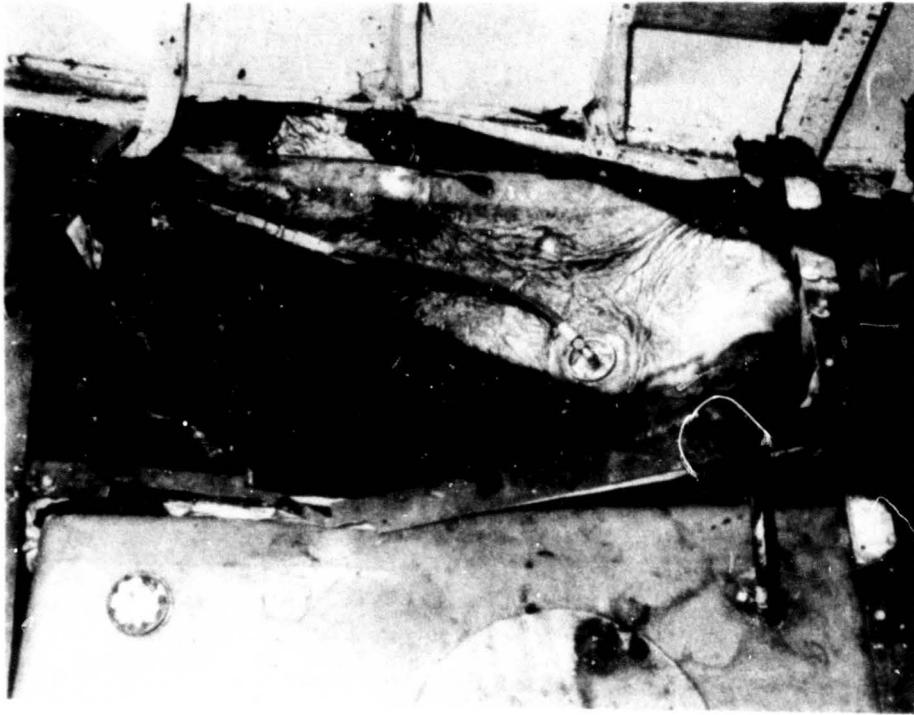
Figure 79. The "Fuzzy Wall" Tank, T-23. (The Nonleaking "Fuzzy Wall" Tank in Location with the Floor Removed.)

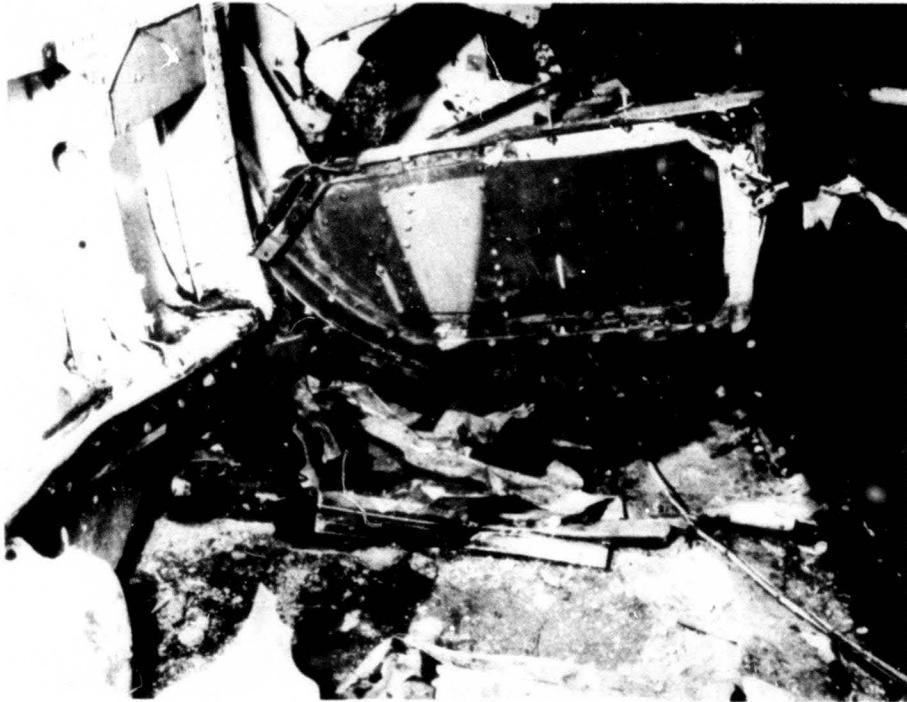
Figure 80. Tank Environment Damage, T-23. (With the "Fuzzy Wall" Tank Removed, the Degree of Structural Failure and Extensive Jagged Metal Surrounding the Tank Installation Are Apparent.)

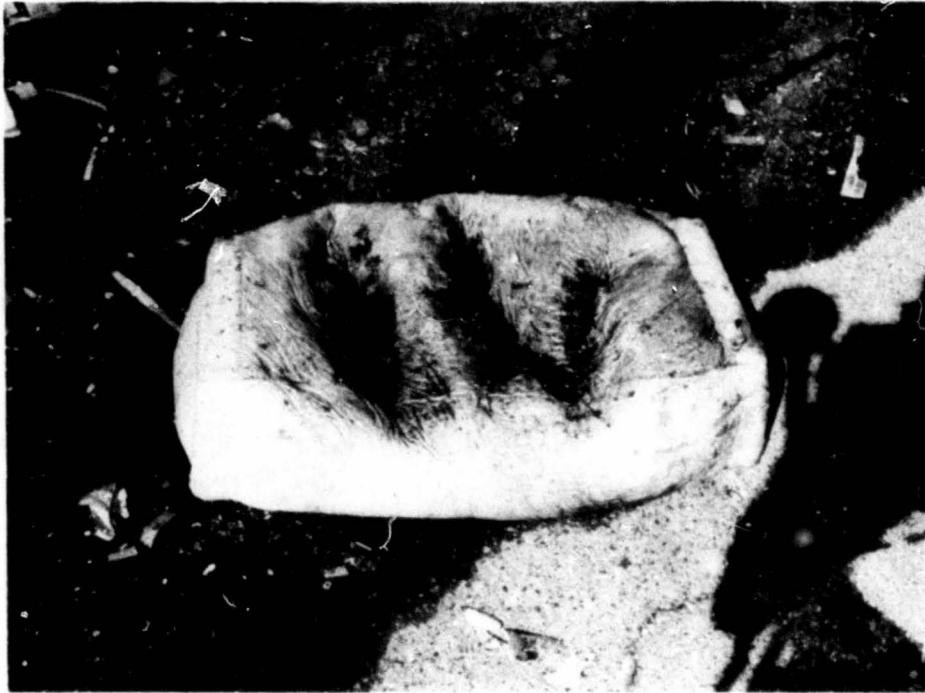
Figure 81. "Fuzzy Wall" Tank, T-23. (The Bulges Apparent on the "Fuzzy Wall" Tank Bottom Are Evidence of the Tank's Ability To Contour and Deform to its Surrounding Environment.)

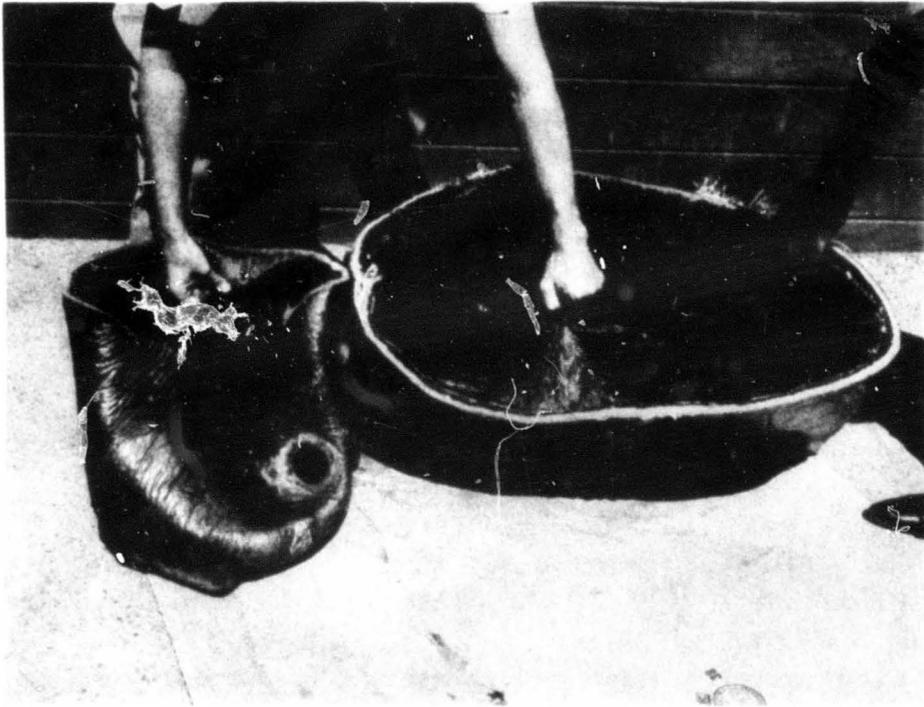
Figure 82. Cross Section of "Fuzzy Wall" Fuel Tank. (Analysis Revealed that the "Crinkl-Core" Has Unfolded in the Lower Regions, Thus Providing an Effective Barrier While the Nylon Pad Elongated. It Was Estimated that this Severe Crash Environment Utilized Less than 20 Percent of the Crashworthy Potential of the Tank.)
