INVESTIGATION OF FRACTURED STEEL PLATES  
REMOVED FROM WELDED SHIPS

MORGAN L. WILLIAMS AND GEORGE A. ELLINGER  
National Bureau of Standards

SHIP STRUCTURE COMMITTEE

DATE: FEBRUARY 25, 1949

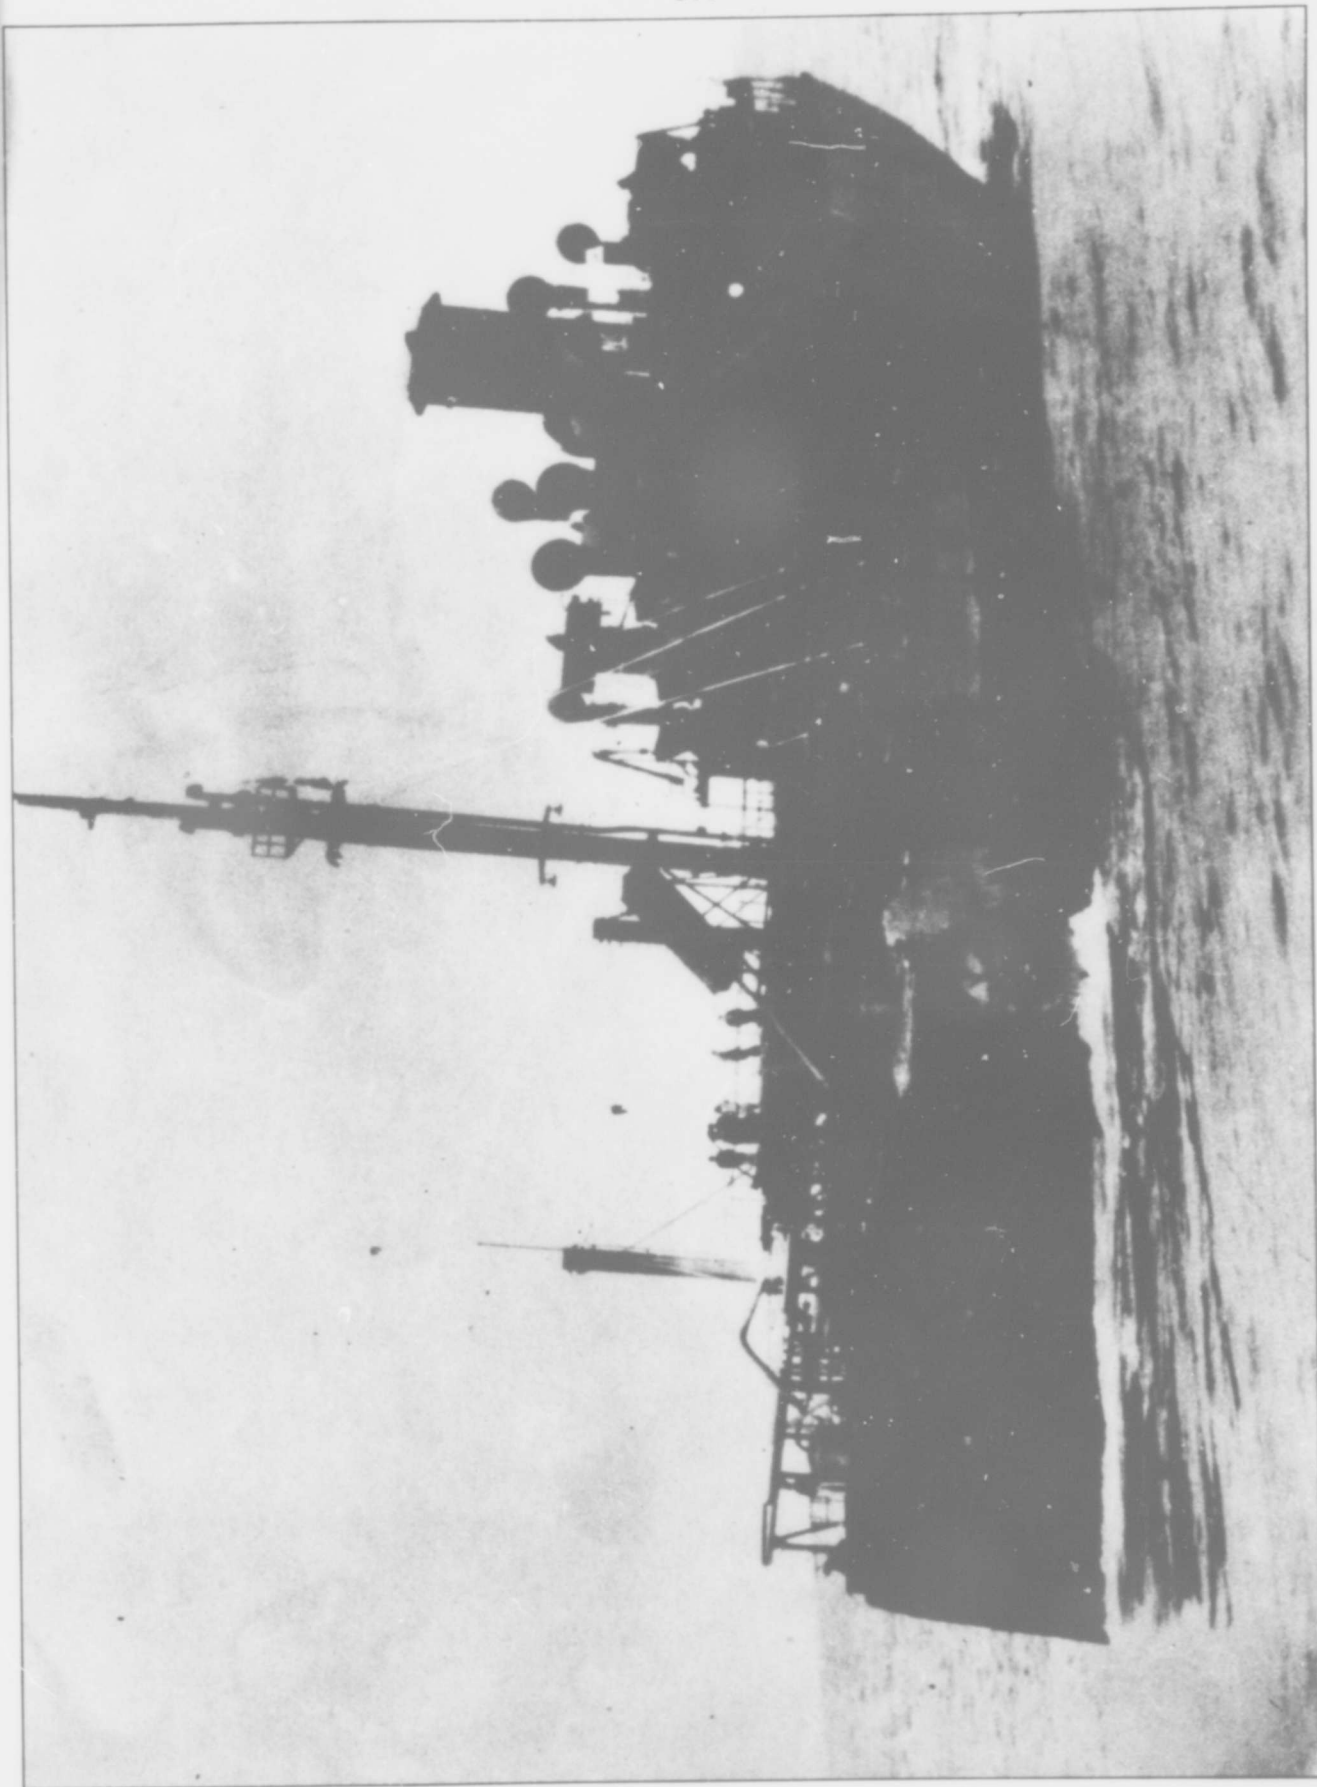
During the period (Jan. 1942 - June 1947) covered by this report at least 15 ships broke in two or were lost as a result of structural failures. From November 1942 thru March 1946 there were 132 major casualties and more than 1300 casualties of a less serious nature<sup>2</sup>. Figure 1 is a typical example of a completely fractured ship.

Fig. 1. Stern section of a T2 Tanker which broke in two at sea. (U. S. Navy Photograph).

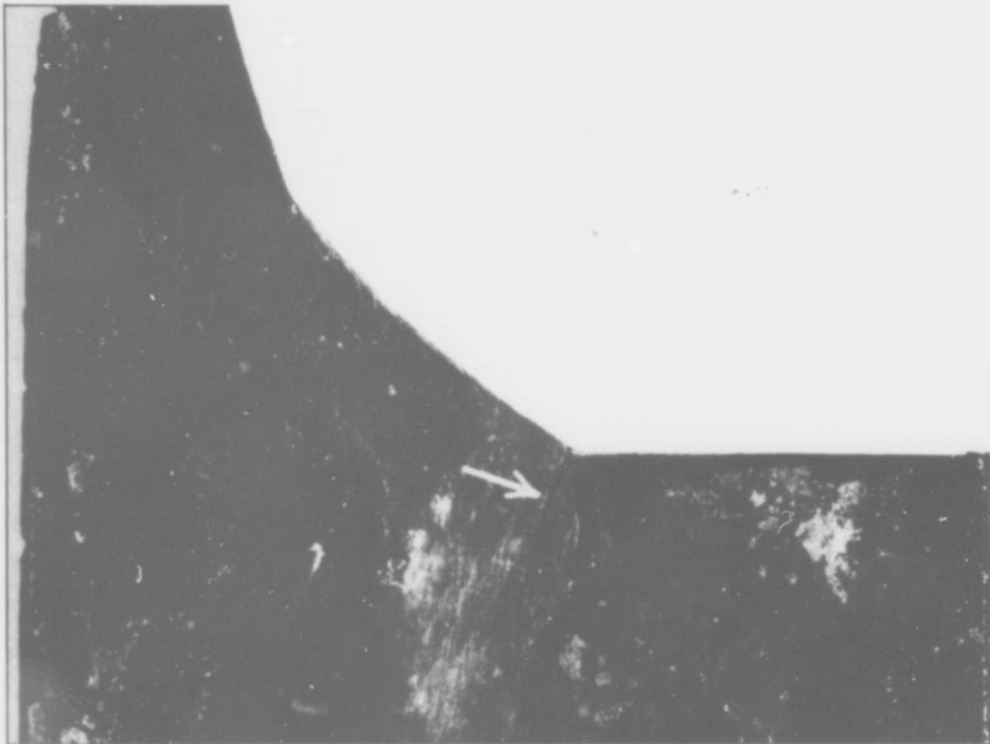
A small crack originating at a sharp corner in a cutout for a ladder opening in the sheer strake of a Liberty ship, type EC2-S-C1 is shown in Figure 2. Similar cracks were found in both the port and the starboard ladder openings of this vessel and although they had progressed only about one inch when discovered, they did form severe notches, which might have led to more serious failures. The openings had been made by hand torch cutting, and subsequently dressed by grinding. Several deep notches, however, still remained on the edges. The fracture, indicated by the arrow, was located at a sharp change in section, which was further aggravated by rough notches resulting from the flame cutting operation.

Fig. 2. Fracture source at cutout in sheer strake. x 1.

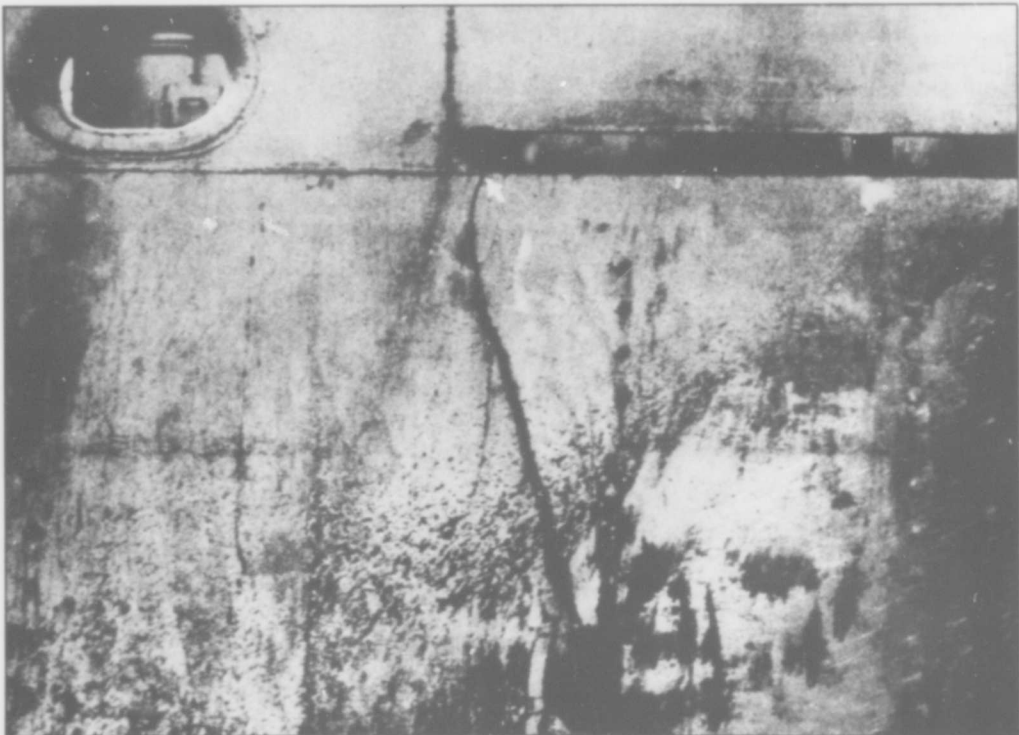
Another fracture also starting at a cutout in the sheer strake is illustrated in Figures 3 and 4. The source of this fracture (Figure 4) was at a sharp change in section at the toe of a fillet weld between the sheer strake (below) and the end of an insert plate (above). A small globule of weld metal (arrow) probably formed by the touching of the electrode to the plate was adjacent to the crack. The heat affected zone under this globule was quite shallow and was about the maximum hardness for this type of steel (Knoop number 400) indicating very rapid cooling and providing a metallurgical notch in addition to the geometrical notch at the change in section. The edge of the sheer strake plate at this point had been prepared by machine gas cutting. A notched bar test specimen taken from a point very close to this edge had an energy absorption only 60 per cent of the average energy absorption of three similar specimens taken from the interior of the plate and tested at the same temperature (70°F). This indicates that the notch sensitivity of the steel, which was already high, had been increased in the region of the flame cut edge by the heating during the cutting operation. The origin of this fracture was attributed to a combination of factors: (1) A notch sensitive steel, with the notch sensitivity at the edge of the plate further aggravated by heating incident to the flame cutting of the edge. (2) Stress concentration at a geometrical notch or sharp change in structural section. (3) A metallurgical notch near the geometrical notch. (4) Low temperature (45°F) and (5) rough seas and a strong wind (force 9) causing unusual stresses in the structure of the ship.

Fig. 3. Fracture originating at change of section at end of slotted freeing port. (U. S. Navy Photograph).

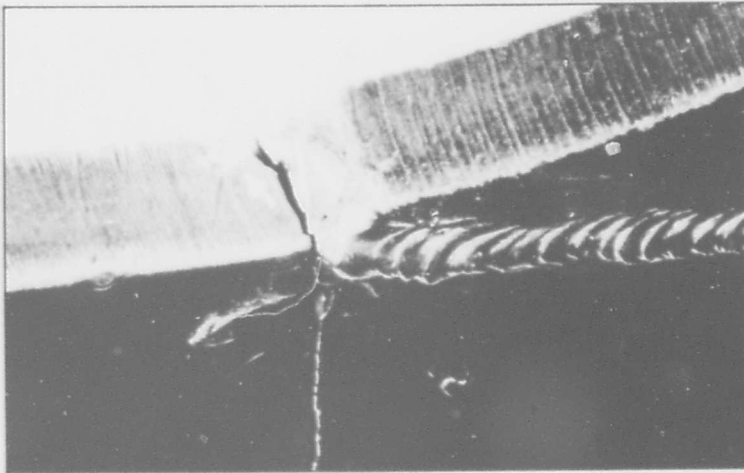
Fig. 4. Source of fracture shown in Figure 3, viewed from inboard and above. Arrow shows globule of weld metal on edge of sheer strake plate. x 1.

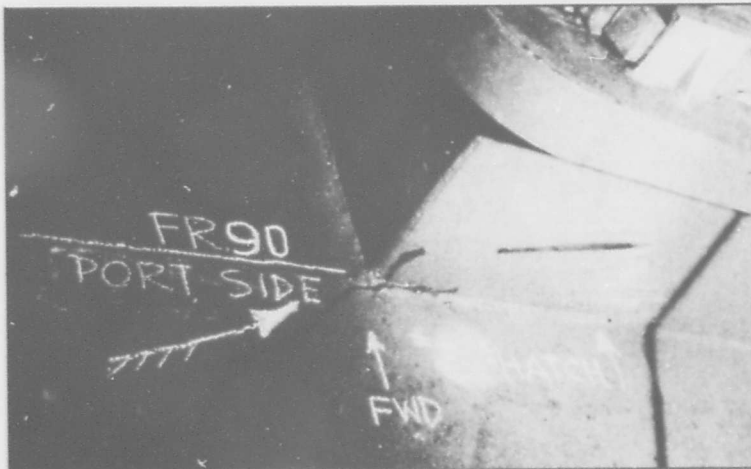
A typical example of a fracture originating at a hatch corner is shown in Figure 5. On this ship, similar fractures originated in the 1-1/4 inch deck insert plate at both the port and starboard after corners of No. 3 hatch. The starboard fracture ended at a bollard on the deck stringer which acted as a reinforcement. The port crack progressed across the deck to the sheer strake and

down the side into the H strake. The hatch end beams and coaming, and the deck in way of the hatch openings, did not fracture except for a few inches near the hatch corners.

Fig. 5. Fracture originating at hatch corner of cargo vessel. (U. S. Coast Guard Photograph).

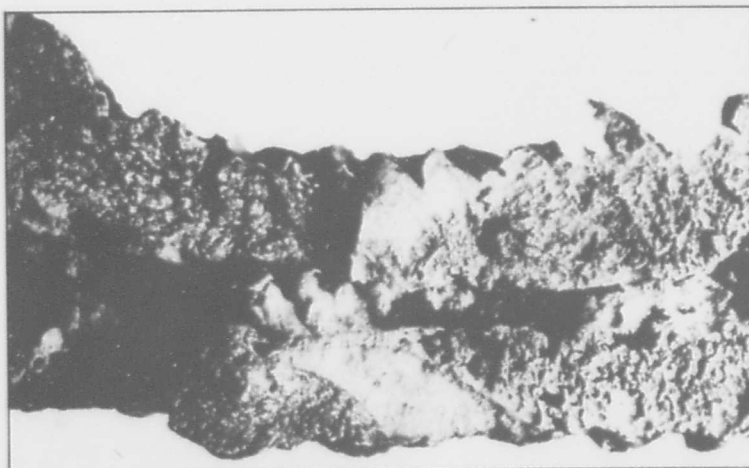
A small fatigue fracture is shown in Figure 6. This is the only fatigue fracture which we have ever found in weld metal, and we have never found the characteristic markings of a fatigue failure in any of the fractured hull plates which we have examined.

Fig. 6. Small internal fatigue fracture in weld metal. Note also the slag inclusions, poor penetration of weld metal, and rough weld beads. x 3.

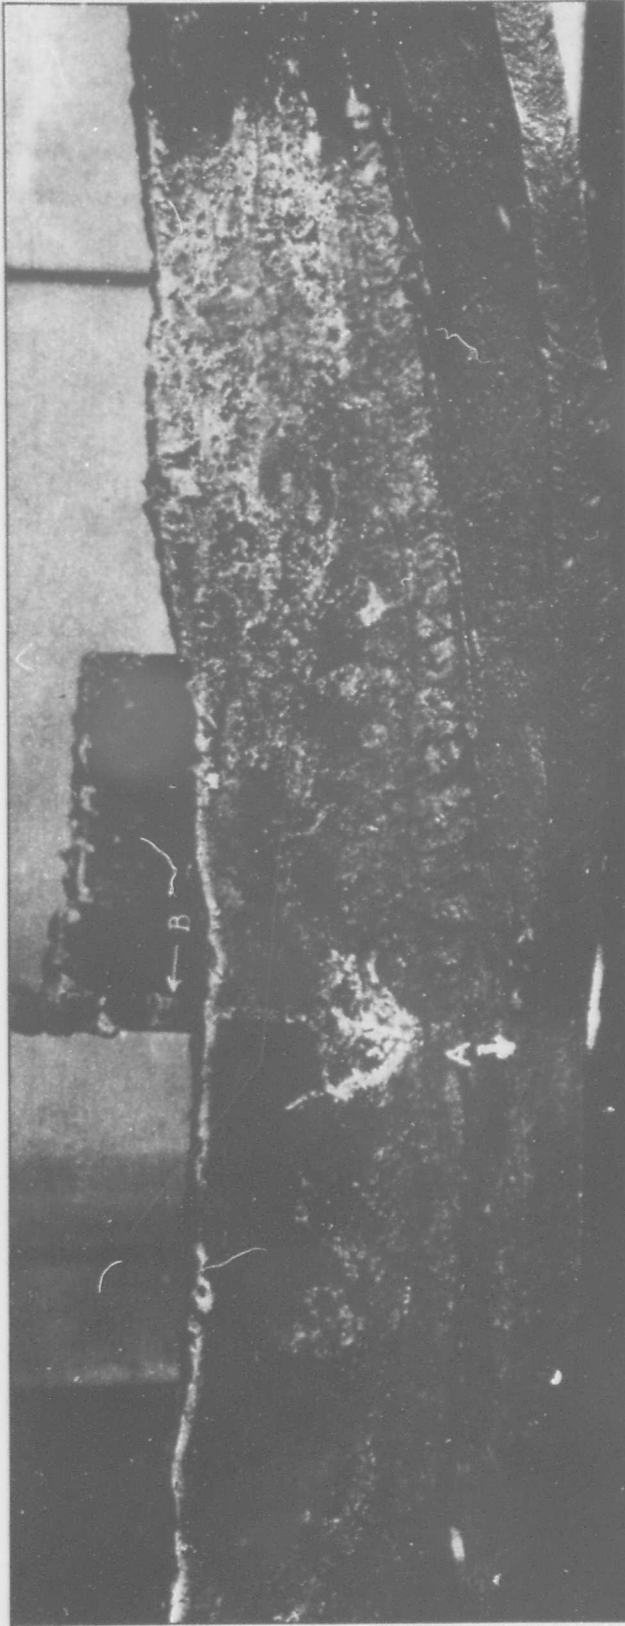
A fracture in the shell plating of a tanker which broke in two at sea is shown in Figure 7. The herringbone markings on the fractured edge clearly indicated the source of the fracture in the shell plate, at the point marked by arrow A. This point, about 2-1/2 inches from a transverse bulkhead (punch-marked BHD in the photograph - top right), was 14 inches below the seam of D and E strakes, and was exactly at an end of a longitudinal. The end of the corresponding longitudinal on the other side of the bulkhead is indicated by arrow B in the photograph. The longitudinals here were interrupted for a space of about 6 inches to allow for insertion of the transverse bulkhead, and were connected through this bulkhead by gusset plates on the flanges of the longitudinals. The longitudinals were rigidly connected to the shell plating by fillet welds all around. The ends of these longitudinals were not rounded or tapered, but were cut square and perpendicular to the shell plating. This condition constituted a structural notch at the abrupt end of the longitudinal stiffener.

Fig. 7. Fracture edge in shell plating of a tanker. Arrow A shows the fracture source, at the point where the longitudinal ended near a bulkhead. Arrow B indicates a similar longitudinal on the other side of the bulkhead.

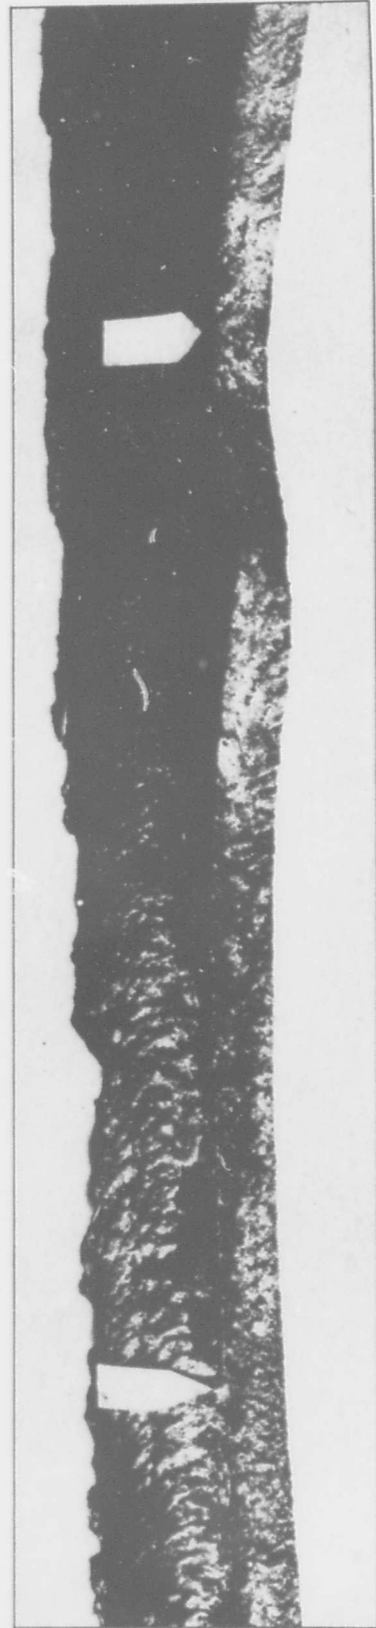
*this ship was built in the very early days of welding - 75*  
A sample of shell plating from a Coast Guard Cutter which was fractured while navigating through an ice pack is shown in Figure 8. There were two sources of fracture in the plate, indicated by arrows; No. 1 about 1/8 inch from the toe of the weld and No. 2 about 1/2 inch from the weld. Both sources were at small weld globules in the plate where arcs had been struck. Several other

examples of fractures starting in arcs struck on the plate metal adjacent to the weld have been observed. A number of fractures also have been found which had their origin in small welds on heavy plate, such as light tack welds or welds for the attachment of small clips.

Fig. 8. Shell plating of vessel damaged by ice collision. Arrows indicate two fracture sources at craters where arc was struck on plate. x 1.

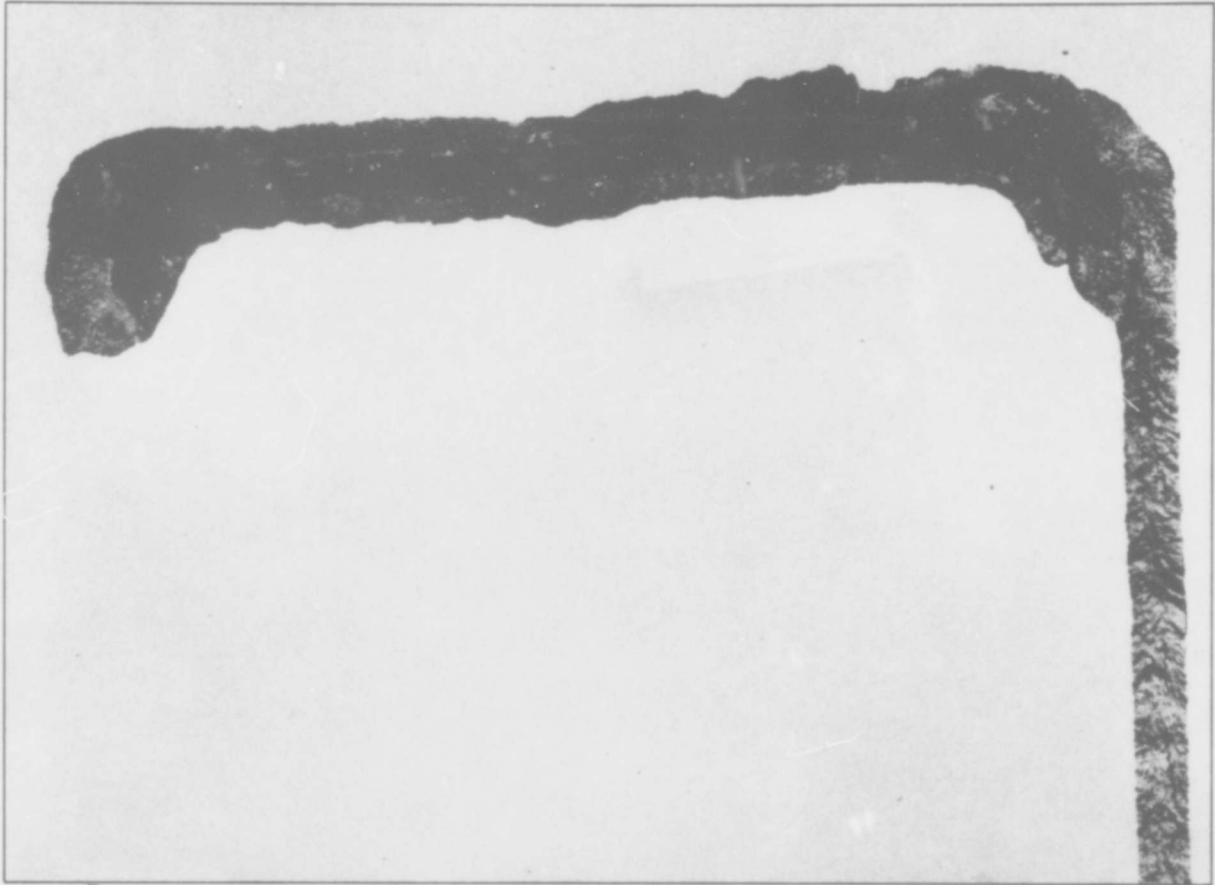
An example of a faulty butt weld in a bulwark cap rail is shown in Figure 9. The edges of the plate were rough and not properly beveled and the weld metal did not penetrate to the center of the joint. The full strength of the joint was not attained, and the weak joint was at a highly stressed part of the vessel (the extreme fibers of a beam). The herringbone markings in the bulwark plate, at the right in the photograph, indicate clearly that the fracture originated in the faulty weld of the bulwark cap rail.

Fig. 9. Saddle weld in bulwark cap rail. Note the herringbone markings in bulwark plate (right) pointing to source of fracture in defective weld of cap rail (top). x 1.

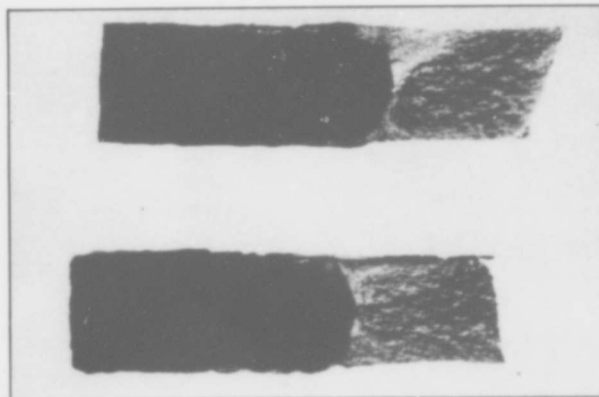
A typical end of a fracture in ship plate is shown in Figure 10. The original crack had rusted, and appears dark in the photograph. The lighter portion at the right was broken in tension in the laboratory. Herringbone markings, pointing to the left, can be seen in both the old and the new portions of the fracture. The original fracture had progressed somewhat farther at the center of the plate than at points nearer to the plate surfaces, resulting in a semi-circular or oval shape at the end of the fracture. Similar oval shapes, of varying symmetry and convexity, were observed at every fracture end which was examined, and in every case the fracture was less advanced at points near the

plate surfaces. The herringbone markings were approximately perpendicular to the oval shapes at the fracture ends, suggesting that these markings were probably the traces of irregularities in the advancing fracture front.

Fig. 10. Typical end of crack. The dark part at the left is the original crack; the light portion was broken in tension in the laboratory. x 1.

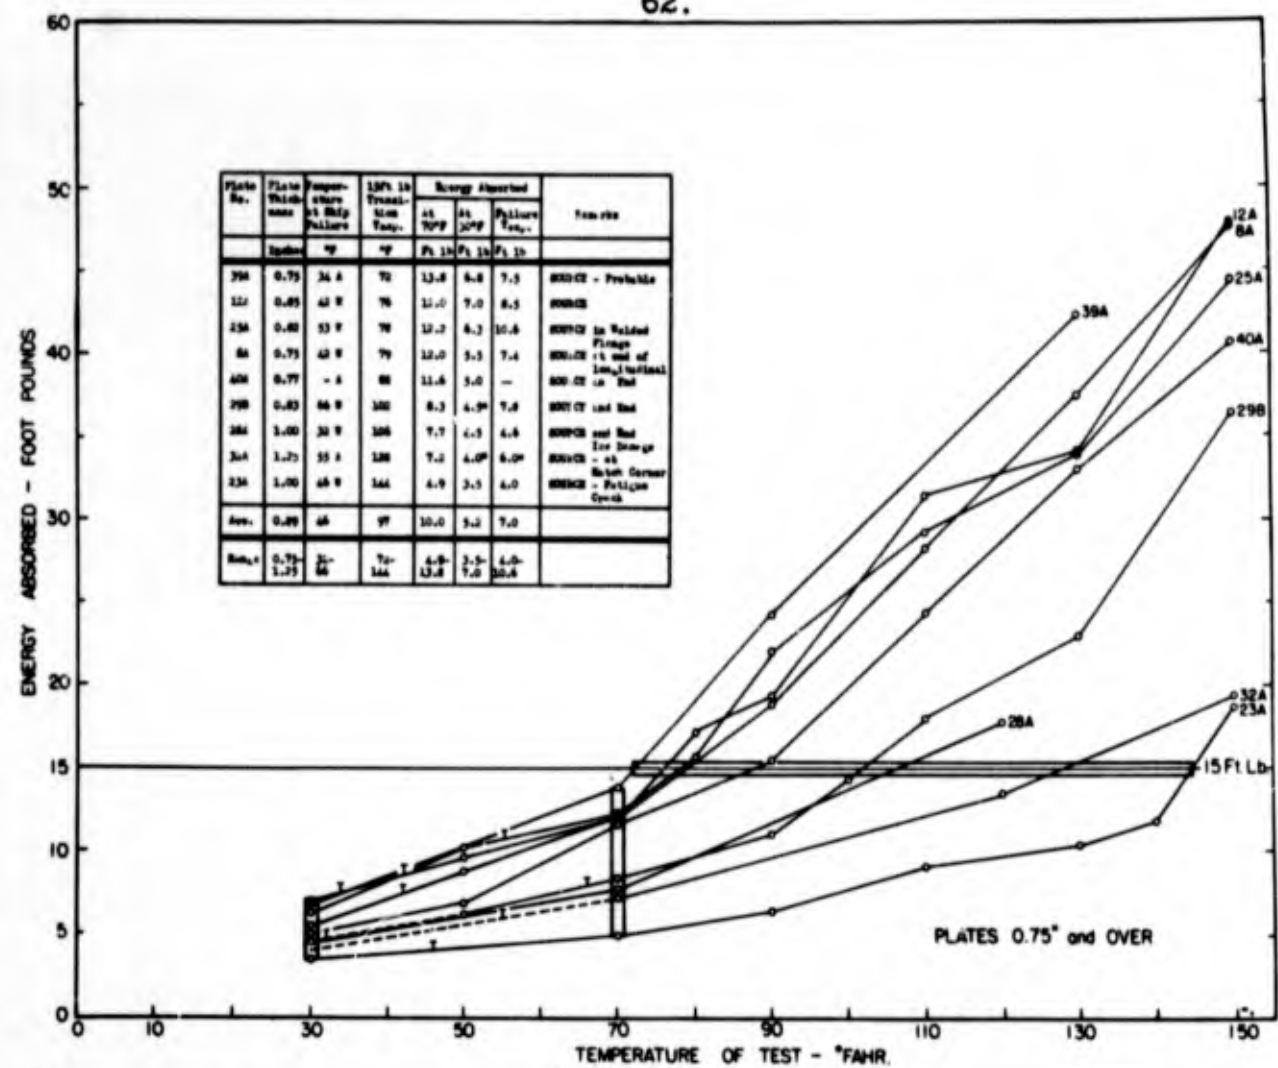
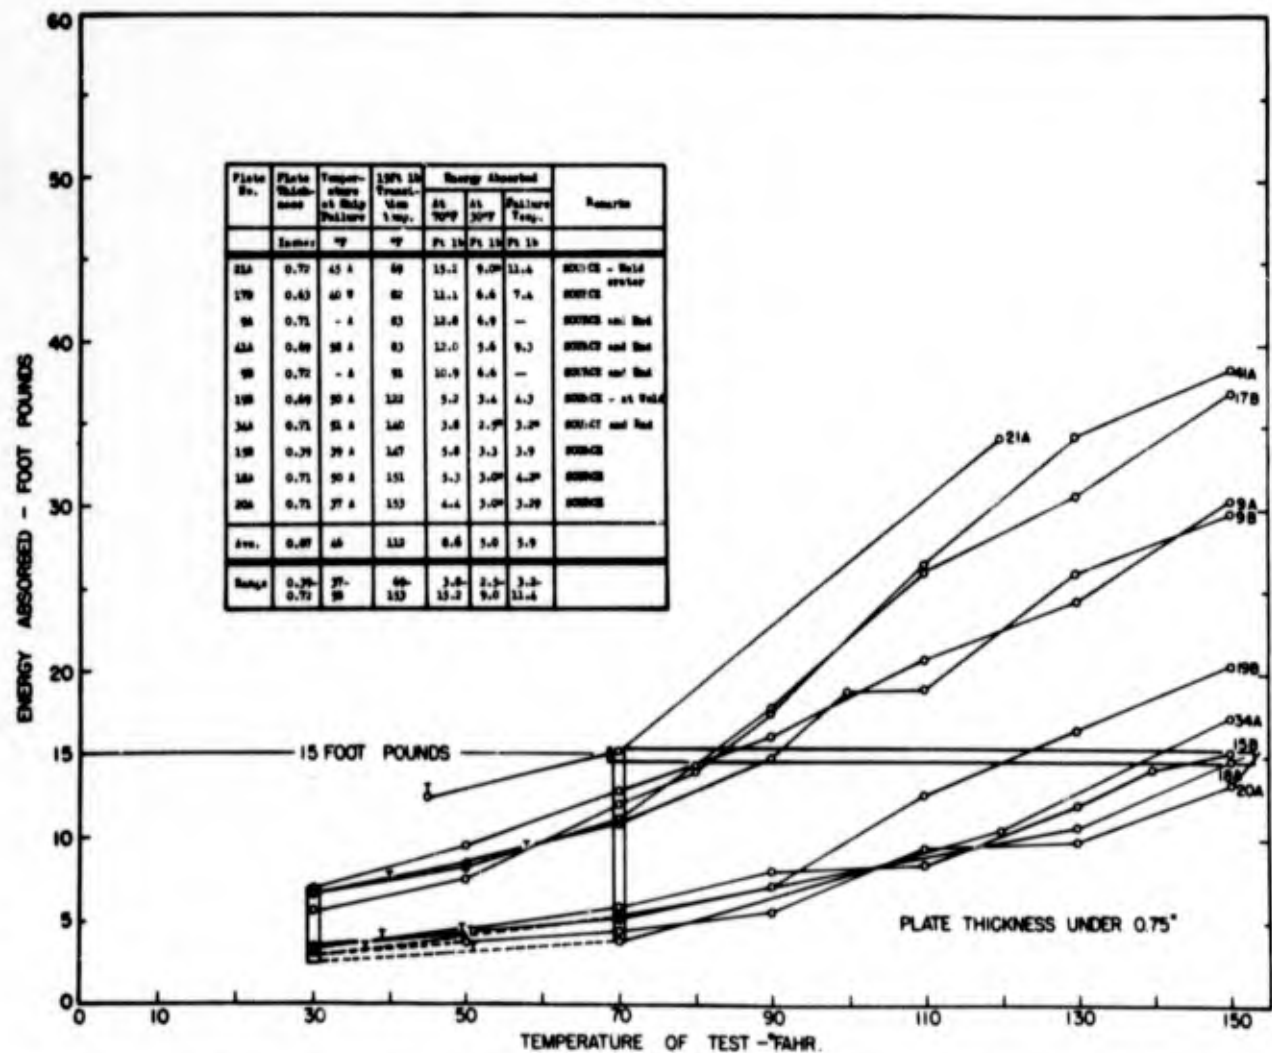
The Charpy notched bar properties at various temperatures of plates which contained a fracture source are shown in Figure 11. The upper portion of the figure contains the curves for 9 plates  $3/4$  inch and over in thickness while the lower portion contains those for 10 plates less than  $3/4$  inch thick.

70°F, for each group of plates. The horizontal bars show the ranges of the transition temperatures for the steels in each group. The temperature at which the energy absorption was 15 foot pounds, (determined from the notched bar test curve for each steel) was taken as the transition temperature of the steel. This provides an index of the notch sensitivity which is relatively easy to determine from the numerical quantities derived from the tests, and which is free from the personal factors involved in determination of the transition from ductile to brittle fractures by examination of the fractured surfaces. Fifteen foot pounds appears to be a reasonable value based on experience in the field, and is the minimum acceptable value specified for Charpy notched bar tests under the ASME Boiler Code.

The reported temperatures at which the ship failures involving these plates occurred are indicated by the letter T above the corresponding curve, and the corresponding energy absorptions for each plate (determined from large-scale drawings of the curves) are shown in the second last column of the tables above each group of curves. The water temperatures reported at the time of the casualties were used for plates below or near the waterline, and air temperatures for plates definitely above the waterline, as indicated by the letters A (air) or W (water) in the third column of the tables. Other quantities, either measured or derived from the curves, are also shown, for each plate, in other columns. The average values of these quantities, and the range of values, for each group of plates are shown at the bottom of the tables.

It may be noted that for these two groups of plates, in which ship fractures originated, the lowest transition temperature is 69°F, and that the highest energy absorption at 70°F is 15.2 foot pounds.

Fig. 11. Notched bar properties of plates in which the ship fractures originated. Temperatures at time of ships failure are indicated by the letter "T" on the curves. In the tables, "A" indicates air temperature, and "W", water temperature (for plates below water line). Compare to Figures 12 and 13.

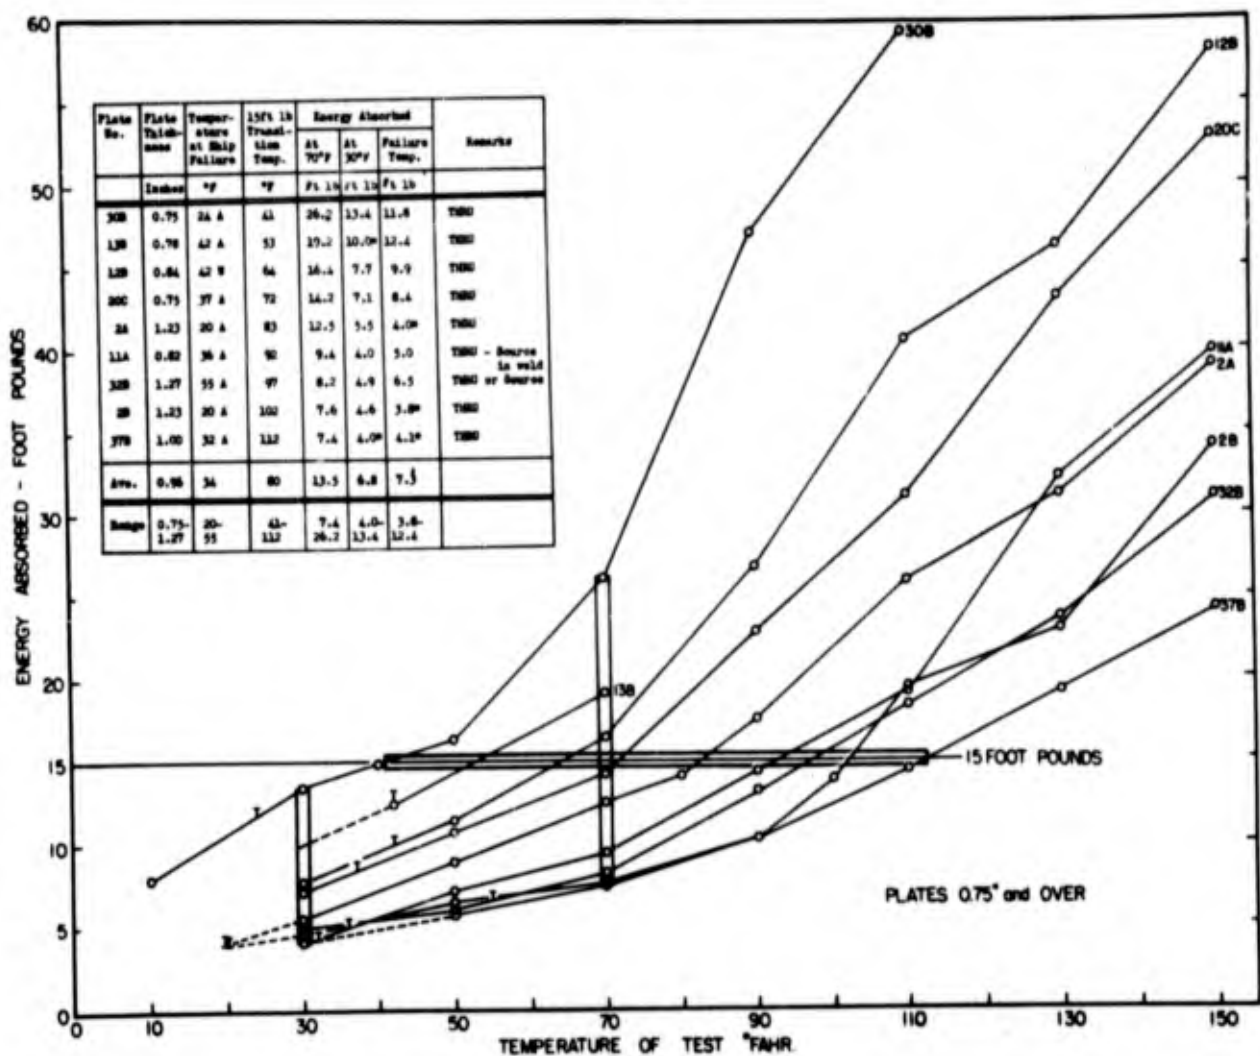
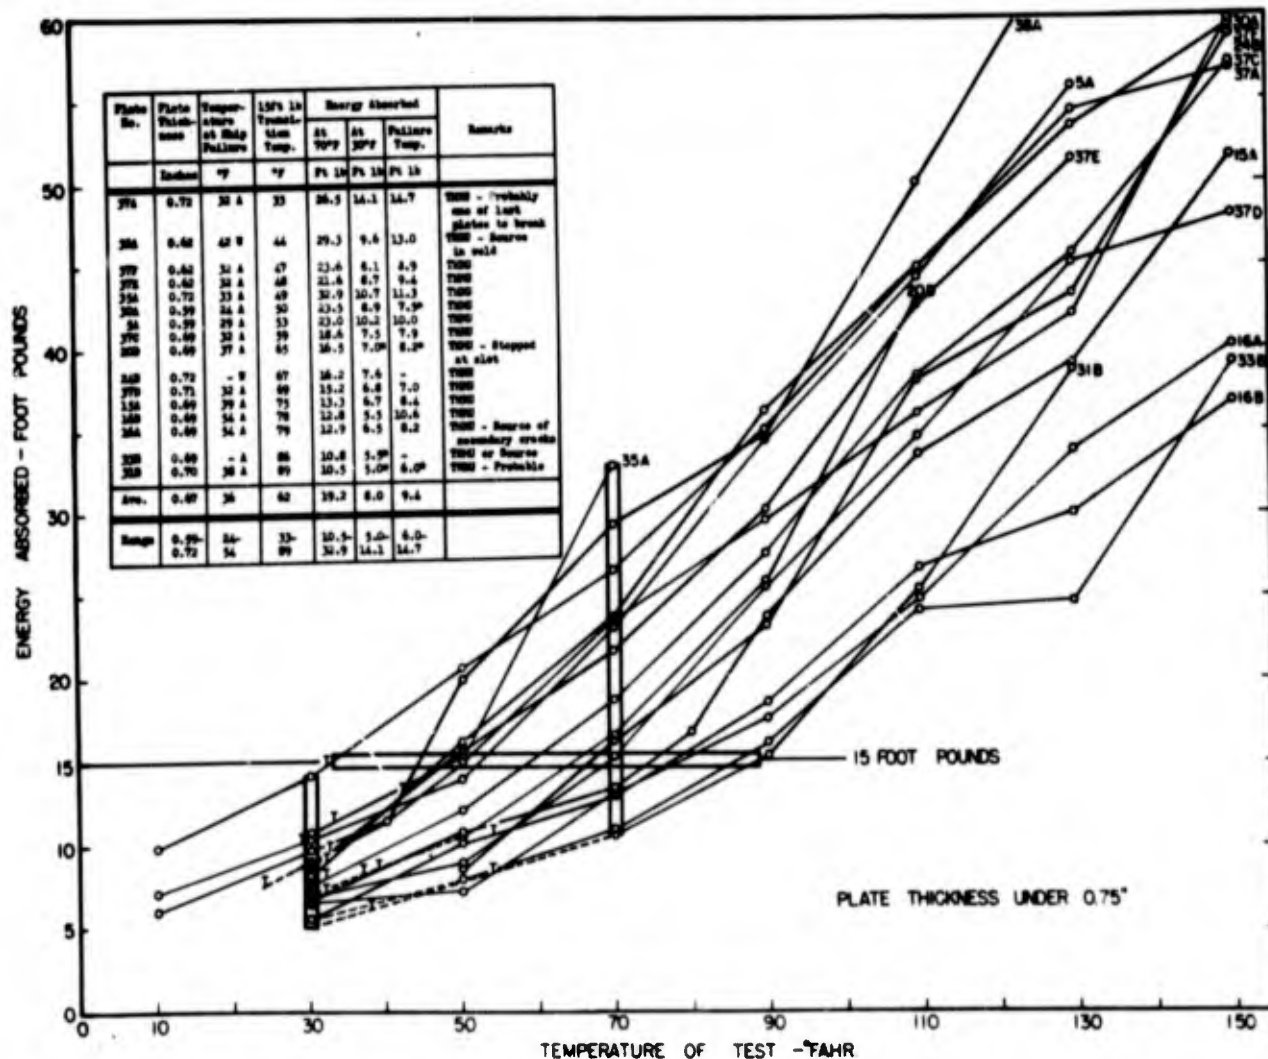
Two similar groups of curves, plotted on the same scale, for 9 plates  $3/4$  inch and over in thickness and for 16 plates less than  $3/4$  inch thick, which were completely fractured in the ship failures, but contained neither the source nor the end of a fracture (designated as the fracture thru groups) are shown in Figure 12. Note that the ranges of the transition temperatures for both of the plate thickness groups, indicated by the horizontal bars, are farther to the left, or toward lower temperatures, than those of the preceding figure, and that the ranges of energy absorption, both at  $30^{\circ}$  and at  $70^{\circ}\text{F}$  (vertical bars) are higher.

Fig. 12. Notched bar properties of plates which were fractured in the ship failures, but which contained neither source nor end of the fractures. Horizontal bars indicate range of transition temperatures. Vertical bars indicate range of energy absorbed in tests at 30°F and at 70°F.

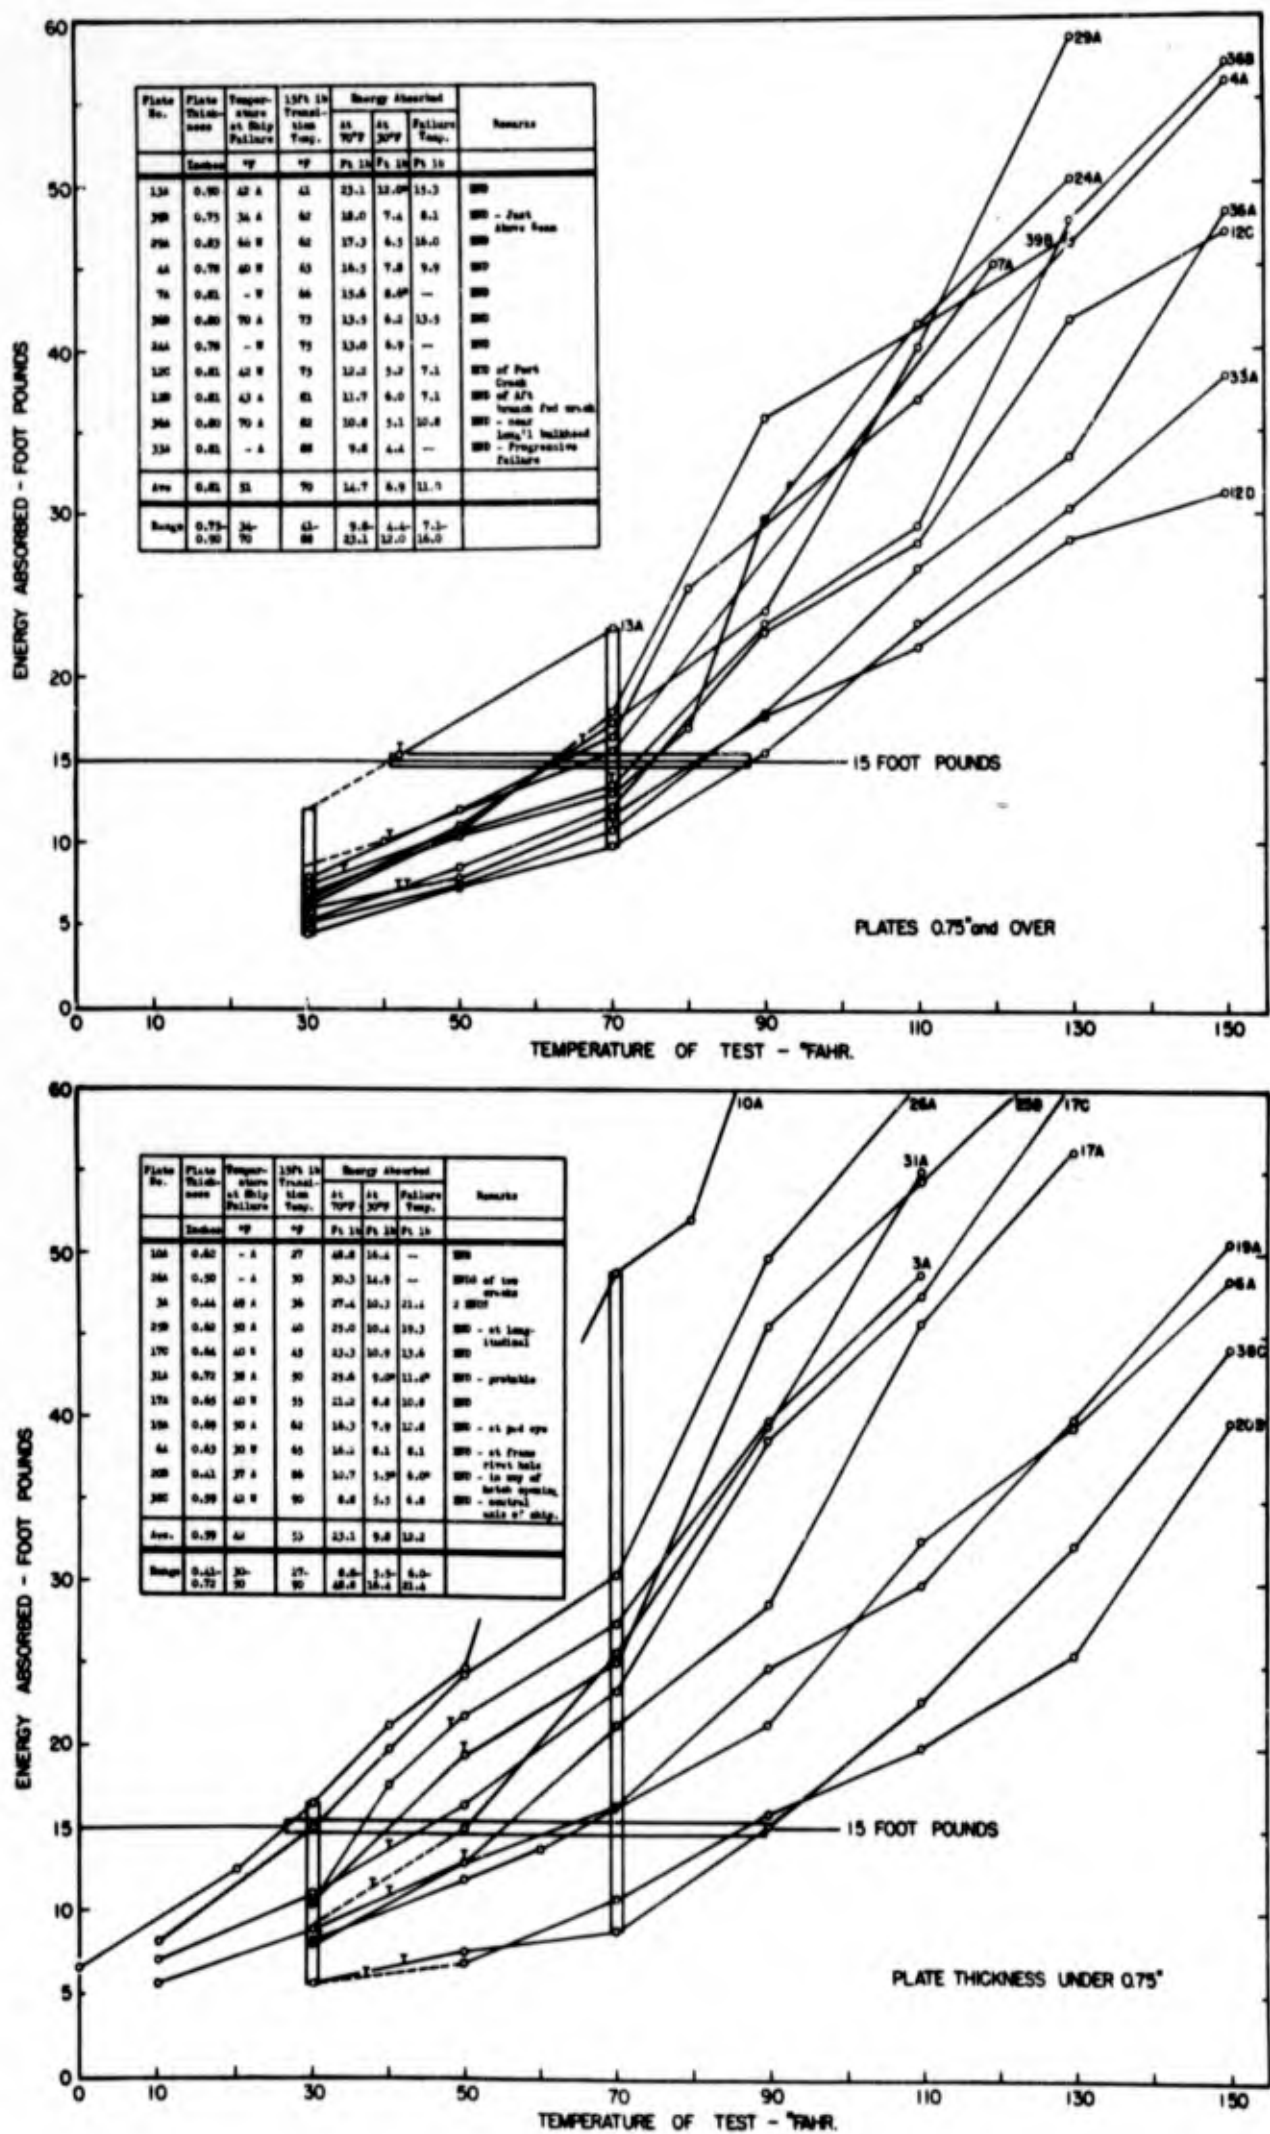
Similar groups of curves, for plates in which the ship fractures ended, are shown in Figure 13. The transition temperatures are still lower, and the ranges of energy absorption are higher, compared to the two preceding figures. This indicates that relative notch toughness of these steels was a contributing factor in halting the propagation of the fractures, just as notch sensitivity was a factor in the origin and propagation of the fractures.

Fig. 13. Notched bar properties of plates in which ship fractures ended. Note lower transition temperatures and higher energy absorption, compared to Figures 11 and 12.

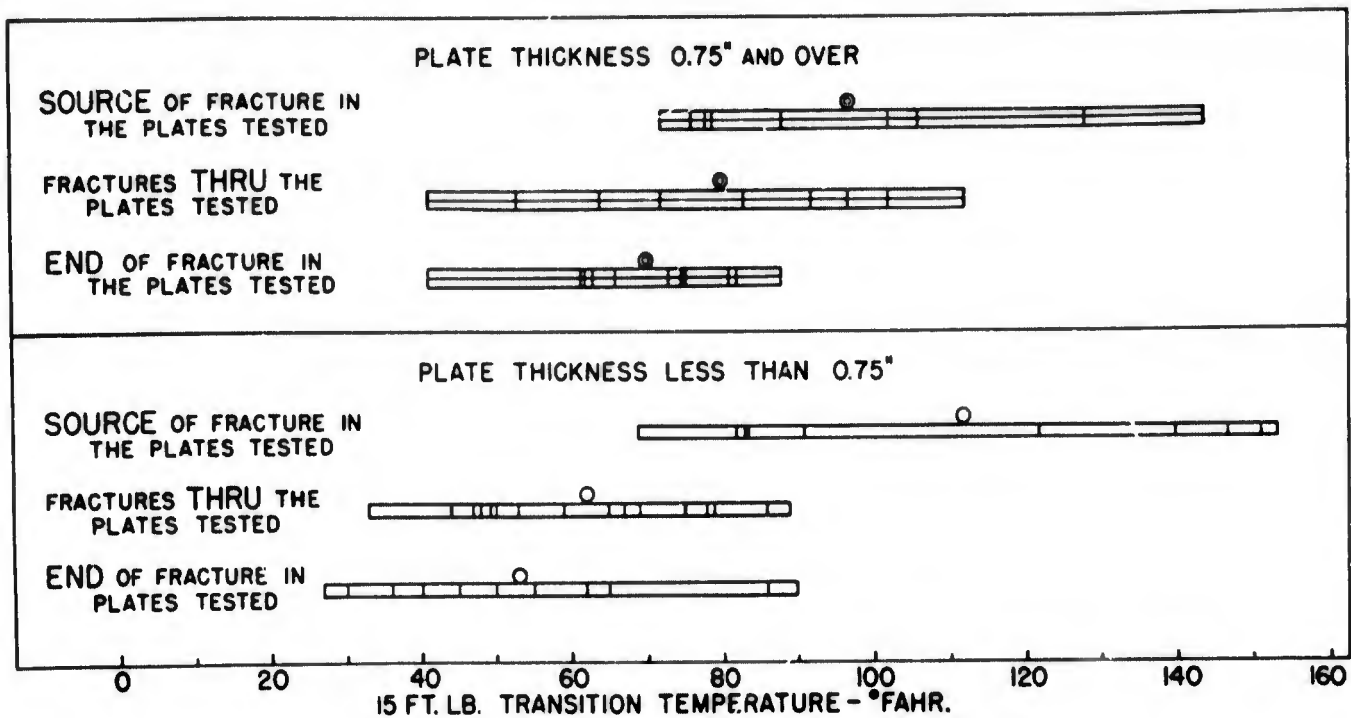
The 15 foot pound transition temperatures for the six groups of plates are compared in Figure 14. The horizontal bars, taken from the three preceding figures, represent the range of transition temperatures for each group, and the circles above the bars indicate the average transition temperatures for all plates in the group. The vertical lines in the bars, including the ends, represent the transition temperatures of individual plates. For plates  $3/4$  inch and over in thickness the average transition temperature for the fracture source group was

higher, by  $27^{\circ}\text{F}$ , than the average for the group of plates in which the fractures ended, and the average for the fracture thru group was between the two. For the plates less than  $3/4$  inch thick, the difference is even more pronounced; the average transition temperature for plates in which the ship fractures originated was  $112^{\circ}\text{F}$ , and for plates in which the fractures ended the average was  $53^{\circ}\text{F}$ , a difference of 59 degrees.

Fig. 14. Relation of 15 foot pound transition temperature to the nature of fracture in ship plates.

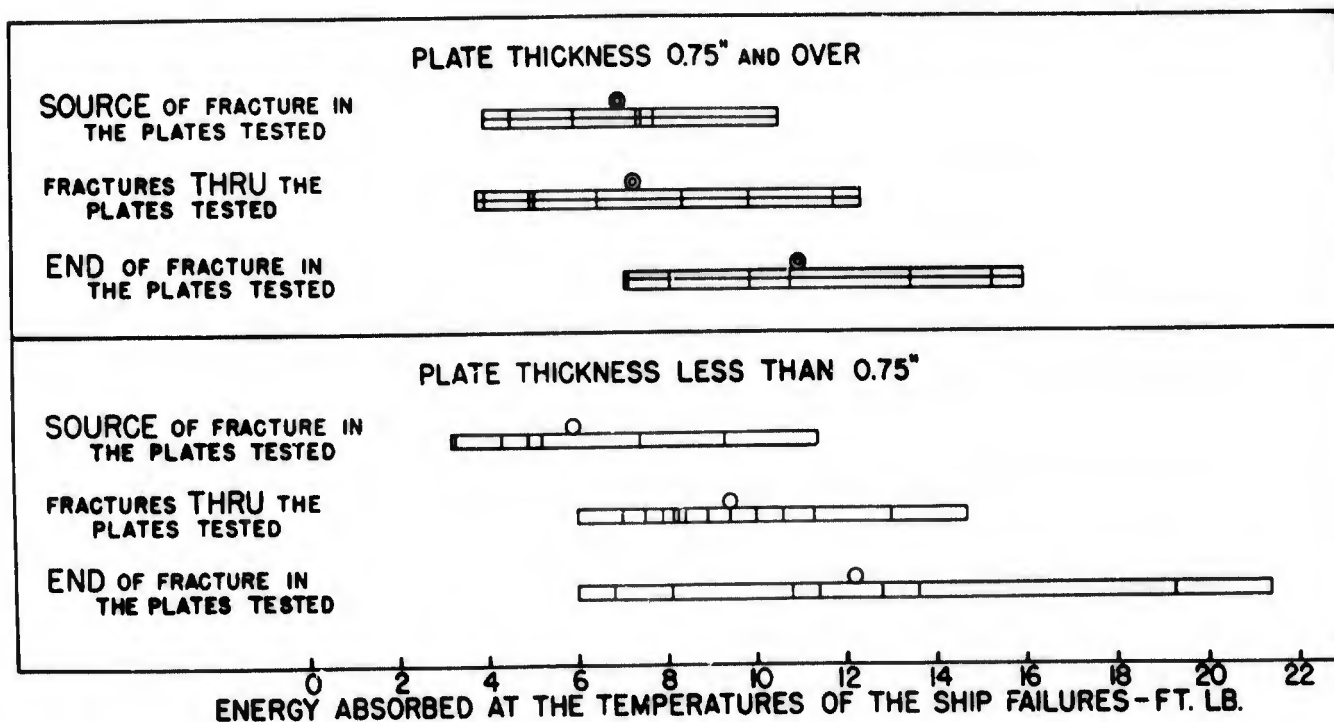
In Figure 15, the horizontal bars represent the range of values of energy absorption at the temperatures of the ship failures, for each of the six groups of plates. The vertical lines in the bars indicate the energy absorption of individual plates, each at the temperature of the ship failure involving that plate. The circles above the bars show the average energy absorption for all plates in the respective groups. The ranges and averages of the failure temperatures for the different groups were nearly the same, as may be seen in Table 3 and in the tables above each group of curves in Figures 11, 12 and 13. For the plates  $3/4$ " and over in thickness, the average energy absorption, at the failure temperatures, of 8 plates in which fractures originated was 7.0 foot pounds. The average energy absorption of eight plates in which the fractures ended was 57% higher or 11.0 foot pounds. For the plates less than  $3/4$ " thick, the value of the average energy absorption of plates in which the ship fractures ended was more than twice that for plates in the fracture source group, the averages being 5.9 foot pounds for 8 plates in the fracture source group, and 12.2 foot pounds for 9 plates in the fracture end group. In spite of the rather large scatter of the values of energy absorption within each group, a very definite difference between the "fracture source" and "fracture end" groups is indicated also by the fact that both the upper and the lower limits of the ranges of energy absorption show the same trend as pointed out above for the average values. It should also

Fig. 15. Relation of energy absorbed in notched bar tests at the temperatures of the ship failures to the nature of fracture in ship plates.
