INVESTIGATION OF FRACTURED STEEL PLATES  
REMOVED FROM WELDED SHIPS

MORGAN L. WILLIAMS AND GEORGE A. ELLINGER  
National Bureau of Standards

SHIP STRUCTURE COMMITTEE

DATE: FEBRUARY 25, 1949

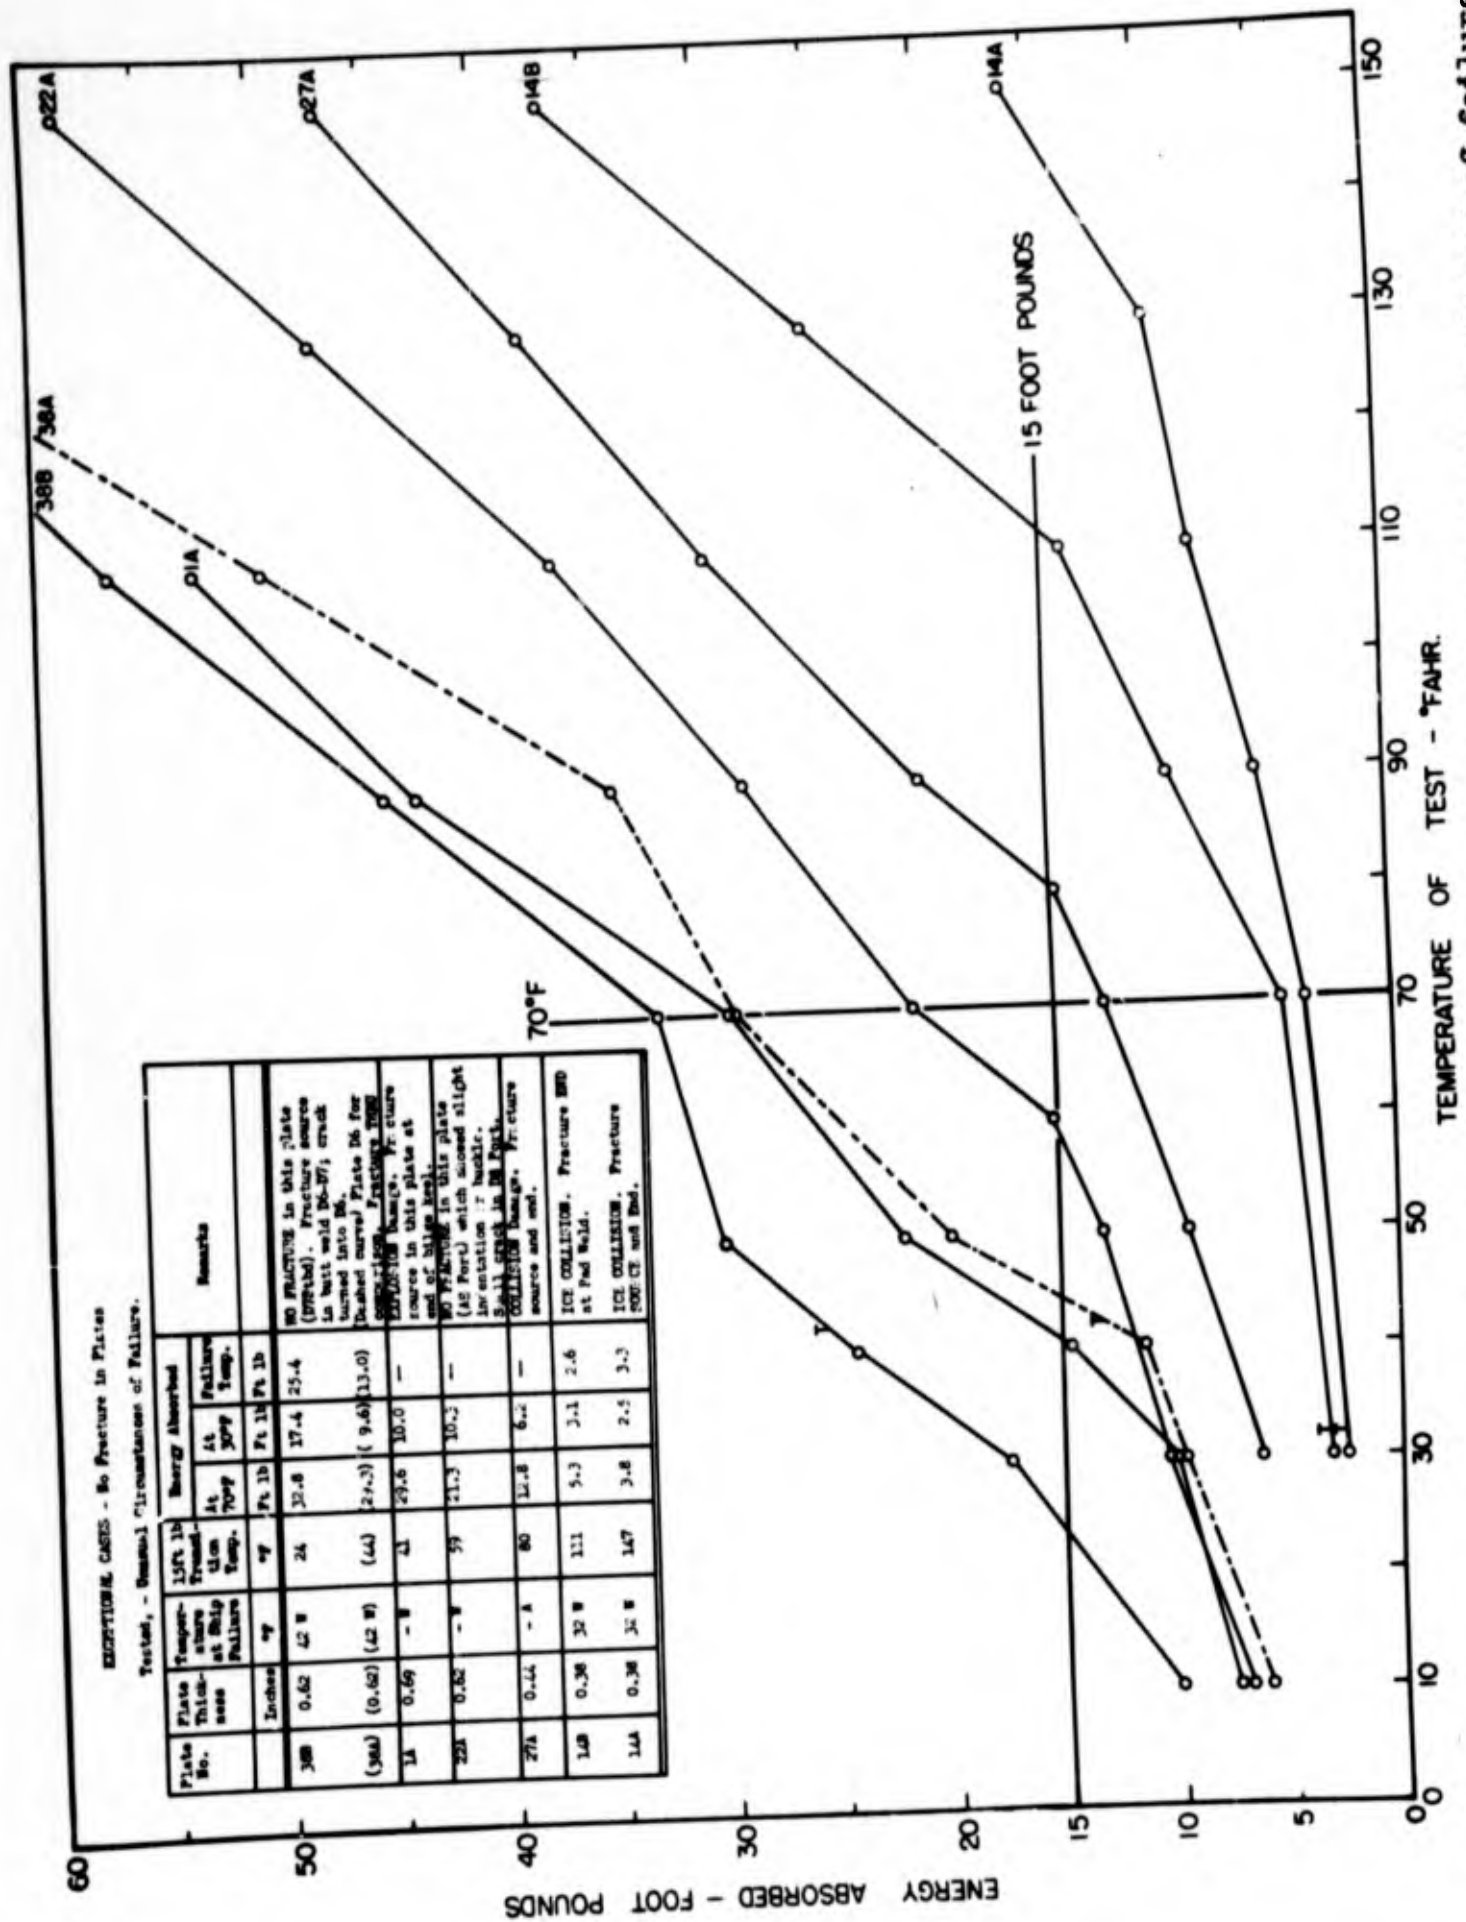
The curves for several plates which were not included in the above analysis, either because the plates tested had not been fractured in the ship failures, or because of unusual circumstances of the failures involved are shown in Figure 16.

Fig. 16. Notched bar properties of plates with no fracture, or unusual circumstances of failure.

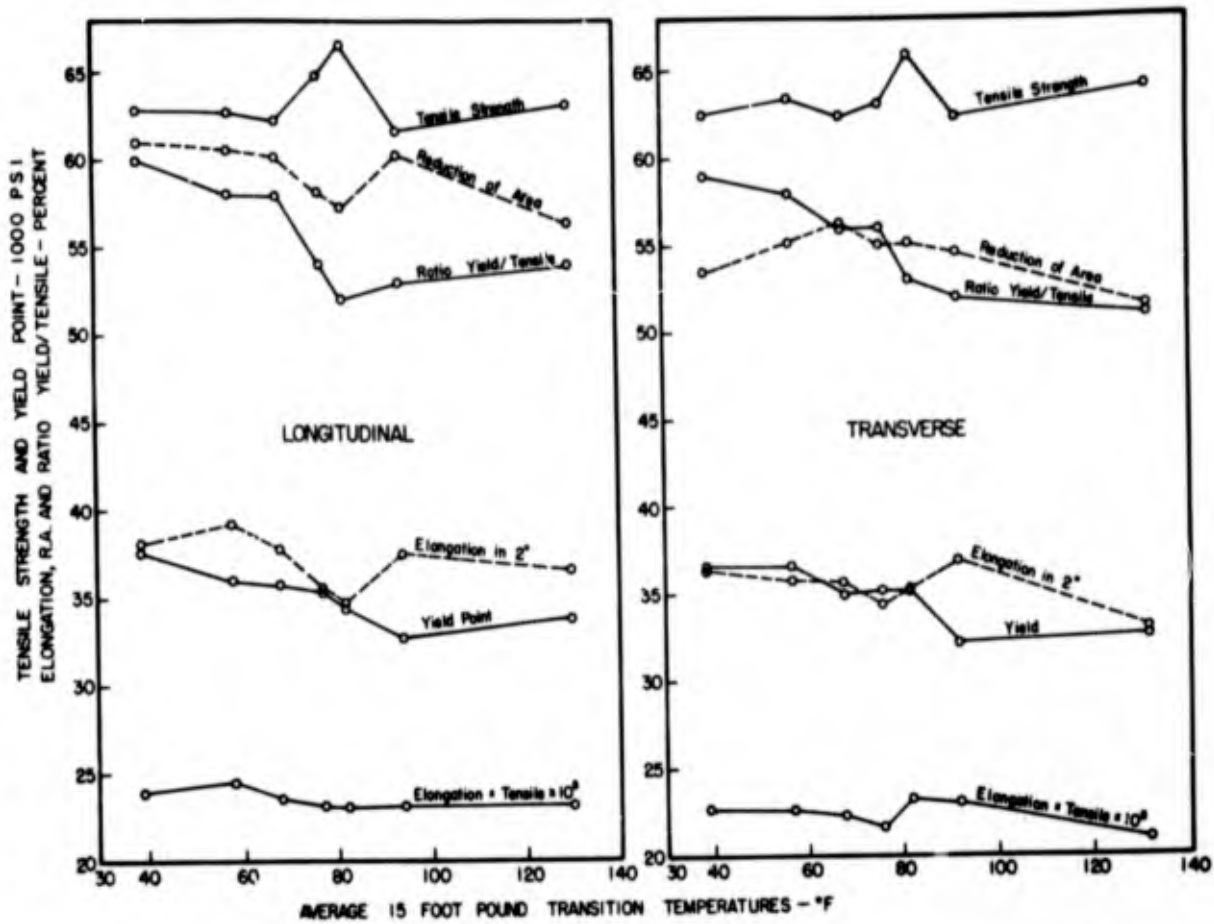
Fig. 17. Relation of average tensile properties of longitudinal and transverse .505" diameter specimens to the average 15 foot pound transition temperatures of successive groups of plates.

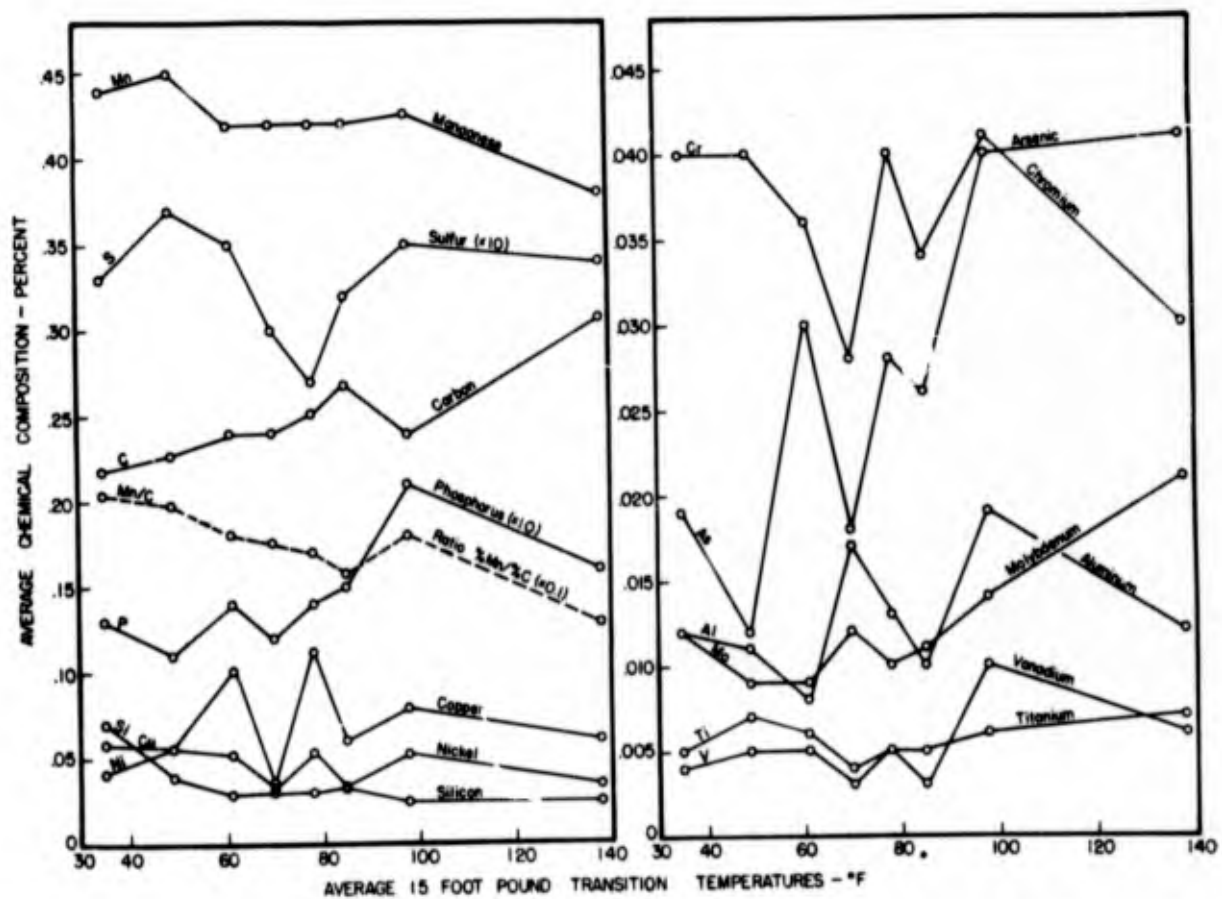
Fig. 18. Relation of average chemical compositions to the average 15 foot pound transition temperatures of successive groups of plates.

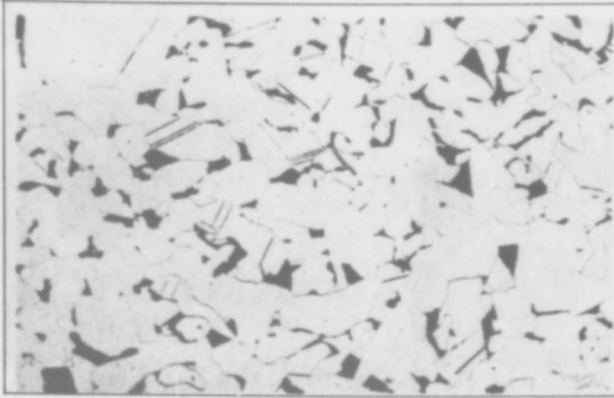
Fig. 19. Neumann bands 1/4 inch from fracture. x 100

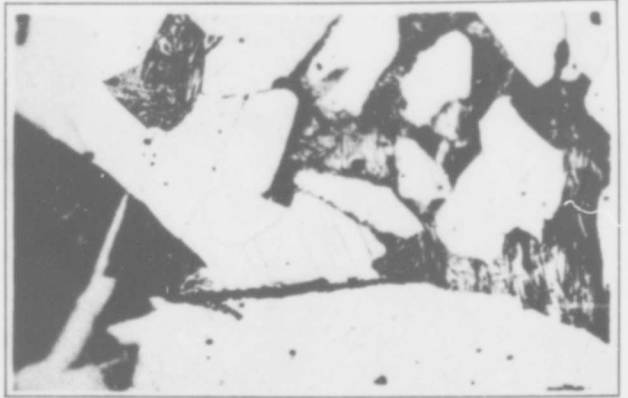
Fig. 20. Neumann bands and cracks. x 500

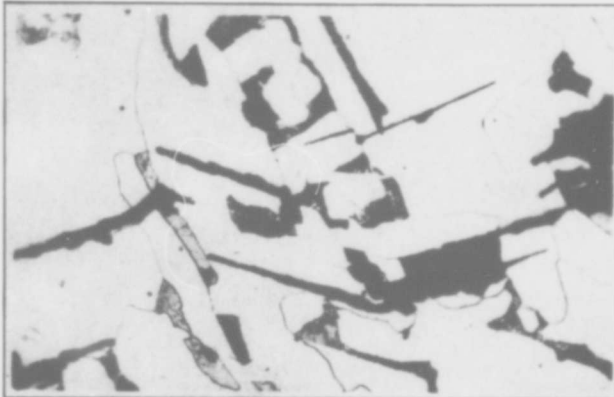
Fig. 21. Directional cracks adjacent to main fracture. x 500

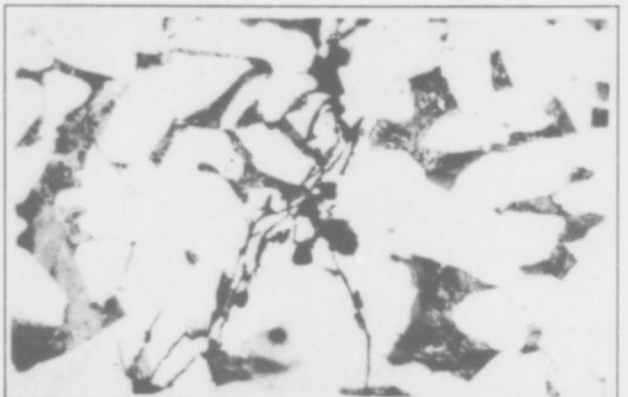
Fig. 22. Shattered zone near main fracture. x 500

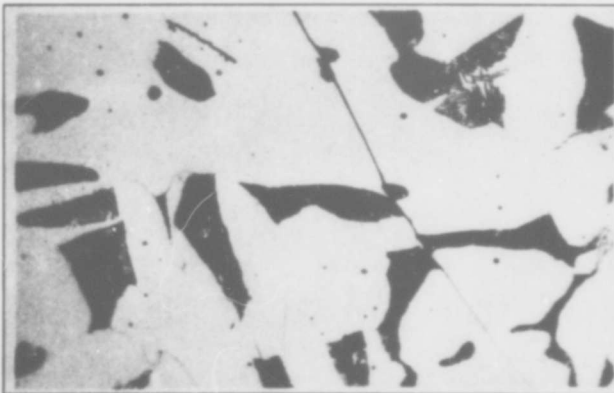
Fig. 23. Displacement of fractured pearlite grains along crack. x 500

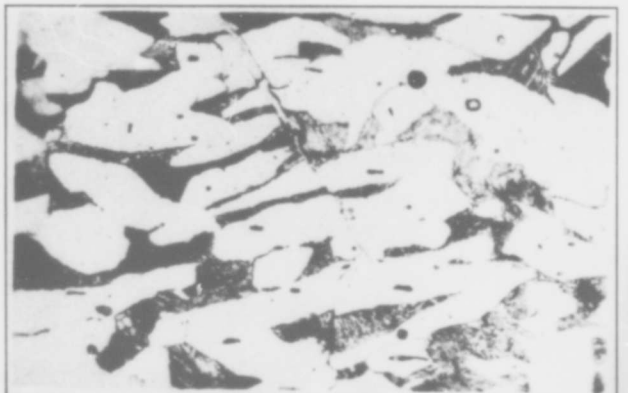
Fig. 24. Displacement of fractured grains along crack. x 500
