The Design
and
Methods of Construction
of
Welded Steel Merchant Vessels

FINAL REPORT OF A BOARD OF INVESTIGATION

To Inquire Into
THE DESIGN
AND METHODS OF CONSTRUCTION
OF WELDED STEEL MERCHANT
VESSELS

15 JULY 1946

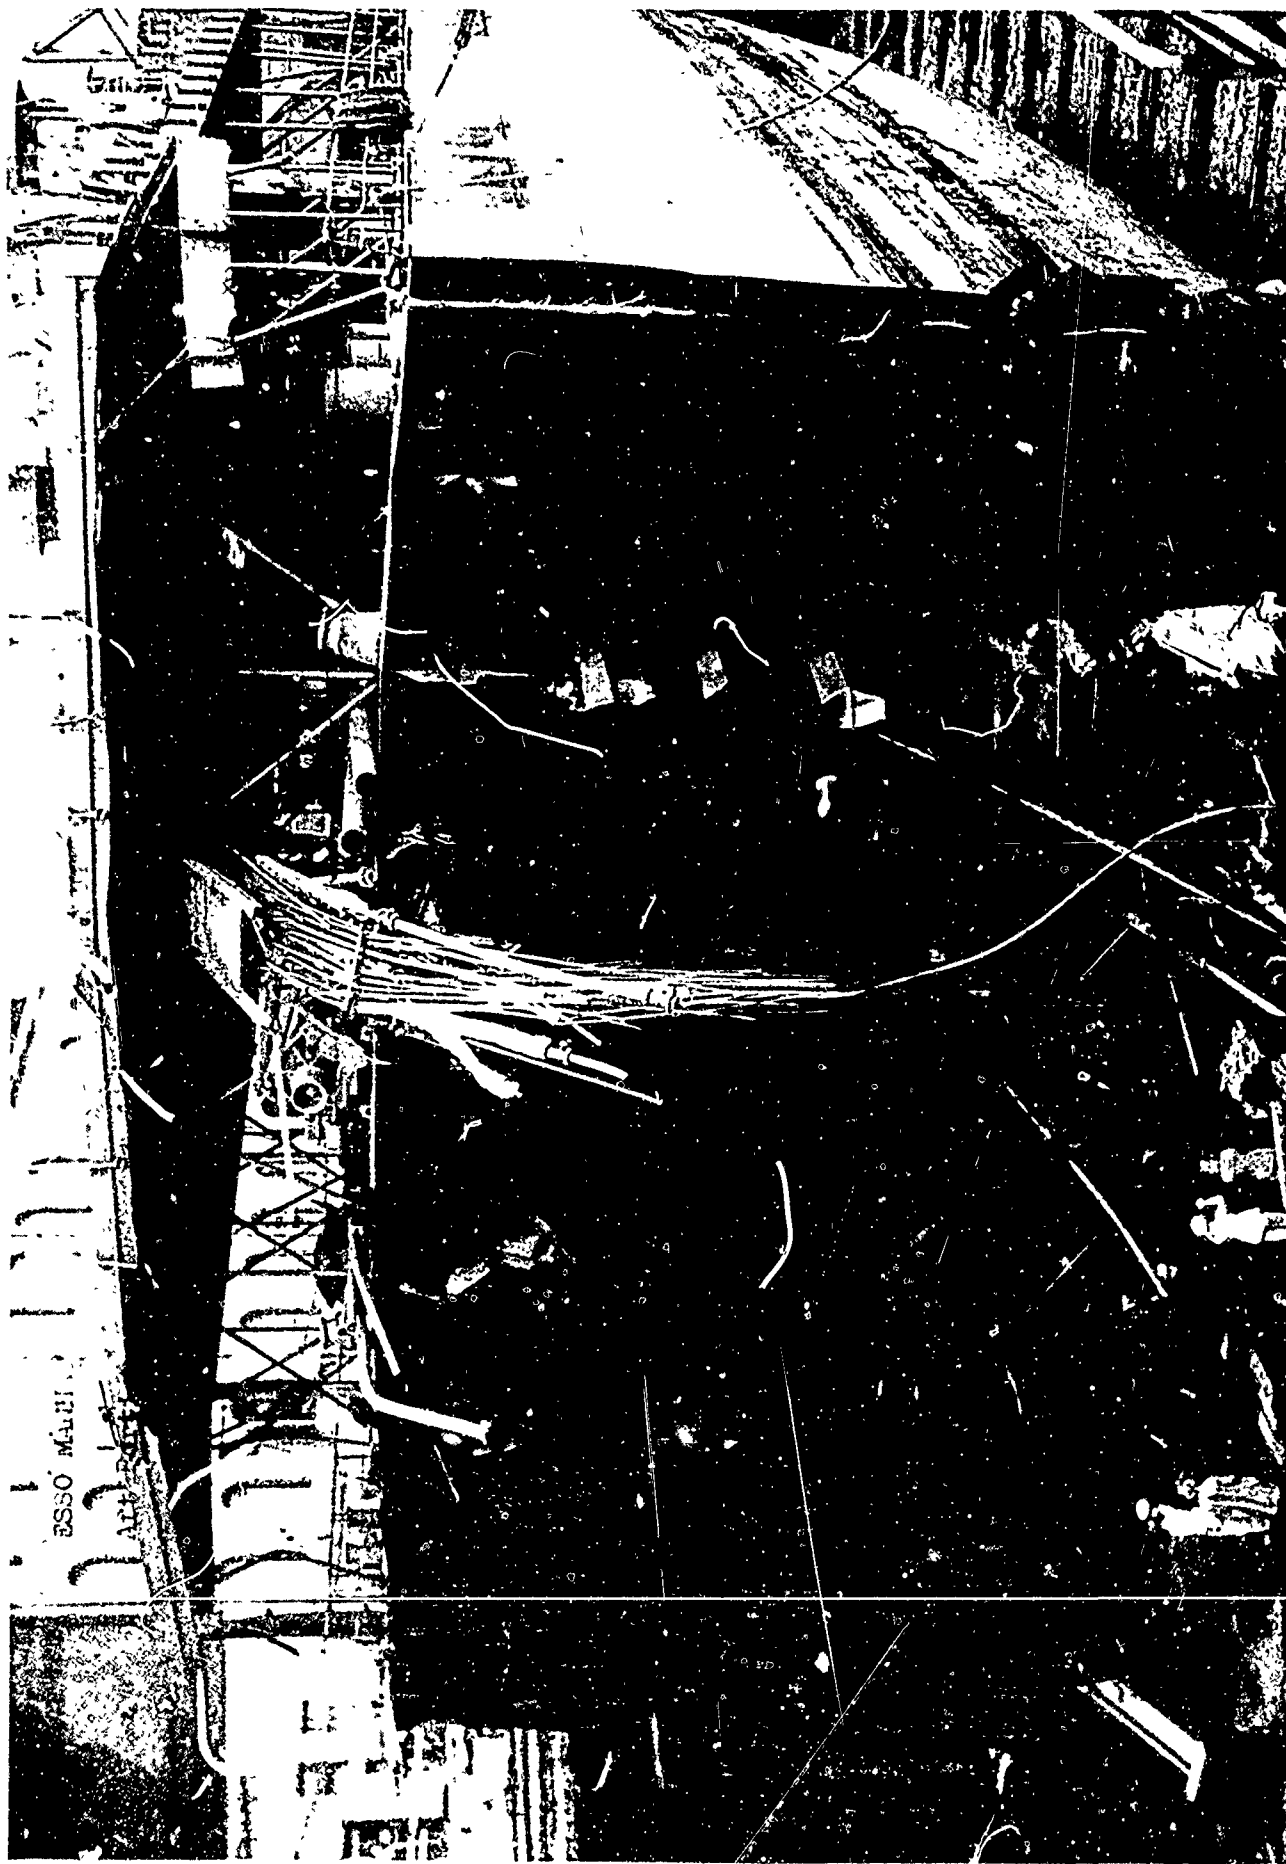
Figure 17.—Aft portion S. S. Esso Manhattan.

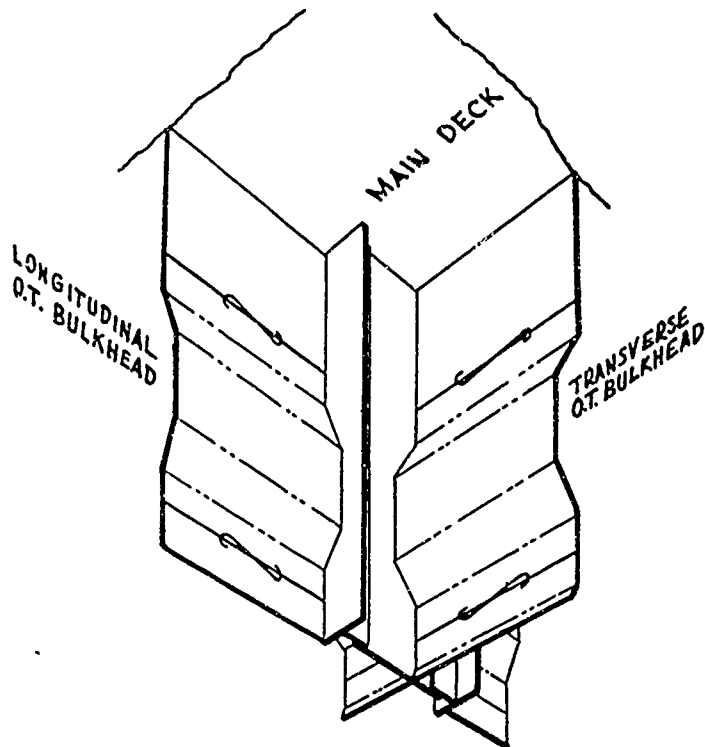
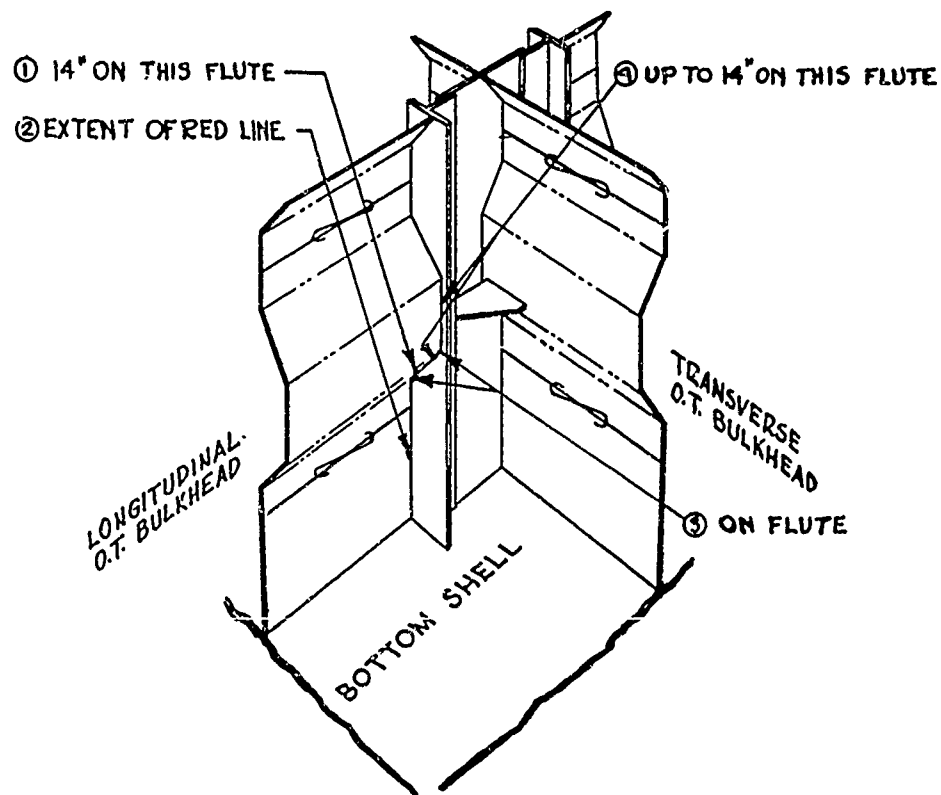
Figure 39.

T2-SE-A1 TYPE
COMPOSITE SKETCH OF FRACTURES
CONNECTION OF FLUTED LONGITUDINAL BULKHEADS TO TRANSVERSE BULKHEADS

UP TO 1 AUG. 1945 325 FRACTURES
 WERE REPORTED AT THESE
 BULKHEAD INTERSECTIONS.

Various alterations have been made at the bulkhead intersections of the T2 Tankers. Test data indicate that the change made should relieve the trouble but actual casualty data are not yet available for this report.

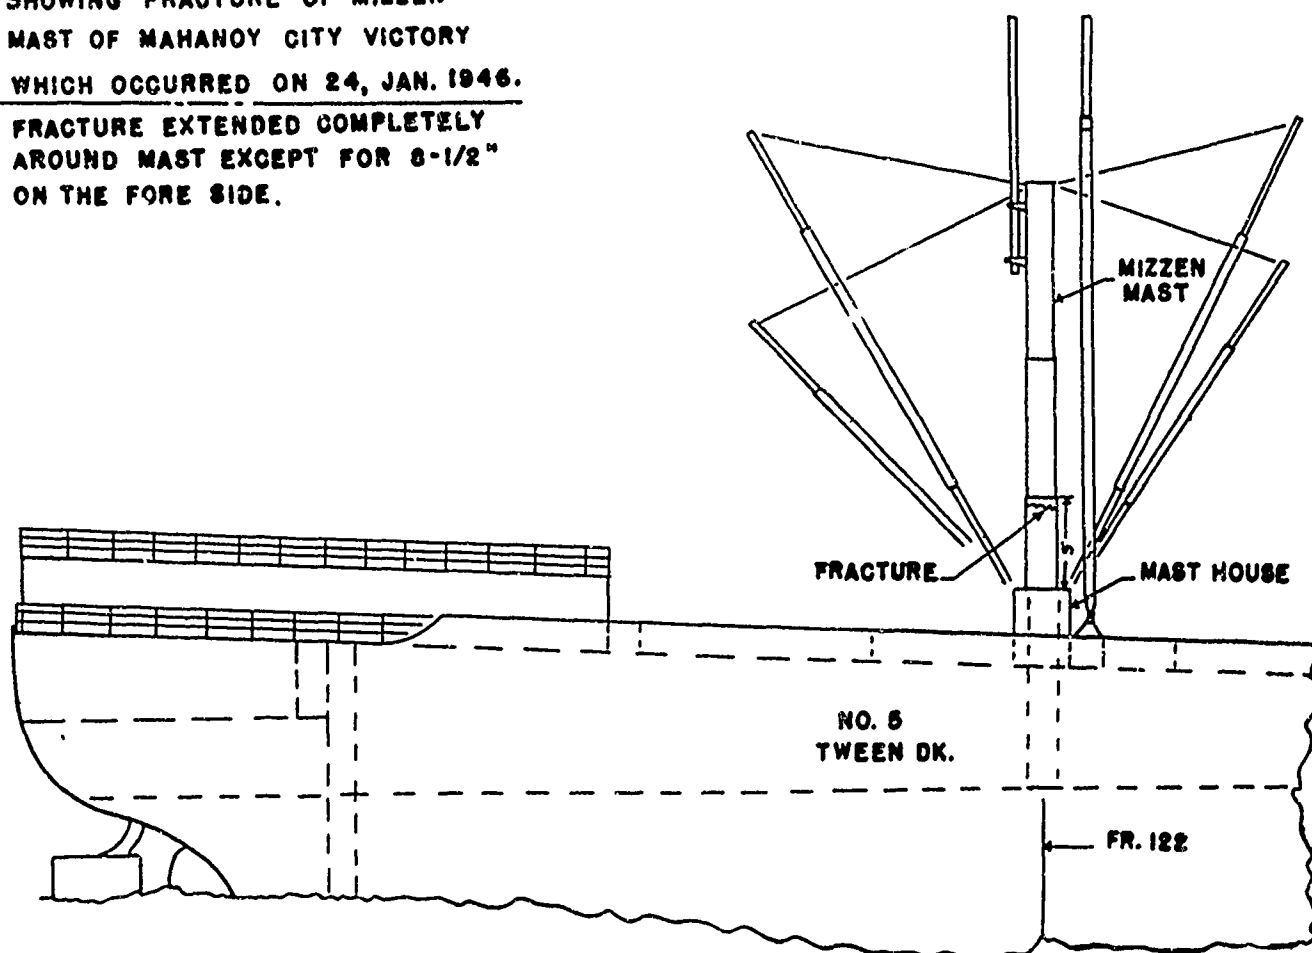
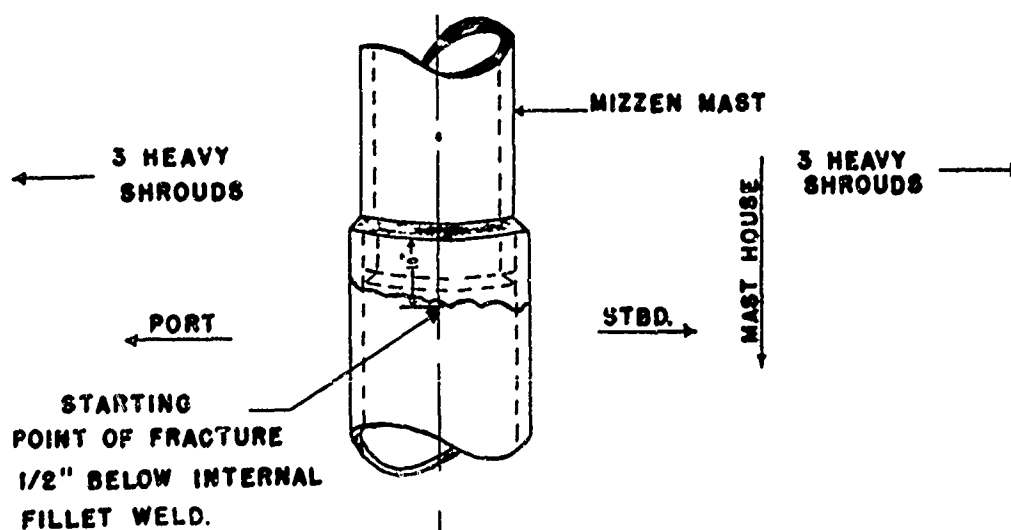
Figure 43.

FRACTURE EXTENDED COMPLETELY
AROUND MAST EXCEPT FOR 8-1/2"
ON THE FORE SIDE.

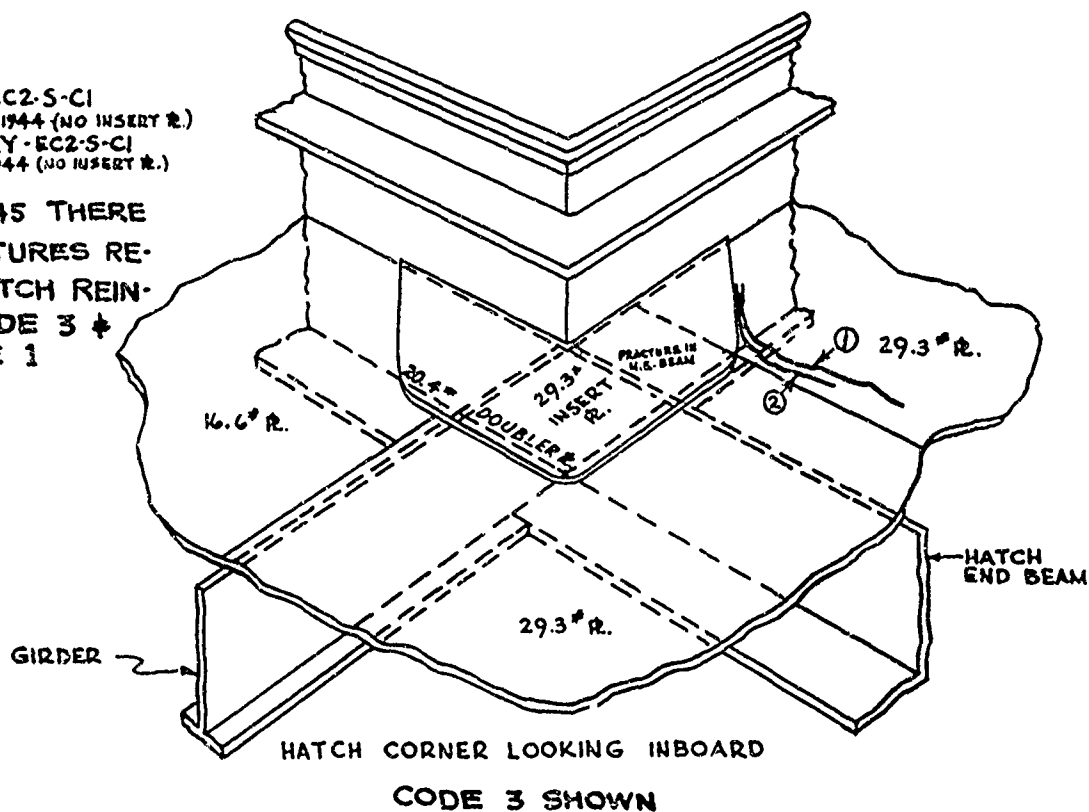
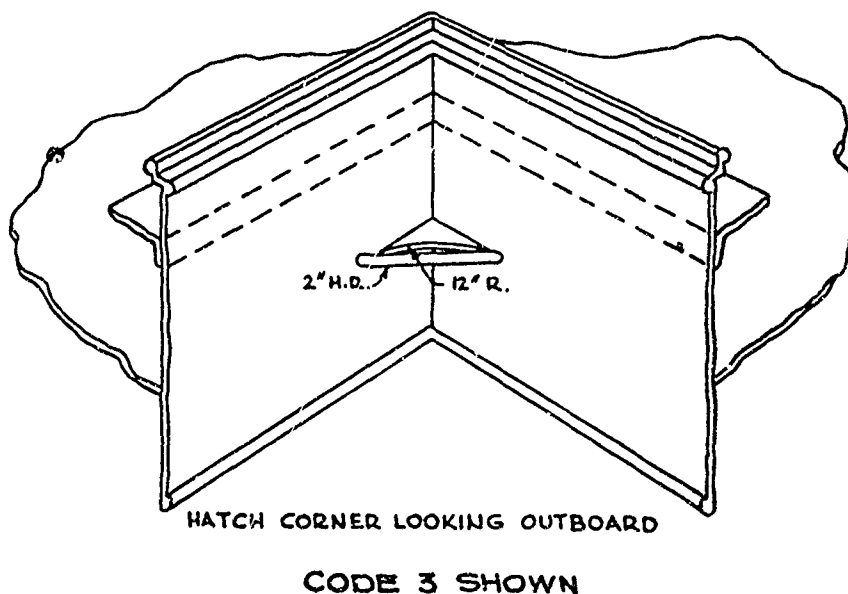
Figure 47.

UP TO 1, AUG. 1945 THERE
 WERE 5 FRACTURES RE-
 PORTED ON HATCH REIN-
 FORCEMENT, CODE 3 &
 NONE ON CODE 1

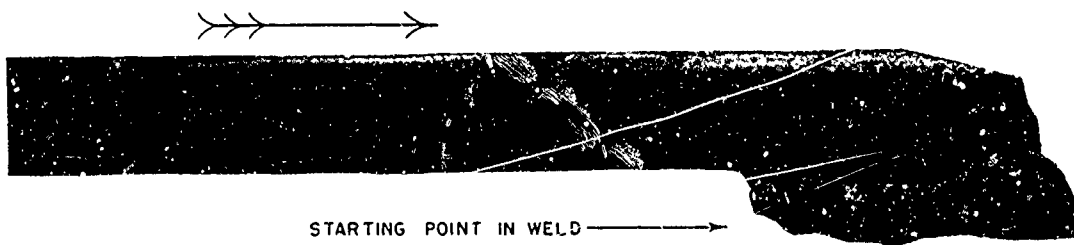
FIGURE 3

FRACTURED 51* DECK PLATE FROM FIGURE 2 SHOWING POORLY FUSED WELD IN UPPER FLANGE OF LONGITUDINAL HATCH SIDE GIRDER.
