INVESTIGATION OF FRACTURE IN THE T1 TANKER CAPITAN

MORGAN L. WILLIAMS AND MELVIN R. MEYERSON
National Bureau of Standards

SHIP STRUCTURE COMMITTEE

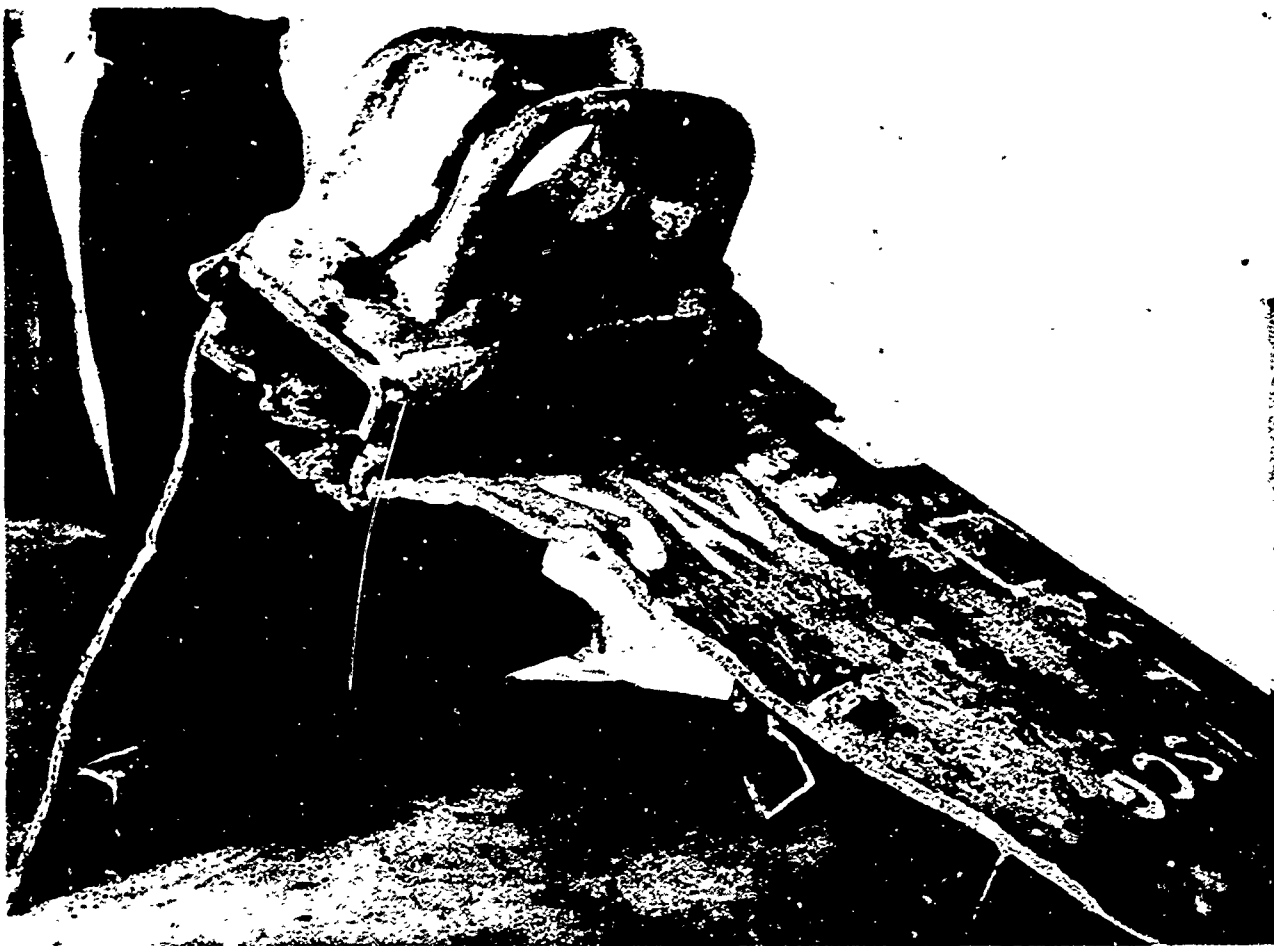
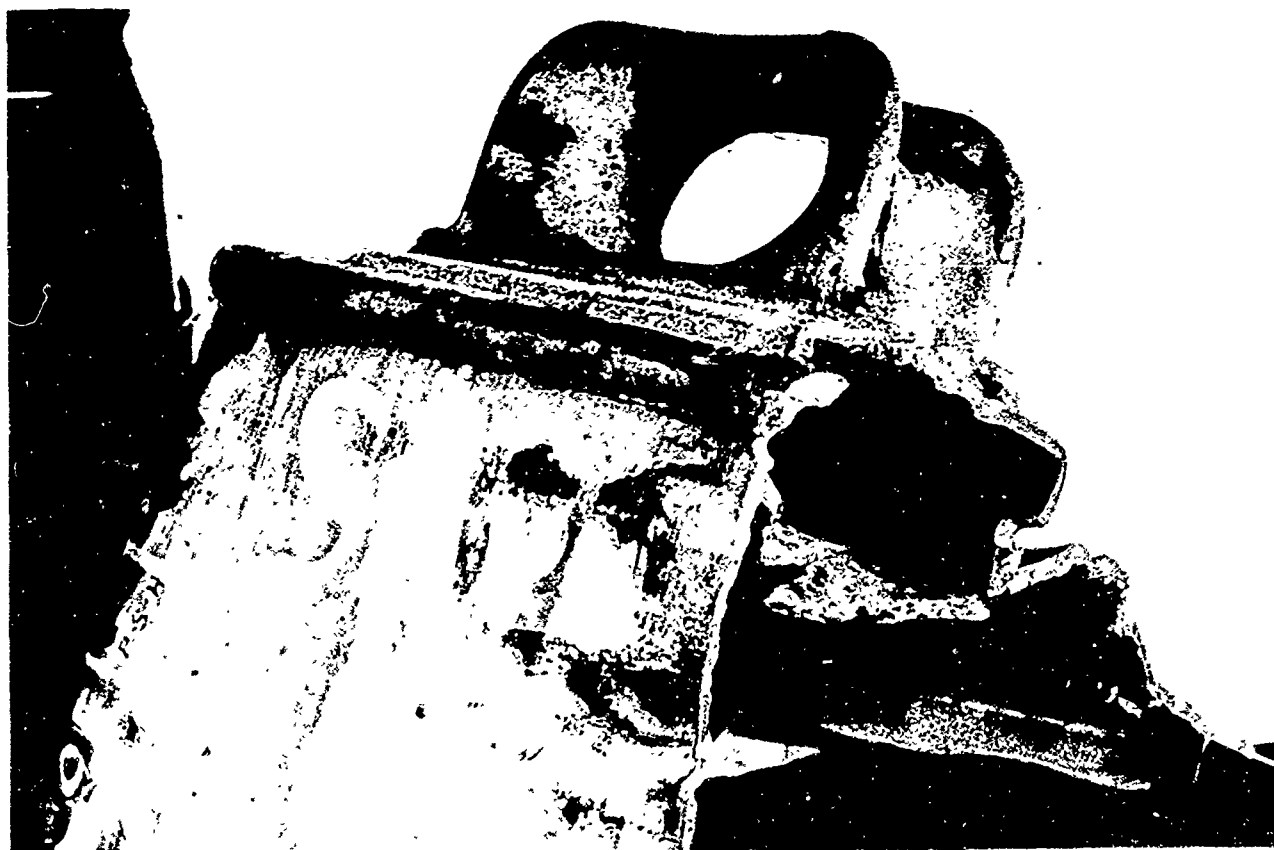
A sample removed from this area was sent to the National Bureau of Standards for more detailed examination and for determination of the properties of the fractured plates. Two views of this sample are shown in Figure 2. The herringbone markings or chevrons on the fracture edges of the deck stringer and the sheer strake indicated that the fracture had originated at some point above the weld joining these two members. The fracture edges at the outboard side of the chock base and at the weld joining the lower part of the half round to the sheer strake were battered by contact with the deck plate of the stern section (Figures 5 and 6) and by the wire rope used for mooring (Figure 1). The exact location of the starting point of the fracture in this sample could not be determined definitely because of this battering, but it appeared to be at or near the top of the half-round.

of Figure 2, where the top longitudinal on the port sheer strake (bow section) was cut to a depth of 17 inches from the fracture edge. The width of the cut was almost exactly equal to the thickness of the sheer strake plate, and the cutout metal was curled up (on the underside of the longitudinal) in a manner similar to the chip formed by a lathe or shaper tool. The corresponding cut in the sheer strake on the stern section of the vessel may be seen in the lower foreground of Figure 5.

Fig. 2. Two views of sample removed from bow section, port side. Note the slight inward bend of the half round near the fracture (under near corner of chock, lower photograph) and the battered condition of the chock base, deck plate and longitudinals.

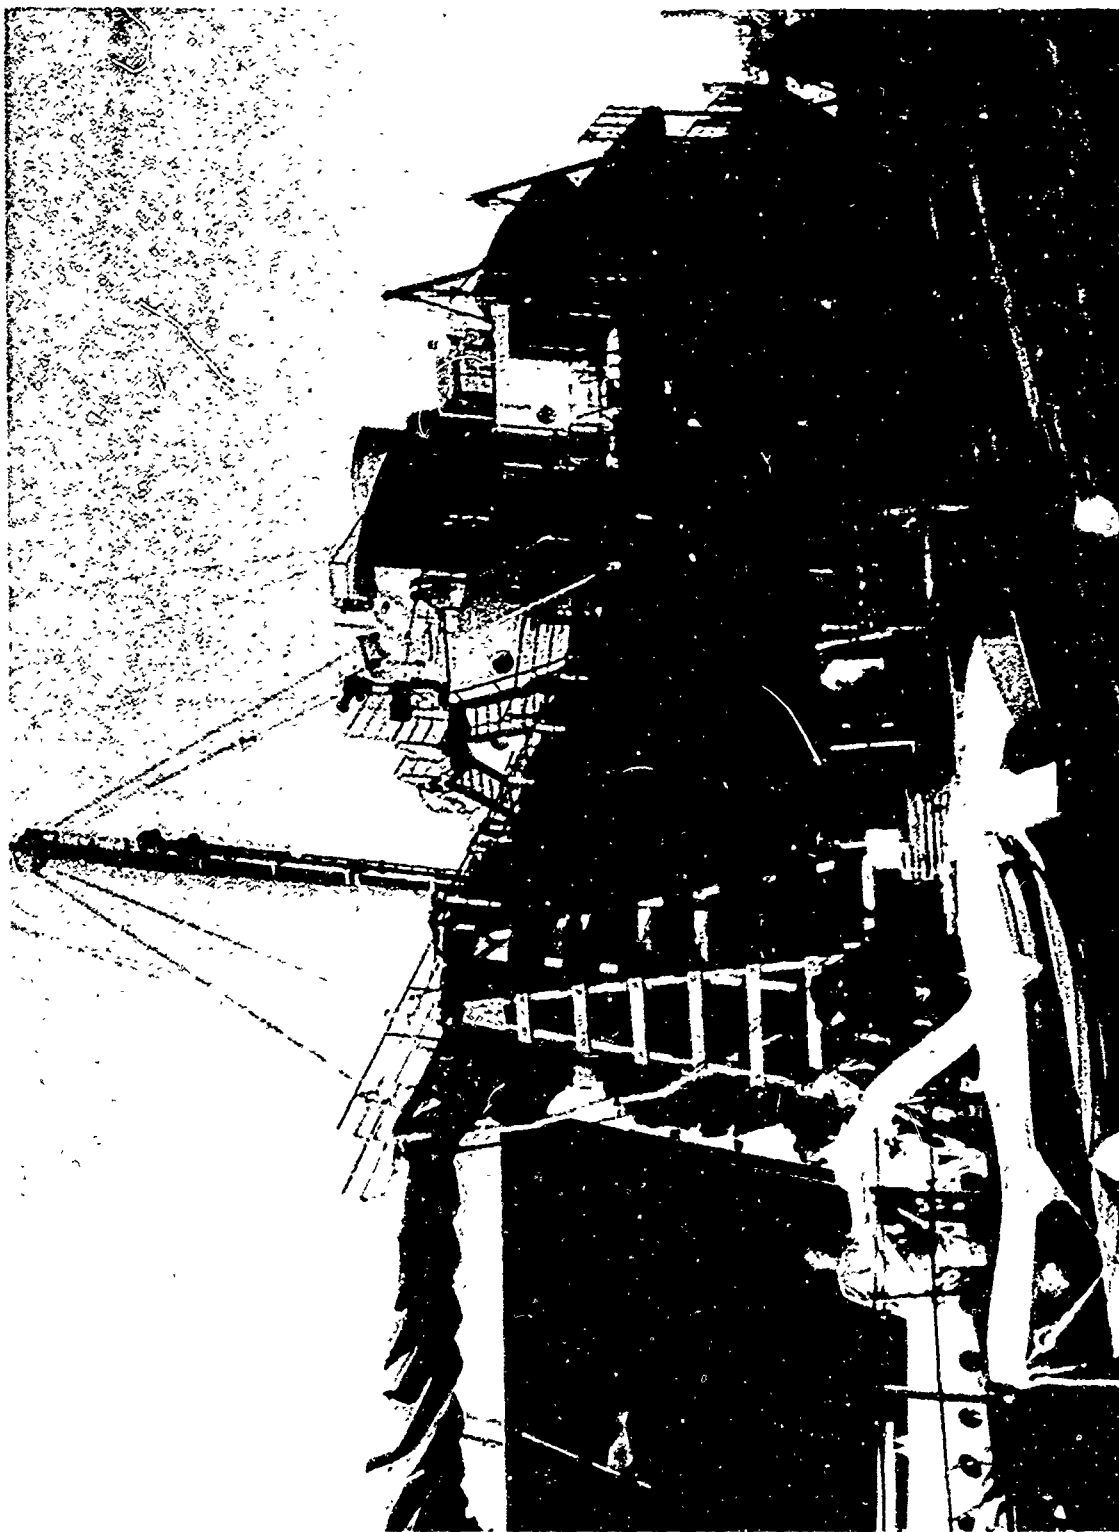
from the area aft of the fracture source in the port sheer strake and deck, and from E and F strakes in the port side shell, were selected for further examination. The locations of these samples, marked with white paint, are shown in Figure 3, which also shows a general view of the stern section. Another view, looking aft at the fracture, is shown in Figure 4.

Fig. 3. General view of stern section, port side, looking aft. Samples selected for examination are marked with white painted lines and symbols (above group of men in foreground and at top of sheer strake near fracture).

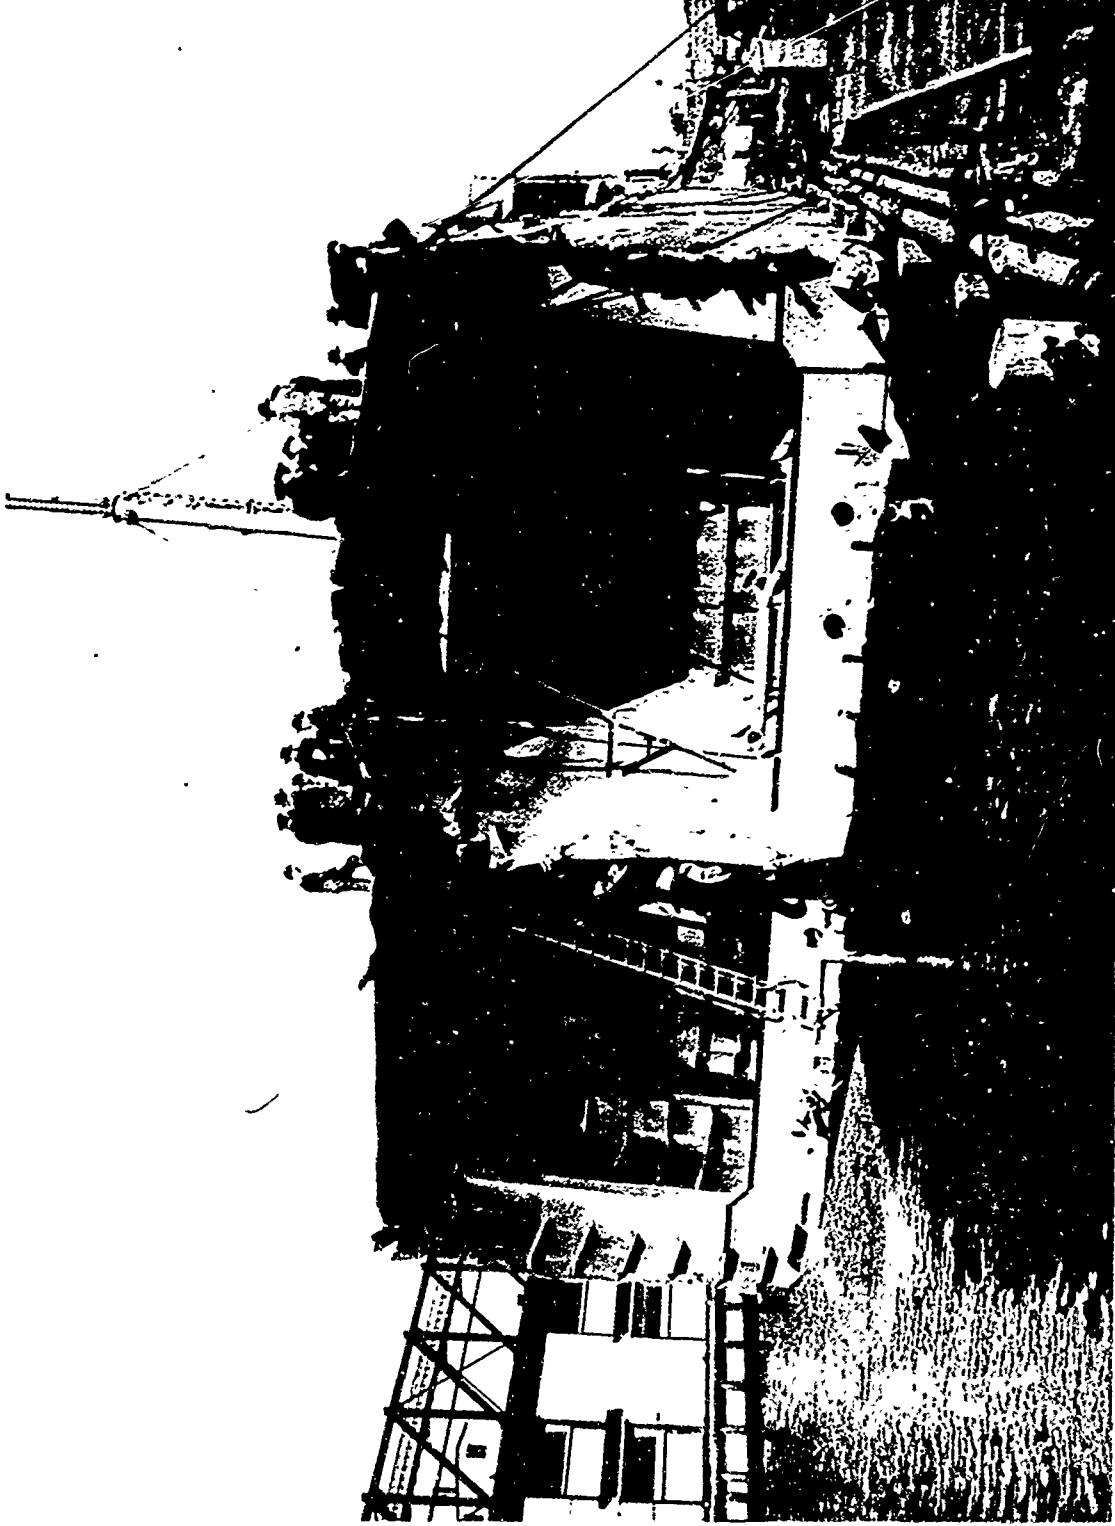
The distortion of the port center deck on the stern section (Figure 4) was of a different nature, without the reverse bends, twisting, and shear type fractures. The distortion in this area appears to be a result of battering against the superstructure in the mating position on the bow section (Figure 1). The fracture edges had been battered at several other points, as may be seen in Figures 1 through 8. Some of the plates and longitudinals, especially on the deck and the port side, had been gouged or cut by violent contact with the opposite section of the vessel. An example may be seen in the upper photograph

Fig. 4. Stern Section showing fracture just forward of frame 35. Note battered condition of plating on port side (right) and centerline bulkhead. The man leaning over the side is examining source of the fracture.

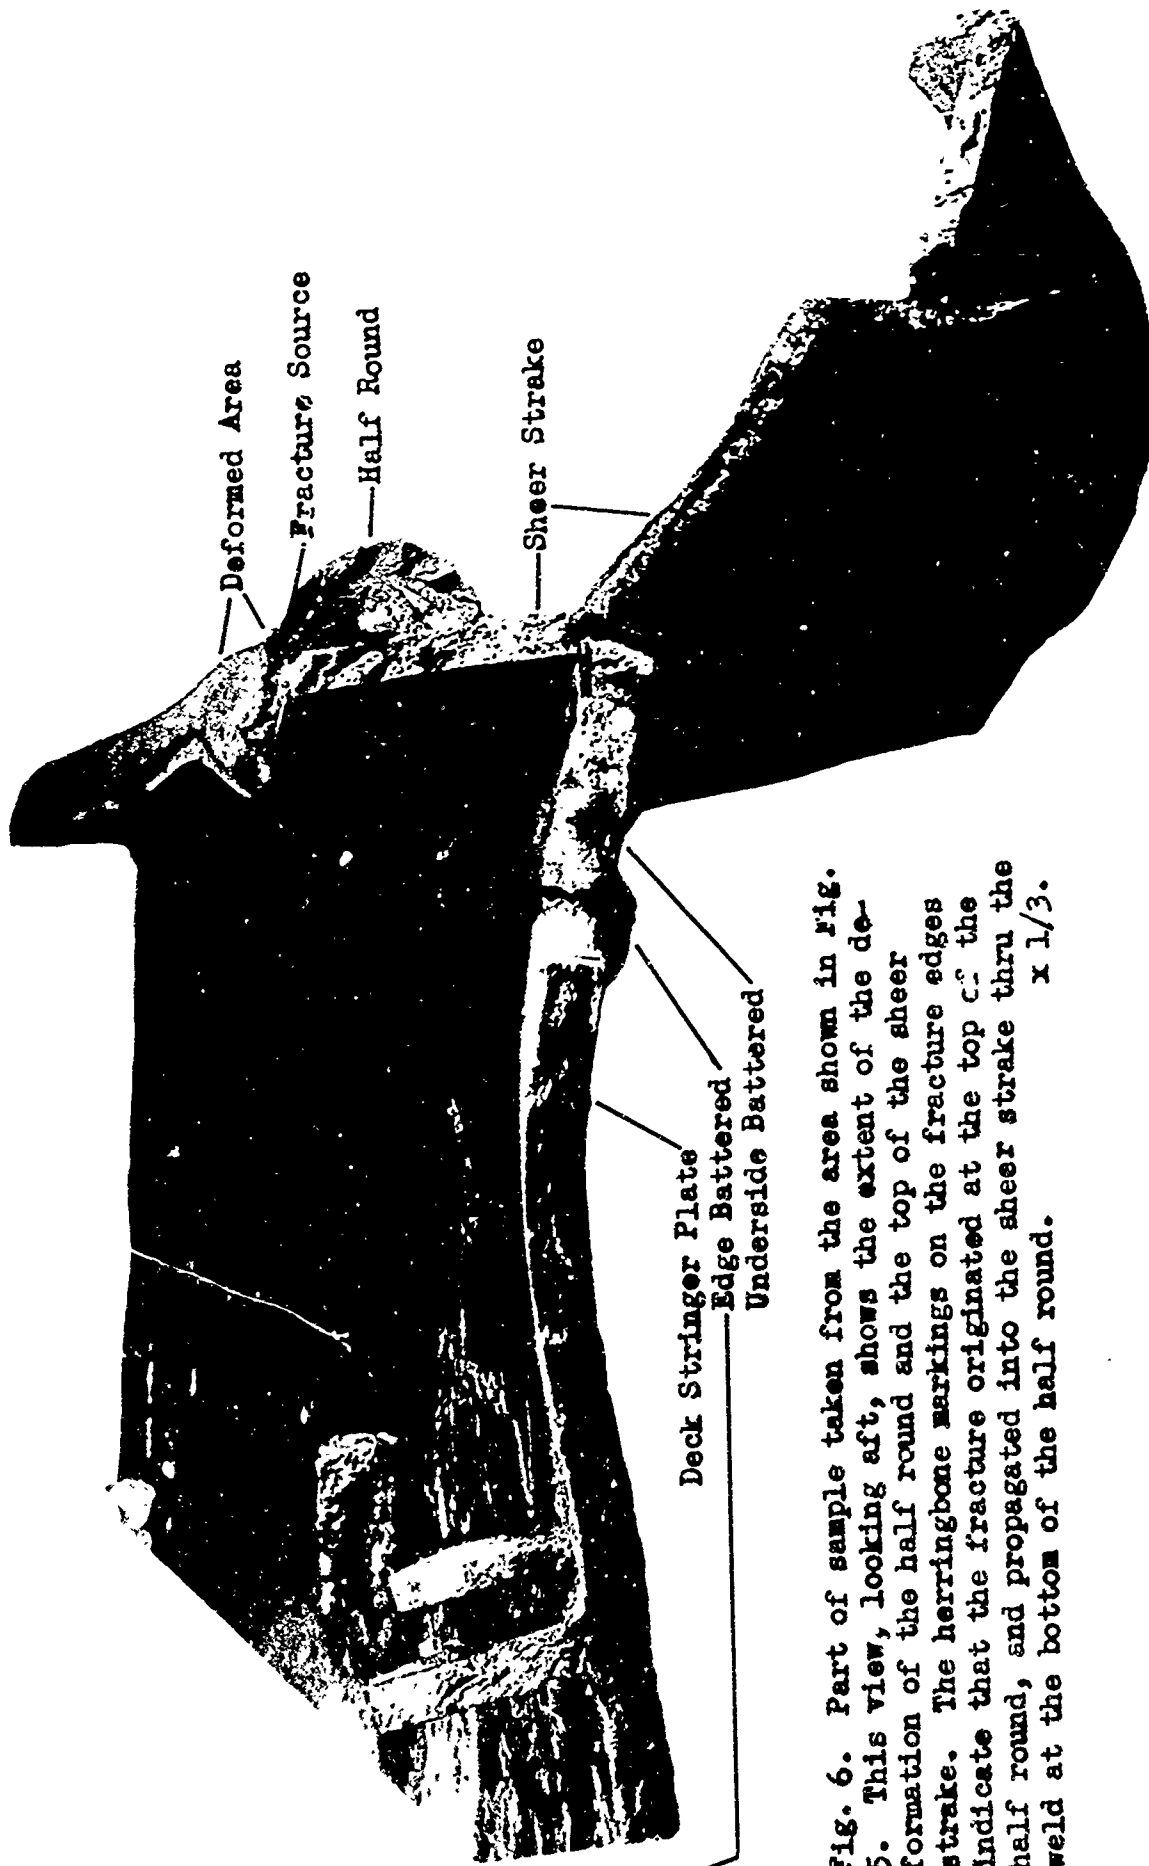
Part of the sample taken from the stern section in the region of the fracture source (Figure 5) is shown in Figure 6. After cleaning the fracture edges, the herringbone markings (which point toward the source of the fracture) were more clearly visible. These markings show that the fracture originated at the top of the half-round, propagated into the sheer strake through the small weld at the bottom of the half-round, and thence into the deck plate. The longitudinal fractures in the deck plate (Figure 6) and in the sheer strake just below the deck (Figures 5 and 6) resulted from battering after this initial fracture. A large indentation on the underside of the deck (Figure 6) and matching marks on the outboard side of the top of the chock (Figure 2) indicated that the deck of the stern section had over-ridden the bow section and had come down violently against the top of the chock. The fracture in the deck plate (Figure 6) originated at the top surface of the plate as a result of bending and did not progress completely to the bottom side of the plate. Similar bending type fractures were found along the inboard edge of the chock base (Figure 2). Two battered areas, about 14 inches apart on the fracture edge of the deck plate (Figure 6) fitted exactly with the battered parts on the bow section (Figure 2) at the inboard leg of the chock base and at the junction of the sheer strake and the lower edge of the half-round.

of the sheer strake were deformed as if by a blow or bump on the outboard side (Figures 5 and 6) and that the half-round forward of the fracture was bent inboard slightly (Figure 2). On first examination this appeared to be another result of the battering which occurred after the ship had fractured. However, when the two parts were fitted together, as shown in Figure 7, it could be seen that the parts of the half round forward and aft of the fracture formed a smooth curve, with the fracture about 4 inches forward of the point of maximum deformation. This shows that the deformation of the half-round must have occurred at some time previous to the fracture, since it is highly improbable that bending of the parts after the fracture could result in such a nearly perfect fit. Also, the reverse bend in the after section (to the right of the fracture in Figure 7) is obviously a result of restraint imposed by the section forward of the location of the fracture.

Fig. 6. Part of sample taken from the area shown in Fig. 5. This view, looking aft, shows the extent of the deformation of the half round and the top of the sheer strake. The herringbone markings on the fracture edges indicate that the fracture originated at the top of the half round, and propagated into the sheer strake thru the weld at the bottom of the half round. x 1/3.

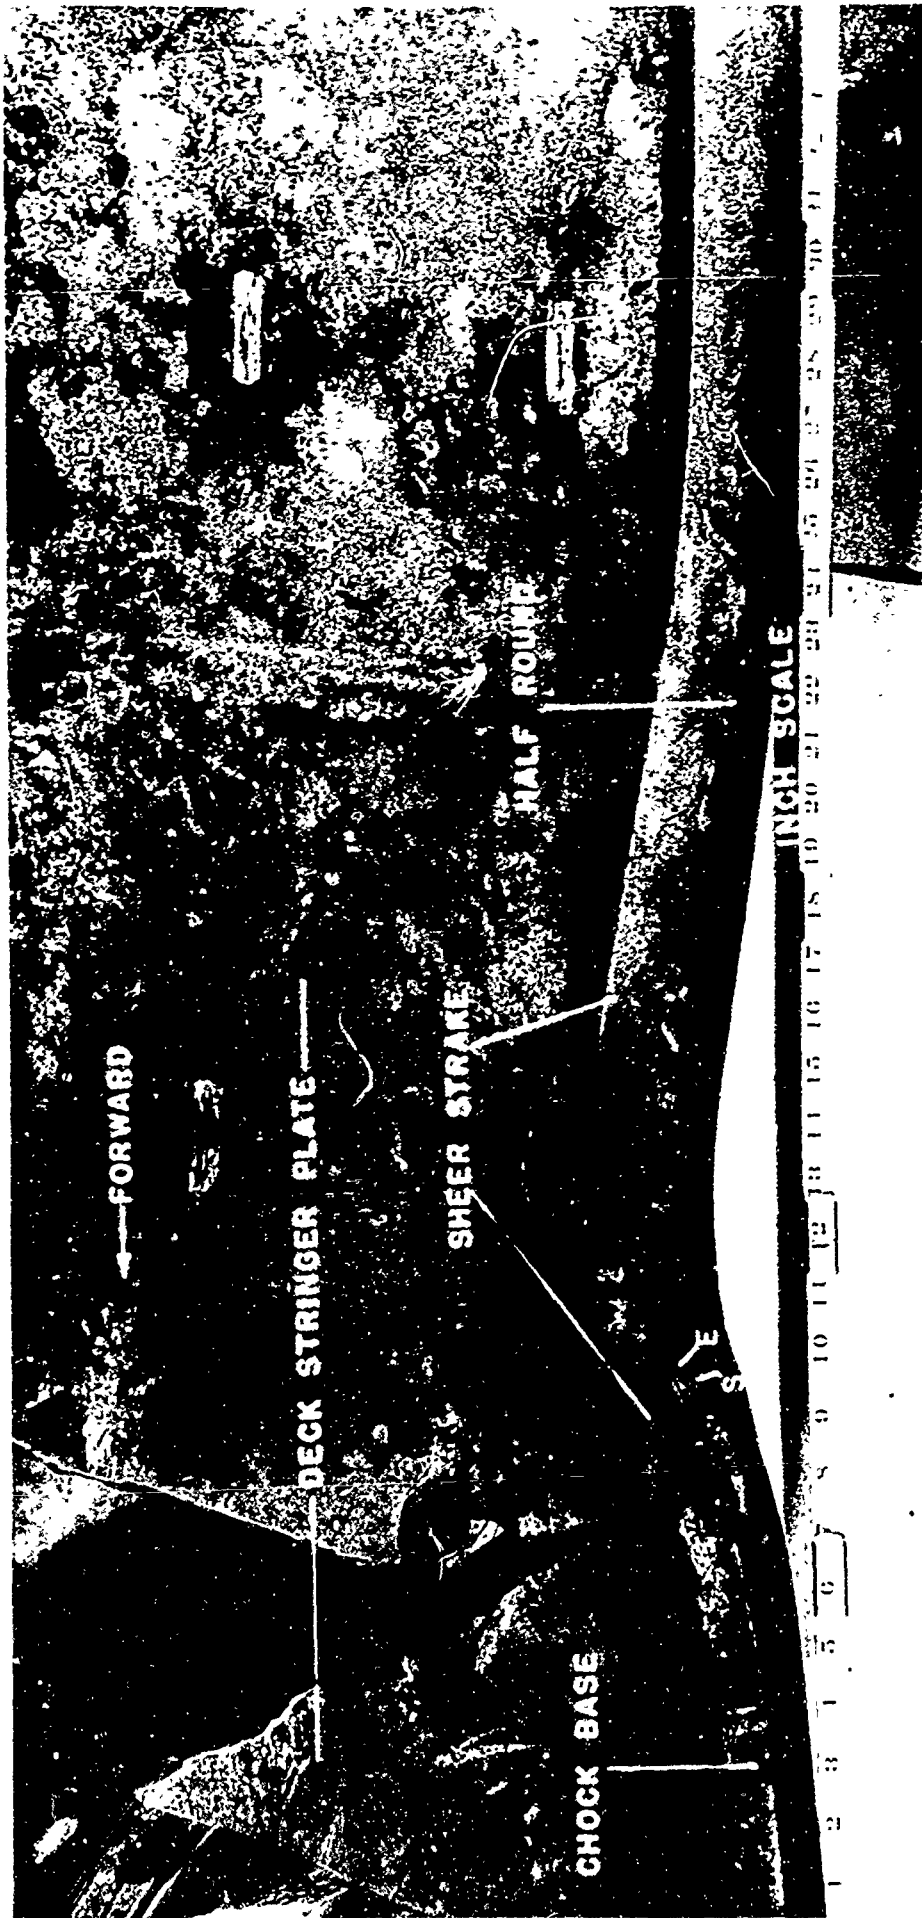
The deformation of the sheer strake is shown in Figure 8 by cross sections of the half-round, sheer strake, and deck stringer taken at locations about 9 inches forward and 4 inches aft of point S in Figure 7. The section from forward of the fracture (Figure 8, right) shows the sheer strake nearly perpendicular to the deck plate, with only slight deformation. The bottom of the half-round had separated slightly from the sheer strake, and a small crack is visible in the weld (arrow).

Fig. 7. Fractured parts of half round fitted together, viewed from above. The smooth curvature on both sides of the fracture indicates that the deformation of the half round and the upper sheer strake occurred before the fracture. E shows longitudinal crack at top of half round. S indicates source of main fracture. The missing part of the deck stringer was bent downward - see fig. 2. x 1/4 approximately.

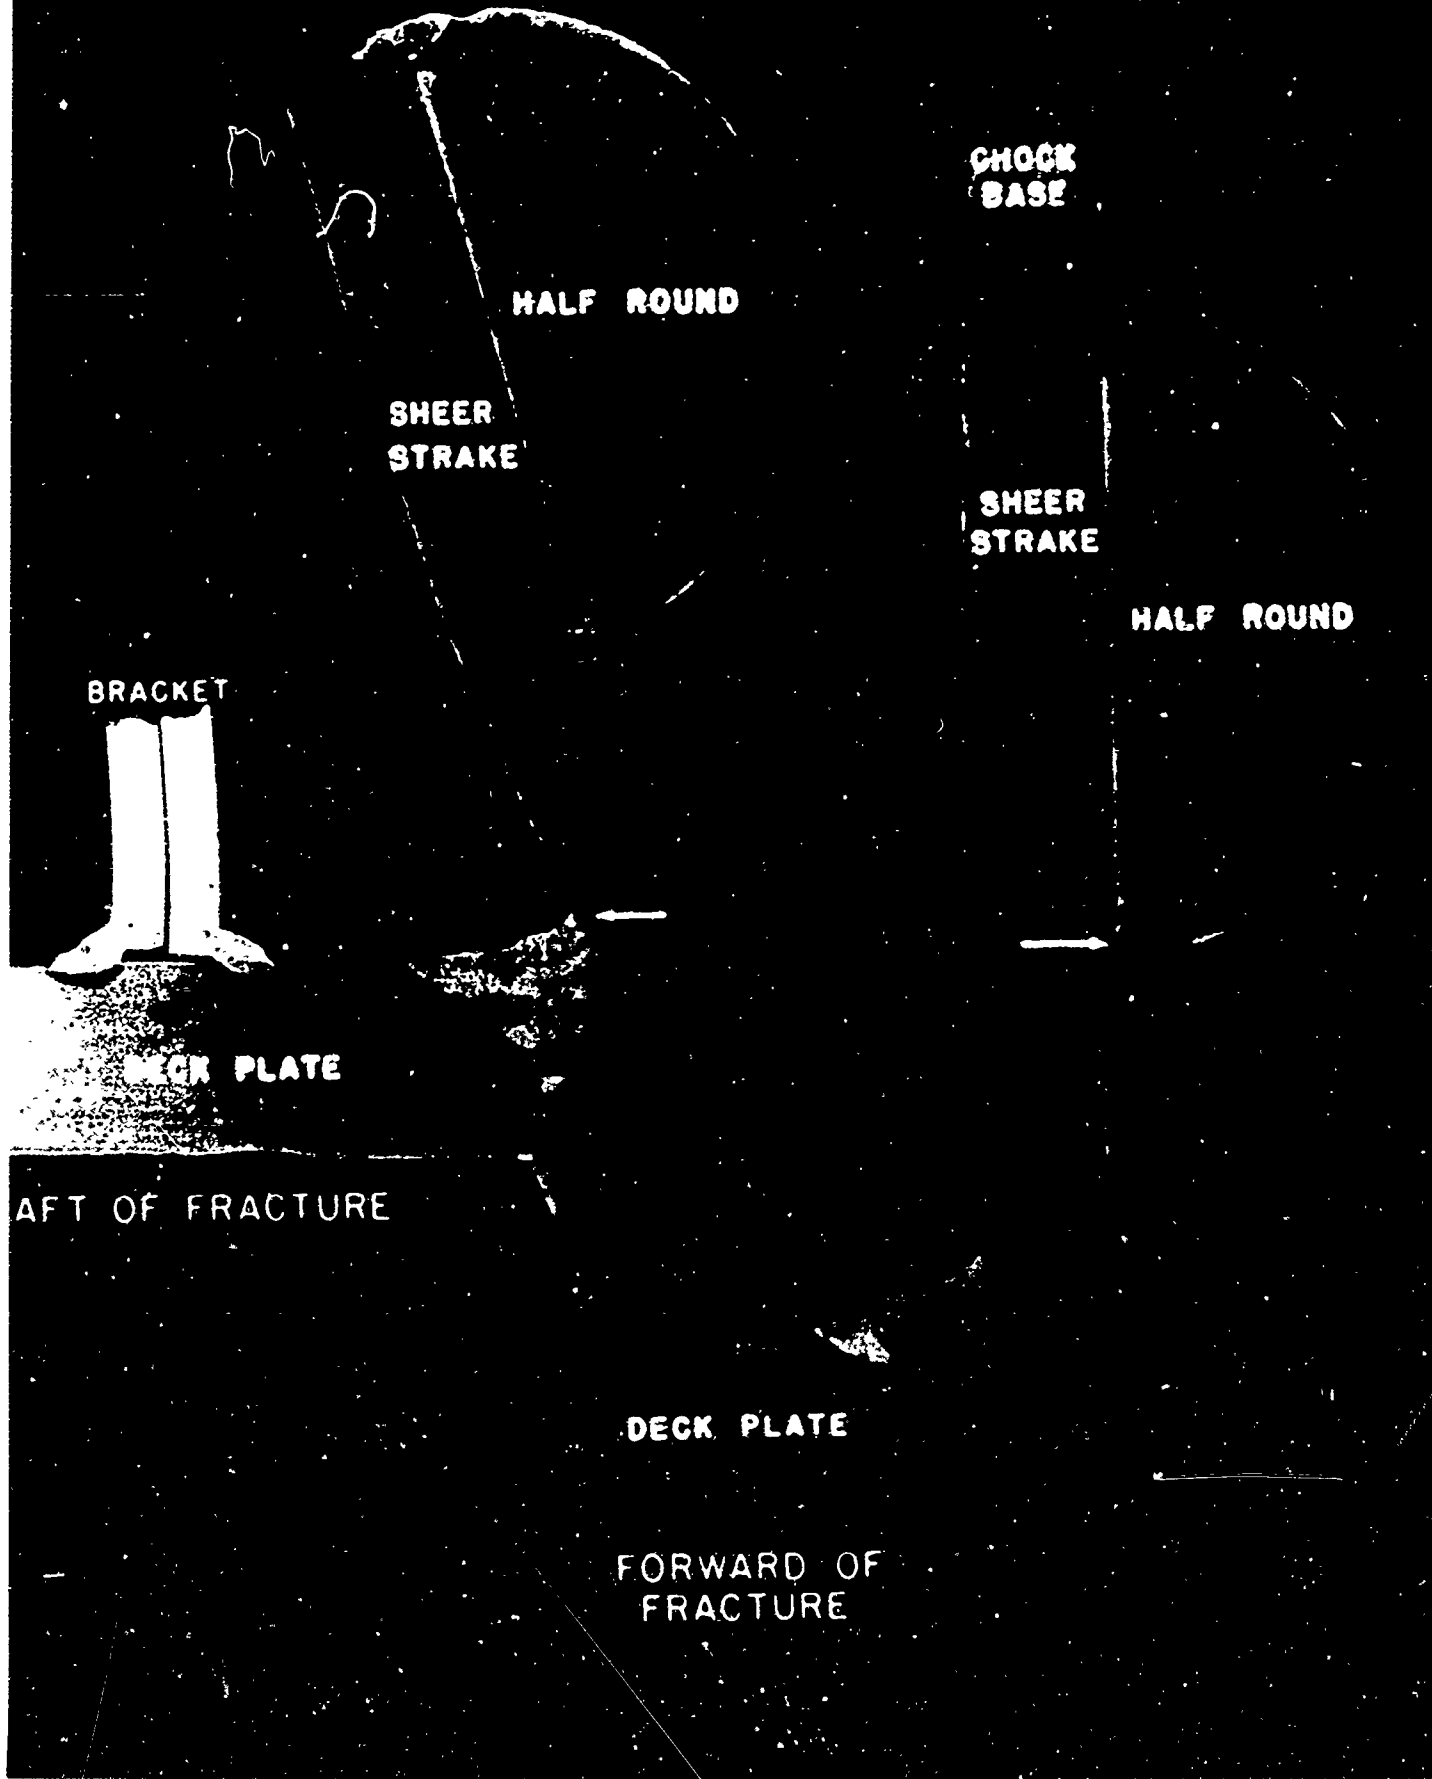
The section from aft of the fracture (left, Figure 8), which was taken near the point of greatest deformation, shows the sheer strake bent inboard above the deck. The deck plate was bent downward slightly at this point as a result of the battering which caused the longitudinal fracture in the sheer strake just below the deck plate (Figure 5). A small crack in the weld joining the sheer strake and the deck stringer is indicated by the arrow.

The cross sections of the deck plate, sheer strake, and half-round, shown in Figure 8, were polished and etched to determine the size and quality of the welds in the vicinity of the fracture source.

The welds joining the deck plate to the sheer strake were somewhat below average quality, since they did not penetrate the joint completely, and contained a number of slag inclusions. However, such defects are rather common

Several small brackets (Figure 7) were joined to the deck by similar small shallow welds, as shown at the left in Figure 8. These resemble the weld attaching a clip to the deck, which was one of the primary factors leading to the failure of a T2 tanker about a year previously. In that casualty, as in the CAPITAN, the fracture originated near the end of a chock base, and at a point where two welds (one of which was small and shallow) were so close together that the heat-affected zones overlapped.

Fig. 8. Cross sections of sheer strake, half round, and deck, port side looking aft. The extent of deformation is shown by the piece at left, taken about 4 inches aft of the fracture. Piece on right, from 9 inches forward of fracture, shows weld connecting chock base to half round and sheer strake. Arrows show small cracks in welds. x 1.

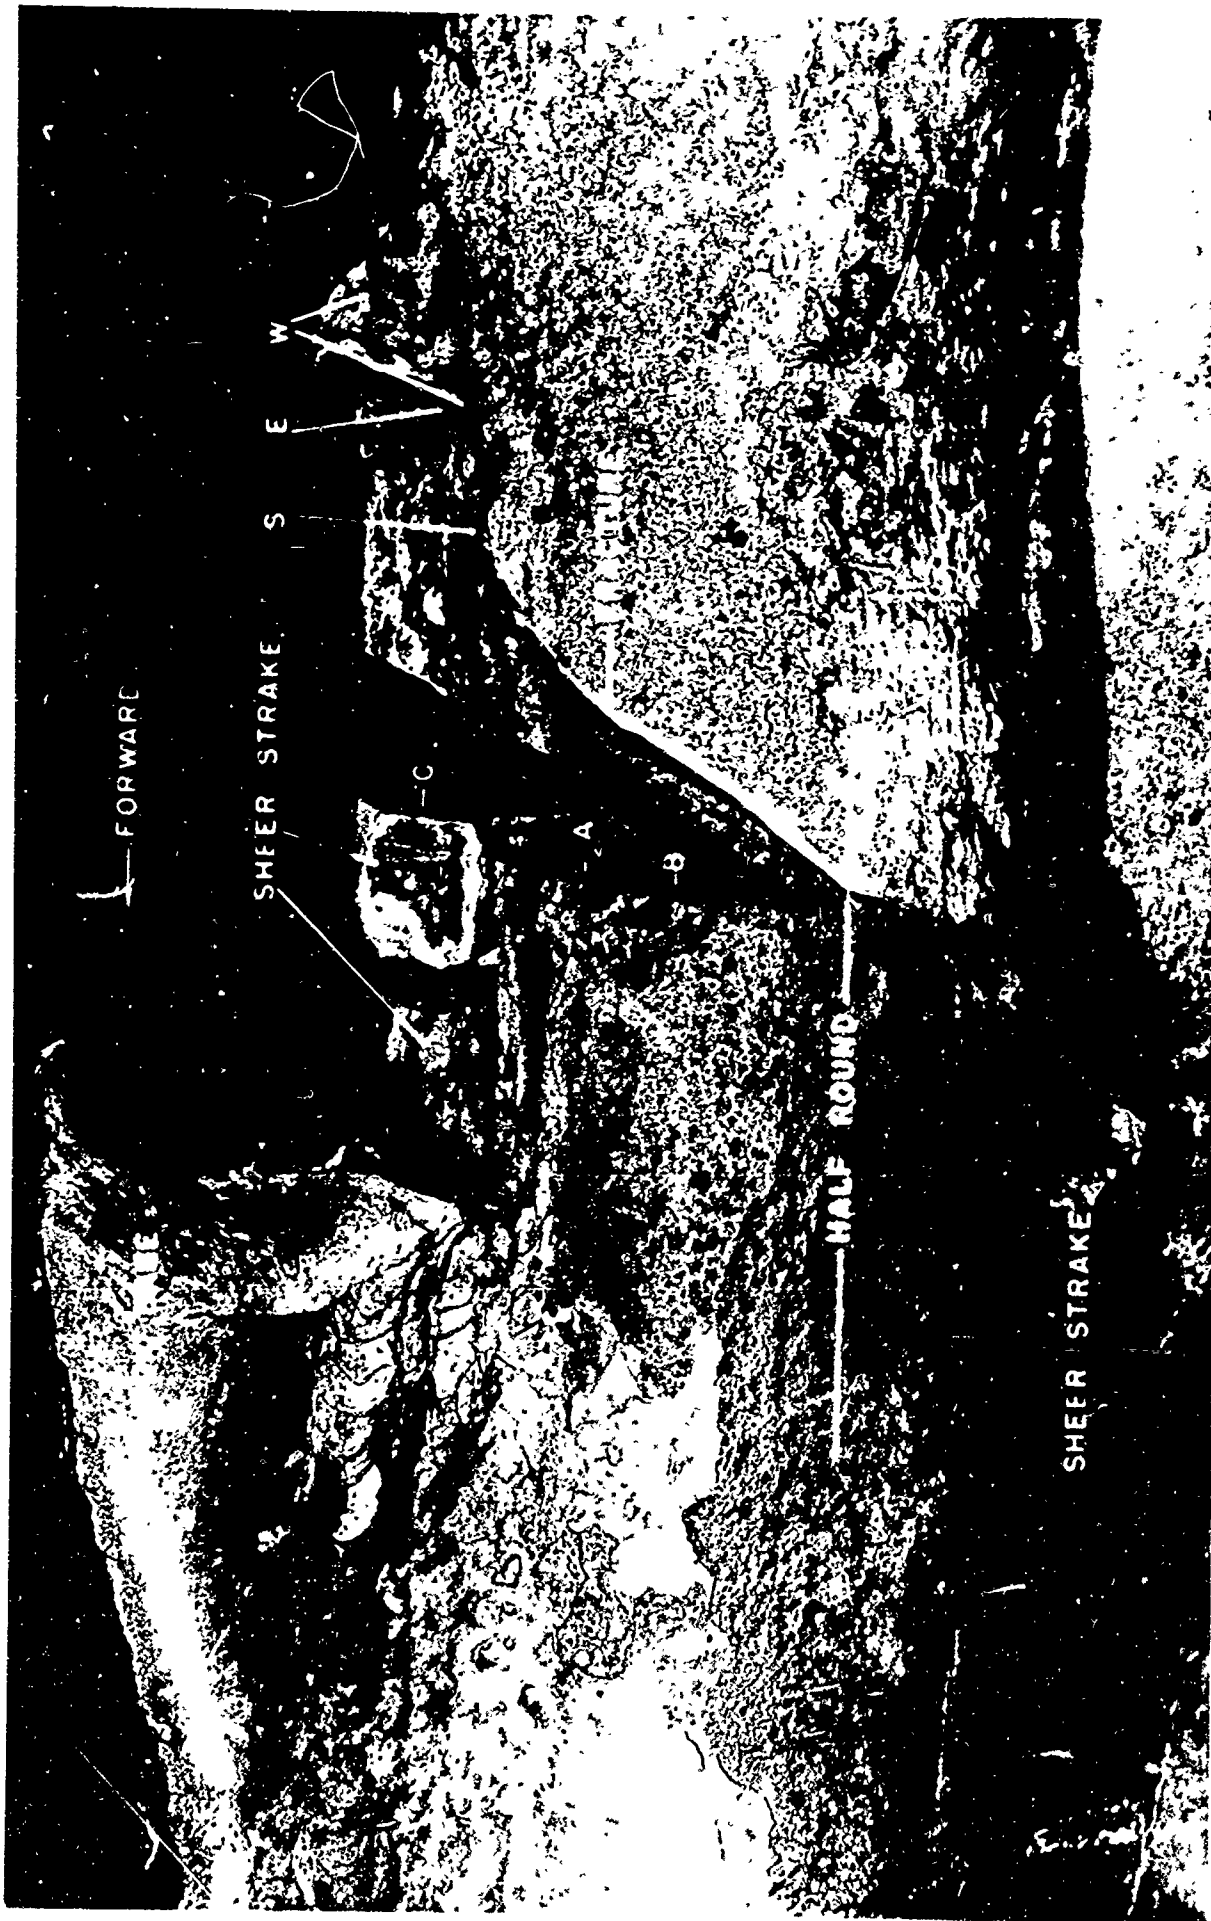
A view of the region of the fracture source, looking from outboard and slightly above, is shown in Figure 9. V-shaped pieces for metallographic examination had been cut out at C, just aft of the fracture in the sheer strake, and at A-B in the half-round forward of the fracture. The fracture source S was about an inch forward of the weld W at the after end of the chock base. Part of the chock base had been lost as a result of battering, and the fractures in the weld at W and at the top of the half-round were also battered and abraded.

Some small depressions, filled with corrosion products, were observed in the top of the half-round just aft of the fracture source, at the points indicated by S and E in Figures 7 and 9. Another V-shaped section was cut from this area, as shown at D in Figure 10, and three cracks, extending approximately vertically downward into the half-round, were found at points E, F, and S. The "depressions" were the result of corrosion at the top edges of these cracks, and the extent of this corrosion indicated that the cracks had existed for a considerable length of time.

Fig. 9. Fracture in half round viewed from outboard side. Part of the chock base, which originally extended to the weld (w) at the right was lost as a result of battering. B, A, and C indicate the location of specimens cut from the half round and the sheer strake for metallographic examination. x 1.

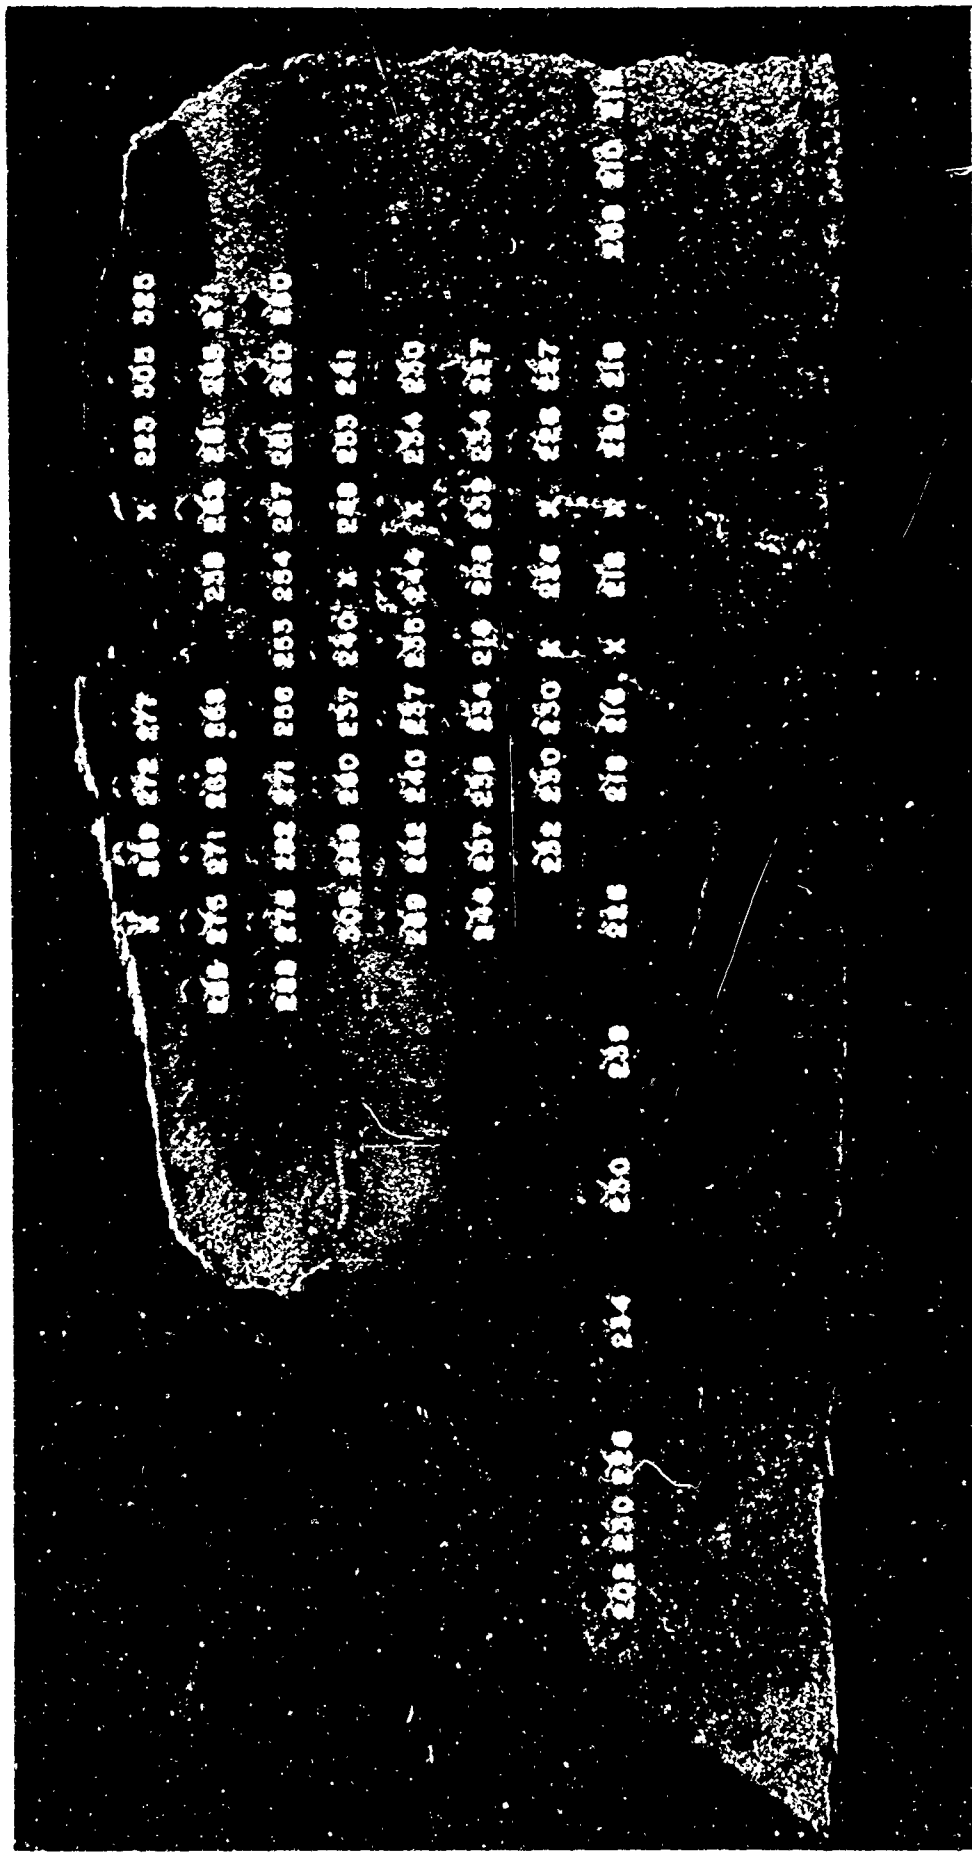
joined. The surface adjoining D-E in Figure 10 (looking in the opposite direction) is shown in Figure 11. Crack E, at the top of the specimen, originated between the weld joining the half-round to the sheer strake (top right) and the weld joining the chock base to the half-round (top left). Another small crack may be seen at the outboard (left) edge of the latter weld. The crack at the bottom in Figure 11 is a part of crack F (Figure 10) which originated between these same welds farther forward, and propagated aft and inboard overlapping but not joining crack E.

After completion of the hardness measurements shown in Figure 11 (which will be discussed later) the specimen was broken apart to expose the surfaces of the cracks. These surfaces, although somewhat corroded, showed the characteristic markings of a brittle fracture. There was no indication that the cracks had originated or propagated as a result of fatigue.

The section from near the fracture source is shown in Figure 11, with the Diamond Pyramid Hardness numbers (20 Kg load) indicated under the corresponding indentations, which were spaced 1 mm apart. (Values which were obviously erroneous due to cracks, corrosion, or unsupported edges near the indentation are indicated by the letter X). These data show that the metal of the half-round was hardened to a considerable degree in the heat-affected zones (lighter areas) under the two welds at the top, and that this hardening extended for some distance from the welds. The effect of the overlapping heat-affected zones could not be determined on this sample because of the cracking and

corrosion in this area. The hardness number 238, near the top of the crack, is probably too low, since a corrosion pit was found immediately under the indentation when the specimen was broken for examination of the crack.

The section from the top of the half-round near the fracture source (Figure 11) was considerably harder, even at some distance from the welds, than the corresponding areas on the sections from forward and aft of the fracture (Table I). This indicates that the area near the fracture source was very severely deformed, probably as a result of the restraint imposed by the chock base.

Fig. 11. Hardness impressions and cracks in section from top of half round. (Surface adjoining D in Fig. 10). Vickers Diamond Pyramid Hardness numbers (20 Kg load) are shown under the corresponding impressions. The crack at the top of the specimen (crack E in Fig. 10) started in the overlapping heat affected zones between two weld beads.
