WT-74

# Operation UPSHOT-KNOTHOLE

Project 3.29

**BLAST EFFECTS OF ATOMIC WEAPONS  
UPON CURTAIN WALLS AND PARTITIONS  
OF MASONRY AND OTHER MATERIALS**

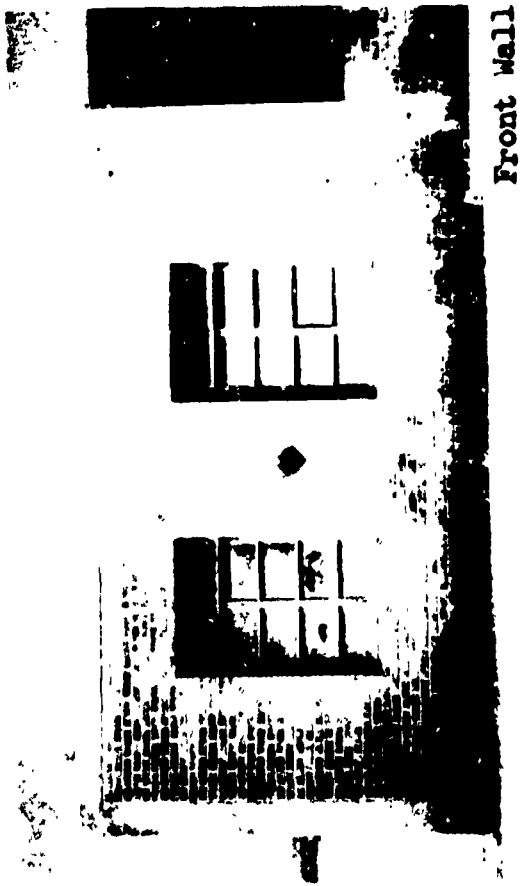
Front Wall

The front partition had its door torn out and was badly cracked. It was slightly bowed.

The front wall was spalled at the top on the outside face. The window frames were bowed in slightly at the cross rail.

The rear wall was marked on the inside face and spalled on the outside face at the top, north edge.

The measured, pre shot, natural frequency of the front wall was 36.1 cps. For the rear wall, the measured, pre shot and post shot, natural frequencies were 36.1 cps and 19.8 cps, respectively.

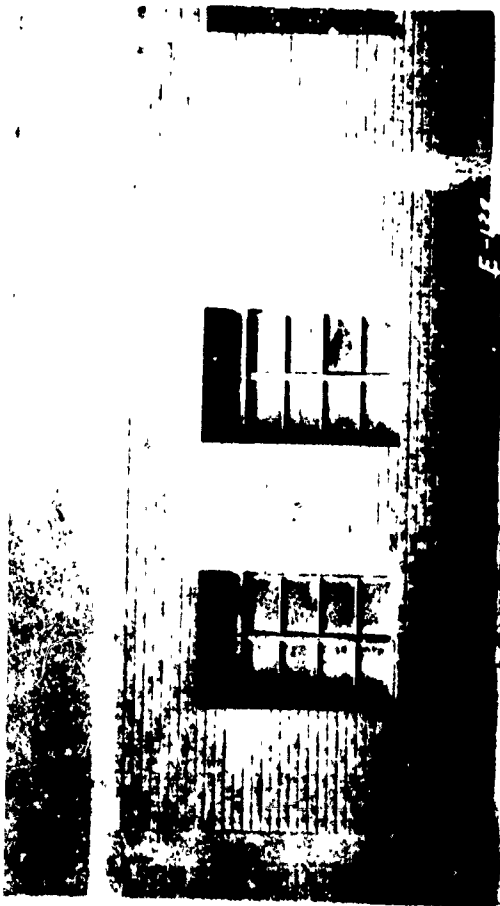
Front Wall

The front wall was spalled at the top on the outside face.

The rear wall was slightly spalled at the top on the outside face. The inside face was covered by the partitions.

The measured, pre shot and post shot, natural frequencies of the front wall were 34.2 cps and 21.9 cps, respectively. For the rear wall, the measured, pre shot and post shot, natural frequencies were 41.1 cps and 31.5 cps, respectively.
