**U.S. Naval Supply Research & Development Facility  
Bayonne, New Jersey**

INTERIM REPORT ON THE INSTALLATION

CARBON MONOXIDE ELIMINATOR MUFFLERS

ENGINEERING REPORT NO. 5.2120  
Project Group No. NT-003-020(b)

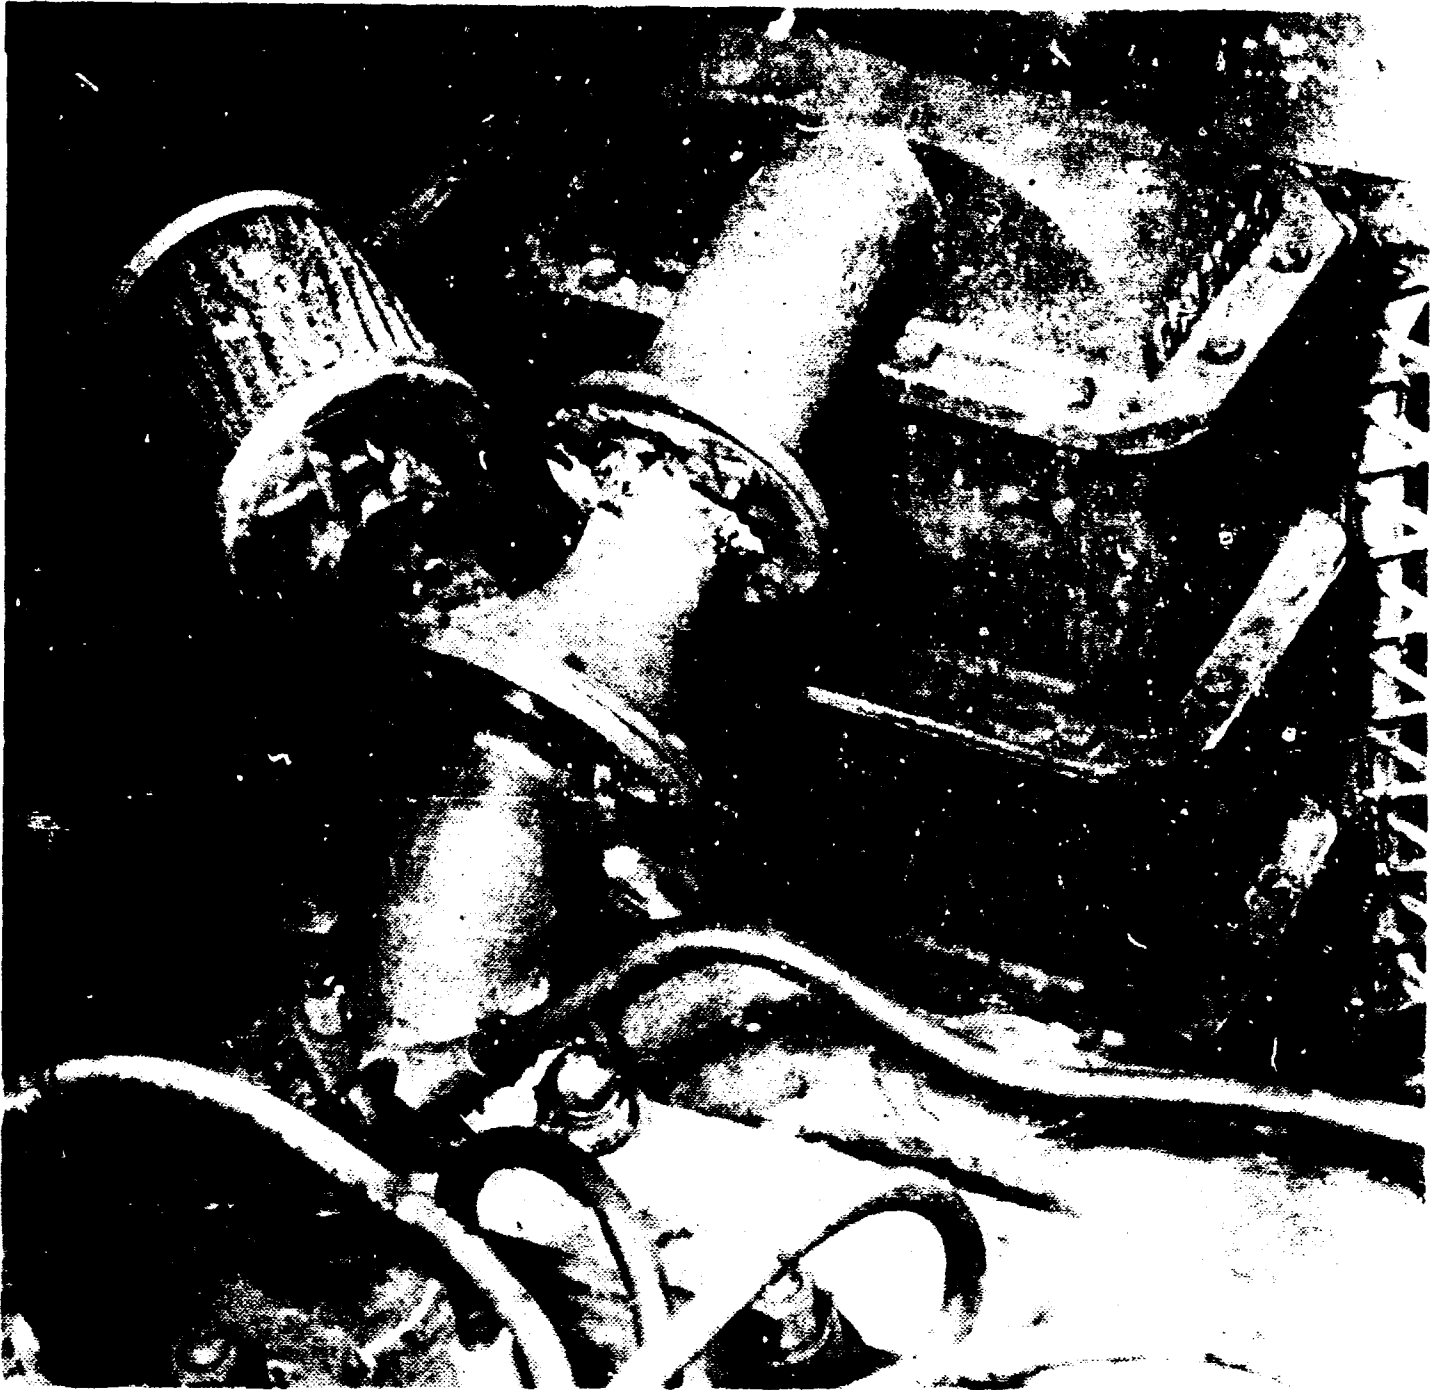
This original muffler had been broken in a number of places. The manifold flange connections had cracked and the venturi coupling had broken a number of times. These mechanical failures were due jointly to the method of supporting the muffler and the connections to the engine. Figures 1 - 4 show the various parts of this muffler and the manner in which it was fastened to the Tomotor Model LT-44 fork truck. Figure 1 shows that the entire weight of the muffler is supported by means of the manifold flange connection. Figure 2 shows how this overhanging load has caused the flanged connection to crack and also shows the weld repairs. Figure 3 shows the failure at the flanged end of

**FIG. 1 METHOD OF CONNECTING AND SUPPORTING MUFFLER SHOWING HOW ENTIRE WEIGHT IS PLACED ON MANIFOLD FLANGE AND VENTURI SECTION (USNSRDF NEG. NO. RDF-596-1)**

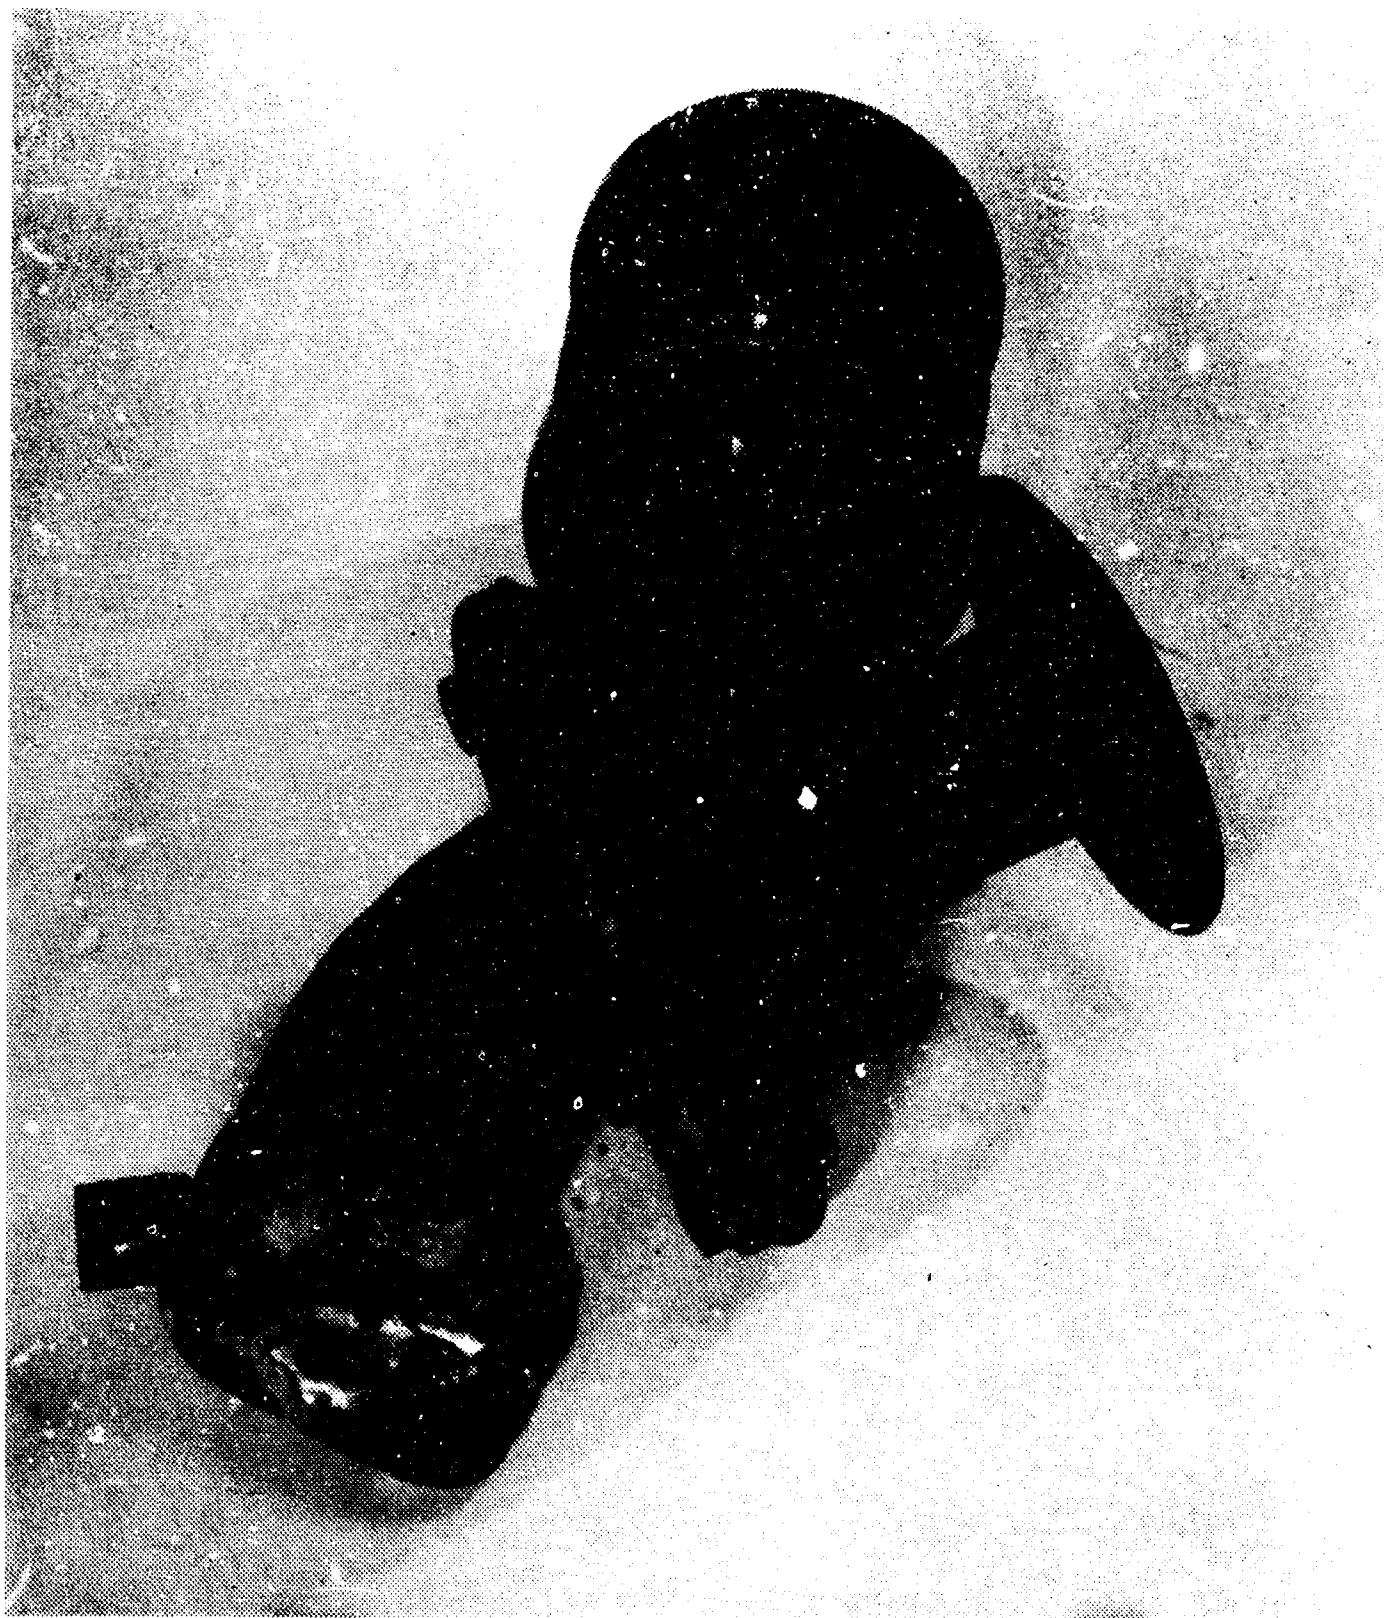
**FIG. 3 CLOSE-UP SHOWING FAILURES OF MANIFOLD FLANGE AND VENTURI COUPLING. (USNSRDF NEG. NO. RDF-596-3)**

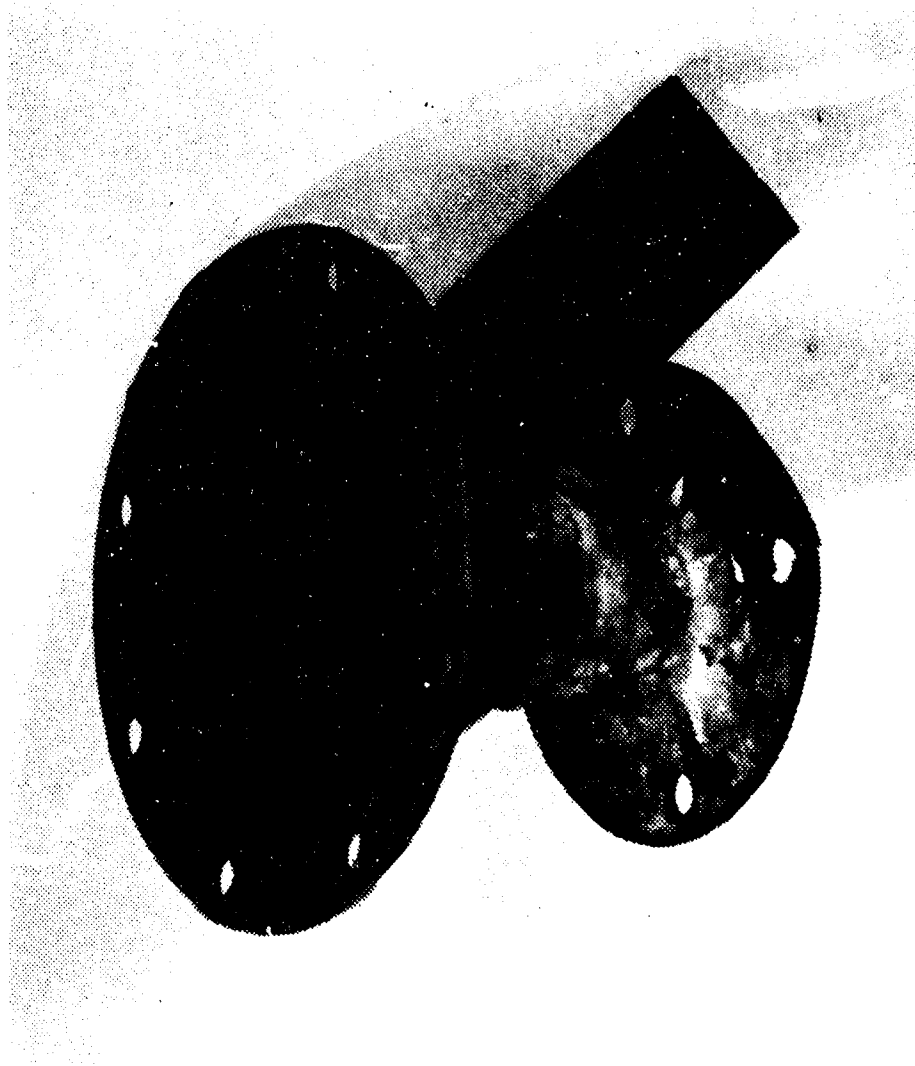
the venturi and the manifold coupling. Figure 4 shows a second failure of the venturi flange after repairs had been made. Note the very light gauge material that has been used in the venturi as compared to the heavy cast flange to which this piece connects.

**FIG. 4 CLOSE-UP OF SECOND FAILURE OF VENTURI  
FLANGE ASCRIBED TO THE USE OF LIGHT GAUGE METAL  
AT THIS POINT. (USNSRDF NEG. NO. RDF-596-4)**

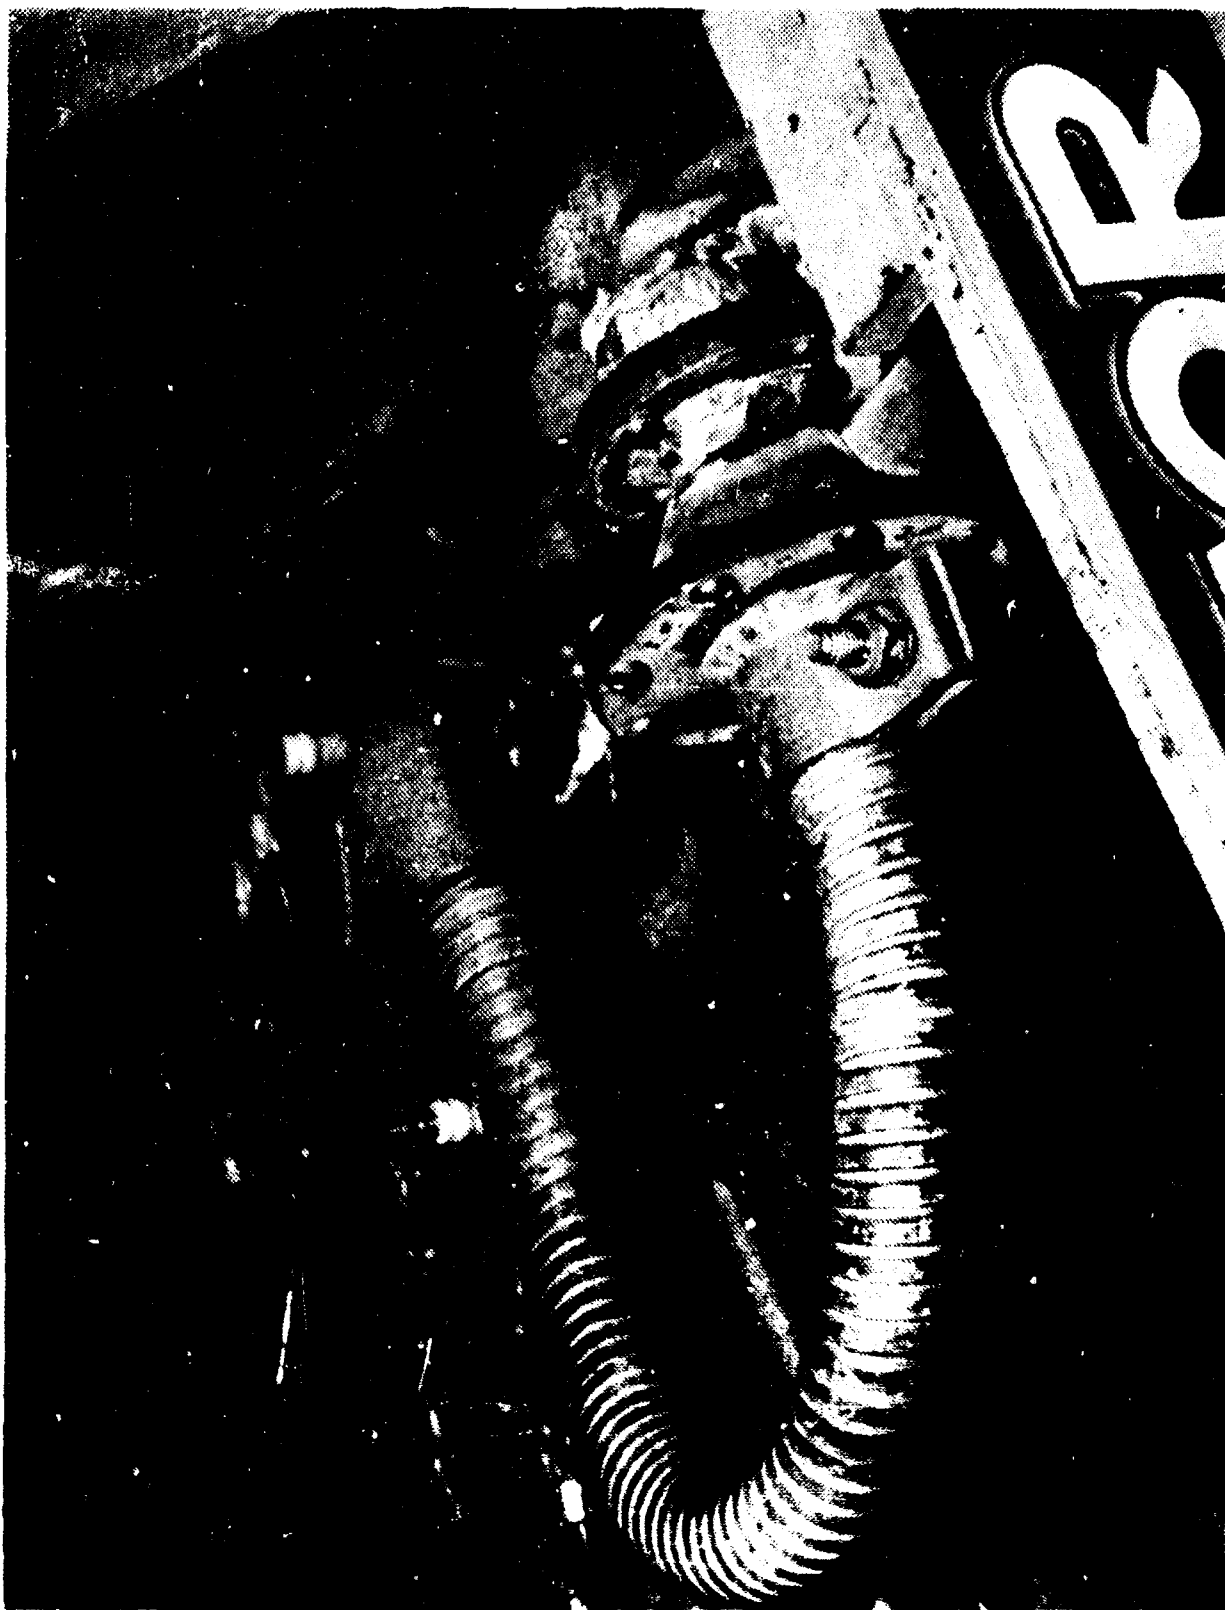
**FIG. 5 CLOSE-UP OF MANIFOLD CONNECTION SHOWING USE OF FLEXIBLE HOSE  
IN AN ATTEMPT TO ELIMINATE BREAKAGE OF THE VENTURI.  
(USNSRDF NEG. NO. RDF-26-2)**

These failures led to a search for a new method of fastening the muffler to the engine and for supporting the muffler more adequately. A method of connecting the manifold to the muffler by means of a flexible coupling was attempted. See Figure 5. In this method the muffler was fastened rigidly to the frame and the flexible tubing was designed to take out the vibration between the engine and the frame. This method of coupling is presently under test.

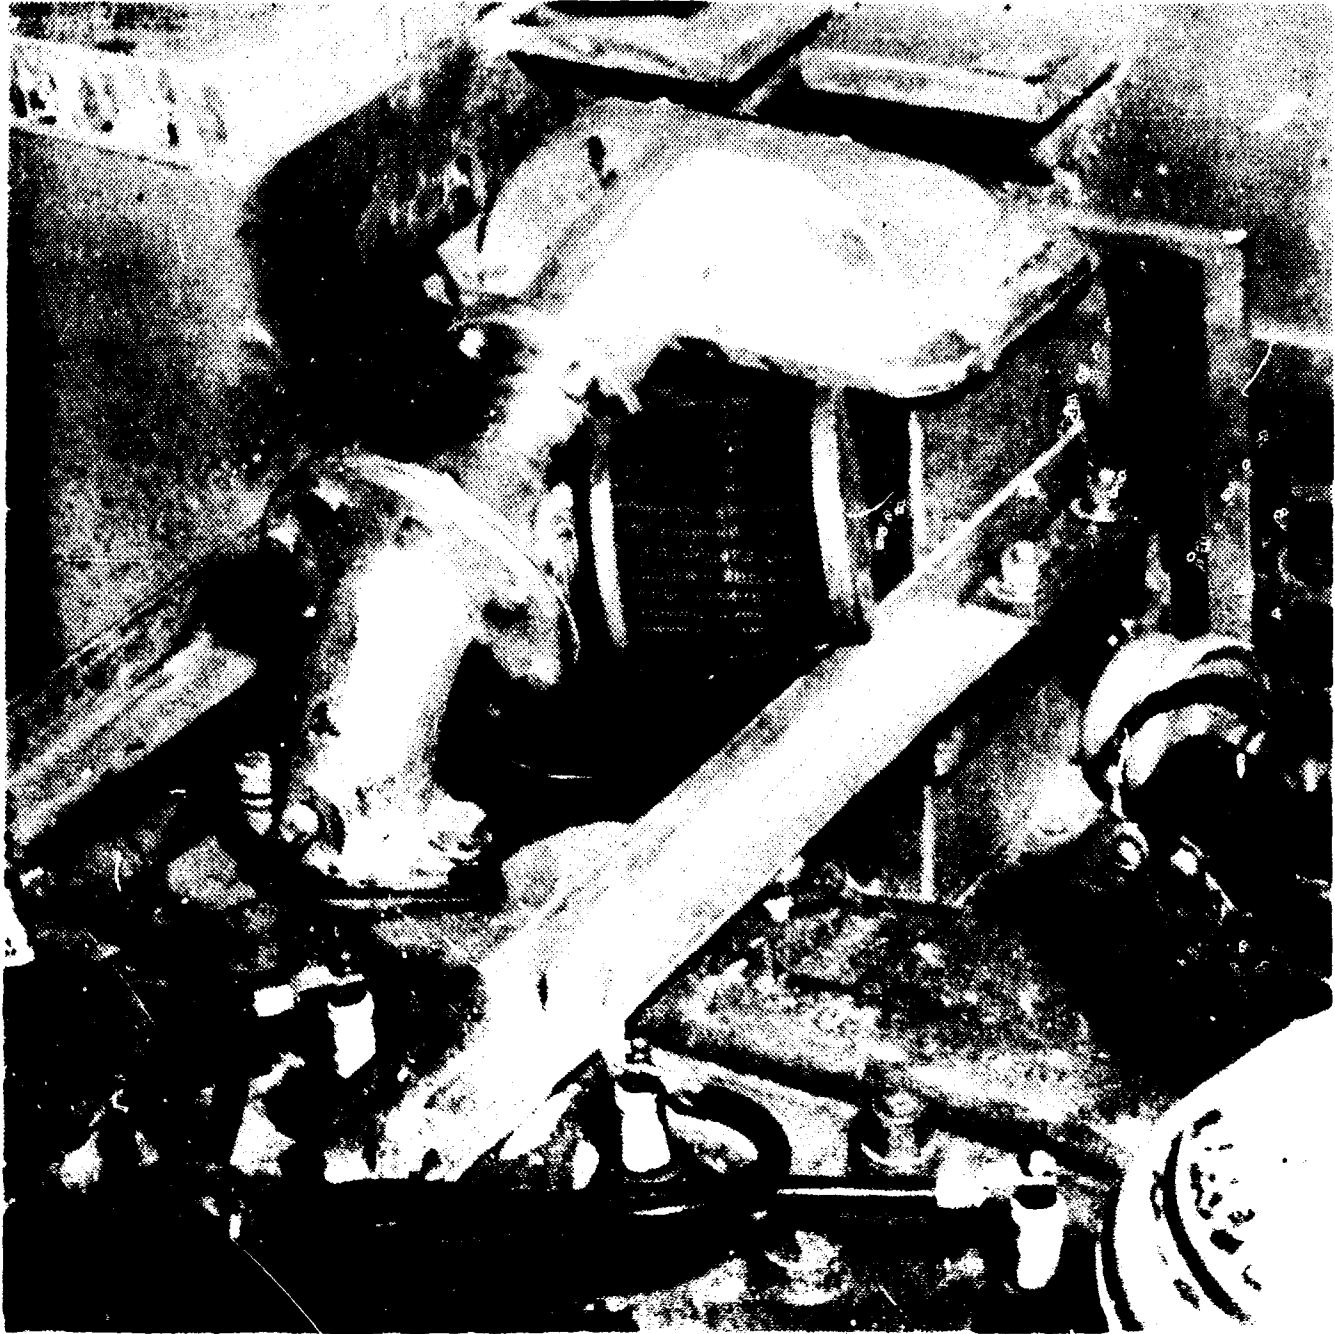
**FIG. 6 METHOD OF INSTALLING MUFFLERS ON TOWMOTOR TRUCKS AT NORFOLK SHOWING SUPPORT BRACKETS FASTENED TO ENGINE HEAD STUDS (USNSRDF NEG. NO. RDF-26-1)**

The mufflers failed to operate on occasion, and it was learned that breaks of the manifold flange, similar to those on the original muffler, had occurred. Three machines developed water leaks about the head stud bolts. This was due to fastening muffler brackets to the engine stud bolts.

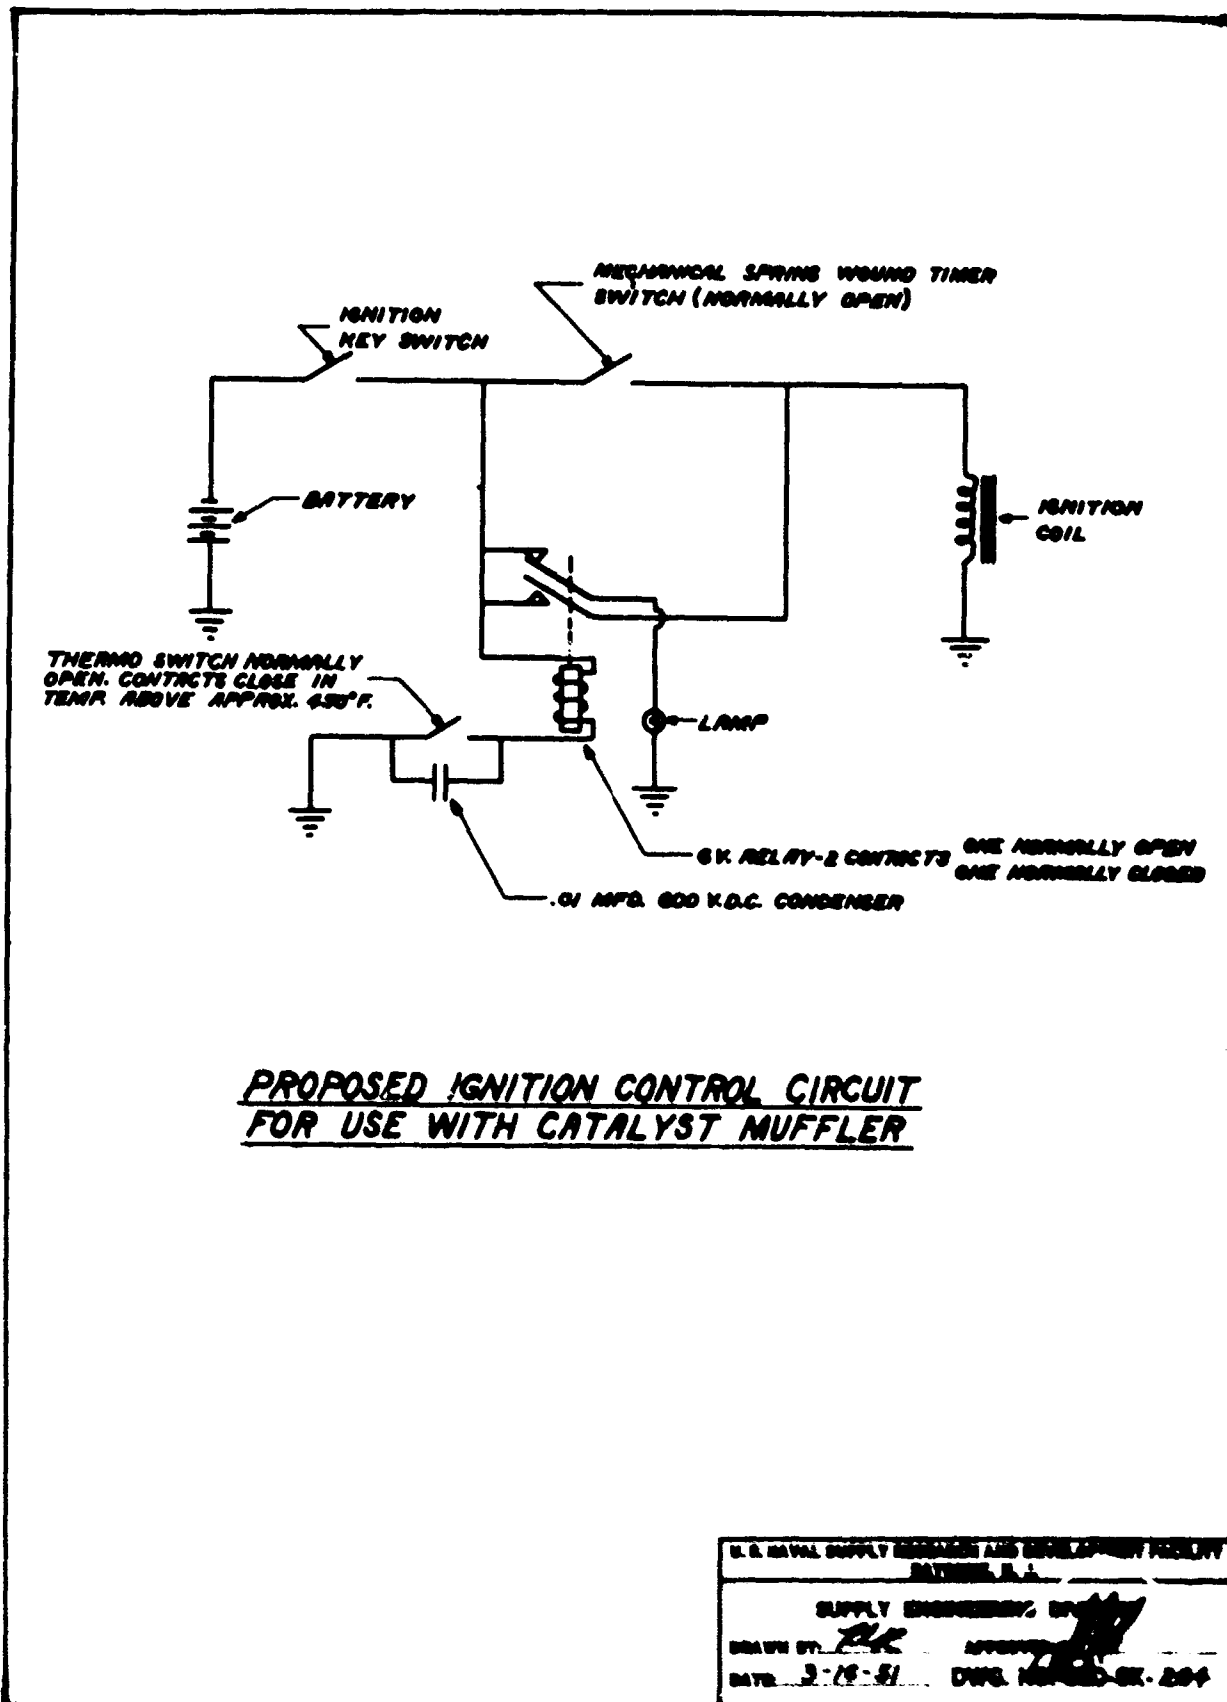
At the time of installation at Norfolk an ignition cut-out system was placed on each machine. See Figure 7. This system provided a means of turning off the engine automatically if the catalyst failed to come up to temperature. The ignition cut-out system showed signs of failure at the time of installation, and two units were inoperative before the company representative left. The three other units failed shortly thereafter and the machines were operated without the alarm system. It is believed that the units failed because the delicate clock and relay mechanisms were unable to withstand the shock and vibration imposed on them.

**FIG. 7 - ALARM DEVICE USED ON FIRST INSTALLATIONS . LATER REPLACED.**

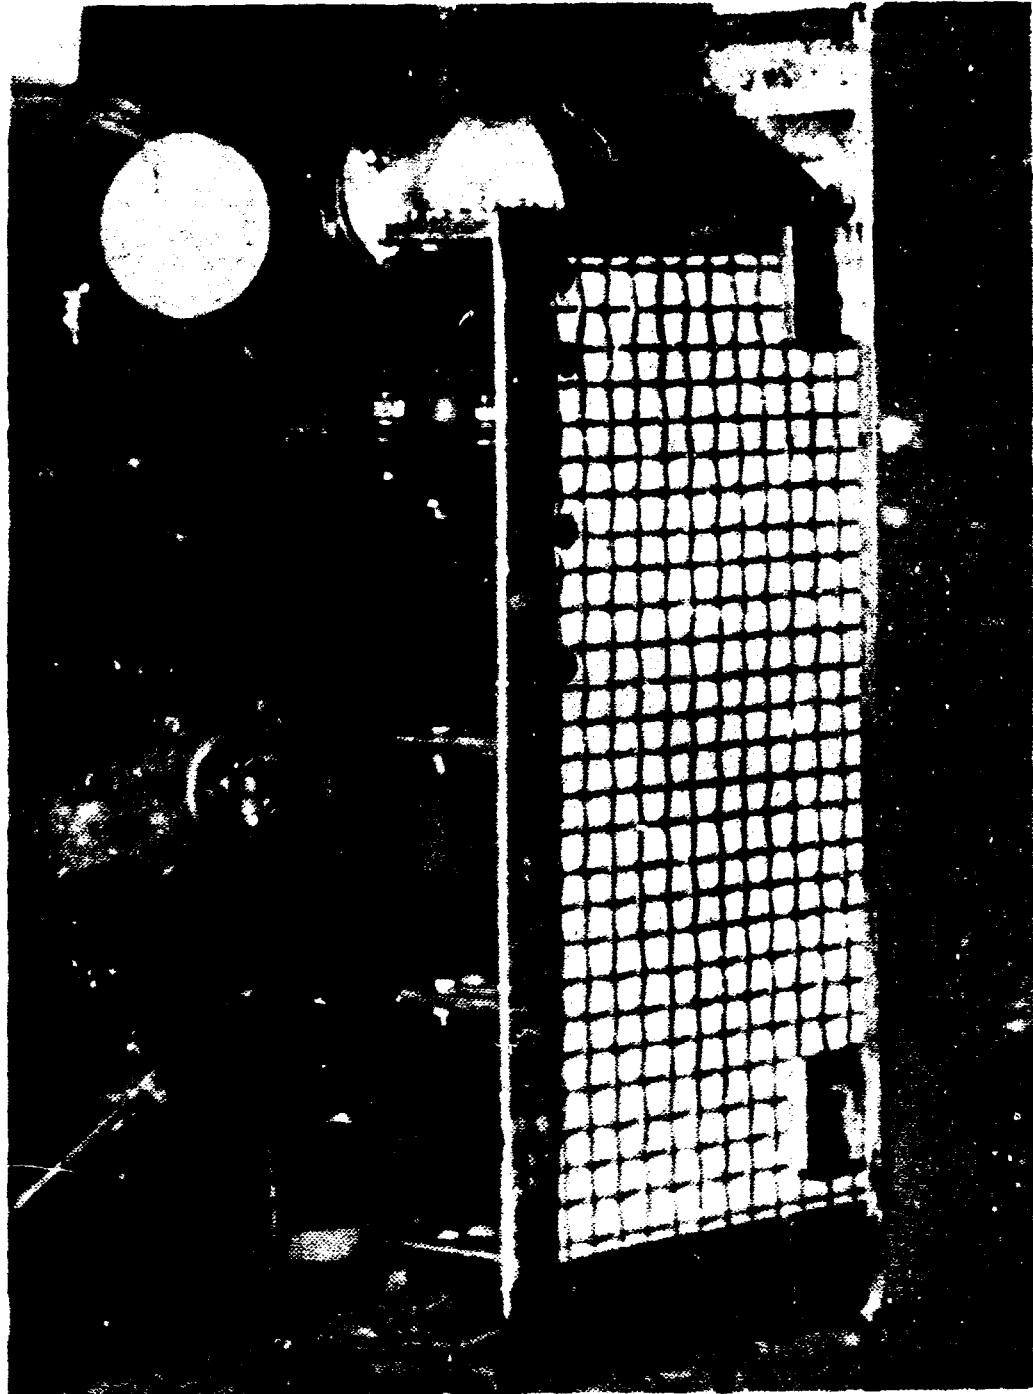
**FIG. 9 HEAT SHIELD DESIGNED AT USNSRDF TO  
OVERCOME EXCESSIVE RADIATION EFFECTS.  
(USNSRDF NEG. NO. RDF-13-i)**

This activity recommended that a "sandwich" of asbestos and metal be placed between the face of the muffler and the side walls of the truck. This measure alleviated the condition. Such a heat shield installation is shown in Figure 9.

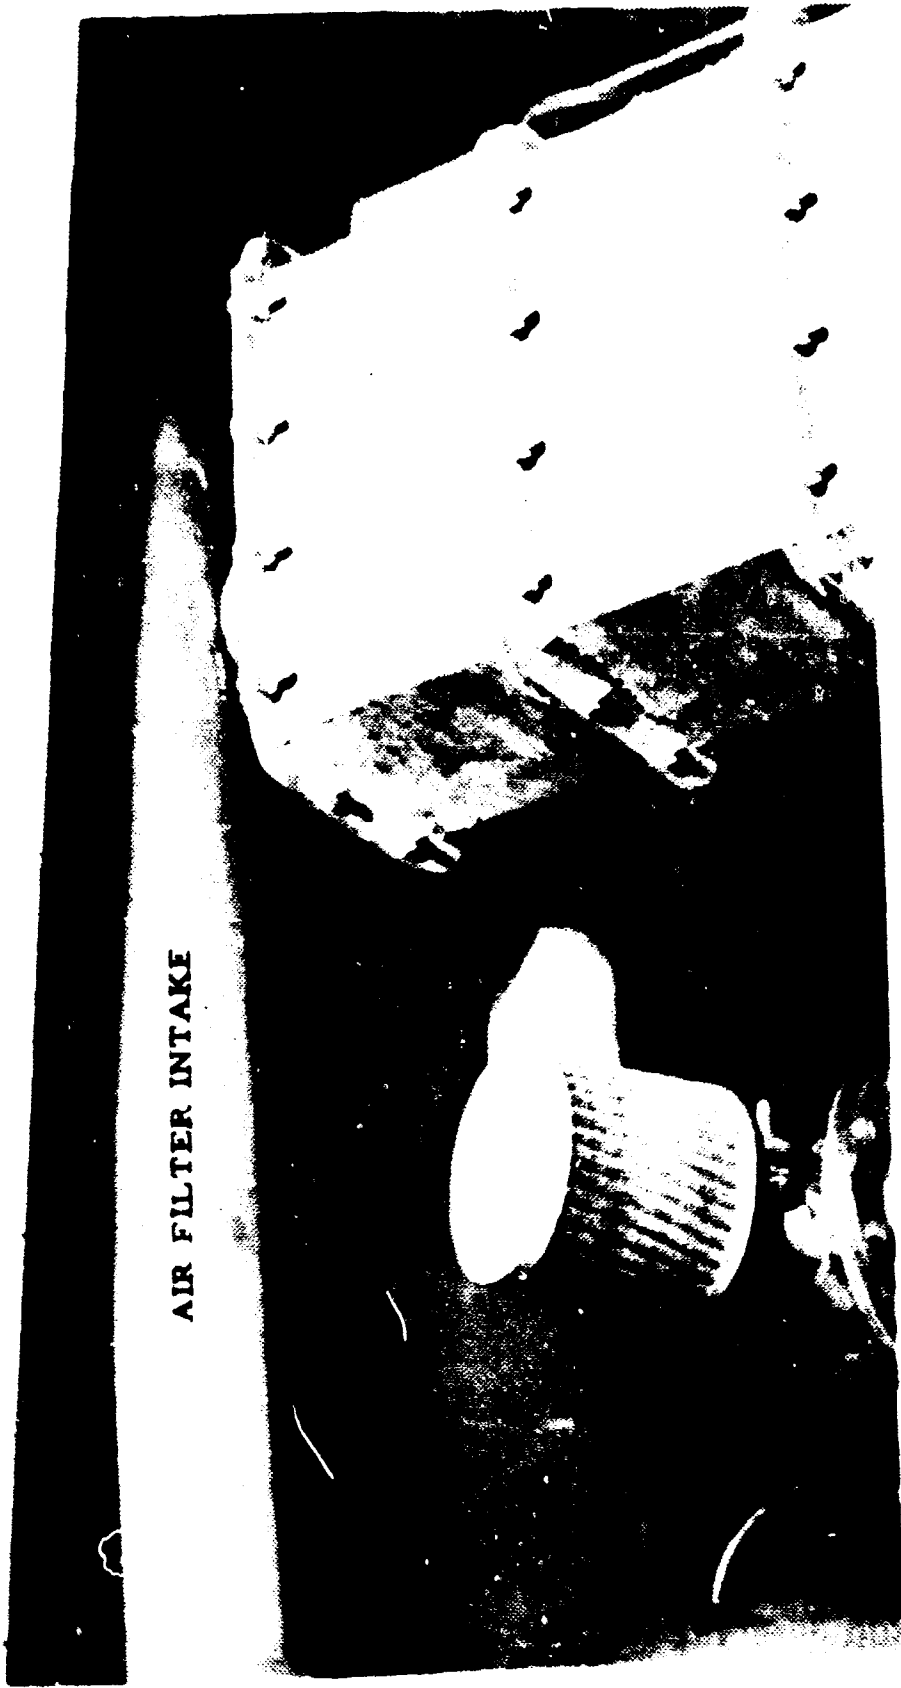
FIG. 15 INTERFERENCE BETWEEN MUFFLER AND AIR FILTER INTAKE ON CLARK "CARLOADER". (USNSRDF NEG. No. RDF 26-3)

The attachment of a muffler to the Clark "Carloader" necessitated the relocation of the carburetor air in-take pipe. See Figure 15. It was directly in the path of the muffler manifold connection. The muffler manufacturer recommended that the muffler be fastened to brackets provided for the truck's original muffler. This was not advisable without increasing the strength of these brackets by means of stiffeners. The clamp provided by the muffler manufacturer to fasten the muffler to the support bracket did not grip the muffler securely. It relied on supporting the muffler without holding it rigidly. See Figure 16. A new clamp was designed, along with the reinforced support bracket, as shown in Figure 17.

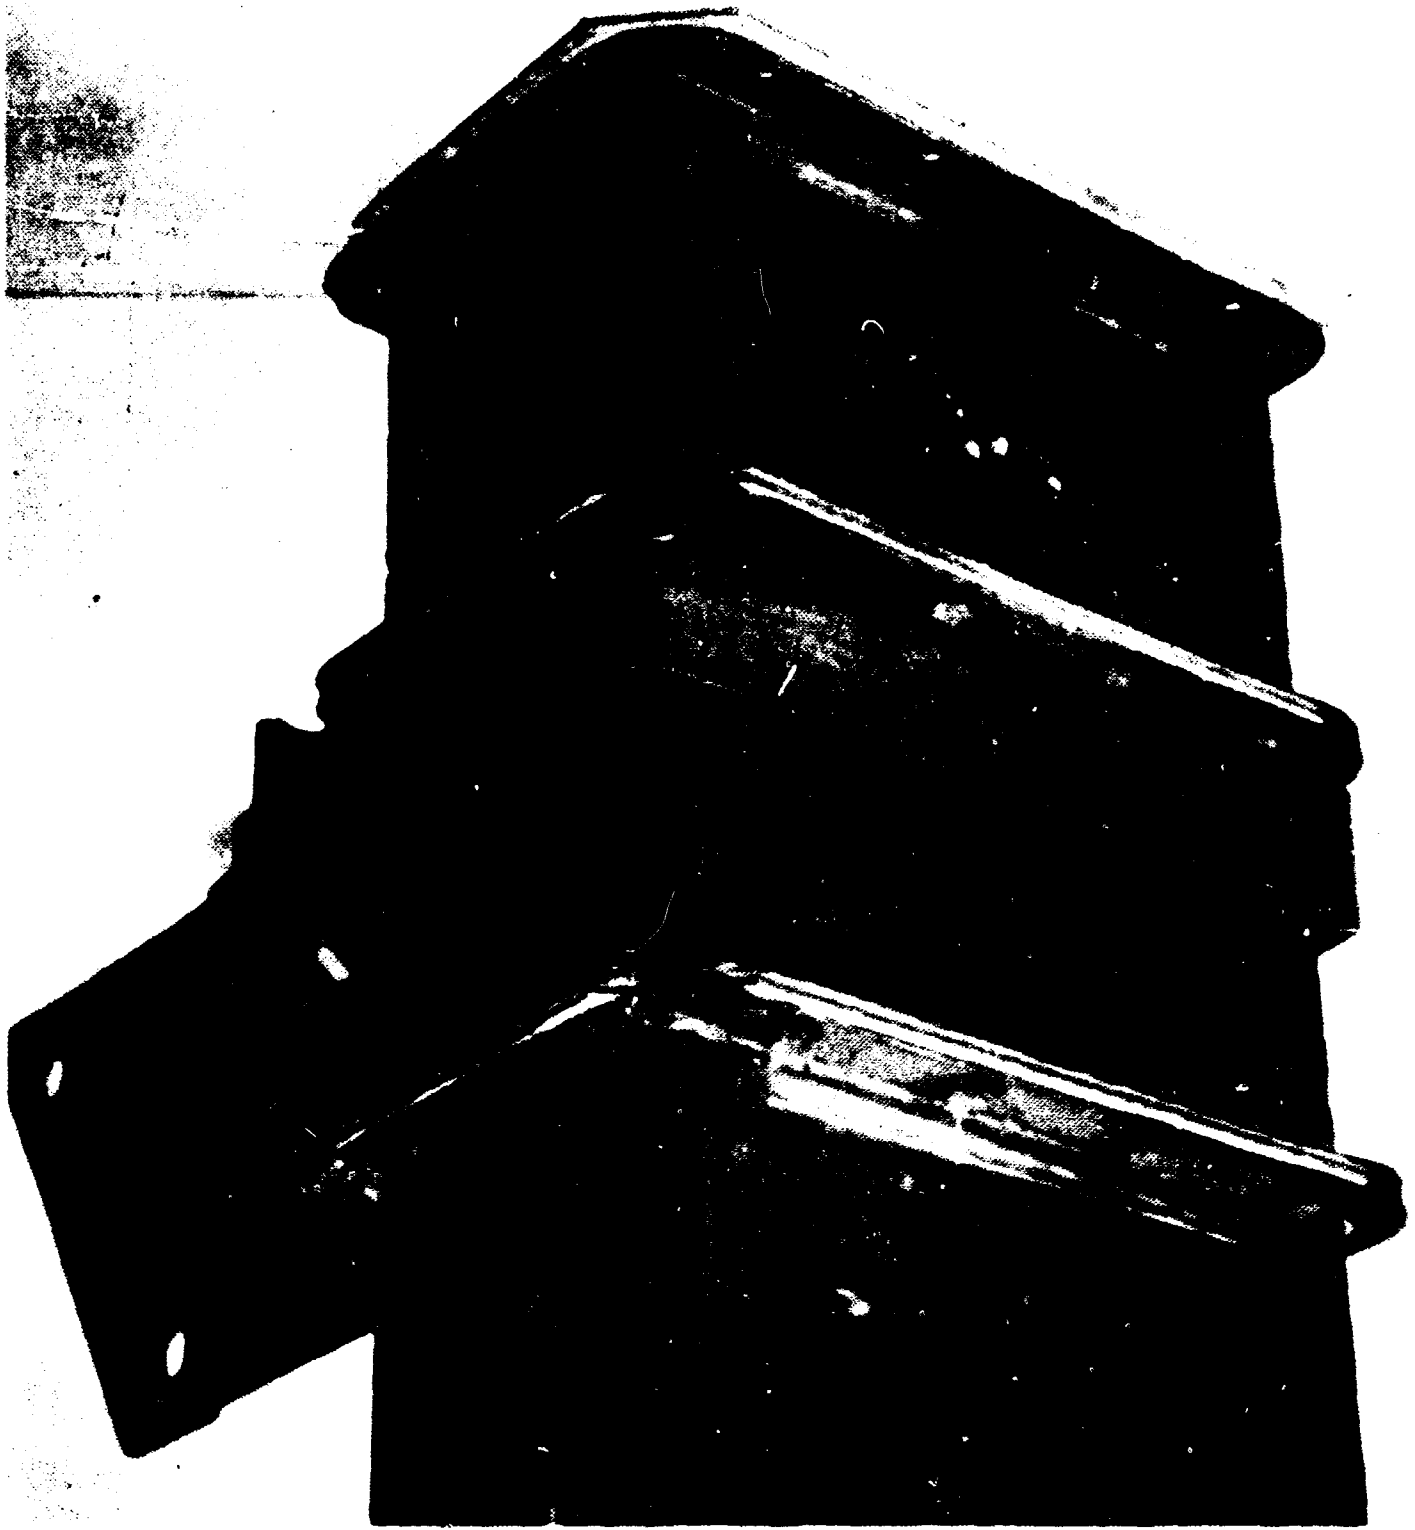
**FIG. 16. MUFFLER SUPPORT BRACKET FURNISHED BY MFR.  
NOTICE GAP BETWEEN CLAMP AND MUFFLER  
(USNSRDF NEG. NO. RDF-26-6.)**

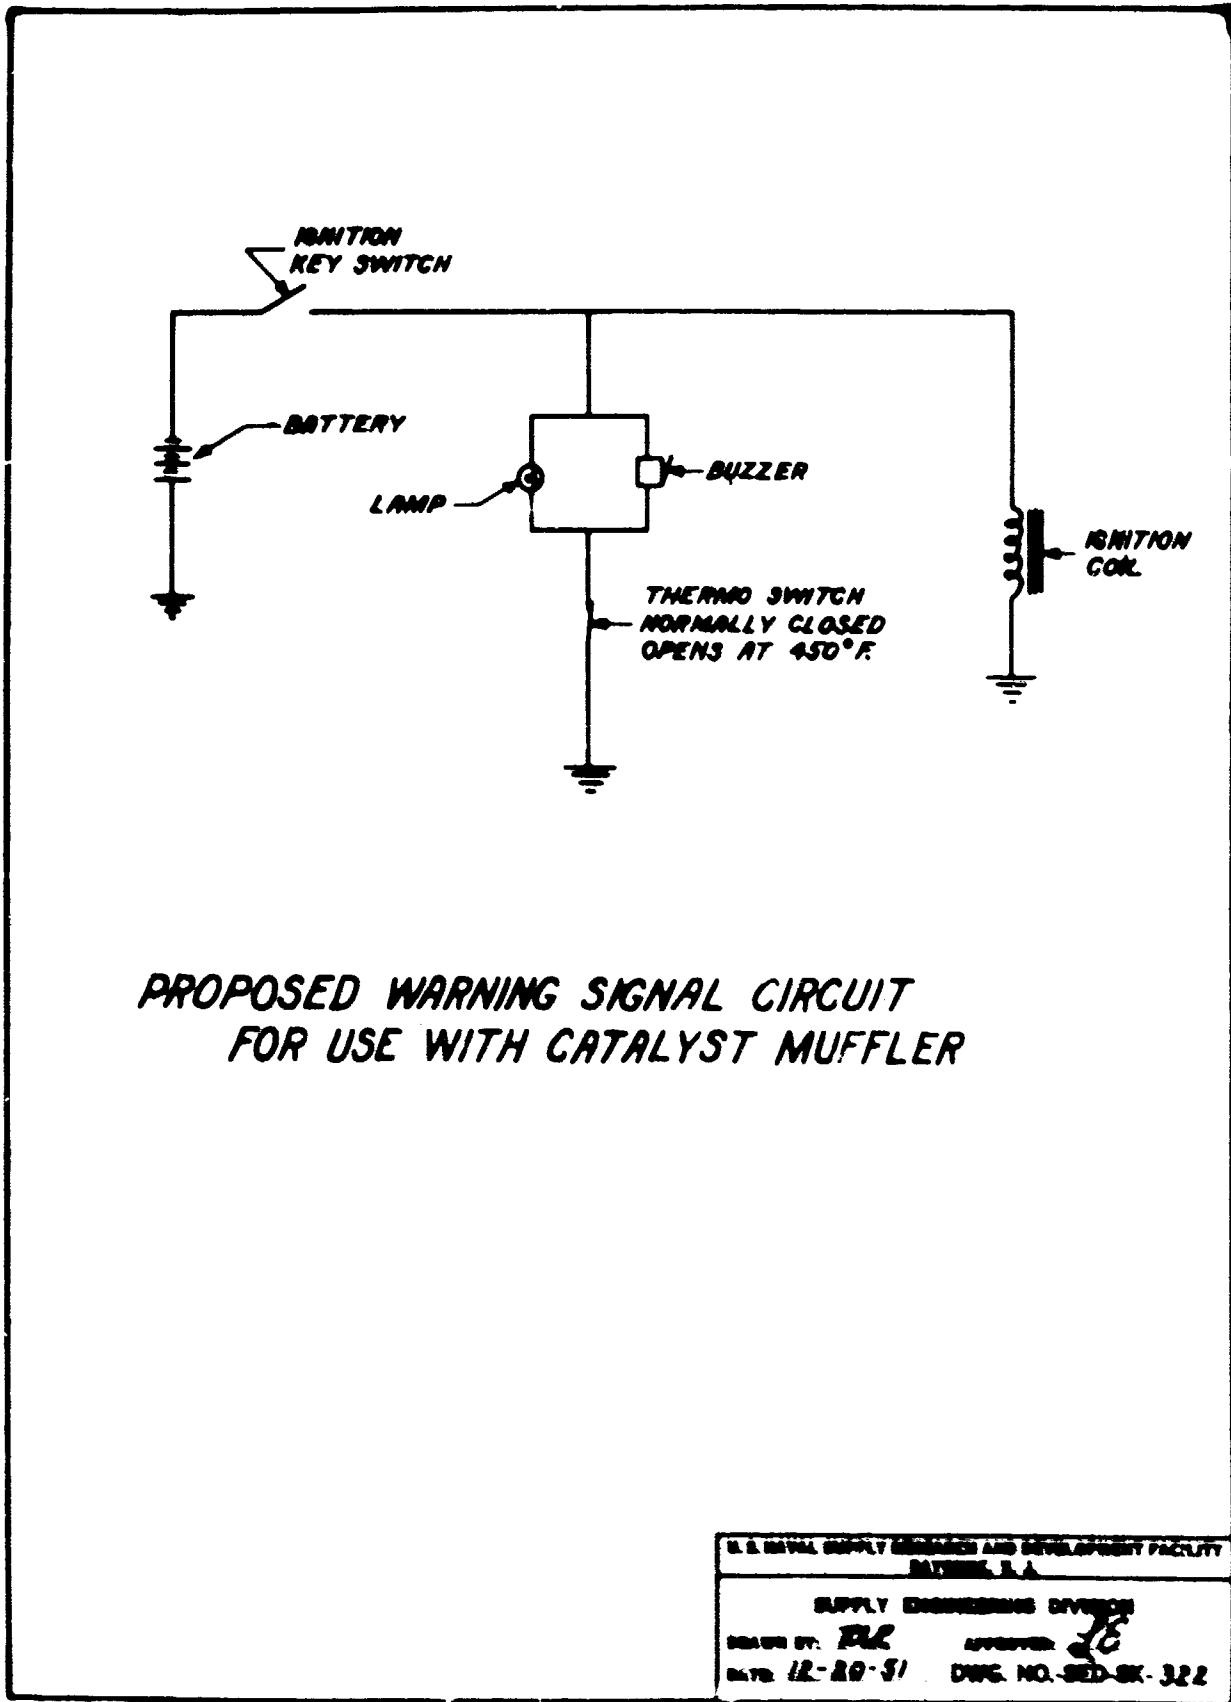
**FIG. 19 - REDESIGNED ALARM SYSTEM NOW IN USE.**

and the circuit is broken. This alarm system has been found to operate satisfactorily and will indicate proper muffler operation as long as the engine is not operating continuously under heavy load. Under this condition, the temperature of the exhaust gases may be high enough to keep the alarm off, although the muffler is not operating properly. The Underwriters Laboratory, Inc. confirms this in a report<sup>6/</sup> on the catalyst muffler.
