FULL-SCALE DYNAMIC CRASH TEST
OF A
LOCKHEED CONSTELLATION MODEL 1649 AIRCRAFT

TECHNICAL REPORT

OCTOBER 1965

Aviation Safety Engineering and Research
Division of Flight Safety Foundation, Inc.
Phoenix, Arizona

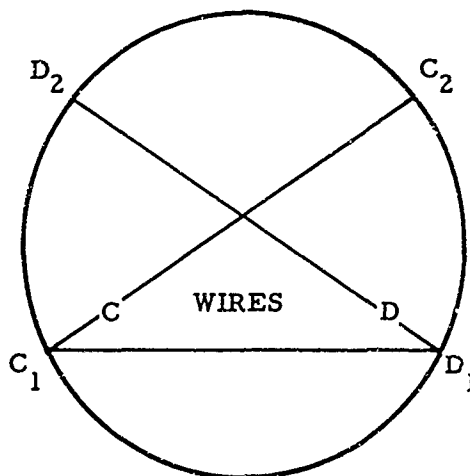
WIRE C. EXPANDED LENGTH
 BROKEN AFTER 121.50"
 DISTANCE BETWEEN C₁ AND C₂ 113.75"
 WIRE D EXPANDED LENGTH 118.5
 DISTANCE BETWEEN D₁ AND D₂ 116.5

FIG. 35 RESULTS OF FUSELAGE VOLUME REDUCTION EXPERIMENTS

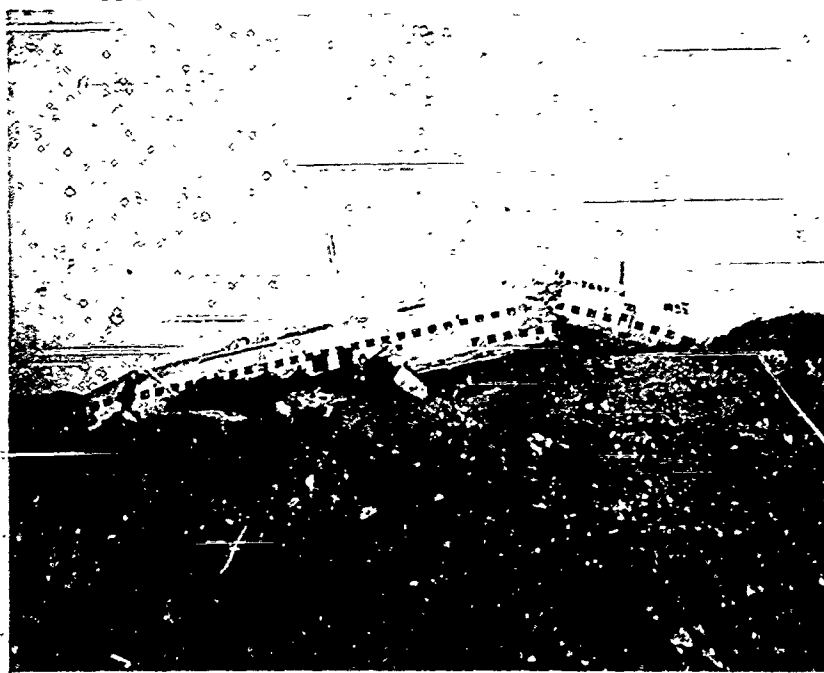
FIG. 36 OVERALL RIGHT SIDE VIEW OF FUSELAGE STRUCTURE

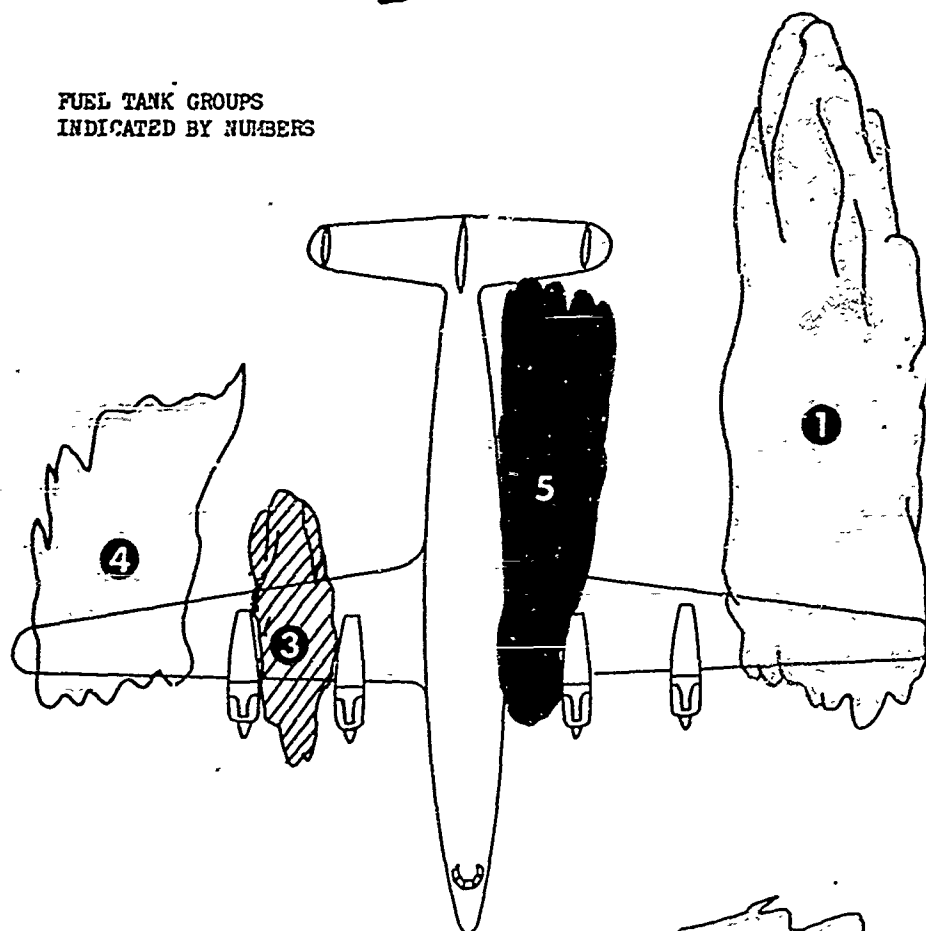
Initial impact and subsequent course of the aircraft through the barriers caused the wings to fail or disintegrate, spilling the simulated fuel. Figures 40, 41, 42, and 43 present a kinematic of the fuel spillage during the crash.

FIG. 41 FUEL SPILLAGE OCCURRING 1.14 SECONDS AFTER
IMPACT WITH MAIN GEAR BARRIERS

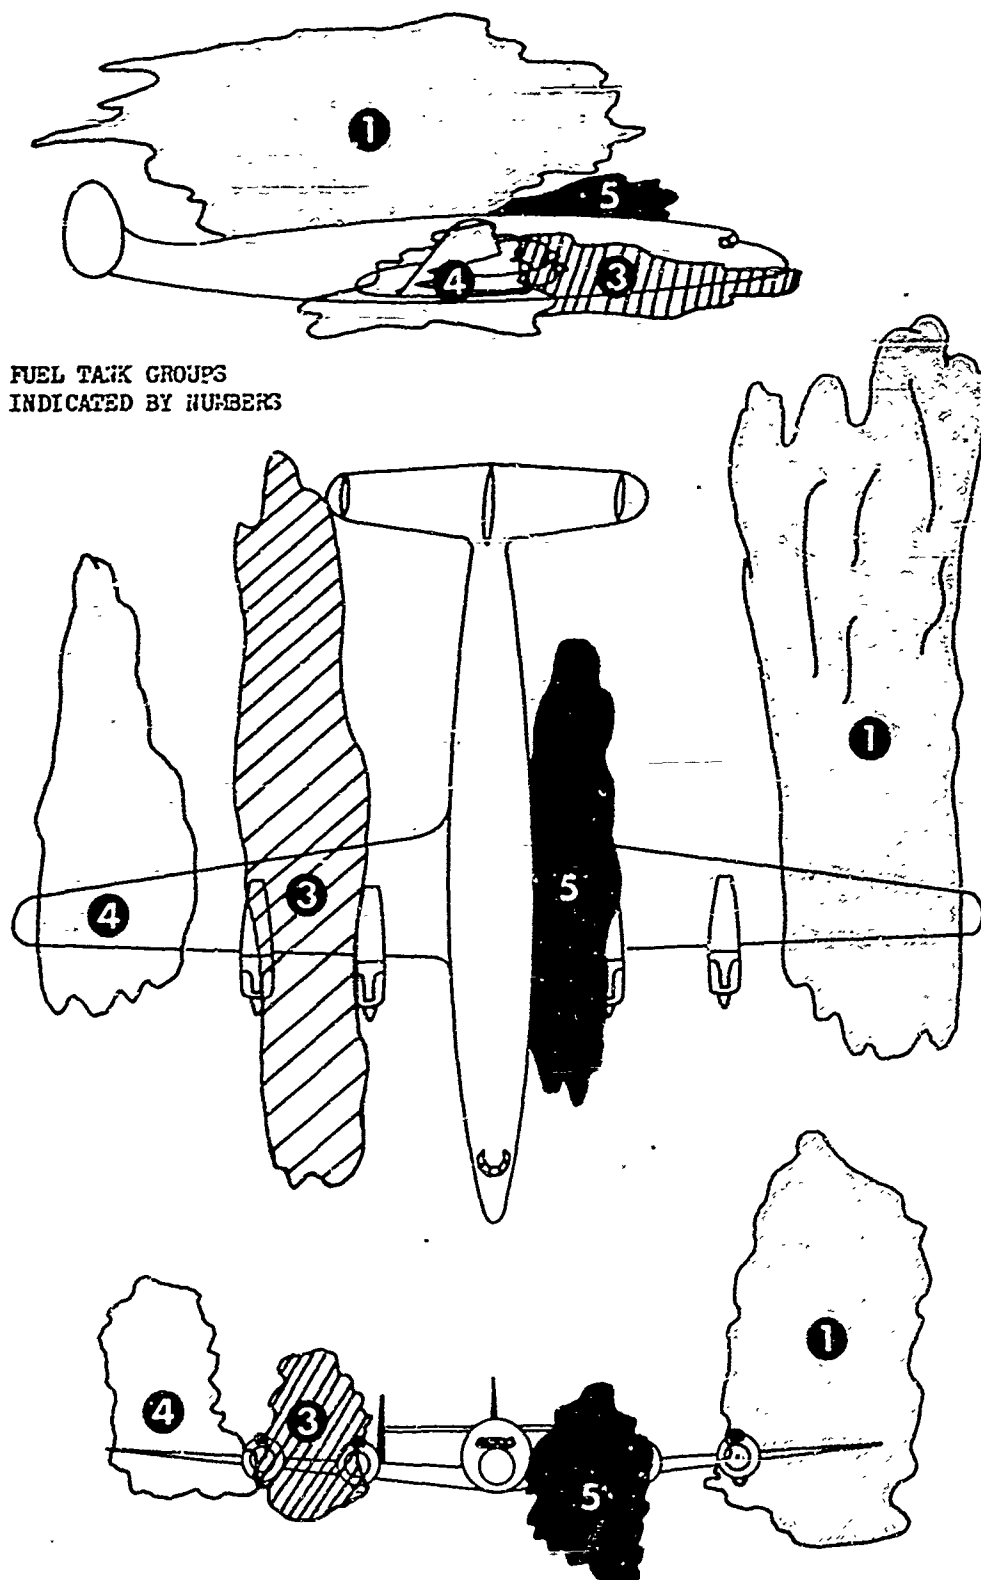
FIG. 42 FUEL SPILLAGE OCCURRING 2.24 SECONDS AFTER
IMPACT WITH MAIN GEAR BARRIERS

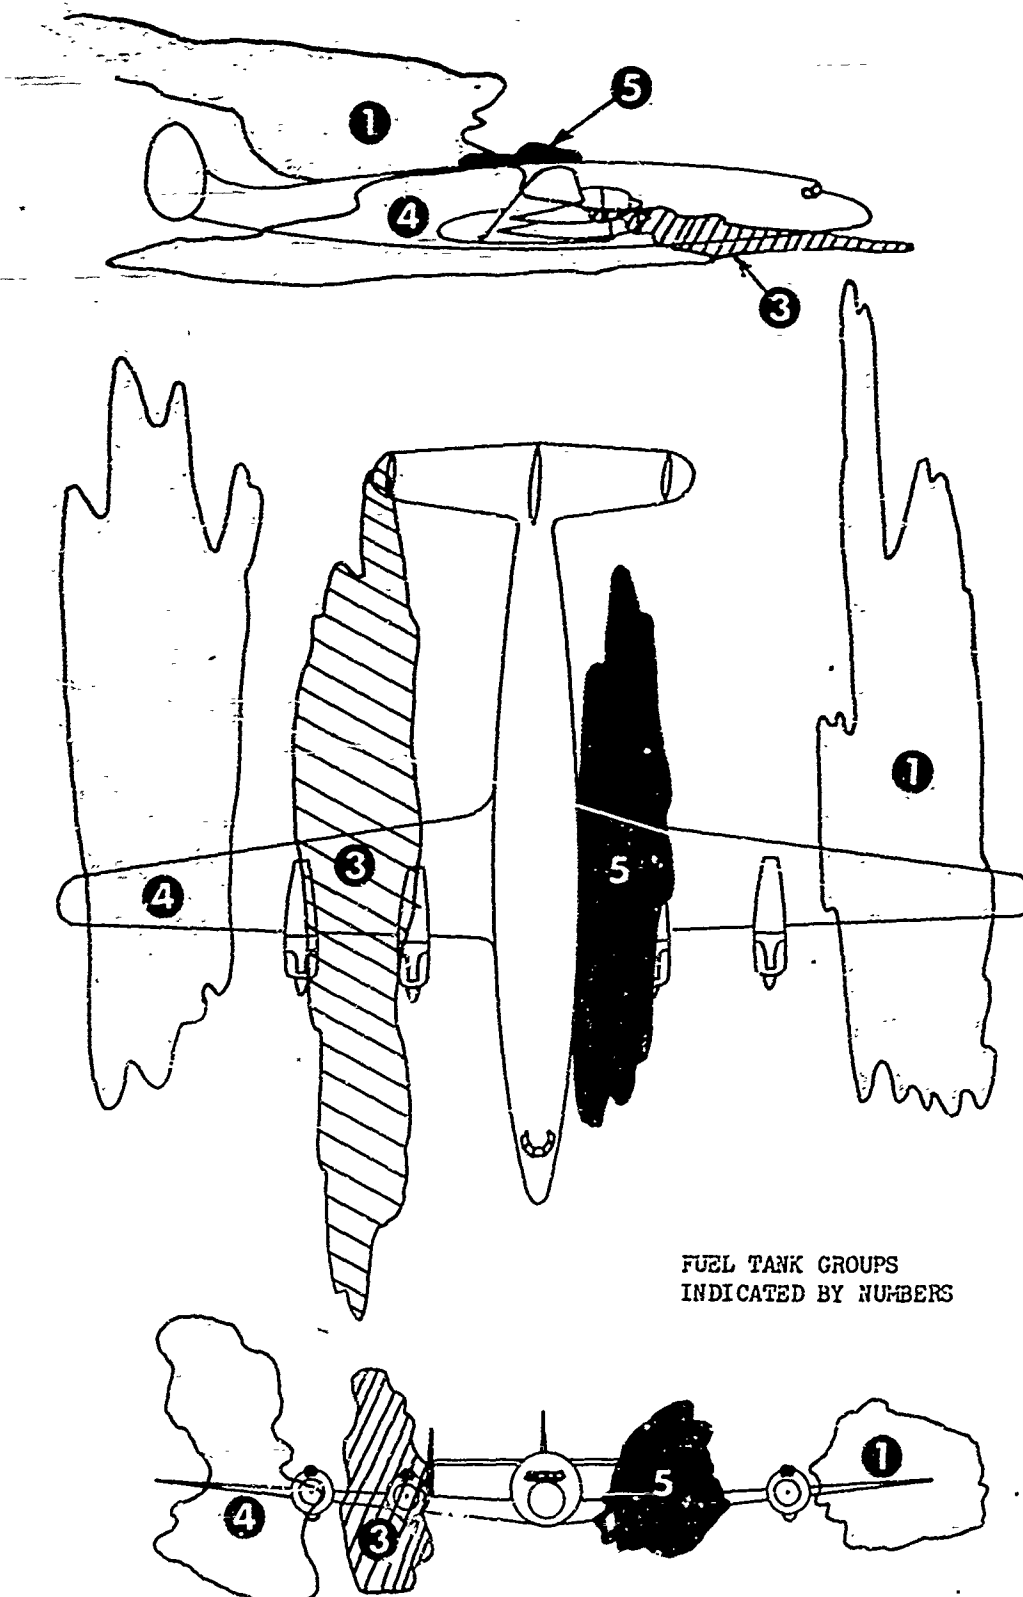
FIG. 43 FUEL SPILLAGE OCCURRING 2.65 SECONDS AFTER
IMPACT WITH MAIN GEAR BARRIERS

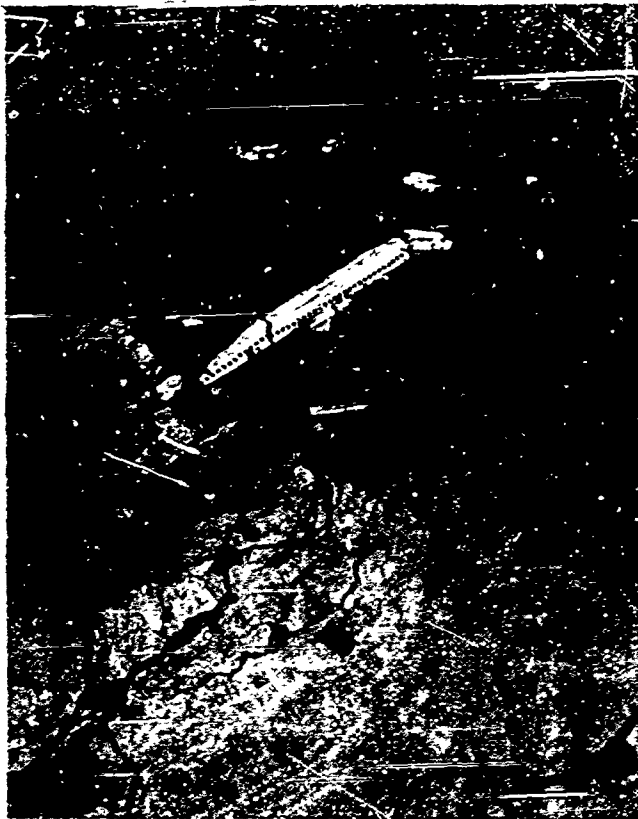
FIG. 44 AERIAL
PHOTOGRAPH
OF THE CRASH
SCENE ILLUS-
TRATING THE
WING FAILURES
AND SPILLAGE
PATTERN
