POSTIRRADIATION EXAMINATION OF THE
PM-3A TYPE 1 SERIAL 2 CORE
PART I. POSTIRRADIATION EXAMINATION
OF FUEL TUBES

February 28, 1967

John B. Brown, Victor W. Storhok, and John E. Gates

BATTELLE MEMORIAL INSTITUTE
Columbus Laboratories
505 King Avenue
Columbus, Ohio 43201

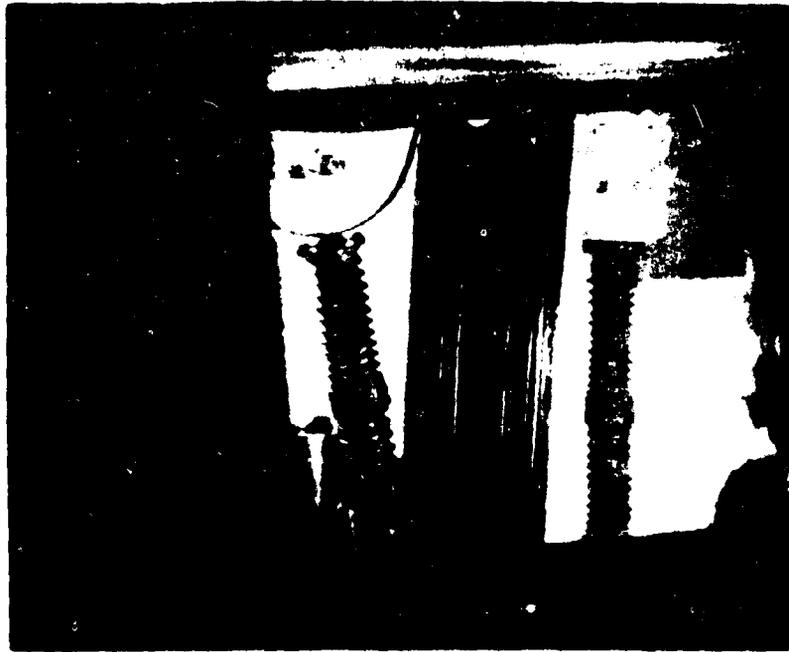
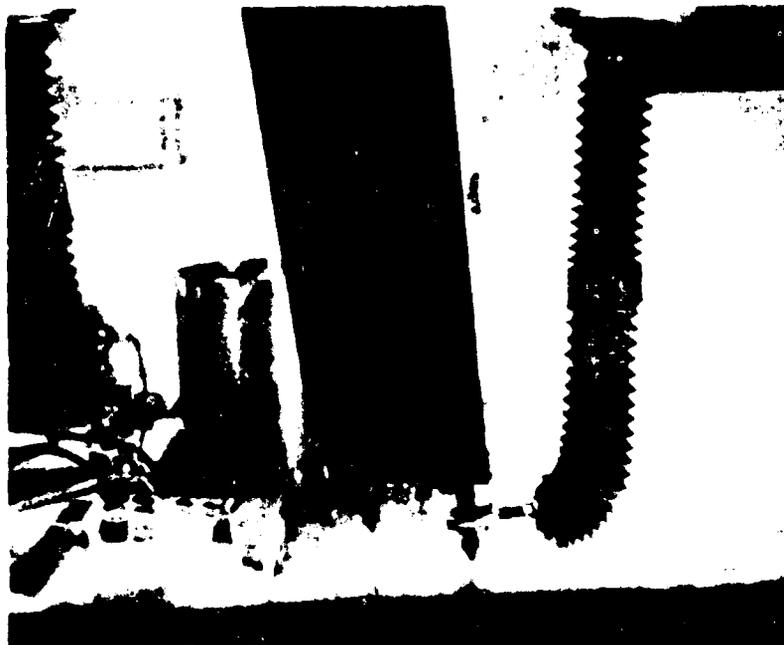
FIGURE 4. PERIPHERAL BUNDLE AS IT APPEARED THROUGH THE HOT-CELL WINDOW

Figure 4 shows peripheral bundle 9 after being lifted from the transfer cask within the beta-gamma cell. Figure 5 shows the control rod exit end of the peripheral bundle 9. Several of the cadmium rods, placed in the core as an added precaution against criticality, are visible in Figure 5. Figure 6 shows end views (less control rod) of peripheral bundle 12. As shown in the above photographs, all core bundle exterior surfaces were coated with a black scale. Passage of light through the tubes provided evidence that the scale buildup did not block any of the coolant flow

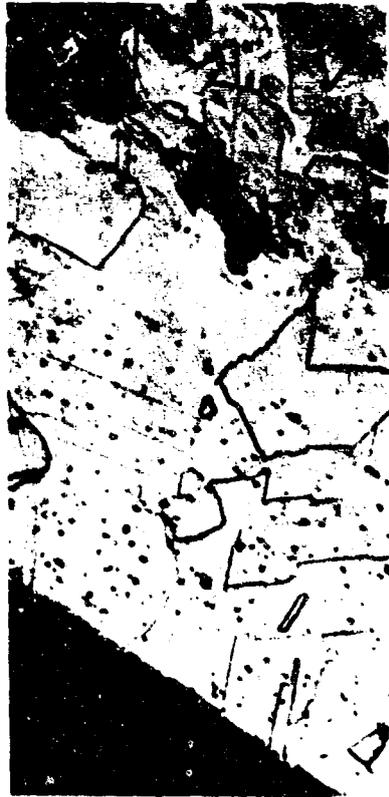
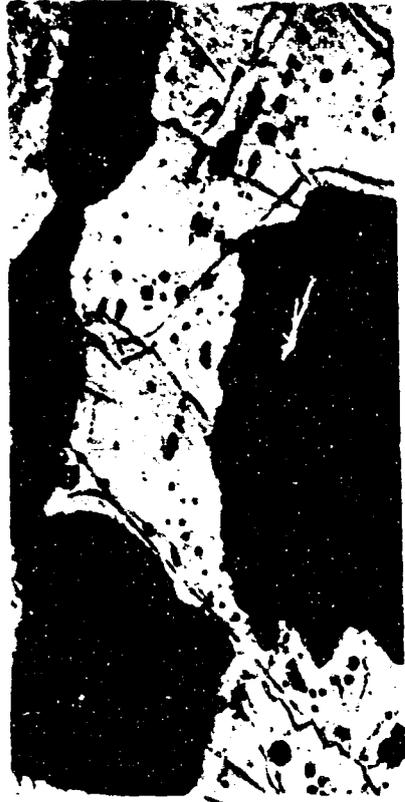
FIGURE 14. MICROSTRUCTURES OBSERVED AT SEVERAL POSITIONS IN FUEL TUBE 12-46

1. Position B: No cracks were found in the clad at this position on fuel element 12-46. Figure 14B-1 shows a typical micrograph of the clad and clad-fuel matrix interface. No damage was noted to clad or clad-fuel interface. Depending on size and orientation of grains, between 3 to 6 grains spanned the cladding thickness. Figure 14B-2 shows a typical micrograph of a UO_2 particle. Some porosity was observed in the UO_2 particles at this location.

2. Positions D and E: Figures 14D-1 and 14E-1 show typical micrographs of the cladding and clad-meat interface at the D and E positions of fuel element 12-46. Discussions of D and E positions are combined because of similar results. The following comments apply to both positions on the fuel element:

- a. About 30 cracks were detected around the periphery of the outer clad.
- b. Many cracks (about 1/3) were double at the outer edge and combined into a single crack at some point within the clad and continued as a single crack which terminated at a fuel particle.

- c. All cracks detected were intergranular.
- d. The cracks appeared to have been initiated at the outside edge of the outer clad since some smaller cracks were started at the outside edge of the clad but terminated before completely penetrating the clad.

- e. No cracks on the inner clad were observed.
- f. All cracks that penetrated the clad appeared to terminate at a UO_2 particle close to the clad-fuel interface.

- g. Grain boundaries appeared to be relatively free of precipitates, indicating that the stainless steel was not sensitized.
- h. In some cases, foreign material appeared in the cracks.

3. Position F: Figure 14F shows a typical micrograph of the clad and fuel matrix at the F position of fuel element 12-46. No crack in the cladding was found to penetrate completely through the clad at this position. The micrograph shown represents the worst clad condition found in this position.
4. Positions G and H: Figures 14G and 14H show typical micrographs of the cladding and fuel matrix at the G and H positions of fuel element 12-46. No cracks or other damage was noted to the cladding or clad-meat interface at this position. Note the absence of spherical porosity in the UO_2 particles.

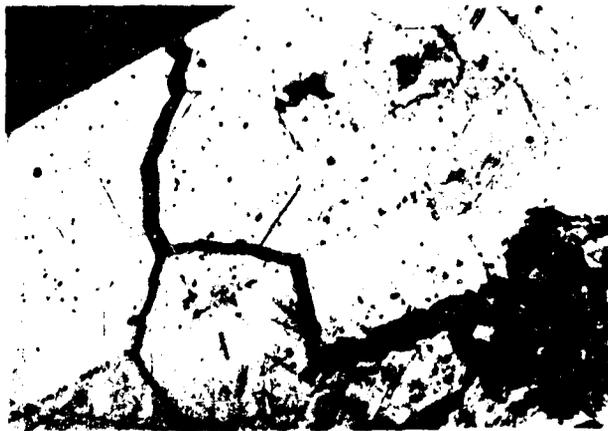
FIGURE 15. SELECTED MICROGRAPHS DETECTING CLAD CRACKING IN SPECIMEN 12-46-E

Figure 15 is a selection of photomicrographs depicting various outer clad cracks found in the high performance fuel tube specimen 12-46-E. Morphology of the cracks in this specimen indicate that corrosive attack to the cladding may have played a role in inducing clad failure:

1. Branch-type cracking observed in the fuel tubes is indicative of stress-activated chemical attack, rather than purely mechanical cracking. One example of branch-type cracking is shown in Figure 15a.

2. One possible explanation to the loss of clad material in the clad crack as depicted in Figure 15c is grain annihilation by corrosive attack. Partial grain annihilation is exemplified by the small grain located adjacent to the cavity which is almost completely surrounded by intergranular attack. Also, the smaller crack that neighbors the major failure is further evidence that corrosive attack was occurring.

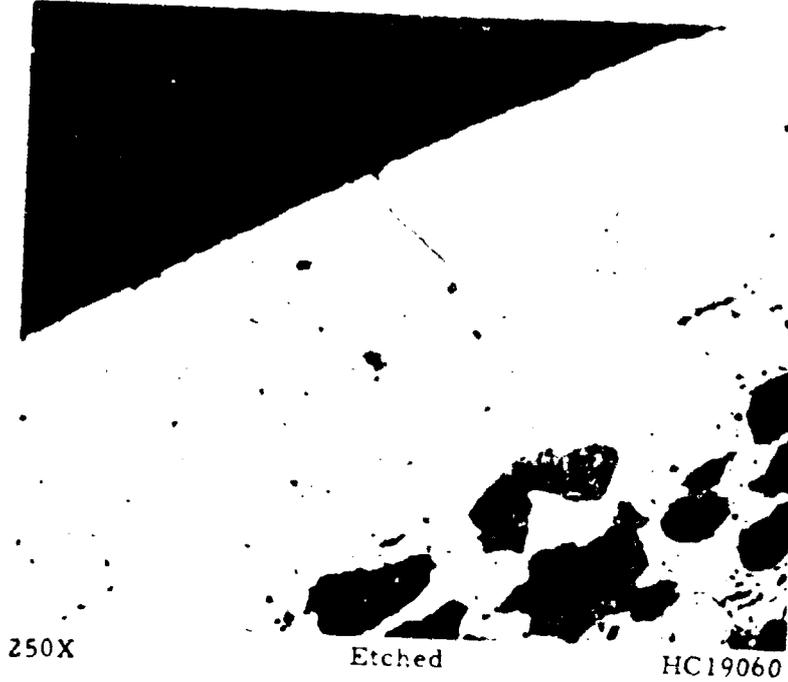
Figures 18a and 18b represent typical microstructures of fuel tube 12-90. Figure 18a shows a crack which extends into the outer clad approximately three mils. This was the only crack found on this specimen which was taken from the high performance region of fuel tube 12-90. Figure 18b shows the condition of the dispersion fuel in the vicinity of a UO_2 particle. An indication of second phase material was also observed in the UO_2 particle. Identification of the second phase was not attempted, since it seemed unlikely that the material contributed to clad failure. The 6-micron-thick band around the fuel particle probably reflects the fission product recoil range, rather than interaction between UO_2 and stainless steel.

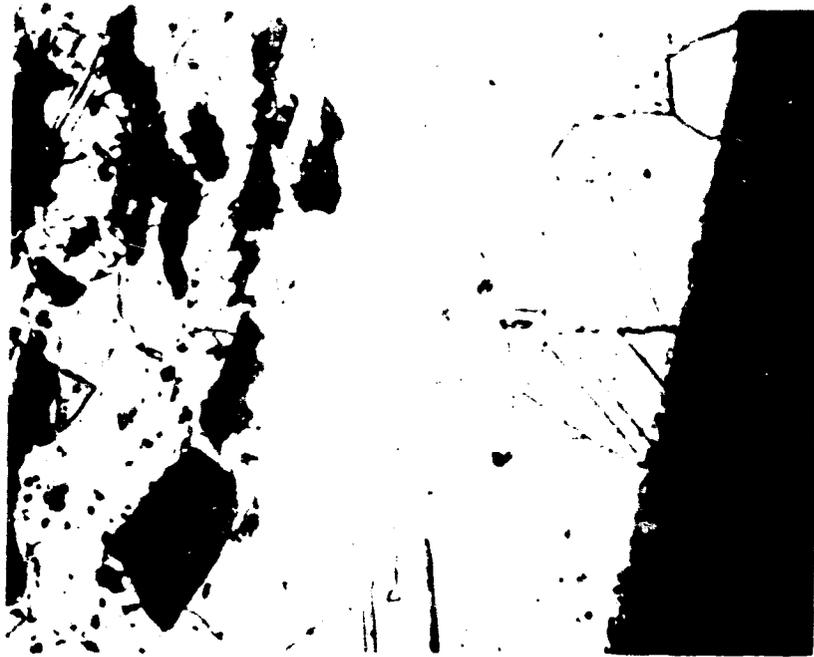
Figures 19a and 19b show micrographs of a transverse specimen taken from a low performance region of fuel tube 12-90. No cracks or crack indications were found in the clad at this position on fuel tube 12-90. Also apparent is the lack of spherical porosity in the UO_2 . A recoil region was visible in the stainless steel matrix around the periphery of the UO_2 particles, Figure 19b.

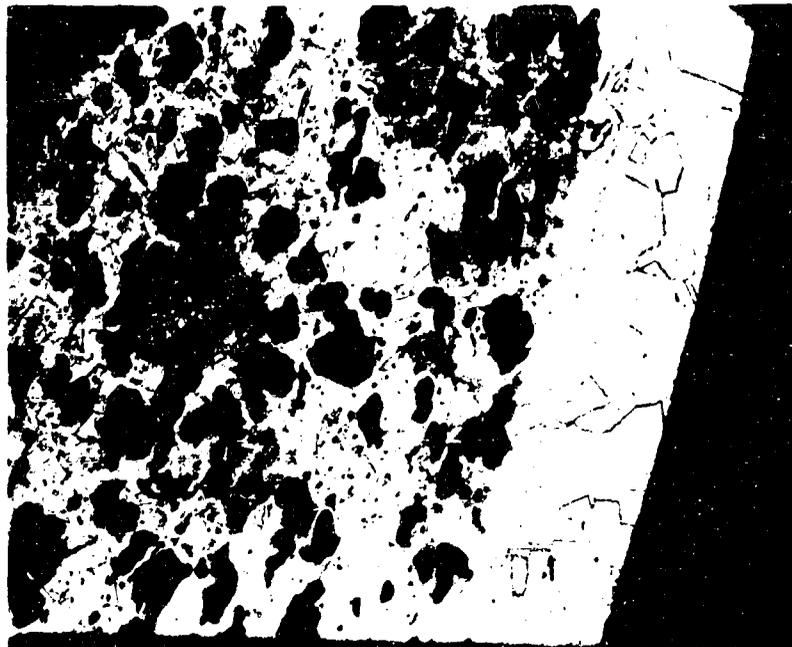
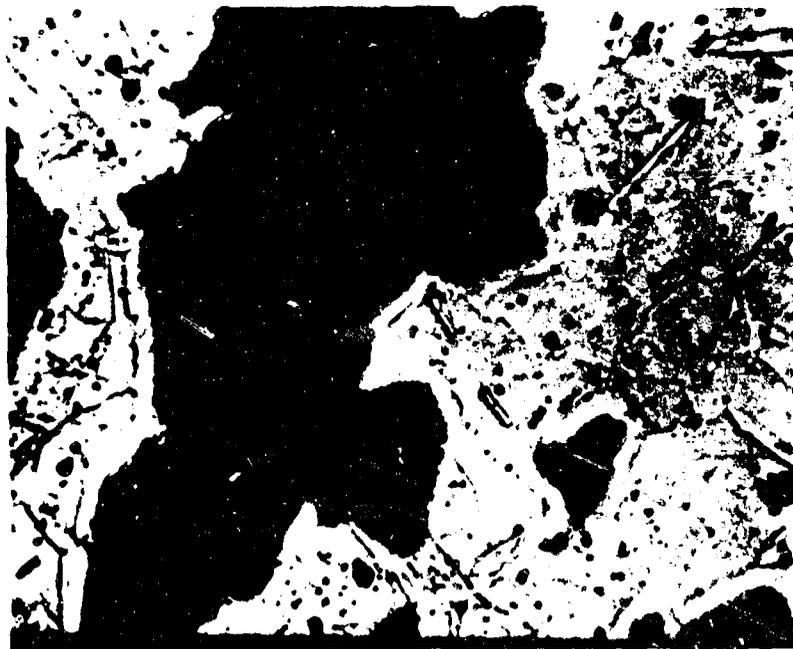
FIGURE 20. TYPICAL MICROGRAPHS FOR SPECIMEN 12-102-E

Figures 20a and 20b are micrographs of a transverse specimen taken from fuel tube 12-102 at the E position. Figure 20a shows the clad condition at this position. No cracks or crack indications were found in the clad at this average performance position on fuel tube 12-102. Relatively large quantities of fission gas bubbles were present in the UO_2 particles in this region, Figure 20b.

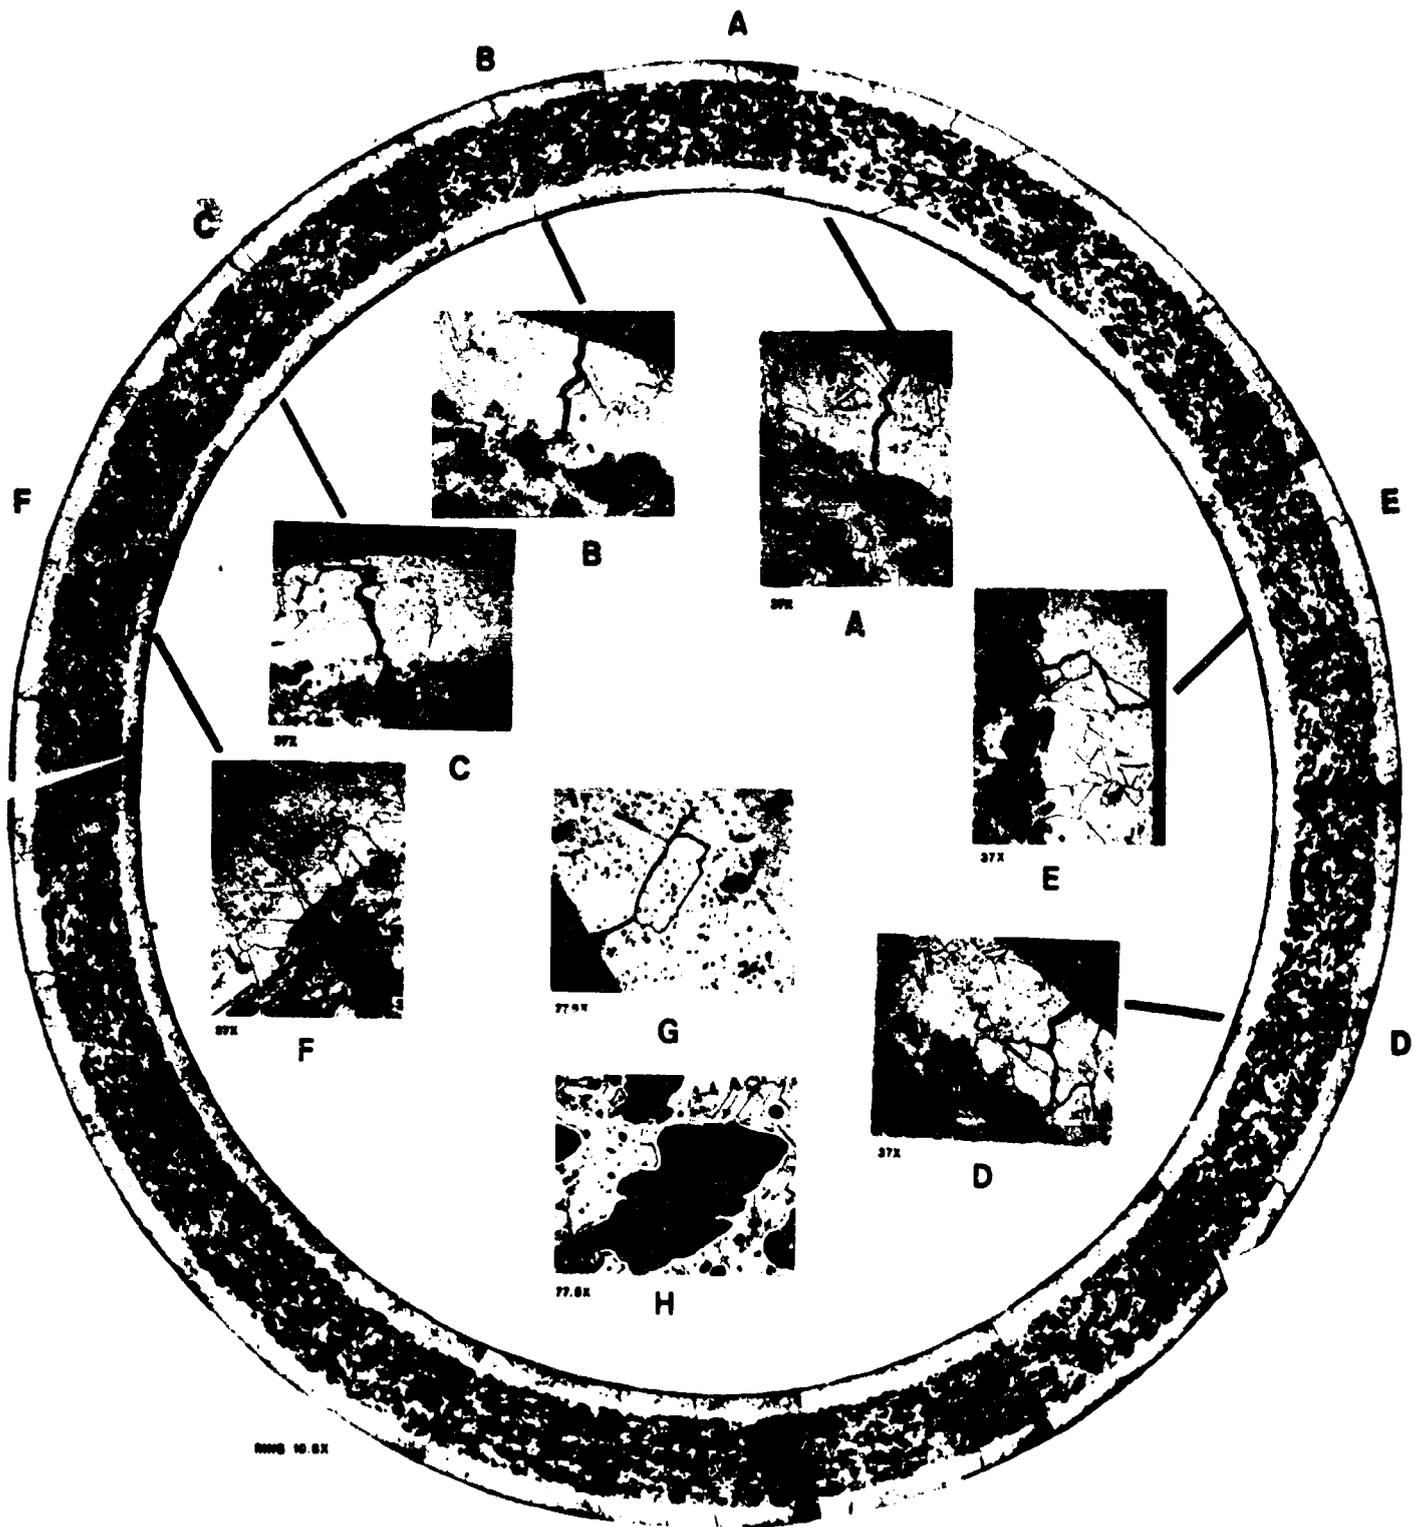
FIGURE 21. MICROGRAPH COMPOSITE OF FUEL-TUBE SPECIMEN C-1-E WITH HIGHER MAGNIFICATION INSERTS

Figures 21 and 22 show results of metallography on two fuel tubes taken from the center bundle. These fuel tubes were located in positions of equal symmetry within the center bundle. Both transverse specimens were cut from the high performance region of both fuel tubes. Figure 21 is composed of a photomicrograph composite of specimen C-1-E with higher magnification micrograph inserts depicting selected clad cracks. Note that there appears to be no preferred pattern as formed by the clad crack positions located within the outer clad. Again, cracks were intergranular in nature, and limited to the outer clad tube. Figure 22 shows selected micrographs depicting microstructure of the specimen taken from the high performance domain of fuel tube C-2, i.e., specimen C-2-E. Figure 22a, and -b are micrographs of the same clad crack. Note that the crack is intergranular and terminates at the surface of a UO_2 particle resulting in an open path between cooling water and fission products. Figure 22c and -d illustrate two more examples of intergranular cracking terminating on the surface of a UO_2 particle. Apparently the void in the stainless steel matrix caused

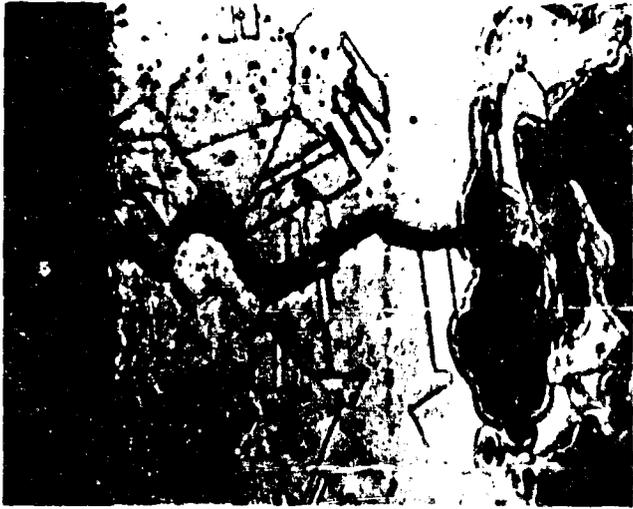
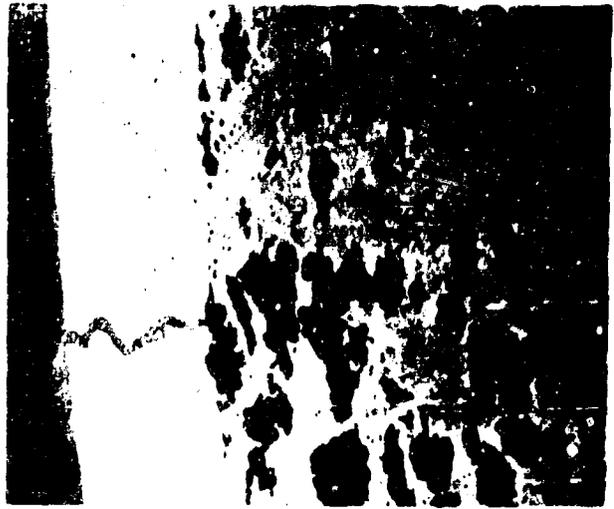
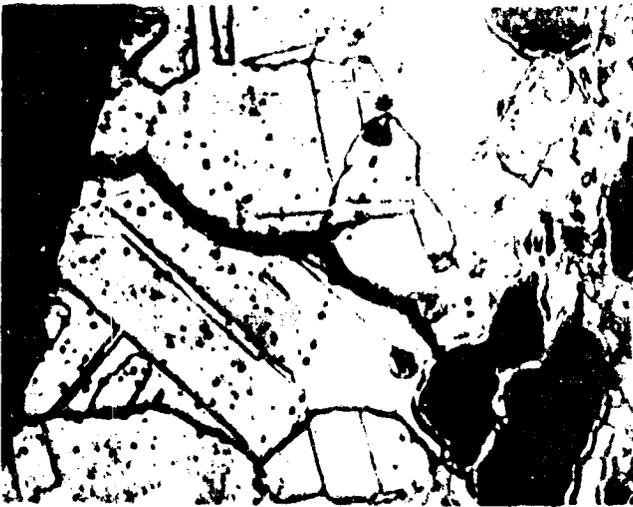
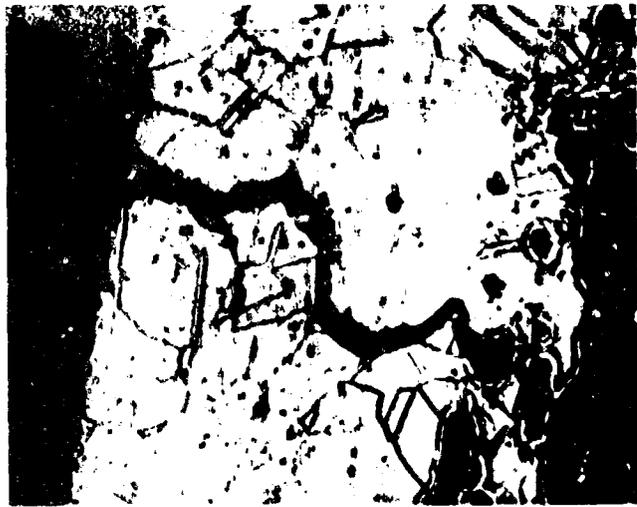
FIGURE 22. SELECTED MICROGRAPHS OF THE MICROSTRUCTURE OF SPECIMEN C-2-E

by the presence of a UO_2 particle acts as a crack arrester. The stress concentration at the crack notch is reduced significantly when the crack notch reaches the surface of a UO_2 particle.

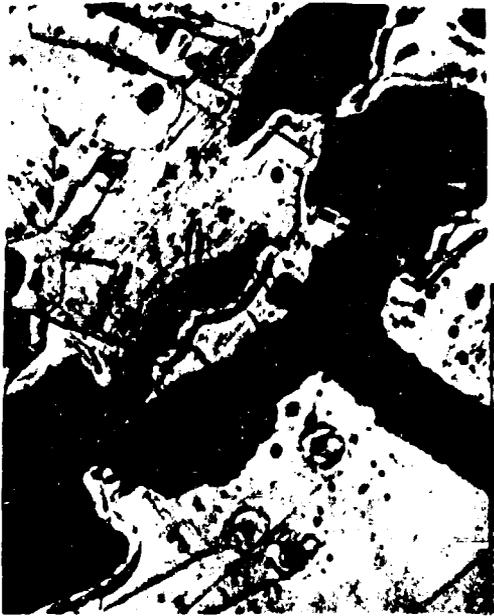
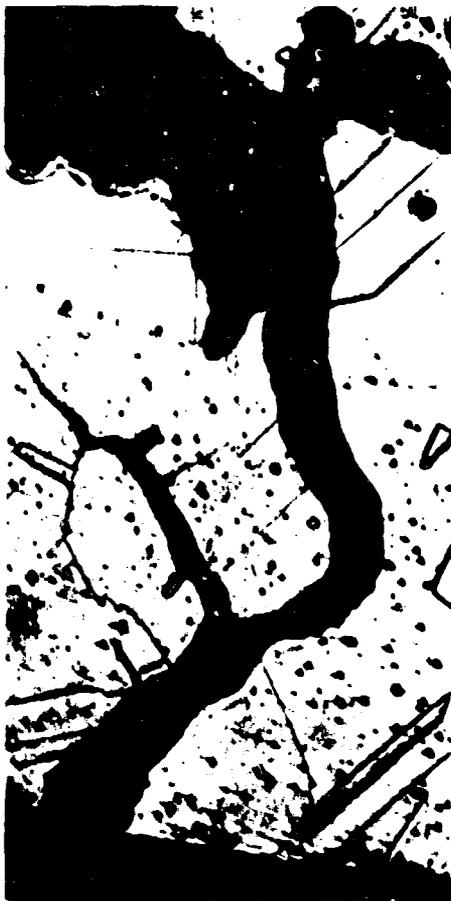
Figure 23 shows two photomicrograph composites depicting two of the many outer clad tube cracks detected in specimen C-2-E. Of special interest here is the fact that some unidentified material appeared to be lodged within the clad cracks, Figure 23a and -b. It appears that the foreign material lodged within the crack was one or both of the following:

1. UO_2 that had extruded, or in some other manner been transported, into the crack, or
2. Products of stainless steel corrosion.

In an attempt to identify the material present in the clad cracks, autoradiographs were taken of metallographic specimen C-2-E to detect the presence of uranium alpha activity in the crack. No evidence of uranium alpha activity in the cracks was detected. The results suggest that the material was not alpha active and hence, is probably a stainless steel corrosion product that formed when the crack surface was exposed to reactor coolant. Furthermore, Figure 23b shows that the foreign material was lodged within a smaller branch crack, the direction of which probably was not susceptible to an influx of material moving out through the trunk crack.

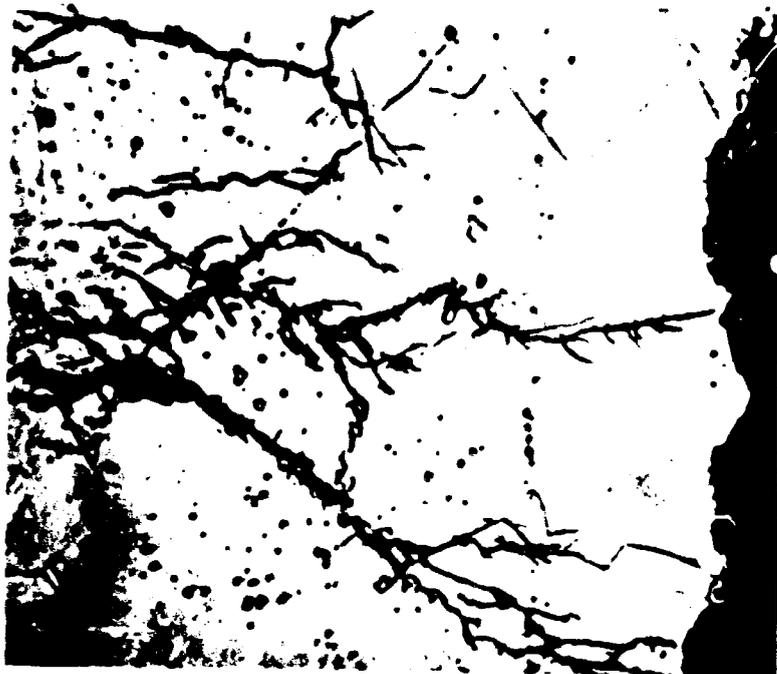
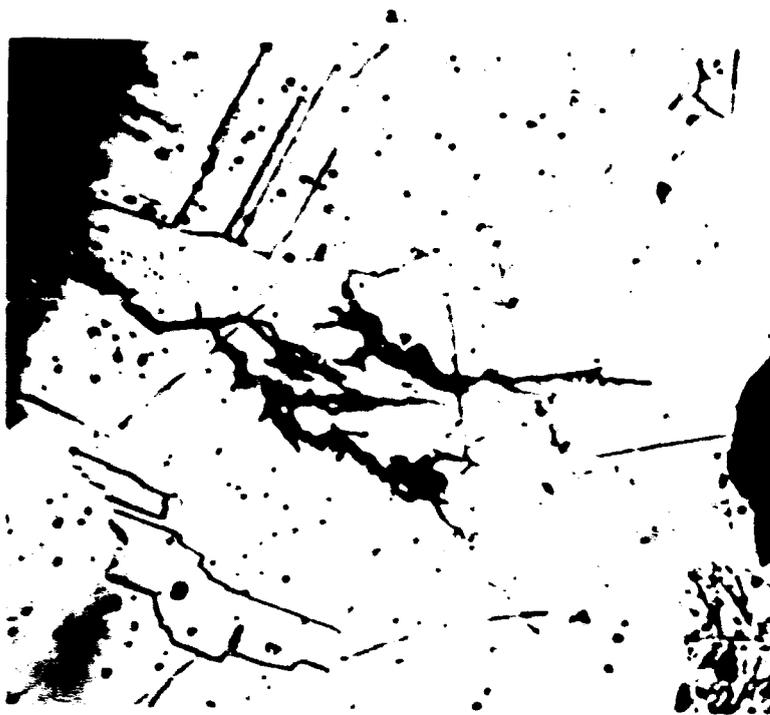
Chloride-Treated Fuel Tube. The cladding of chloride-treated fuel tube 12-139 which was removed from a low-performance region of the core was metallographically examined for cracks. No visual evidence of cracking was observed on fuel tube 12-139 prior to treatment. As shown in Figure 24, transgranular cracks typical of chloride-induced stress-corrosion cracking⁽¹⁰⁾ were found only in the outer cladding. The
