CLAY MOBILITY

PORTUGUESE BEND, CALIFORNIA

PAUL F. KERR and ISABELLA M. DREW

Scientific Report No. 1

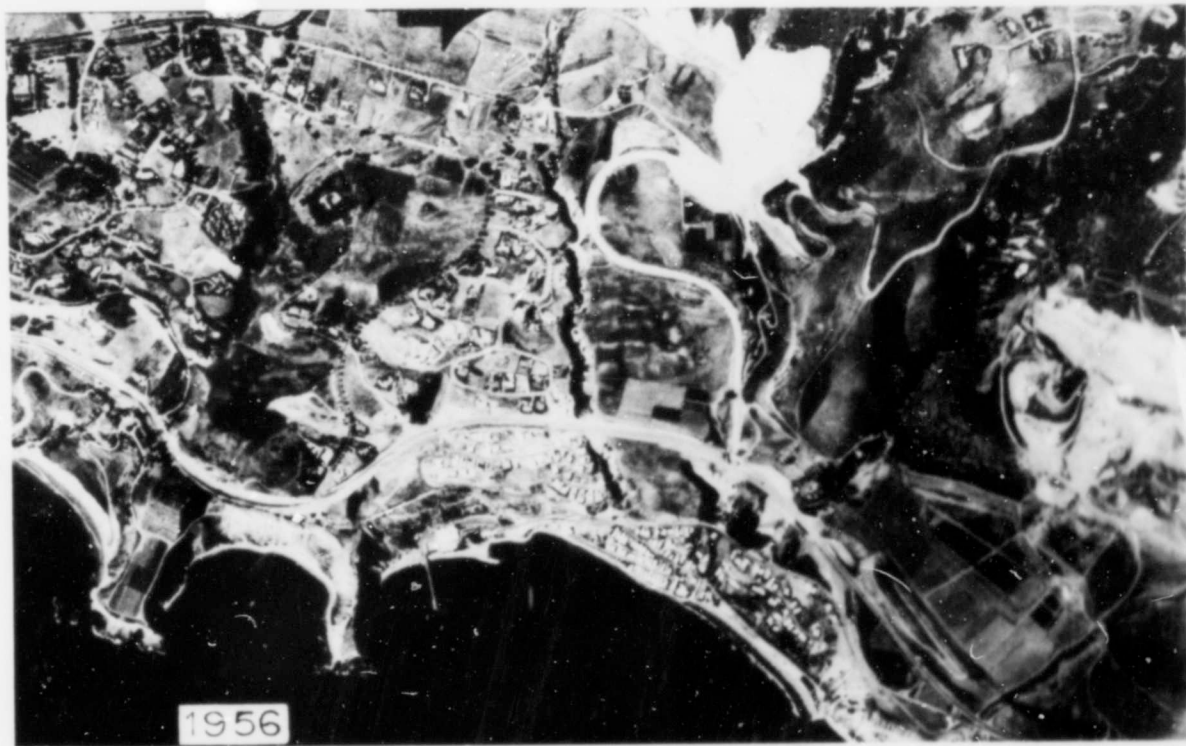
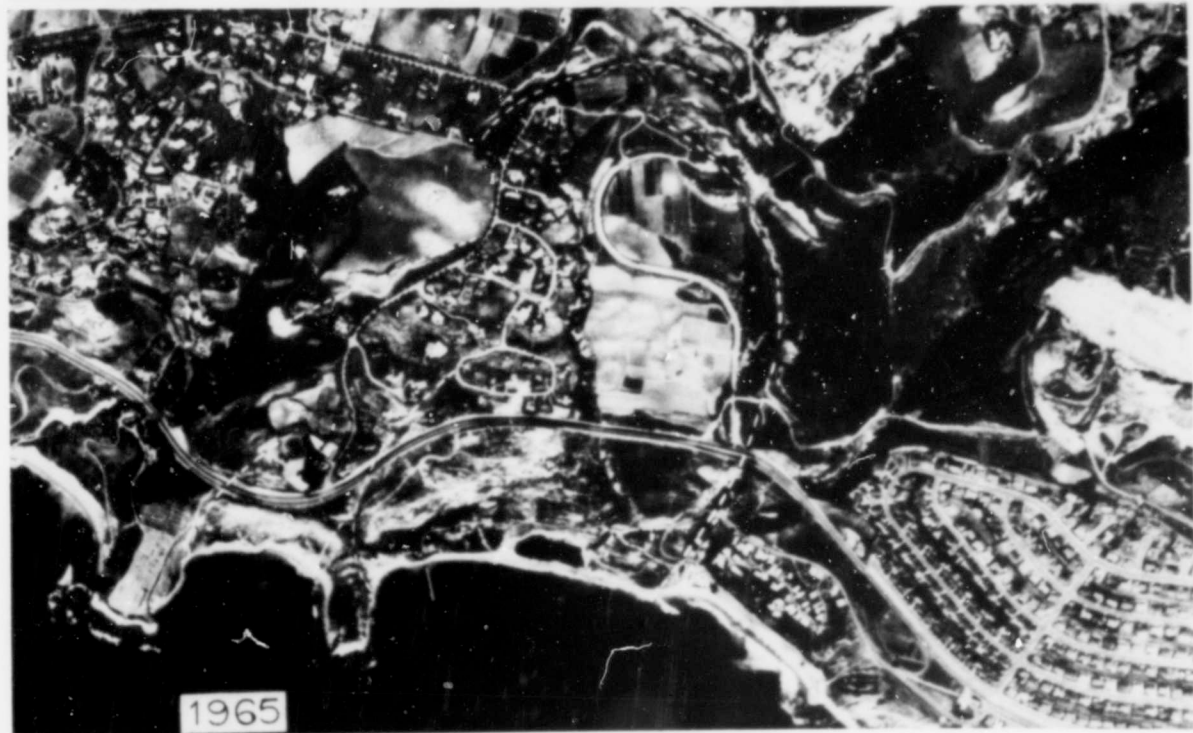
Plate 1

Aerial photographs of the same Portuguese Bend landslide area taken in 1956 and 1965. Note the absence of many houses between the highway and the shore in 1965. Dashed lines indicate approximate slide boundaries (1965).

Beginning in 1956, approximately one-fourth of the previously known landslide area became noticeably active (Pl. 1). Earthflow at the rate of 0.03 to 0.1 feet per day down a mean slope of 6.5° has continued since that time (Fig. 3). The cumulative effect of such slide action may be highly damaging in a residential area, but it is not immediately devastating. Motion differs greatly from such a slide as the 1950 quick clay slide at Surte, Sweden that moved on a slope of about 1° at a rate

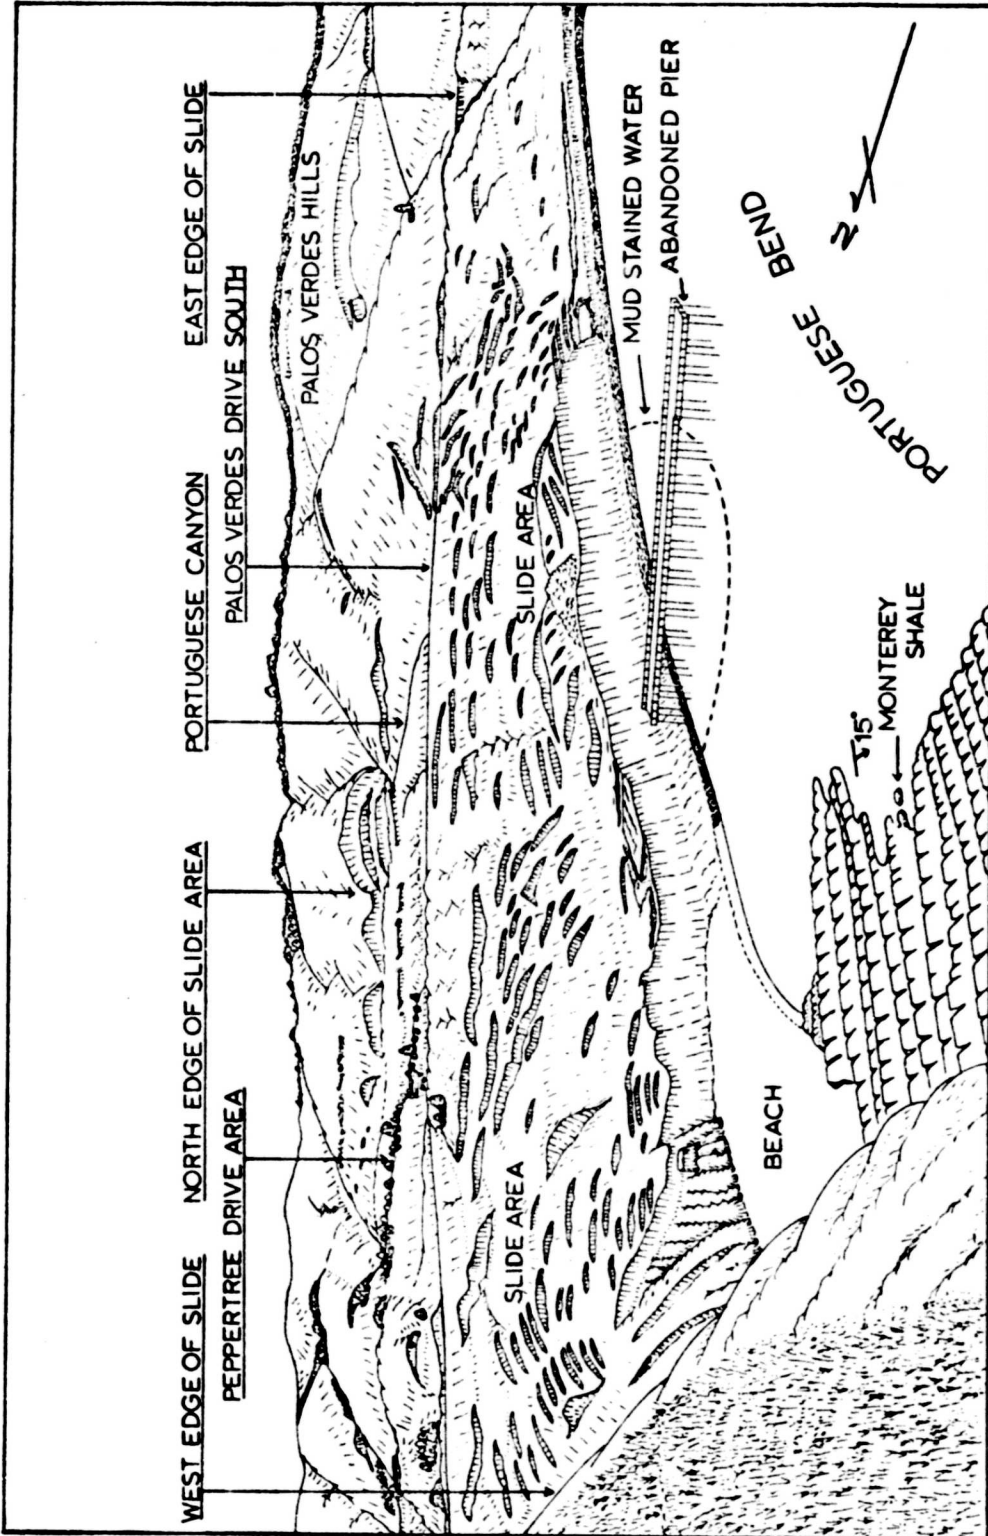
Fig. 2. A sketch of slide topography as observed in 1966.

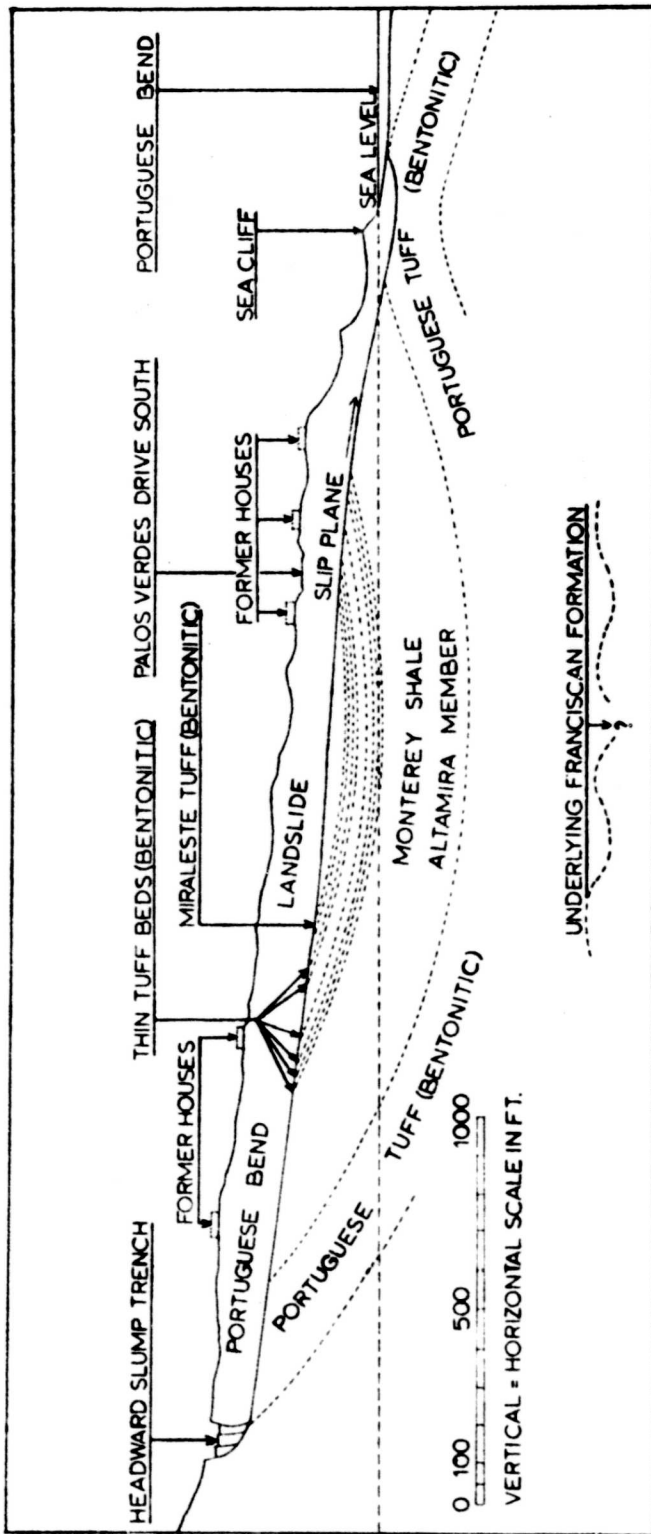
Fig. 3. An approximate structural interpretation of the Portuguese Bend landslide.

A cross section of the Portuguese Bend landslide is shown in Figure 3. It is based on stratigraphic data by Woodring and others (1946, p. 20-21), their geologic map (1946, Pl. 1), subsurface contours of the slip plane, by Stone Geological Associates, and geological observations on several occasions in connection with this study. The structure as projected beneath the slip plane is largely schematic, based on the interpretation by Woodring and others of a structural basin beneath the landslide.

The dip of the slip plane is south, aside from a concave depression beneath the sea-cliff where it extends below sea level and emerges off shore. Mud apparently extruded from the Portuguese Tuff on the ocean's floor stains the water near an abandoned pleasure pier (Pl. 2, Fig.2). No attempt has been made to distinguish the bentonitic from the non-bentonitic portions of the tuff. However, bentonite is restricted to tuff, although much less abundant than the replaced volcanic ejecta. Never-the-less, the accumulation of moist bentonite along the slip plane as indicated by borings is believed to be adequate to provide a lubricated surface for movement as suggested by physical tests.

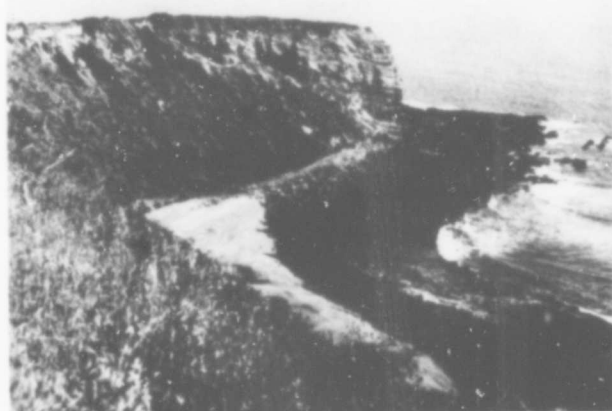
Fig. 1

Fig. 1: The stable cliff of Inspiration Point, looking east. Resistant outcrops of Monterey Shale appear on the sea-cliff and along the seashore. Fig. 2: Slide area south of Inspiration Point. Tilted tennis courts and an abandoned pier appear in the foreground. Fig. 3: Fissure in slide area near Inspiration Point. The fissure is about 20 feet deep. Fig. 4: Pond between parallel fissures at head of Peppertree Lane (August, 1966). Water from fault lines would be expected to increase the mobility of bentonite along buried slip planes.

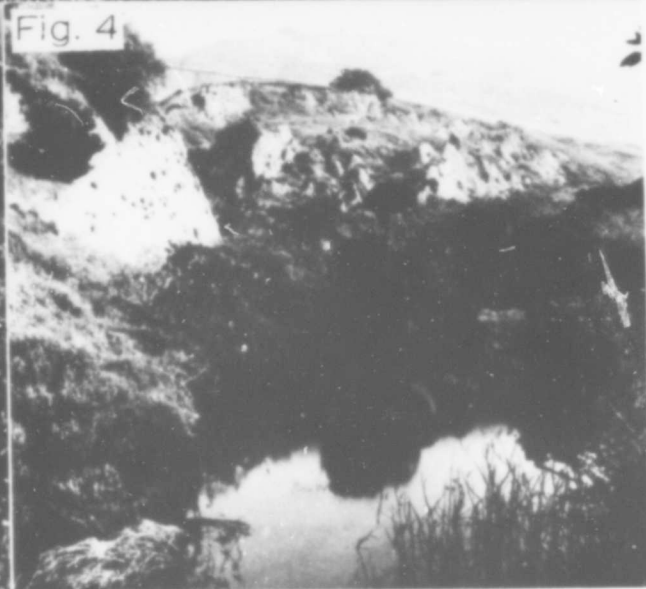
Fig. 4 Pond between parallel fissures at head of Peppertree Lane (August, 1966). Water from fault lines would be expected to increase the mobility of bentonite along buried slip planes.

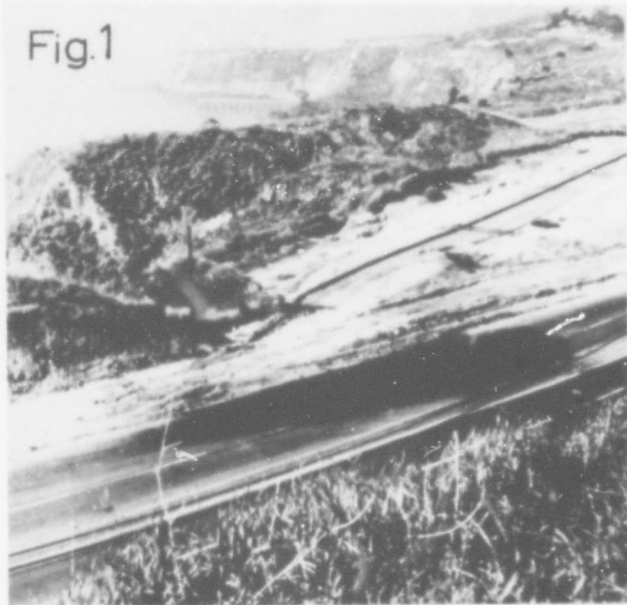
Fig. 1 Recently relocated (Feb. 1967) portion of Palos Verdes Drive South looking southwest at east margin of slide. Note service pipe on surface crossing former highway area.

Fig. 1: Recently relocated (Feb. 1967) portion of Palos Verdes Drive South looking southwest at east margin of slide. Note service pipe on surface crossing former highway area. Fig. 2: Marine terrace tilted inland by slide rotation. Looking west along Palos Verdes Drive South at east margin of slide area. Fig. 3: Looking north across carnation nursery in area depressed by slide action. Fig. 4: Looking north at the scarp along the east margin of slide area north of Palos Verdes Drive South.

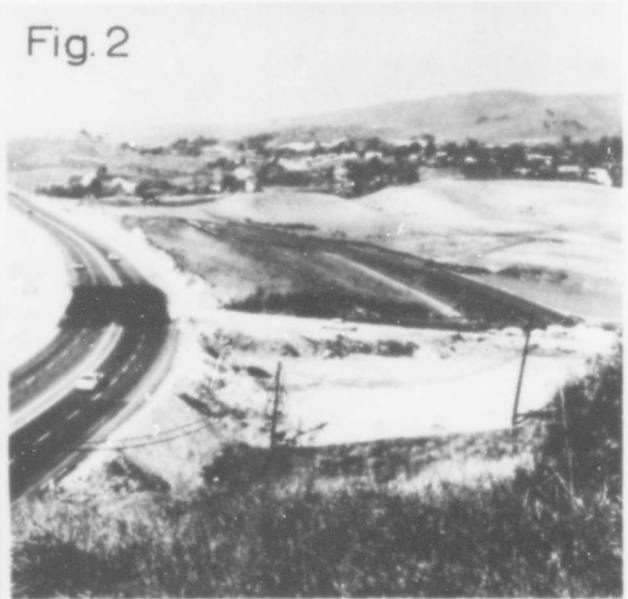
Fig. 2 Marine terrace tilted inland by slide rotation. Looking west along Palos Verdes Drive South at east margin of slide area.

Present movement south of Palos Verdes Drive (Pl. 3, Fig. 3) consists of slow earth movement in which crushed debris and bentonite undergo plastic flow. North of the drive, larger blocks may move fairly intact (Pl. 3, Fig. 2), but are shifted relative to one another and in places exhibit marginal fissures. At the head of the slide, block rotation may be observed (Pl. 2, Fig. 2). A cyclic variation in slide movement can be correlated to precipitation with a lag of several months between rainfall and slippage (Merriam, 1960).

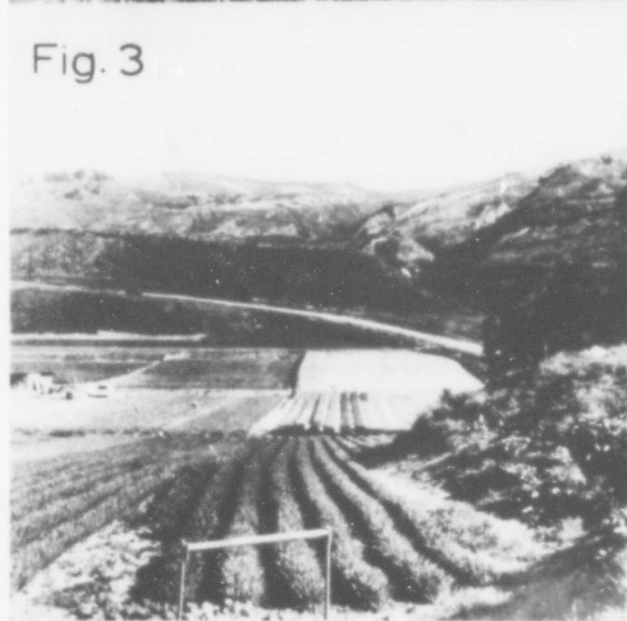
Fig. 3 Looking north across carnation nursery in area depressed by slide action.

The depressed nursery area clearly represents considerable subsidence and the cause of the sinking is of interest. In the absence of sink hole development, it seems likely that bentonitic extrusion along the slide slip plane 50-150 feet below the surface may account for the subsidence. Extrusion of plastic clay along the seashore (Fig. 3) below sea level if long continued might account for volume changes adequate to cause the depression.
