X353-5B PROPULSION SYSTEM FLIGHTWORTHINESS TEST REPORT

LIFT FAN FLIGHT RESEARCH AIRCRAFT PROGRAM

CONTRACT DA 44-177-TC-715

GENERAL ELECTRIC COMPANY

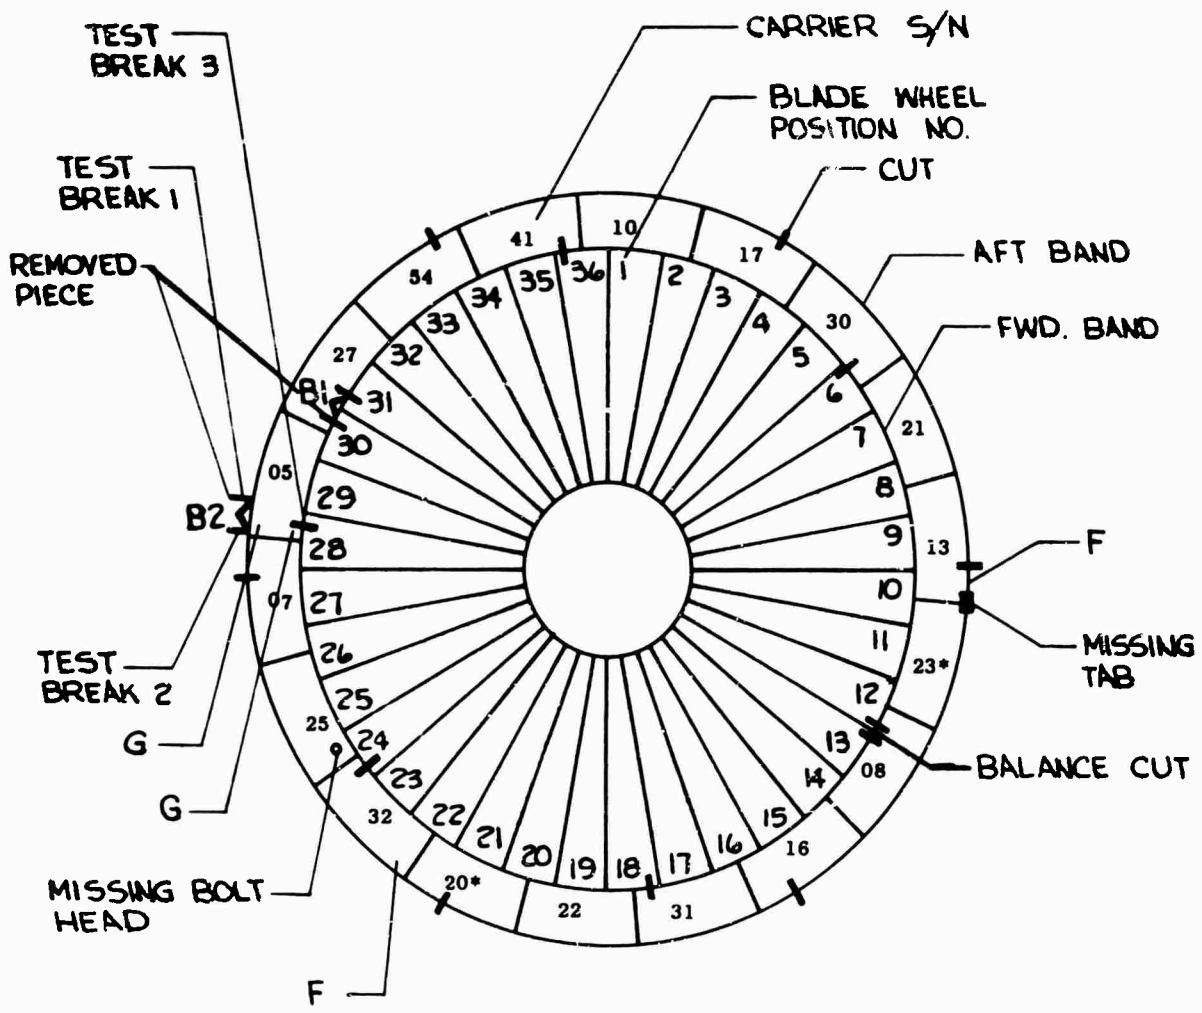
Figure I-66. Lift Fan Rotor Configuration and Test Incident Schematic

There were only minor discrepancies found in the diverter valve and pitch fan hardware at disassembly. The lift fan had considerable damage resulting from the shedding of a small metal tab from the rotor during the last endurance cycle of the test. Lift fan aluminum inlet vanes and exit louvers were of generally poor manufacturing quality and did not satisfactorily complete the test.

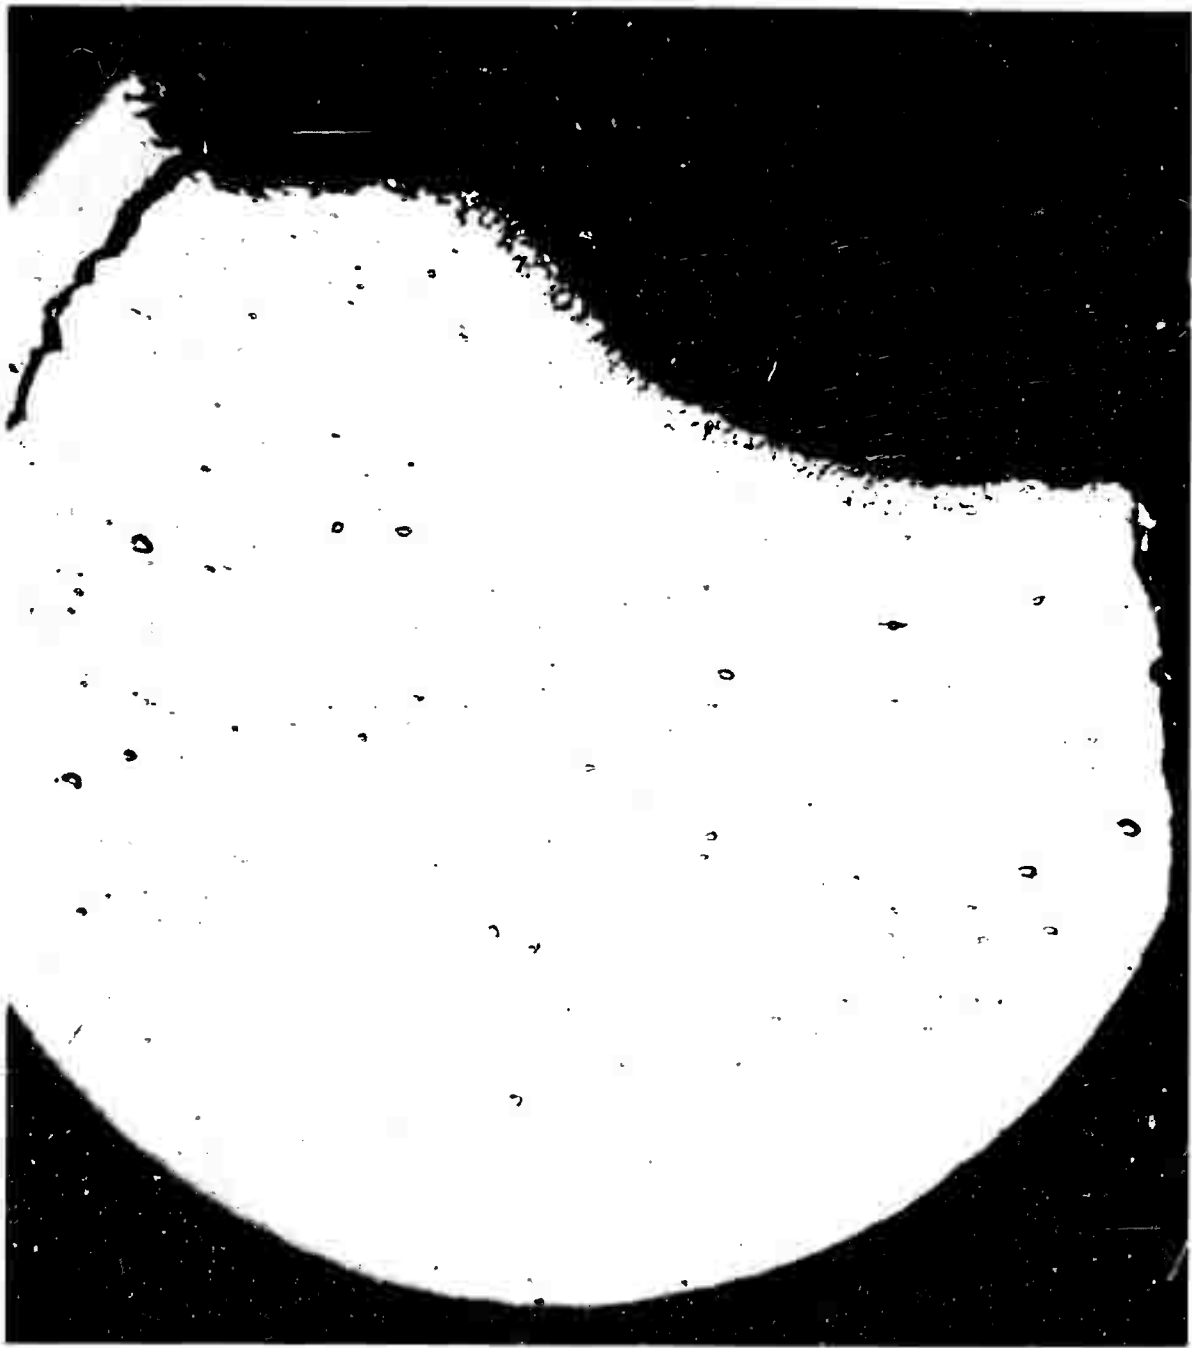
The microscopic examination of the bolts was performed on a plane taken through the longitudinal center axis of the threaded stem. The plane was located to pass through the fatigue failure side of the bolt. This examination shows the primary cause of failure to be excessive intergranular attack (IGA) at the head to threaded stem radius. The IGA was measured at 0.001" to 0.0015" deep. The IGA promoted premature fatigue failure. The fatigue crack propagated to a point where the reduced area could no longer support the load and the rest of the fracture is typical of tensile failures.

The surface condition appearance in the radius under 250X magnification is normal and is not considered a notched condition. Note the secondary crack in Figure I-68.

Figure I-68 250X Microscopic Examination of One Failed Bolt
at the Head to Stem Radius. (Sectioned)

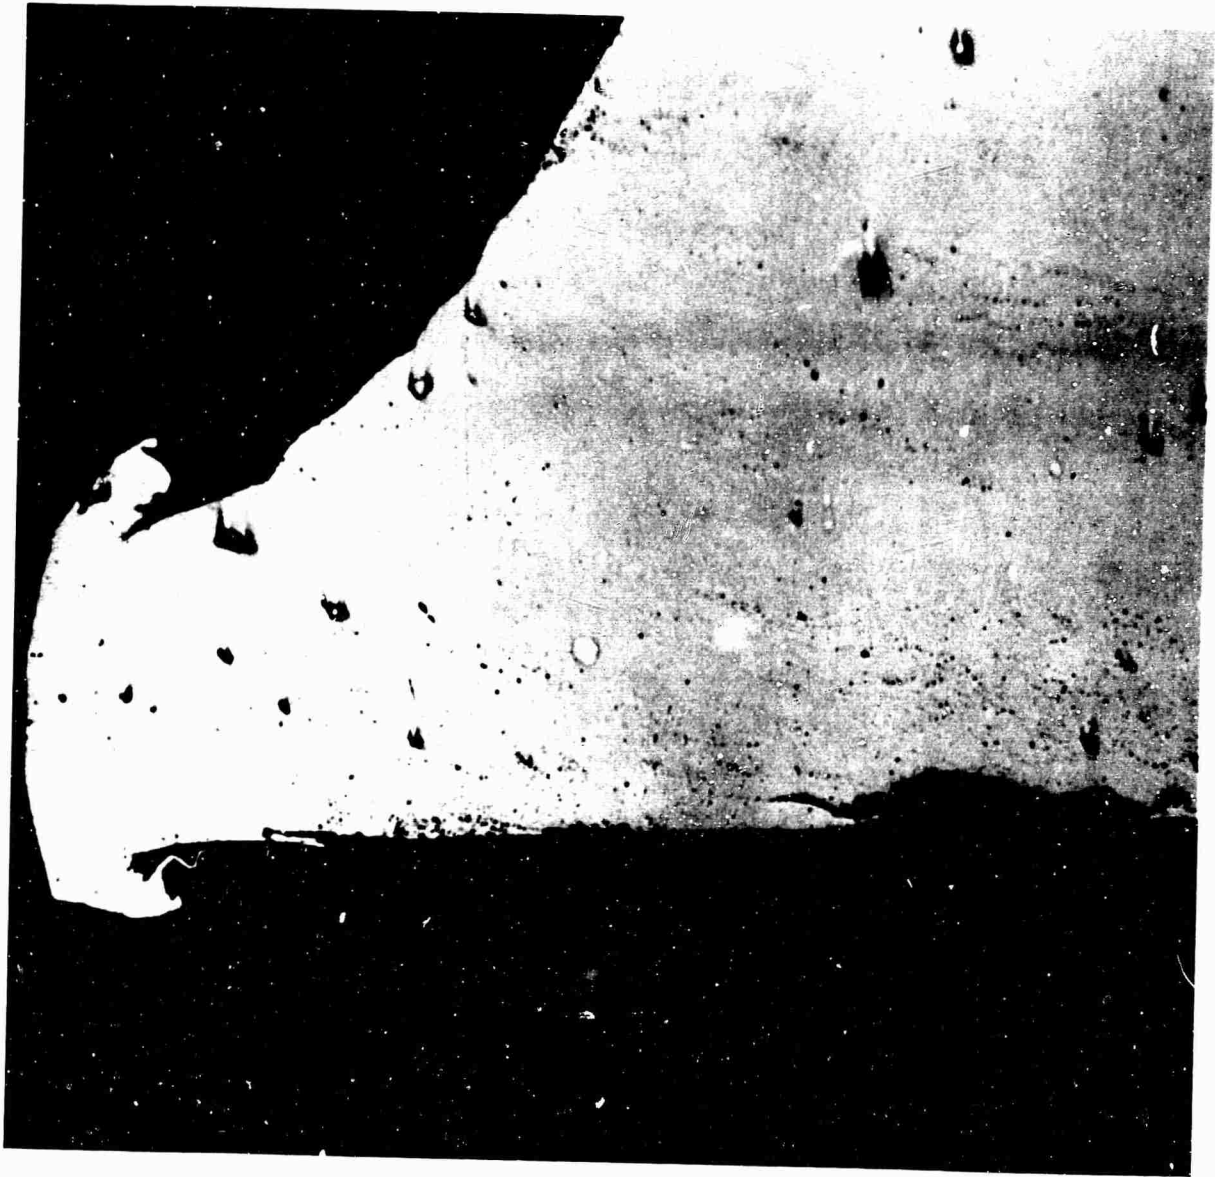
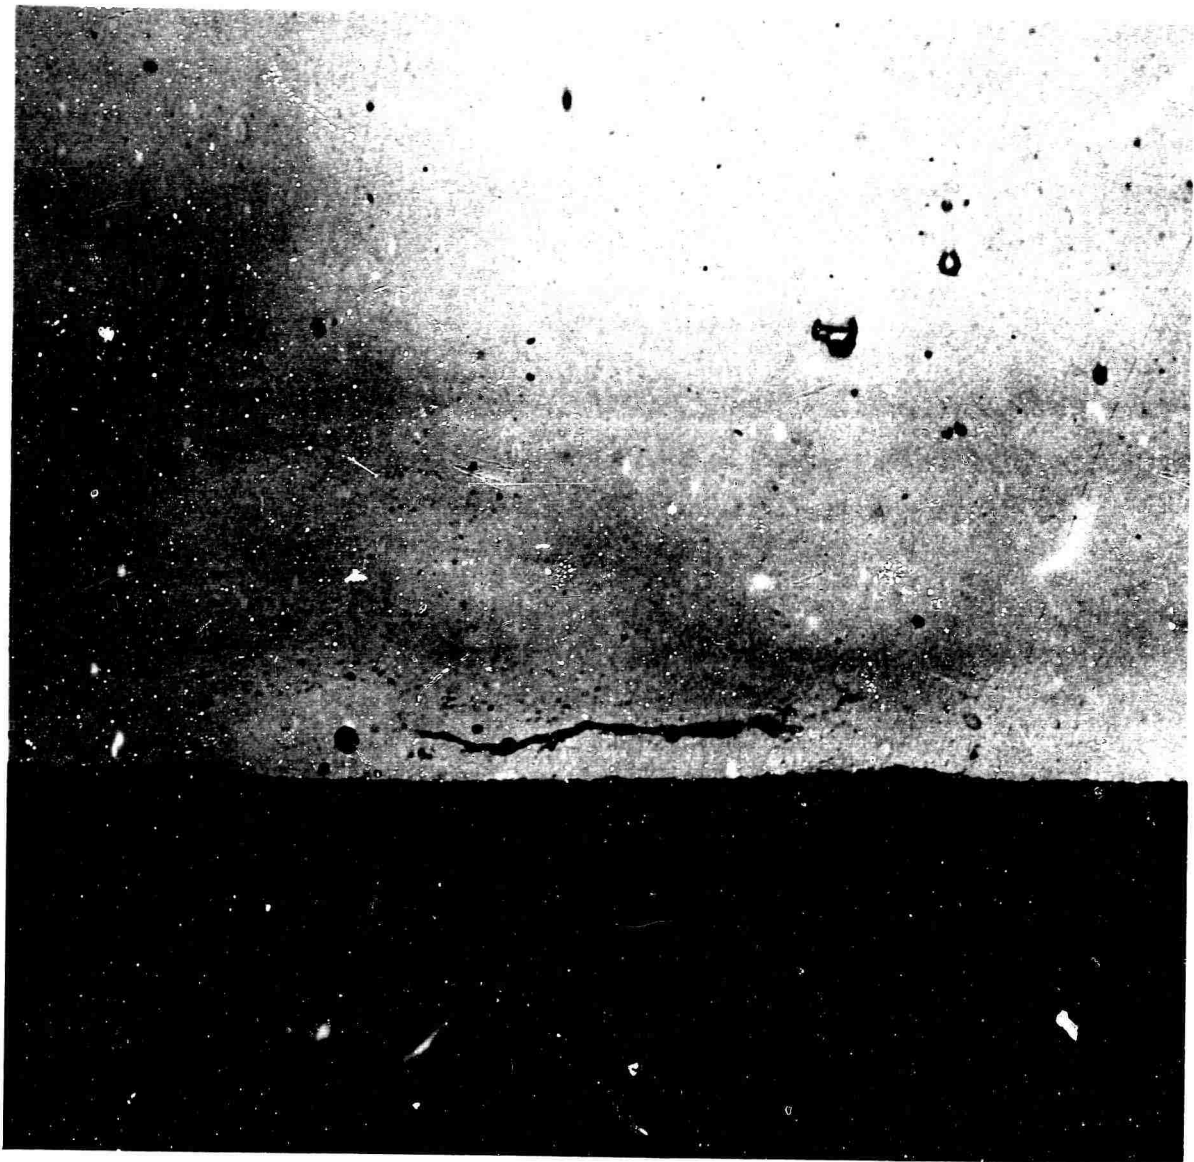
Non-metallic inclusions are known to be stress risers and contribute to a reduction in fatigue strength. Similarly fretting is known to play a strong role in the reduction of a material fatigue strength. Since some areas were observed to have more or as much fretting damage as the failure area and did not crack it is reasoned that the fretting combined with the non-metallic inclusions caused the failure in the band.

If the fretting exposes a non-metallic inclusion to the surface the combined effect is much more severe than the inclusion or fretting alone.

Figure I-71 A, B, C, D, E, and F. 500X Microscopic Examination of Torque Band Failure (Test Break No. 3) - Progressive Views Across the Failure

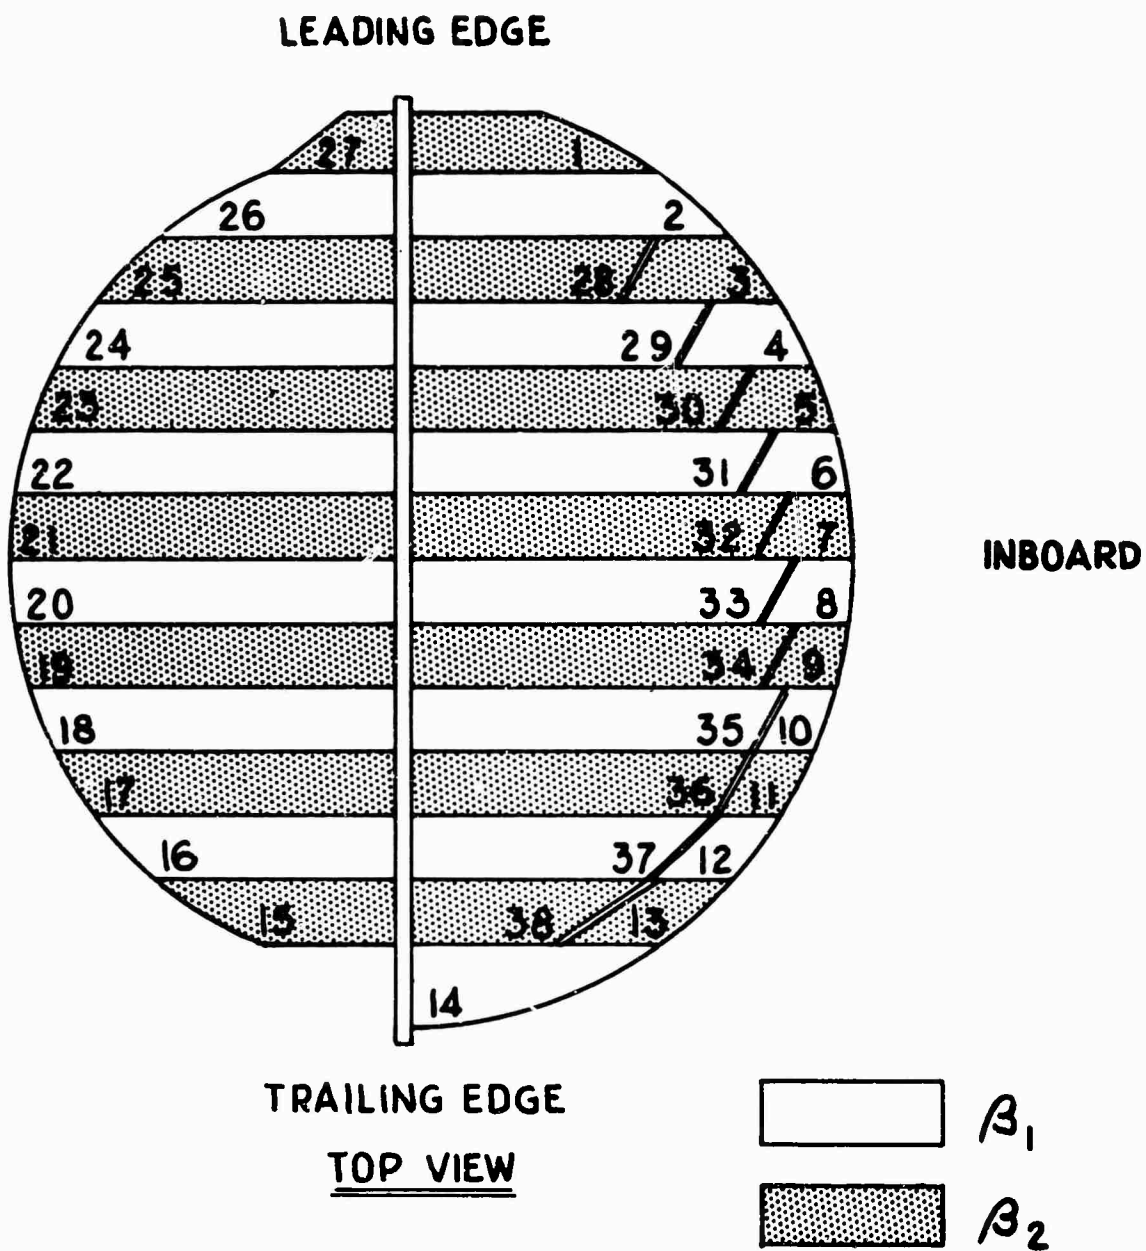
Figure I-74. Lift Fan Exit Louver Arrangement (Left Fan)

1. All Inconel X louvers completed the FWT without test fault.
2. Ten of 22 aluminum louvers completed the FWT without test fault.
3. Over 80% of the repairs were required to louvers on the inactive arc half of the fan.
4. Four louvers required replacements.
5. The frequency of repair incidents was one every 4.17 hours.
6. The average time between repairs for a given louver was 17.57 hours.
