# UNITED STATES ARMY HELICOPTER ACCIDENTS INVOLVING FIRE

By  
Emil Spezia

Report No. 1-64

UNITED STATES ARMY BOARD FOR  
AVIATION ACCIDENT RESEARCH  
Fort Rucker, Alabama

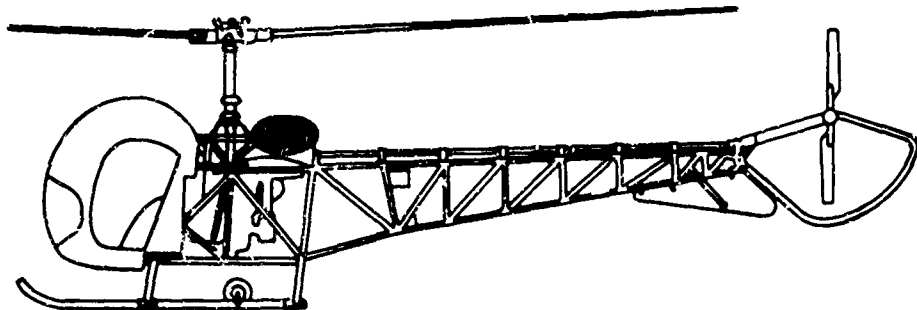
FIGURE 1

OH-13 models D and E single fuel cell

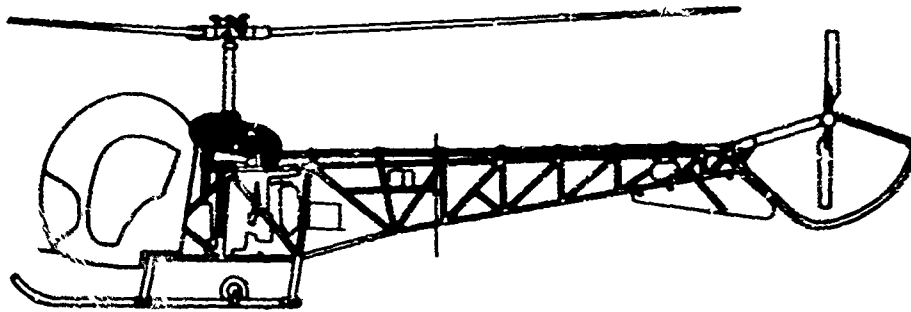
FIGURE 2  
OH-13 models G and H twin fuel cells

The susceptibility of fuel cells to rupture when located in a position similar to those of the OH-13G and H series is reflected in this statement: "The main rotor blades struck the ground six times and stopped revolving. The impact of the main rotor blades caused the aircraft to roll to its left and strike the ground with the left gasoline tank, then bounce and come to rest on its right side. As it came to rest, the fuel tank and lines were ruptured allowing fuel to contact the hot engine. . . "7

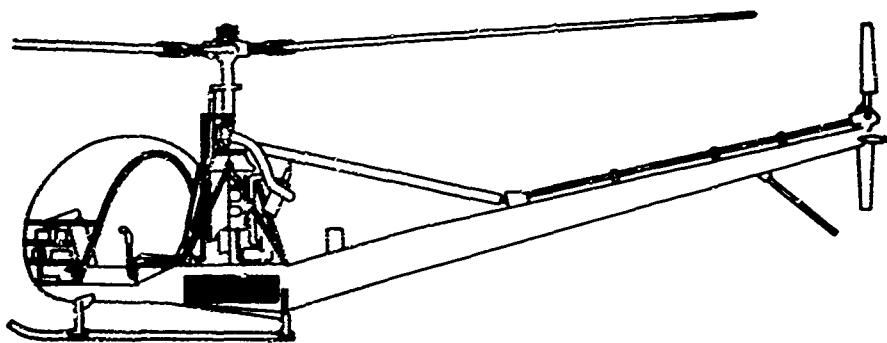
FIGURE 3

OH-23 single bladder-type fuel cell

type fuel cells, shielded by the cockpit floor and outer skin, is near ideal (Figure 3). The type of flying done by the OH-23 and the type of accidents it is involved in indicates that the OH-23 fuel cell installation has proven to be highly crash resistant (Table 5).

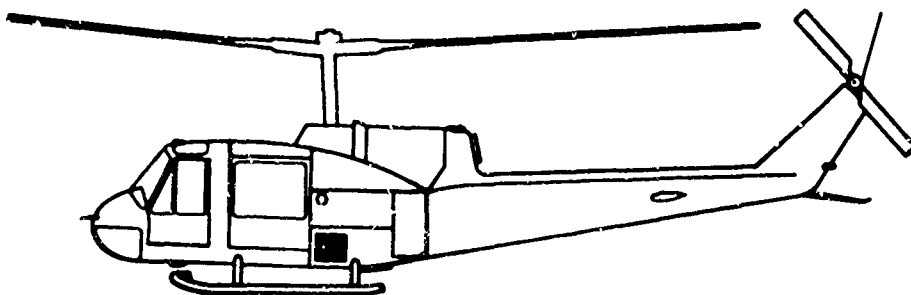
FIGURE 4

The UH-1 bladder-type cells located aft and outboard of the cockpit with most of the cells above the cockpit floor provide added protection (Figure 4). The lower portion of the cells are extra strength self-sealing, while a layer of energy-absorbing honeycomb surrounds the lower portion of cells adjacent to the skin. As a result, statements taken from a UH-1D, FY 1964, accident report read: "Sharp object (tree trunk) penetrated the fuselage bottom under the left forward fuel cell and crushed the protective honeycomb layer without affecting fuel cell integrity."<sup>2</sup>

UH-1 bladder-type fuel cells aft and outboard of the cockpit

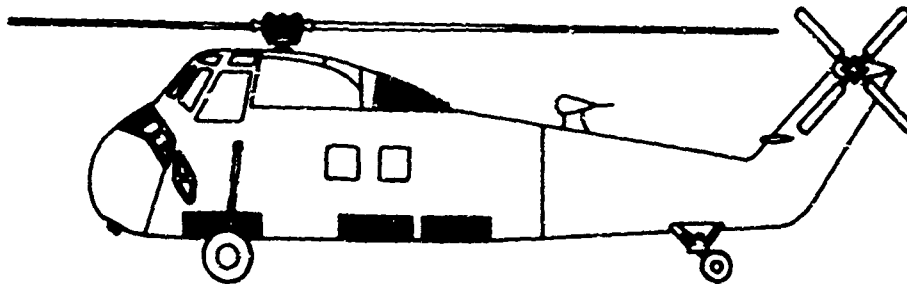
FIGURE 5

CH-34 with three fuel cells in the belly of the helicopter

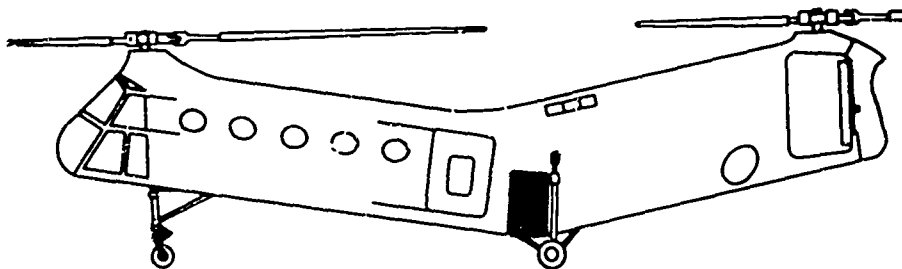
FIGURE 6

Fire erupting due to the landing gear penetrating the fuselage and puncturing the fuel cells is not an unusual experience for the CH-21 and UH-19. Figures 6 and 7, respectively, show the relative location of the fuel cells and landing gear in these aircraft.

CH-21 fuel cell location in relation to landing gear

The fire hazard in this type of installation is evident in the following statement: "The aircraft (CH-21) contacted the ground with an excessive rate of descent resulting in a hard touchdown which caused both main gear struts to detach at the upper end and the fuel cells to rupture. The aircraft immediately burst into flames."<sup>8</sup> Fire in the two CH-21 roll-over type accidents listed in Table 5 are also the result of gear punctured fuel cells.

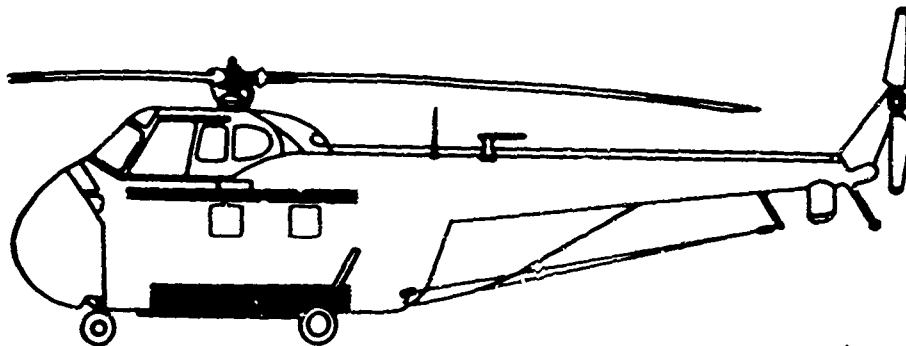
FIGURE 7

UH-19 fuel cell location in relation to landing gear

The UH-19 and CH-34 experience, as the following statement from a UH-19 report illustrates, are quite similar. In addition, the fire origin is pinpointed—a fact seldom determined. "The left main gear was forced upward by the impact and punctured the left side of the aft tank. Subsequent pitching motion caused fuel from the punctured tank to splash forward making contact with either the engine exhaust or the engine itself, causing the fire."<sup>9</sup>
