**Final Report of the
Pre- and Postshot
Structural Survey**

FINAL REPORT OF THE
PRE- AND PCSTSHOT STRUCTURAL SURVEY
PROJECT DRIBBLE
SALMON EVENT

UNITED STATES ATOMIC ENERGY COMMISSION
NEVADA OPERATIONS OFFICE

Prepared By
HOLMES & NARVER, INC.
ON-CONTINENT TEST DIVISION
Las Vegas, Nevada

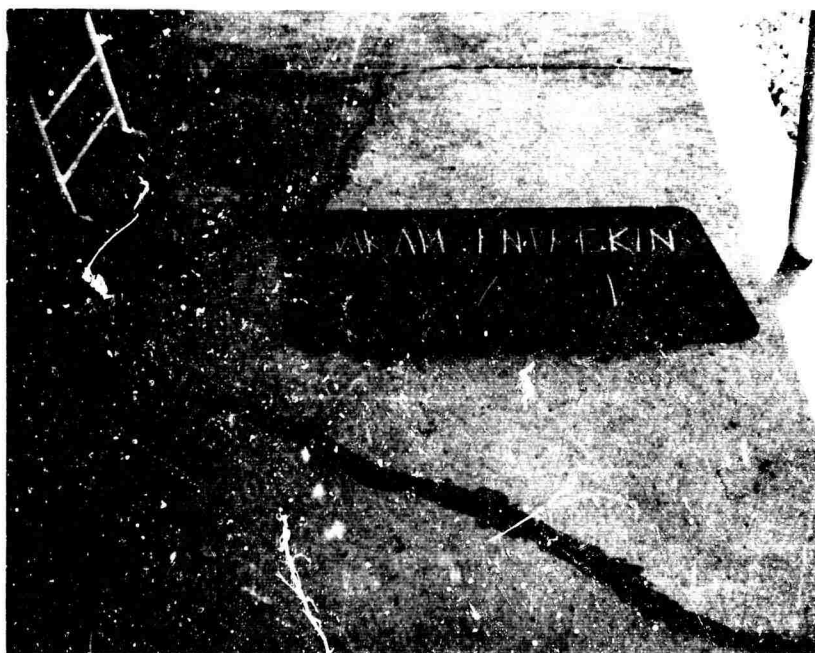
Photo No. 2 - Pre-Shot Front Porch Slab - H&N No. 73

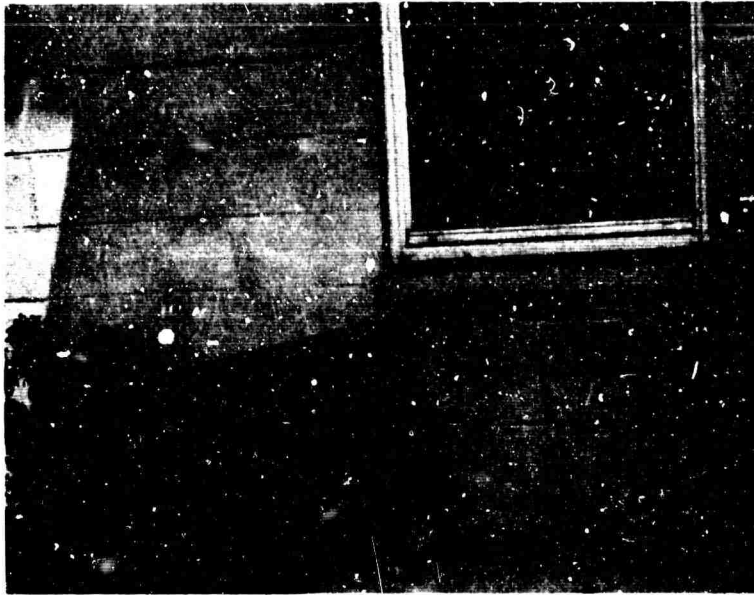
Photo No. 3 - Pre-Shot Cracks, H&N No. 73

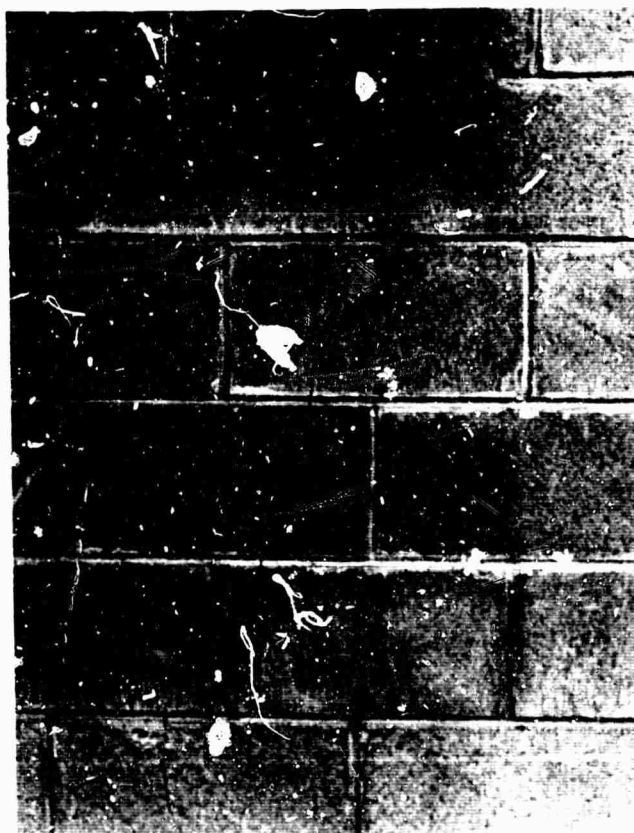
Photo No. 8 - Pre-Shot Shrinkage Cracks, H&N No. 83

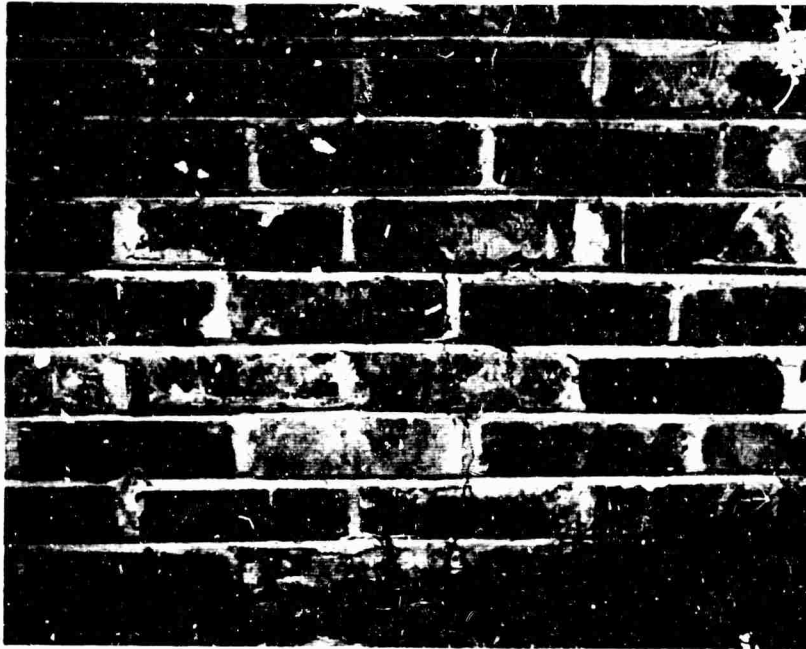
Photo No. 11 - Pre-Shot Cracks, H&N No. 190

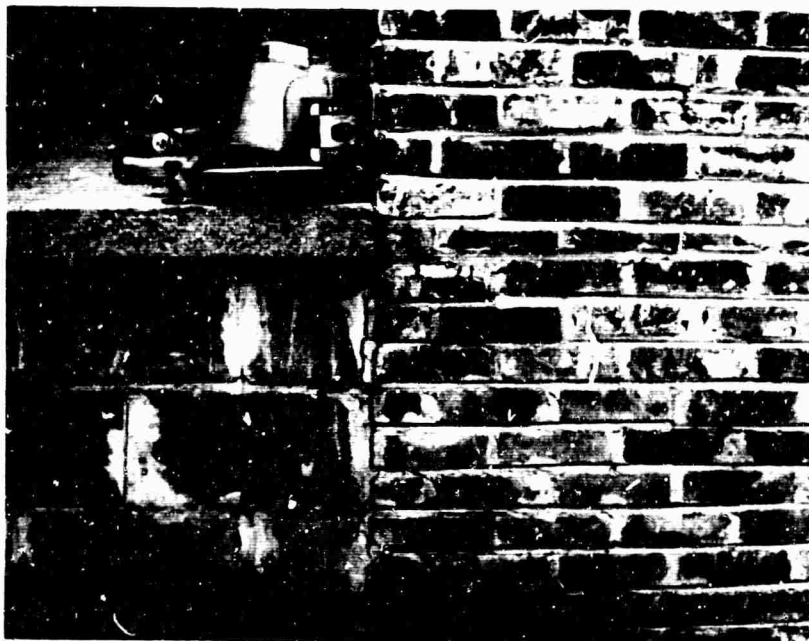
Photo No. 12 - Pre-Shot Cracks, H&N No. 190

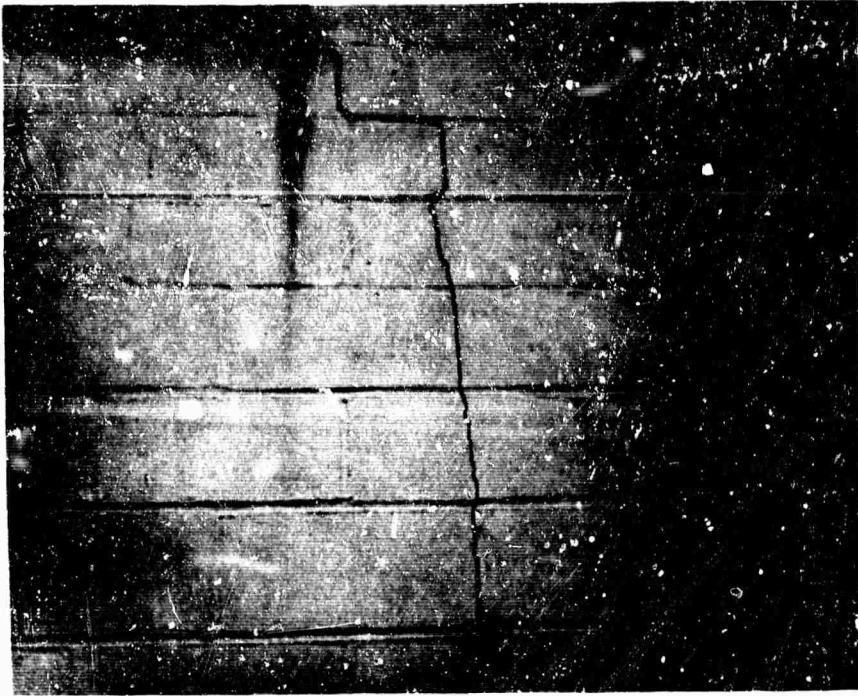
A group of concrete block structures, the Baxterville School (H&N 116), were surveyed 6,950 meters from SZ. The ground motion was predicted to be 4 cm/sec. A large number of cracks were documented in the pre-shot survey (photos no. 19 to 22). The postshot survey indicated only possible minor aggravation. The engineer's report states, "It is remotely possible that some of the hairline cracks in the masonry have been aggravated". Photo no. 23 is a postshot picture of the crack illustrated in photo no. 22 taken immediately after the event. To determine the increase in the cracks with time, photo no. 24 was also taken of the same crack ten months after the event. It is apparent that there was only a small increase in the size of the crack.

Photo No. 23 - Postshot of H&N No. 116 - Immediately After Event

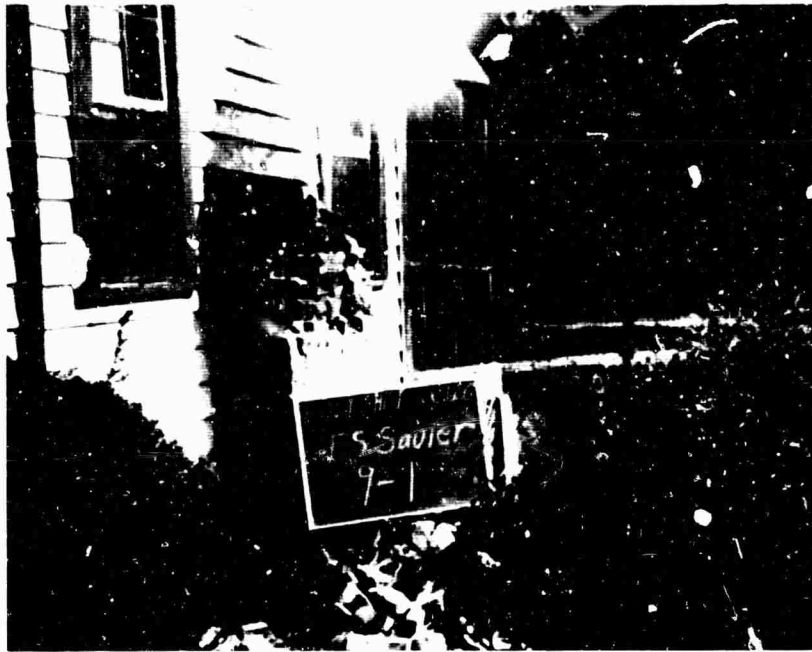
Photo No. 31 - Postshot of H&N 9 - After Removal of Bracing

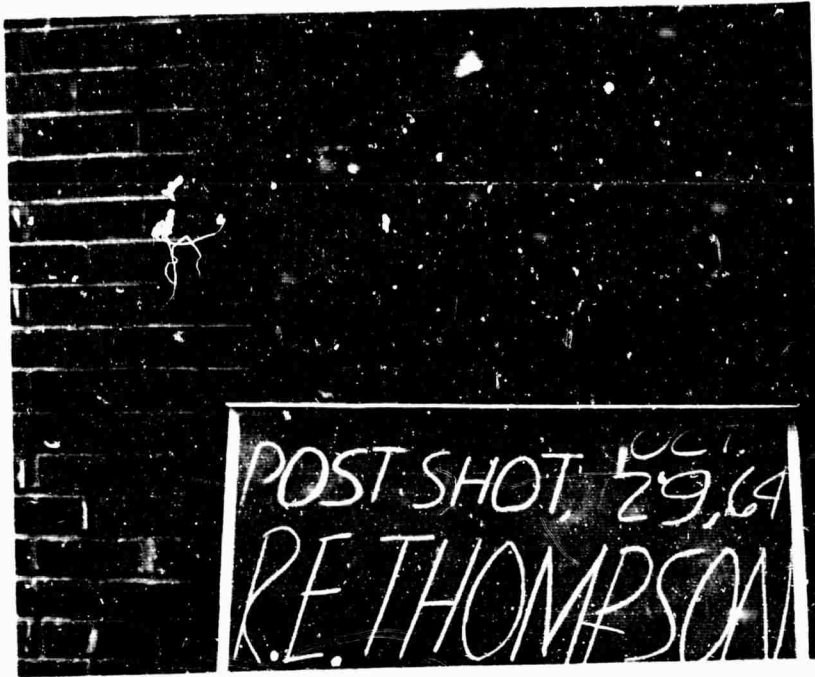
Photo No. 32 - Postshot Cracking in H&N No. 66 Chimney

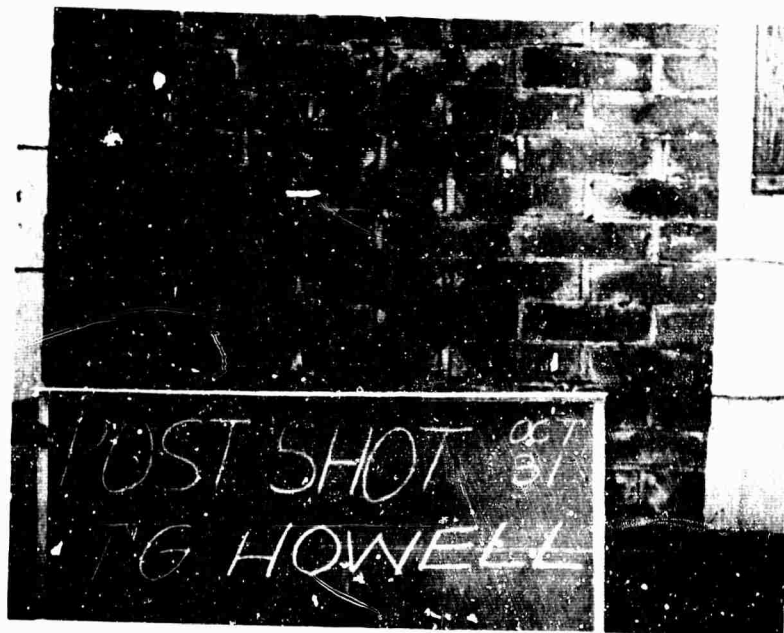
Photo No. 36 - Postshot Cracks in H&N No. 256 Chimney

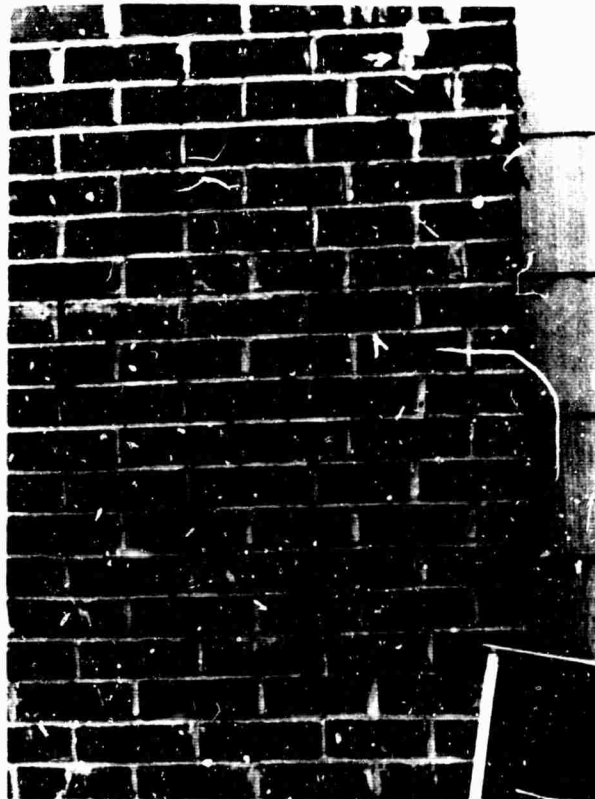
Photo No. 44 - Postshot Cracks in H&N No. 228 - Chimney

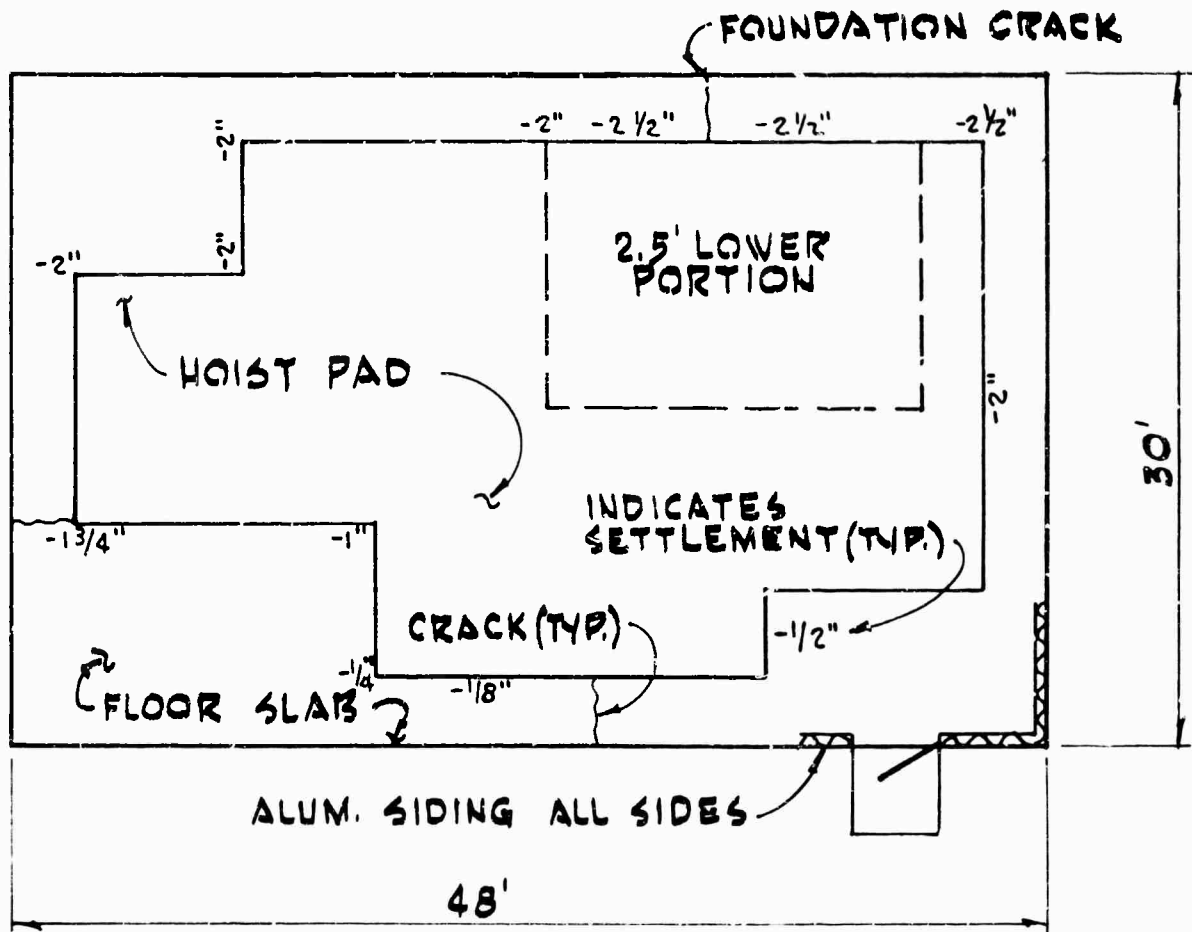
POSTSHOT CRACKS IN HOIST HOUSE
NO 1 SLAB

Hoists were housed in two structures on the Dribble Site. The hoist houses were prefabricated structures with aluminum siding and a continuous concrete floor slab around a large hoist pad foundation (photos no. 68 and 69). Both were located approximately 565 meters from SZ where the predicted peak ground motion velocity was 120 cm/sec. After the event, cracks were evident in the floor slabs of both structures; and approximately 1 cm of settlement of the floor slabs was also indicated after the event, however, no cracks appeared in the hoist foundation pads (sketches no. 6 and 7).

NOTE: THERE ARE VARIOUS MISC. CRACKS
IN THE FLOOR IMPOSSIBLE TO TRACE
BECAUSE BUILDING IS FILLED WITH
BOXES AND CARTONS.
