NRL Memorandum Report 1913

Failure Analysis of Lift Pad Studs for the Recovery of Objects from the Ocean

H. L. SMITH AND J. A. KIES

August 1968

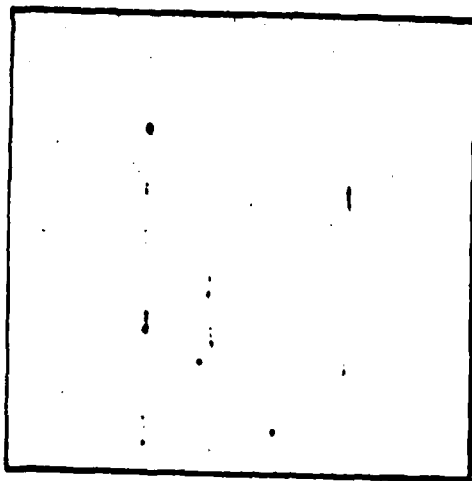
B. Area in the body of the steel stud showing typical stringers of inclusions extending in the same direction as the corrosion pits.

CORROSION PITTING AND STRINGER INCLUSIONS
Unetched, X100
