USAAVLABS TECHNICAL REPORT 68-30

INSPECTION, REPAIRS AND MODIFICATIONS, AND FLIGHT TEST OF THE FLEXIBLE-WING MANNED TEST VEHICLE XV-8A

JUNE 1968

CONTRACT DA 44-¹⁷⁷~~44~~-AMC-402(T)
RYAN AERONAUTICAL COMPANY
SAN DIEGO, CALIFORNIA

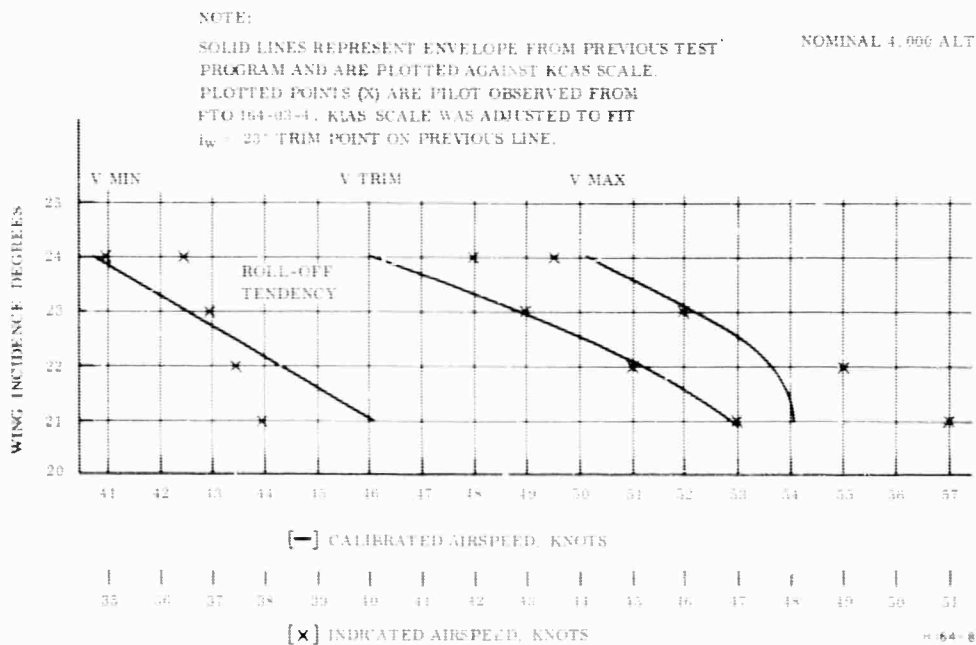
Figure 10. Flight Envelope for 2300 Pounds Gross Weight and Mid-C.G.

Flight Envelope. Data were obtained on the mid c.g., design gross weight flight envelope in FTO 164-03-4. Figure 10 shows the pilot-observed points in comparison with the trim and limit speed lines obtained in the previous test program. The airspeed scales were adjusted as indicated on the plot. Minimum speeds were obtained with near-full-aft stick (not on aft stop) and above a speed with any roll-off tendency. Control forces were noted to be heavy in the aft stick position. Maximum speeds were limited by full forward stick under the aileron oscillation limit. On one previous flight, an aileron oscillation had been triggered at 52 to 52.5 KIAS by a wind gust.
