NRL Memorandum Report 1950

Analysis of the Failure of the AUTEC TOTO II Deep Sea Moor and the Performance of its Cathodic Protection System

R. E. GROOVER

November 1968

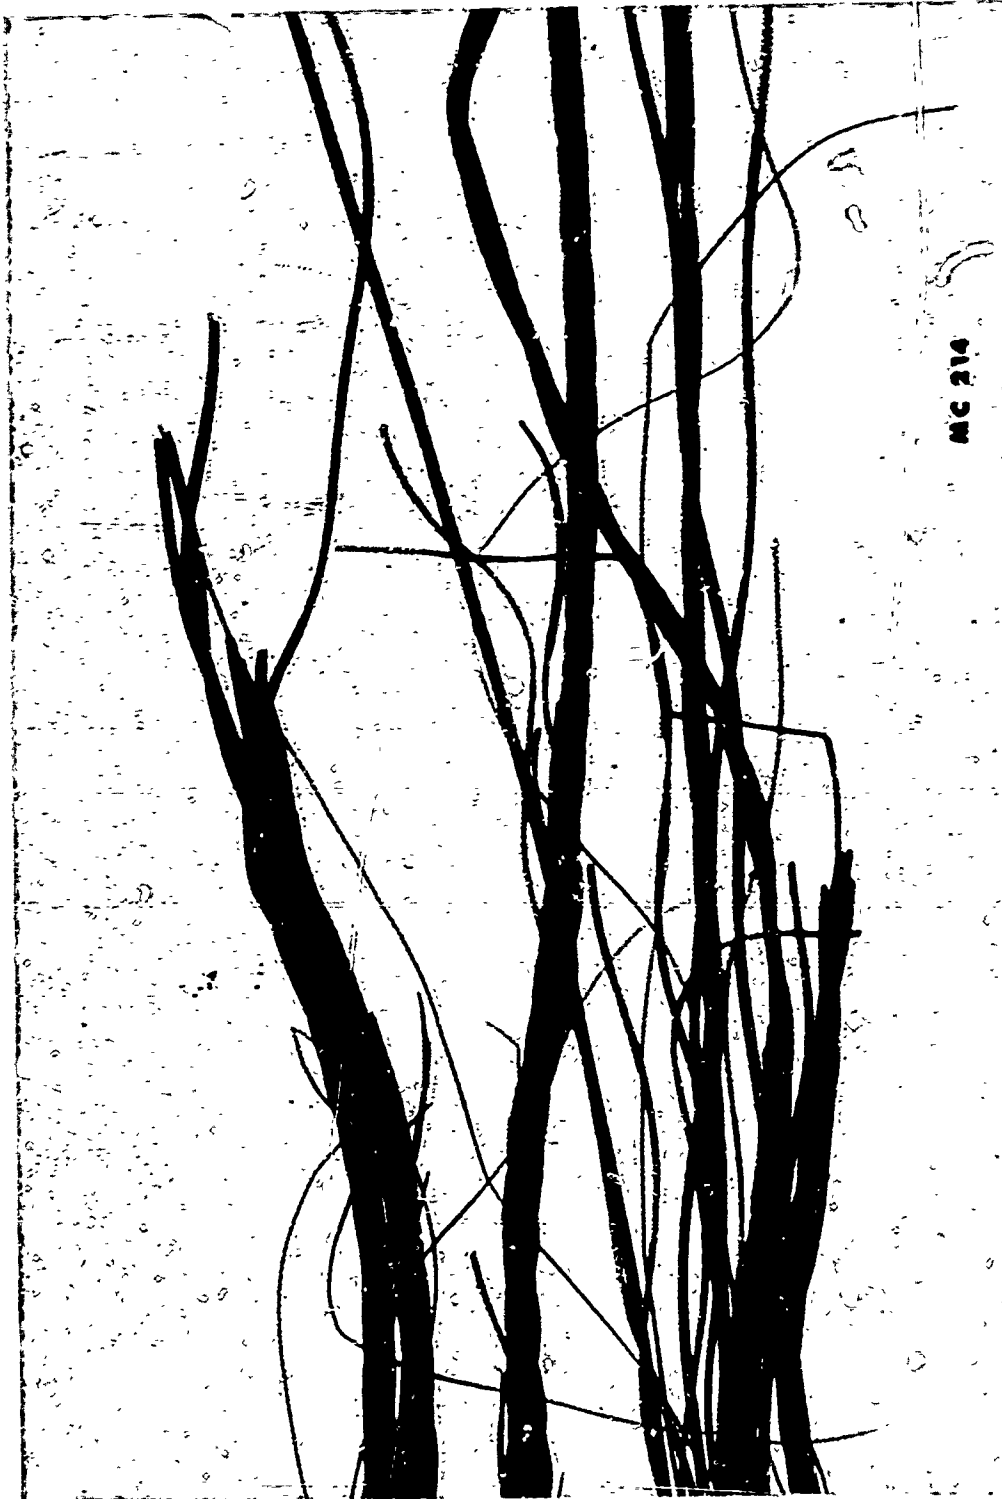
Multiple broken wires and a failure of the wire rope occurred 680 ft from the lower anode connection on the 270° lower catenary. The wire rope was severely corroded at and above the point of failure (Fig. 2). All other multiple broken wires and failures were at least 1000 ft from the nearest anode connection. Field observations relative to broken wires are given in Table 1.

Fig. 2 - Failure of the 270° leg lower catenary 680 ft from the nearest intended anode connection. The 400 lb anode was probably lost when the moor was laid (based on relative condition of other lower catenaries).
(a) The failed end of the catenary. Many outer wires are missing.

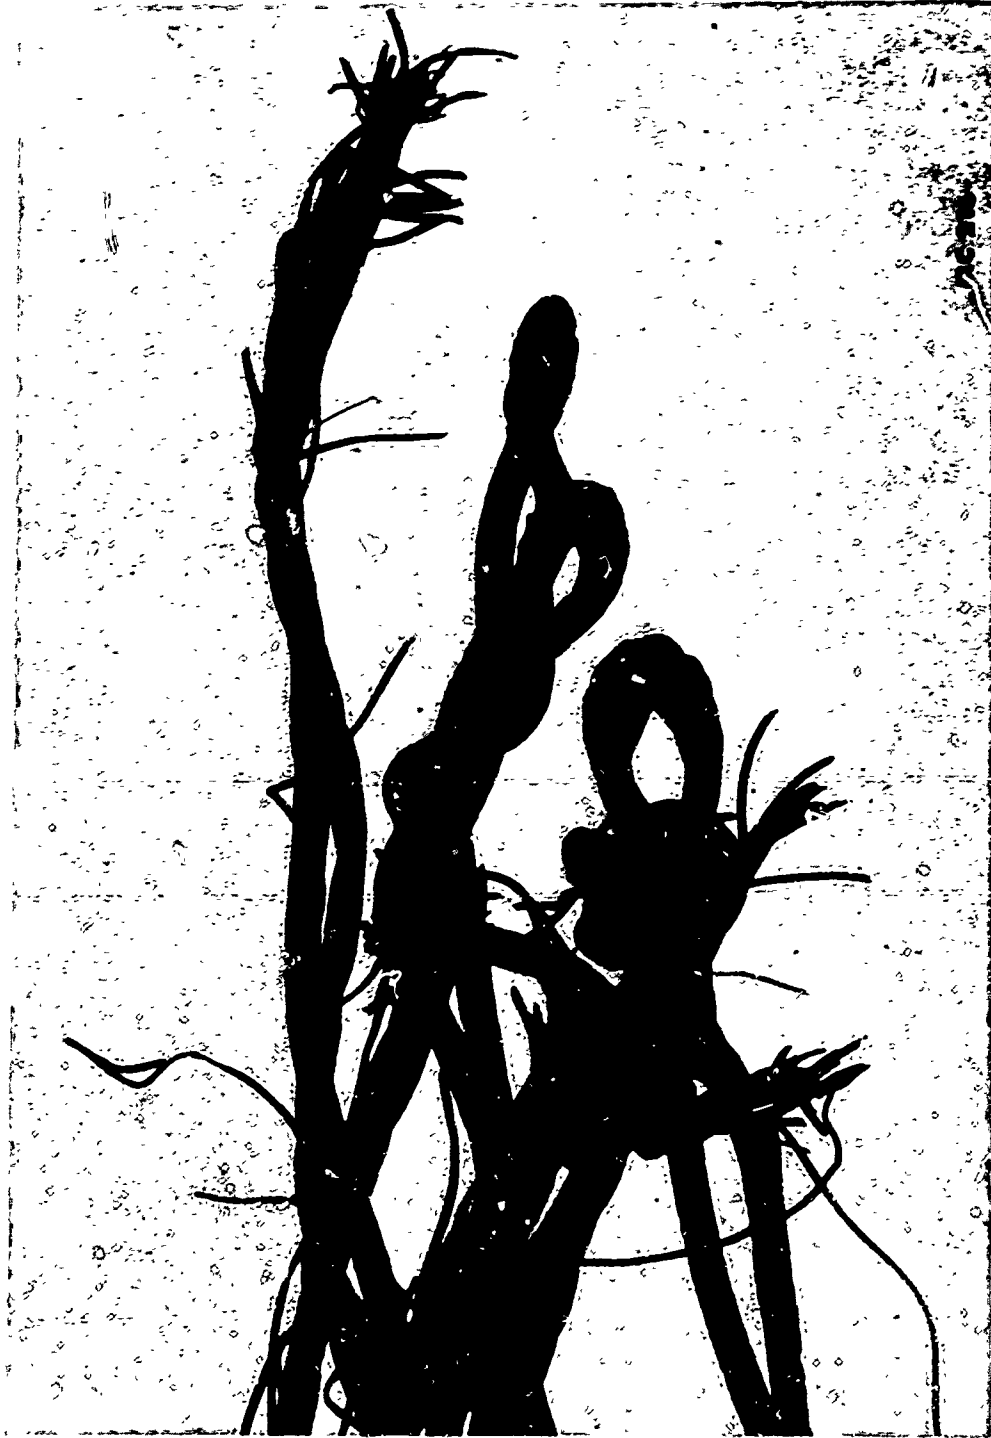
The upper and lower catenaries on the 030° leg failed prior to salvage. Corrosion on the catenaries was not severe and is not believed to have been the cause of the failures. The 25-ft section of the upper catenary in which failure occurred had been twisted prior to failure. Color photographs are available at NRL (Code 6325) which show in detail the twist and failure. The lower catenary appeared to have kinked before or during failure (Fig. 3). It can be surmised that the 030° catenaries failed as a result of ships improperly mooring to the intermediate buoy rather than to the main buoy.

3. The failure of the 1 1/4-in.-diam wire rope upper and lower catenaries on the 030° leg was associated with twists and kinks in the catenaries rather than with severe corrosion. This suggests that these failures may have occurred as a result of a ship improperly mooring to the 030° leg intermediate buoy rather than to the main buoy.

Fig. 3 - Failed end of the 030° leg lower ca-enary 1350 ft from the nearest anode connection. Note twists and kinks; severe corrosion had not occurred.

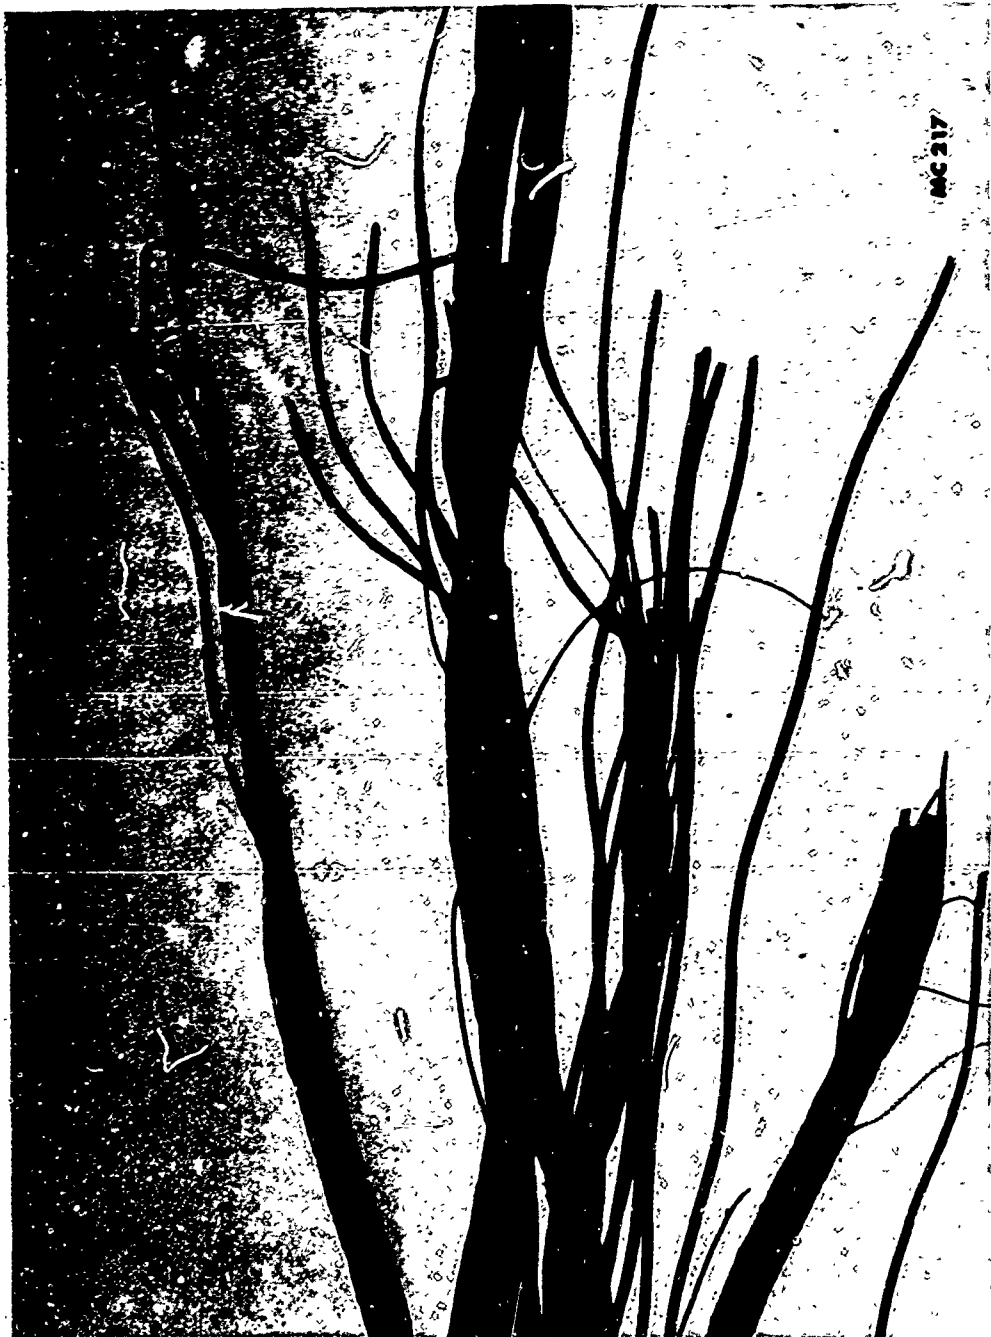
The 270° leg vertical riser failed about 2580 ft below the intermediate buoy. The appearance of the failed end is shown in Fig. 4.

Fig. 4 - Failed end of the vertical riser 2580 ft below the 270° leg intermediate buoy or 1520 ft from nearest anode connection; severe corrosion was evident.

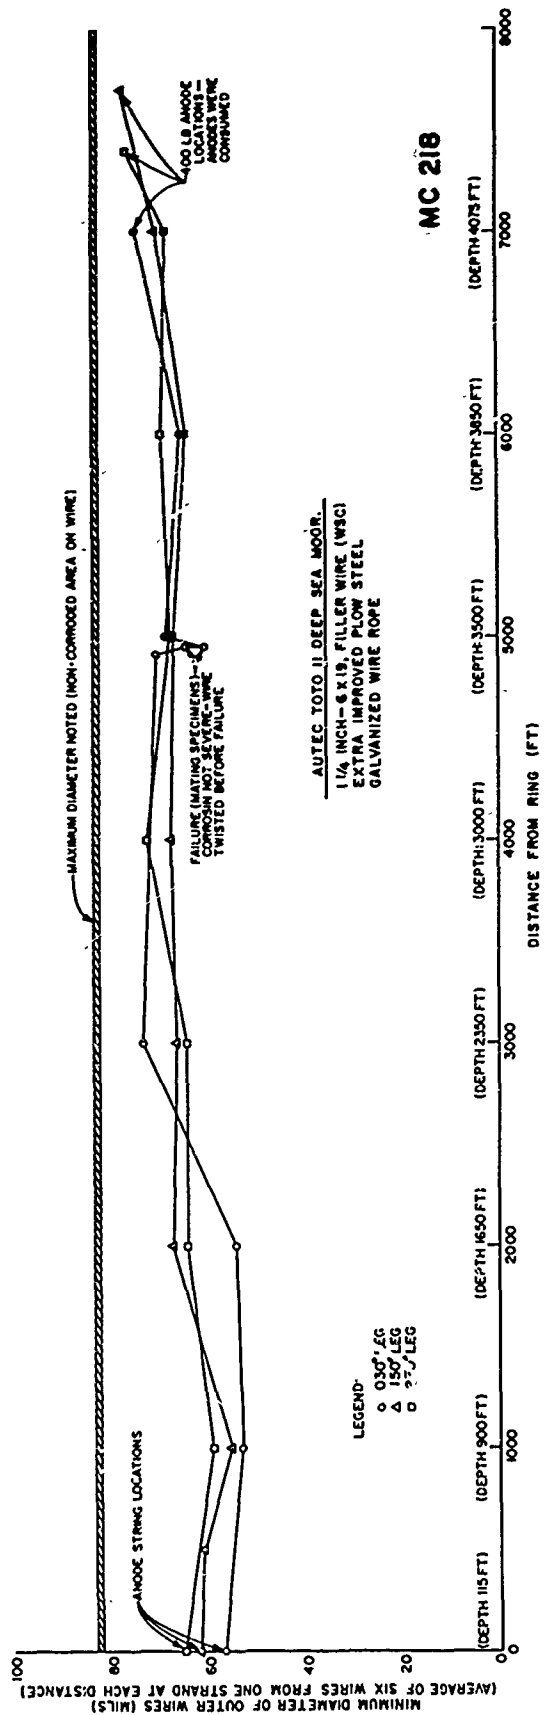
Figure 5 shows that the average minimum diameter of outer wires from the upper catenaries ranged from 53 to 77 mil. The wires having smaller residual diameters were located about 1000 ft from the upper anodes, and those having larger residual diameters were at the lower ends of the catenaries near the 400-lb anode connections. The 030° leg upper catenary twisted and failed at the location shown in the figure. It is apparent that the point of failure was not associated with minimum wire diameter or the point of highest natural stress since both would be towards the upper end of the catenary. The appearance of failed ends of wires from the 030° leg upper catenary is shown in Fig. 6.

Fig. 5 - Minimum diameter of outer wires from the upper catenaries. Distances are relative to the ring located 115 ft below each main buoy as zero. Approximate depths of water are shown in parentheses.

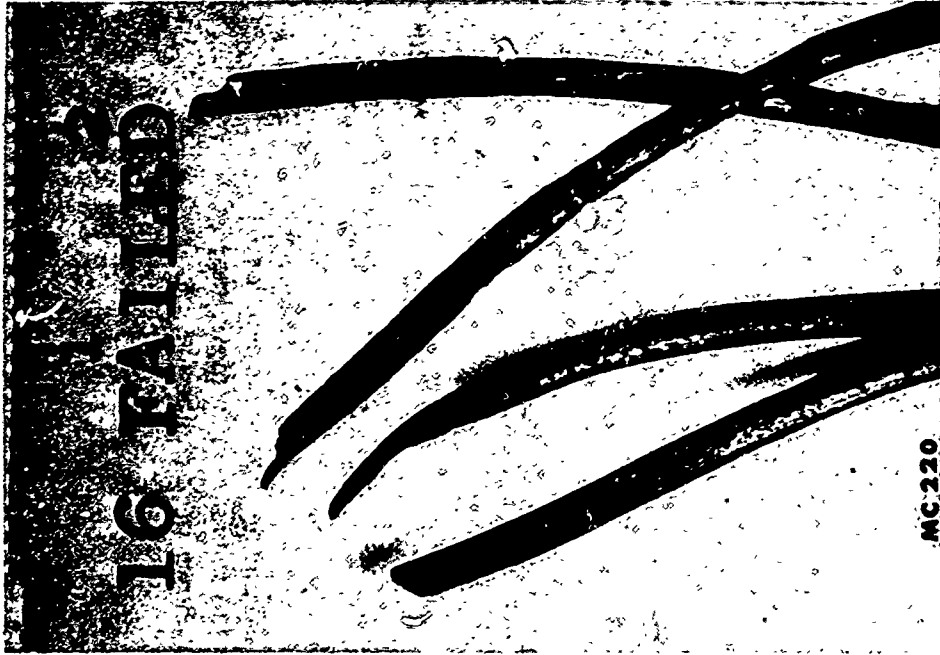
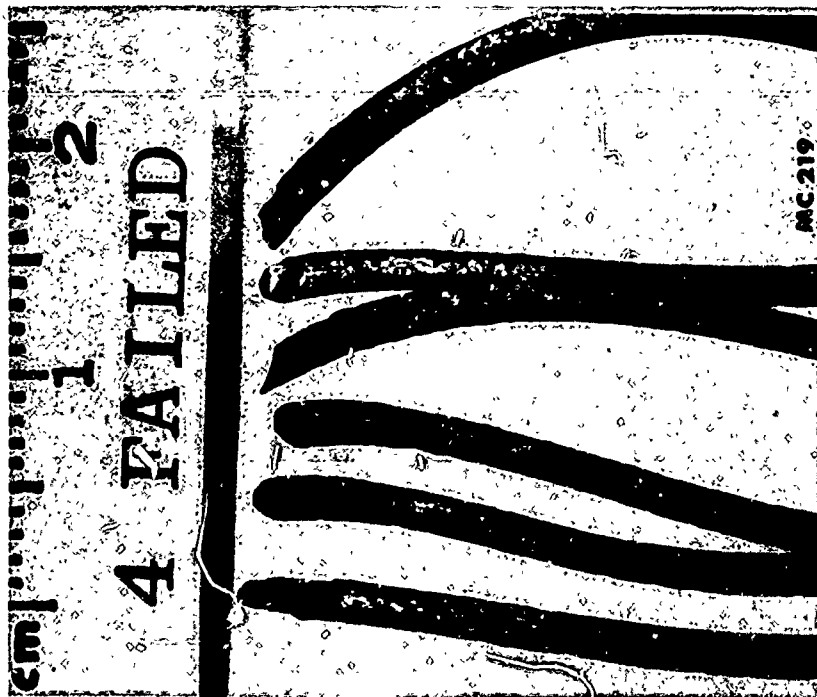
Fig. 6 - Failed ends of wires from the 030° upper catenary. Fractures on individual wires varied in appearance and wire diameters were not severely reduced.

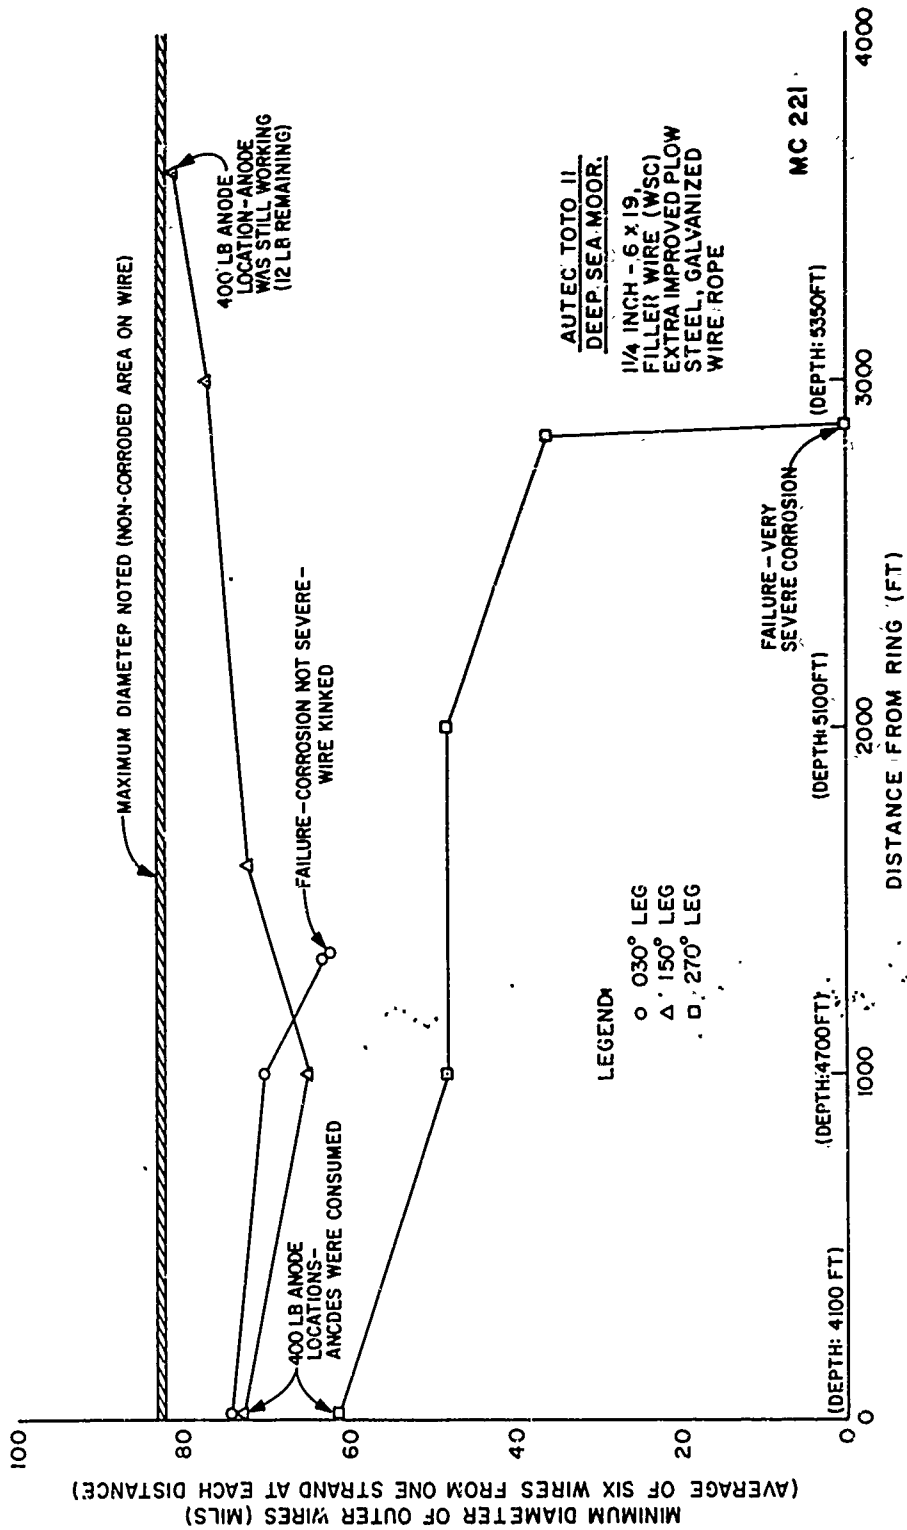
The average minimum diameter of the outer wires of the lower catenary ranged from 0 to 81 mil as shown in Fig. 7. The outer wires from the 270° lower catenary at the point of failure were completely severed by corrosion. Severe corrosion was also noted on the core strand of the 270° lower catenary at this point. Severe reduction of the diameter of the outer wires was not noted on the 030° lower catenary which failed or on the 150° lower catenary. This suggests that the 400-lb anode at the lower end of the 270° lower catenary was lost when the moor was laid and thus permitted severe corrosion to occur. Another significant factor which contributed to the severe corrosion of the 270° lower catenary was the relatively poor coverage of bituminous coating on the strands (Table 2). The appearance of failed ends of wires from the 030° leg lower catenary is shown in Fig. 8.

Fig. 7 - Minimum diameter of outer wires from the lower catenaries. Distances are relative to the ring located about 4100 ft below each intermediate buoy as zero. Approximate depths of water are shown in parentheses.

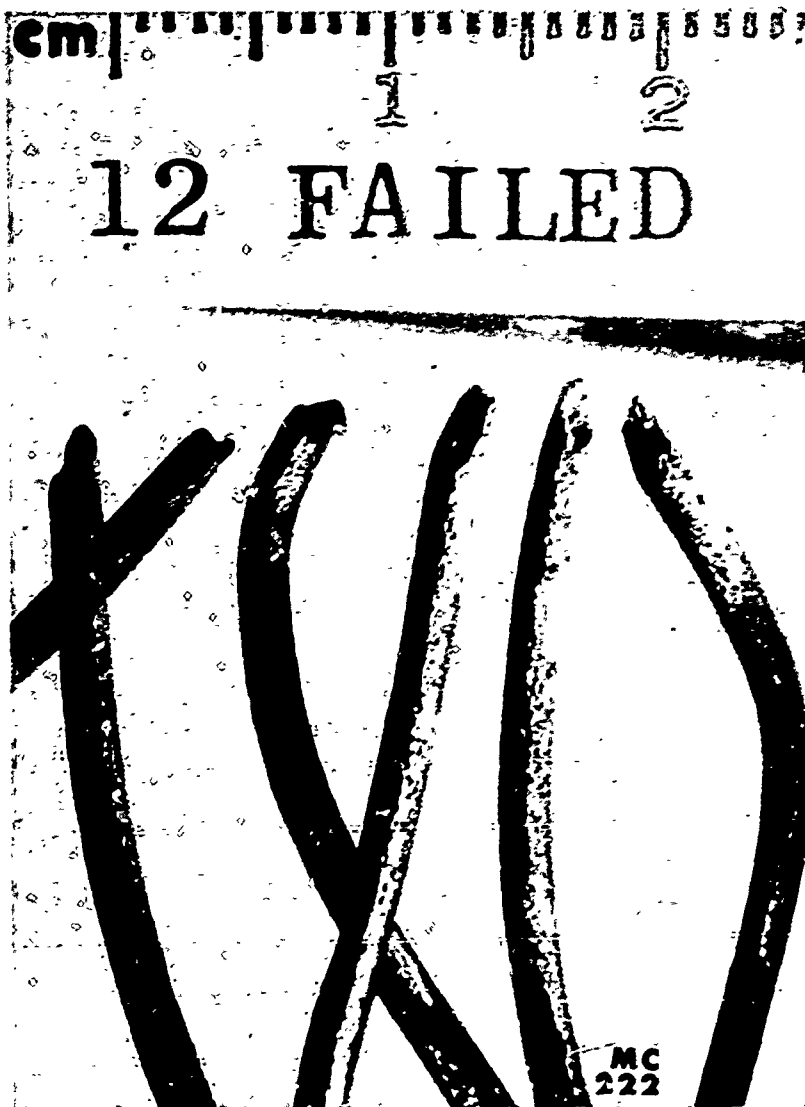
Fig. 8 - Failed ends of wire from the 030° lower catenary. The fracture appearance on individual wires varied and wire diameters were not severely reduced.

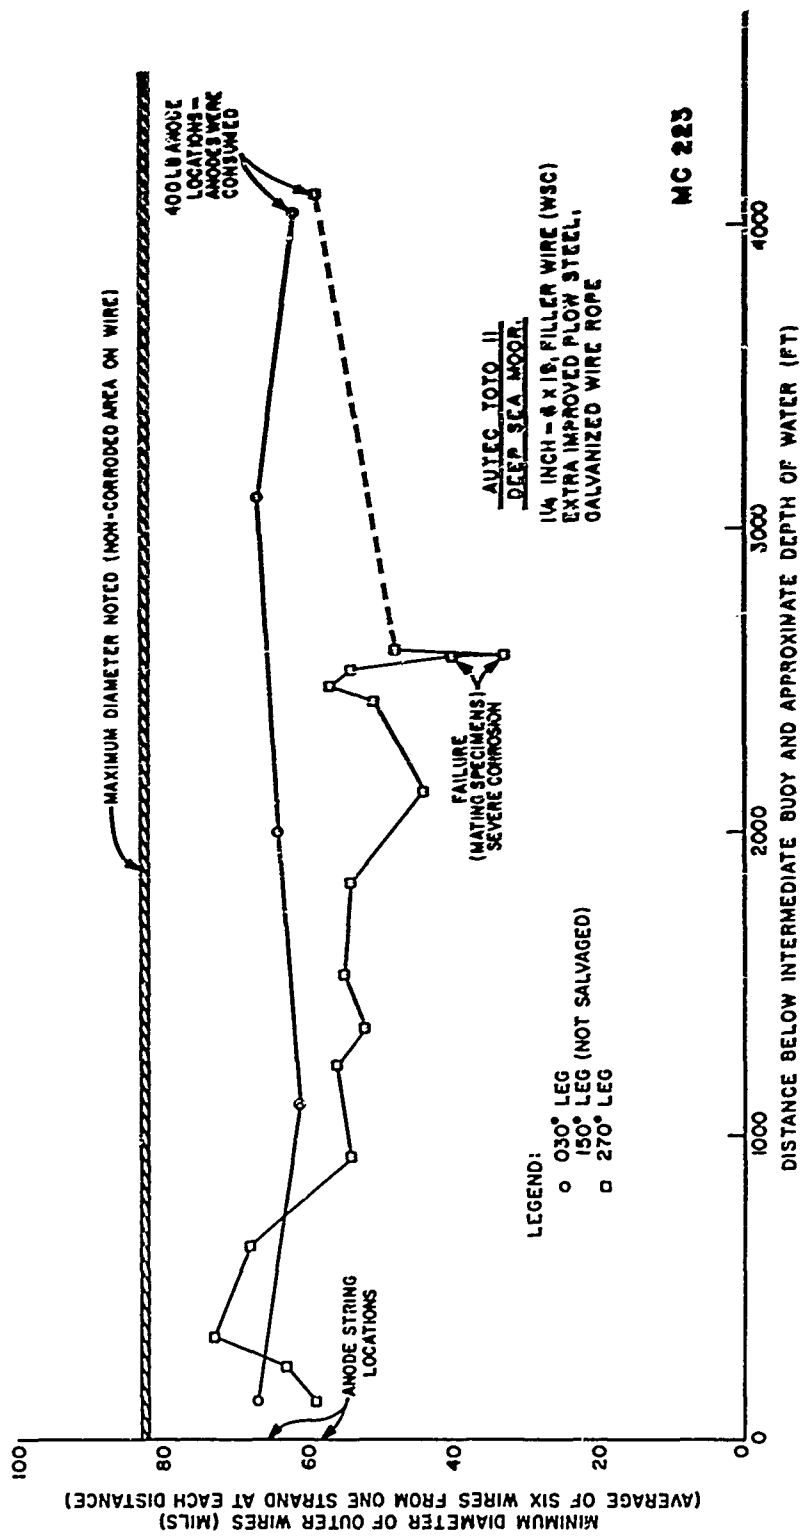
The contrast in performance of the risers beneath the intermediate buoys of the 030° and 270° legs is shown in Fig. 9. Data from the failed 150° leg riser are not shown because samples were not available. It is evident from Fig. 9 that the diameters of outer wires from the 030° leg riser were not drastically reduced, but the opposite effect was noted for the 270° leg riser which failed because of severe corrosion. The only apparent explanation for the divergent behavior of risers is that the 030° leg riser was relatively well protected by the bituminous coating (Table 2). A cross section of the 270° leg riser approximately 50 ft above the failure is shown in Fig. 10, and the appearance of failed ends of wires from this riser is shown in Fig. 11.

Fig. 9 - Minimum diameter of outer wires from the vertical risers beneath the intermediate buoys. Distances are relative to each intermediate buoy as zero.

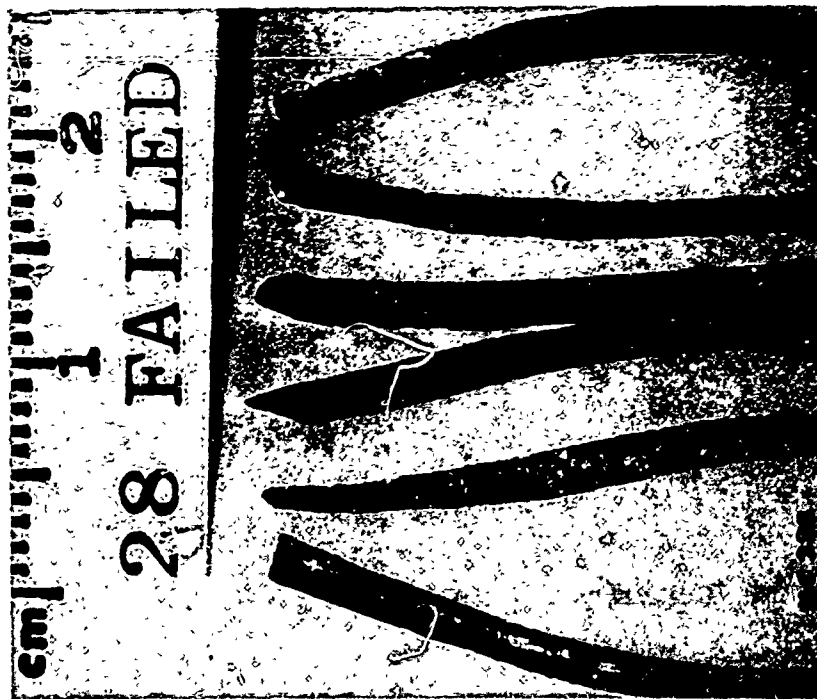
Fig. 11 - Failed ends of wires from the 270° leg intermediate buoy riser. Fracture appearance on individual wires varied and the diameter of some wires was severely reduced.
