Technical Note N-830

AIRFIELD PAVEMENT EVALUATION - USNAF CHINA LAKE, CALIFORNIA,

July 1966

U. S. NAVAL CIVIL ENGINEERING LABORATORY  
Port Hueneme, California

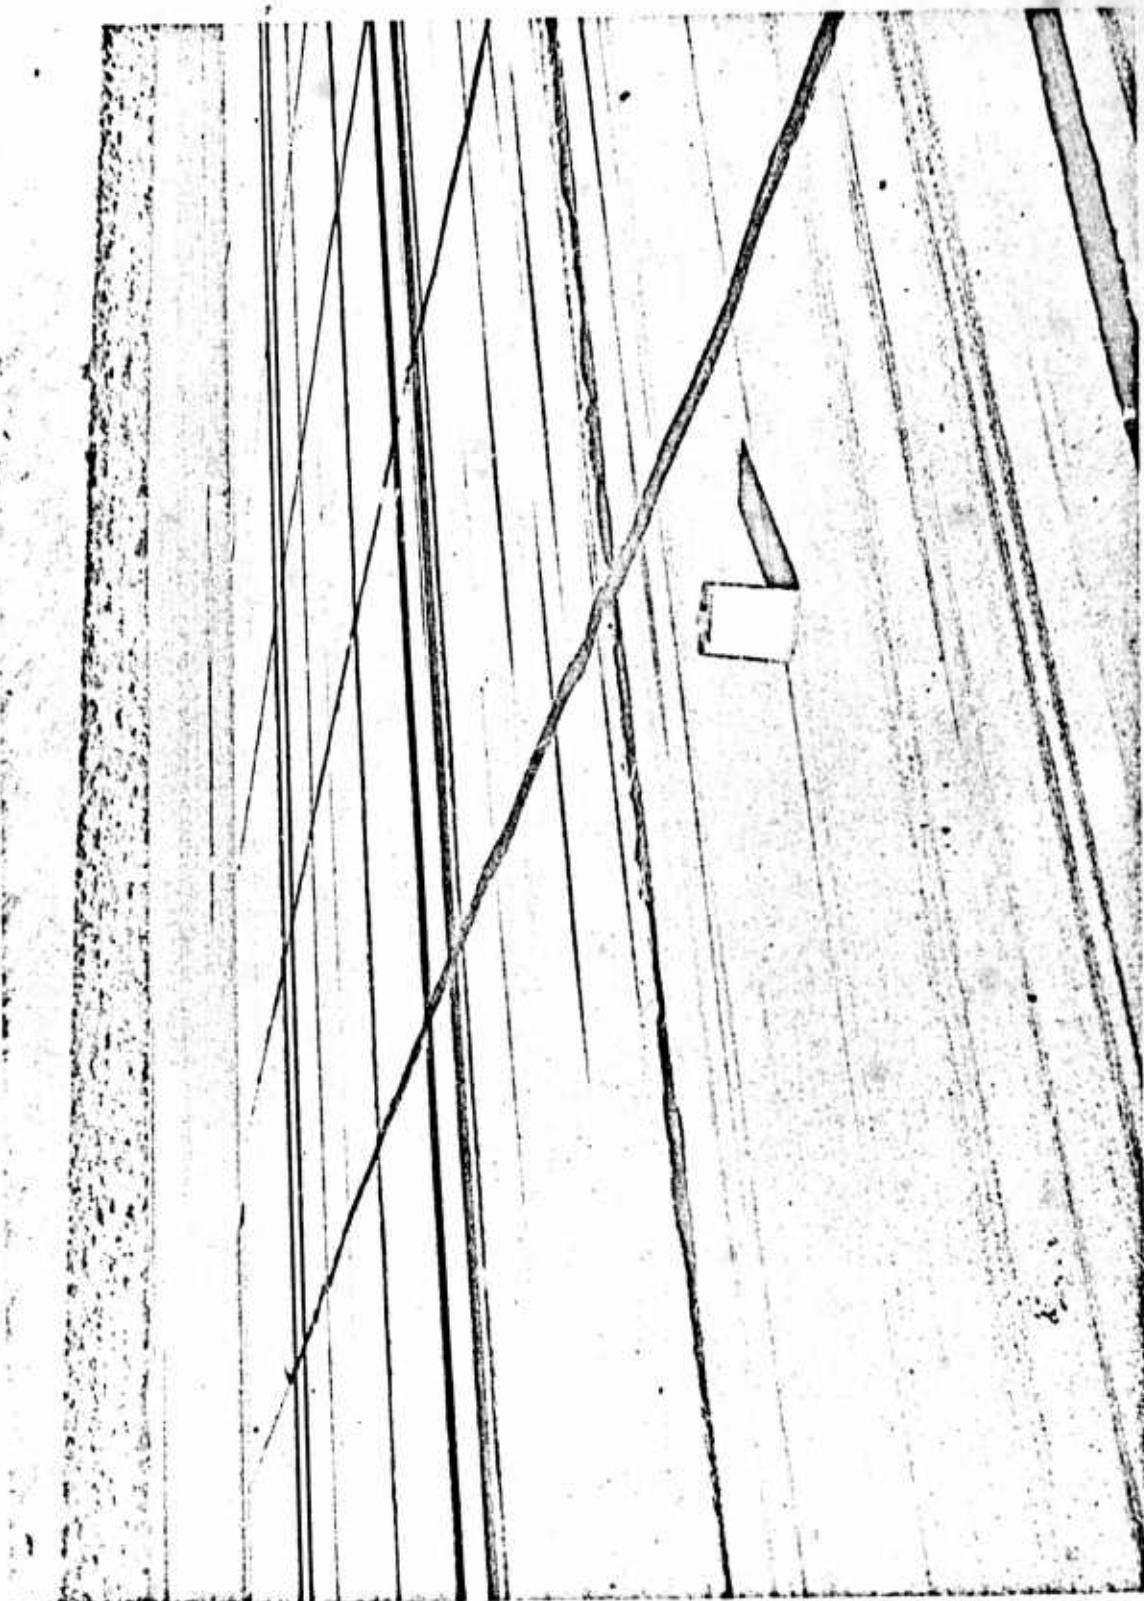
Figure 2. Surface defects in concrete on Runway 14-32, U. S. Naval Air Facility, China Lake, California.

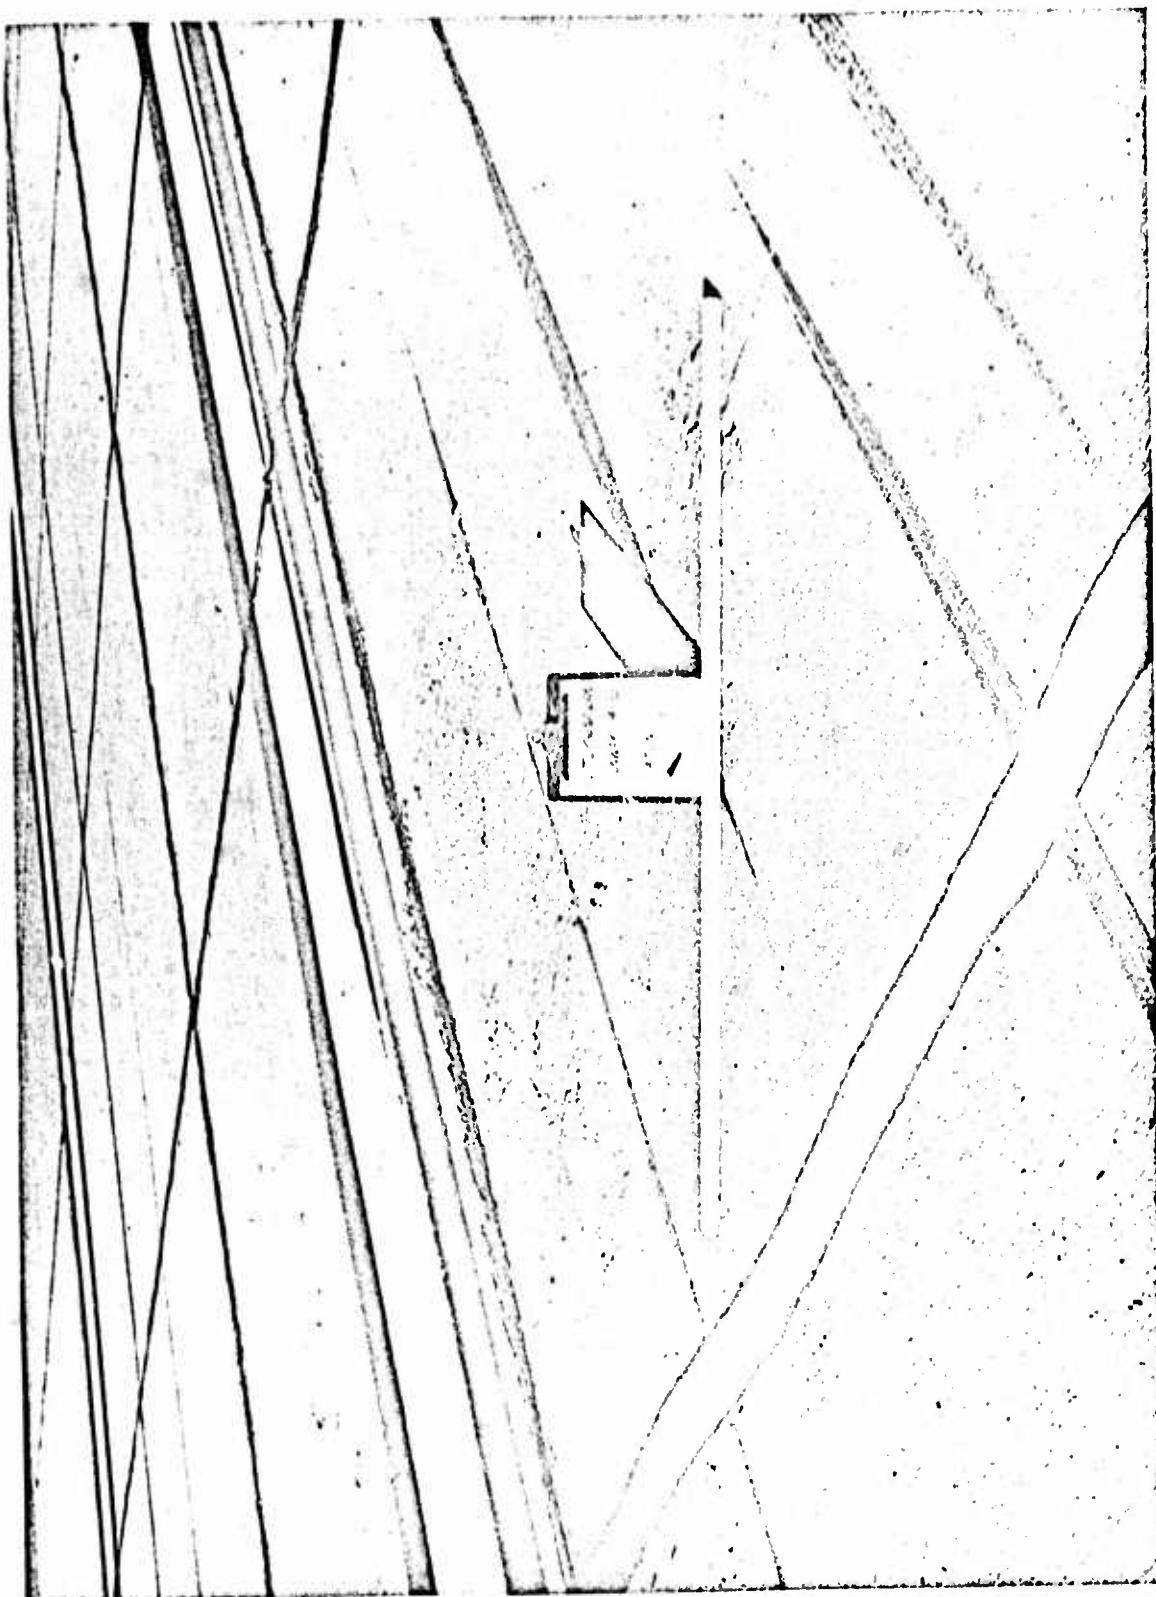
Figure 3. Close-up of concrete spall area of Runway 14-32, U. S. Naval Air Facility,  
China Lake, California.

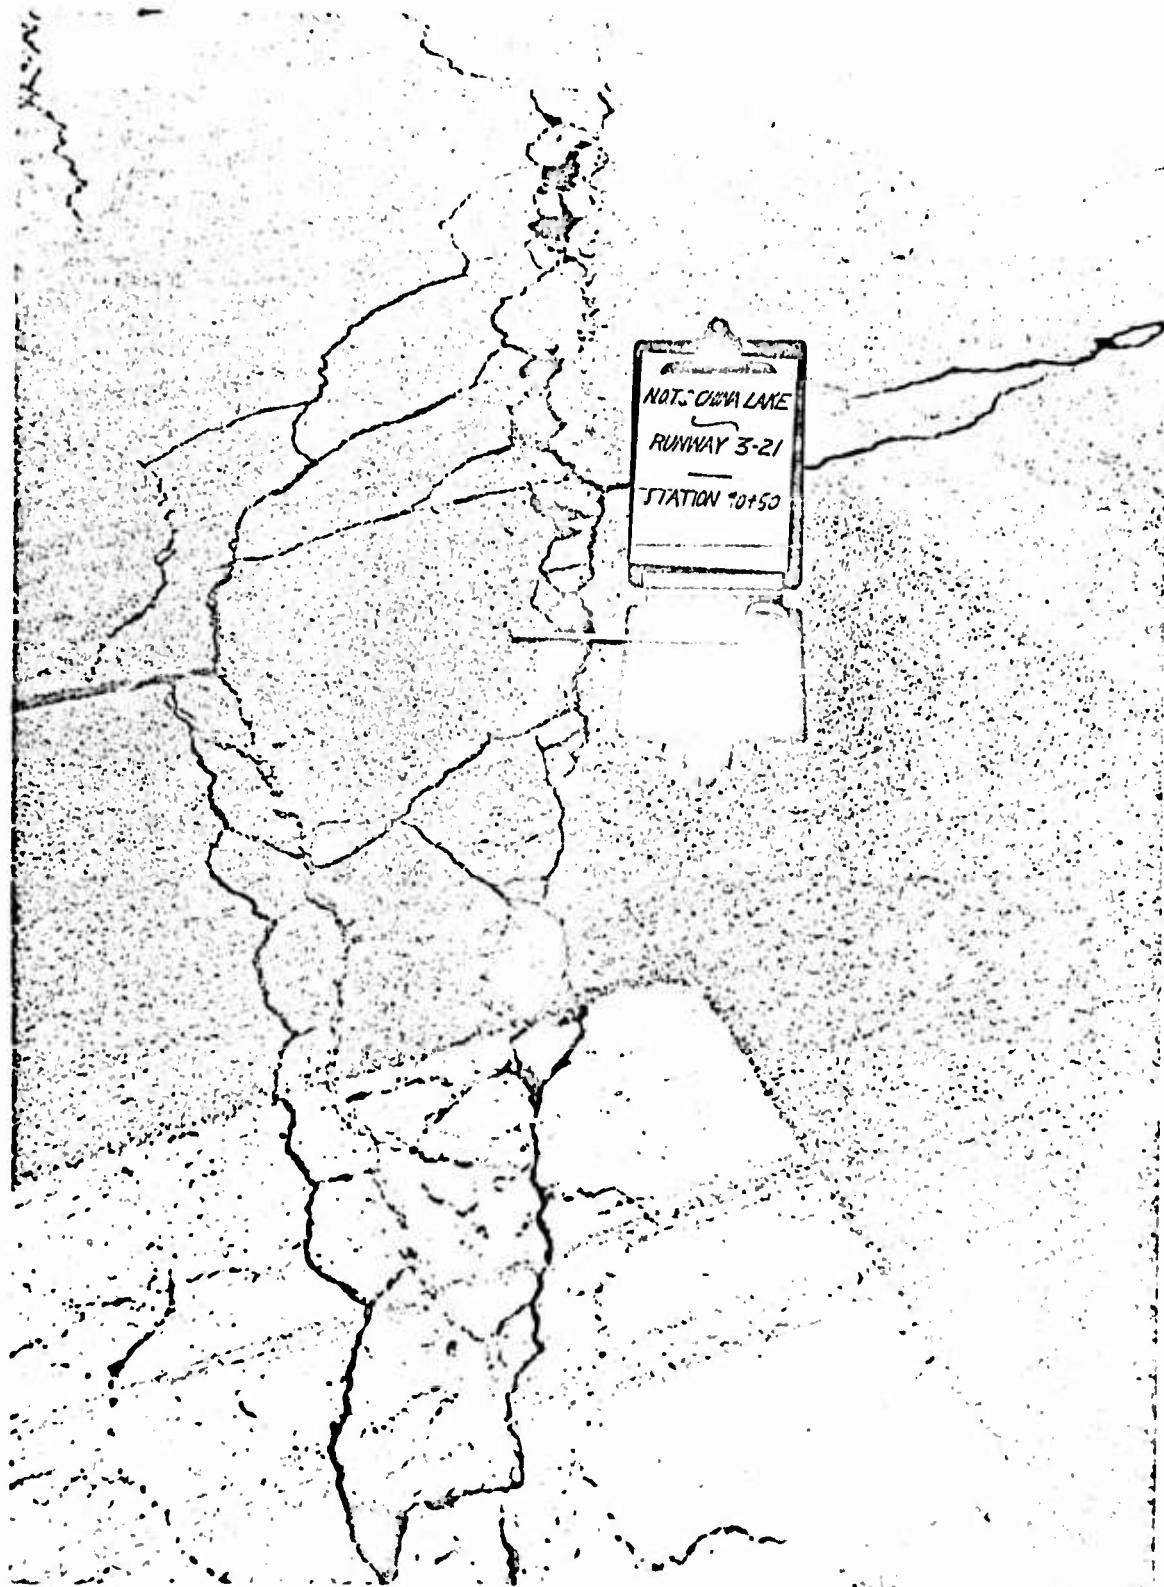
Figure 13. Severe cracking and spalling combined with raveling on Runway 3-21, U. S. Naval Air Facility, China Lake, California. 43

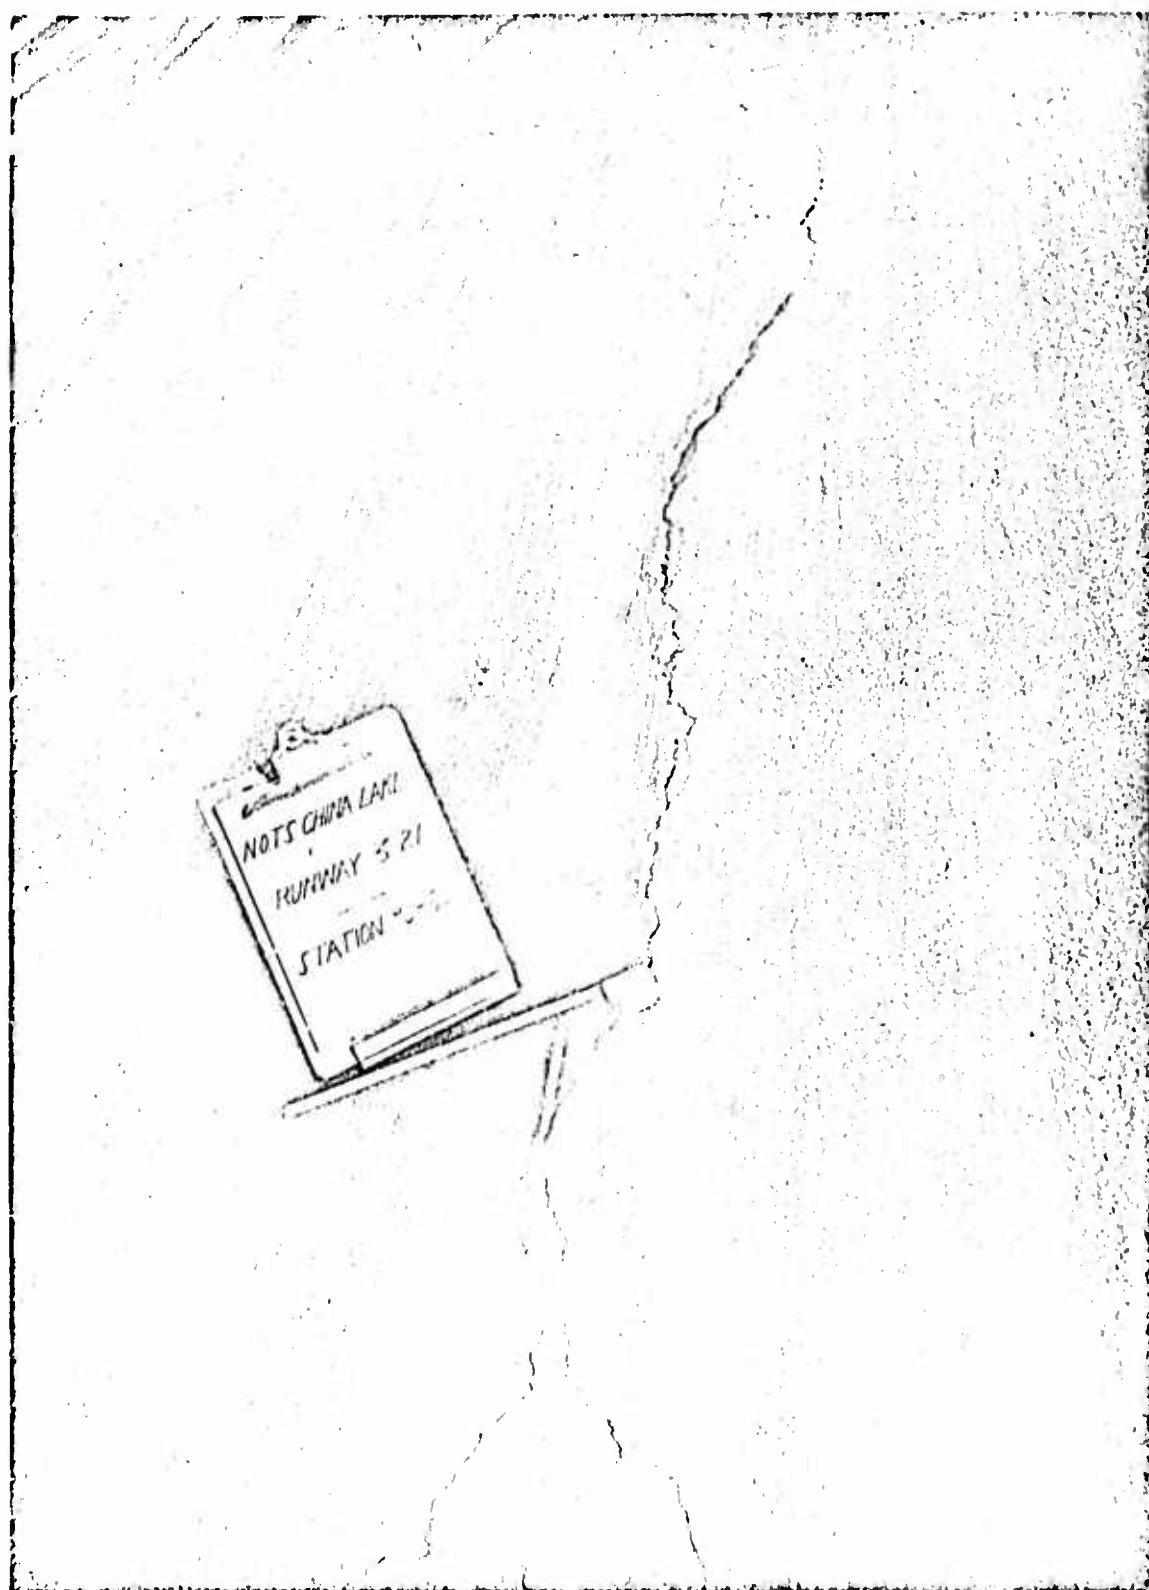
Figure 14. Close-up view of raveling along longitudinal crack on Runway 3-21, U. S. Naval Air Facility, China Lake, California. 45

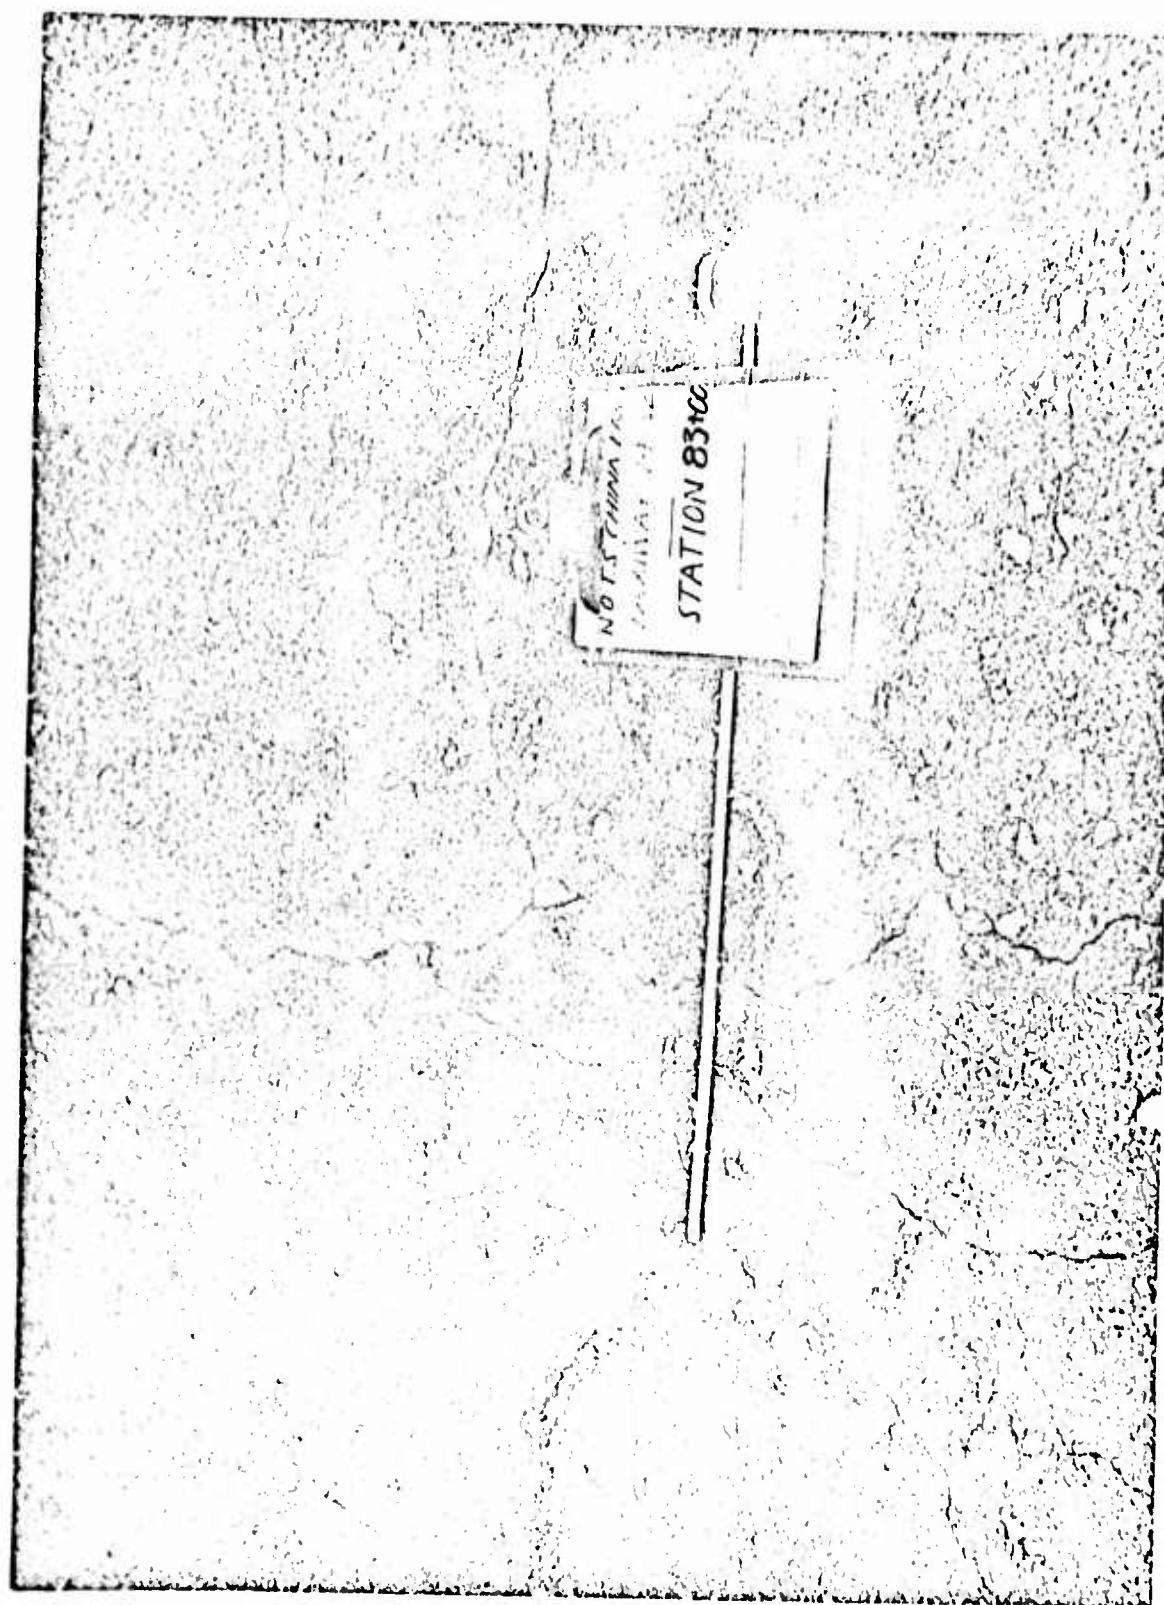
Figure 17. Close-up of surface deterioration on Taxiway 14-32, U. S. Naval Air Facility, China Lake, California.

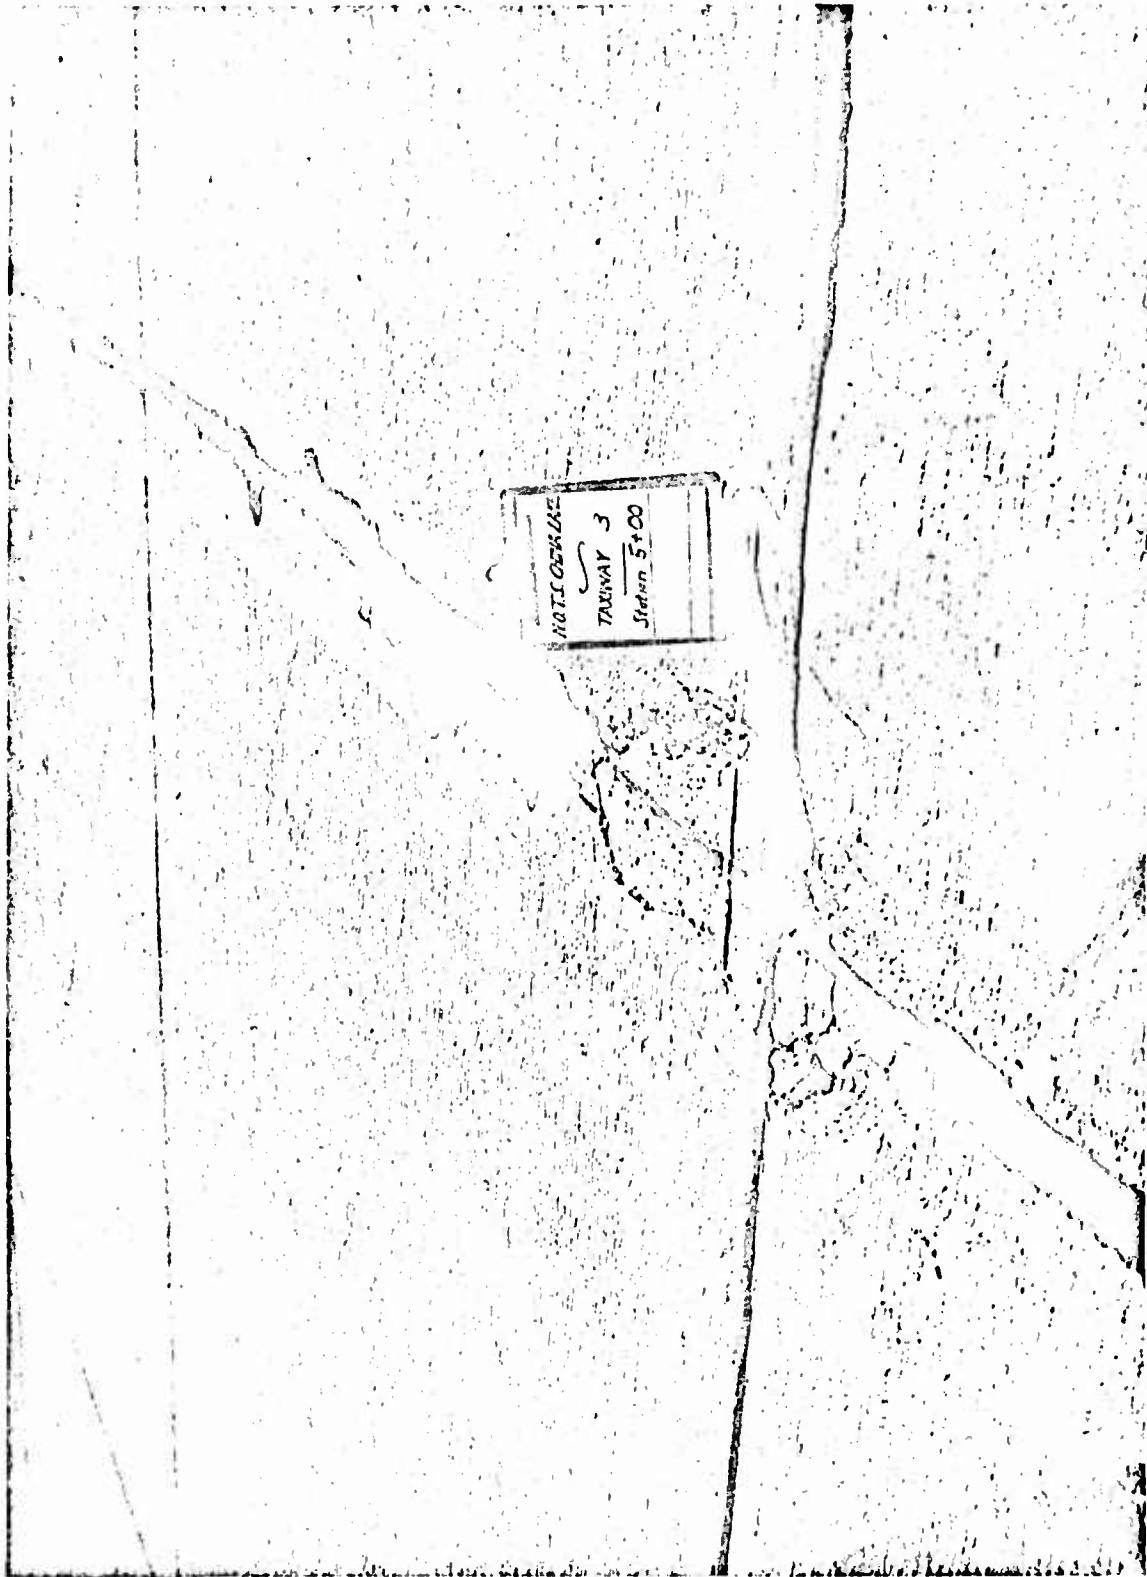
Figure 18. Poor portland cement concrete corner patch with additional cracking and spalling on Taxiway 3, U. S. Naval Air Facility, China Lake, California.

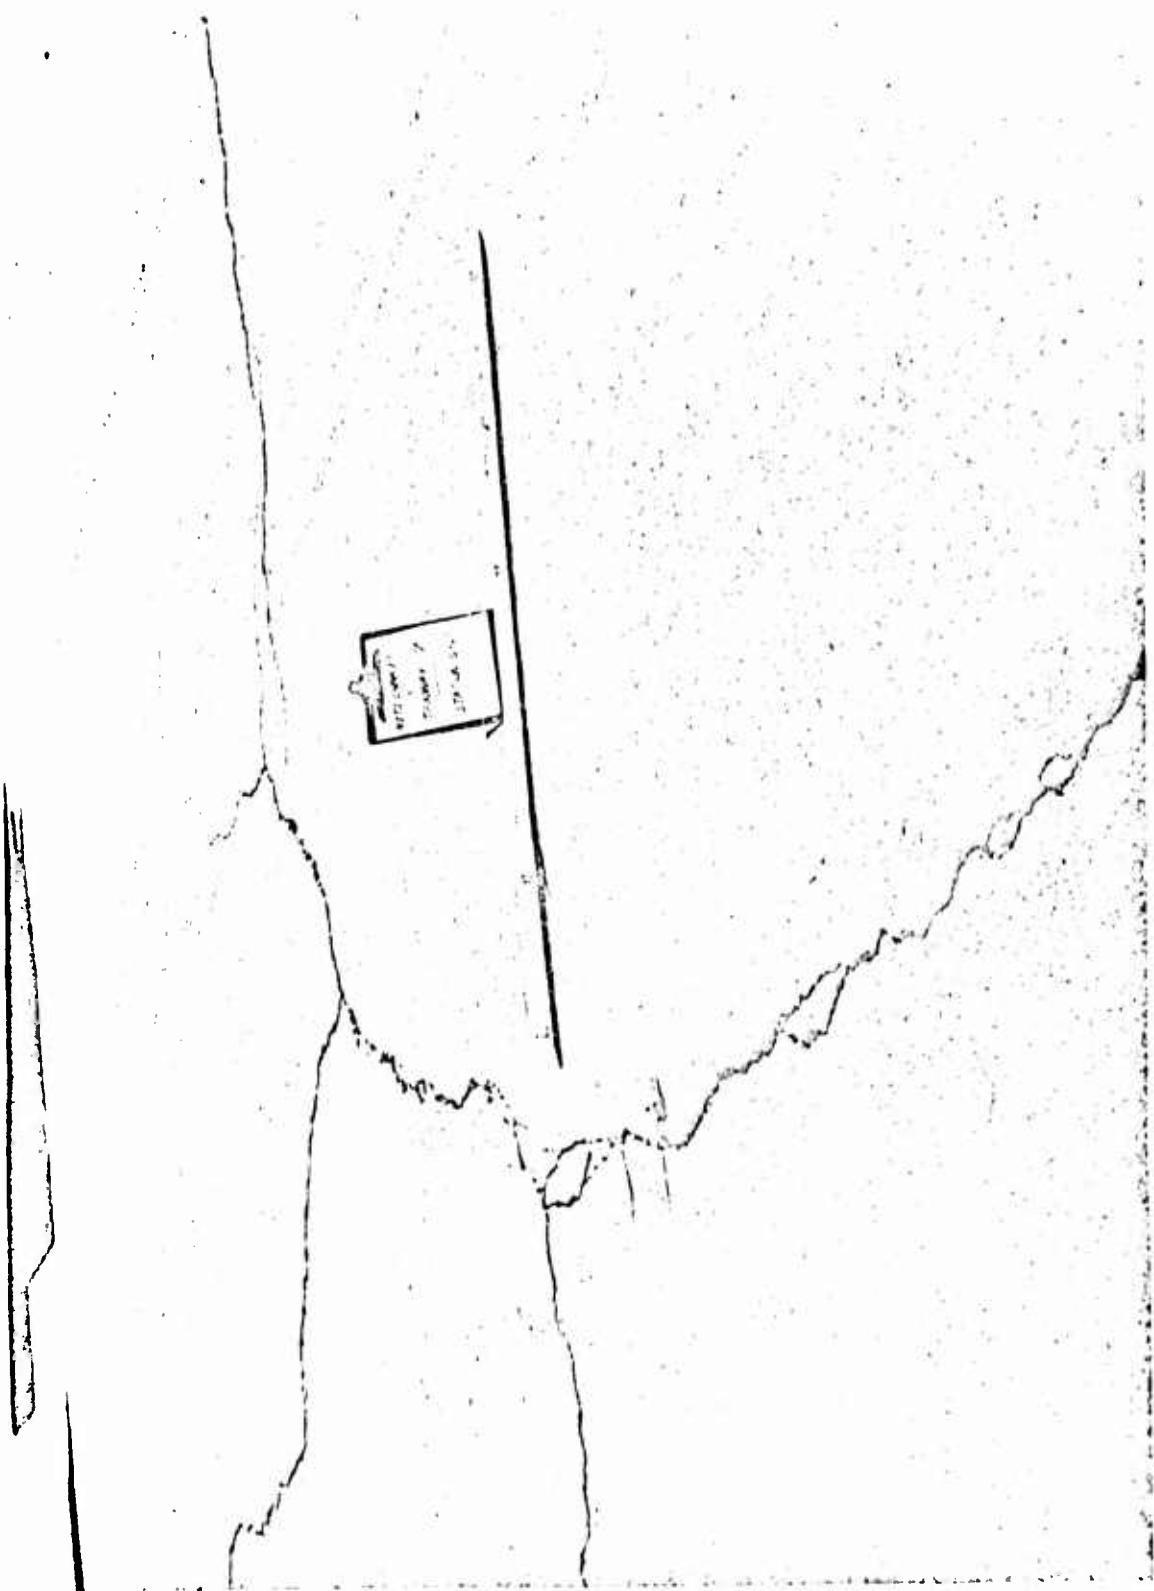
Figure 20. Severe longitudinal, diagonal, and transverse cracking and raveling on Taxiway 7, U. S. Naval Air Facility, China Lake, California.

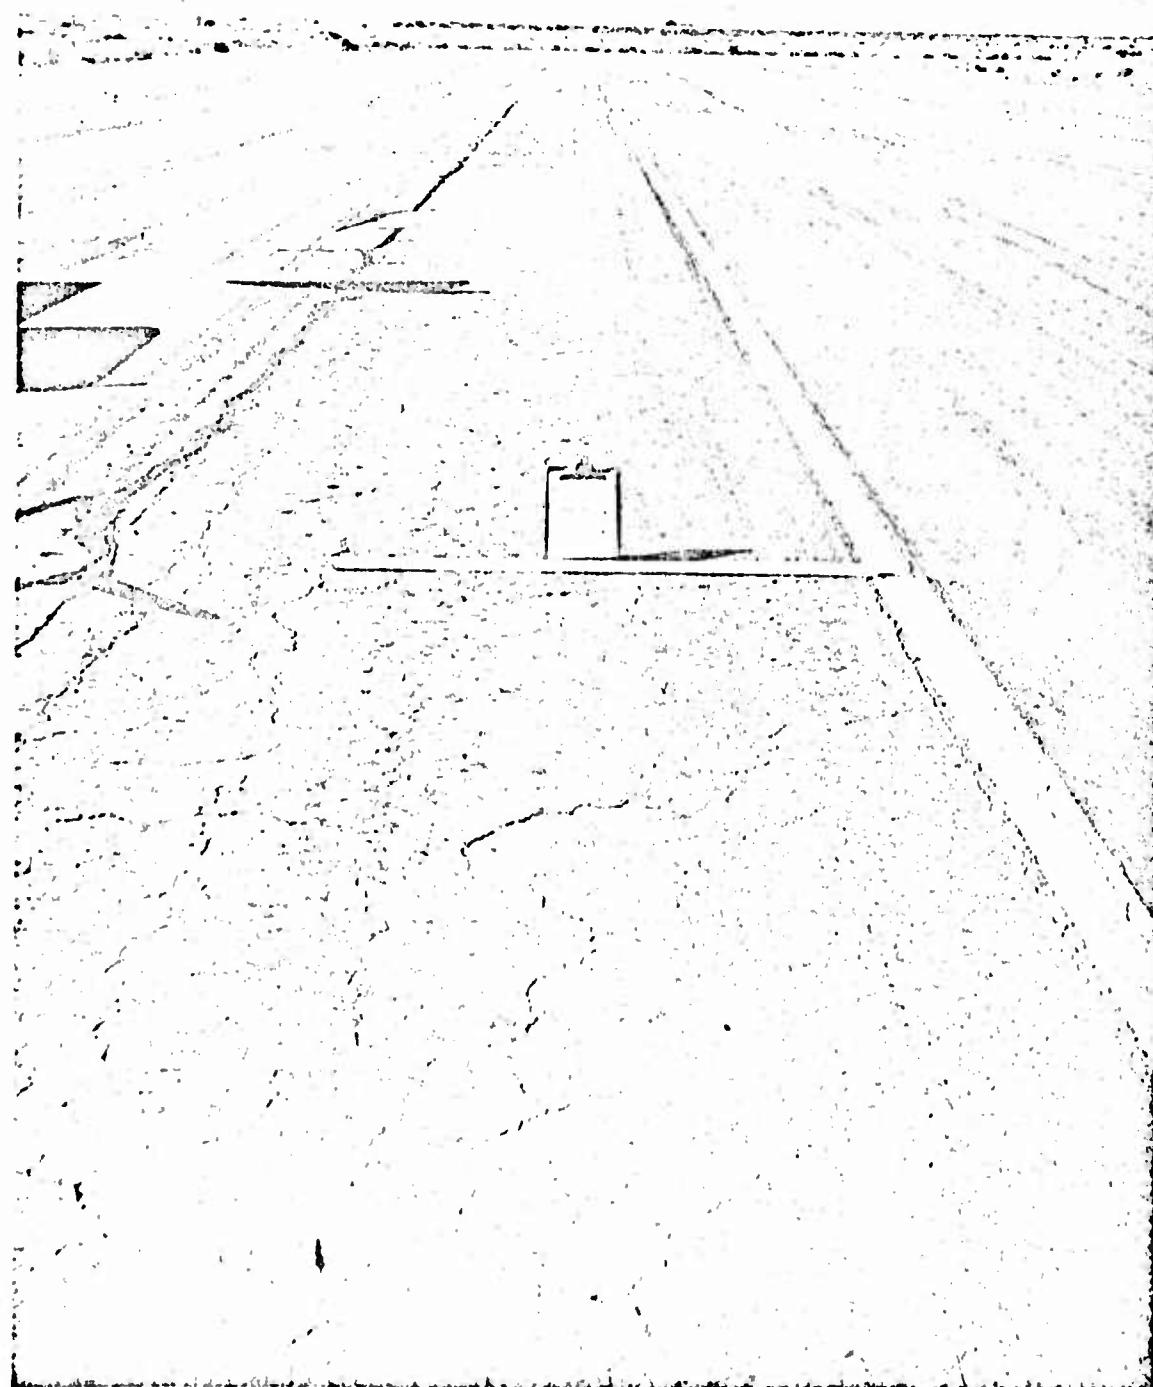
Figure 23. General view of Taxiway 25 showing various types of cracks and rutting. U. S. Naval Air Facility, China Lake, California. 63

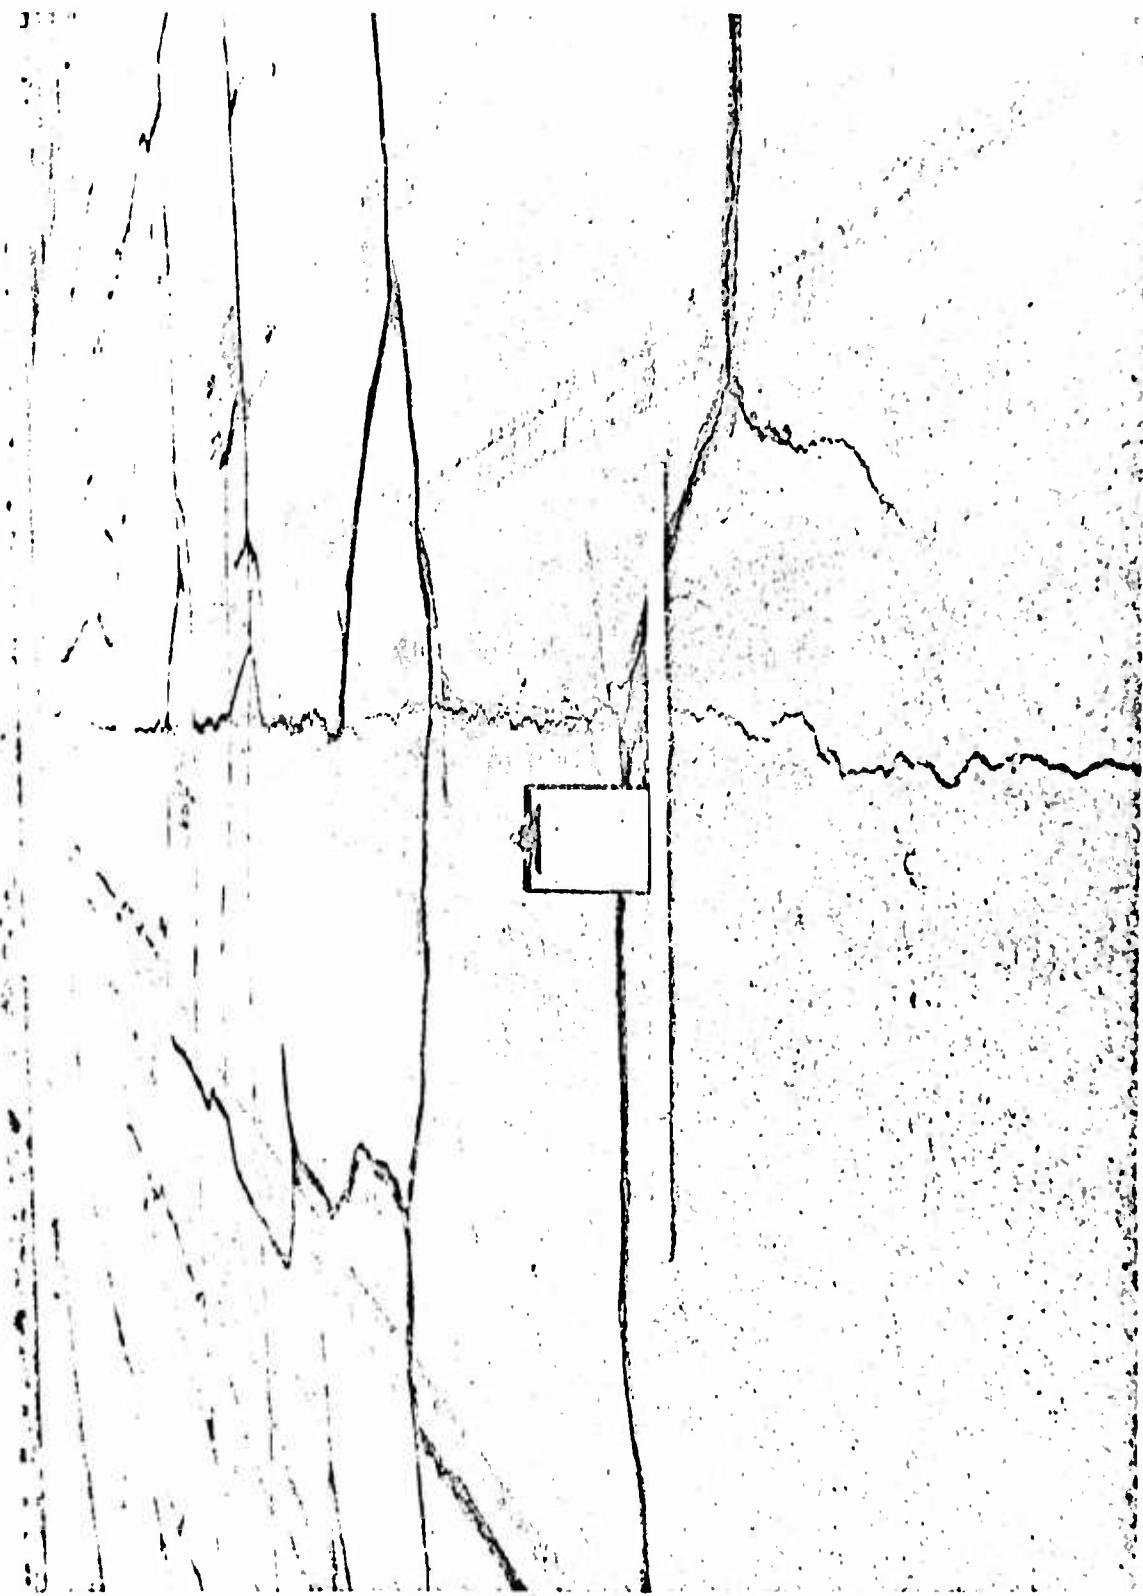
Figure 24. General view of Connecting Taxiway A showing severe crack patterns, U. S. Naval Air Facility, China Lake, California.

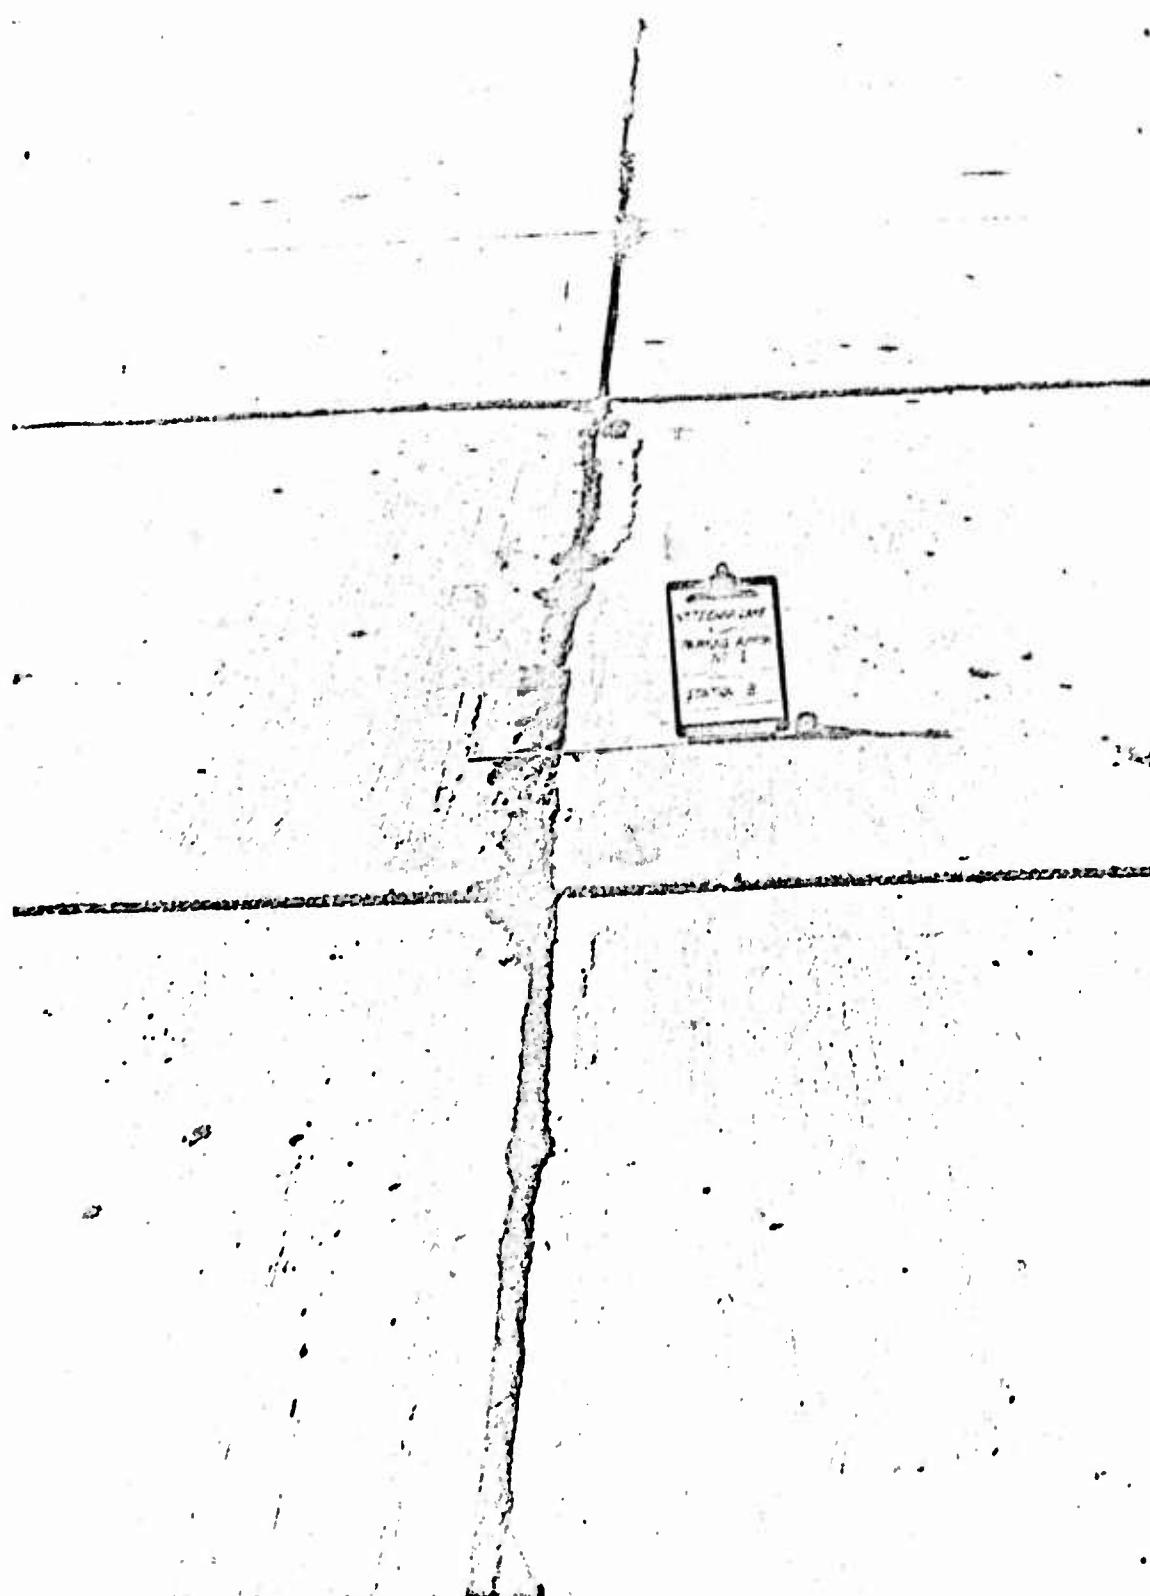
Figure 25. Longitudinal joint spall and patches on Parking Apron 1. The spall appears to have been a patch. U. S. Naval Air Facility, China Lake, California.
