Technical Note N-815

TECHNICAL PROGRESS SURVEY - BYRD STATION, ANTARCTICA

C. R. Hoffman

June 1966

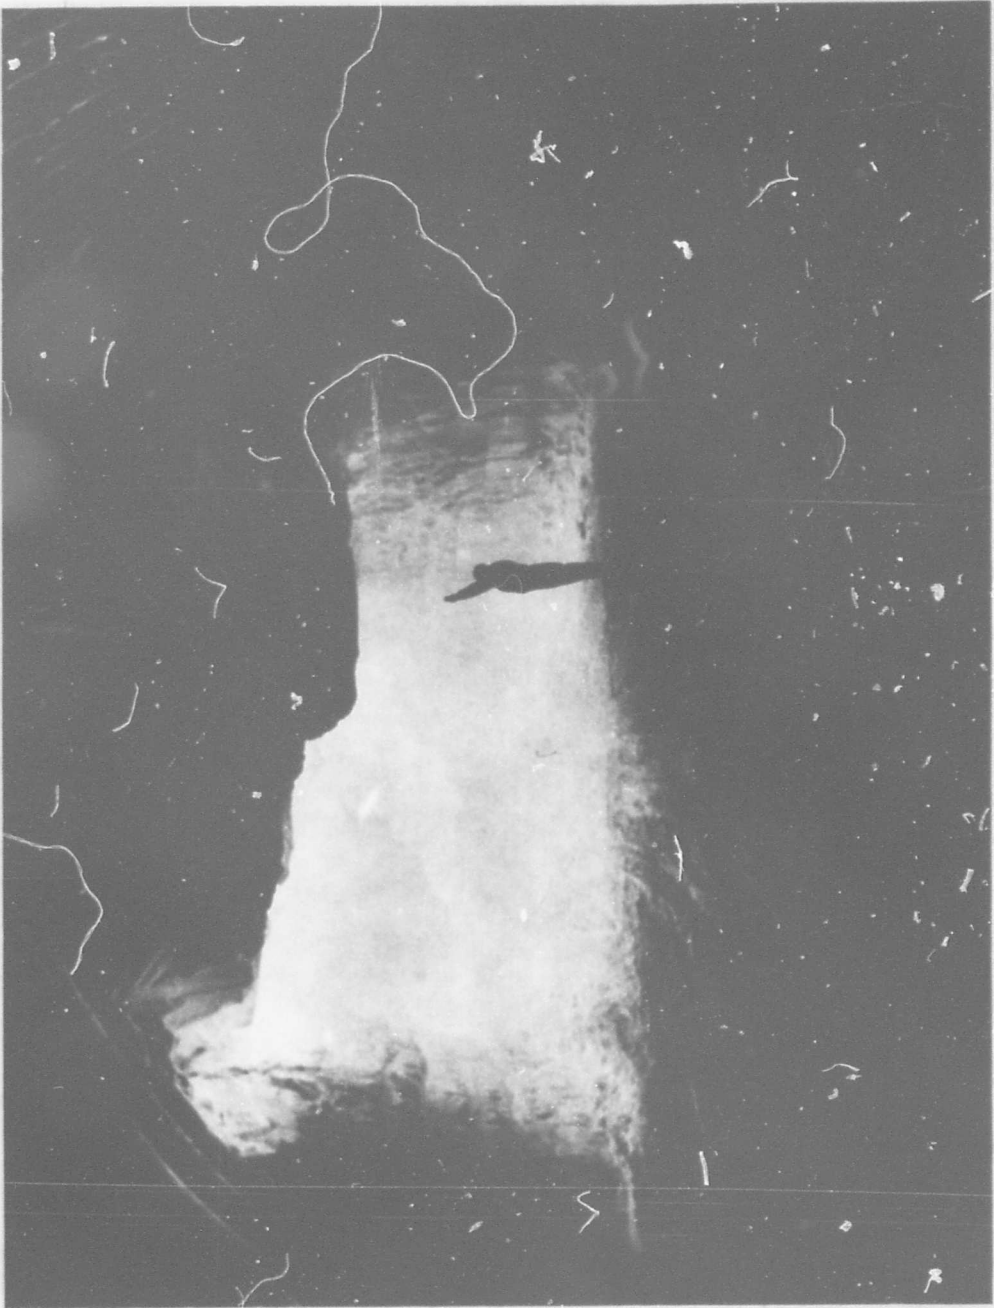
Visual inspection shows an inward movement of the tunnel walls and the arch footings. This movement has produced a general buckling of the steel arches at the crown (Figures 2 and 3). While undesirable, this does not appear to be a serious structural weakness. The steel arch in tunnel L-3 is badly deformed over the maintenance shops as a result of the structural fire in that area, and appears to contribute little to the support of the overlying snow. A similar condition exists at the vehicle entrance ramp in the same tunnel. The increasing weight of snow overhang caused by drift at the entrance has resulted in failure of several feet of arch (Figures 4 and 5).

Figure 5. Surface-ramp entrance as seen from tunnel L-3.

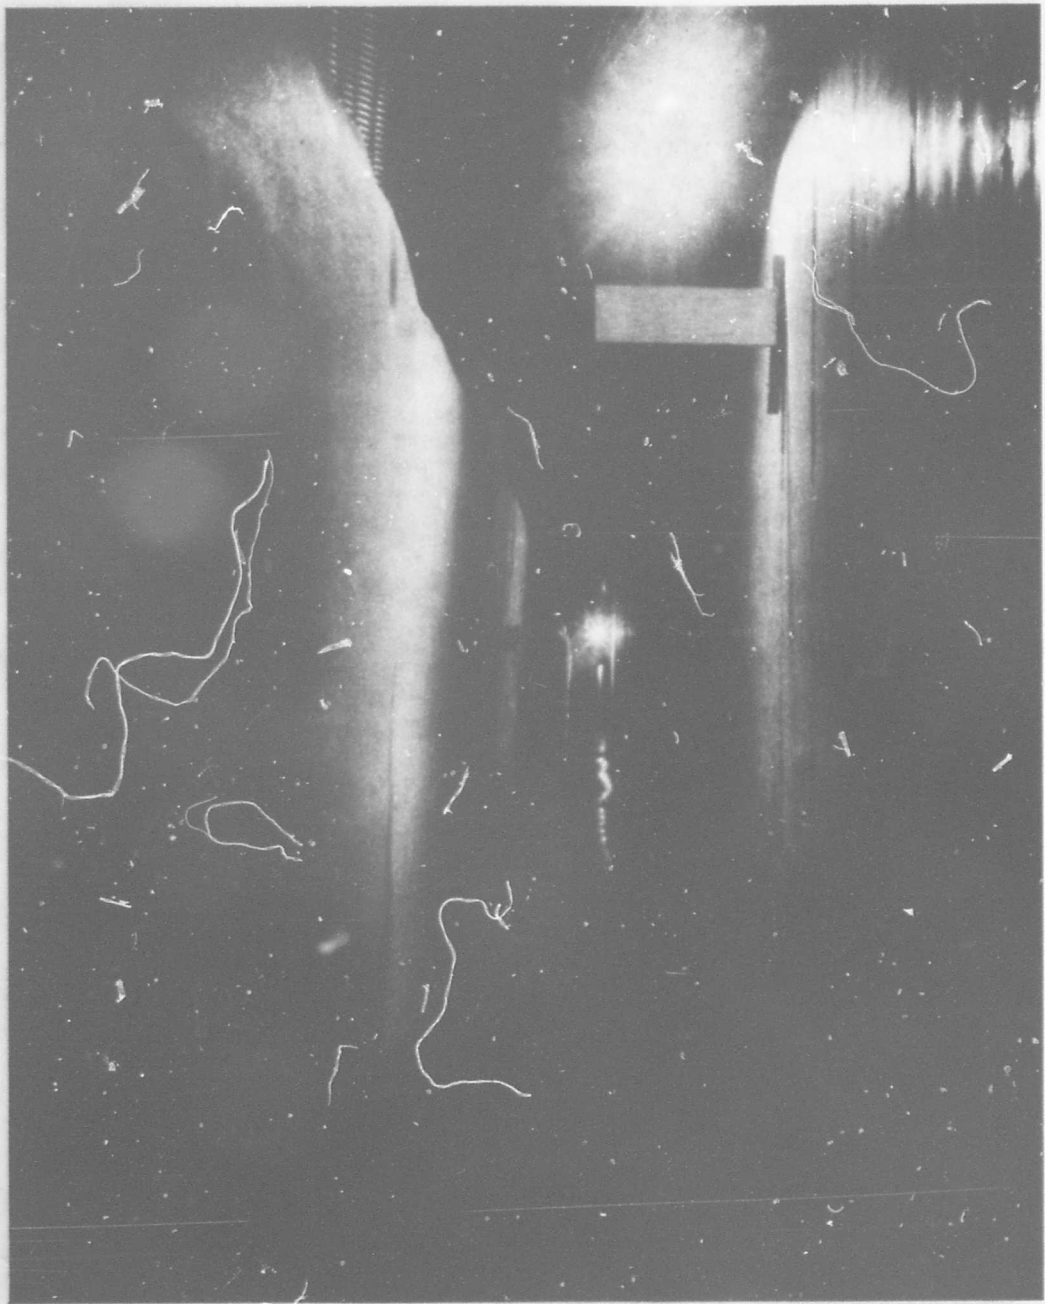
Loss of space around buildings due to inward movement of tunnel walls was corrected with extensive sidewall trimming performed by DF-65 winter-over personnel. A crew of four reportedly spent about 2 weeks trimming the walls where required. Chain saws and the NCEL trimming frame and snow-melting disposal system² were used in this work. Tunnels with low internal heat load have never been trimmed. At present all tunnel sidewalls are in good condition (Figure 6) and should not require additional work for several years.

Figure 6. Walkway on north side of quarters building in tunnel L-5. Snow walls trimmed 12 months previous.

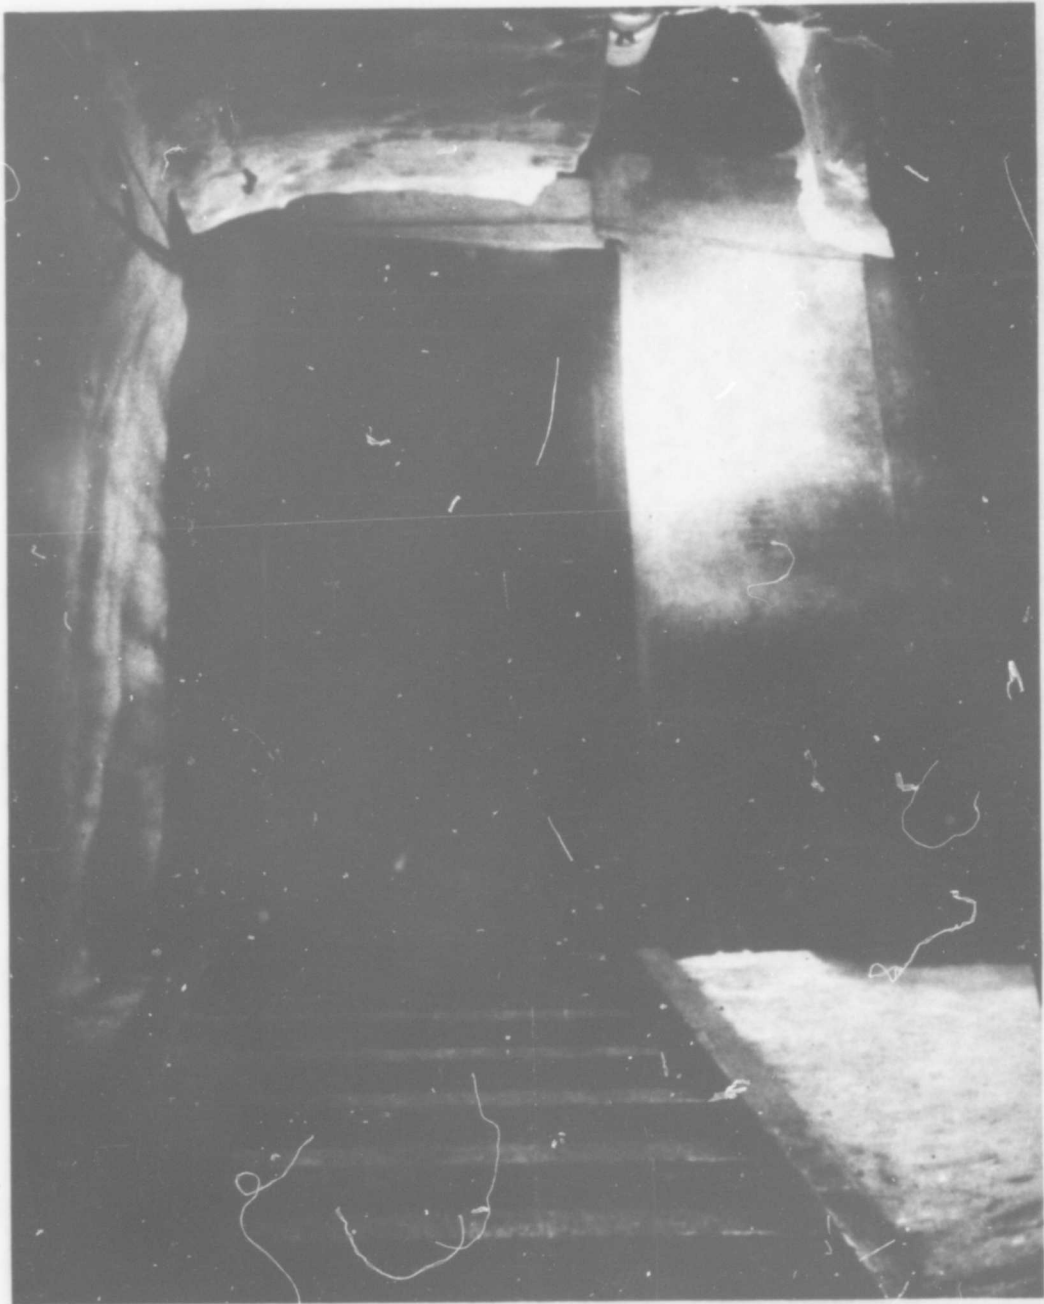
Little reduction in tunnel temperatures can be expected until the entrance and free circulation of warm surface air through the camp is eliminated. Doors at the tunnel passageways are required as well as sealing of snow bulkheads. Openings several times larger than needed now exist around utility lines penetrating these bulkheads (Figure 7).

Figure 7. Passageway from tunnel M-1 to L-5 showing door and bulkhead opening around overhead water line.
