Technical Note N-832

CATHODIC PROTECTION OF MOORING BUOYS AND CHAIN

PART II. FURTHER FIELD STUDIES

U. S. NAVAL CIVIL ENGINEERING LABORATORY  
Port Huene, California

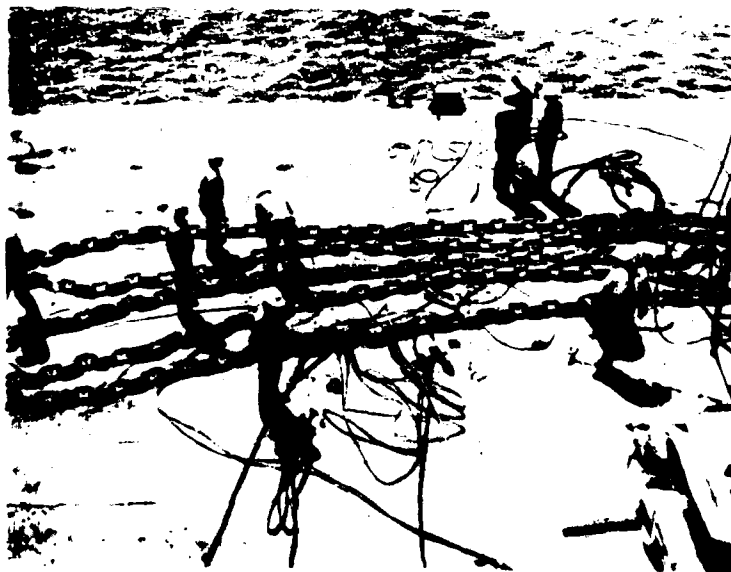
Figure 6. Ground leg on deck of floating crane showing cables threaded through it.

The ground legs on the test mooring were very tight. Frequent use of a mooring by ships tends to displace and slacken the ground legs. This would decrease electrical continuity and reduce the degree of cathodic protection. Thus use of wire cables threaded through the ground legs to provide the necessary continuity seems most desirable. The results in Table 3 indicate that Leg 4 is completely protected and the anchor is receiving nearly complete protection. Should this protection continue for a prolonged period of time, cables will be added to the other ground legs. Since the silver-soldering to chain links is time-consuming and may very slightly decrease their strength, consideration will be given to the use of screw-fitting connectors to join the cable to chain links.
