WT-1454

OPERATION
PLUMB BOB

Project 30.7

TEST OF GERMAN UNDERGROUND
PERSONNEL SHELTERS

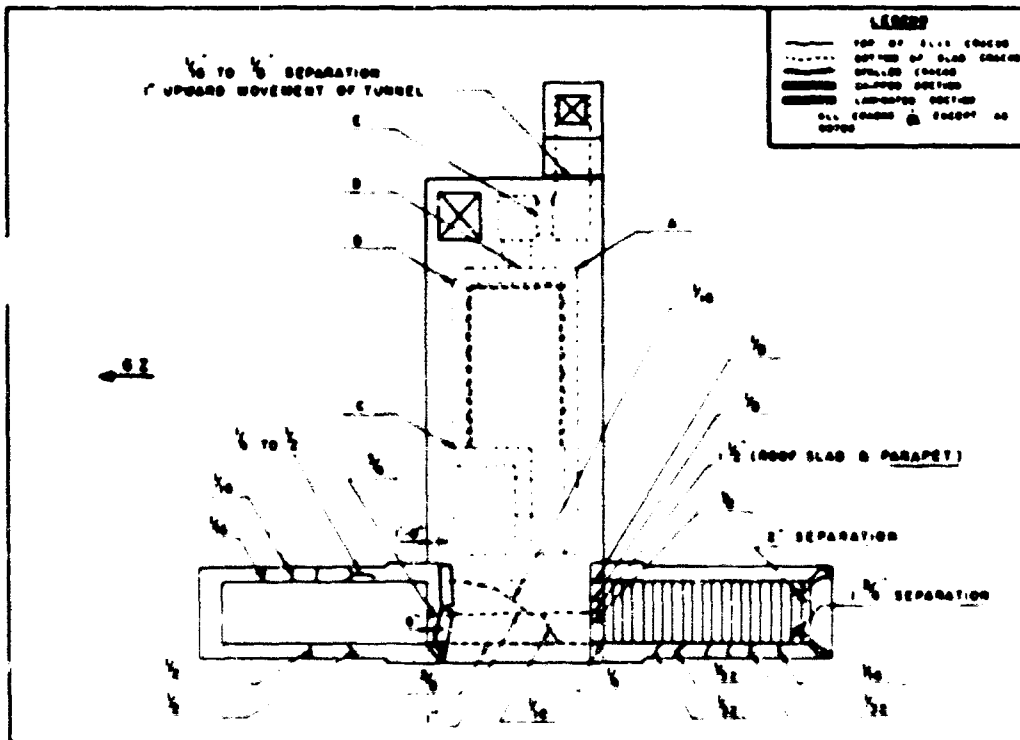
(c) *Main Chamber.* Hairline cracks were formed at the intersection of the roof slab and the haunches along the rear and side walls of the main chamber. The intersection of the walls located at points A, B, and C of Fig. 3.1 had continuous hairline cracks the full height of the walls. Diagonal hairline cracks were formed at the four corners of the door opening located at point D. Numerous transverse and longitudinal hairline cracks were produced on the floor slab of the main chamber. No cracks were present in the floor slab of the main chamber adjacent to the main seal door.

Fig. 3.1—Roof-slab crack pattern (structure RAa).

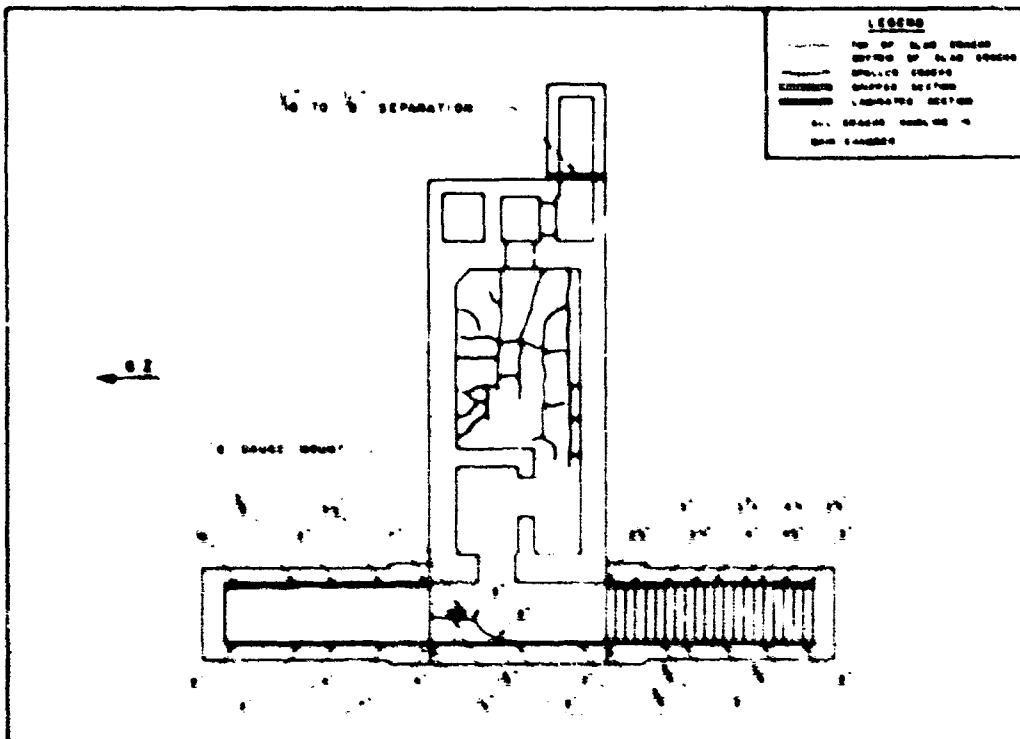
Fig. 3.2—Floor-slab crack pattern (structure RAa).

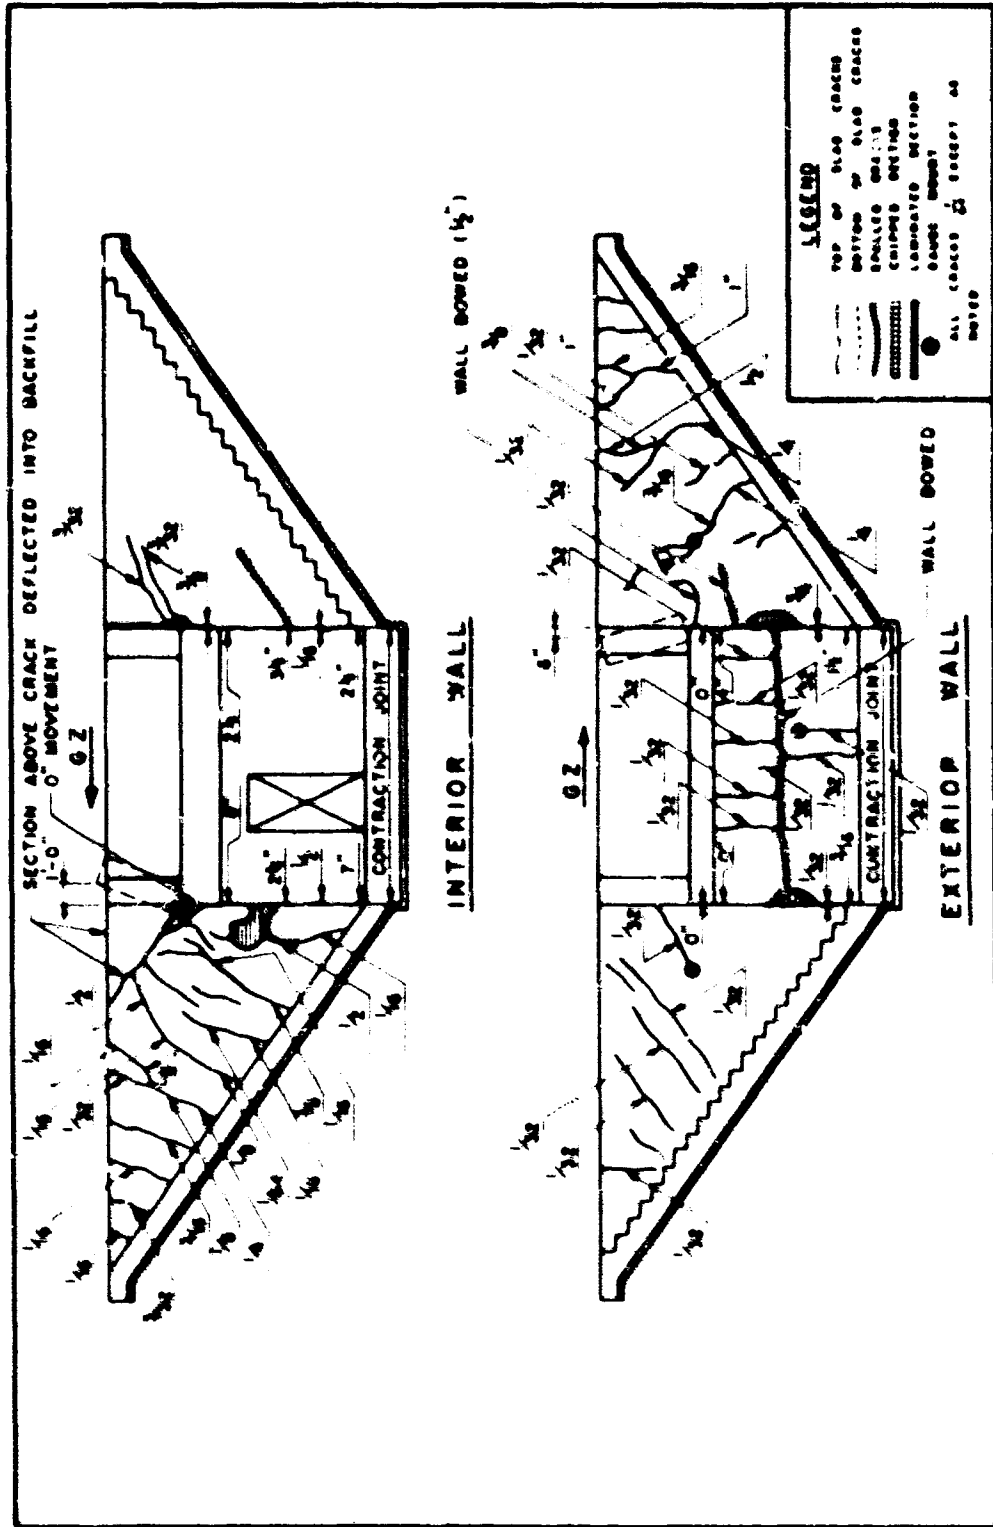
(a) *Entranceways.* In the ramp entrance facing GZ separations formed at the intersections of the interior and exterior walls with the ramp slab. The interior wall was pulled away from the slab 7 in. at the bottom and $\frac{1}{16}$ in. at the top of the ramp. The intersection of the ramp and exterior wall was similar to that at the interior wall; that is, the crack varied from 4 to 7 in. near the bottom to zero inches at the top of the ramp. Bowing of the interior wall into the backfill was produced at the quarter-height along the contraction joint. A $\frac{1}{16}$ - to $\frac{1}{2}$ -in. vertical crack was formed near the bottom of the ramp. This crack terminated at a laminated area located at the mid-height of the wall. There was spalling on both sides at the upper section of the crack. Cracks varying from $\frac{1}{16}$ to $\frac{3}{8}$ in. in width, perpendicular to the plane of the ramp, were located approximately 2 ft on center along the length of the wall. The majority of these cracks ran the full height of the wall. A crack starting at a chipped-out section located at the intersection of the end of the roof slab and the interior wall ran diagonally toward the top of the wall. The section of the wall above this crack was deflected back into the fill. The exterior wall damage was similar to that described for the interior wall. A chipped section of the exterior ramp wall was located approximately 4 ft above the landing at the contraction joint. A horizontal crack, with spalling on both sides, above this section produced a $\frac{1}{2}$ -in. bow in this wall. There were numerous diagonal cracks perpendicular to the plane of the ramp located approximately 2 to 3 ft on center in the upper two-thirds of wall. These cracks varied in size from $\frac{1}{32}$ to 1 in. in width. The top of the parapet located above the landing roof slab that faces GZ was deflected into the backfill 6 in. at the intersection of the exterior wall and 1 ft at the interior wall. The corners of the parapet and side walls were chipped, and the reinforcement was exposed.

Fig. 3.3—Entrance crack pattern (structure RAa).

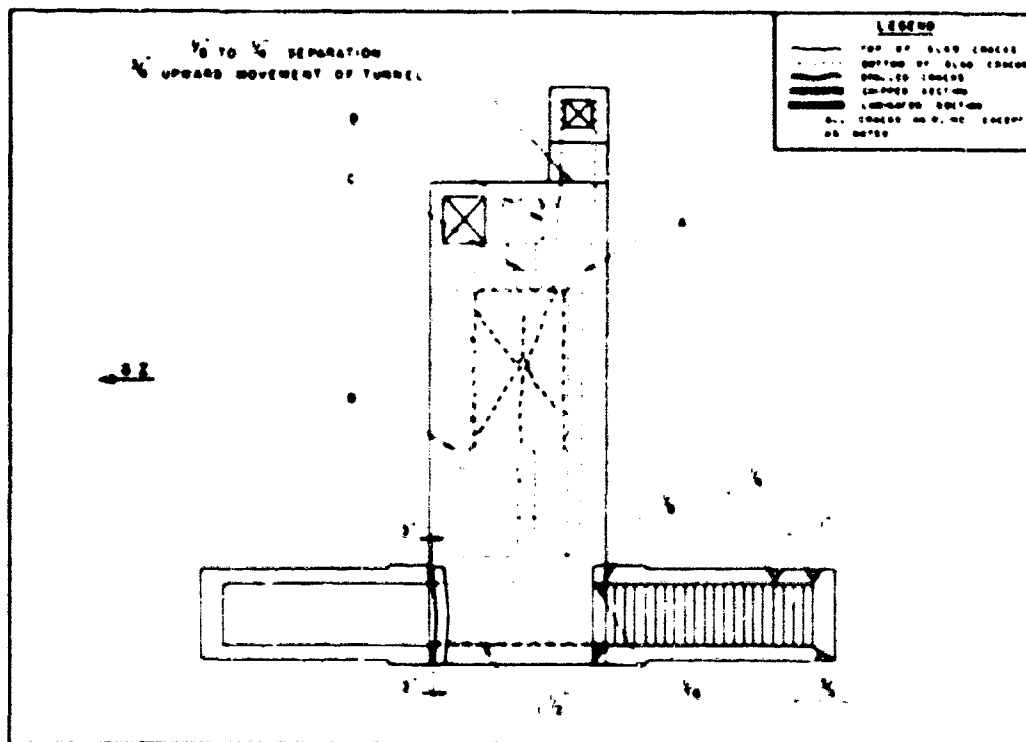
Fig. 3.25—Roof-slab crack pattern (structure RAb).

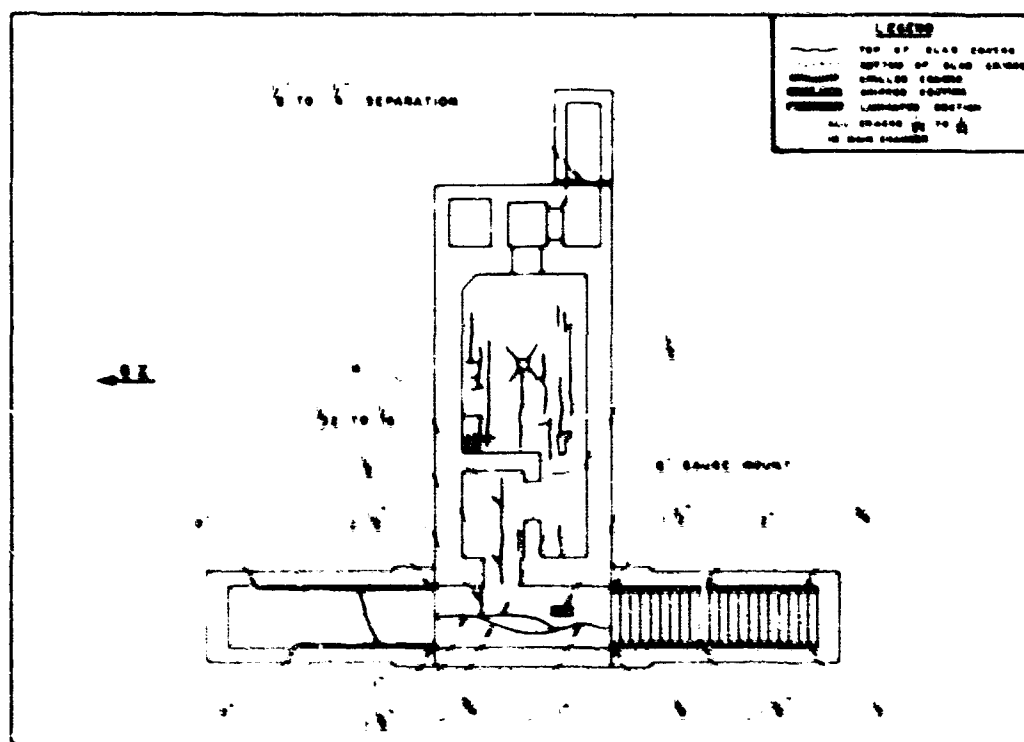
Fig. 3.26—Floor-slab crack pattern (structure RAS).

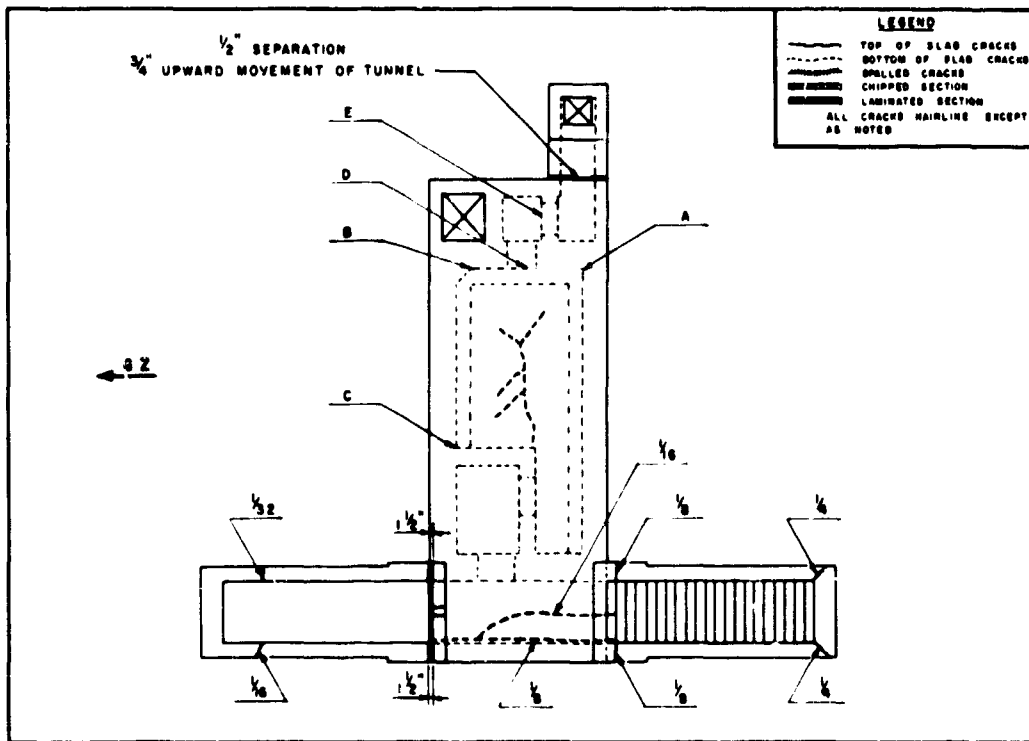
Fig. 3.33—Roof-slab crack pattern (structure RAc).

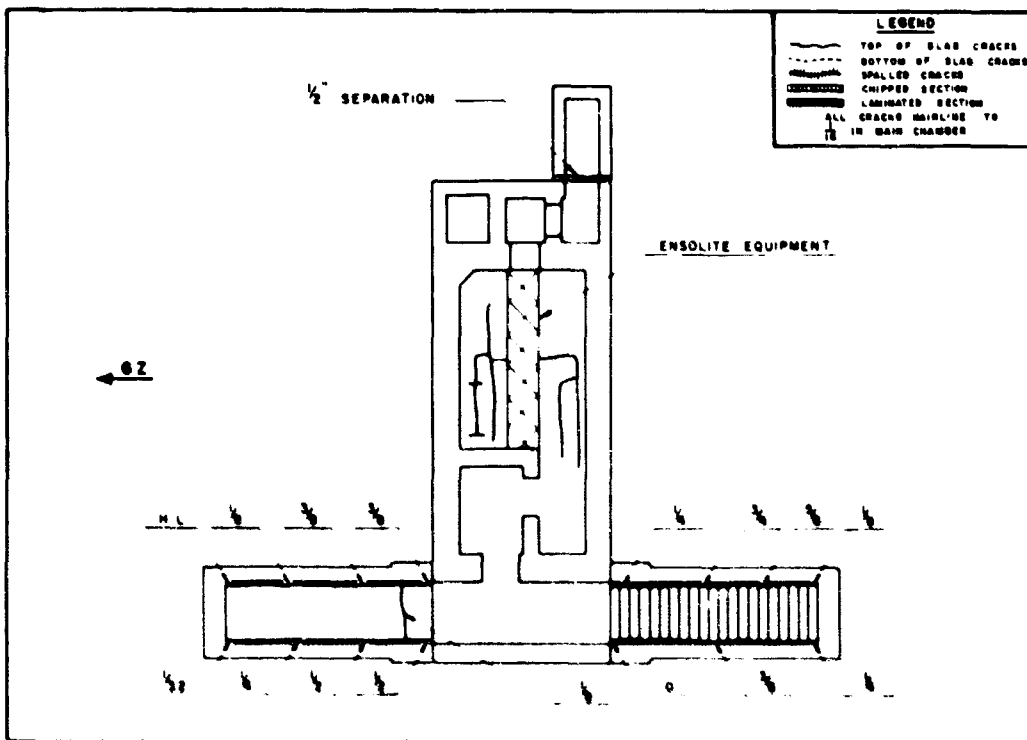
Fig. 3.34—Floor-slab crack pattern (structure RAc).

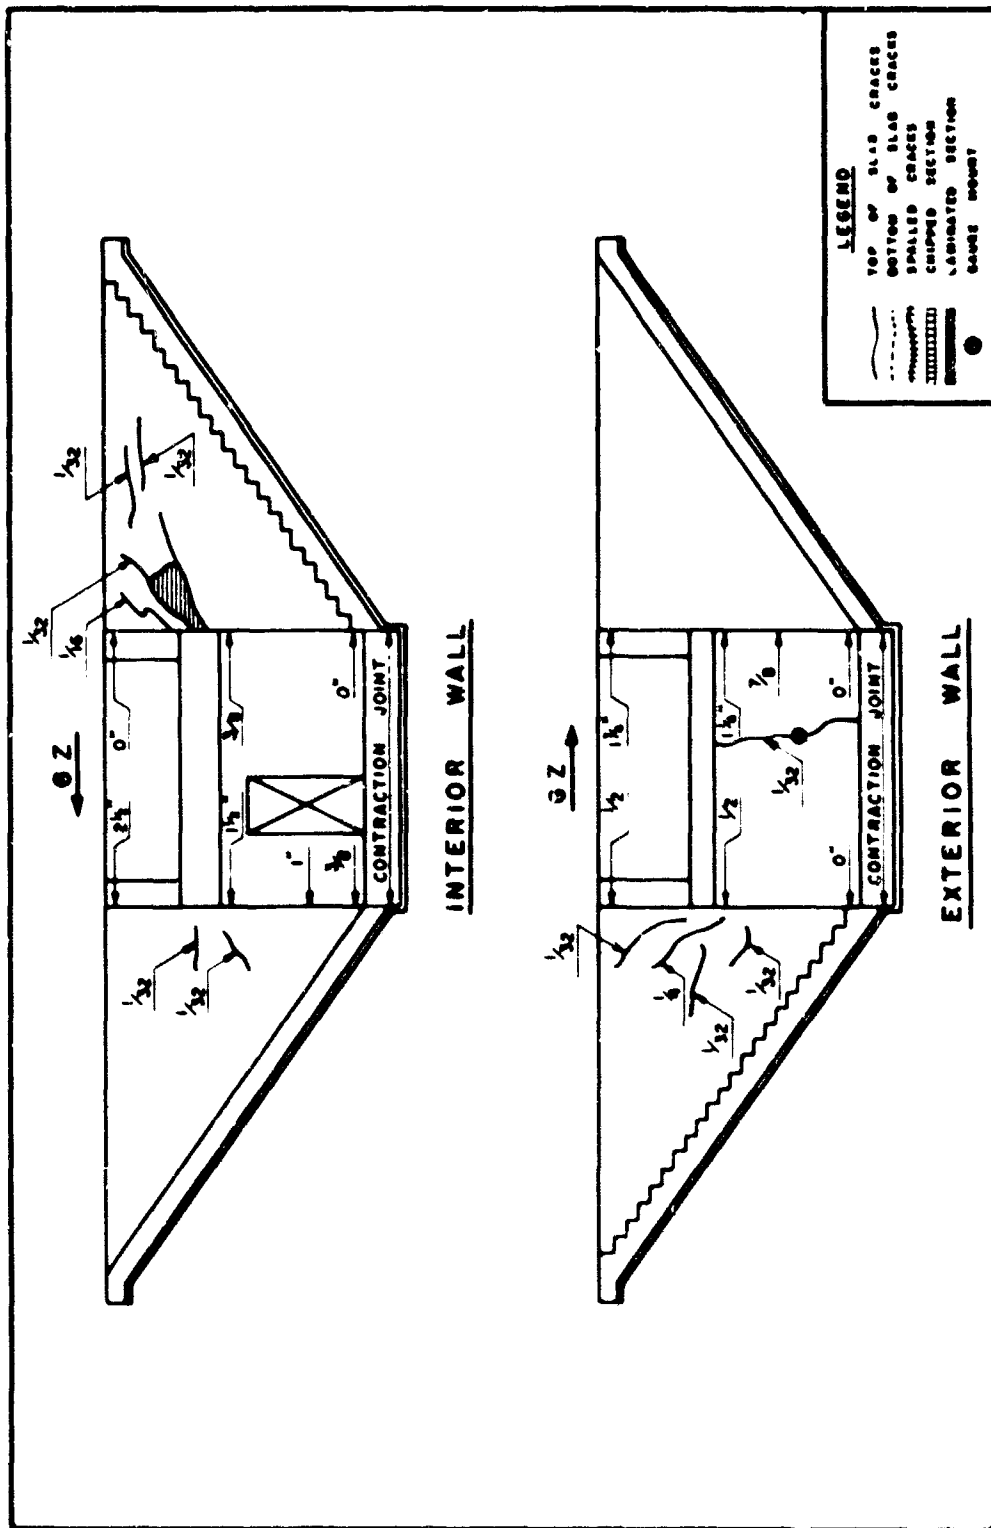
Fig. 3.35—Entrance crack pattern (structure RAc).

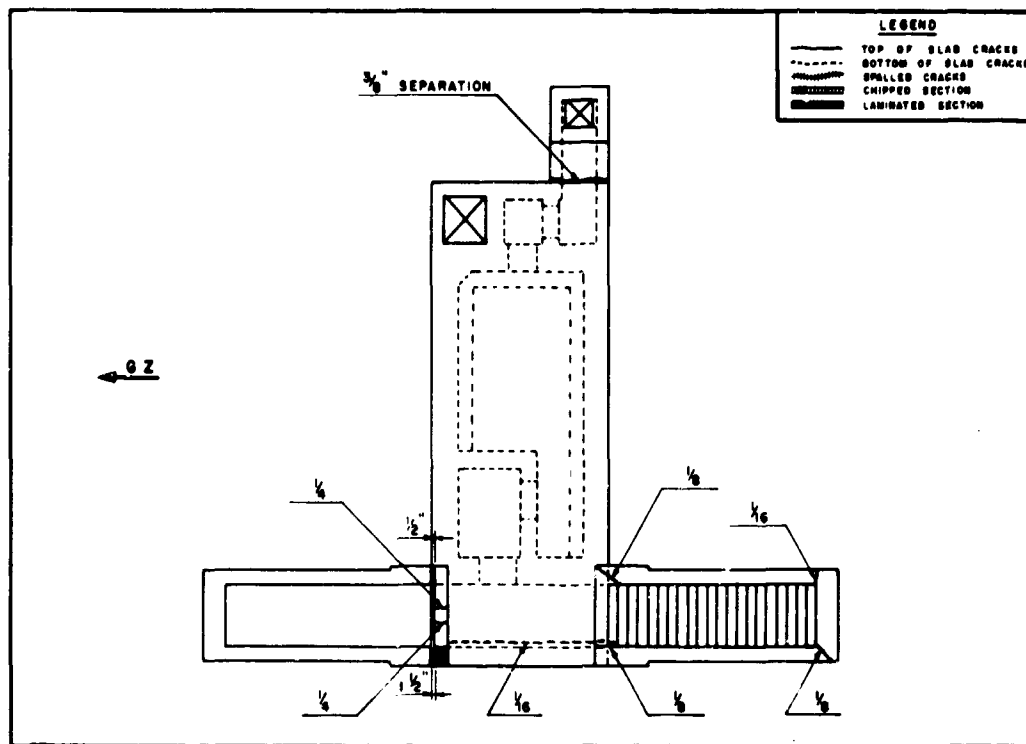
Fig. 3.54—Roof-slab crack pattern (structure RAD).

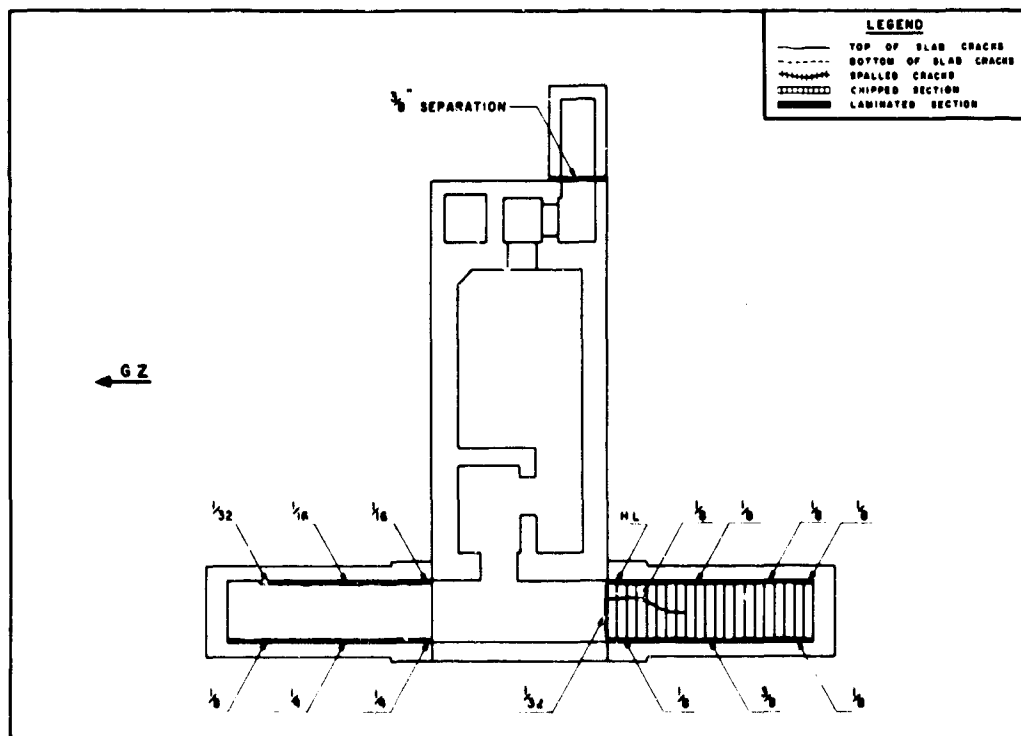
Fig. 3.55—Floor-slab crack pattern (structure RAD).

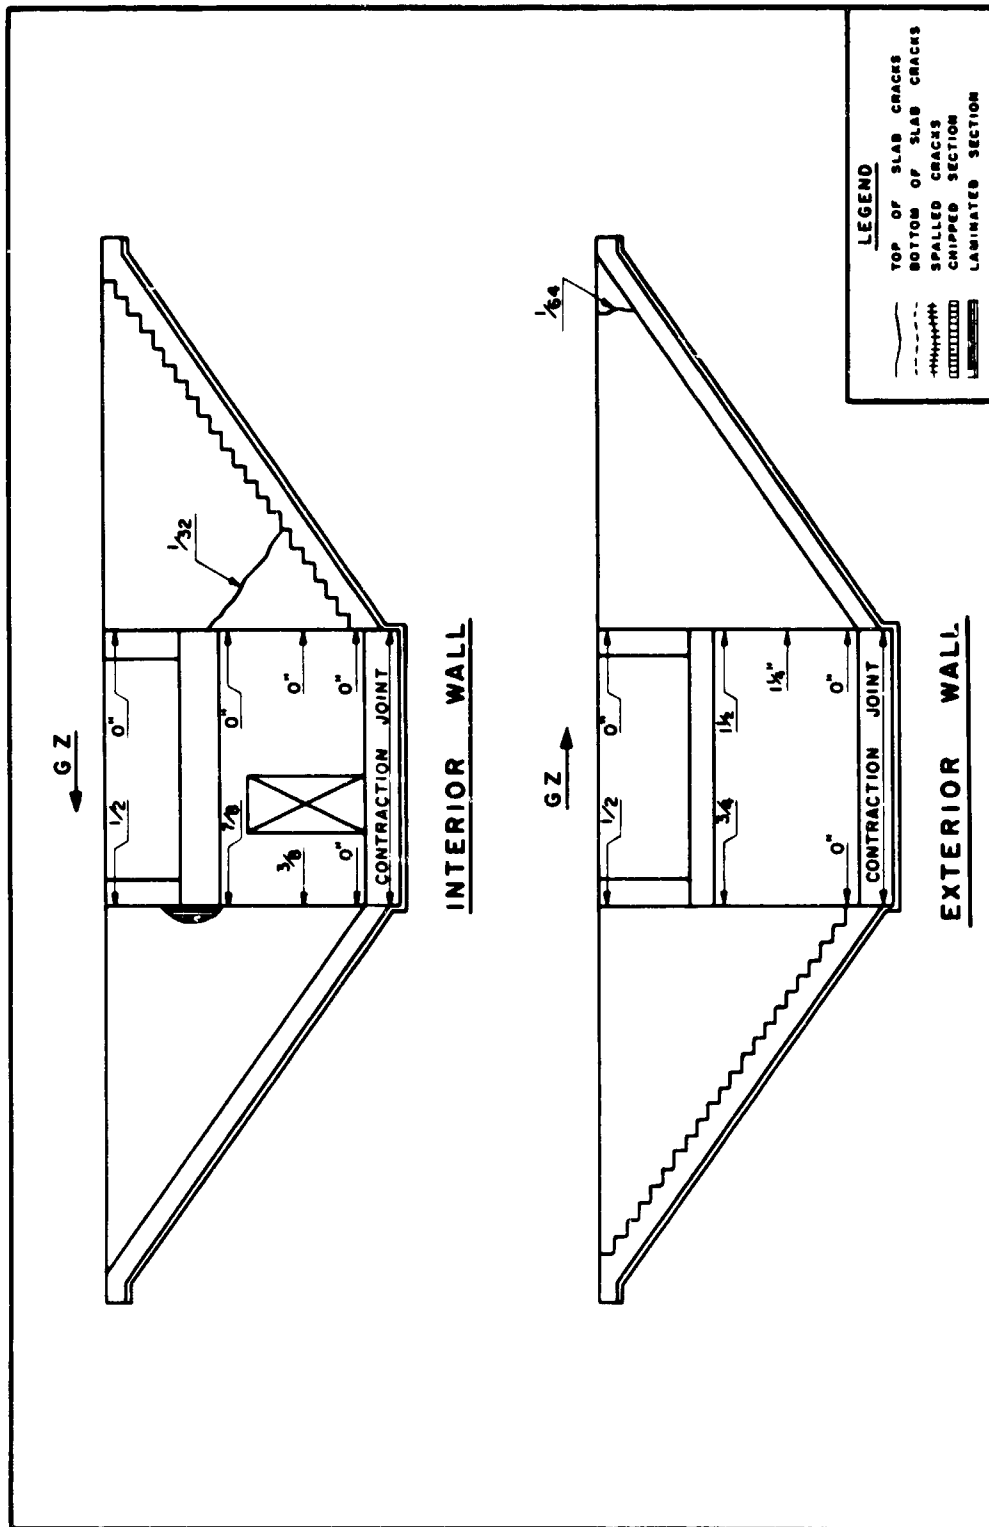
Fig. 3.56—Entrance crack pattern (structure RAD).

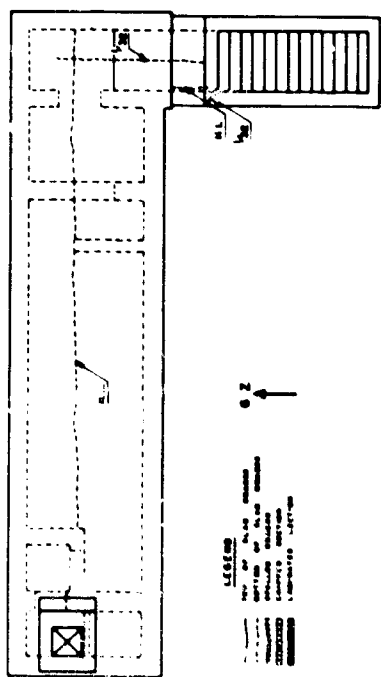
Fig. 3.58—Roof-slab crack pattern (structure CAAs).

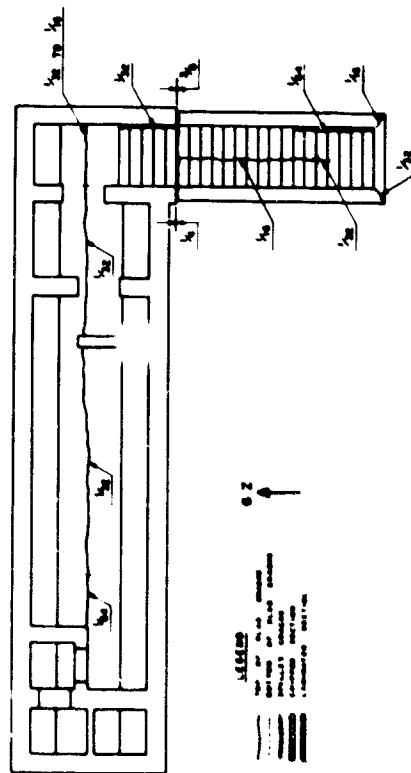
Fig. 3.59—Floor-slab crack pattern (structure CAAs).

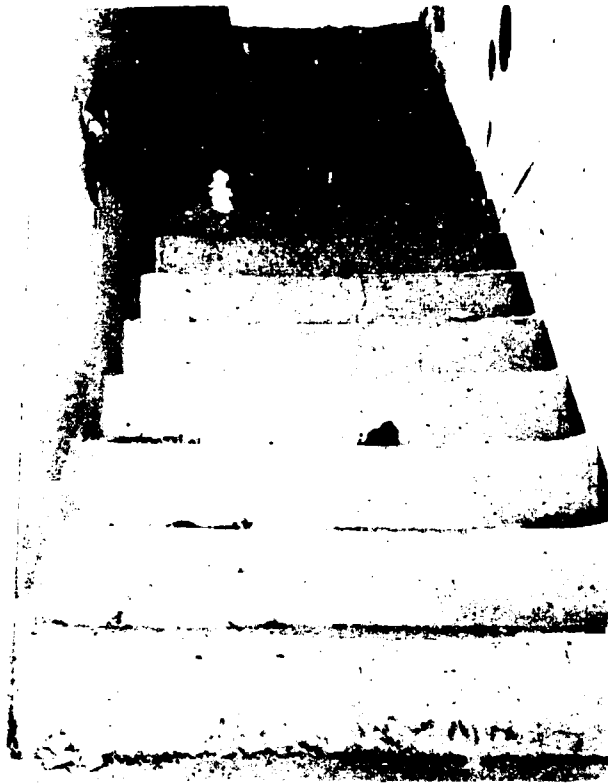
Fig. 3.71—Looking up stairs facing away from GZ (structure CAa). Note crack running up stairs and separation of construction joint.

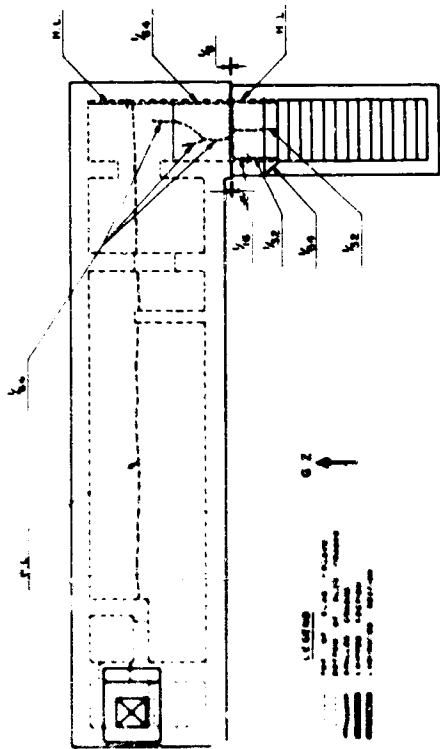
Fig. 3.73—Roof-slab crack pattern (structure CAb).

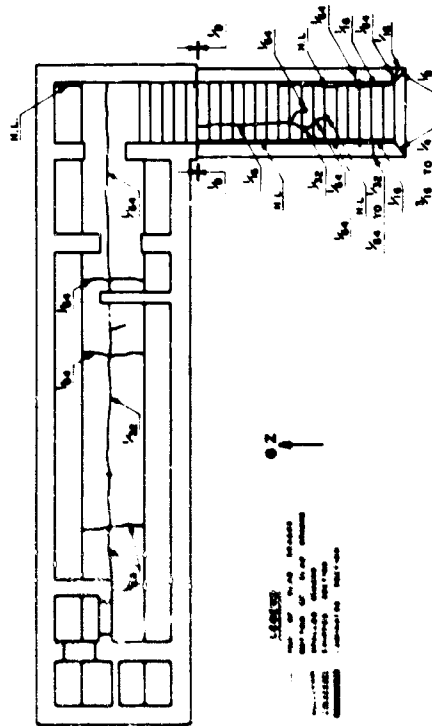
Fig. 3.74—Floor-slab crack pattern (structure CAb).

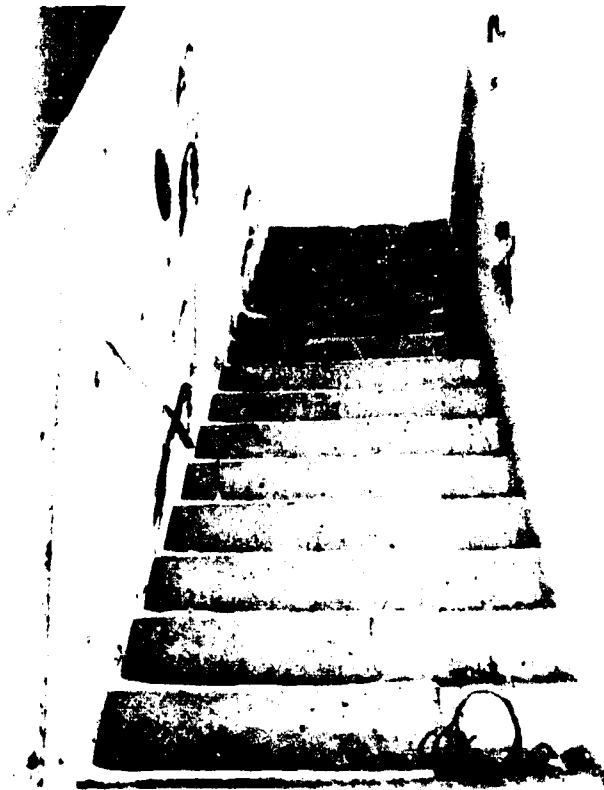
Fig. 3.80—Looking up stairs facing away from GZ (structure CAB). Note crack running up stairs.

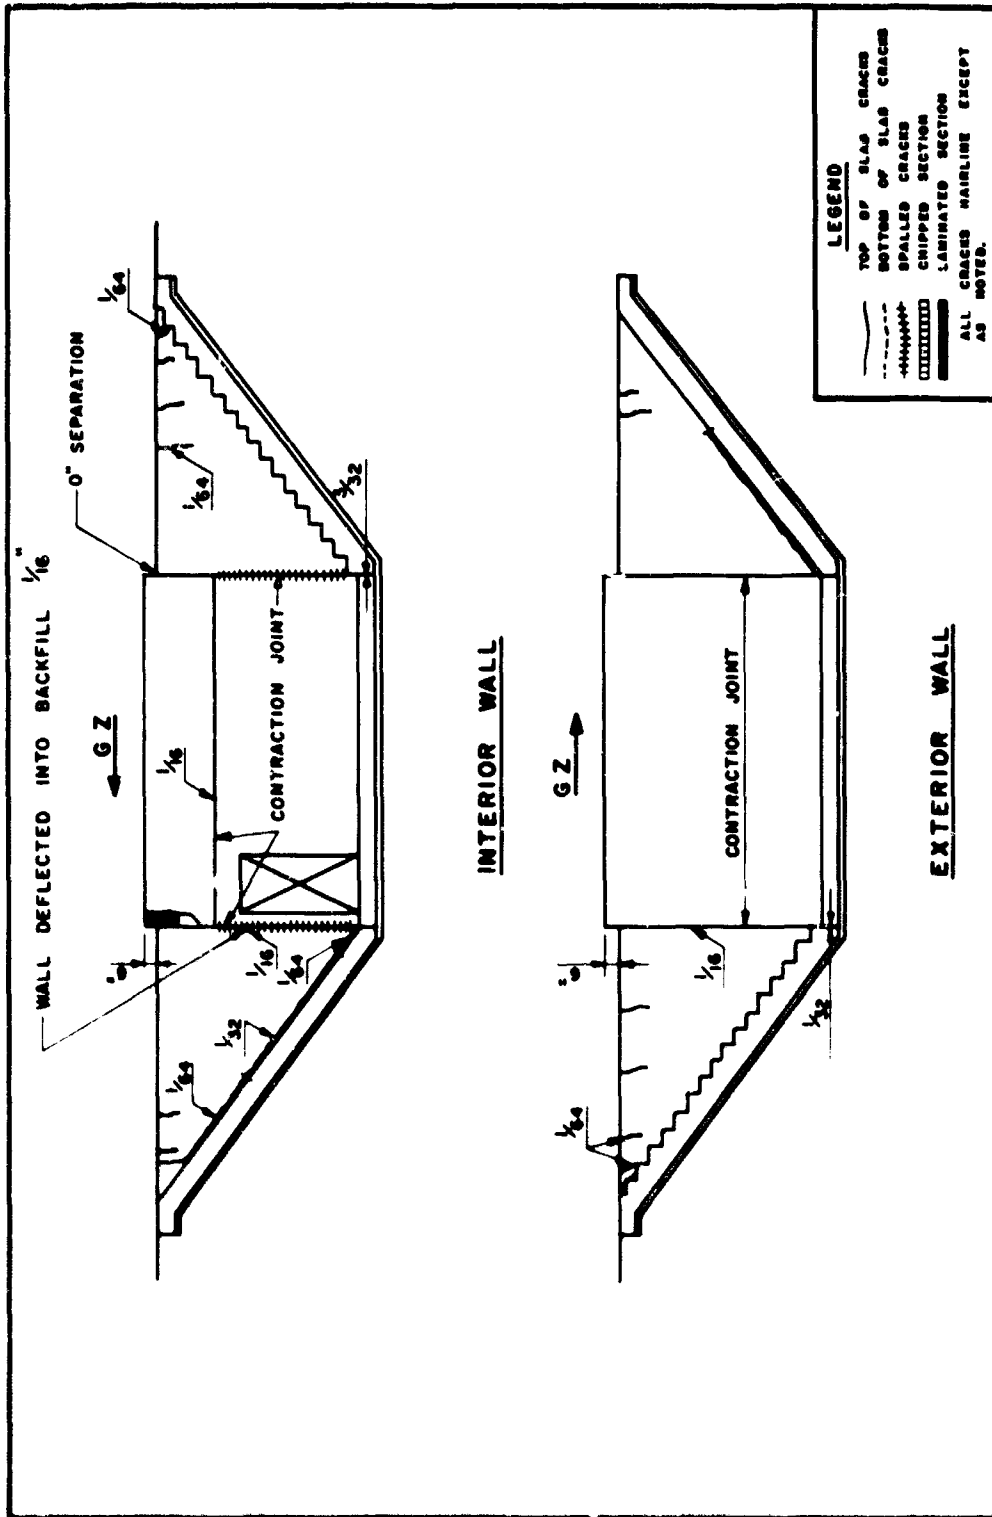
Fig. 3.84—Entrance crack pattern (structure RCa).

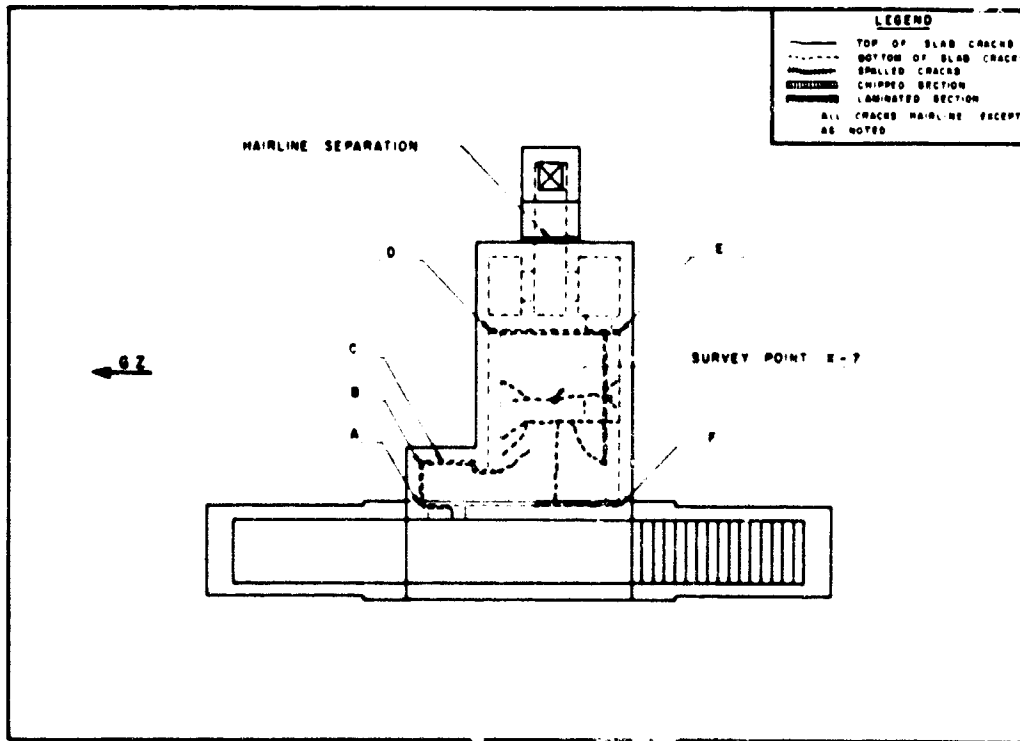
Fig. 3.92—Roof-slab crack pattern (structure RCb).

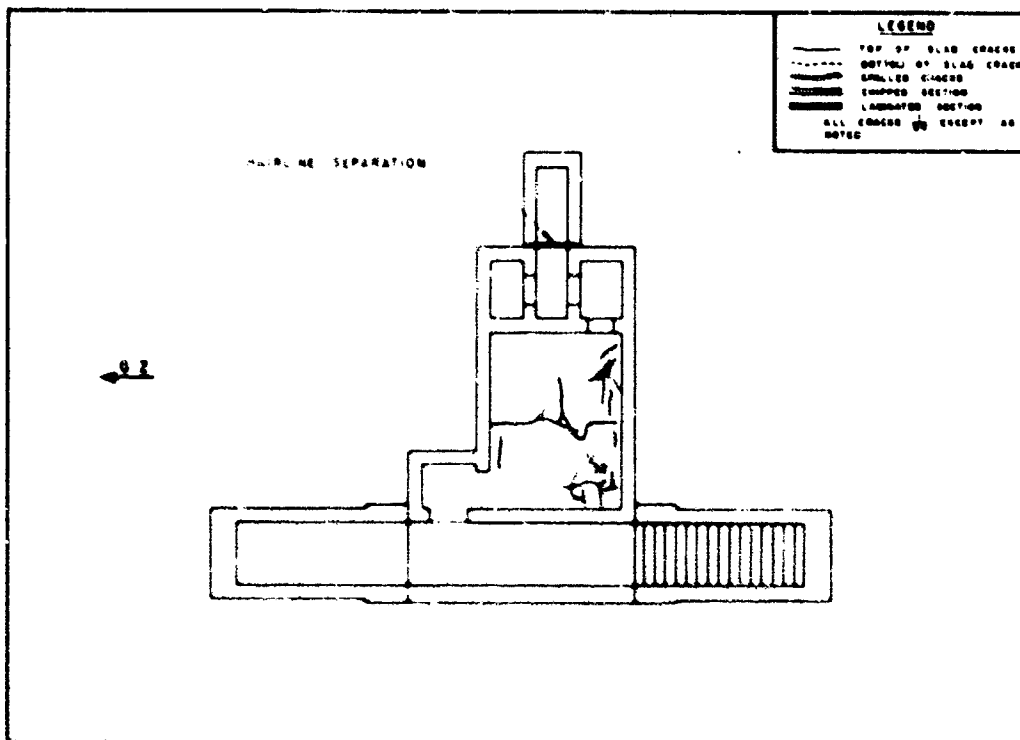
Fig. 3.93—Floor-slab crack pattern (structure RCb).

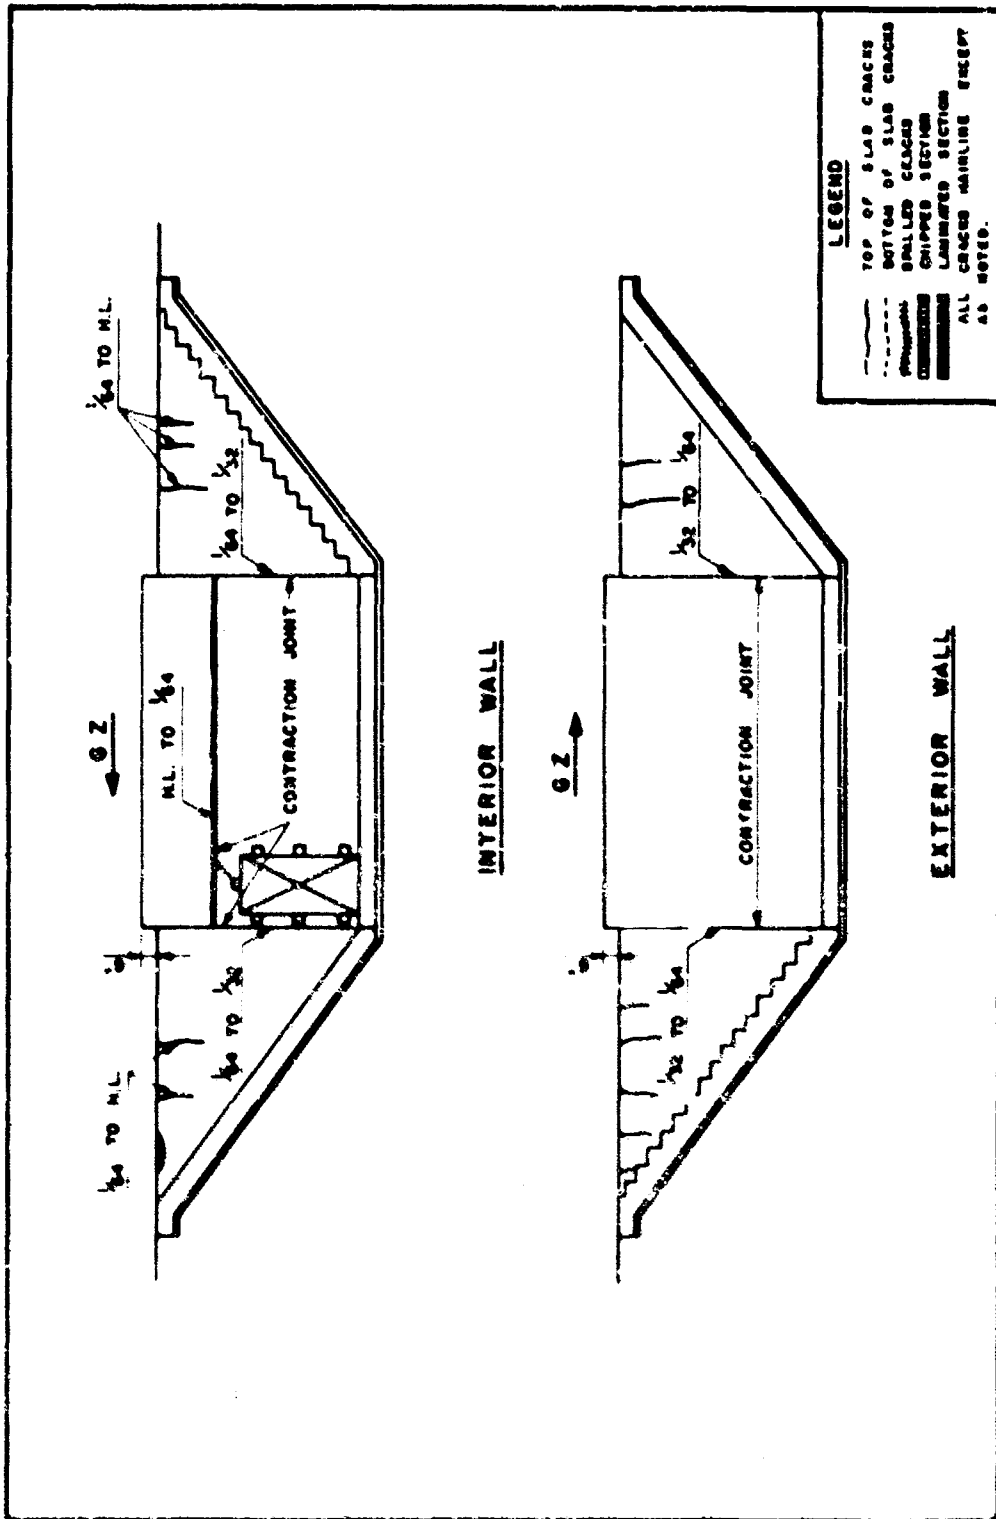
Fig. 3.34—Extrance crack pattern (structure KCb).

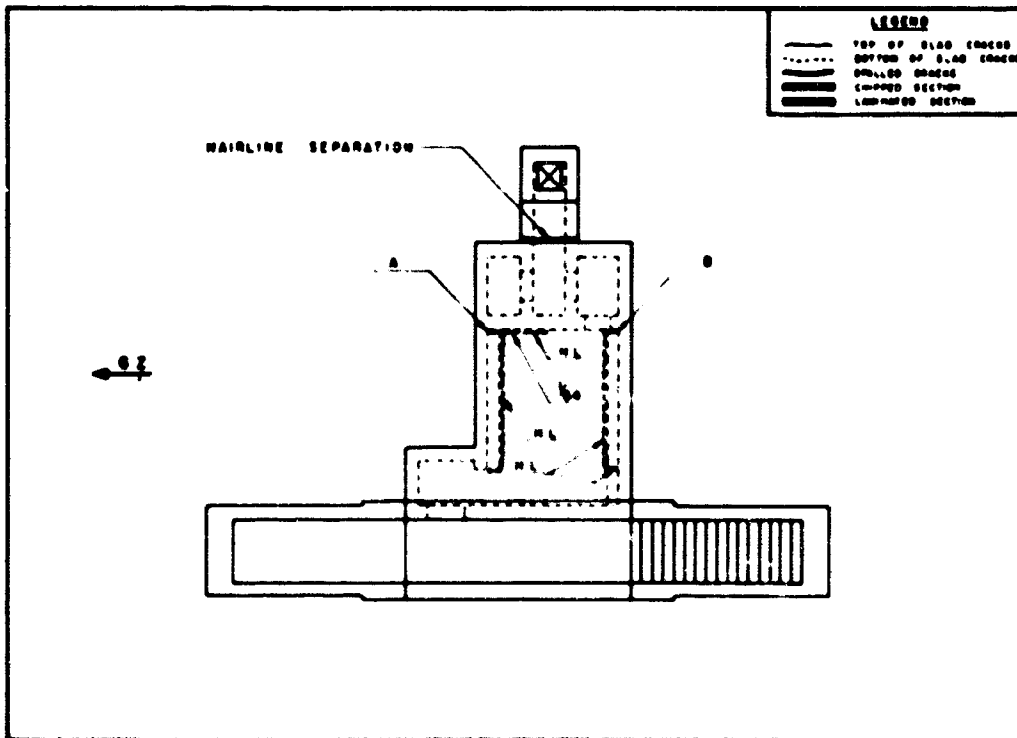
Fig. 3.99—Roof-slab crack pattern (structure RCc).

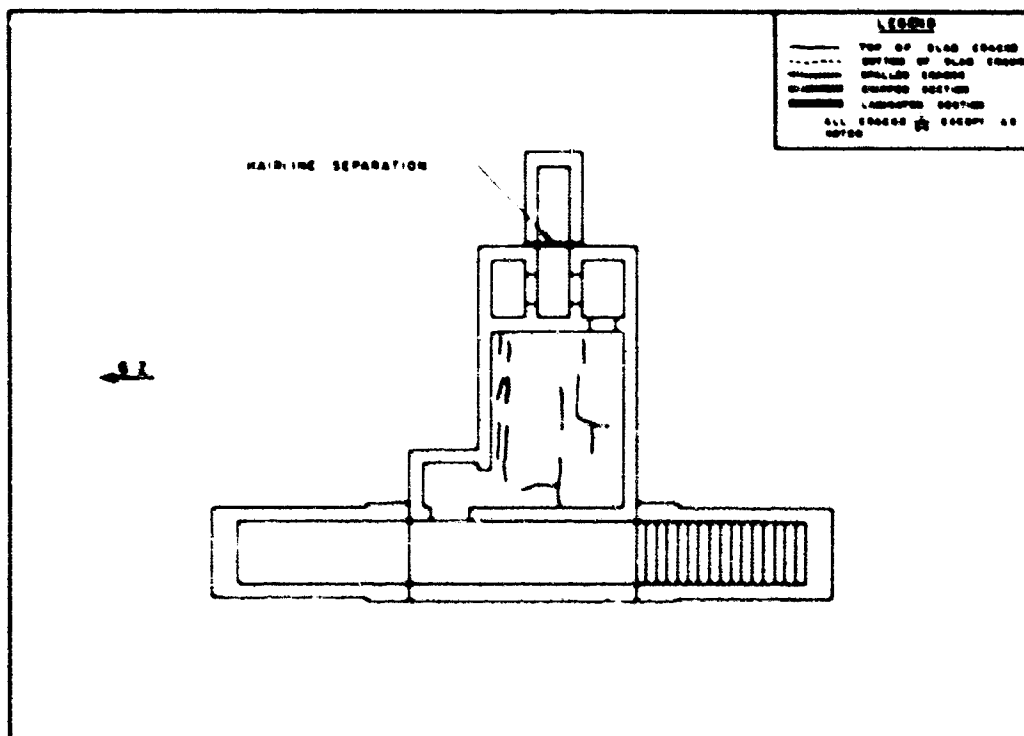
Fig. 3.100—Floor-slab crack pattern (structure RCc).

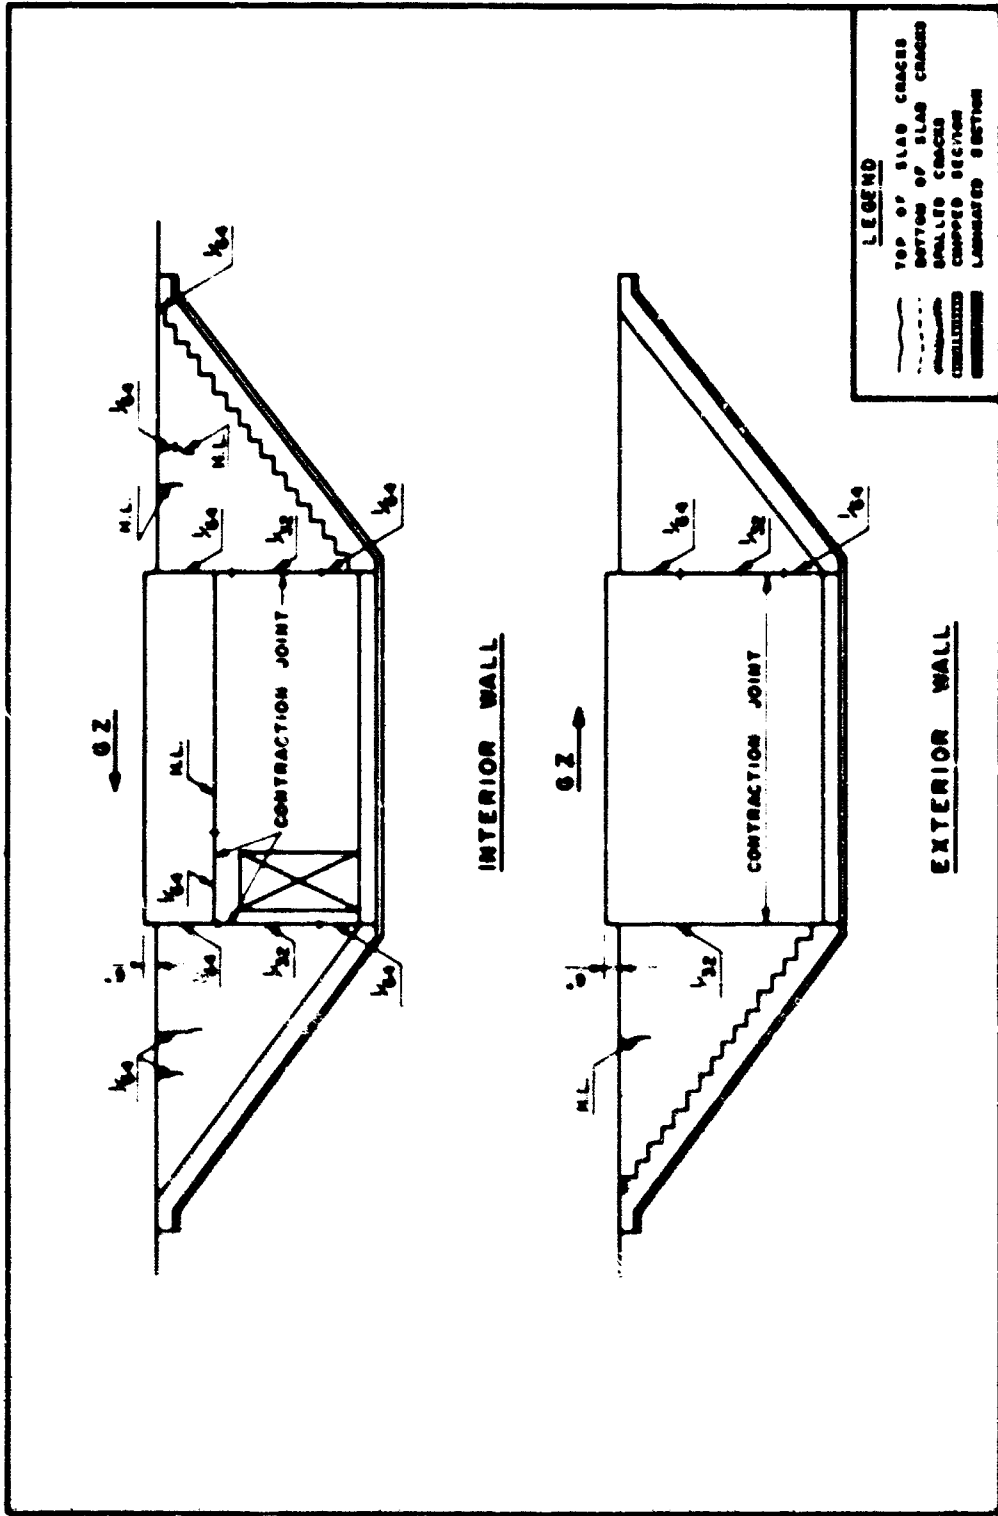
Fig. 3.101 — Entrance crack pattern (structure RCc).
