FINAL REPORT  
(YSB Interim Report R6-1-0469)

ENVIRONMENTAL EXPOSURE OF  
SAMPLE MODEL MARINE FUEL TANKS

UL ASSIGNMENT 65WW63  
File MM-36

DATE: 27 February 1970

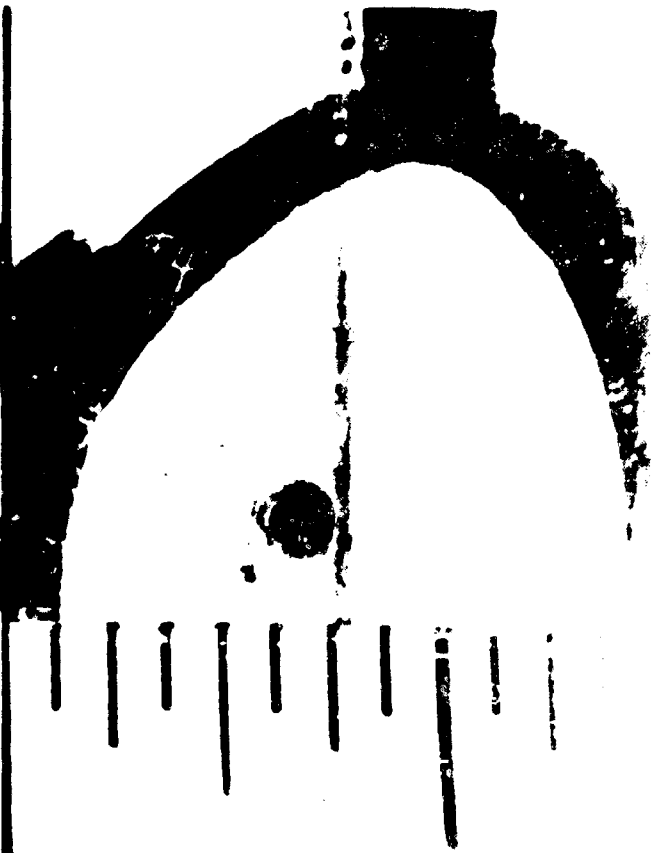
Final Inspection Report  
FIG. NO. 29

Upper surface of tank, before removal of sea water reservoir, shows stains and pitted areas near suction and vent fittings. Lower surface shows pits and corrosion spots in "open" areas. See Fig. No. 30 for representative corrosion.

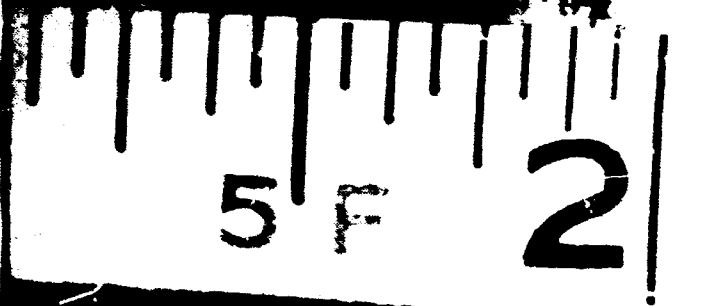
Final Inspection Report  
FIG. NO. 42

Upper and lower surfaces of tank show generally good condition except for corrosion build-up near fittings and along longitudinal welded seam. See Fig. No. 43.

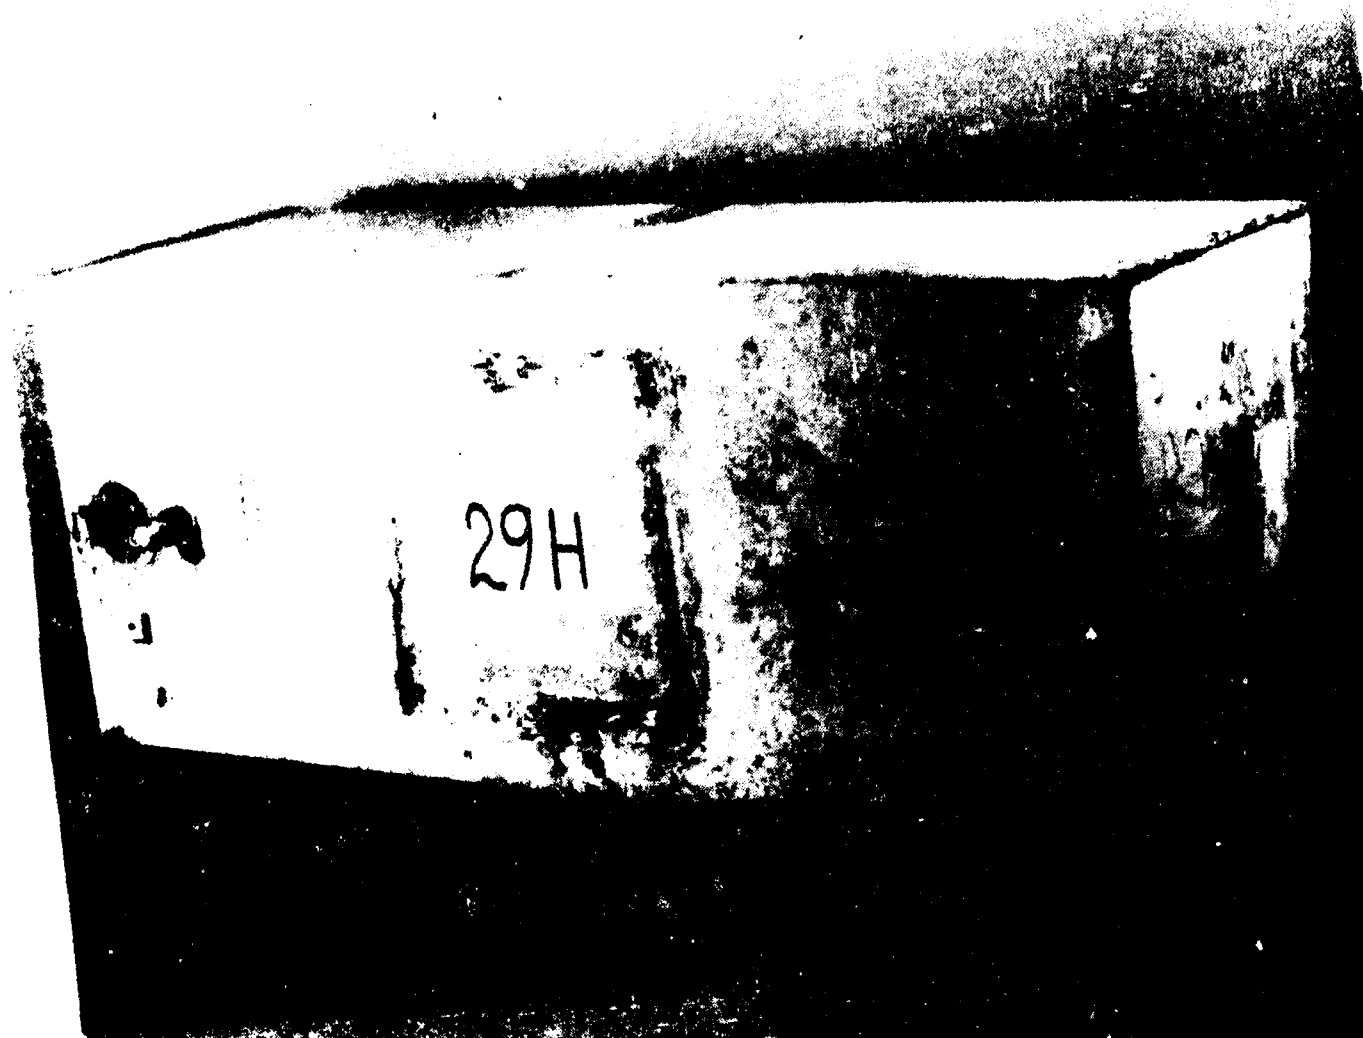
Final Inspection Report  
FIG. NO. 54

Tank, in general, is in good condition. There is heavy rust in way of end closure flange, which is painted after welding has destroyed local zinc coating. However, thickness of metal at this point is ample to permit considerably longer exposure of this type without failure.

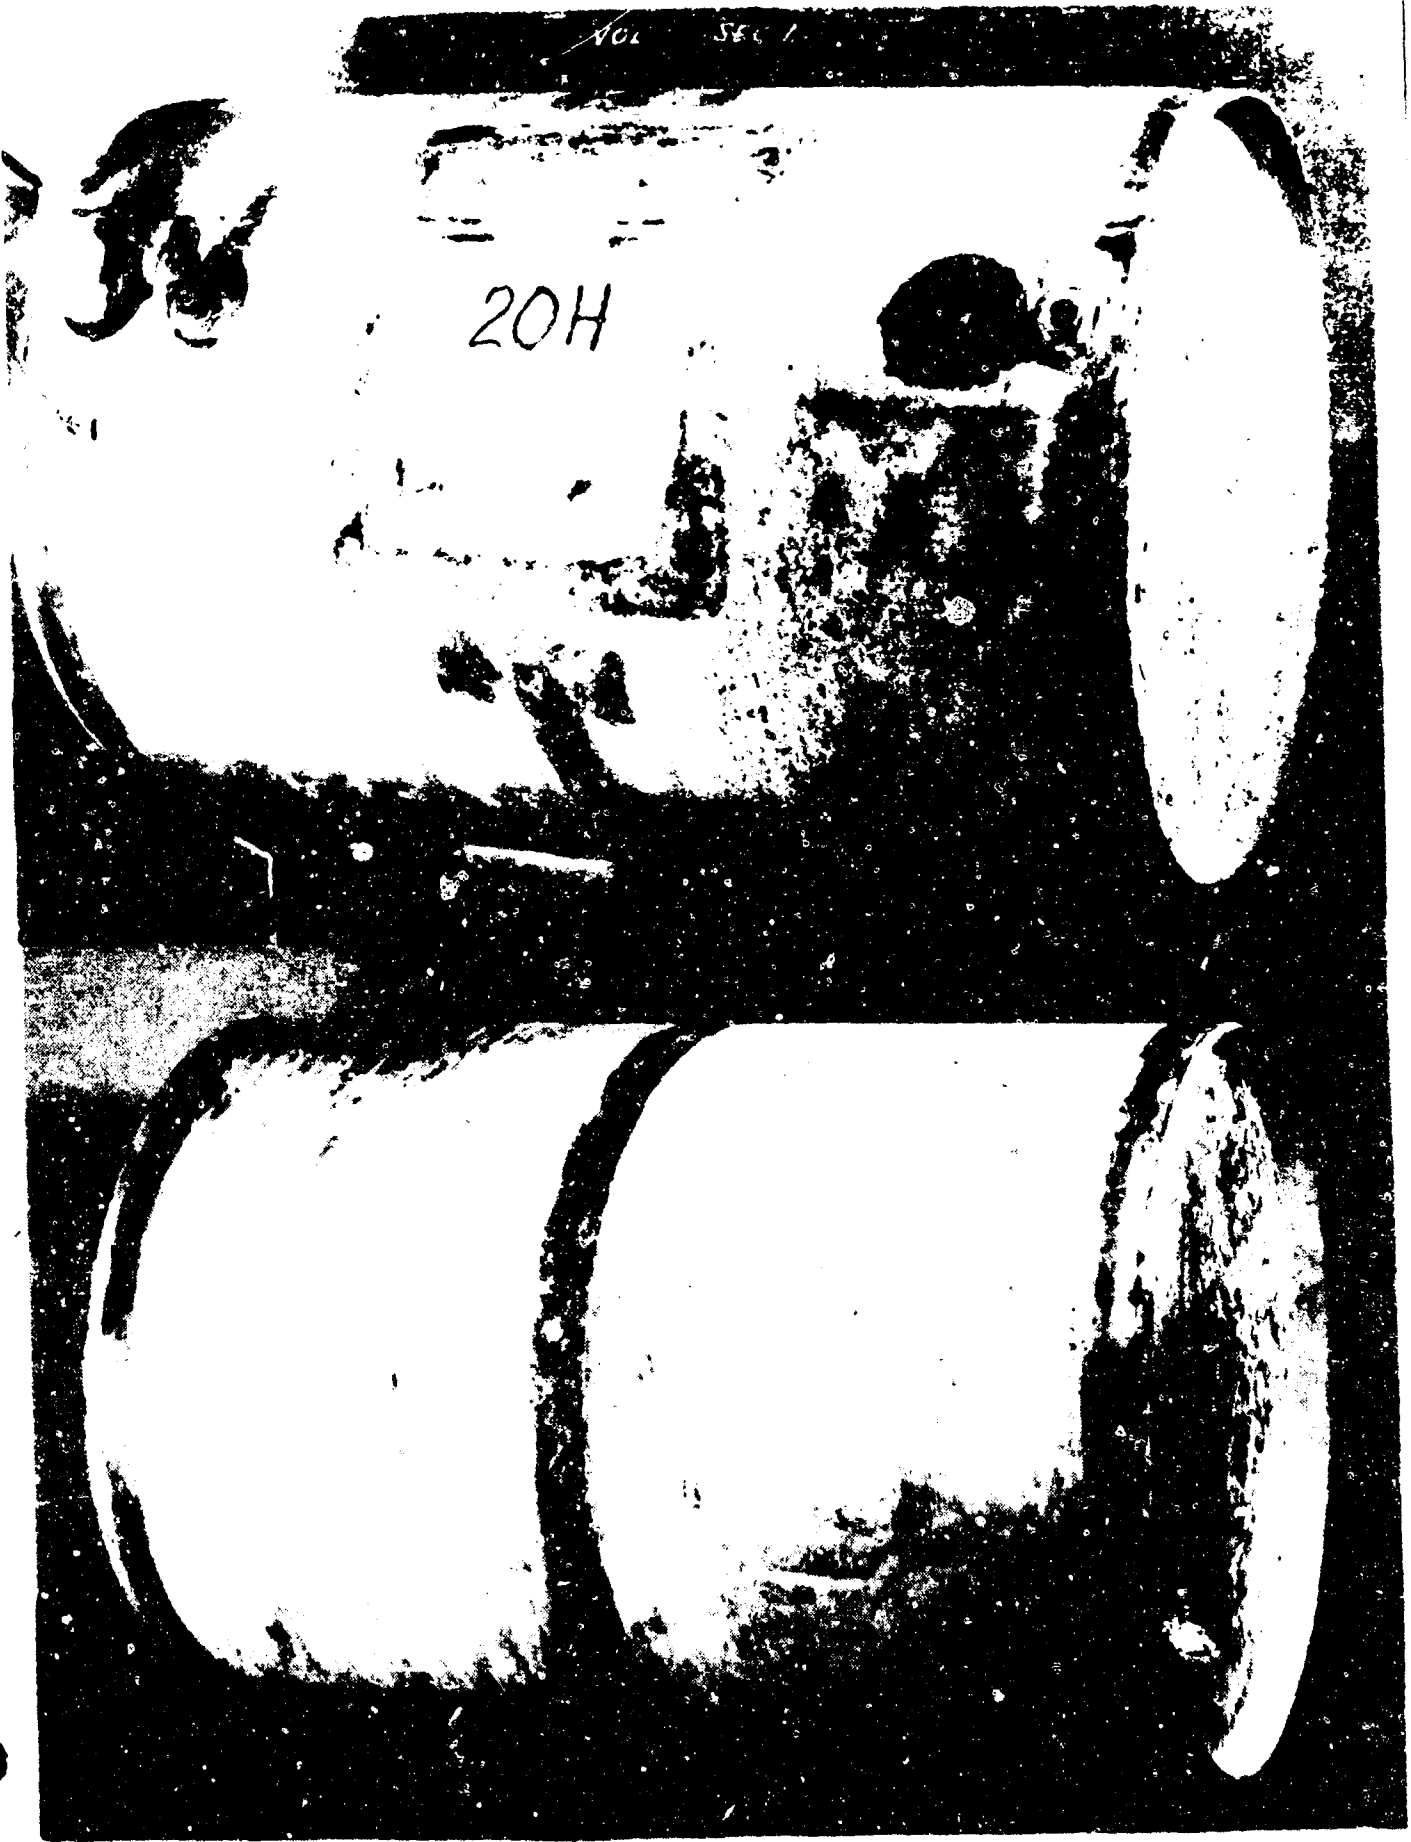
Final Inspection Report  
FIG. NO. 56

Upper and lower surfaces of tank show characteristic "chalking" of sacrificial zinc coating. Dark areas show protection from environment provided by chock liners and hold-down straps. Aside from the fuel level transmitter plate, the only area of corrosion is in way of the painted end flange.

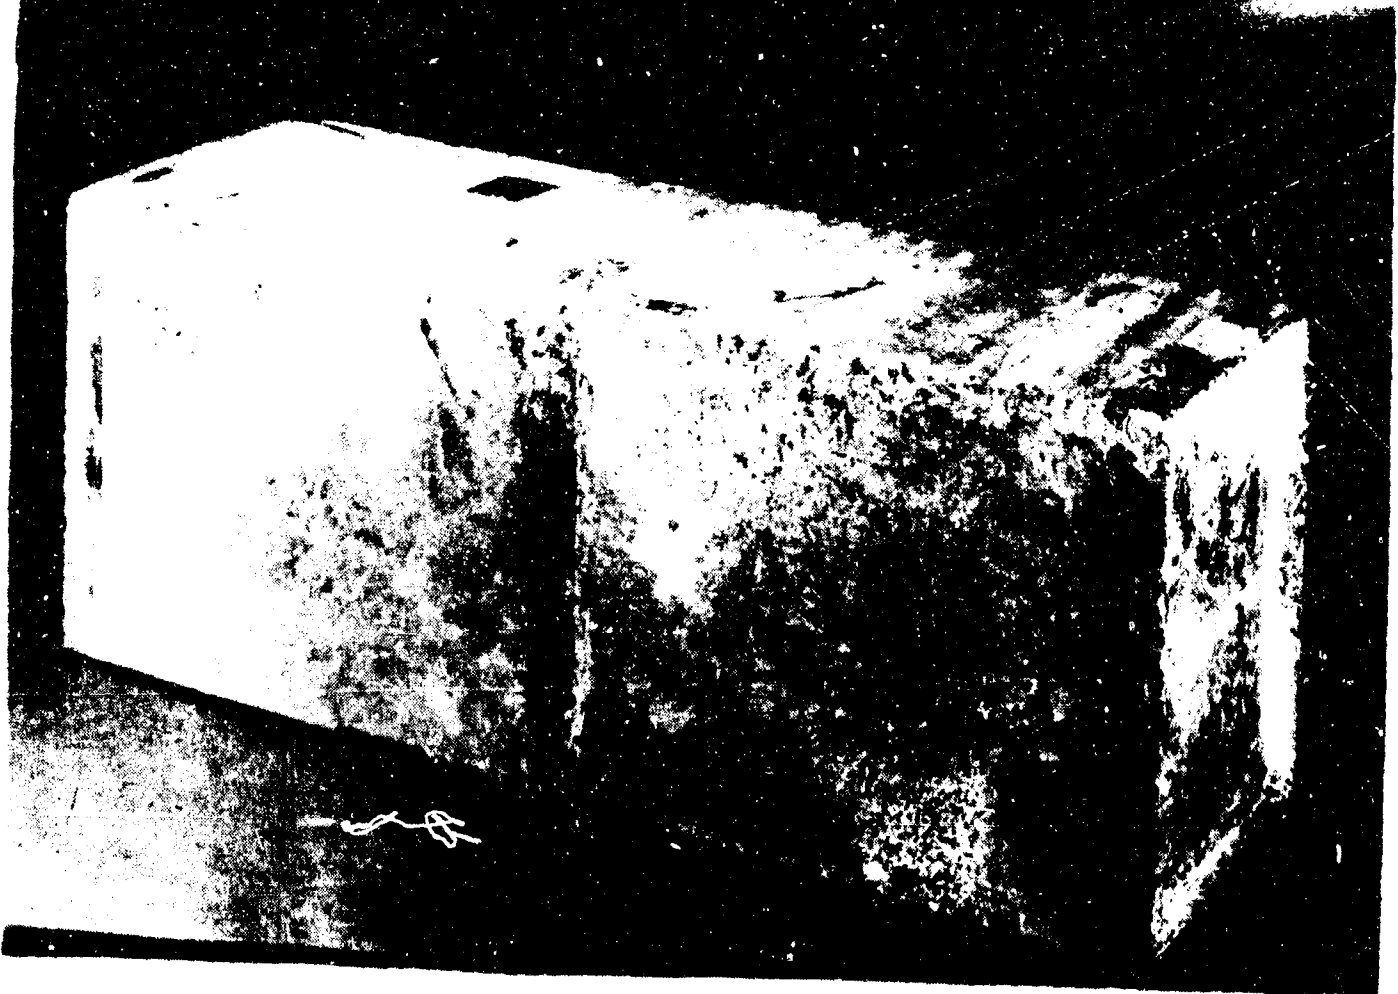
Final Inspection Report  
FIG. NO. 57

Views of upper and lower surfaces show tank to be in good serviceable condition. Dark lines emanating from corner of sea water reservoir are streaks of bedding compound - not corrosion.
