Special Report 150

CAMP CENTURY REVISITED A PICTORIAL VIEW - JUNE 1969

Austin Kovacs

July 1970

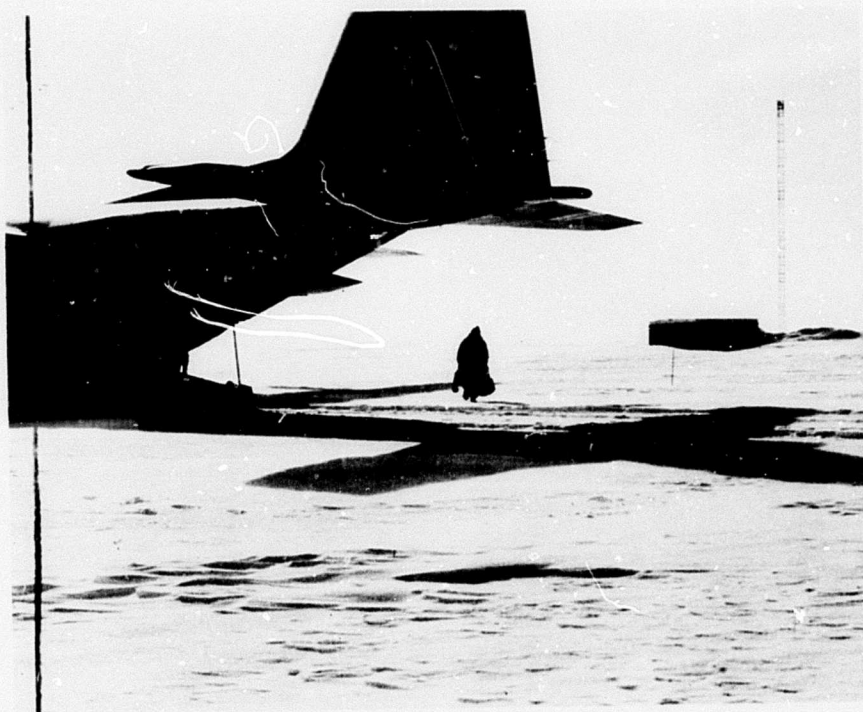
Figure 3. Arrival day. The structure protruding above the snow surface was built in 1964 on piles and was at that time 12 ft above the surrounding snow surface (see Fig. 4). This facility was occupied by the 1967 and 1969 field parties. In the background is the Sig. Met Tower.

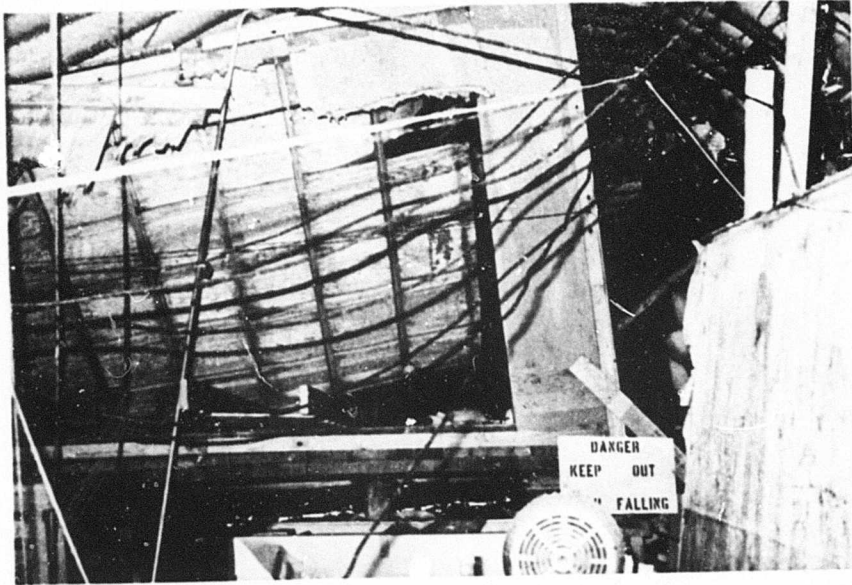
Figure 13. Snow load from above deforms metal arch, crushing wooden structure in Trench 2.

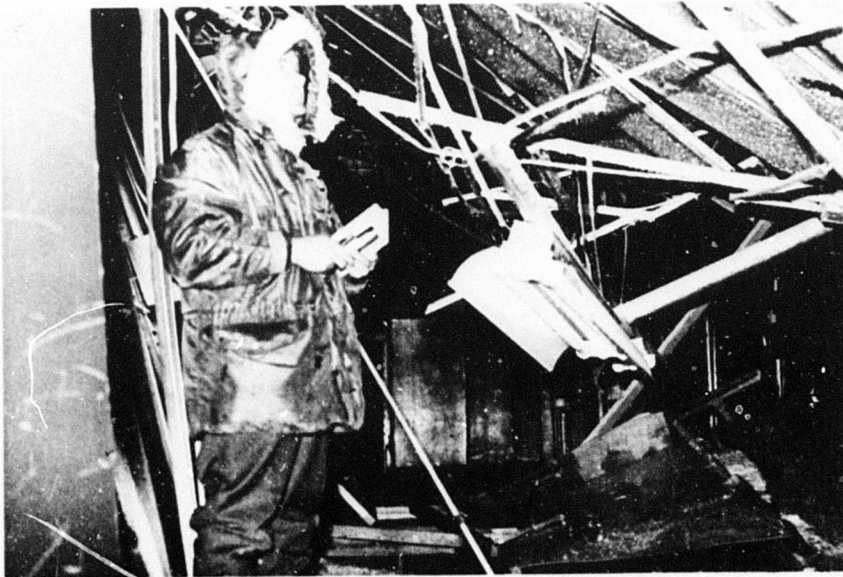
Figure 14. Crushing of wood and steel reactor building in Trench 3.

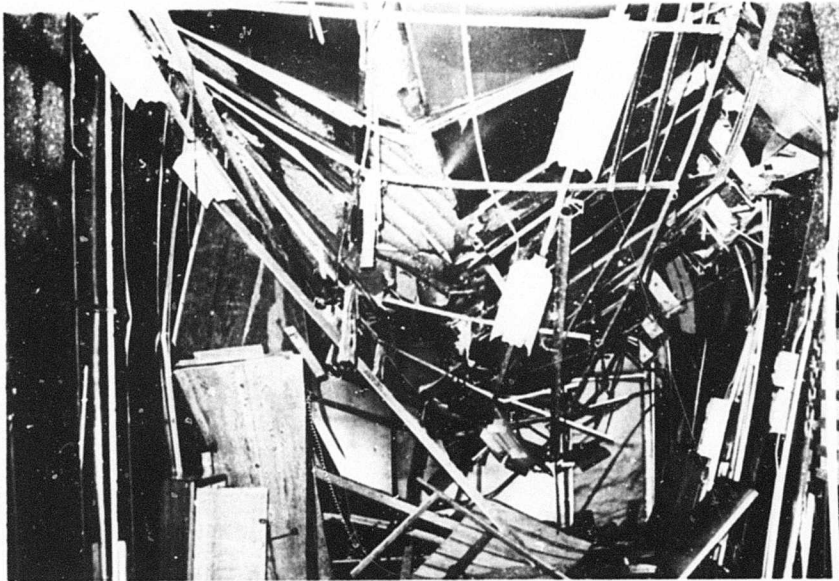
Figure 15. Snow-loaded arch pushes through roof of a reactor building in Trench 3.

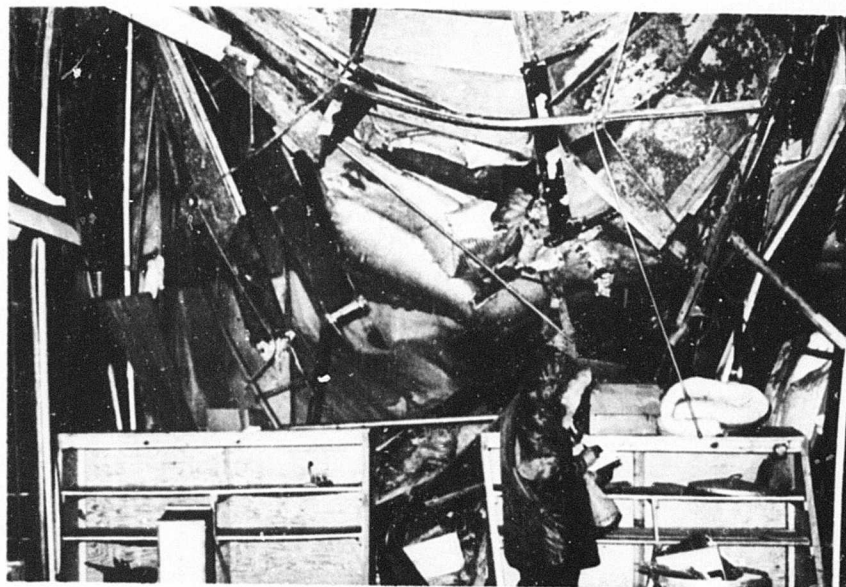
Figure 17. Metal arch pushing through roof at west end of reactor building (Trench 5).

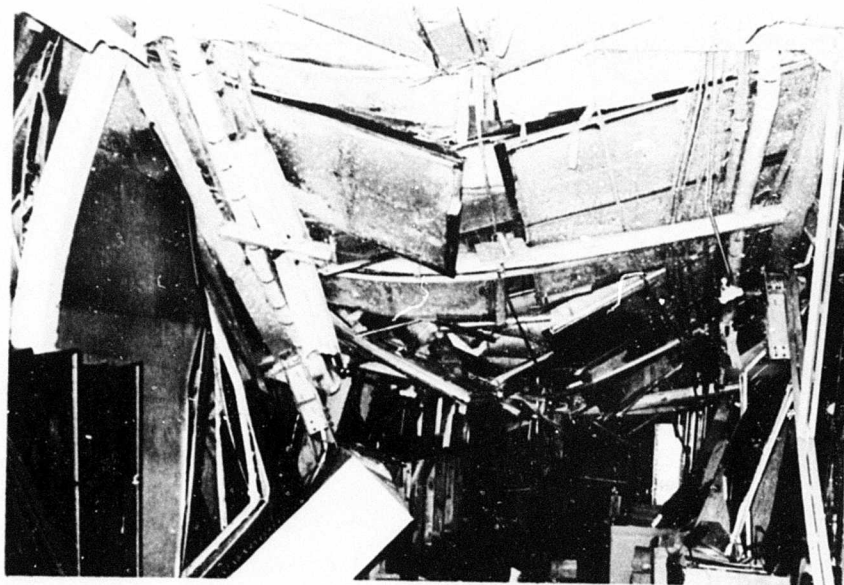
Figure 18. Deterioration of reactor building (Trench 5).

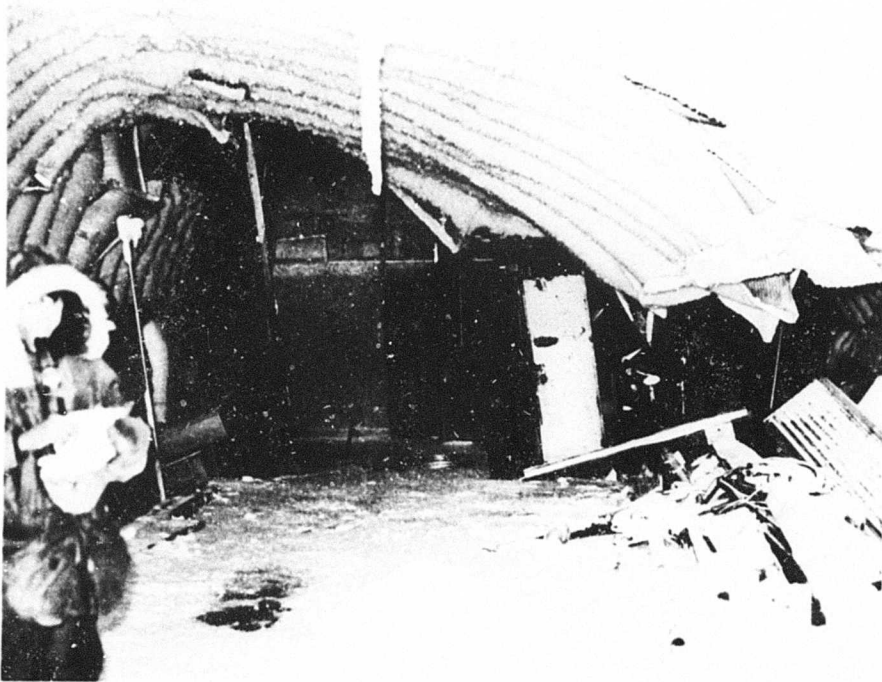
Figure 21. Metal arch buckling (Trench 5).

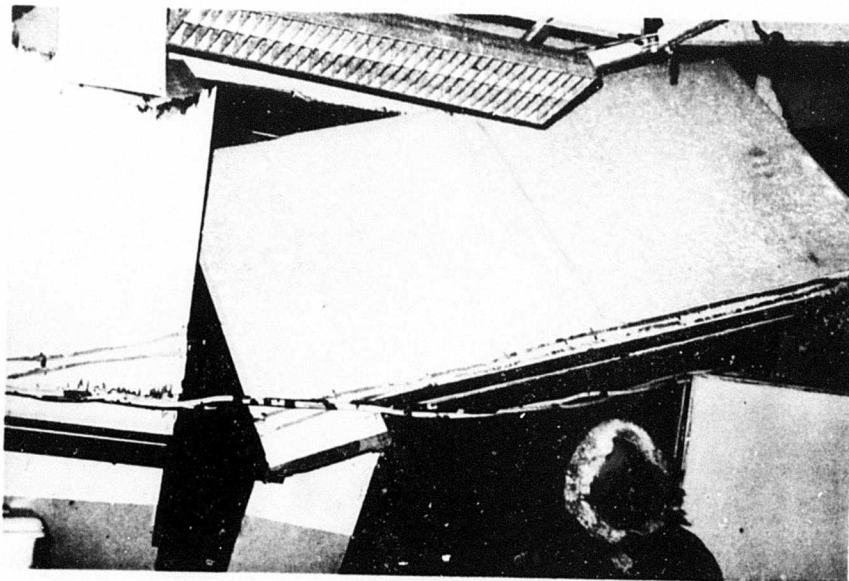
Figure 25. Wall and ceiling destruction in mess hall.

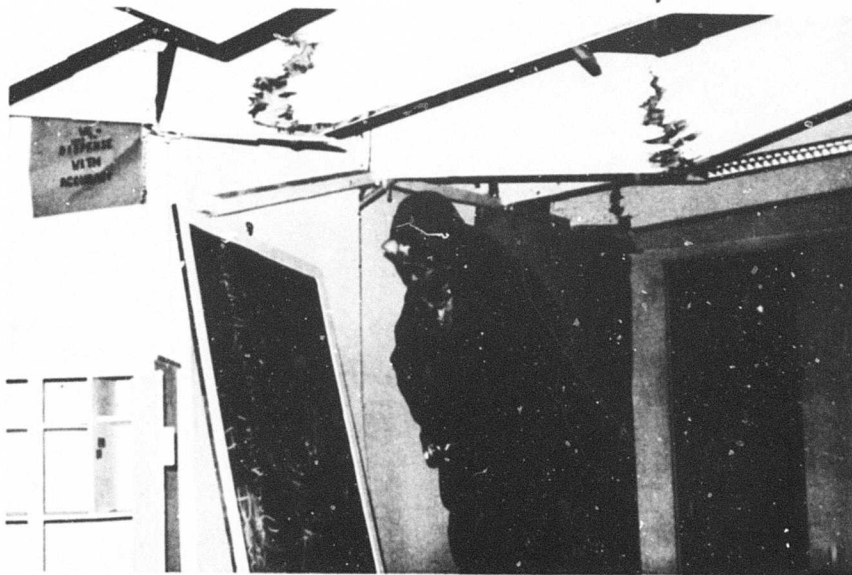
Figure 37. Overloaded ceiling joists in dispensary.

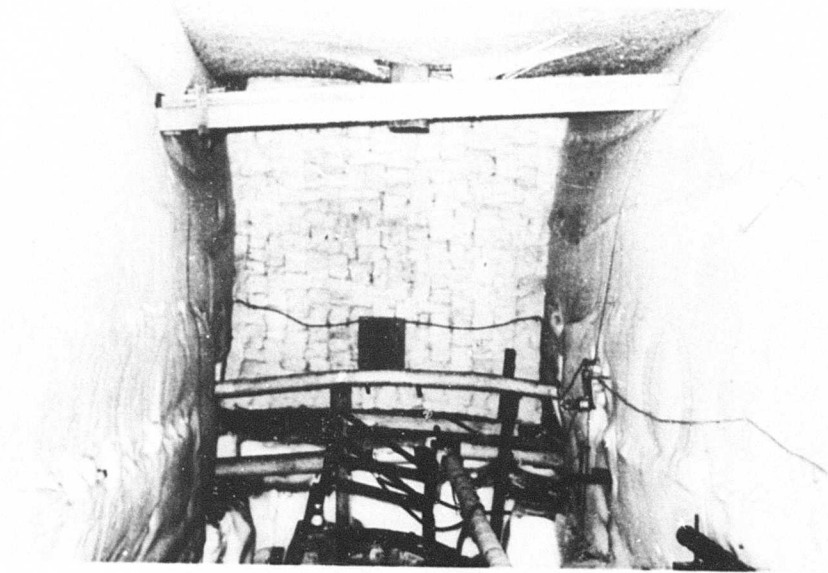
Figure 39. Snow deformation in Trench 8 causes pipeline to buckle.

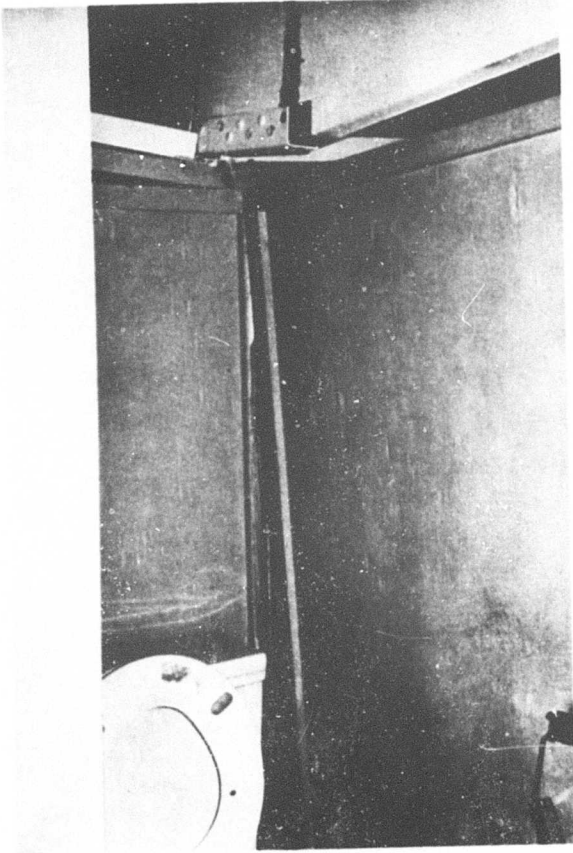
Figure 43. Ceiling and wall deterioration.

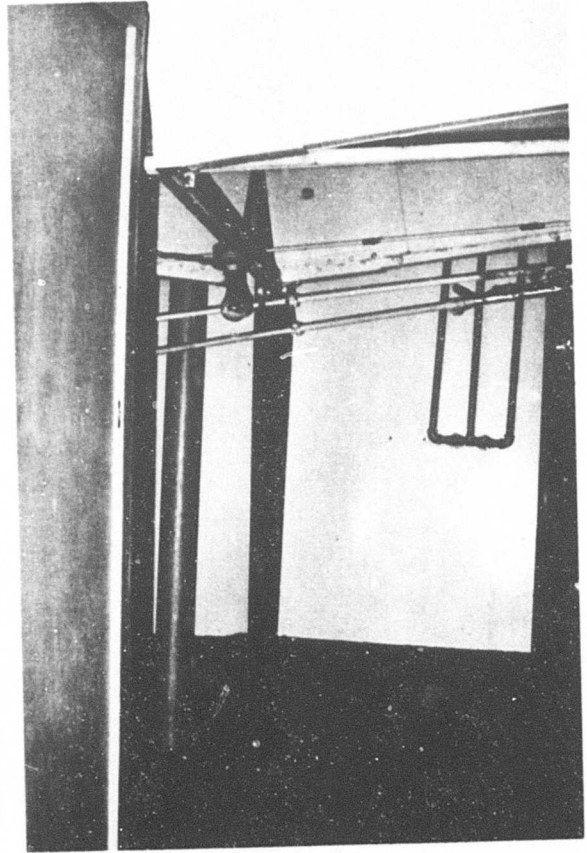
Figure 44. Roof deformation pushes shower stalls apart.

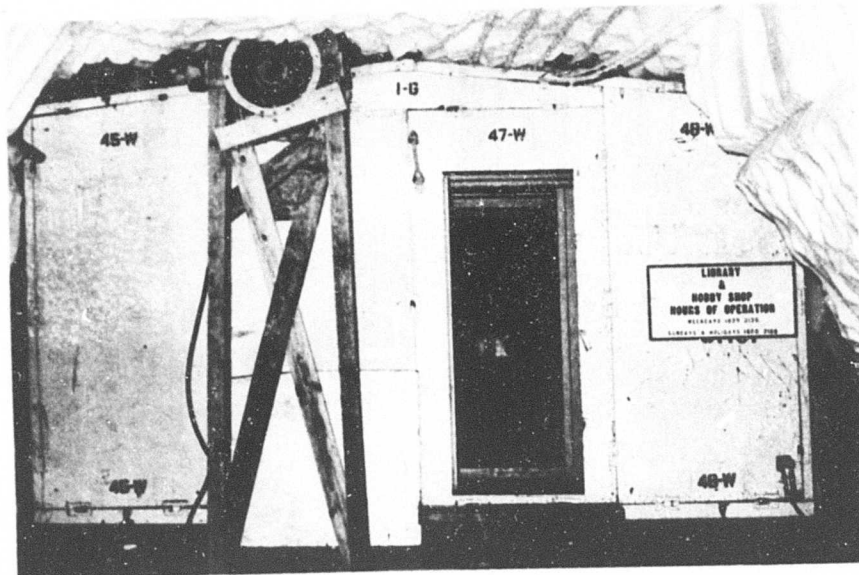
Figure 45. Snow encroaching on hobby shop and fan mounted on wooden framework.

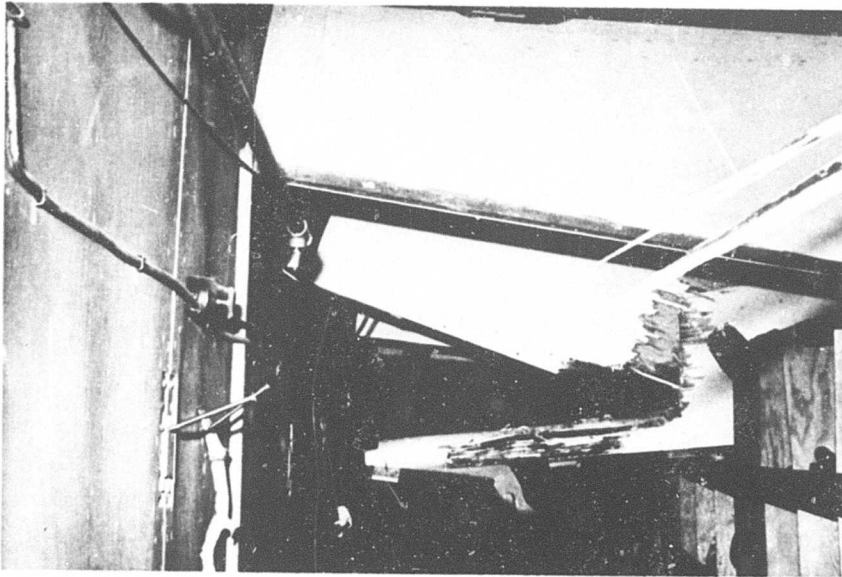
Figure 50. Split ceiling joist in R & U shop.

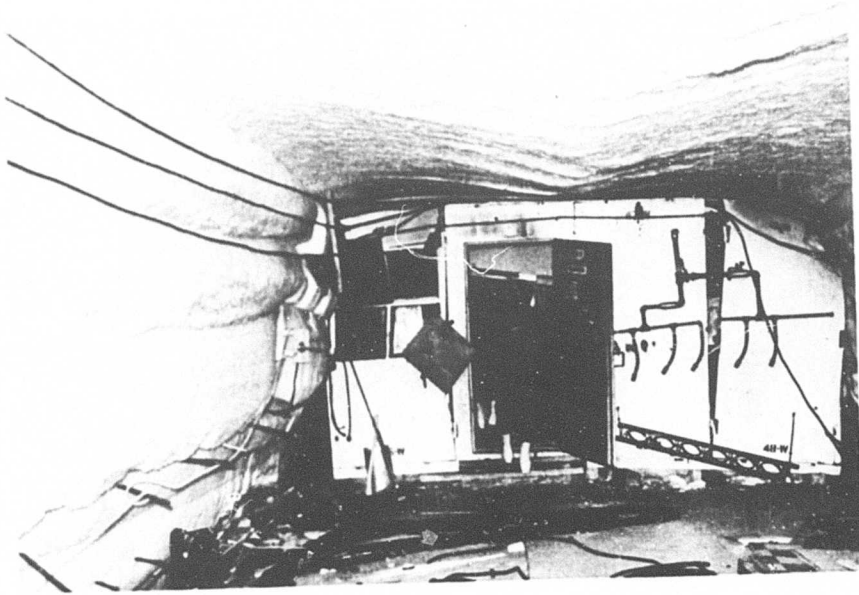
Figure 52. Back entrance to R & U shop. Note displaced wall panels.

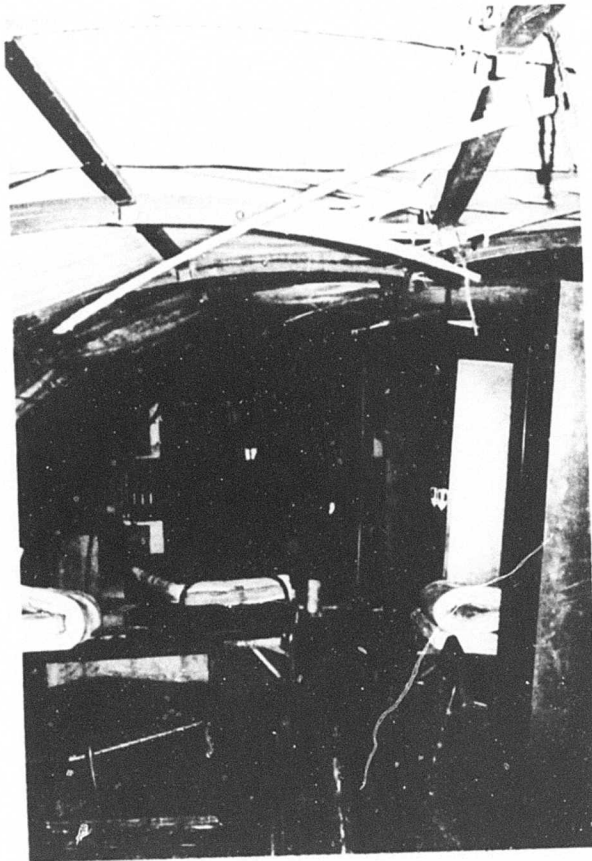
Figure 53. Interior view of Jamesway, Trench 10. Note floor panel being displaced by effect of trench floor arching.

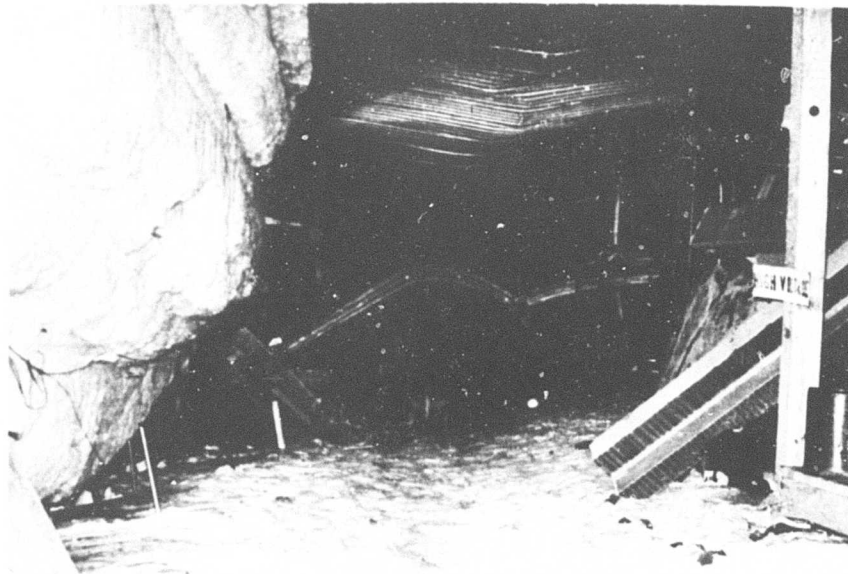
Figure 60. The floor and end wall panels of this plastic building known as the CRREL Lab were removed in 1966 to allow the removal of drilling equipment from the rear of Trench 12. The wall-roof panels later collapsed under excessive snow loading.

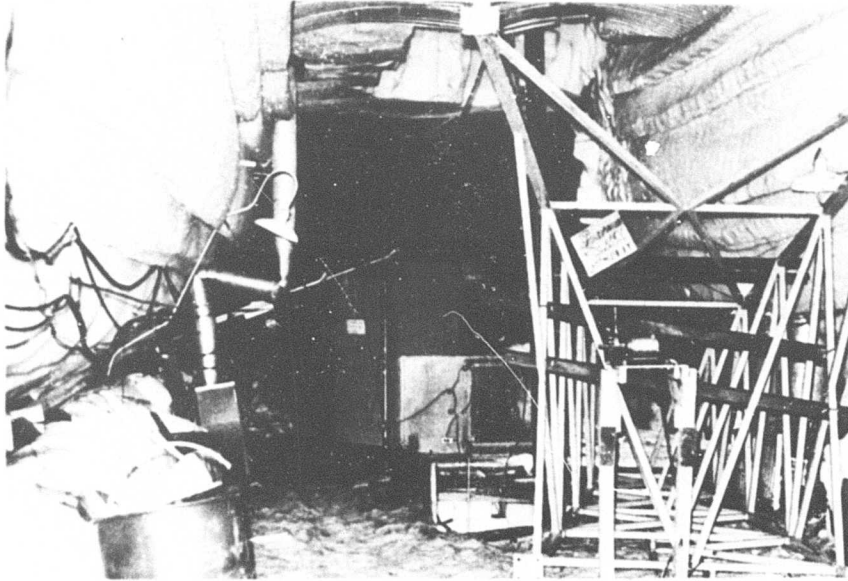
Figure 64. Drill rig and tower. Note kink in stack as a result of ceiling and snow subsidence.

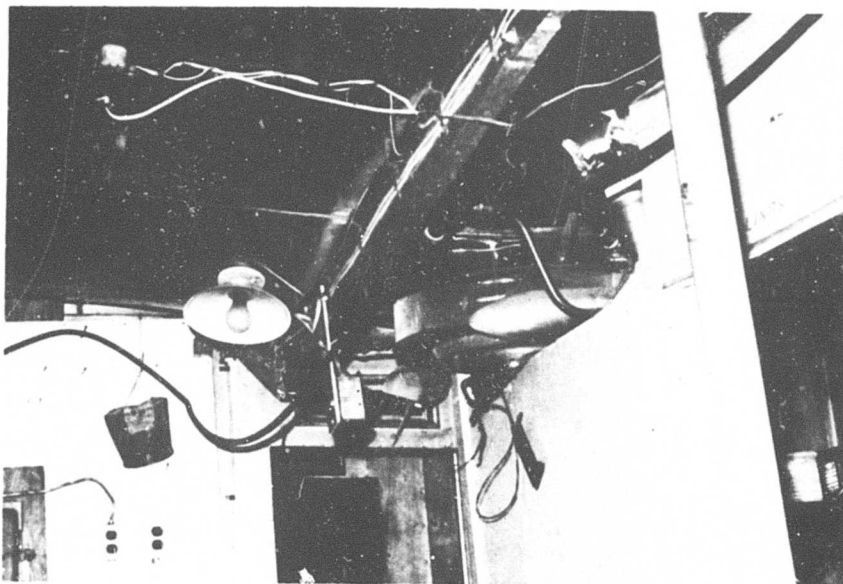
Figure 66. Snow loading of workshop ceiling has caused carrying beam to fracture and heating fan housing to be pushed into partition.

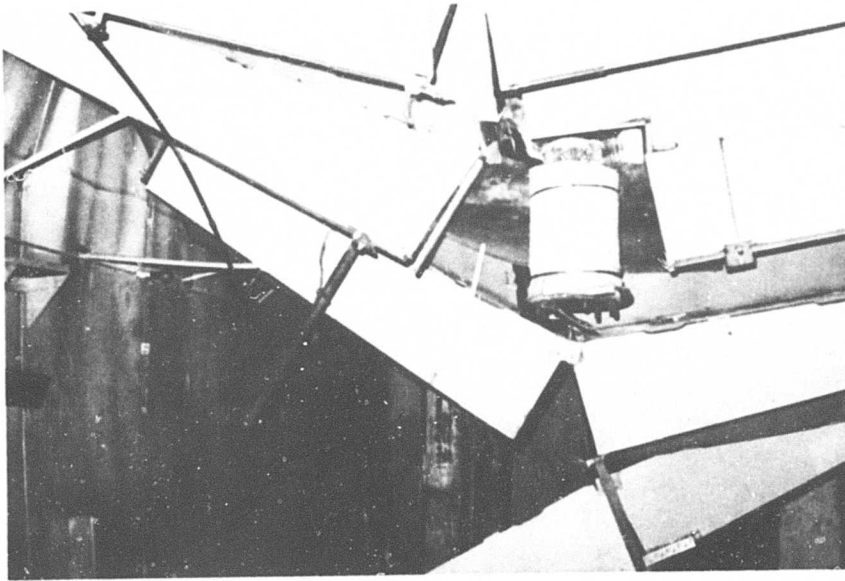
Figure 69. Effect of snow on truss ceiling Trench 15.

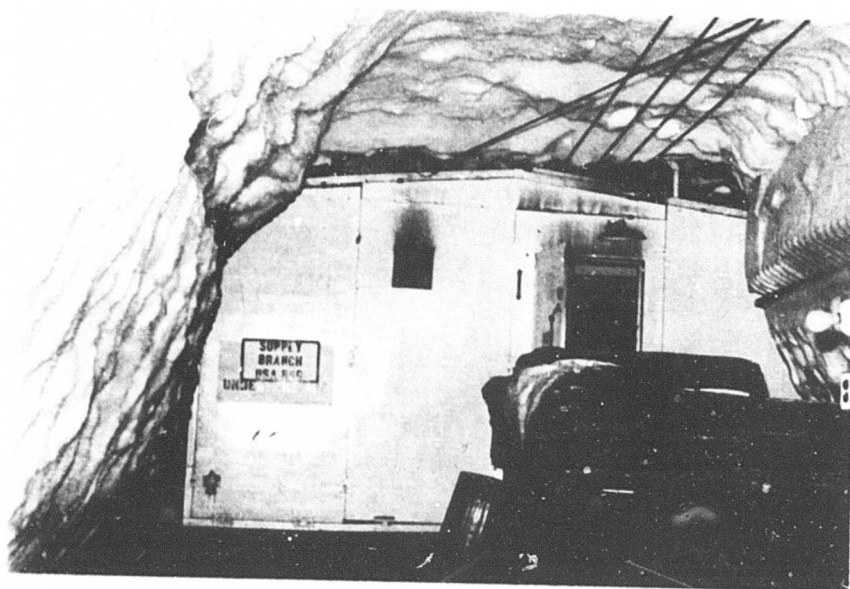
Figure 72. Snow load on roof and walls causes T-5 end wall panels to pull apart.

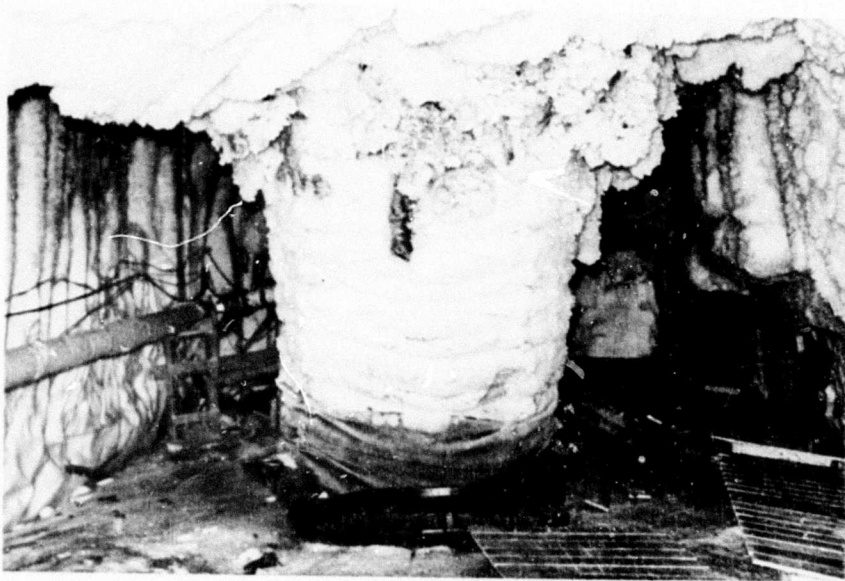
Figure 78. Crumpled escape tower (Trench 19).

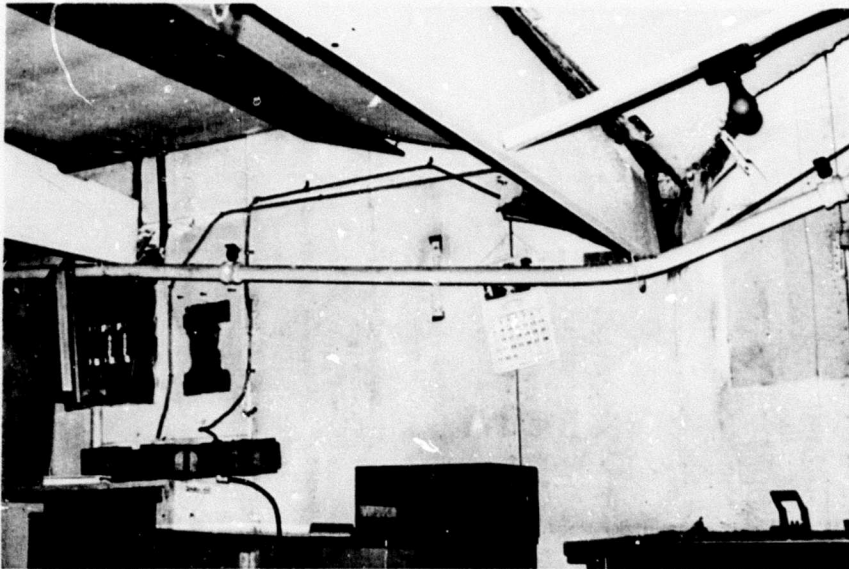
Figure 80. Sheared wall panel in headquarters building, Trench 20.

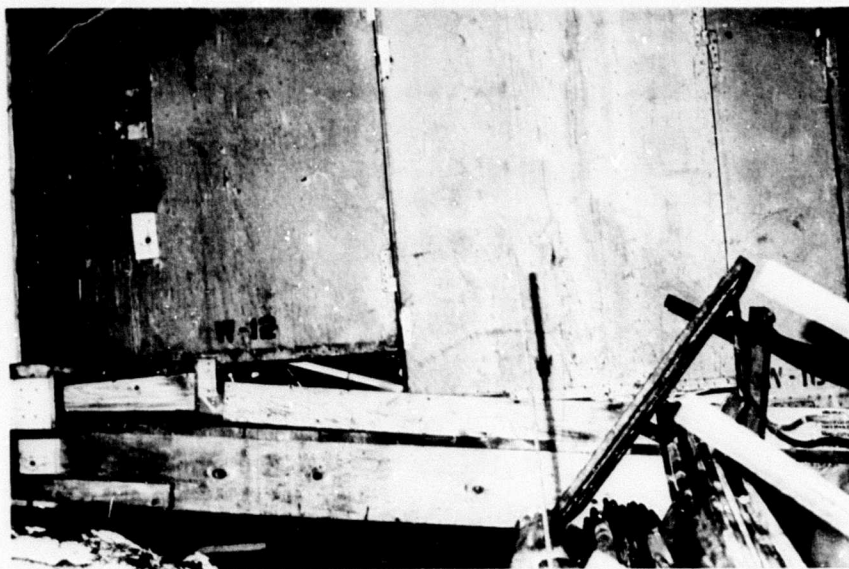
Figure 82. Displaced walls and floor at front entrance to maintenance shop, Trench 21.

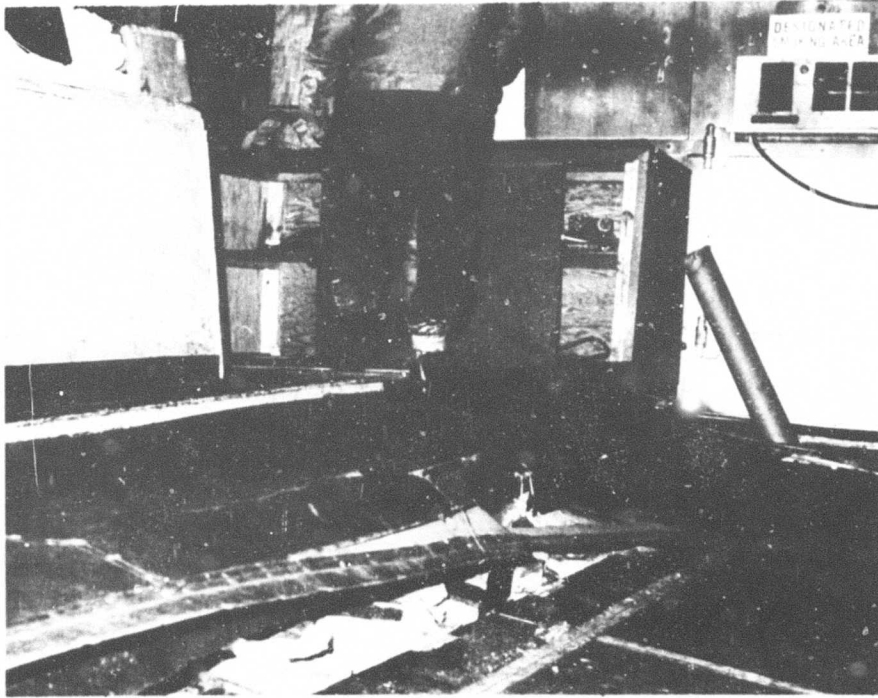
Figure 83. Tearing of maintenance shop floor as a result of trench floor arching.

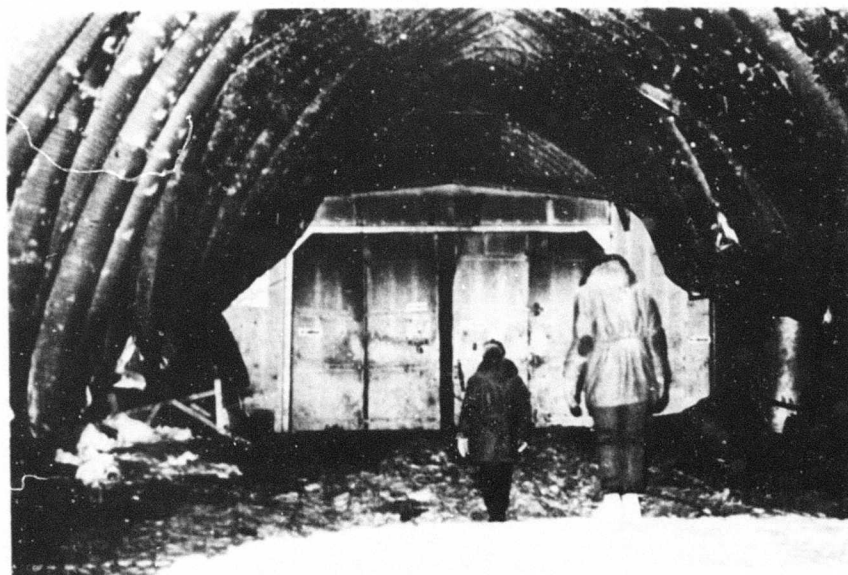
Figure 85. Steel arch deformation around maintenance shop.

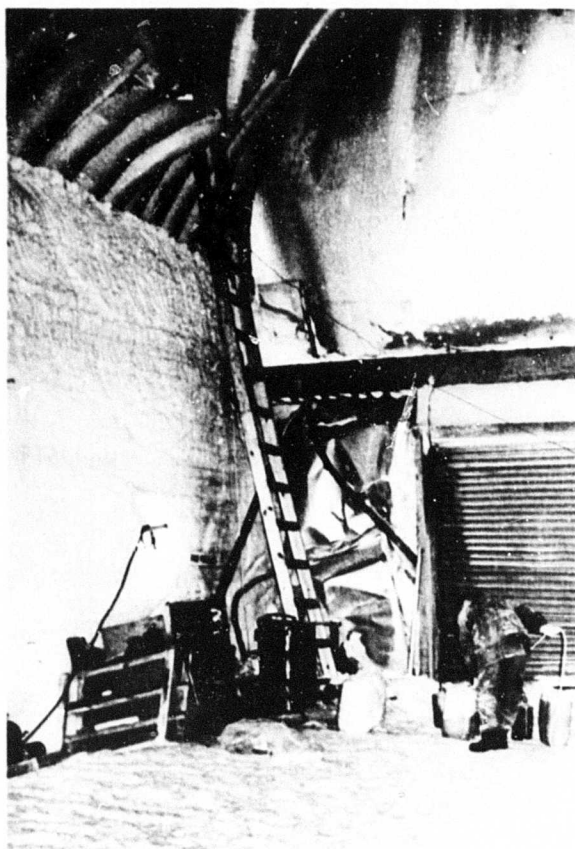
Figure 94. Effects of snow load are visible on Trench 33's deformed arch, end wall and access ladder.

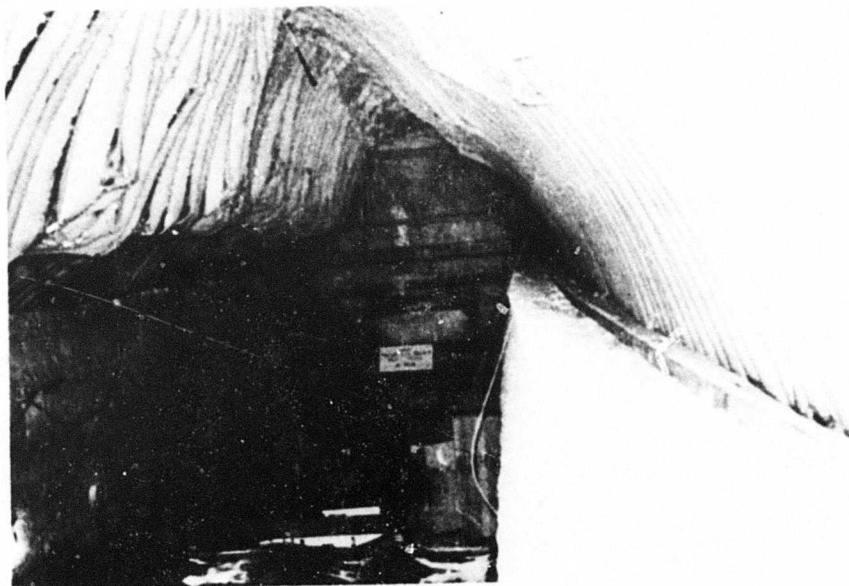
Figure 95. Looking toward north end wall of Trench 33. Note bowing and bulging of side walls.
