**R 705**

Technical Report

**AIRFIELD MARKING PAINTS FOR  
ASPHALTIC PAVEMENTS**

**NAVAL CIVIL ENGINEERING LABORATORY**

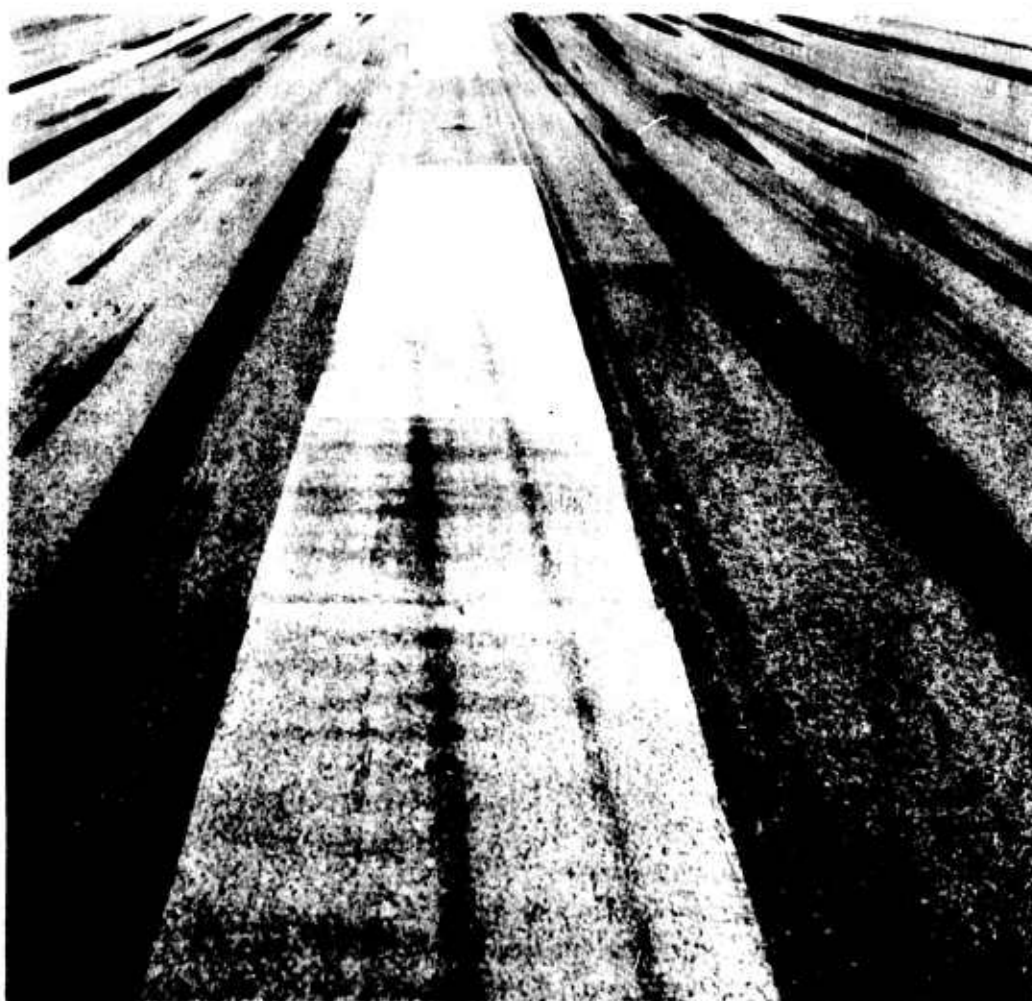
Figure 1. Test area at NAS, Agana showing marks of aircraft touchdown.

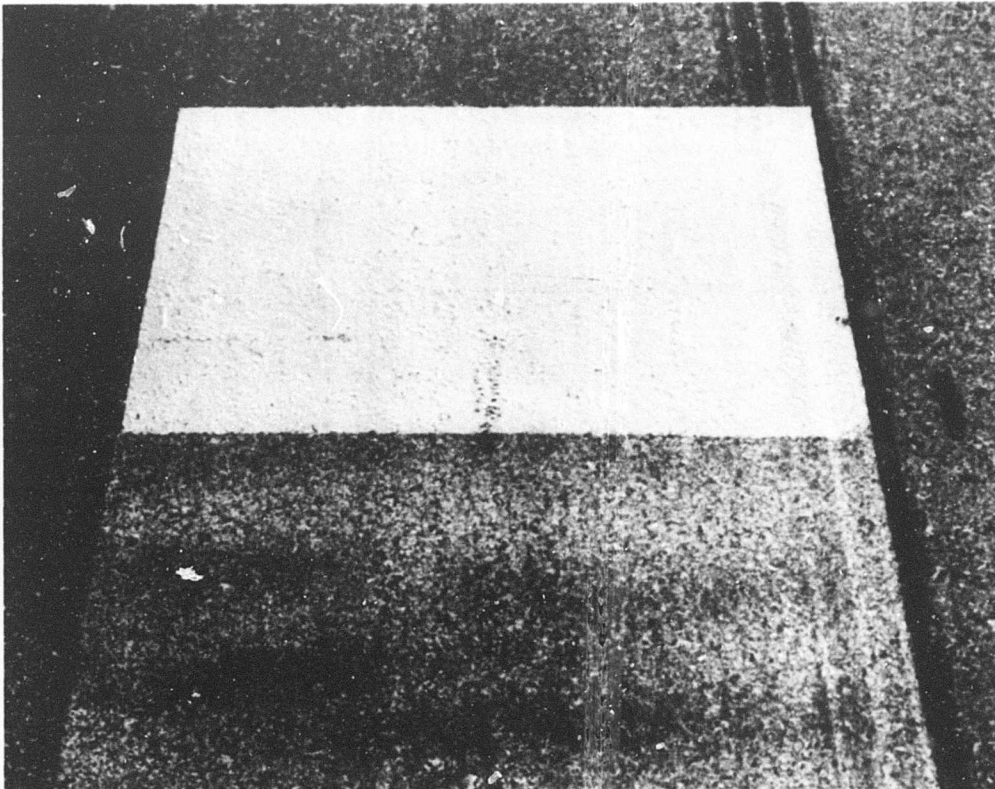
Figure 2. Test plot of Formulation 108 at NAS, Agana 1 year after application.

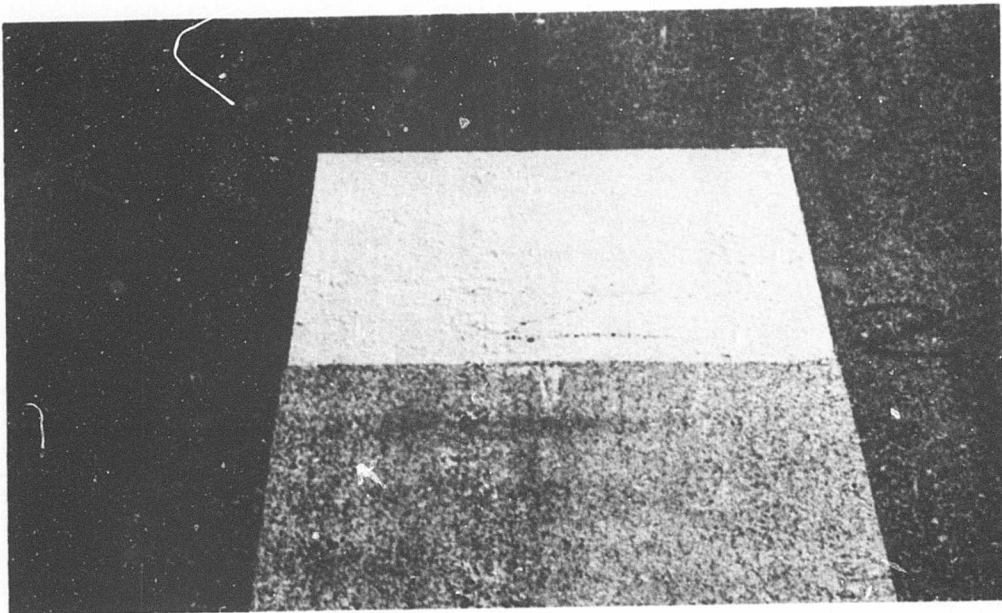
**Formulation 109, long oil oleoresinous phenolic varnish.** This paint (Figure 3) performed quite similarly to Formulation 108 but had slightly more cracking and less reflectivity.

Figure 3. Test plot of Formulation 109 at NAS, Agana 1 year after application.

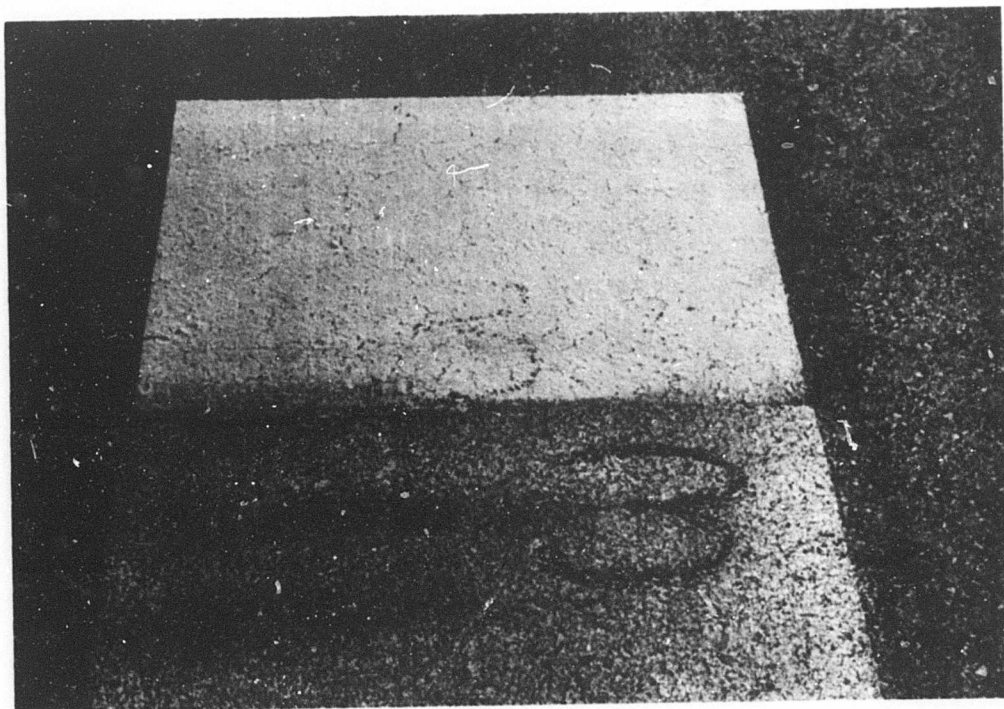
**Formulation 110, medium oil oleoresinous phenolic varnish with plasticizer.** This paint (Figure 4) performed quite similarly to Formulation 109 but had slightly more cracking.

Figure 4. Test plot of Formulation 110 at NAS, Agana 1 year after application.

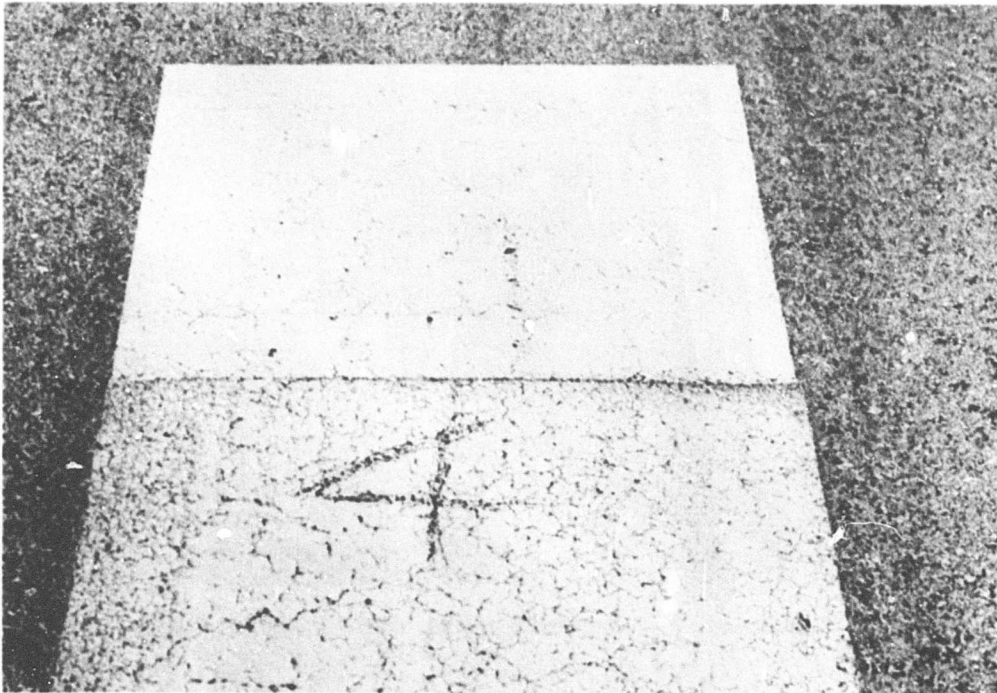
Figure 5. Test plot of Formulation 101 at NAS, Agana 1 year after application.

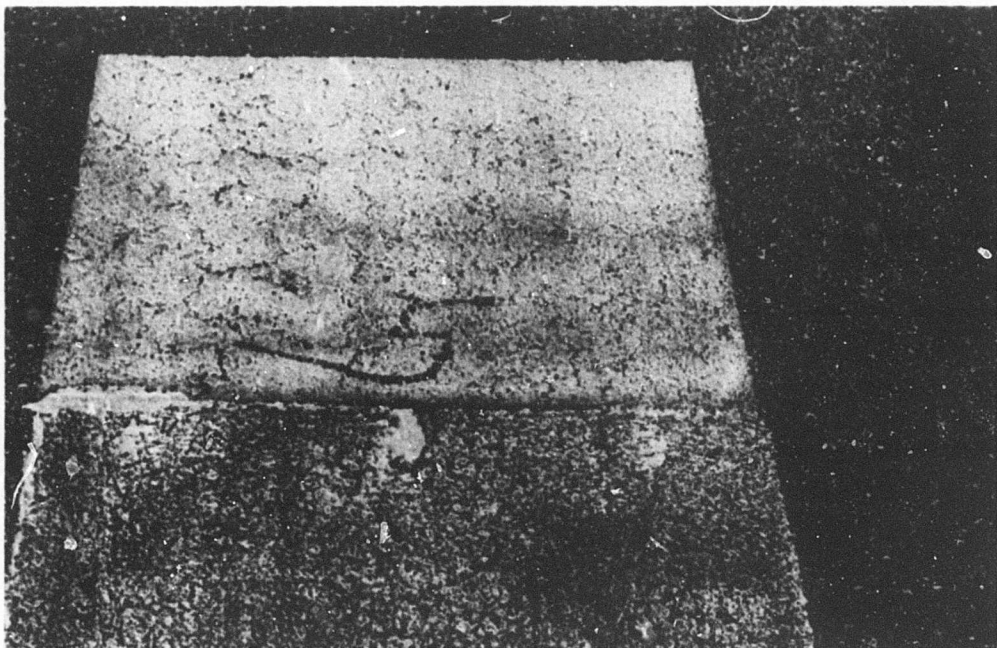
**Formulation A, alkyd.** This paint (Figure 6) lost virtually all of its glass spheres and was the dirtiest of all.

Figure 6. Test plot of Formulation A at NAS, Agana 1 year after application.

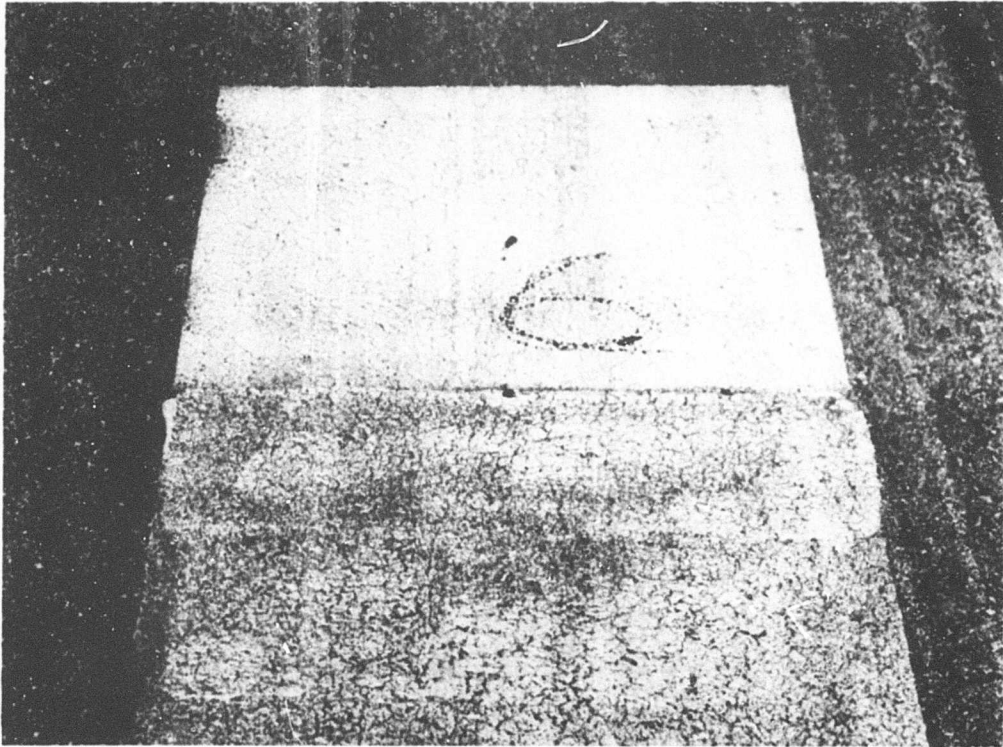
**Formulation 115, vinyl toluene-butadiene.** This paint (Figure 7) lost virtually all of its glass spheres and had the worst chipping and erosion of all.

Figure 7. Test plot of Formulation 115 at NAS, Agana 1 year after application.

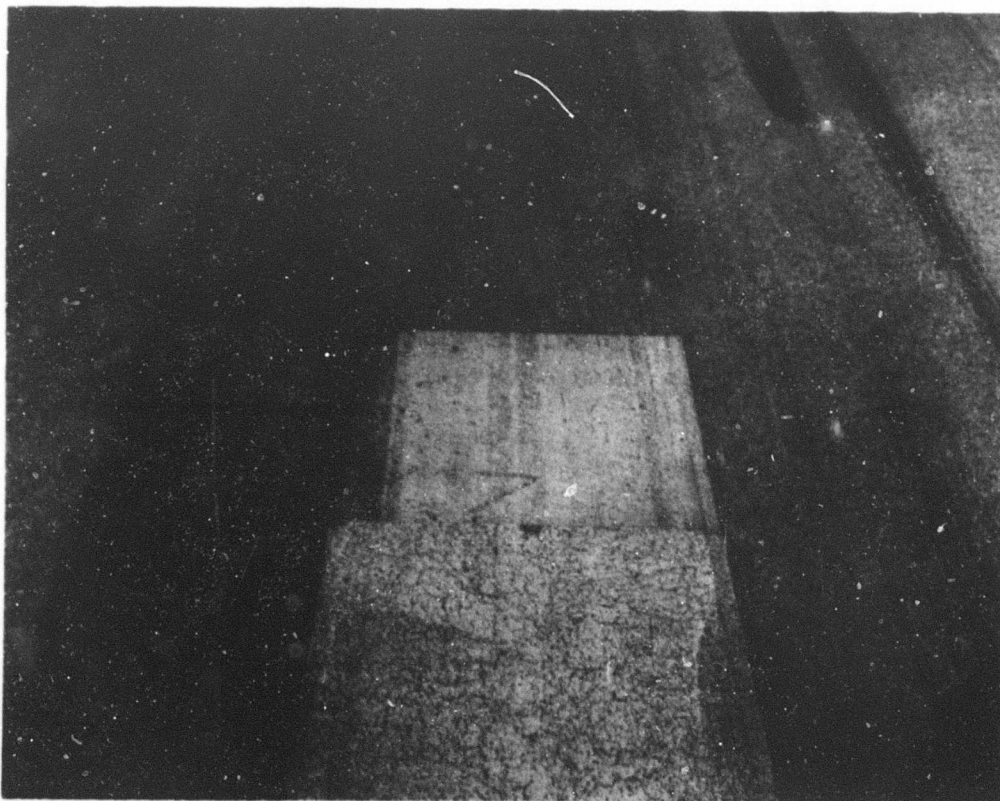
***Formulation 114, water-emulsion polyvinyl acetate.*** This paint (Figure 8) had no cracking or chipping, and it had the best retention of glass spheres. Its erosion rating was as high as any of the others. Its reflectivity and general appearance ratings were probably affected more adversely by its greater touchdown of aircraft than those of the other paints.

Figure 8. Test plot of Formulation 114 at NAS, Agana 1 year after application.

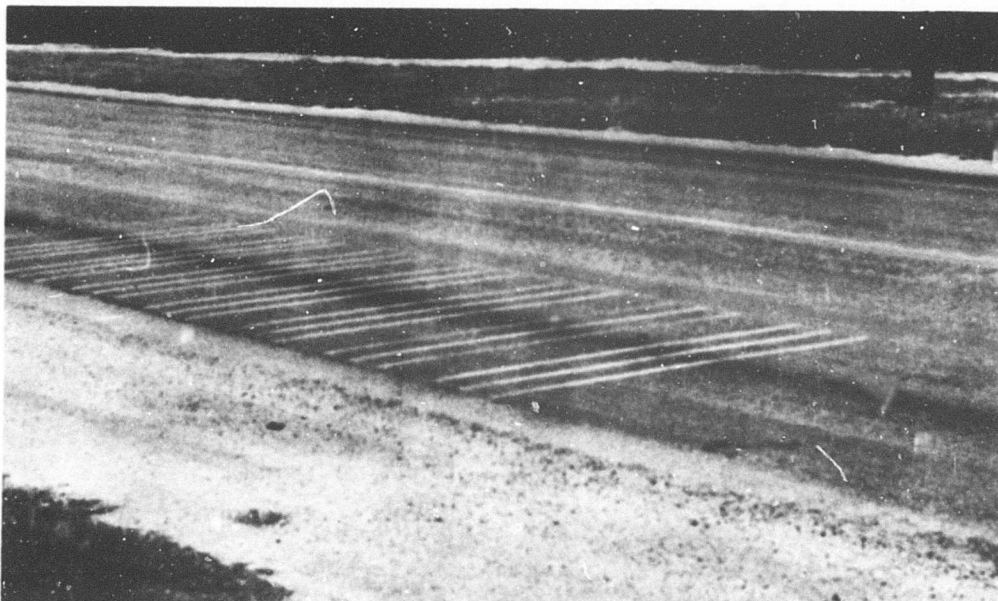
Figure 9. Roadway at USNS, Guam with the seven sets of painted stripes 1 year after application.

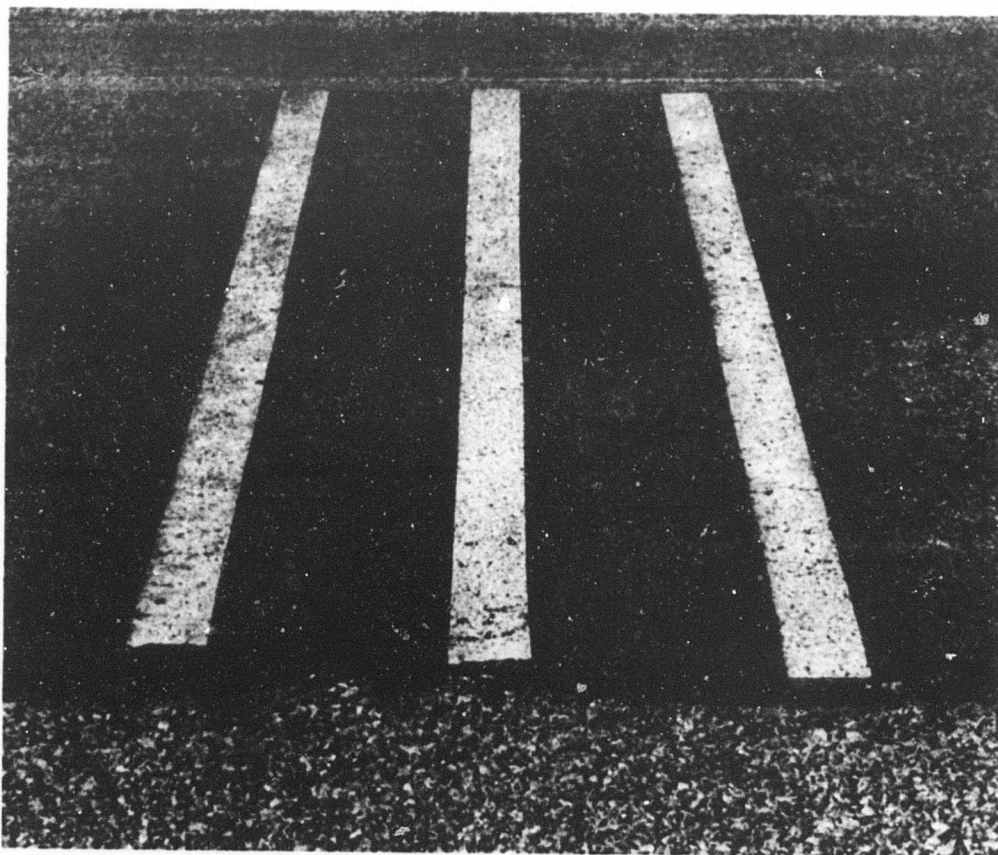
***Formulation 110, medium oil oleoresinous phenolic varnish with plasticizer.*** These stripes (Figure 10) were the cleanest and had little chipping or erosion.

Figure 10. Set of stripes of Formulation 110 at USNS, Guam 1 year after application.  
Left to right: single-thickness, reflectorized; double-thickness, reflectorized;  
single-thickness, unreflectorized.

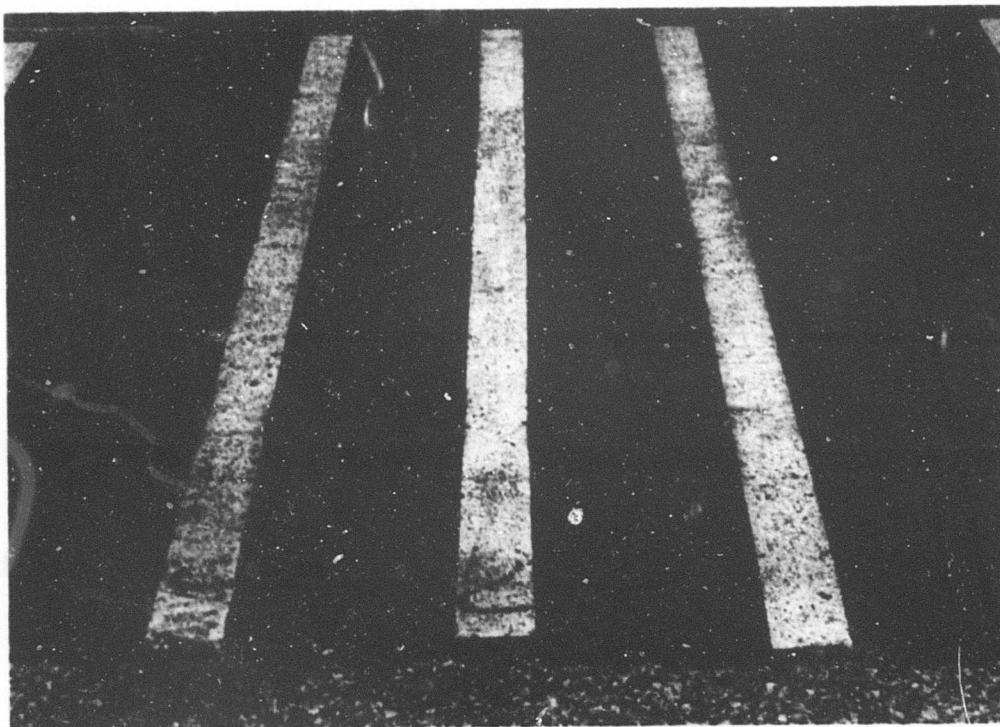
***Formulation 109, long oil oleoresinous phenolic varnish.*** These stripes (Figure 11) looked almost as good as those of Formulation 110.

Figure 11. Set of stripes of Formulation 109 at USNS, Guam 1 year after application. Left to right: single-thickness, reflectorized; double-thickness, reflectorized; single-thickness, unreflectorized.

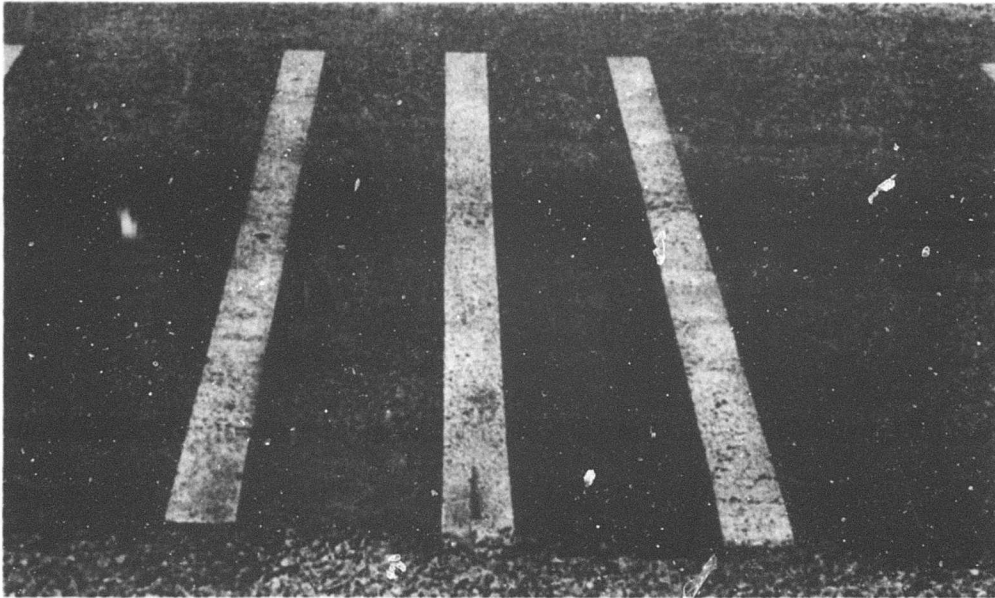
*Formulation 108, medium oil oleoresinous phenolic varnish.* These stripes (Figure 12) looked almost as good as those of Formulation 109.

Figure 12. Set of stripes of Formulation 108 at USNS, Guam 1 year after application.  
Left to right: single-thickness, reflectorized; double-thickness, reflectorized;  
single-thickness, unreflectorized.

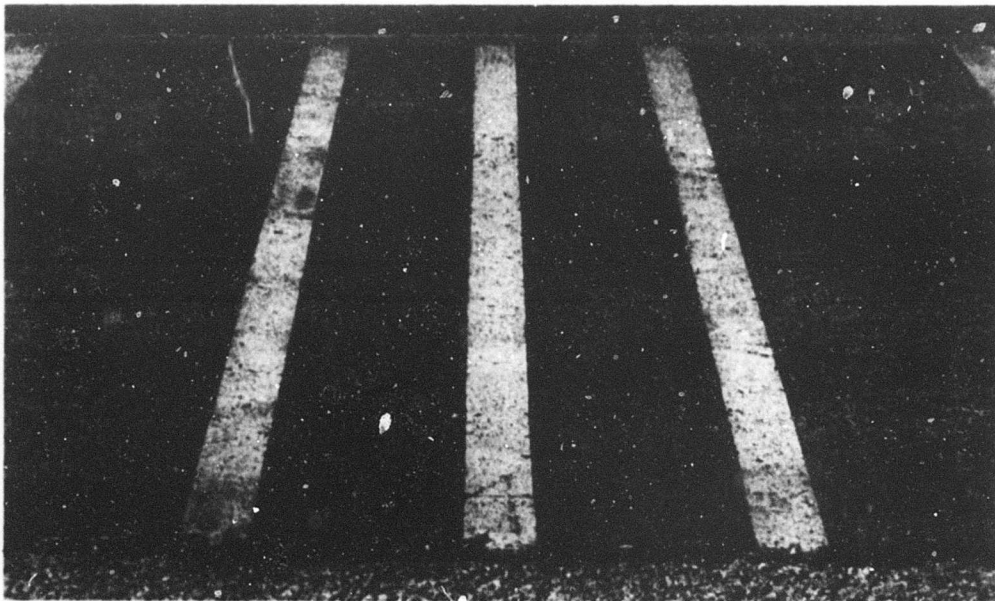
*Formulation 101, medium oil alkyd.* These stripes (Figure 13) looked almost as good as those above but had slightly more cracking.

Figure 13. Set of stripes of Formulation 101 at USNS, Guam 1 year after application.  
Left to right: single-thickness, reflectorized; double-thickness, reflectorized;  
single-thickness, unreflectorized.

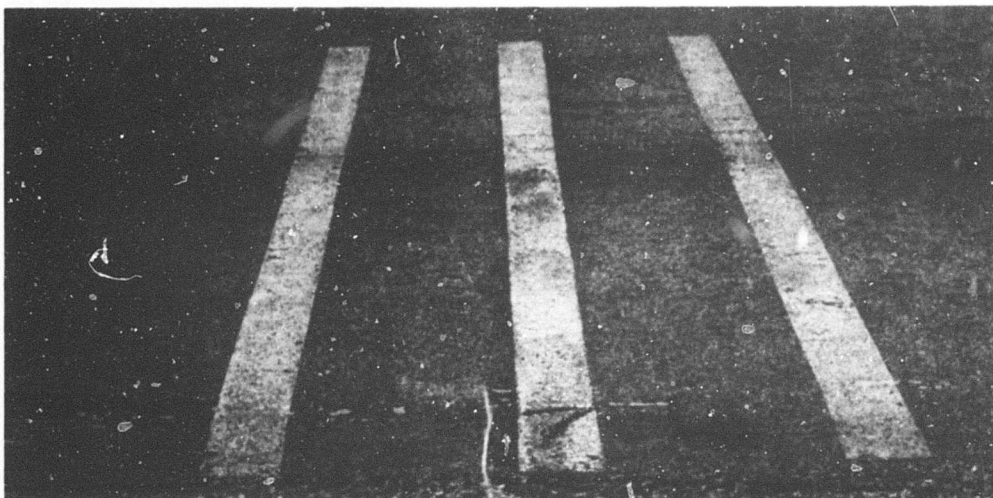
Figure 14. Set of stripes of Formulation 114 at USNS, Guam 1 year after application.  
Left to right: single-thickness, reflectorized; double-thickness, reflectorized;  
single-thickness, unreflectorized.

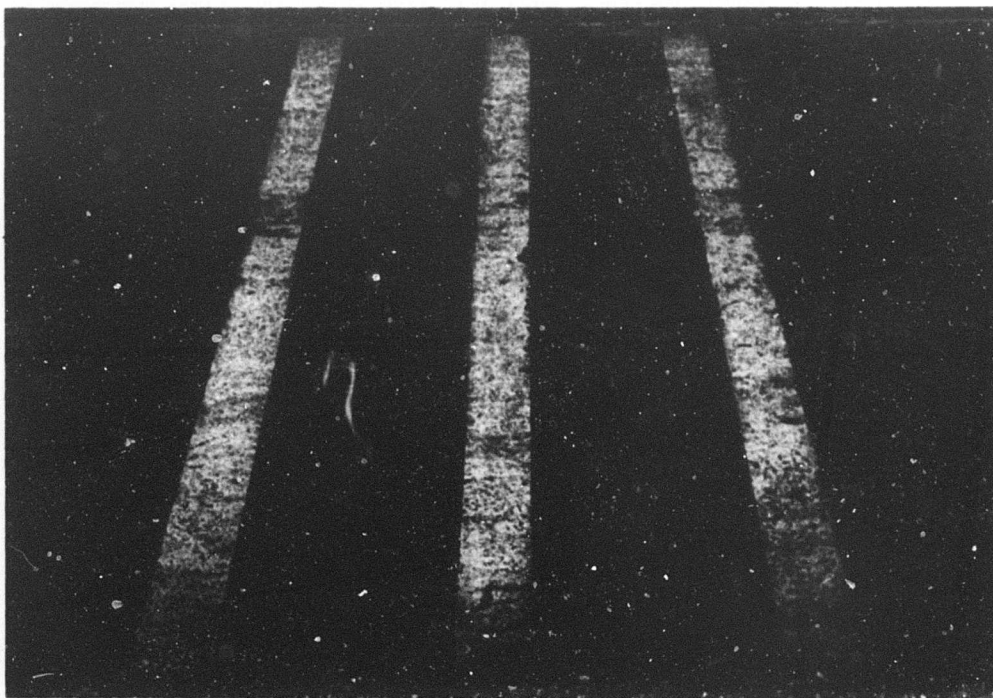
Figure 15. Set of stripes of Formulation A at USNS, Guam 1 year after application.  
Left to right: single-thickness, reflectorized; double-thickness, reflectorized;  
single-thickness, unreflectorized.

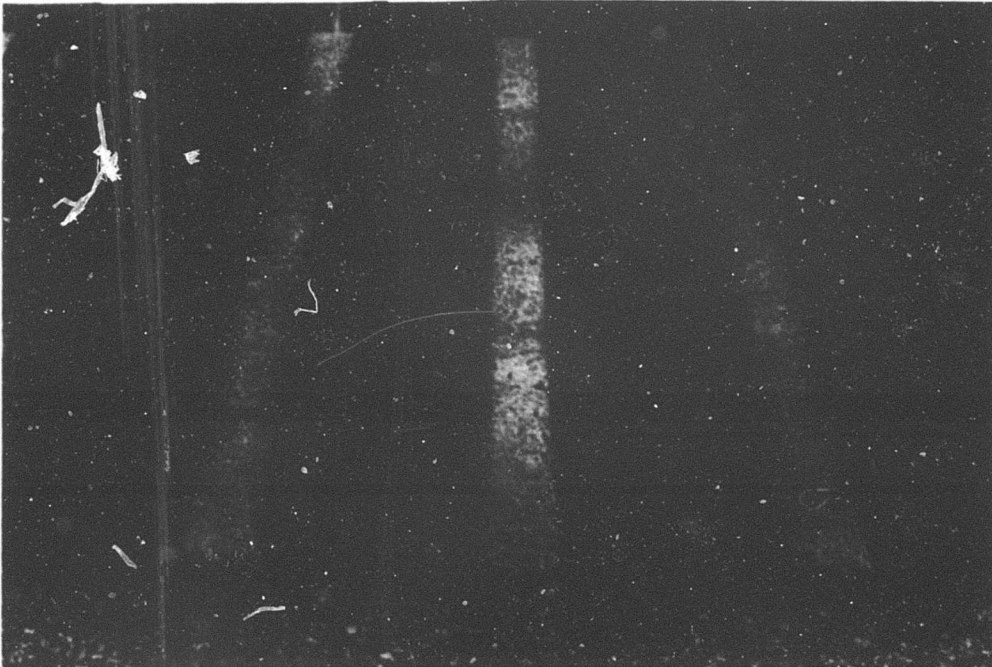
Figure 16. Set of stripes of Formulation 115 at USNS, Guam 1 year after application. Left to right: single-thickness, reflectorized; double-thickness, reflectorized; single-thickness, unreflectorized.

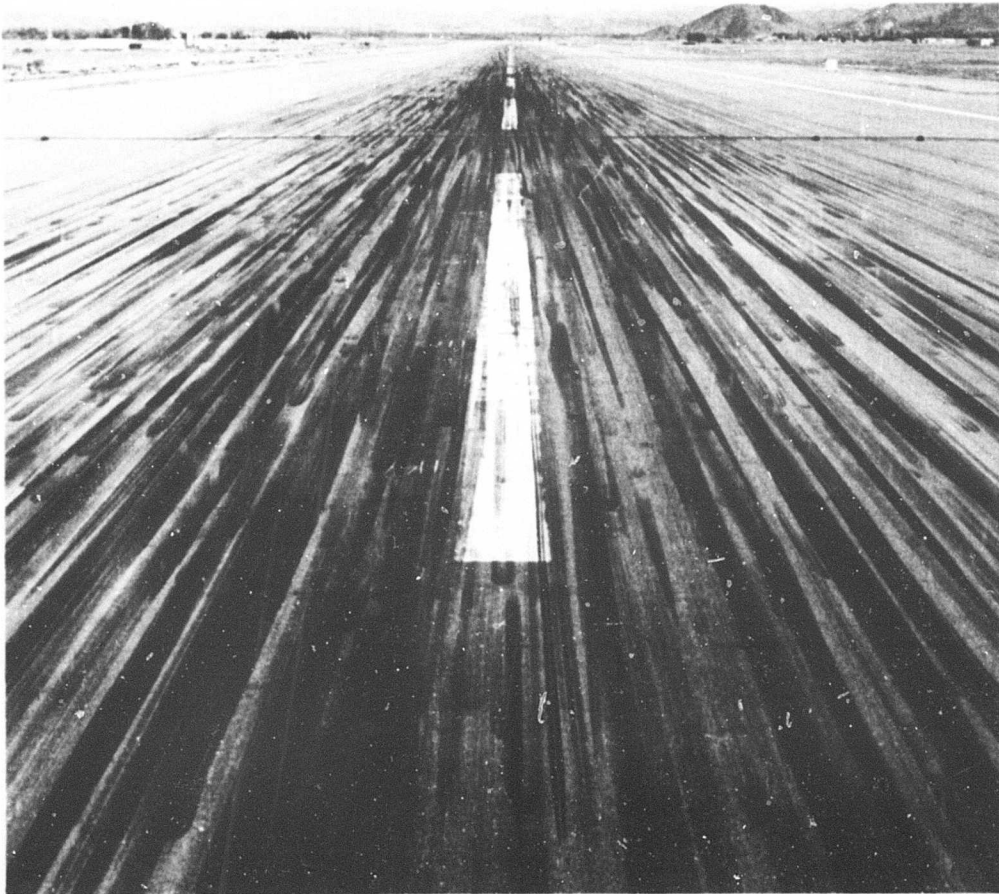
The test sections deteriorated very slowly, but rapidly received black tire markings (Figure 17) from touchdown of aircraft. Ratings received after 8-1/2 and 26-1/2 months are listed in Table 9. The rating totals were weighted

Figure 17. Sections of test paints at NAS, Point Mugu after 26-1/2 months.

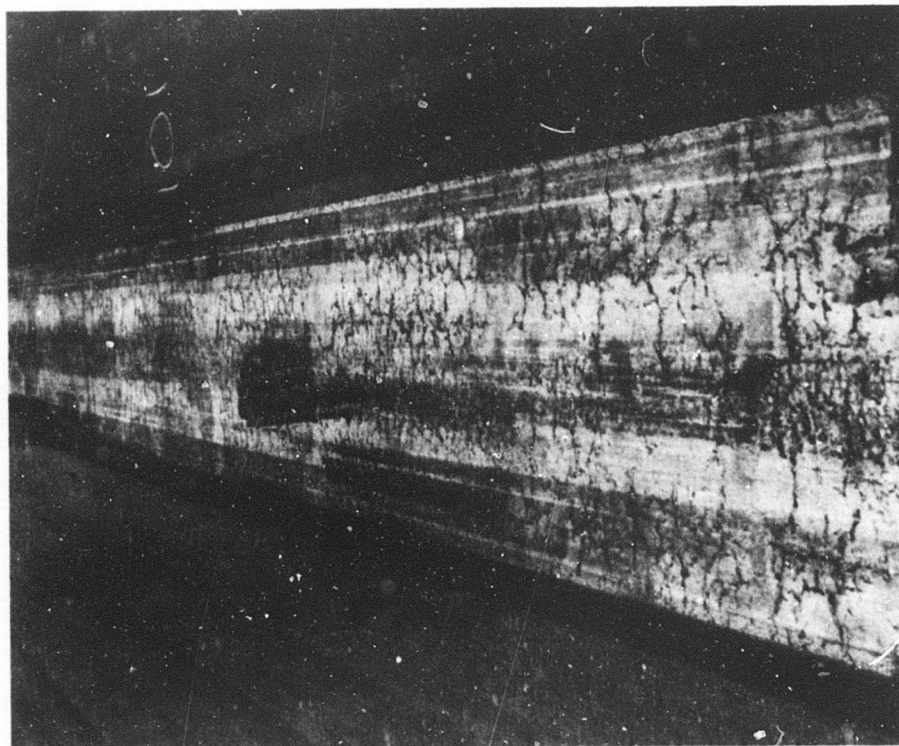
***Formulation 101, medium oil alkyd.*** This paint (Figure 18) had excessive loss of reflective spheres. It also had some localized damage from oil spillage.

Figure 18. Formulation 101 at NAS, Point Mugu after 26-1/2 months.

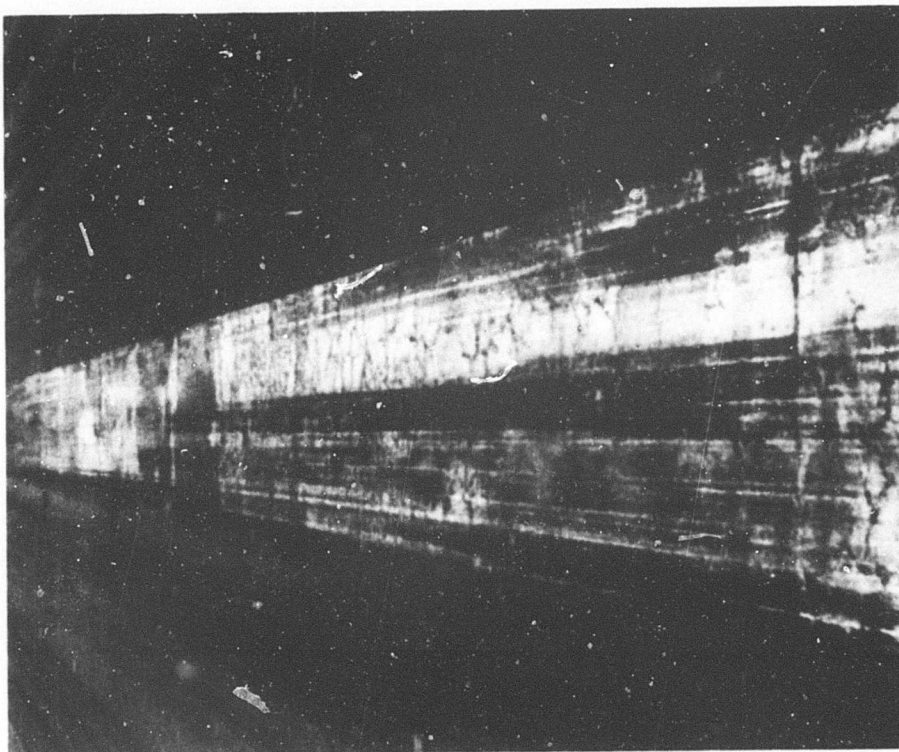
Figure 19. Formulation 108 at NAS, Point Mugu after 26-1/2 months.

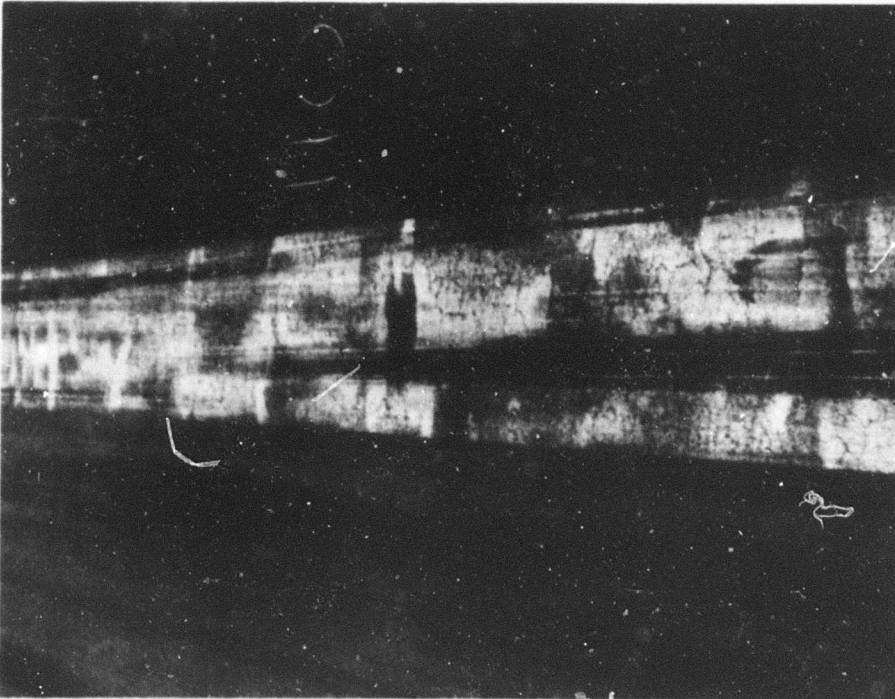
***Formulation 110, medium oil oleoresinous phenolic varnish with plasticizer.*** This paint (Figure 22) performed relatively poorly and had the most chipping of all.

Figure 22. Formulation 110 at NAS, Point Mugu after 26-1/2 months.

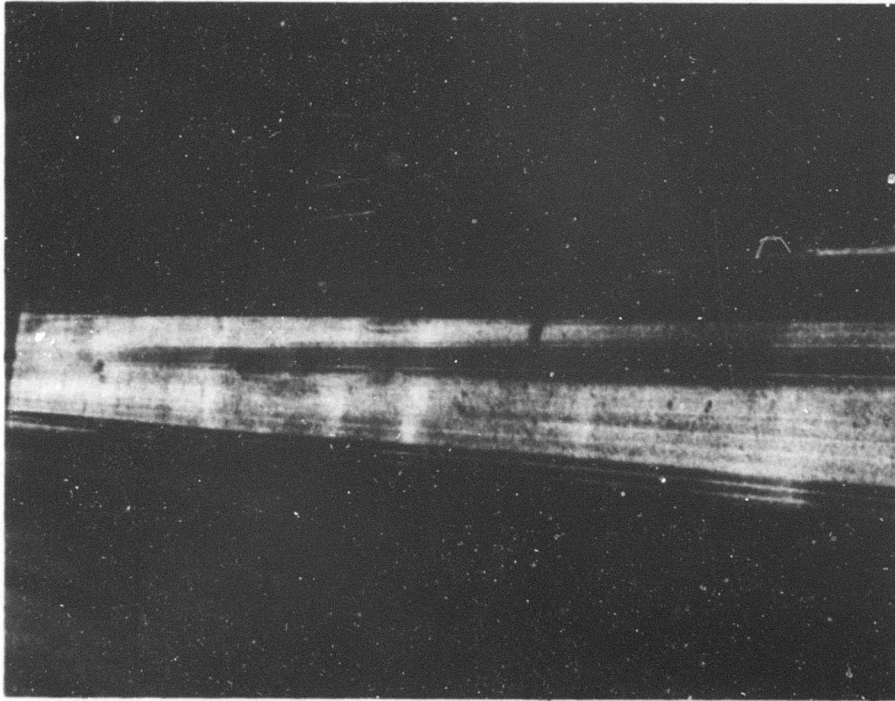
**Formulation 114, water-emulsion polyvinyl acetate.** This paint (Figure 23) performed better and was noticeably whiter than the other test paints on the centerline throughout the 26-1/2 months of exposure.

Figure 23. Formulation 114 at NAS, Point Mugu after 26-1/2 months.

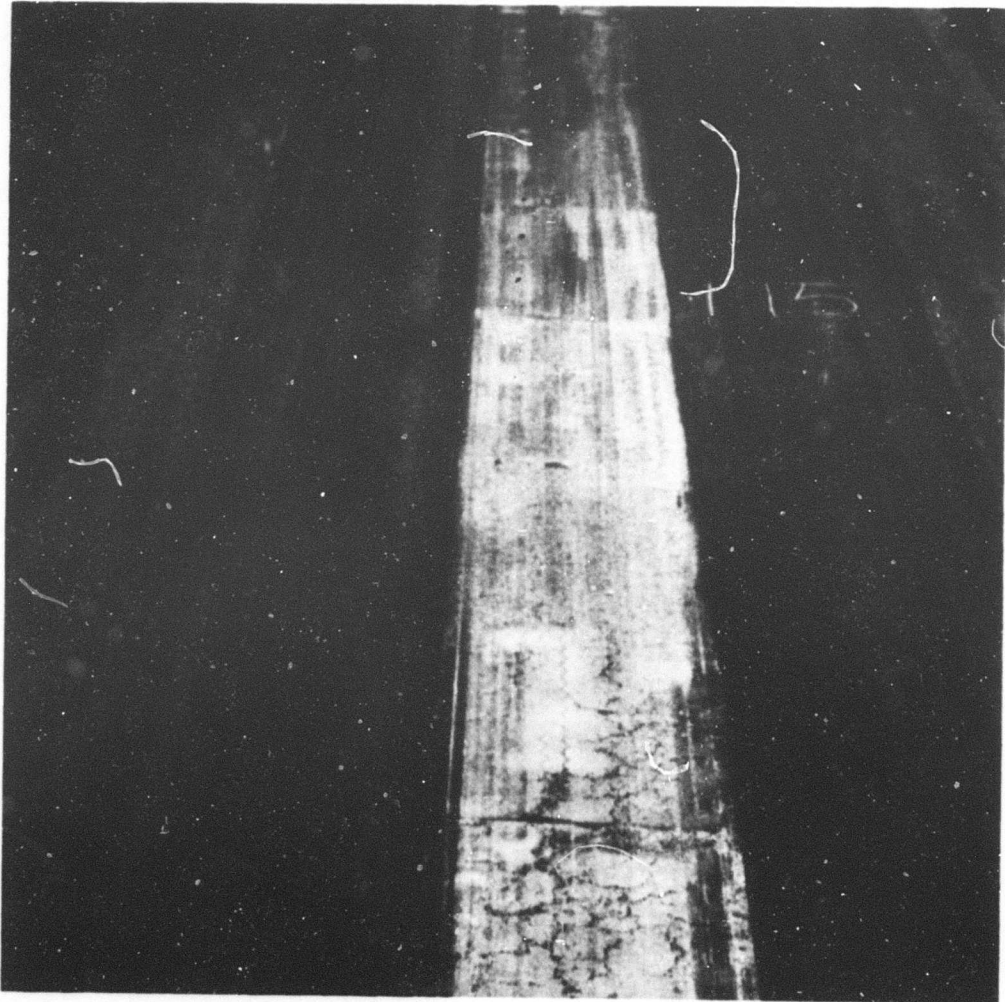
**Formulation 115, vinyl toluene-butadiene.** This paint (Figure 24) performed poorest of all through 26-1/2 months of exposure with low cracking, chipping, and glass sphere retention ratings.

**Figure 24. Formulation 115 at NAS, Point Mugu after 26-1/2 months.**

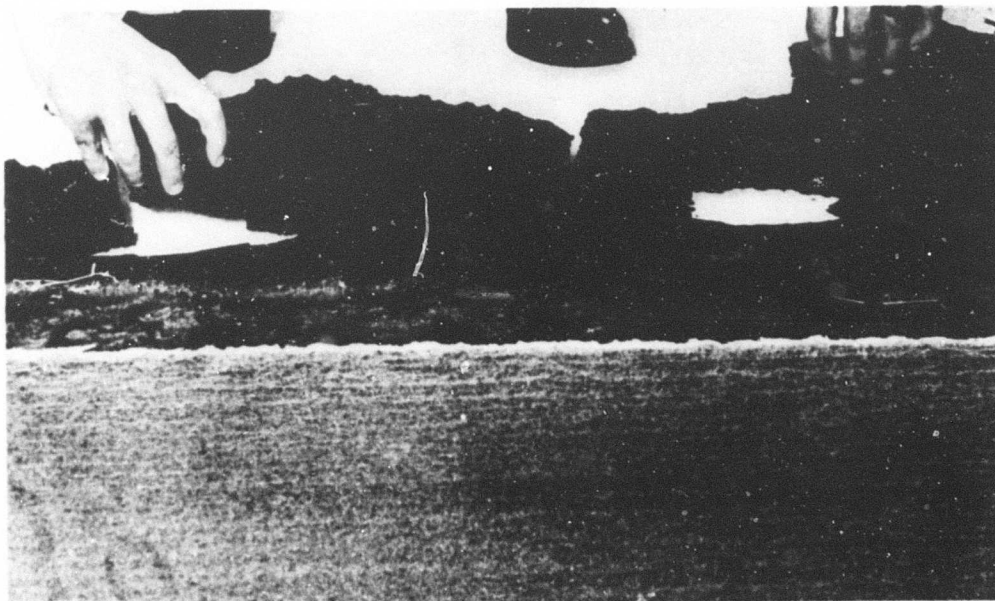
Figure 25. Peeled alkyd paint and slurry seal on side line striping of asphaltic runway at Oxnard Air Force Base, spring 1965.

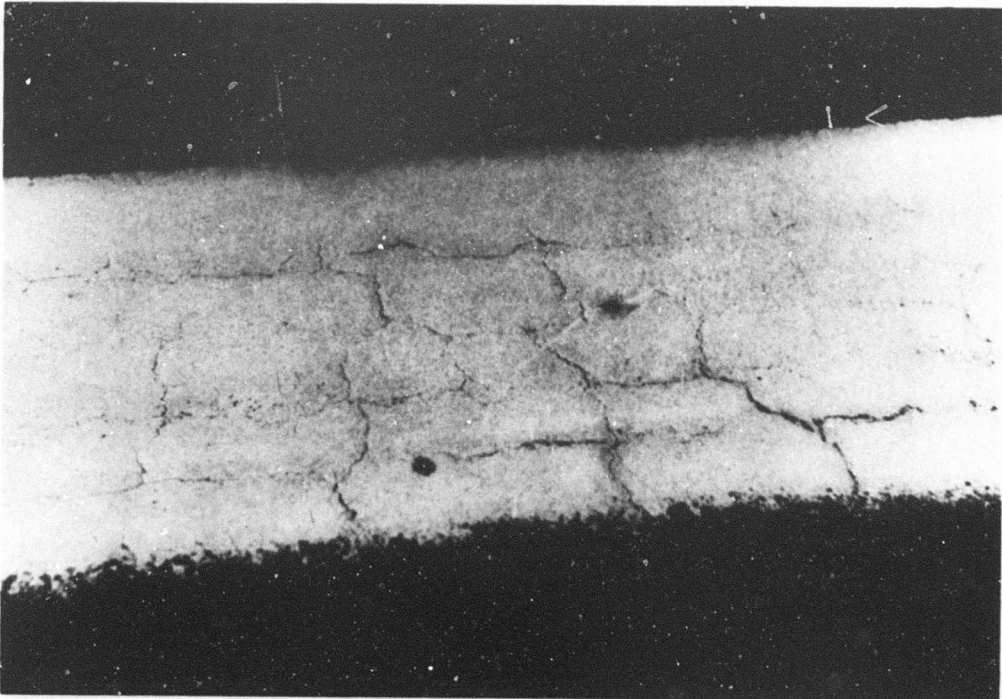
The oleoresinous phenolic varnish paint performed in a most satisfactory manner. When examined in September 1967, the side line stripes were still in good condition and had retained good retroreflectivity, but the centerline required restriping due to deposition of rubber from touchdown of aircraft tires onto the paint. This was especially noticeable on the section of portland cement concrete; the black tire markings had reduced both visibility and retroreflectivity. The side line stripes on the overlay had reflection cracks (Figure 26) of the underlying portland cement concrete but showed none of the peeling associated with the previously used alkyd paint.

**Figure 26. Oleoresinous phenolic varnish striping on side line of asphaltic runway at Oxnard Air Force Base, September 1967.**

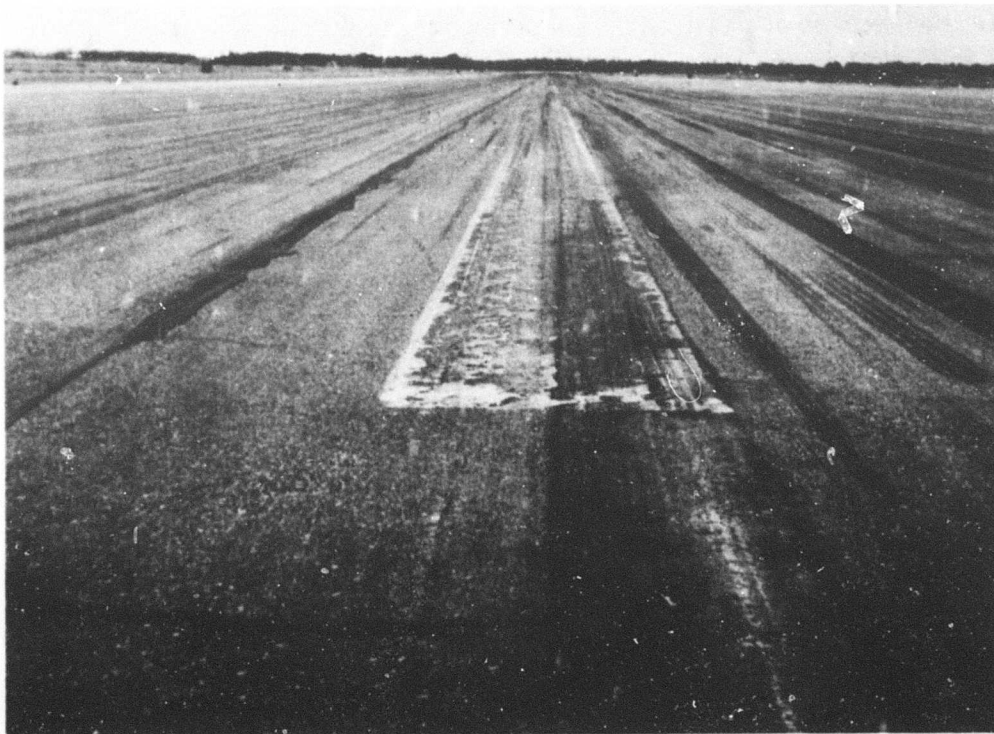
the centerline (Figure 27) was almost completely lost, and the side line stripes were in very bad condition. The condition on the asphaltic portion of the runway was much worse than that on the portland cement portion (Figure 28). When the broken pieces of the deteriorated stripings were held on edge, the alternate layers of white paint and asphalt seal (Figure 29) were readily visible. Although the original paint (oleoresinous phenolic varnish) had performed well, the two topcoats of alkyd paint had imposed sufficient additional strain on the marking that the bond between the underlying slurry seal and substrate was broken with the resultant peeling and loss of paint and slurry seal.

**Figure 27. Deteriorated centerline striping at Oxnard Air Force Base, December 1969.**

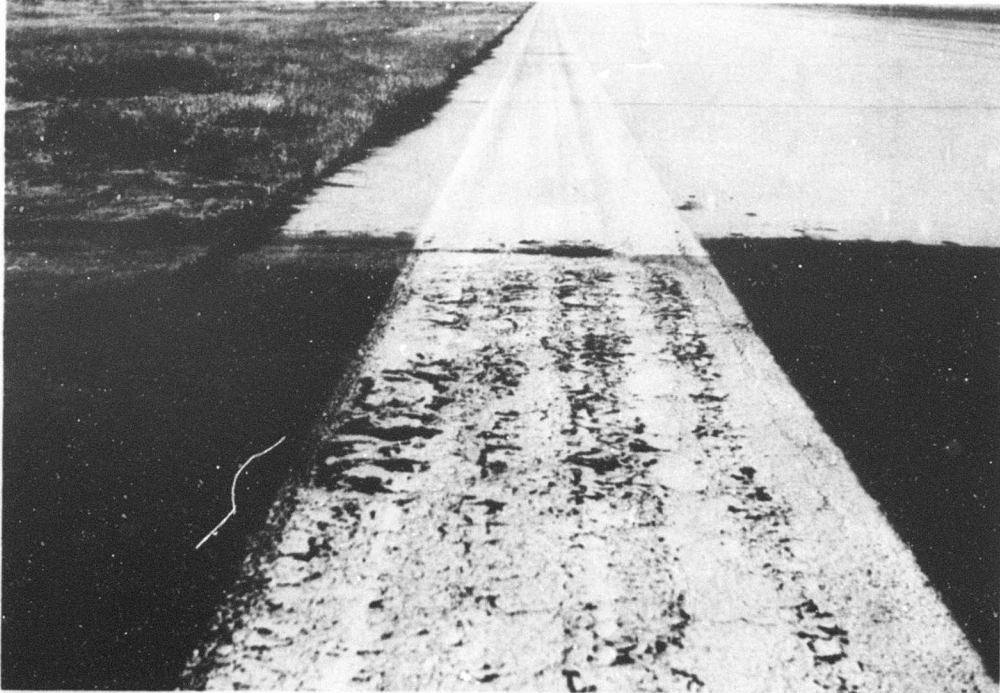
**Figure 28.** Deteriorated side line striping at Oxnard Air Force Base, December 1969. Note better condition of striping on portland cement concrete portion than on asphaltic portion.

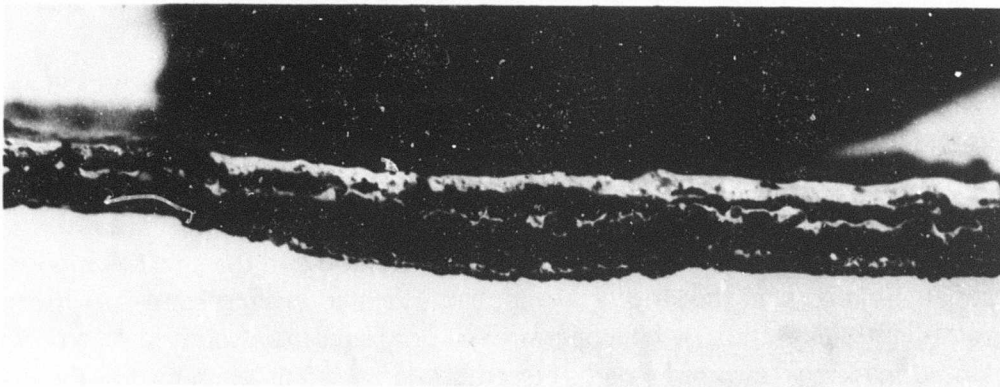
**Figure 29.** Edge view of peeled runway striping from Oxnard Air Force Base showing three alternate layers of paint and asphalt.

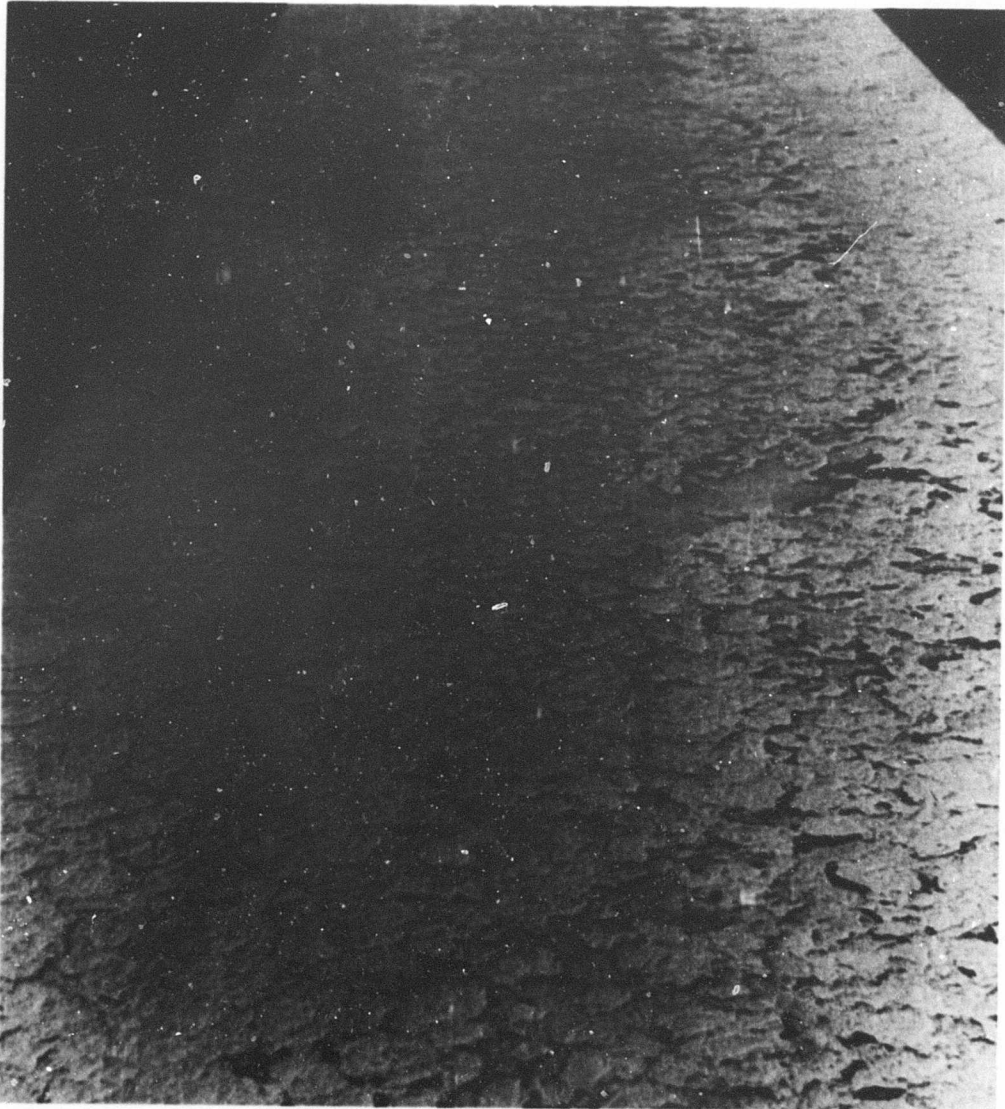
for other markings. After a month, paint and sand seal began to crack (Figure 30) and come loose in large pieces from both the centerline and side lines. A representative of the Office of the Inspector of Naval Material inspected the runway to determine if the contractor should be required to restripe the runway because of poor paint application or inferior paint. The inspector accepted the paints as conforming to specification and attributed poor paint performance to the presence of moisture on the pavement at the time of application. Because Public Works personnel had the responsibility of determining the suitability of application conditions, the contractor was relieved of further responsibility.

**Figure 30.** Airfield marking at NAS, Imperial Beach in August 1966, 10 months after striping.

markings. It was recommended that restriping be done with a long oil length oleoresinous phenolic varnish paint conforming to TT-P-85<sup>15</sup> and having a low boiling, high aromaticity solvent. Because of funding considerations, it was decided that only the loose paint and sand seal should be removed by chipping before replacement of the stripes.

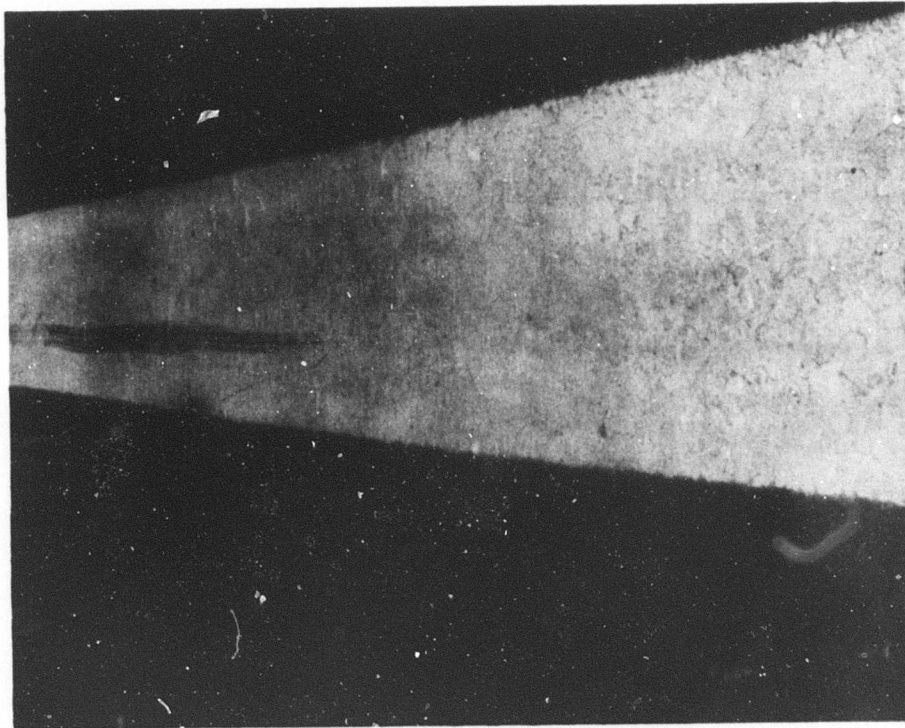
Figure 31. Restriped centerline passing through bird bath at NAS, Imperial Beach in April 1967, 3 months after restriping.
