**R 705**

Technical Report

**AIRFIELD MARKING PAINTS FOR  
ASPHALTIC PAVEMENTS**

**NAVAL CIVIL ENGINEERING LABORATORY**

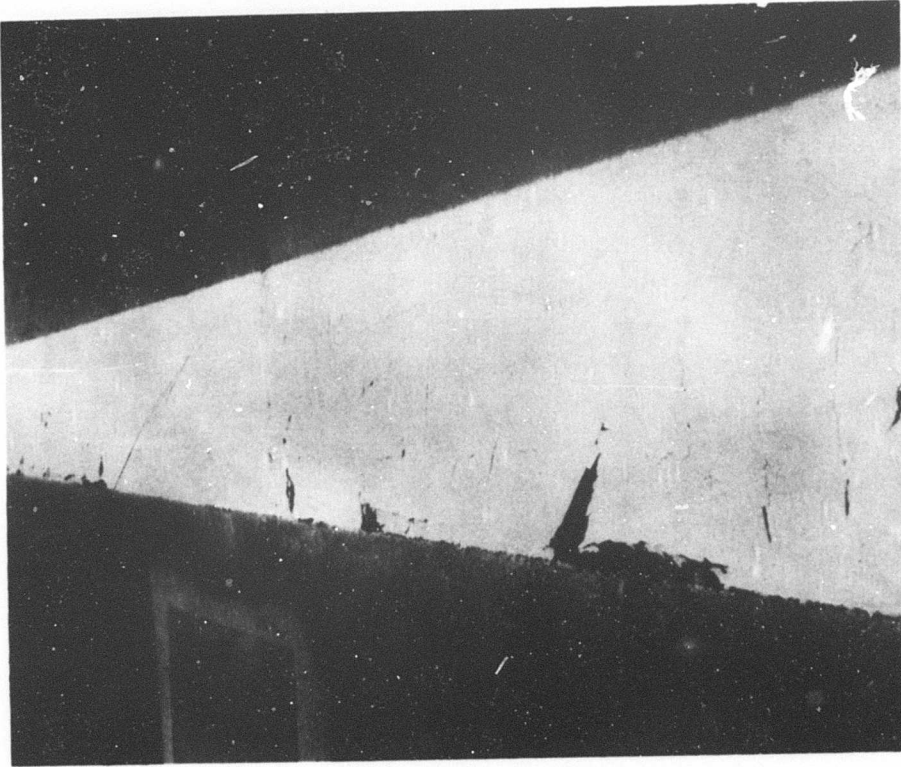
Figure 32. Restriped side line at NAS, Imperial Beach in June 1967, 5 months after restriping.

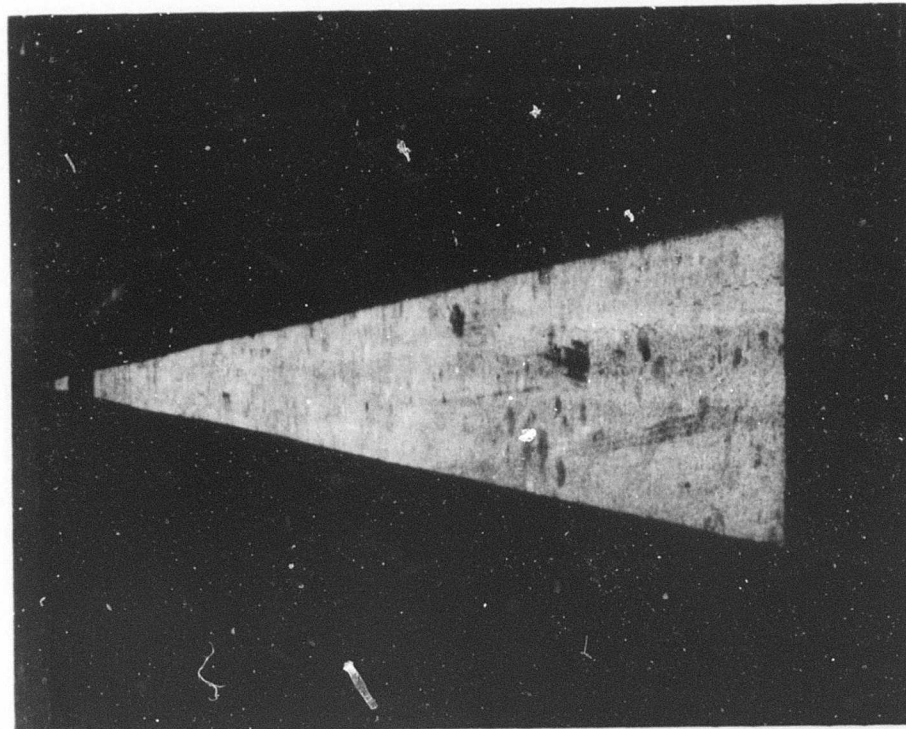
The latest airfield markings have performed very well at NAS, Imperial Beach for 1-1/2 years on the centerline (Figure 33), on the side lines (Figure 34), and on the numerals identifying the runway at its extremities. There are very few cracks on the markings, no peeling of the sand seal, and excellent retention of reflectorized glass spheres. The absence of erosion and the small number of rubber tire marks on the striping are probably related in significant part to the use of light planes, mostly helicopters. The only significant deteriorations of painted markings occurred where the centerline passed through bird baths (Figure 35). The Public Works Office at NAS, Imperial Beach is quite pleased with the performance of this paint (similar to NCEL Formulation 109), especially when their past history of problems associated with airfield striping is considered.

Figure 33. Side line at NAS, Imperial Beach in December 1969,  
1-1/2 years after striping.

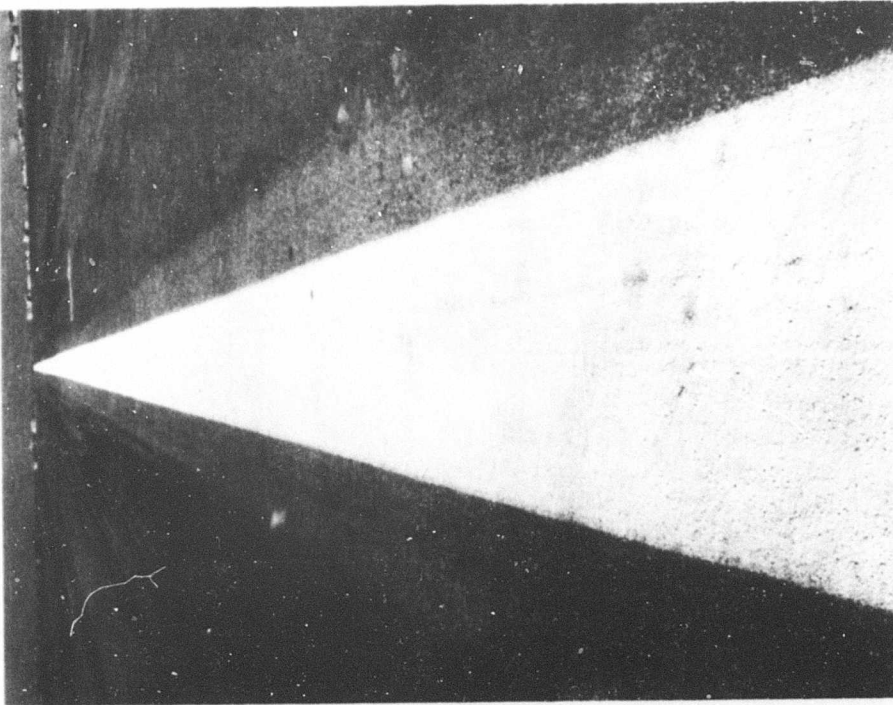
Figure 34. Side line at NAS, Imperial Beach in December 1969,  
1-1/2 years after striping.

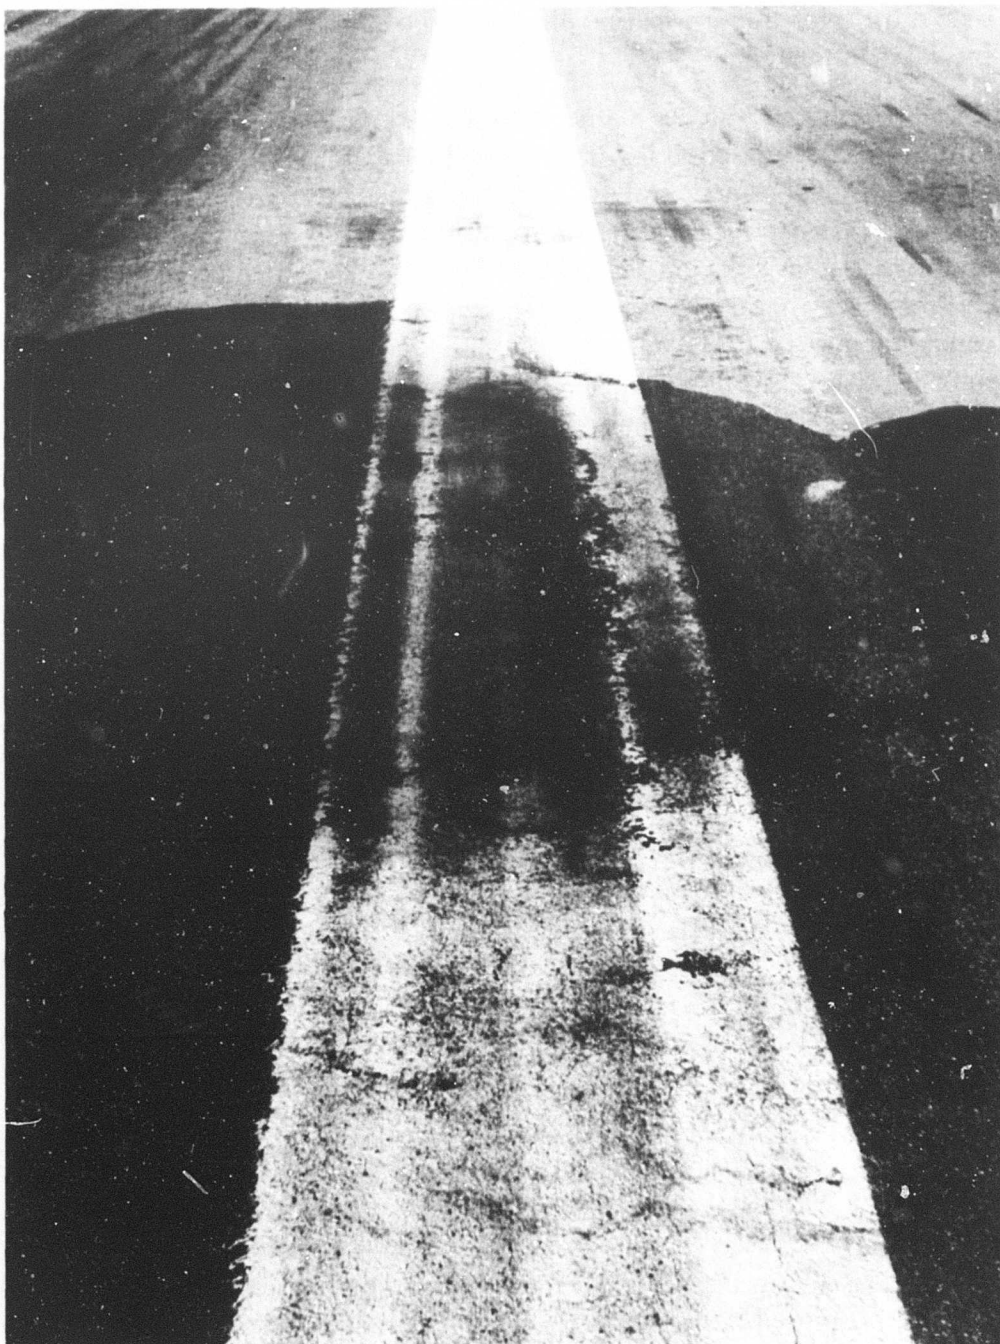
Figure 35. Paint deterioration on centerline at NAS, Imperial Beach where it passes through a bird bath.

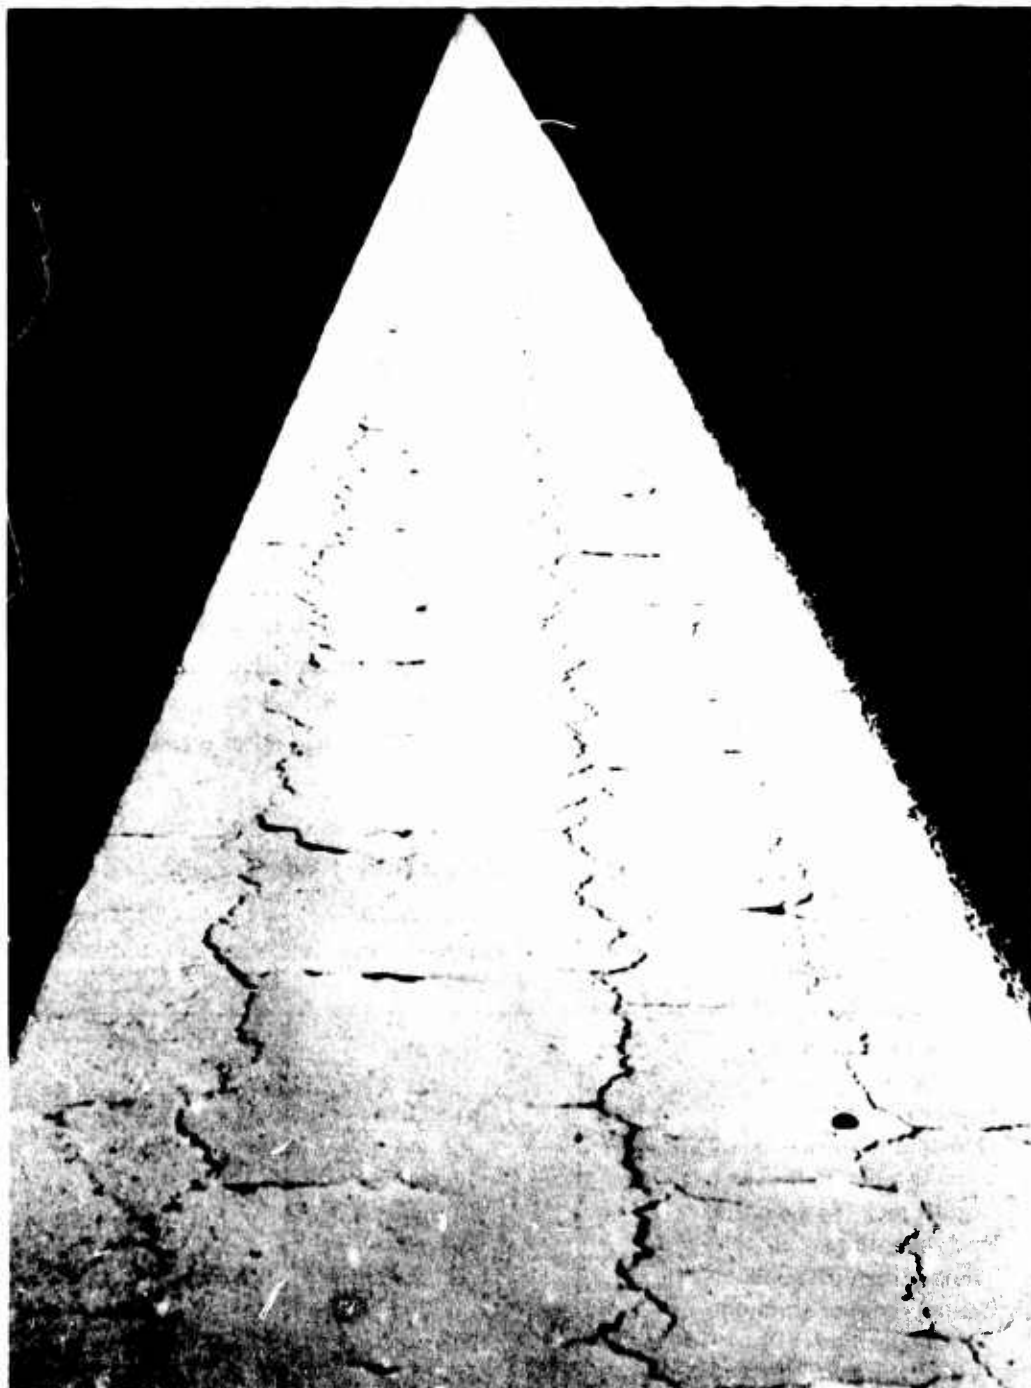
**Figure 36. Deteriorated side line striping on Runway 17-35, MCAS, Yuma, in October 1968.**

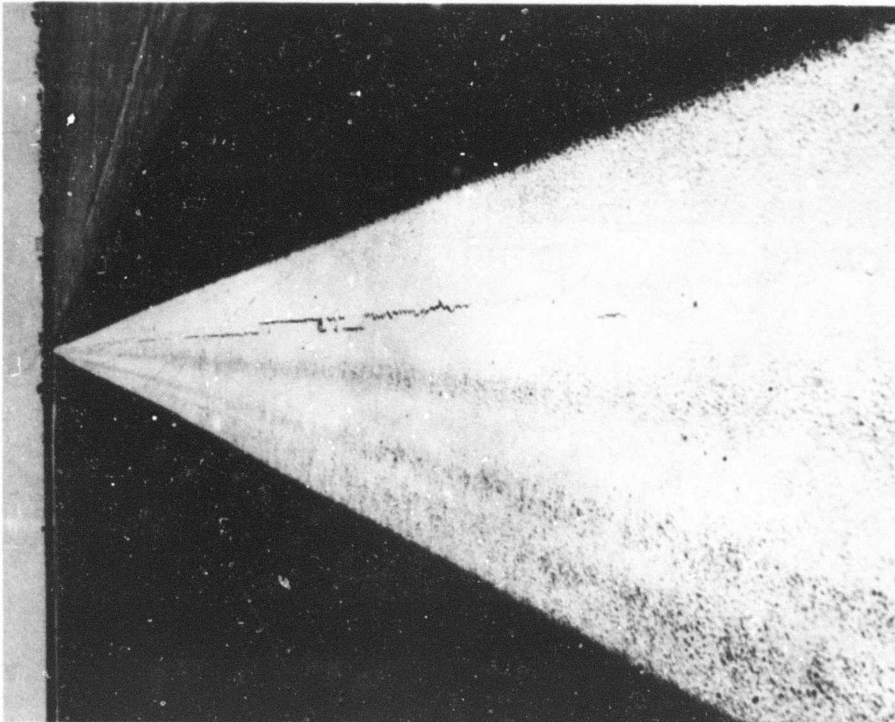
Figure 37. Striping on Runway 8-26, MCAS, Yuma, in October 1968. Note long crack parallel to direction of striping.

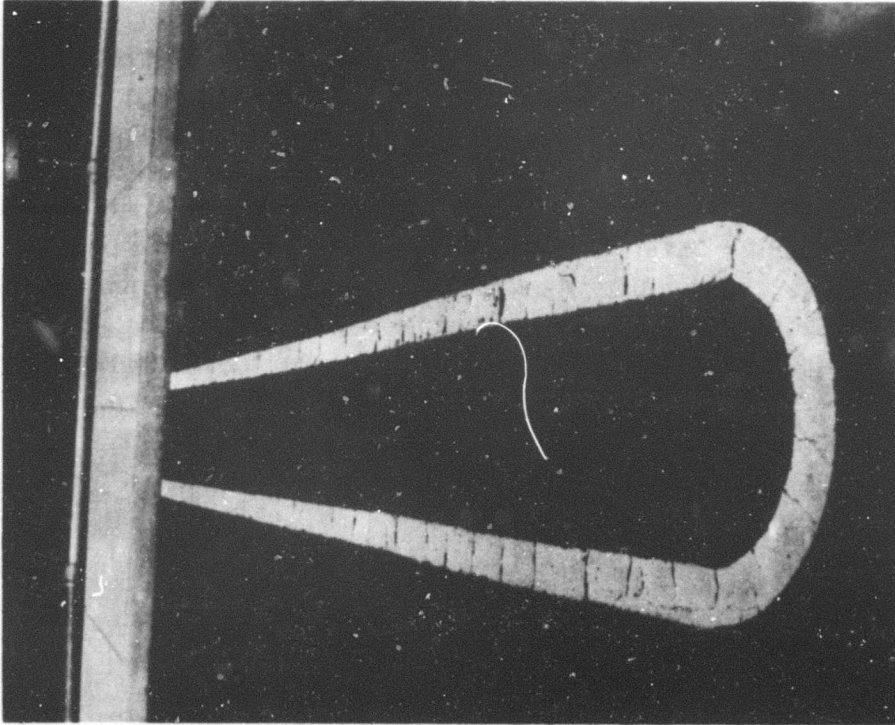
Figure 38. Deteriorated painted marking and underlying asphaltic substrate in parking lot at MCAS, Yuma.
