Technical Note N-1148

AIRFIELD PAVEMENT CONDITION SURVEY,
USNAS POINT MUGU, CALIFORNIA

D. J. Lambiotte and R. B. Brownie

February 1971

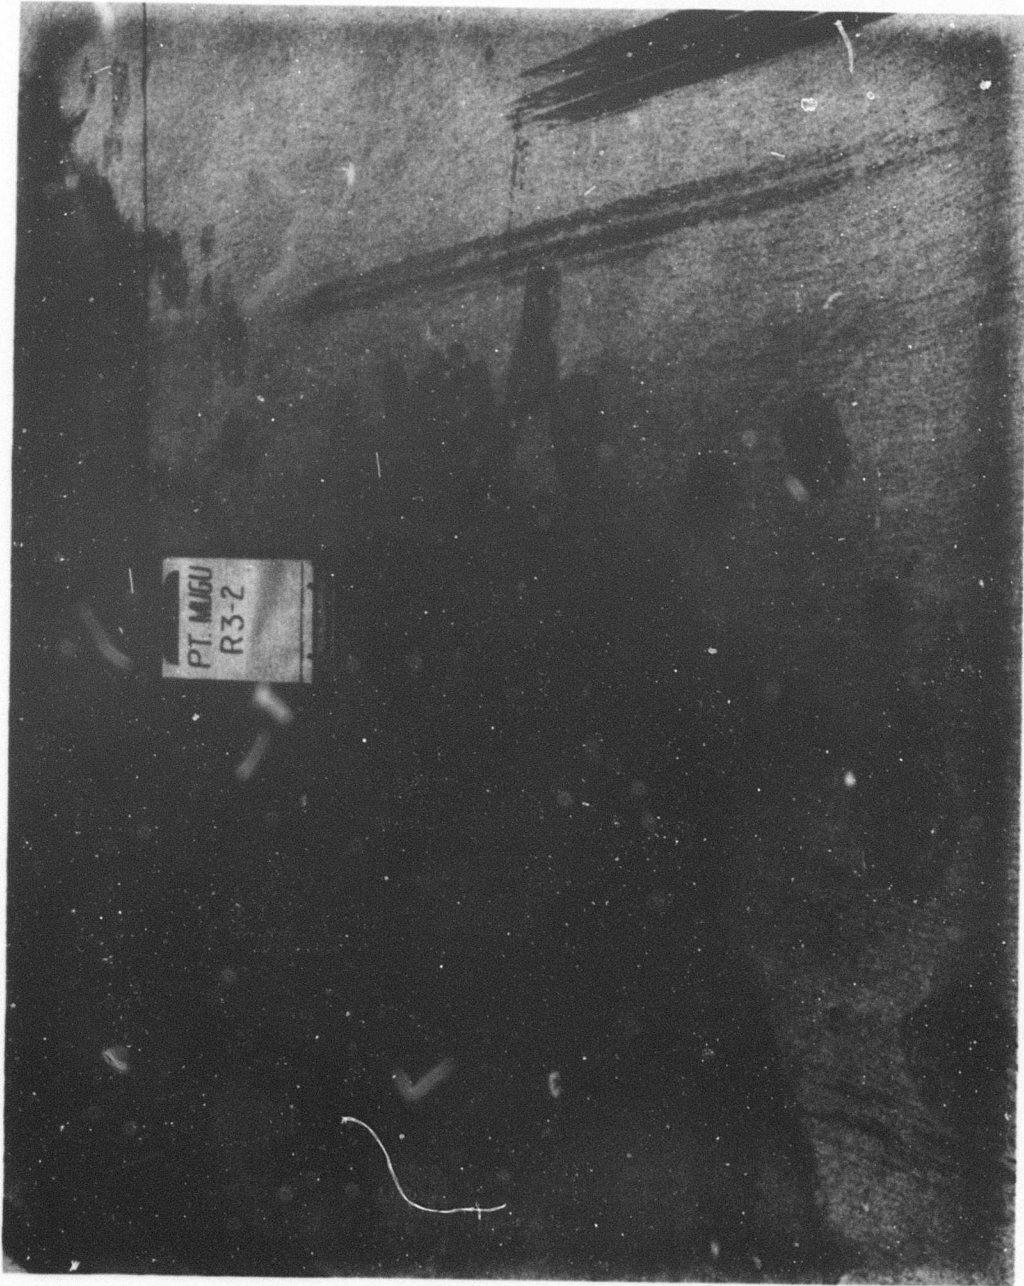
Figure 5. Repaired jet blast spalls, discrete area R3-2.

Remarks on Pavement Condition
 Spalls were up to 6 inches wide and some contained loose chunks. The joint seal was hardened and occasionally was missing in strips up to 2 feet long. Severe surface spalling due to jet blast had taken place at the west end of the runway. Approximately 95% of the surface spalls were repaired. See Figure 5.

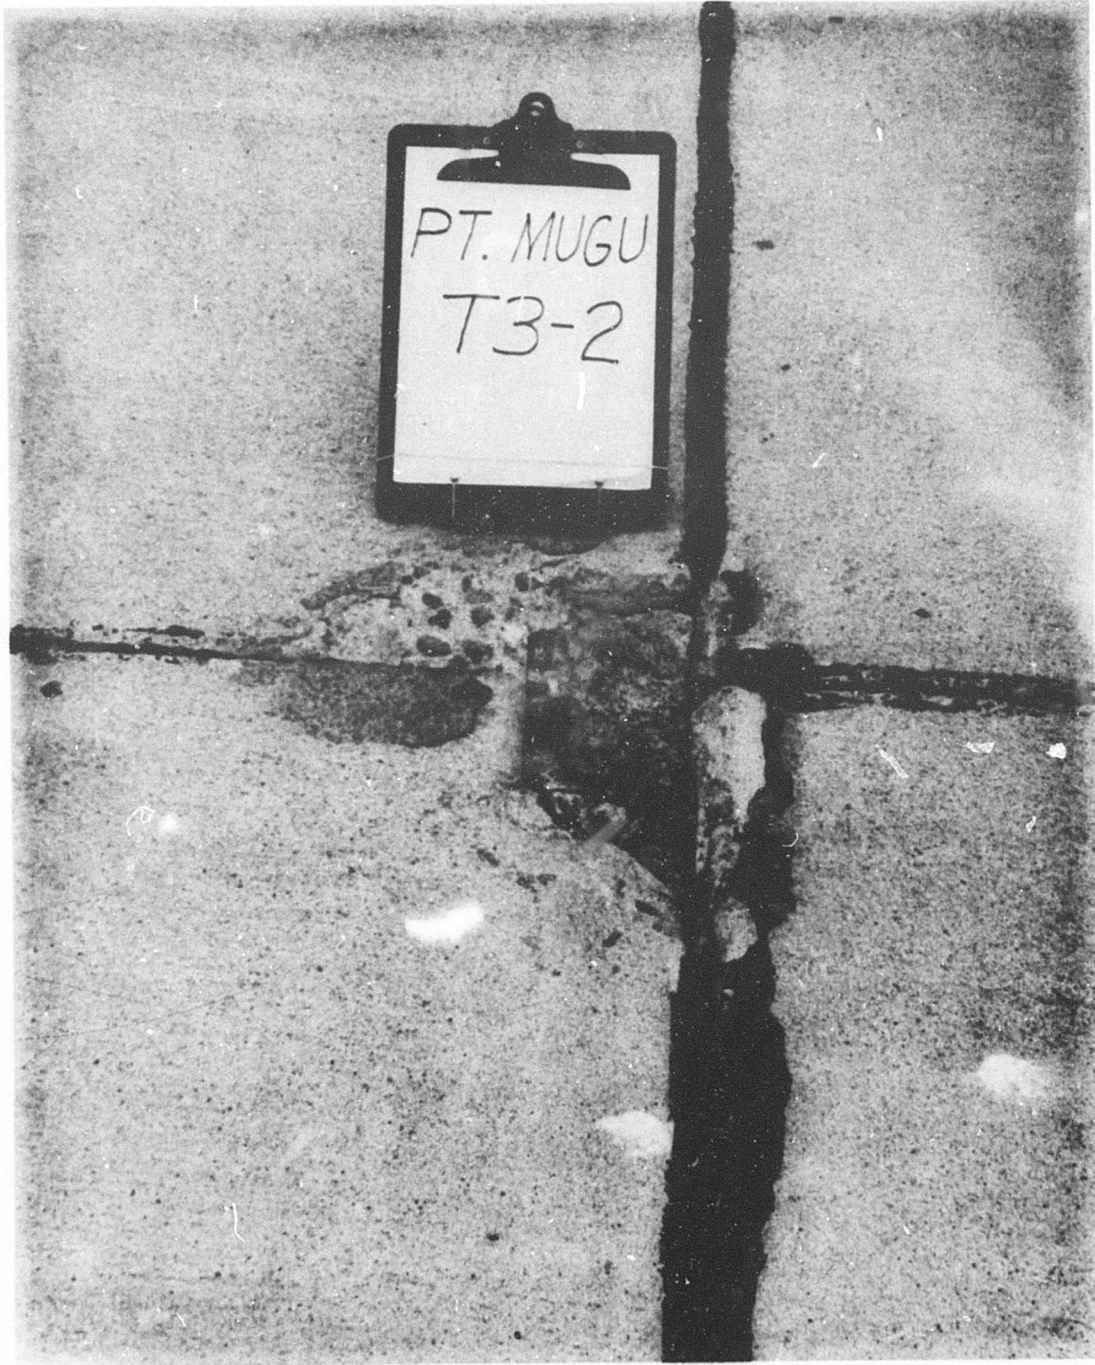
Figure 6. Failed corner spall repair, discrete area T3-2.

Spalls occurred primarily on corners and transverse expansion joints. Spalls were up to 8 inches wide and exhibited loose material. Joint seal was shriveled and had lost bond. See Figure 6.

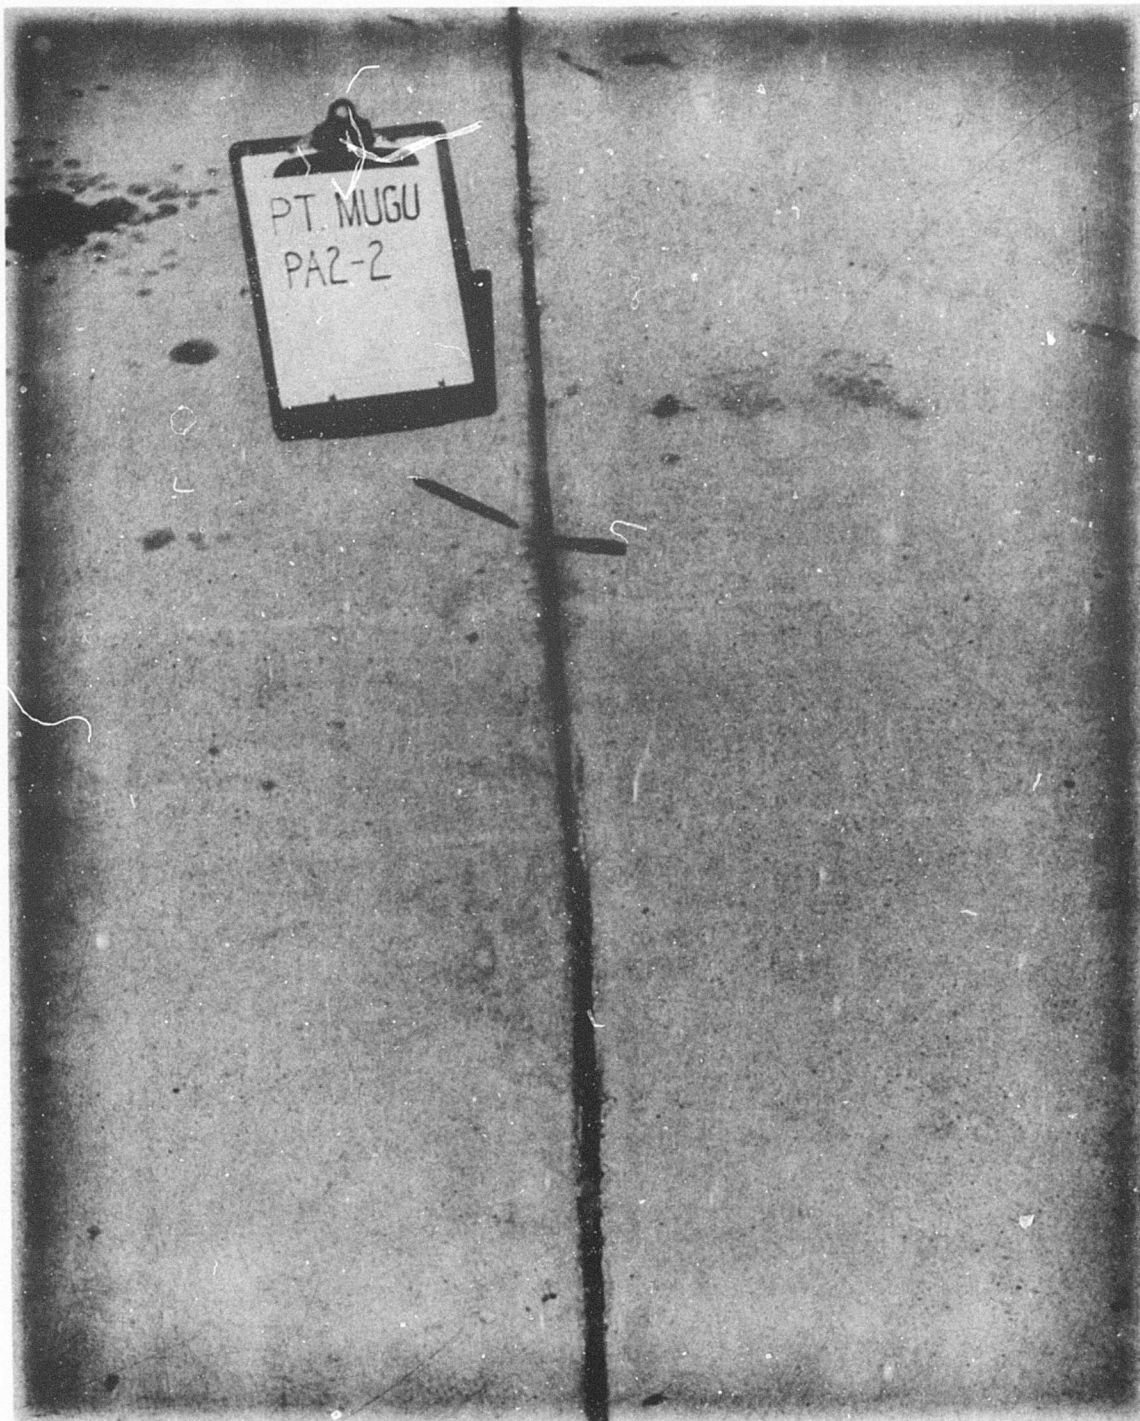
Figure 7. Missing joint seal, discrete area PA2-2.

Defect Type	No. of Sample Slabs w/Defect	Total Slabs w/Defect: c x a/b	Defect Density (per slab) d/a	Defect Severity Weight	Weighted Defect Density e x f
	(c)	(d)	(e)	(f)	(g)
Faulting					
Corner Break					
L.C. or T.C.*	4	16	0.067	1.0	0.07
I.C.**					
Depression					
Spalling	16	64	0.267	7.5	2.00
Scaling					
Shattered Slab					
Joint Seal	60	240	1.000	2.5	2.50
Pumping					
"D-line" cracking					
Remarks on Pavement Condition					Total
					4.57C
<p>Spalls were up to 3 inches wide. Joint seal had lost bond and was occasionally missing. See Figure 7.</p>

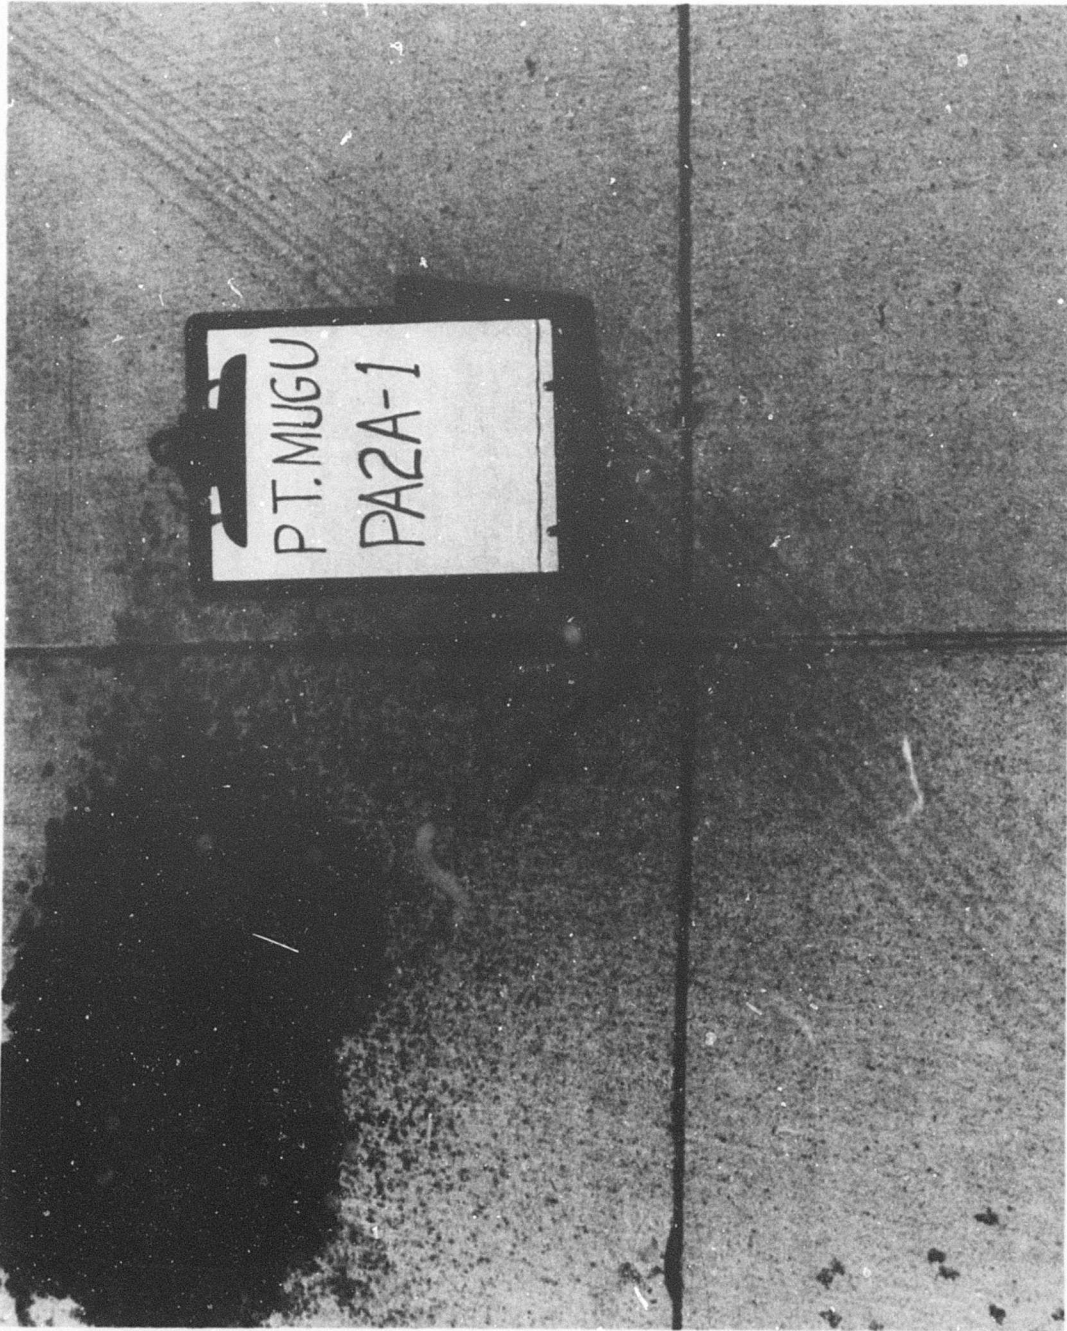
Figure 8. Missing and poorly bonded joint seal, discrete area PA2A-1.

Spalls were small, generally less than 1 inch wide and contained no loose material. Transverse cracks noted were unsealed. Joint seal had lost bond on one side of most joints. Occasionally the joint seal was missing. See Figure 8.

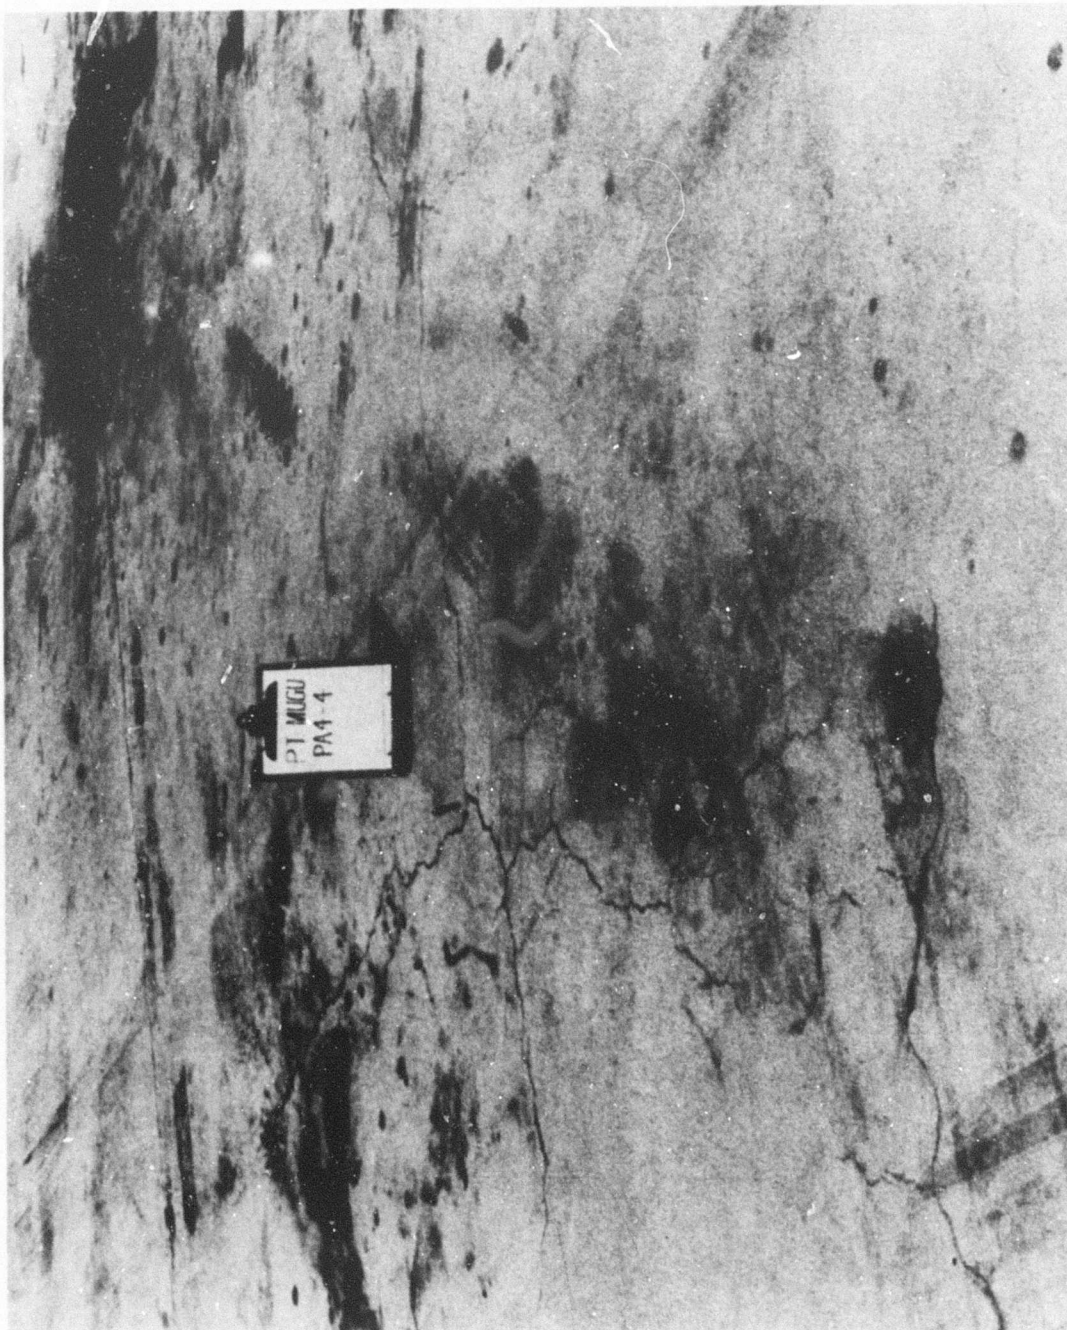
Figure 11. Shattered slabs, discrete area PA4-4.

The 60' x 60' slabs had cracked into several pieces. All cracks were unsealed. Spalls were up to 6 inches wide. See Figure 11.

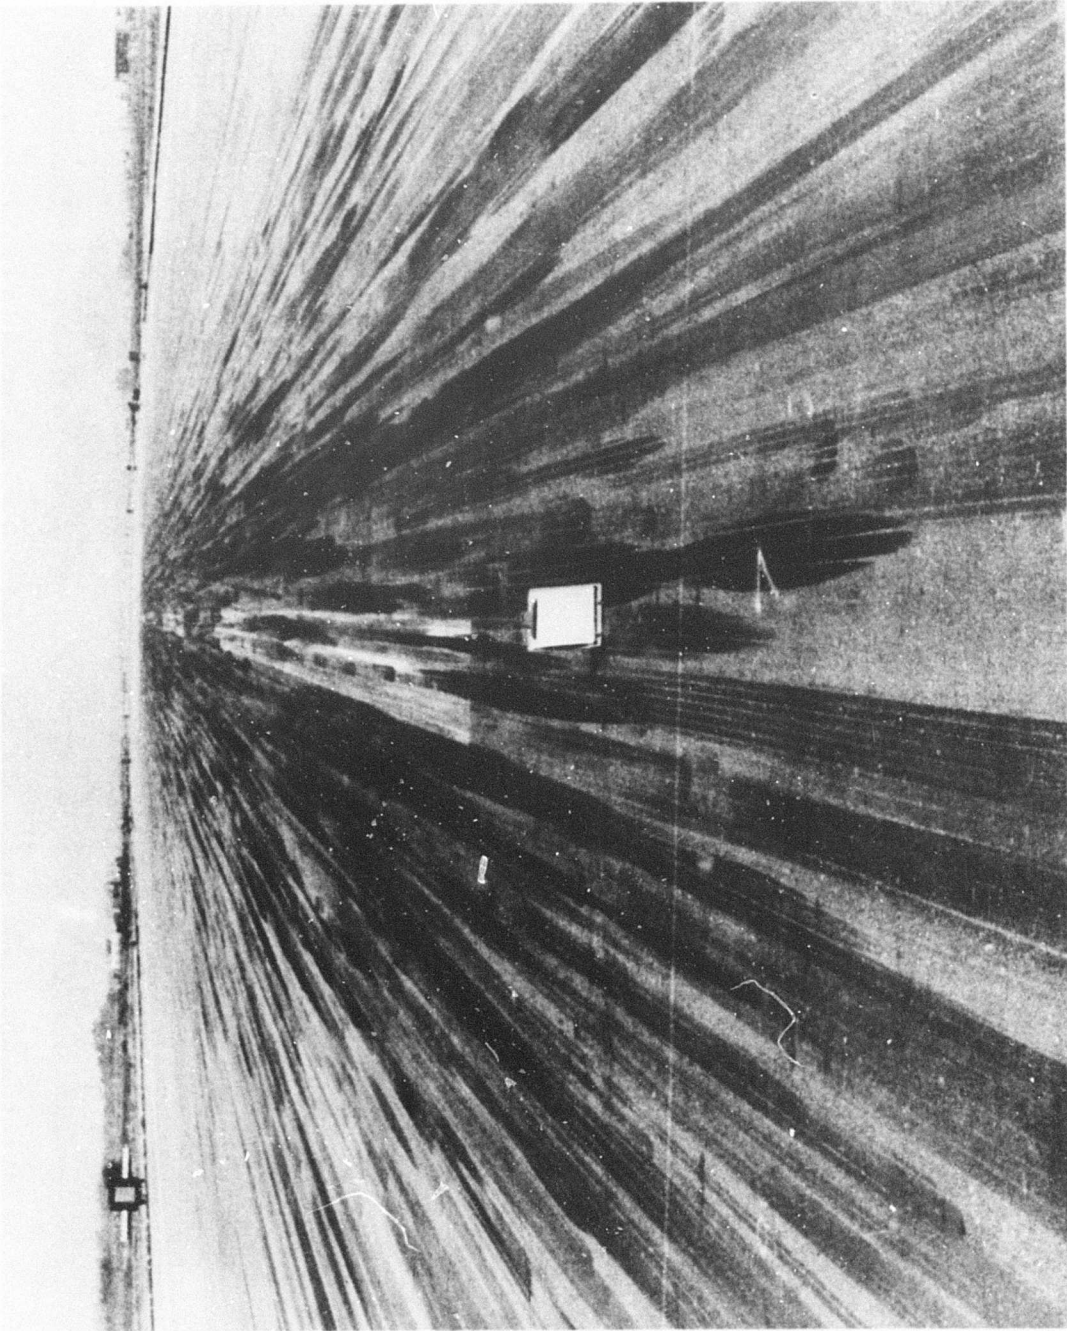
Figure 12. General view showing the excellent condition of discrete area R3-1.

Defect Type	Length or Area of Sampled Defects	Total Length or Area of All Defects (c) x Ratio	Defect Density (per 10 sq ft) 10 d/a	Defect Severity Weight	Weighted Defect Density (e) x (f)
	(c)	(d)	(e)	(f)	(g)
T.C., L.C. or LCJ*					
Reflection Crack					
Faulting					
Patching					
Settlement or Depression					
Pattern Cracking					
Rutting					
Raveling					
Erosion - Jet Blast					
Oil Spillage					
Broken-up Area					
Total					0.00A
Remarks on Pavement Condition					
<p>The surface aggregate of the 1967 overlay was just beginning to become exposed. No measurable defects were found. See Figure 12.</p>

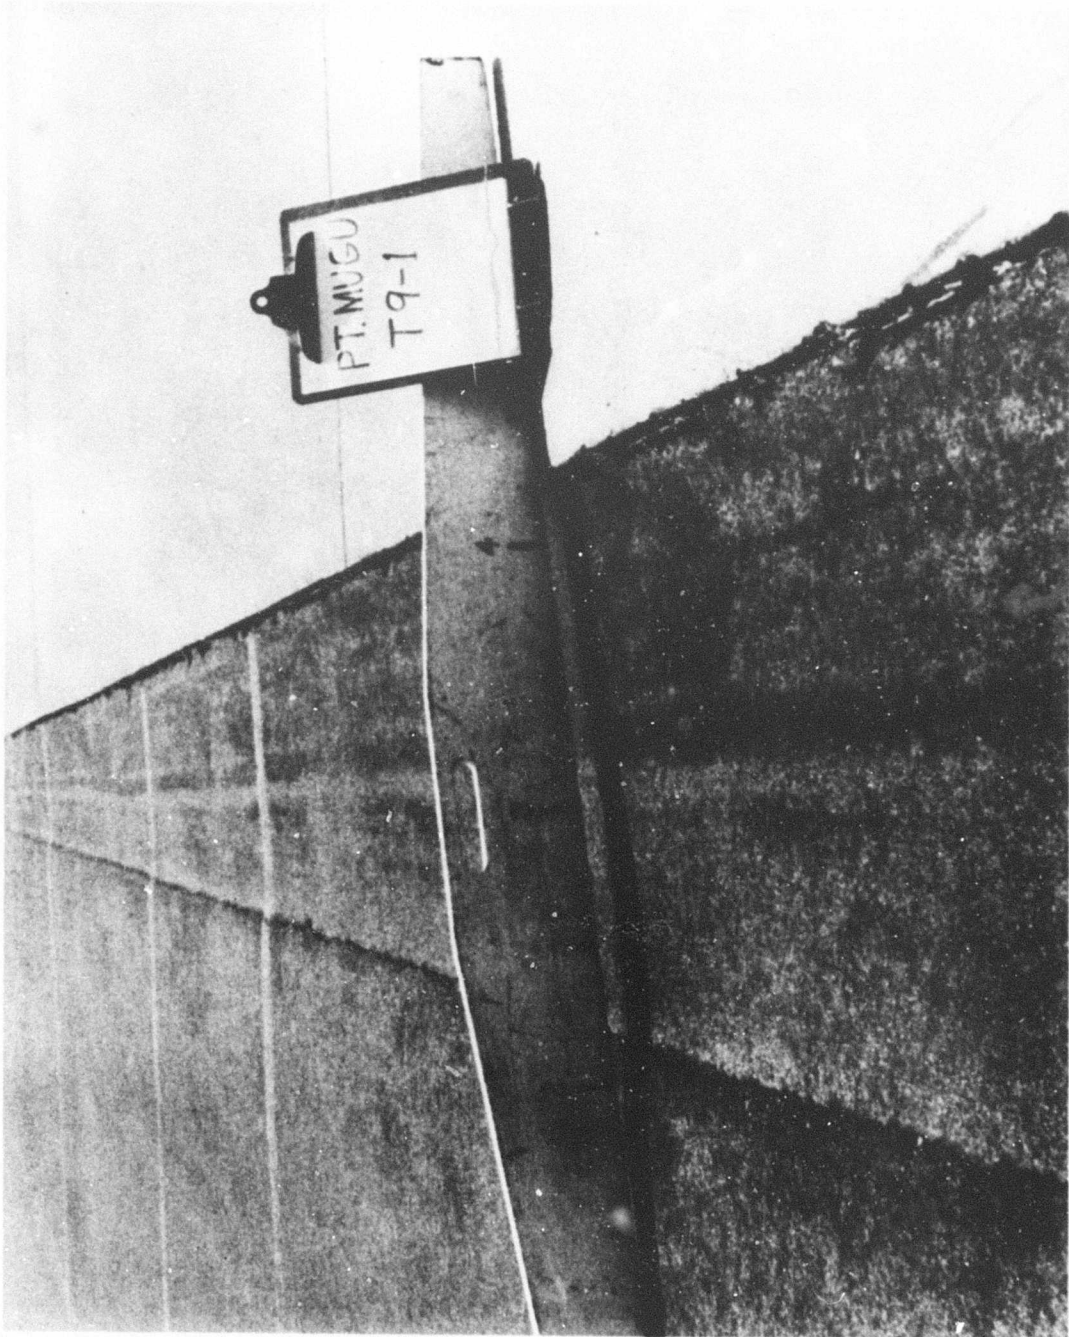
Figure 15. Faulting along taxiway edge, discrete area T9-1.

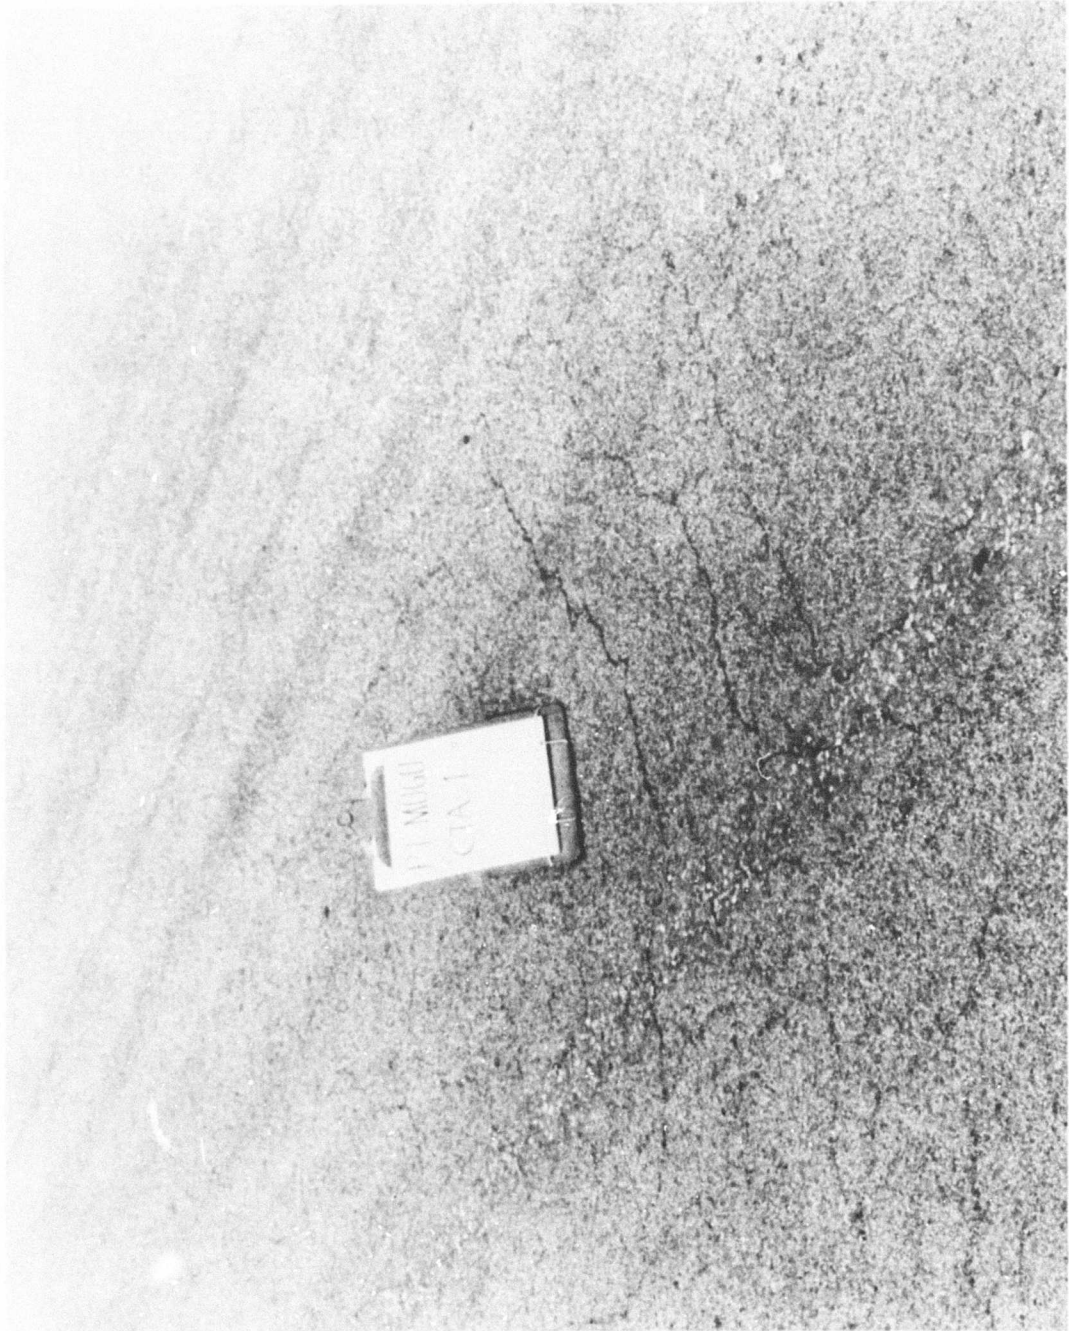
Figure 16. Pattern cracking, discrete area CTA-1.

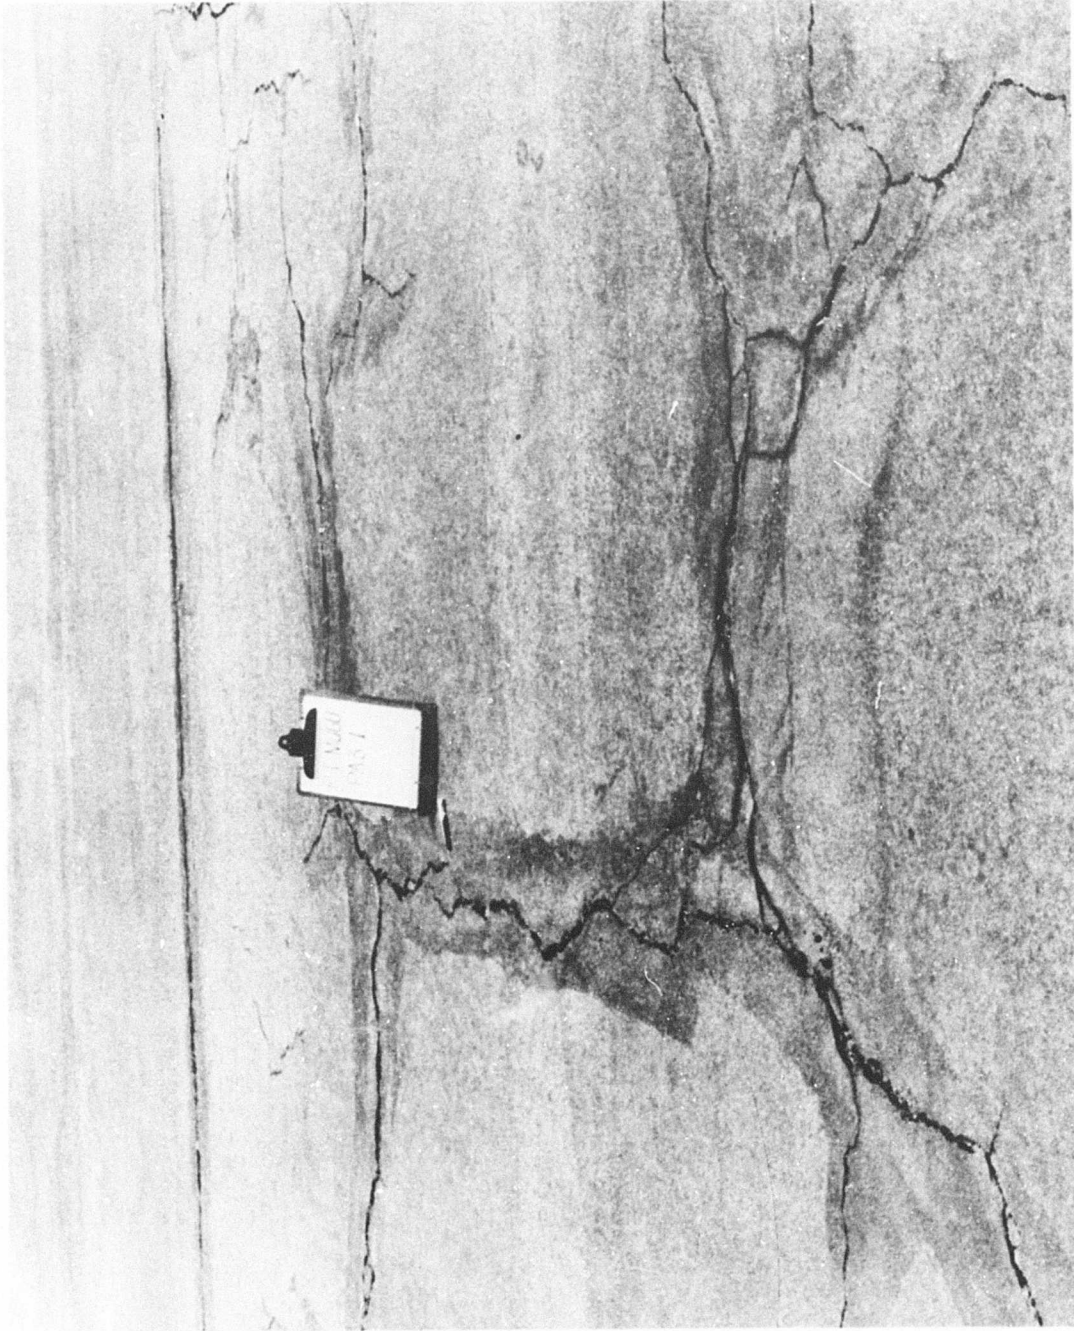
Figure 18. Pattern cracking, discrete area PA3-1.

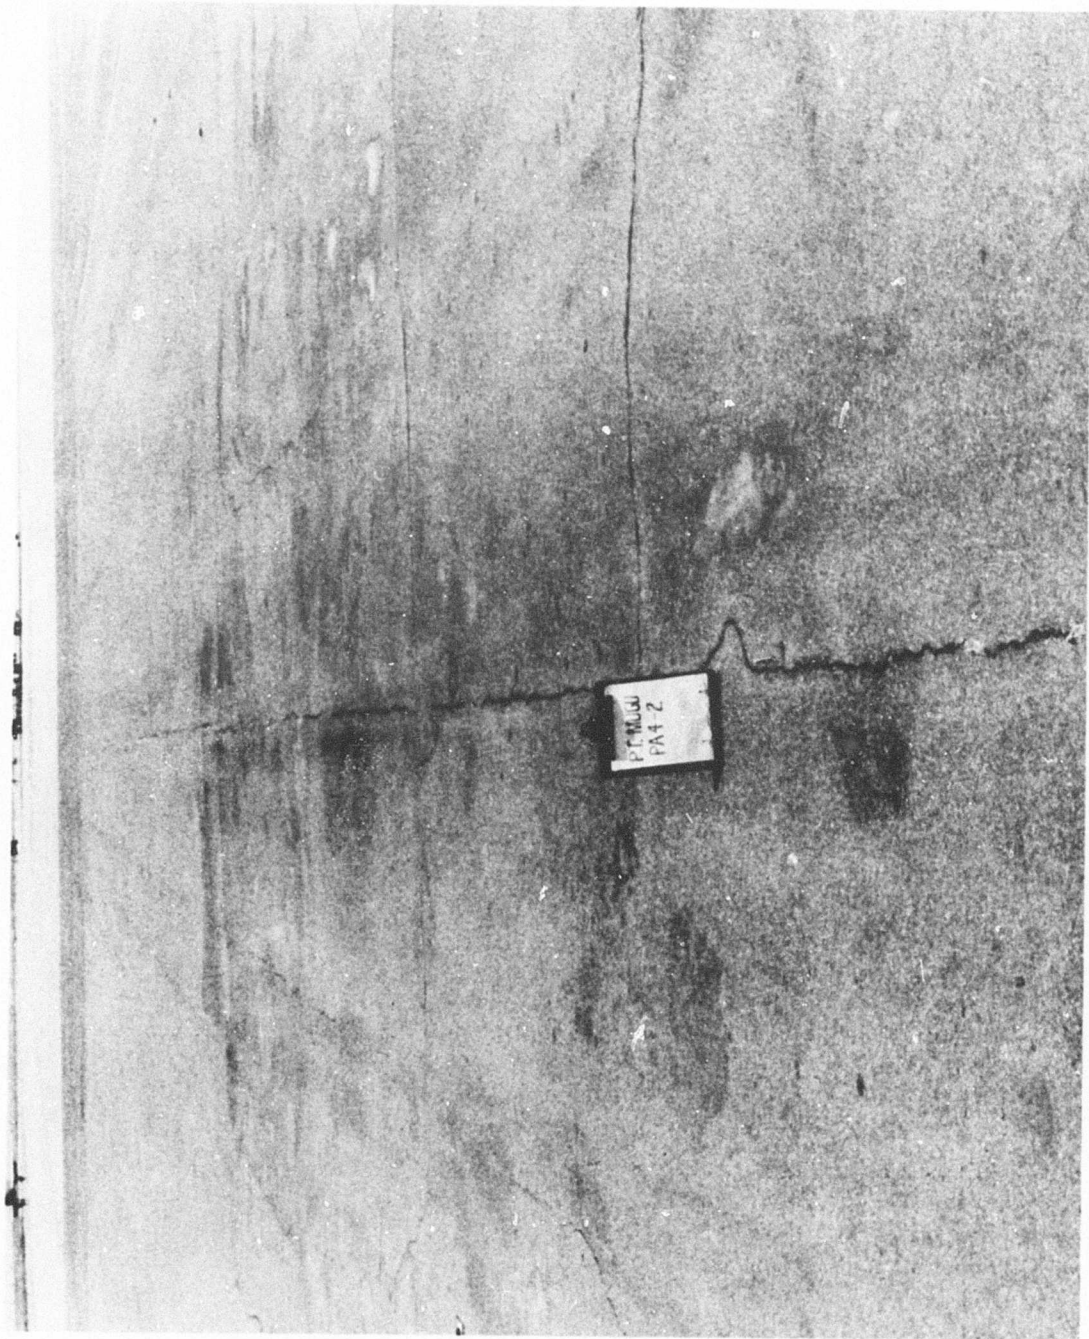
Figure 20. Unsealed longitudinal and transverse cracks, discrete area PA4-2.

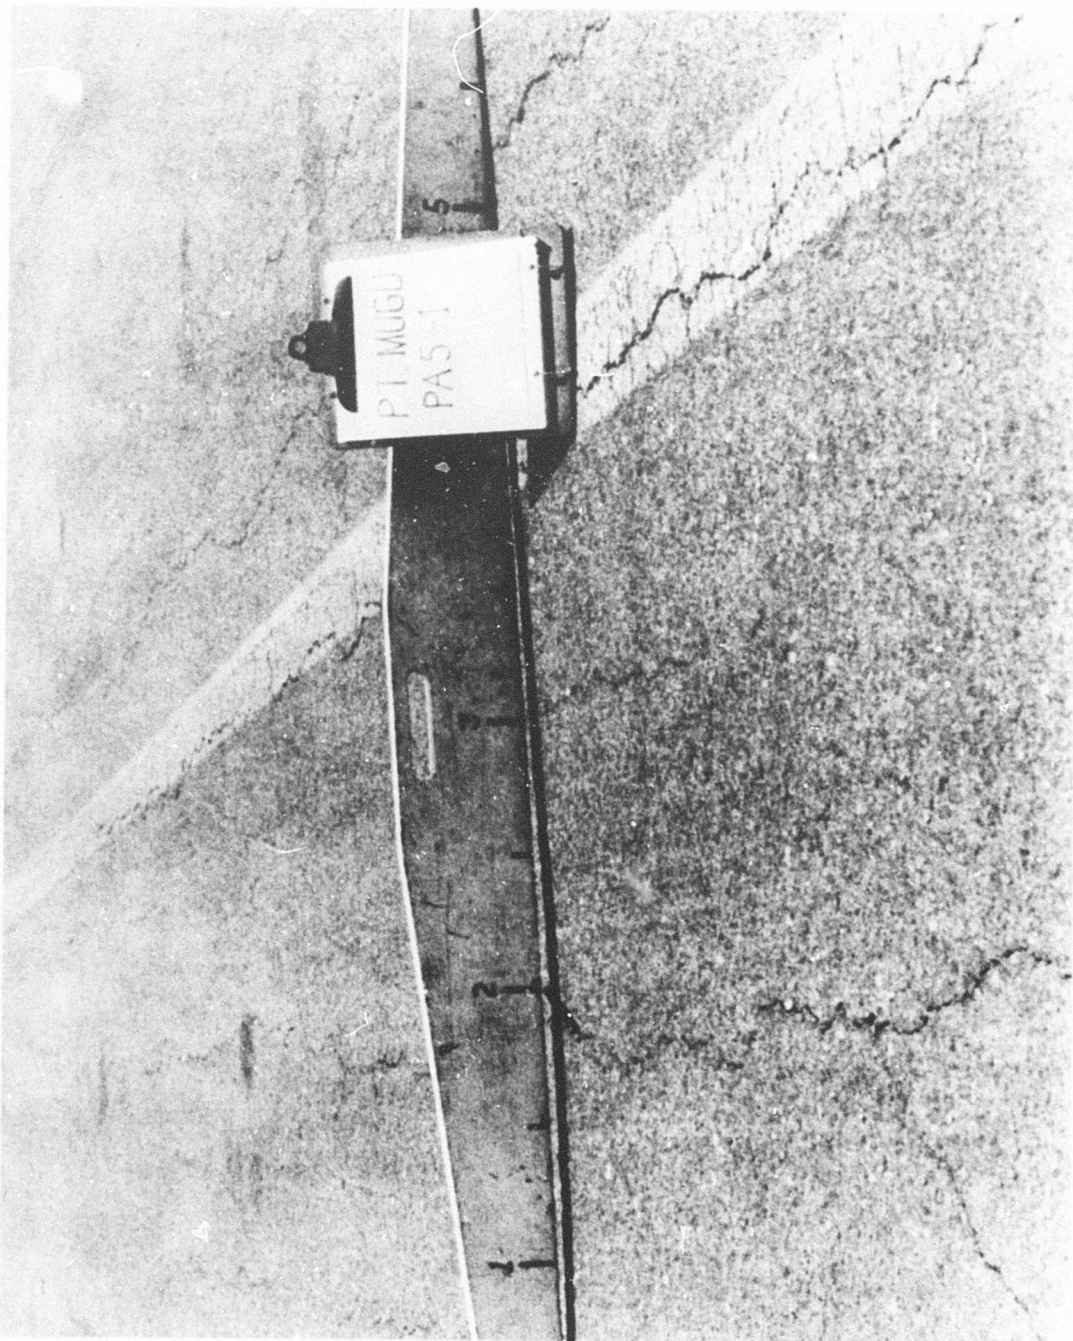
Figure 21. Rutting and pattern cracking, discrete area PA5-1.

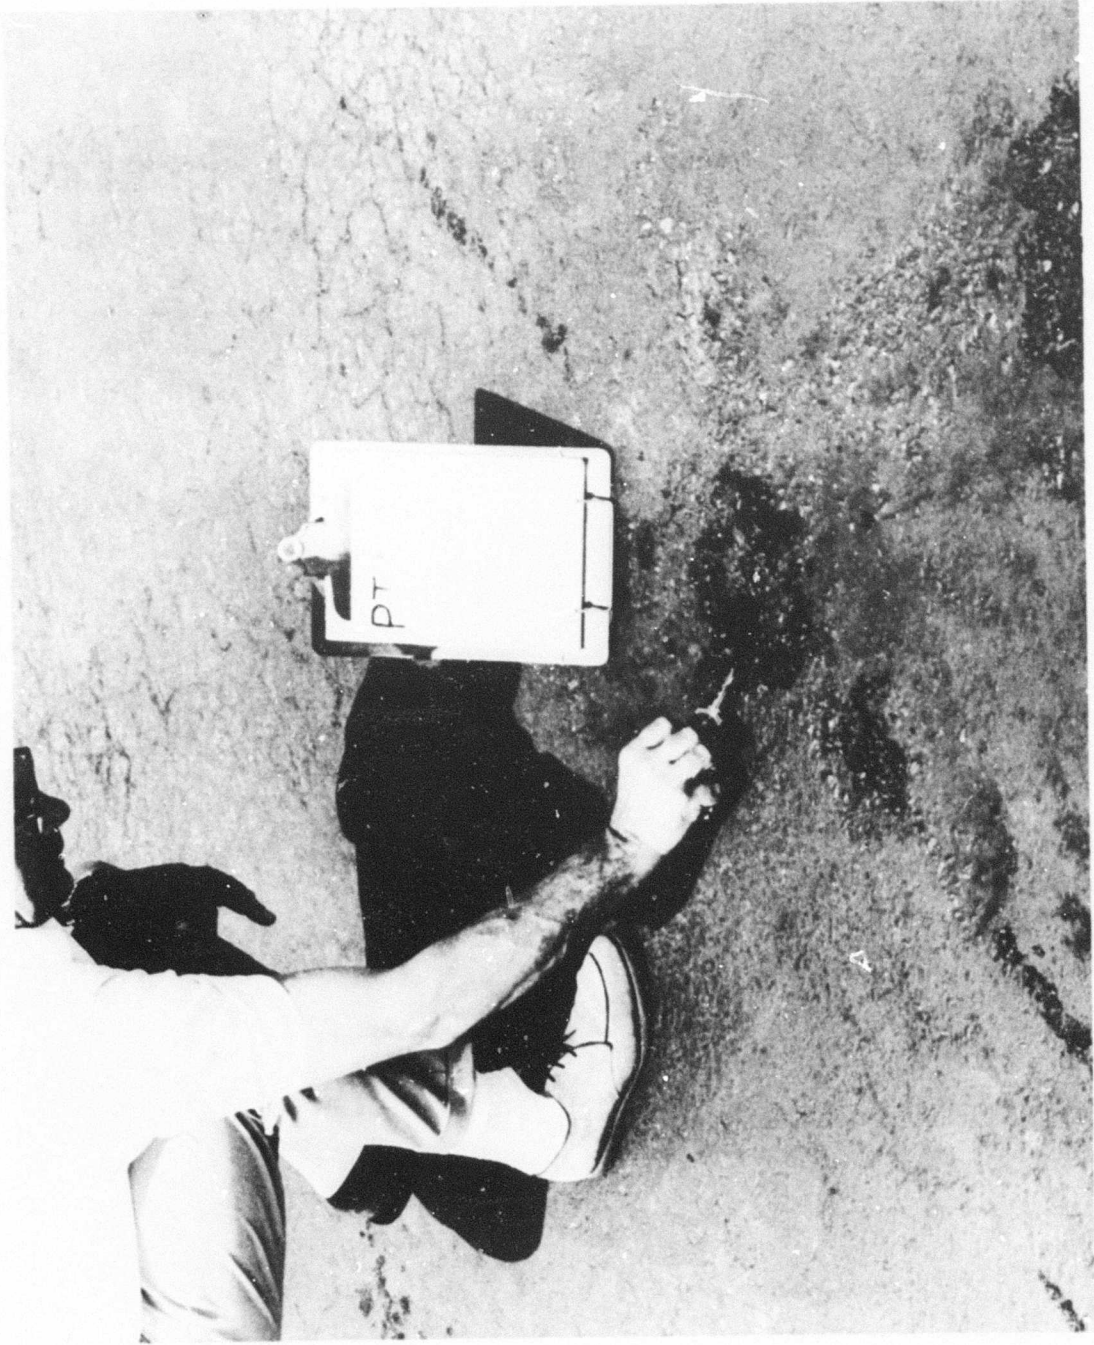
Figure 22. Surface softened by fuel or oil spillage, discrete area PA6-2.

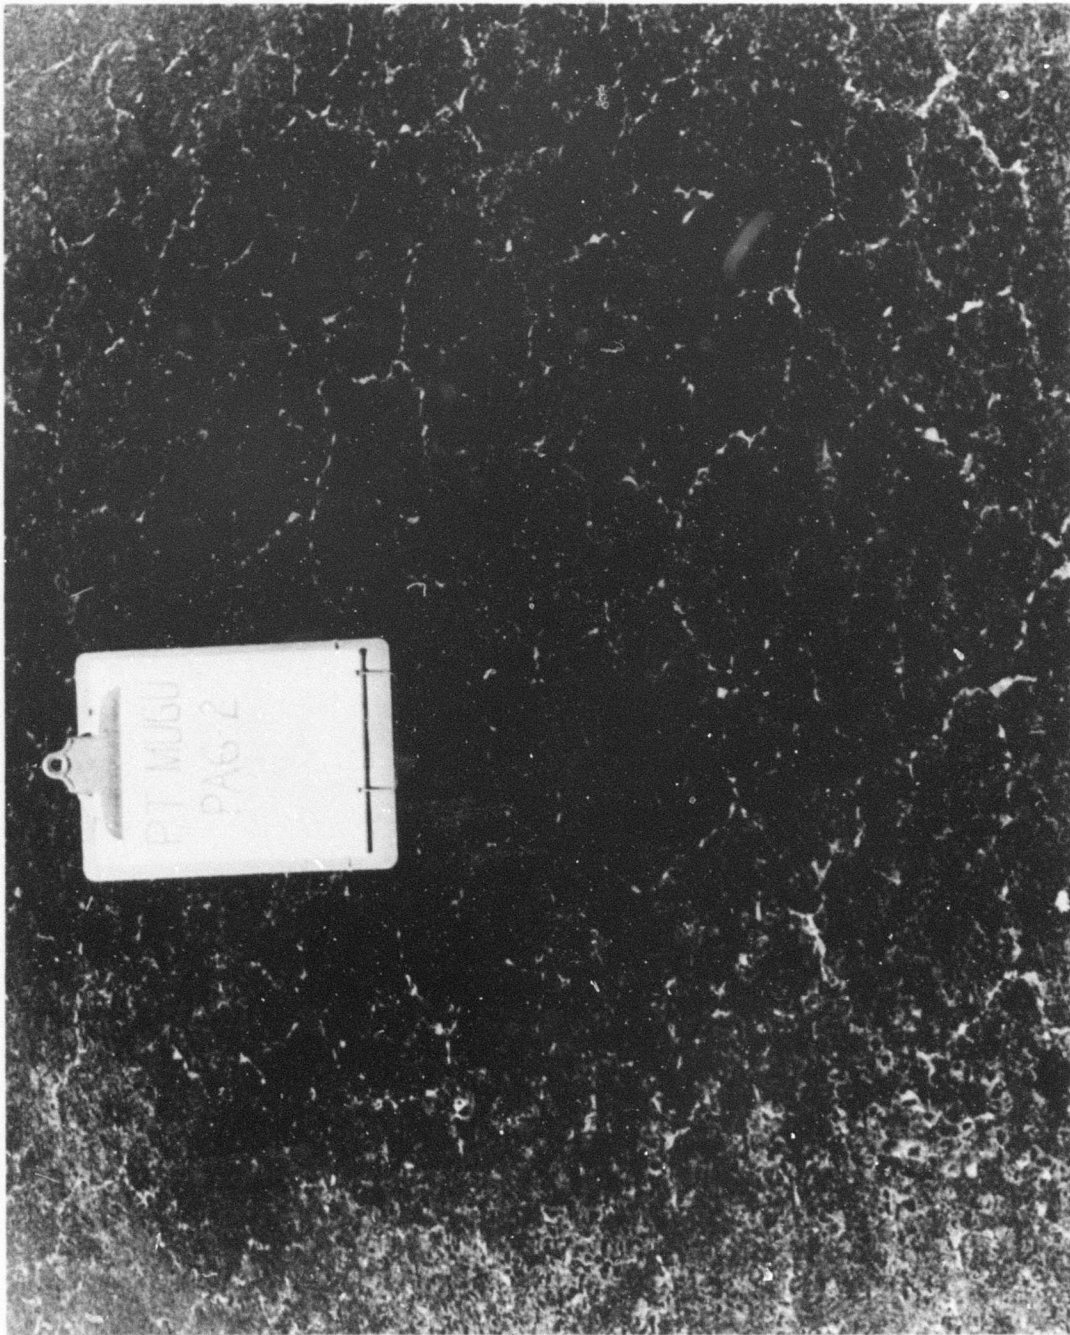
Figure 23. Pattern cracking, discrete area PA6-2.
