MISCELLANEOUS PAPER S-71-11

# CONDITION SURVEY, LIBBY ARMY AIRFIELD FT. HUACHUCA, ARIZONA

April 1971

Conducted by U. S. Army Engineer Waterways Experiment Station, Vicksburg, Mississippi

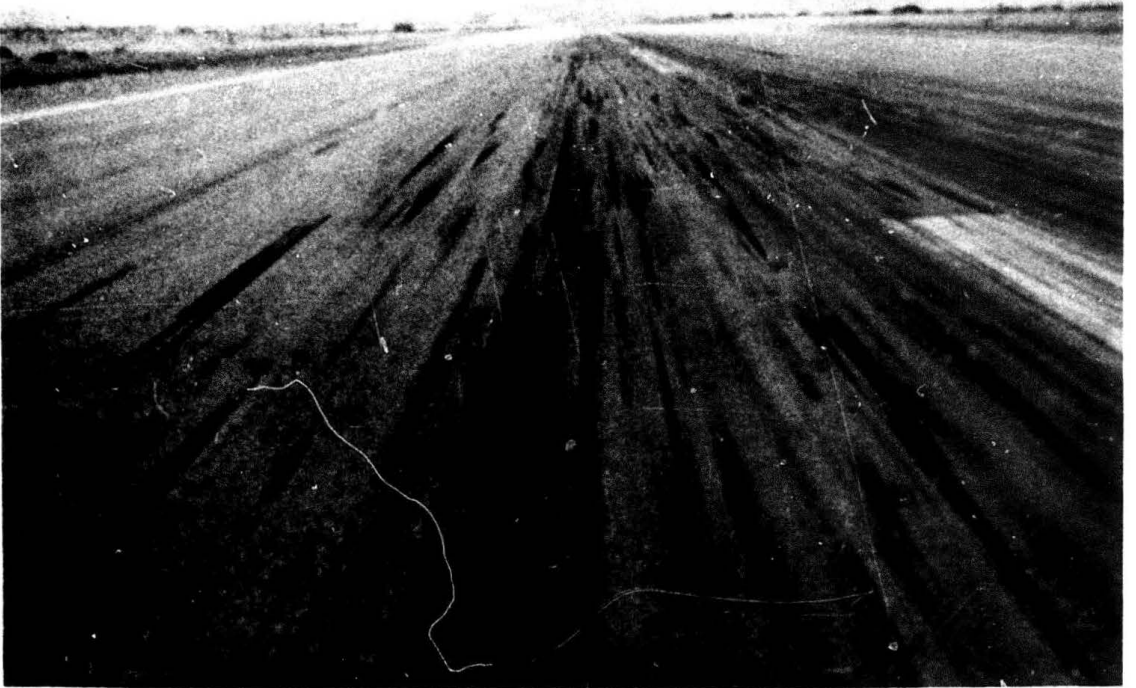
10. A visual inspection of the pavements in September 1970 indicated the pavement condition to range from poor to excellent. The sand seal placed on the primary runway in 1969 appeared to be in good condition on both the runway and shoulder areas (photographs 1-3). There was no evidence of any scuffing of the sand seal where aircraft had made 180-deg turns on the runway. There were two areas on the runway that contained birdbaths (photographs 2 and 4) and a depression from a drainage structure about midway of the runway. There was evidence of a few areas of longitudinal shrinkage cracking, but in general the runway condition was considered good. The surface of the crosswind runway, which was sand sealed in 1968, was considered to be in good

Photograph 1. View to northwest near southeast end of primary runway

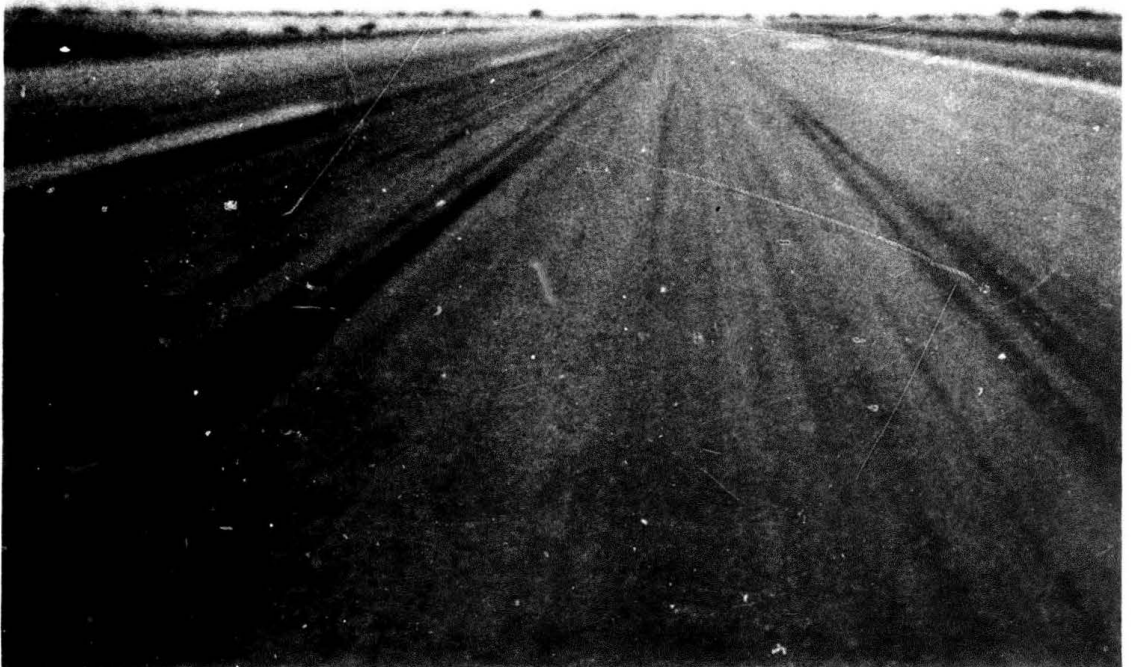
Photograph 2. View to northwest near center of primary runway. Note the  
birdbath near right edge of runway

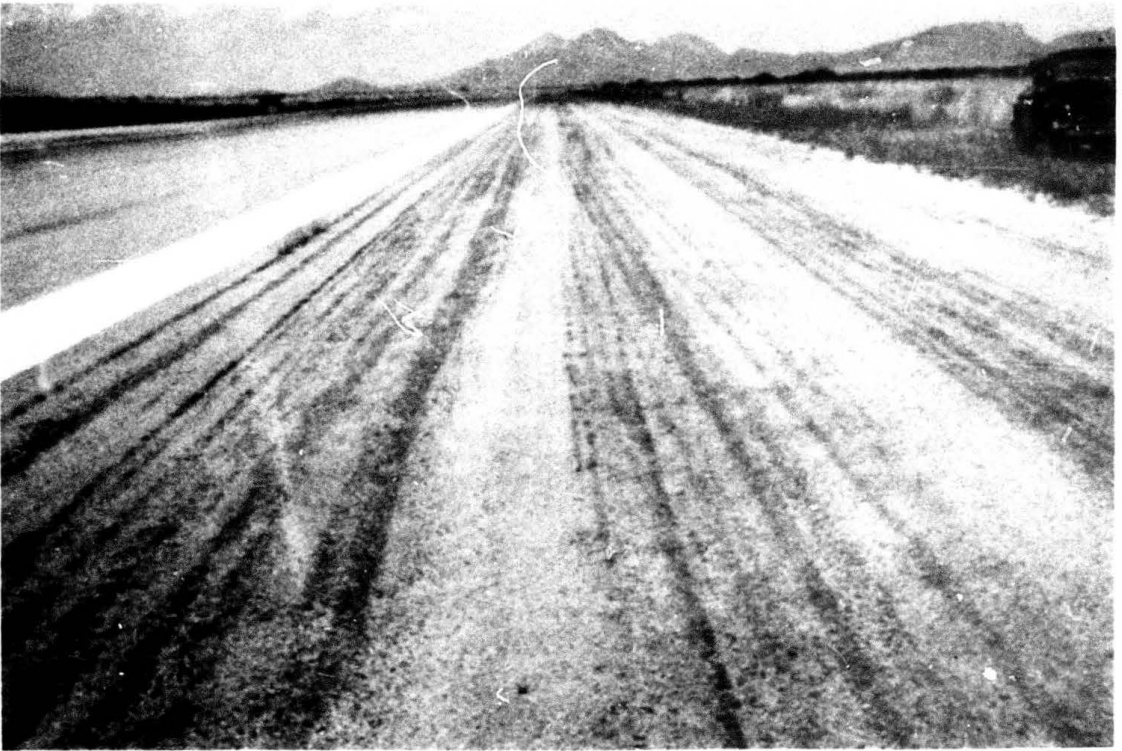
Photograph 3. Sand seal on surface of shoulder area along primary runway

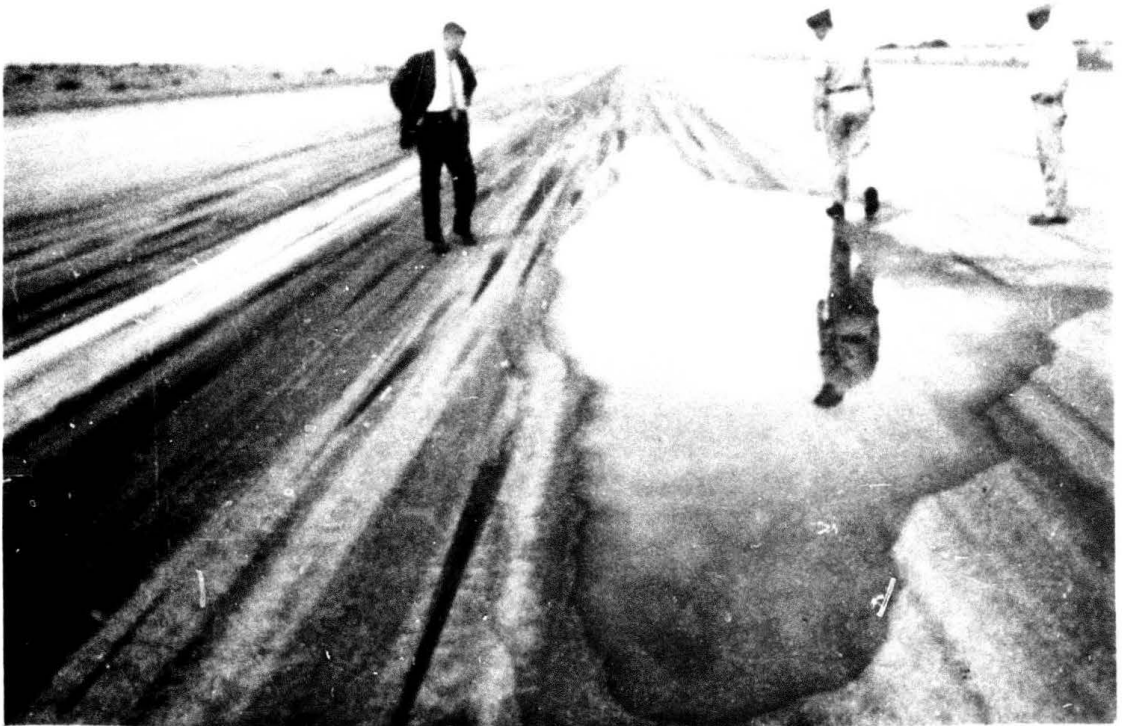
Photograph 4. Birdbath near southeast end of primary runway

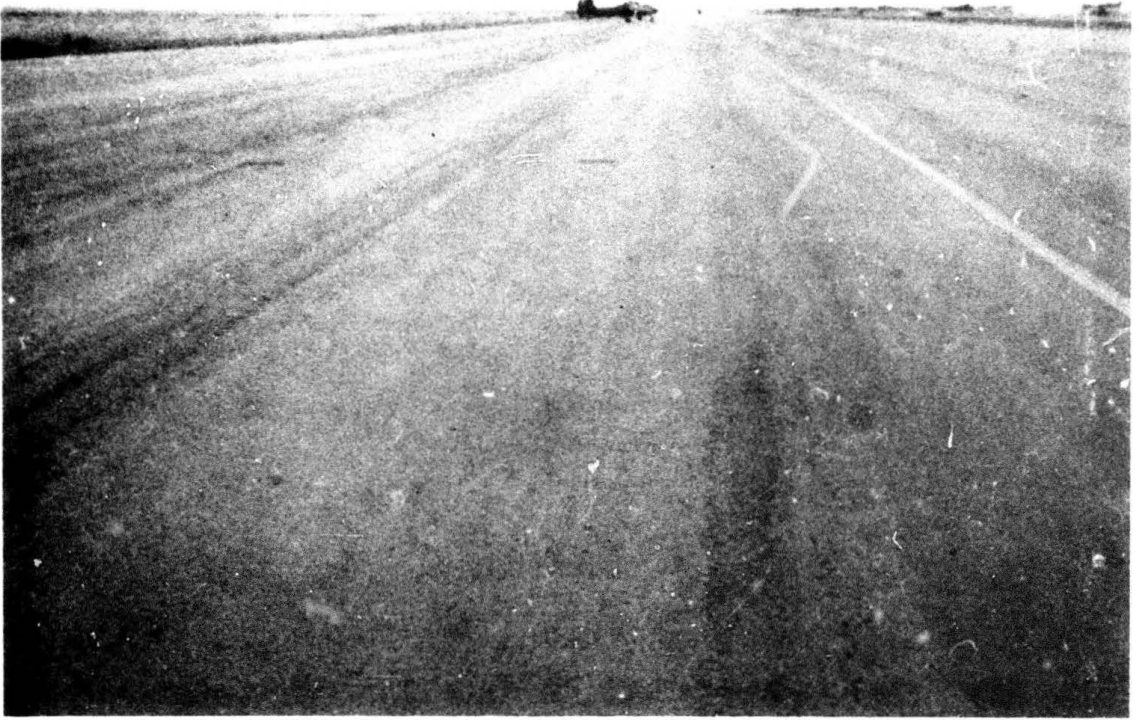
Photograph 5. Original E-W runway now used for aircraft parking

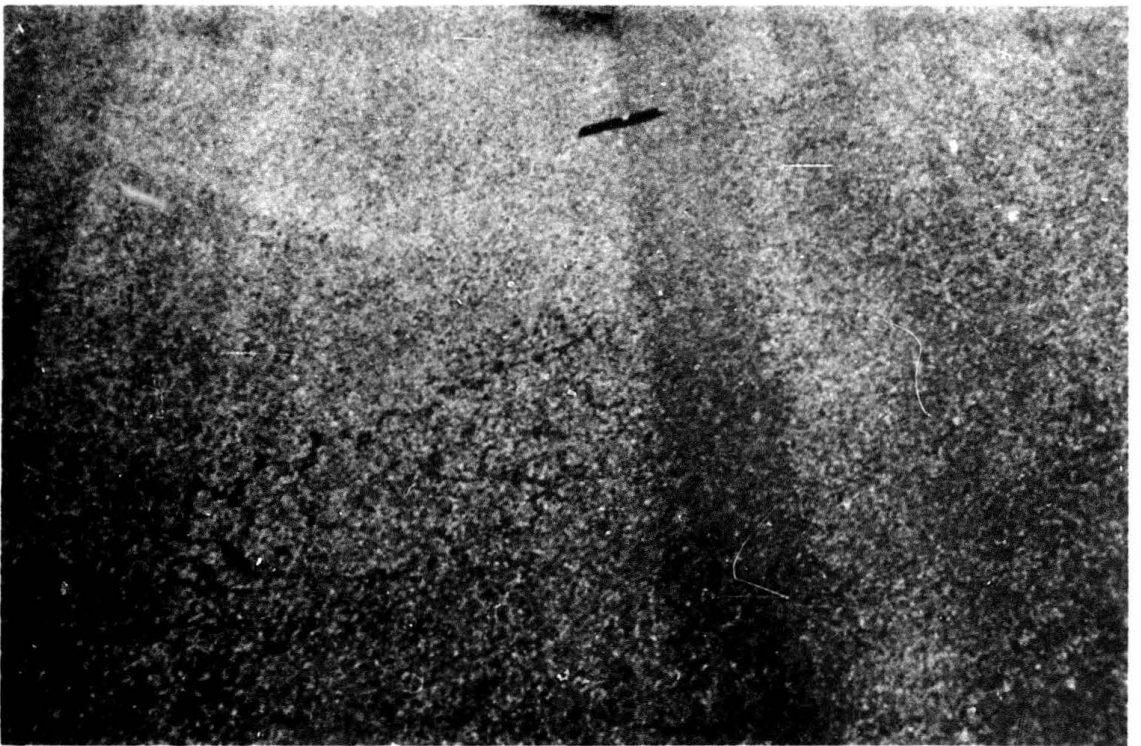
condition. The shoulders on this runway had not received a sand-seal treatment. The taxiway to the security area was sand sealed in 1968 and was in the same general condition as the crosswind runway. The portland cement concrete areas on the east and west connecting taxiways were in excellent condition. The portland cement concrete on the apron area was in poor condition. A considerable number of the slabs contained structural cracking from overload. The original E-W runway was in fair-to-poor condition (photograph 5). Evidence of distress in the form of cracking and deterioration of the pavement surface along the center line of the runway where aircraft taxi was observed. This area is used as a parking area when needed. Continued use will cause further distress in the pavement surface; however, the life of the pavement could be extended by moving the taxiing lane off the center line. The flexible pavement portion of the east connecting taxiway was sand sealed in 1969 and appeared to be in excellent condition (photograph 6).

Photograph 6. Condition of pavement surface on east connecting taxiway near intersection with primary runway
