ARMY MIDAIR

COLLISIONS

PREPARED BY THE U. S. ARMY BOARD FOR AVIATION ACCIDENT RESEARCH ■ FORT RUCKER, ALABAMA

I. ABSTRACT. This report contains analyses of 56 Army midair collisions which occurred during the period January 1963 to November 1969 and conclusions and recommendations based on the analyses.

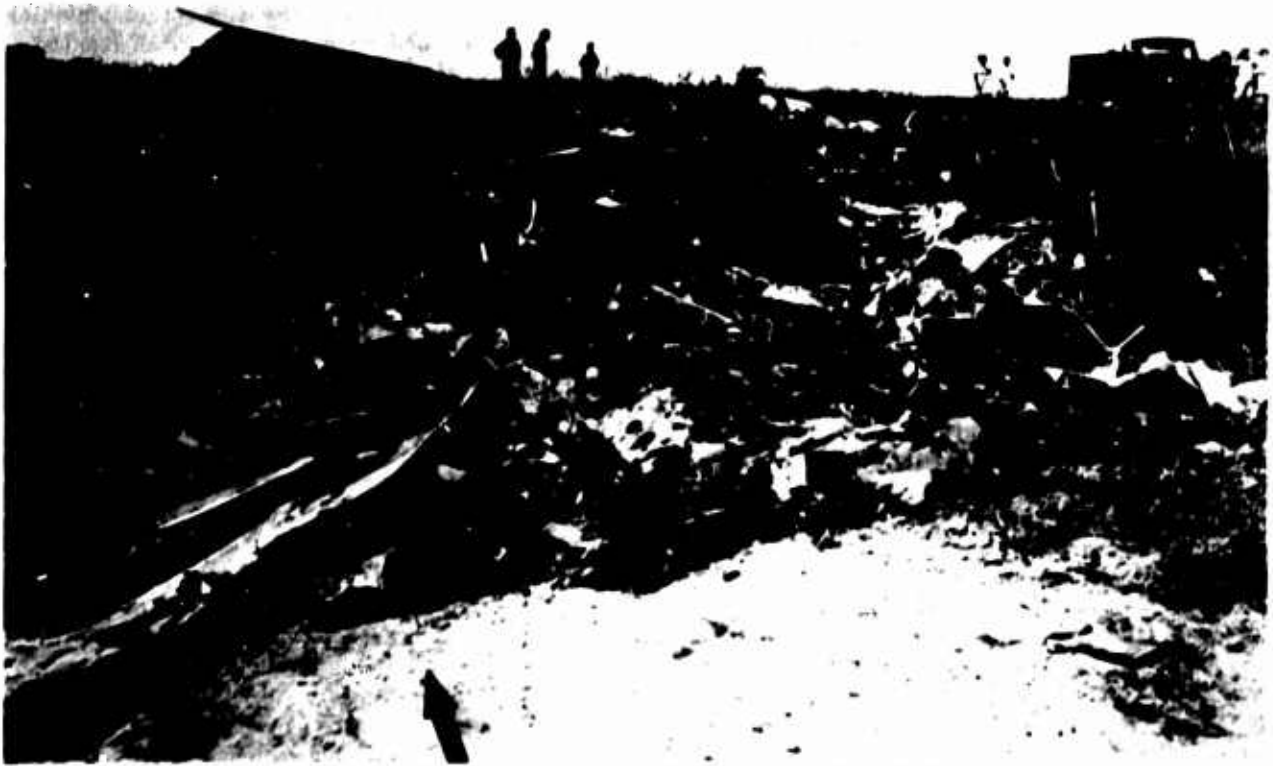
This UH-1B was one of two which collided and crashed during training, killing all four occupants and destroying both aircraft.
