MISCELLANEOUS PAPER S-68-22

**A STUDY OF THE CONDITION OF
PIEZOMETERS IN THE 1949 INSTALLATION
AT REID - BEDFORD, LOUISIANA**

November 1968

**U. S. Army Engineer Waterways Experiment Station
CORPS OF ENGINEERS
Vicksburg, Mississippi**

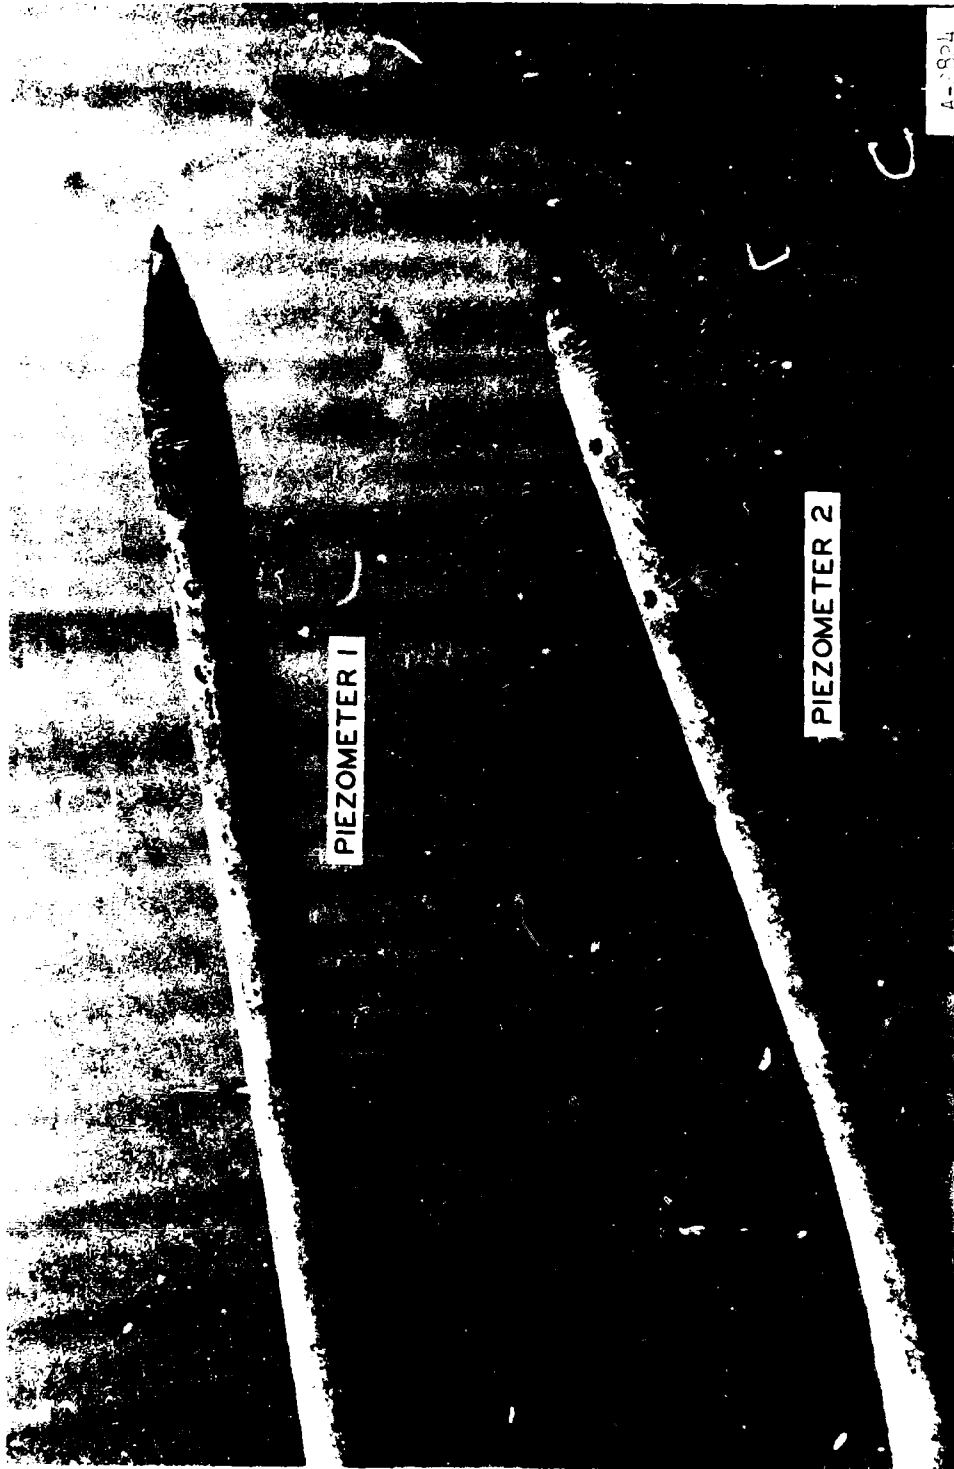
20. Drive point piezometers 1 and 2 were found to be completely clogged. In the 1949 study these two piezometers were operated as closed systems and consistently showed pressures indicating water elevations at or above the natural ground surface (approximately el 82). At the time, the high readings were attributed to an accumulation of gas in the piezometers. It is probable that these piezometers became clogged during driving and have never functioned properly. The other two drive point piezometers, 14 and 15, were found to be partially clogged, although piezometer 15 gave readings only slightly higher than the piezometers considered to be still giving satisfactory data. It was noted in the 1949 study that piezometers 14 and 15 were very slow in reacting to changes in hydrostatic pressure as compared to the reactions of the other open-system piezometers. It is probable that these piezometers have also been clogged to some extent ever since installation.

Photograph 1. U. S. Bureau of Reclamation drive point piezometers 1 and 2

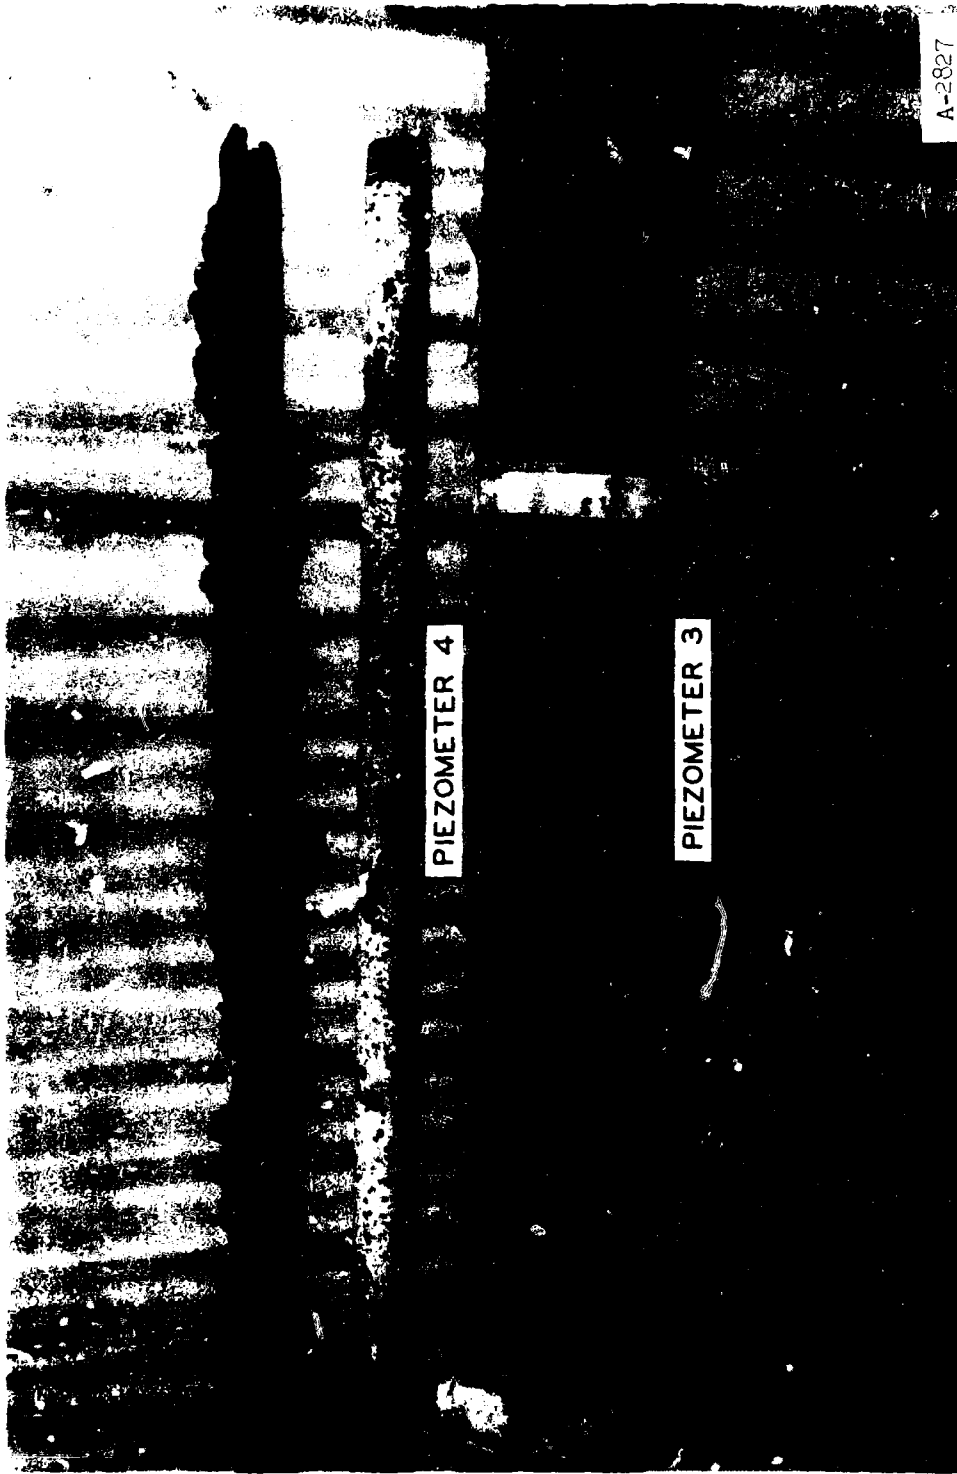
Photograph 2. Standpipes from Cherry Creek piezometers 3 and 4

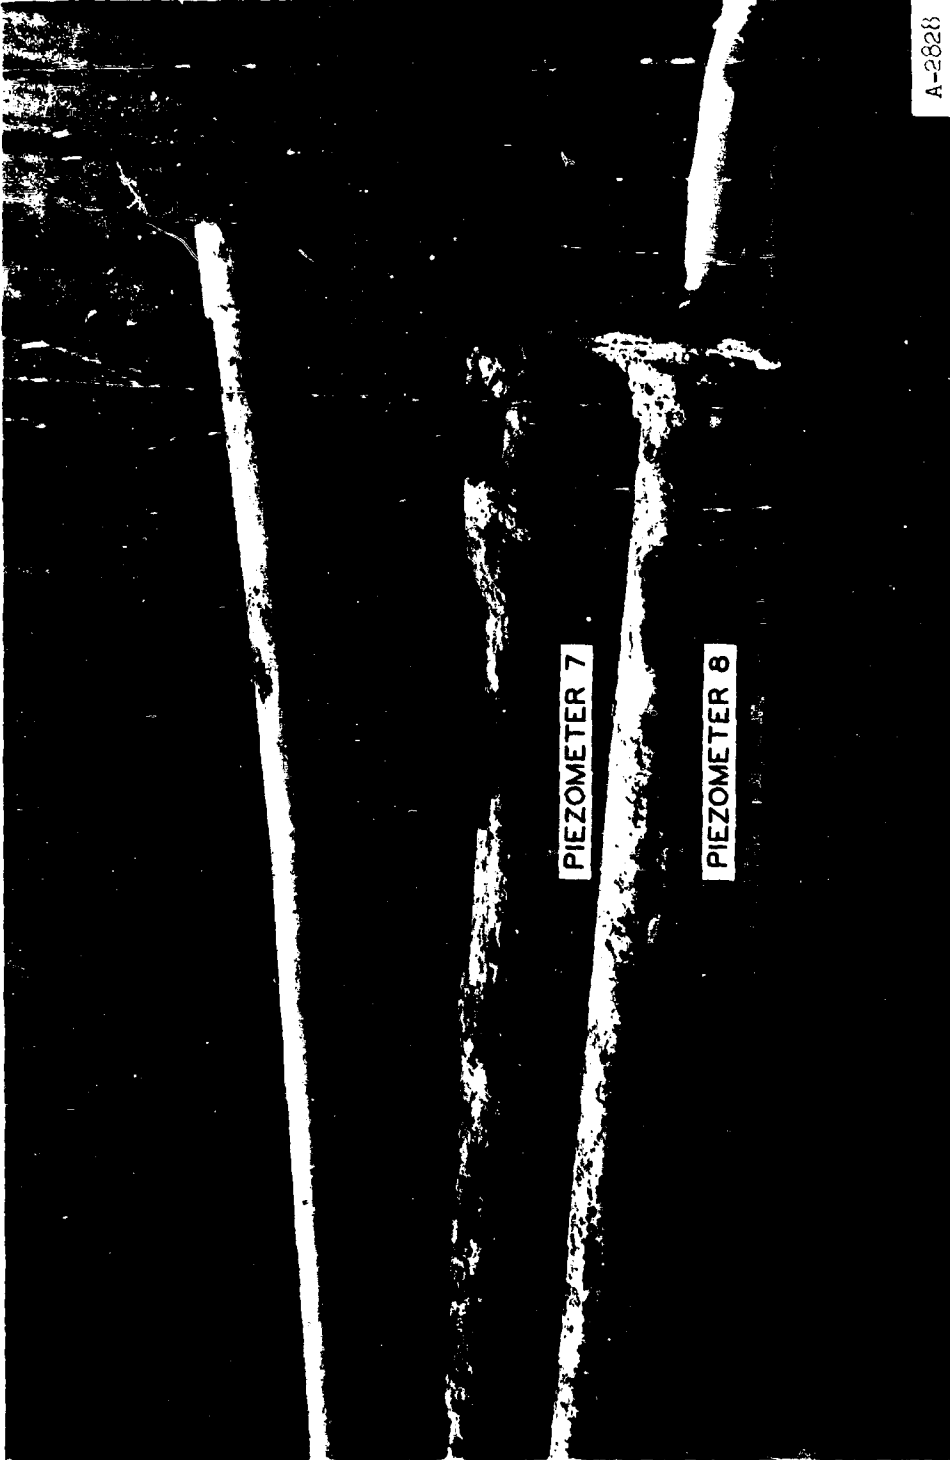
Photograph 5. Standpipes from Casagrande piezometers 7 and 8 with Saran tubing attached to 8

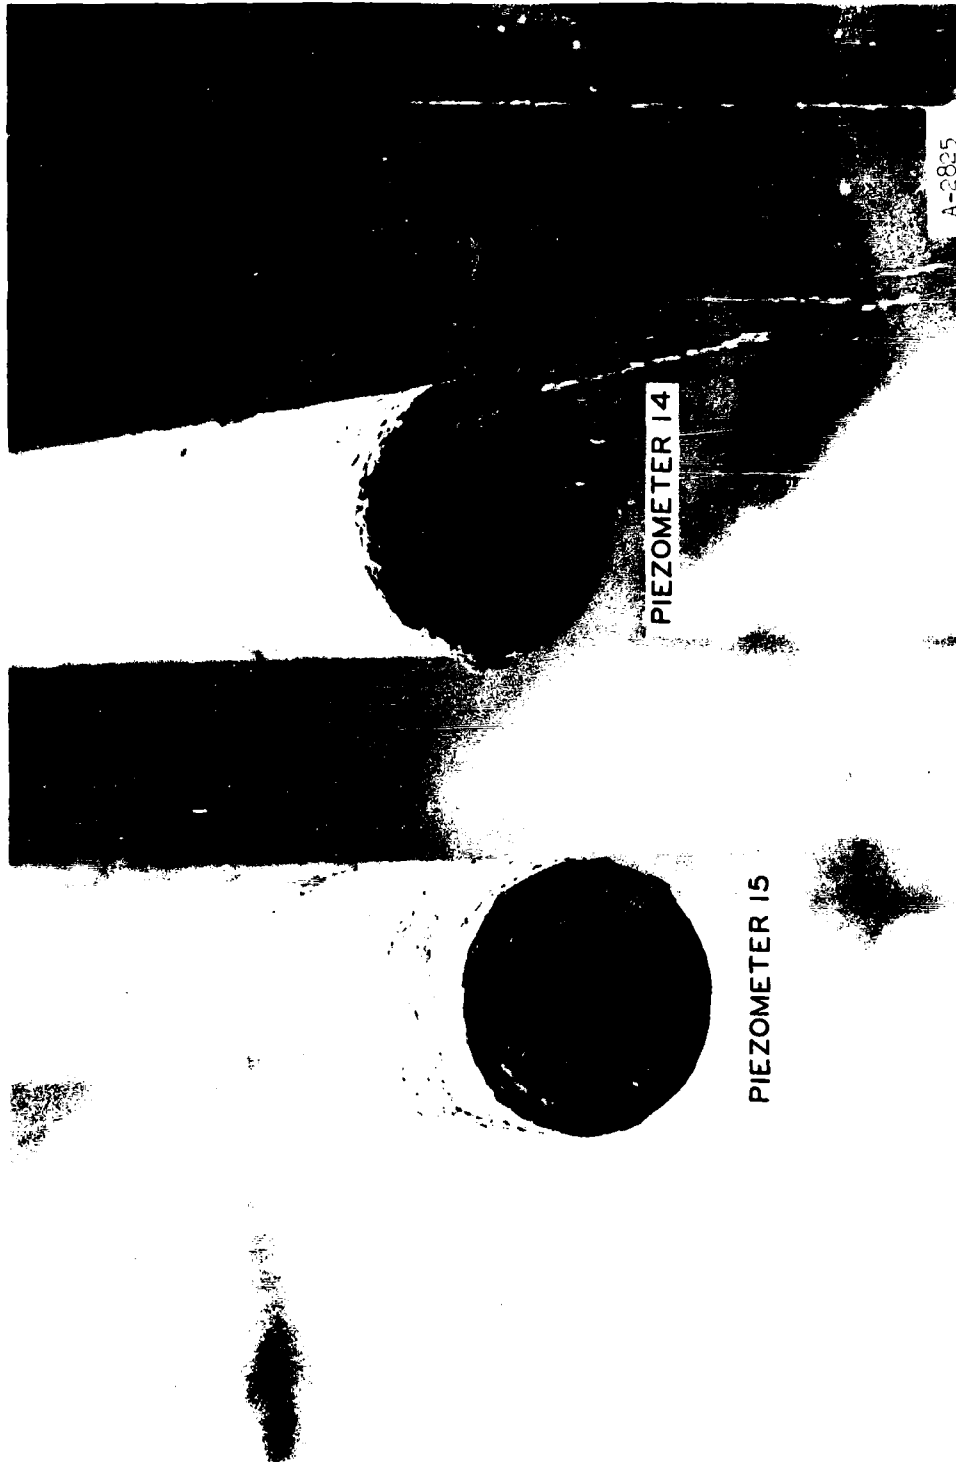
Photograph 7. Drive point piezometers 14 and 15
