MISCELLANEOUS PAPER S-68-26

CONDITION SURVEY, DAVISON ARMY AIRFIELD, FORT BELVOIR, VIRGINIA

November 1968

U. S. Army Engineer Waterways Experiment Station
CORPS OF ENGINEERS
Vicksburg, Mississippi

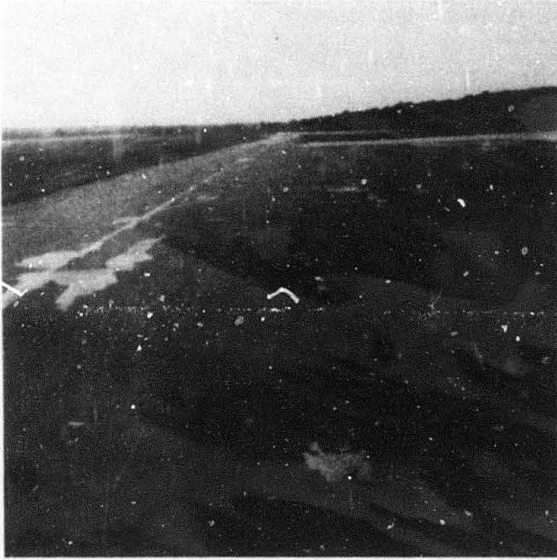
satisfactory condition. The slurry seal coat placed over the portland cement concrete area was peeling badly (photograph 4). The runways and parking apron in the heliport area were in excellent condition, but the parallel taxiway from the heliport area to the northwest end of the runway was in poor condition (photograph 5).

a. Portion of taxiway adjacent
to parking apron

Photograph 4. Slurry seal coat peeling off portland cement
concrete portion of taxiway and parking apron

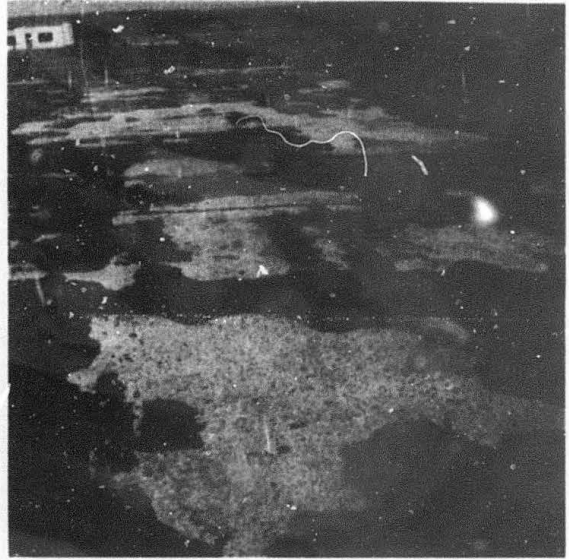
b. Seal coat peeling off portion of
fixed-wing parking apron

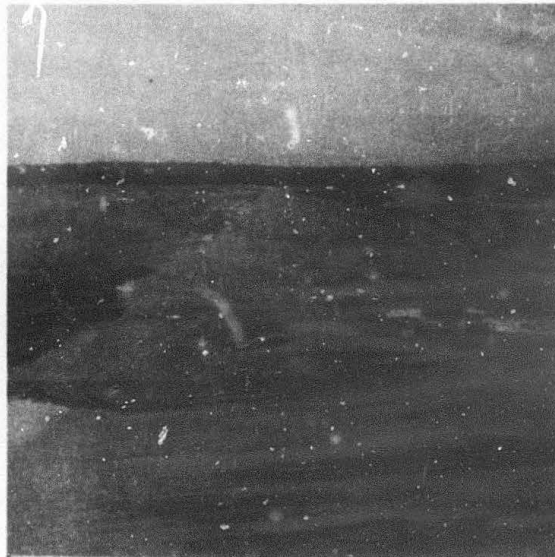
Photograph 5. Taxiway adjacent to heliport area
