MISCELLANEOUS PAPER 5-69-37

**CONDITION SURVEY, HUNTER ARMY AIRFIELD  
SAVANNAH, GEORGIA**

August 1969

**U. S. Army Engineer Waterways Experiment Station  
CORPS OF ENGINEERS  
Vicksburg, Mississippi**

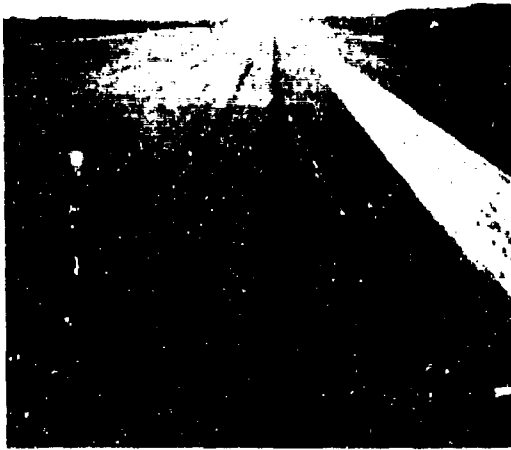
9. A visual inspection in February 1969 indicated the airfield pavement to be generally in good condition. The surface of the 11,375-ft-long east-west runway (photograph 1) was in good condition although the asphalt showed signs of weathering and aging; however, no extensive cracks or other signs of imminent problems were observed. Most of the asphaltic-concrete taxiways and apron areas were recently treated with a maintenance-type bituminous pavement coating material. This coating was applied between May 1967 and May 1968. A more detailed discussion of this material is presented in paragraphs 11-14.

Photograph 1. View looking westward  
along the runway

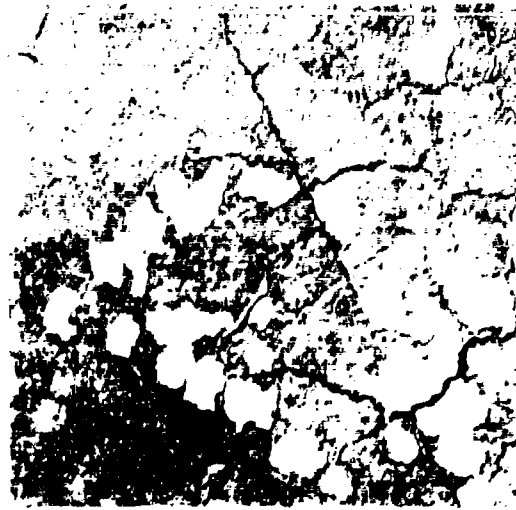
12. Prior to placing the material, the existing asphaltic-concrete surfaces were scaling and cracking, with some cracks as wide as 1/2 in. These surfaces had been sealed 8 to 10 years ago with a tar seal, and the latter material was scaling from the surface. Photographs 2 and 3 show the condition of the pavement surface in an area that was not treated and indicate the general condition of the surface prior to application of the bituminous pavement coating.

Photograph 2. Scaling of the old tar  
surface seal

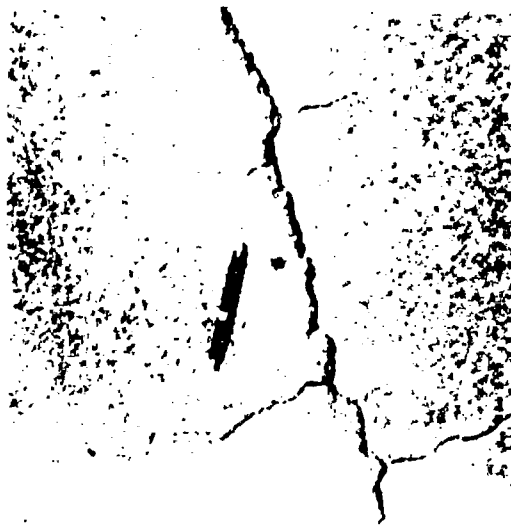
Photograph 3. Typical cracks in  
untreated pavement

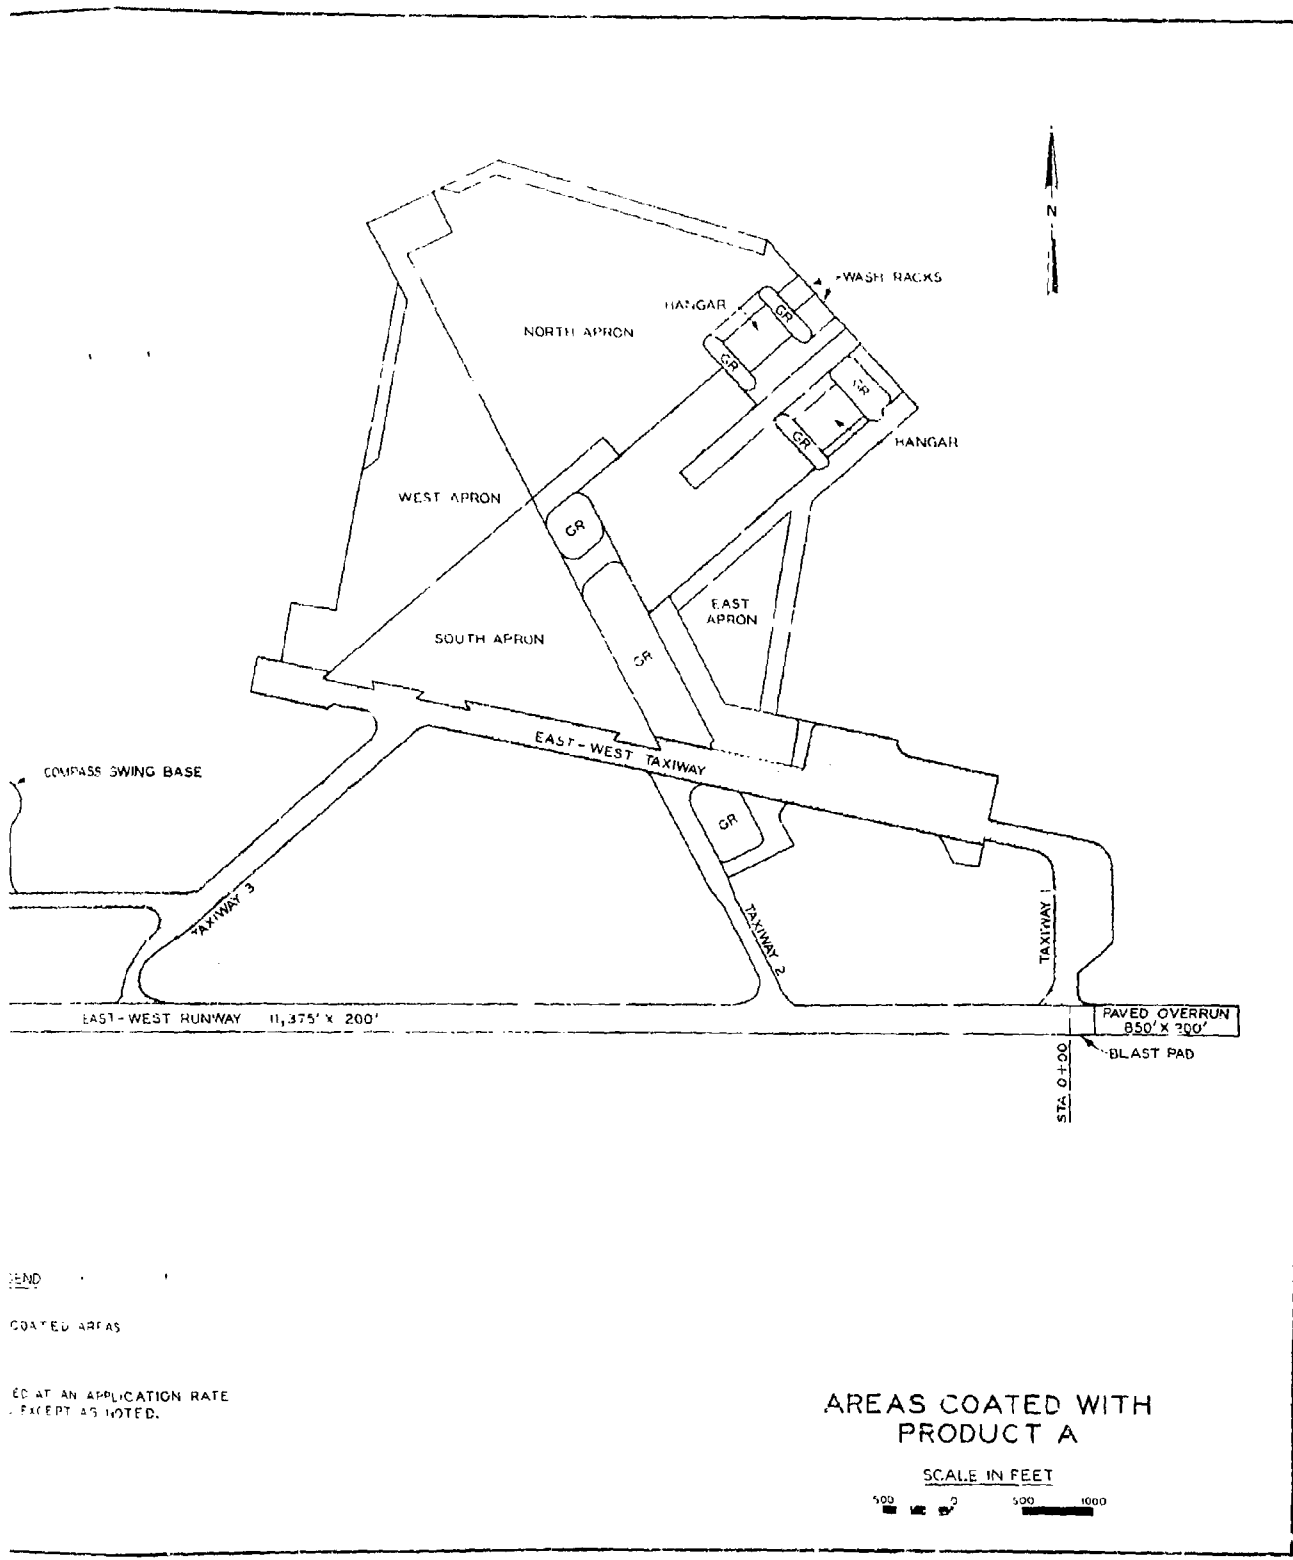
AREAS COATED WITH  
PRODUCT A

11. A bituminous pavement coating material (Product A) was used extensively on HAAF's existing asphaltic-concrete taxiways, aprons, and shoulder areas for adhering loose pavement particles and sealing the aging surfaces. The airfield pavements that were coated during the period between May 1967 and May 1968 are shown in plate 4. This proprietary material is primarily a combination of a fast-drying solvent and a hard-base asphalt.

13. Product A was sprayed on the asphaltic-concrete surface at a rate of 0.2 gal/sq yd. There was one exception to this. A portion of the warm-up apron on the west end of taxiway 5 was treated at a rate of 0.3 gal/sq yd (plate 4). This small section was reported to contain more cracking in the surface, and this was the reason for the heavier application.
