AFRPL-TR-71-84

**ADVANCED ACS VALVE  
SEALING SURFACE COMPATIBILITY  
INVESTIGATION**

AD 735286

G. R. Pfeifer  
H. Wichmann  
Dr. R. Kratzer

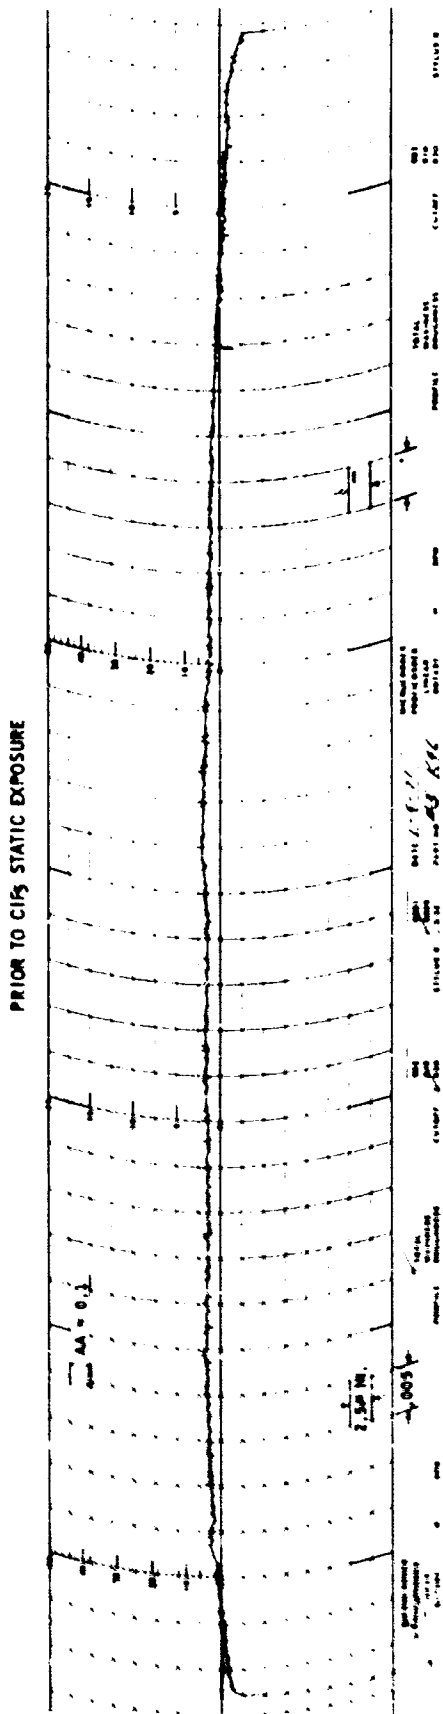
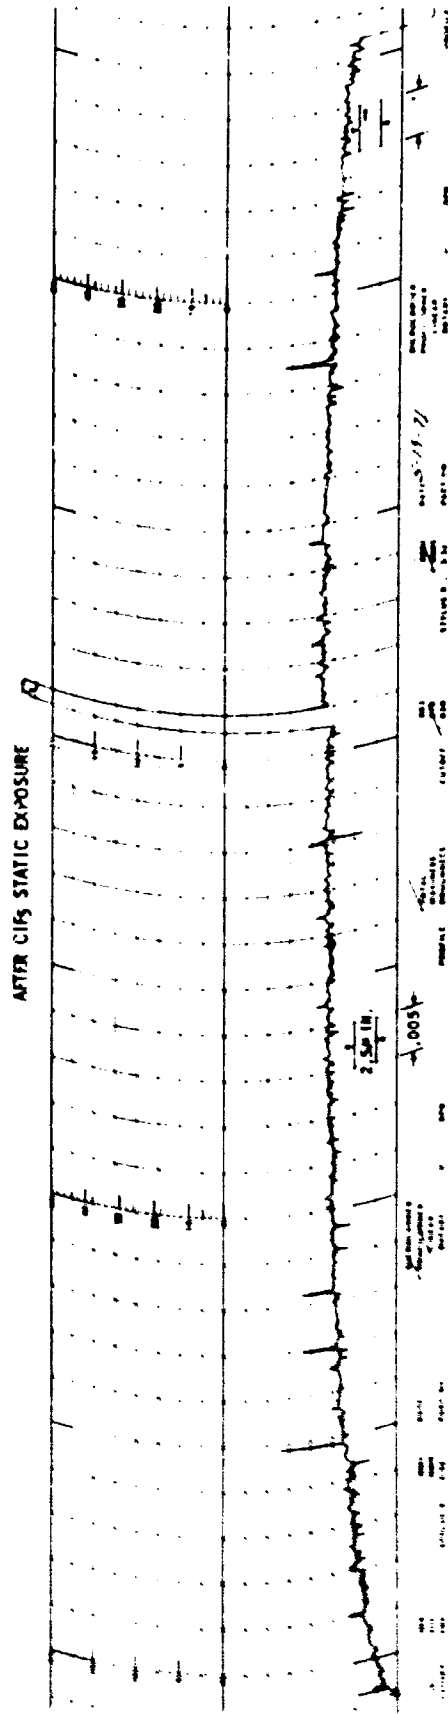
Figure 27

# K-96 STATIC EXPOSURE POPPET SURFACE PROFILE BEFORE AND AFTER CIF5 STATIC EXPOSURE

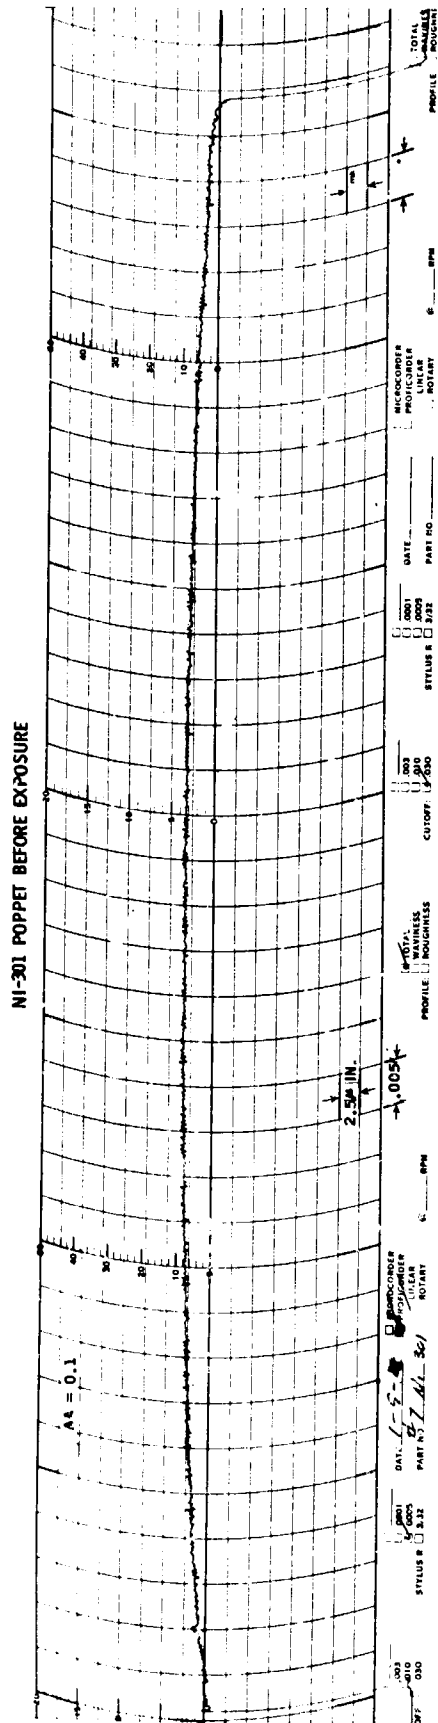
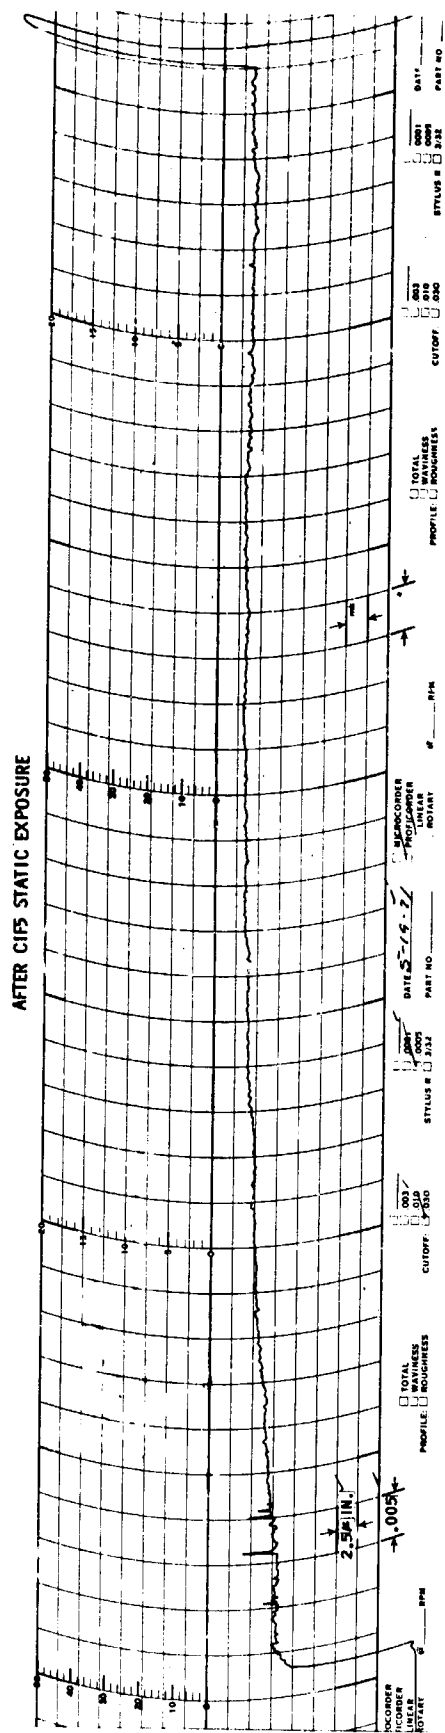
Figure 33

NI-301 STATIC EXPOSURE POPPET  
 SURFACE PROFILE BEFORE AND AFTER STATIC EXPOSURE TO CIF5

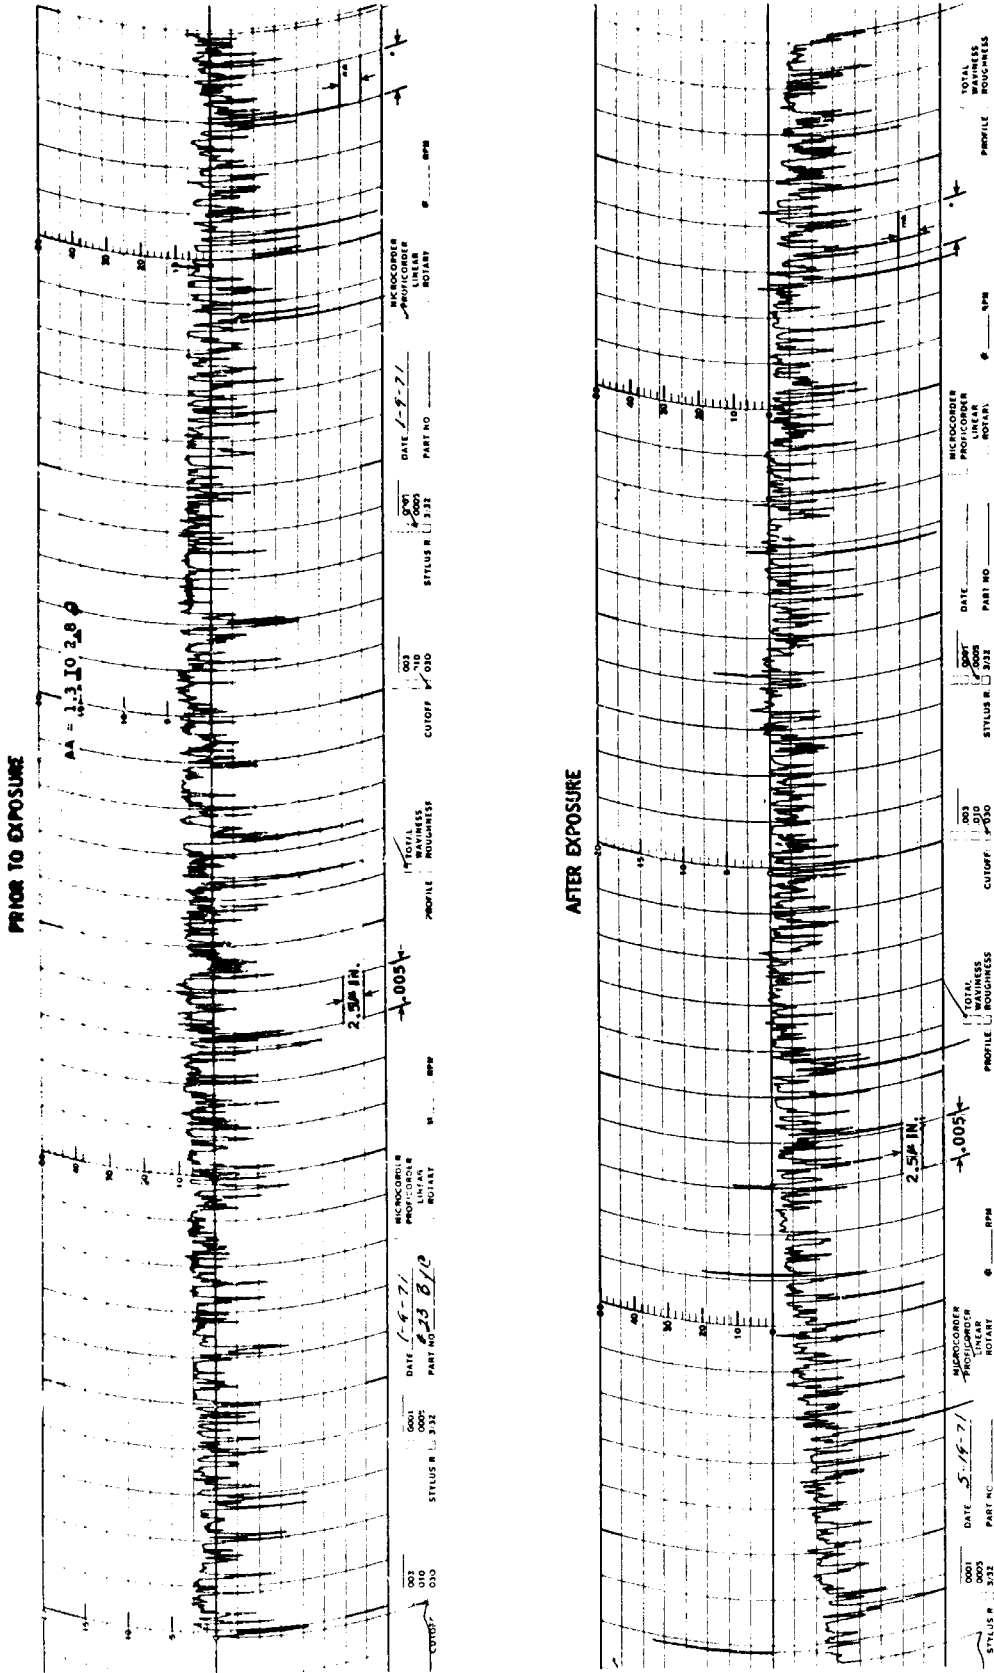
Figure 45

AL2 03  
SURFACE PROFILE BEFORE AND AFTER CIF5 STATIC EXPOSURE

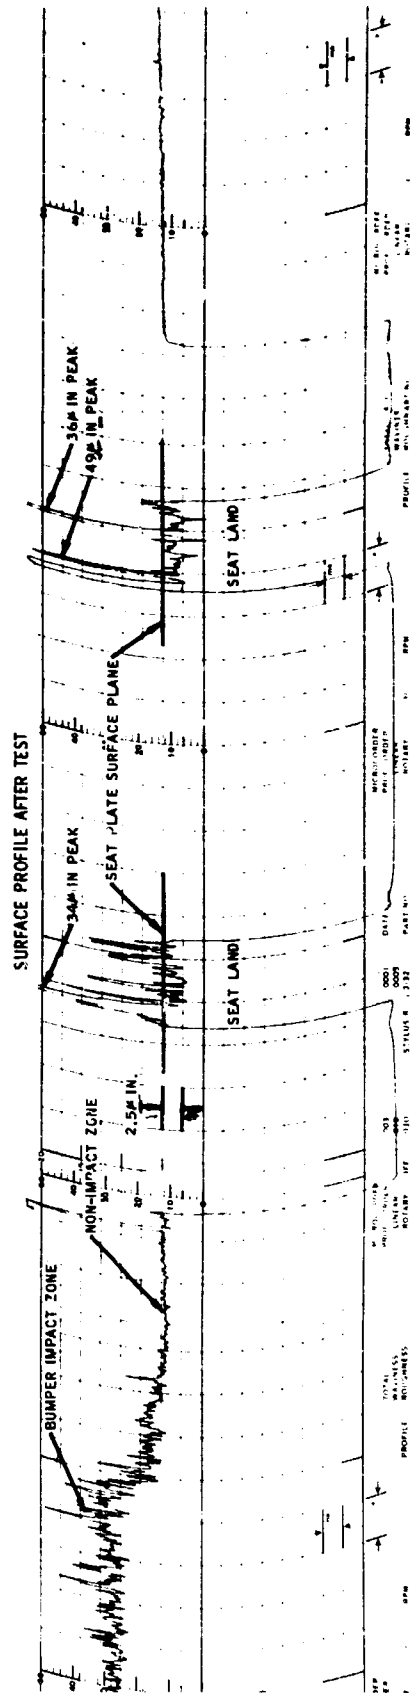
Figure 59

NI-301 SEAT  
SURFACE PROFILE BEFORE AND AFTER 100,000 CYCLE VALVE TEST - LOW IMPACT - CIF5

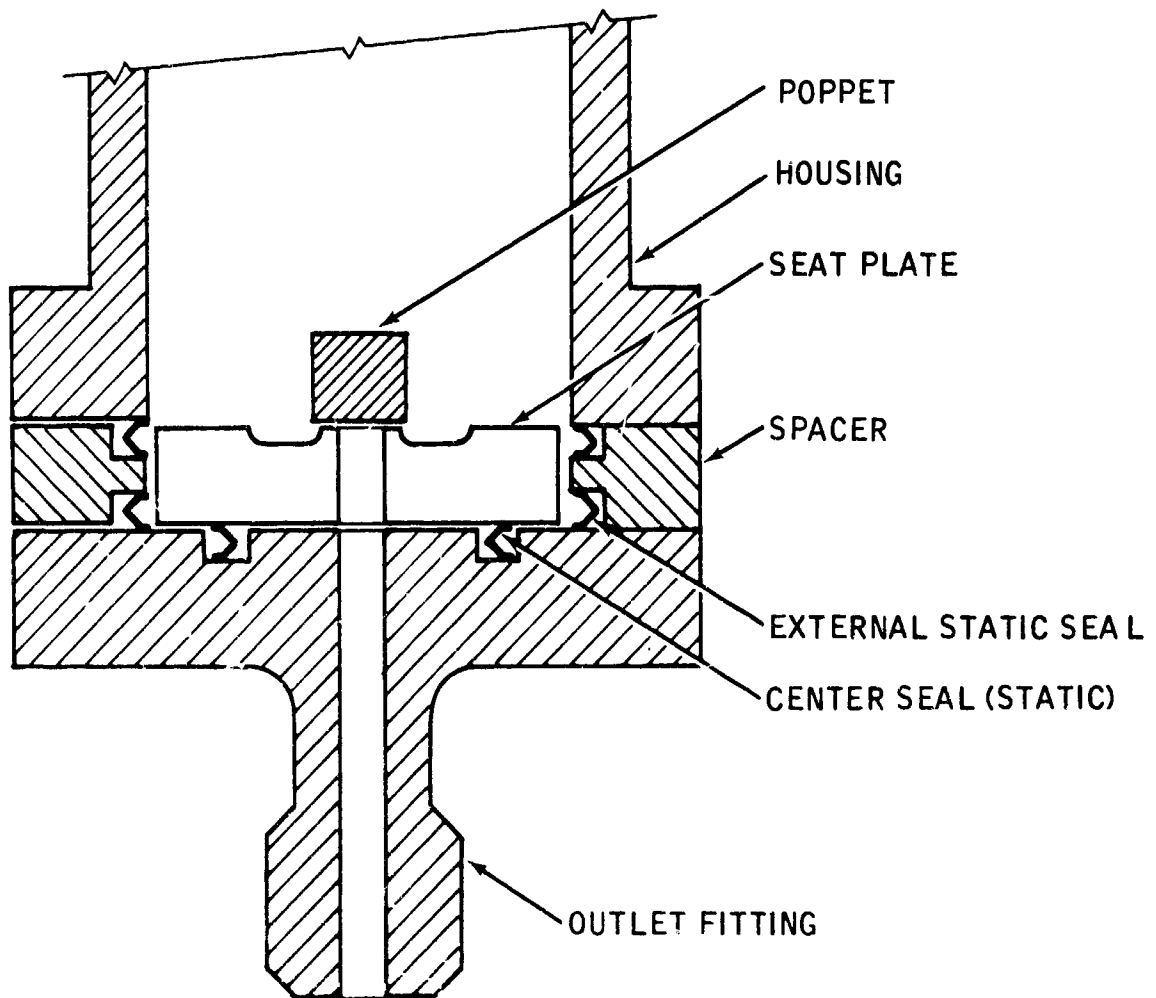
# COMPONENT VALVE SEAT SEALS

In the case of the nickel 301 valve tested at low impact, it is concluded that the failure of the test valve to adequately seal resulted from two sources:

1. Primary cause of measured leakage was probably failure of the valve downstream center seal during the passivation procedure.
2. A contributing source of probable additional (not verified) leakage was degradation of the poppet and seat seating surfaces through adhesive wear, resulting from extremely minor lateral motion of the poppet, relative to the seat after valve closure. This action resulted in a positive buildup of material in the poppet center section with resultant rounding of the sealing surface.

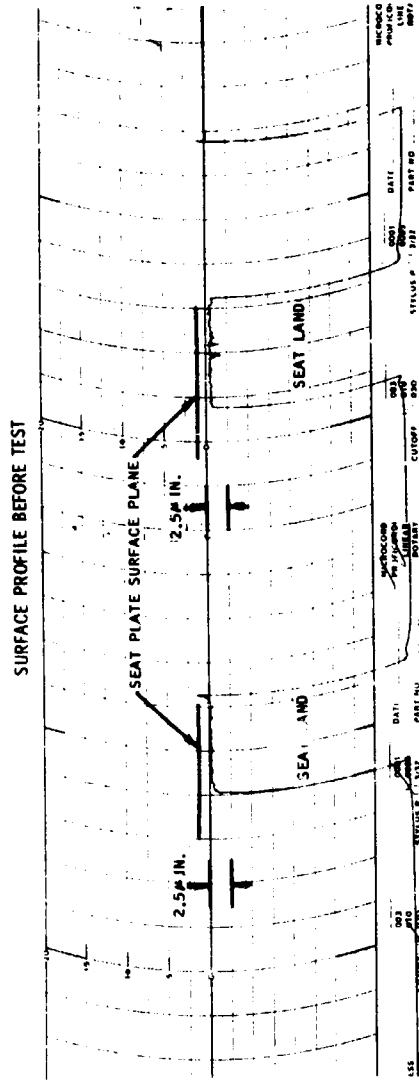
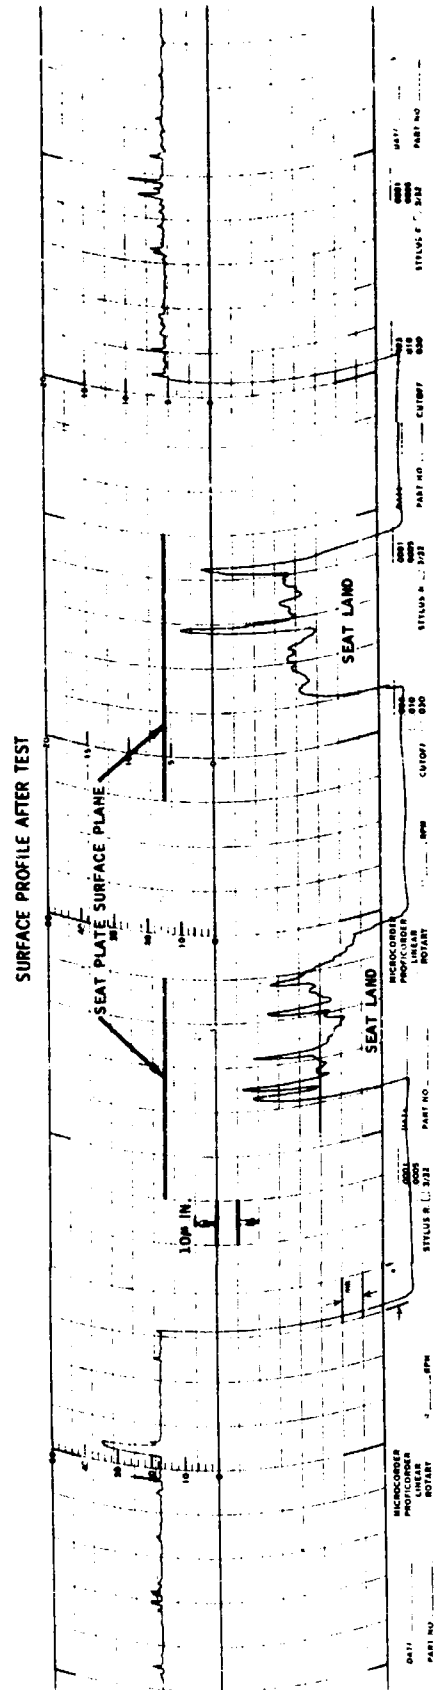
Figure 66

K-96 SEAT  
SURFACE PROFILE BEFORE AND AFTER 100,000 CYCLE VALVE TEST - NORMAL IMPACT - CIF5

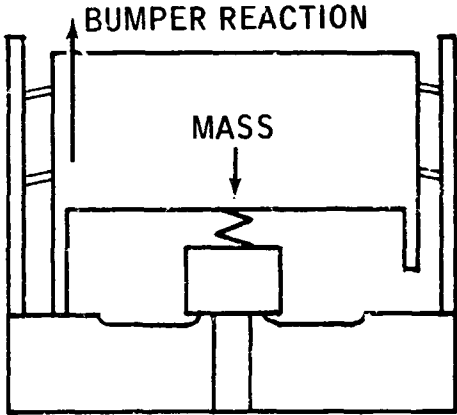
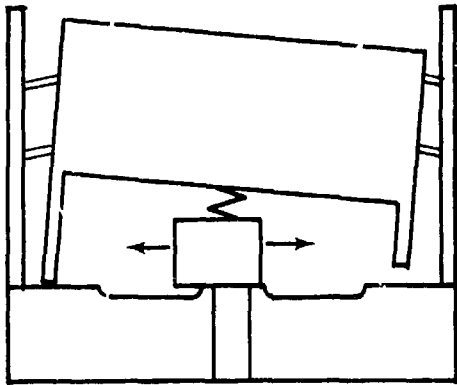
# NONUNIFORM BUMPER IMPACT

POPPET STRIKES FIRST

NONUNIFORM BUMPER IMPACT CAUSES COUPLE

RESULT - LATERAL MOTION

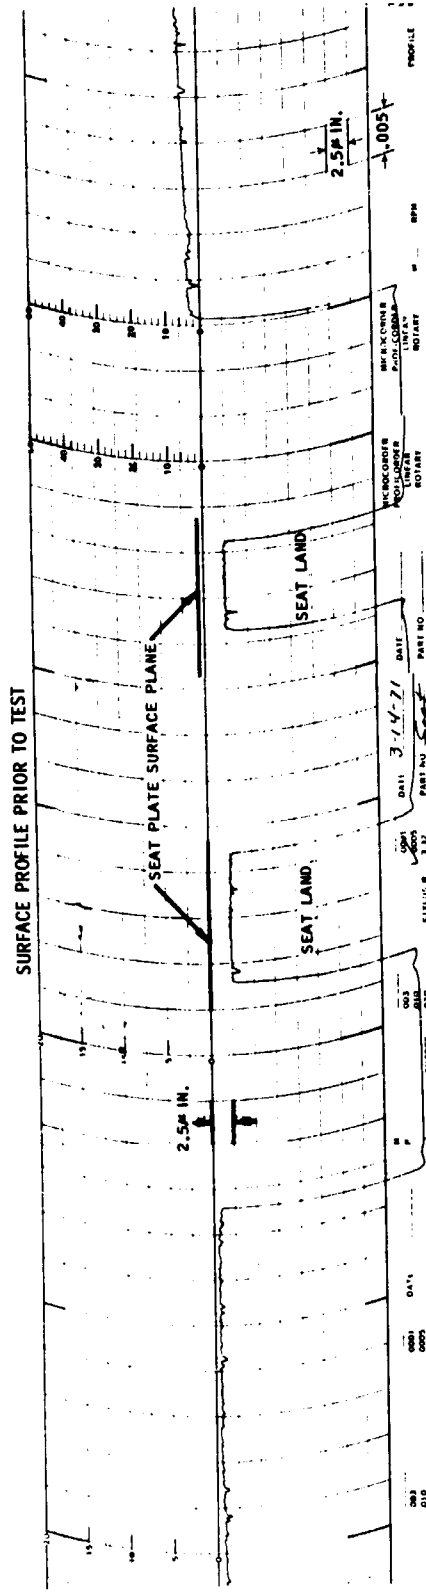
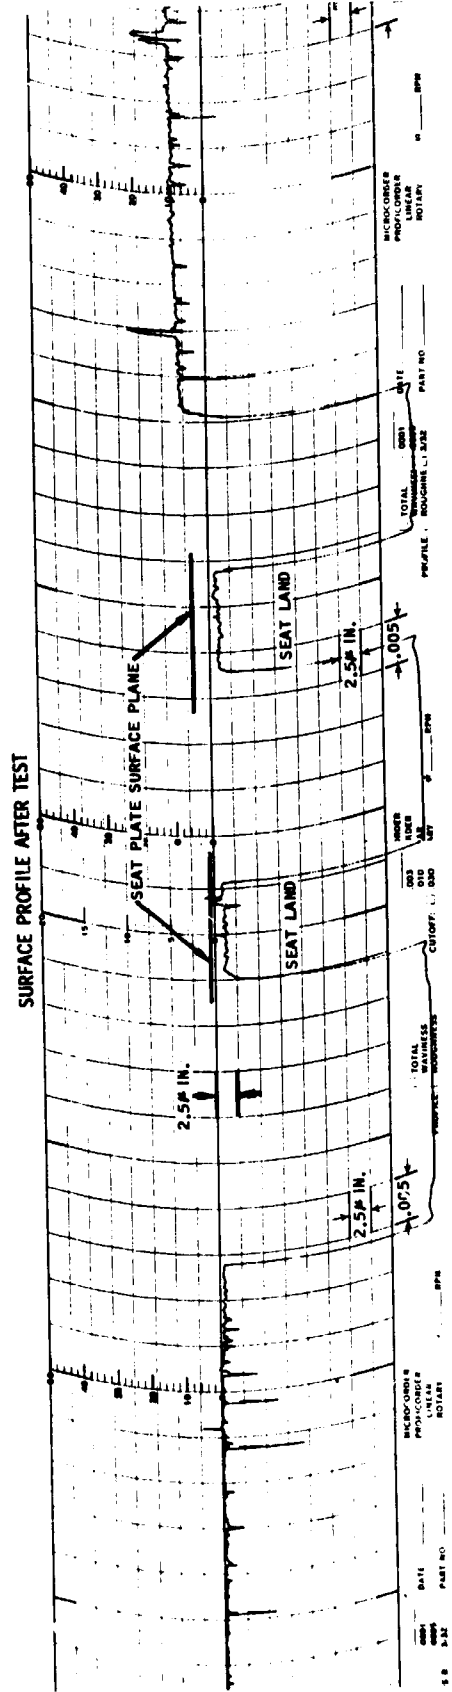
Figure 76

B4 C SEAT  
SURFACE PROFILE BEFORE AND AFTER 100,000 CYCLE VALVE TEST - LOW IMPACT - CIF5

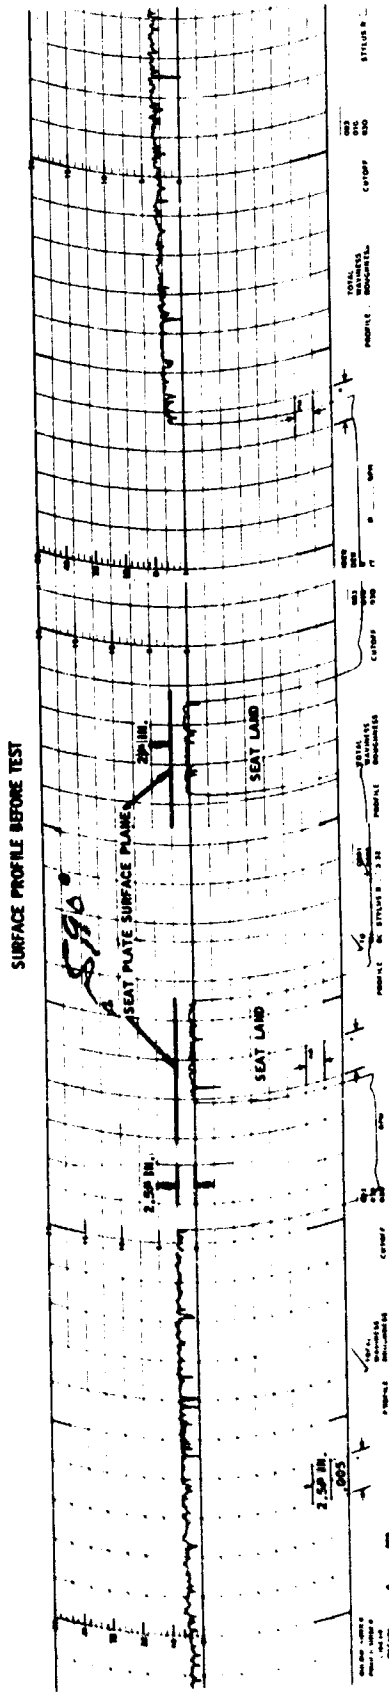
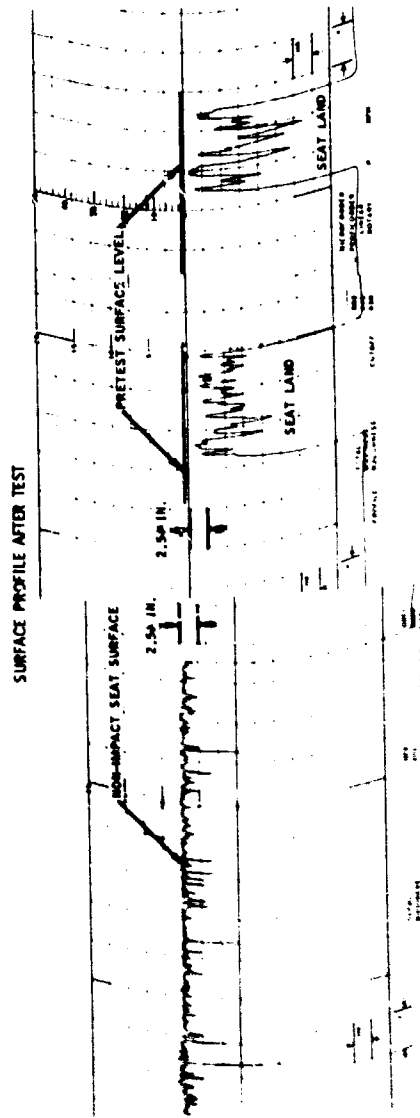
Figure 77

# BORON CARBIDE SEAT SURFACE PROFILE BEFORE AND AFTER 100,000 CYCLE VALVE TEST - NORMAL IMPACT - CIF5

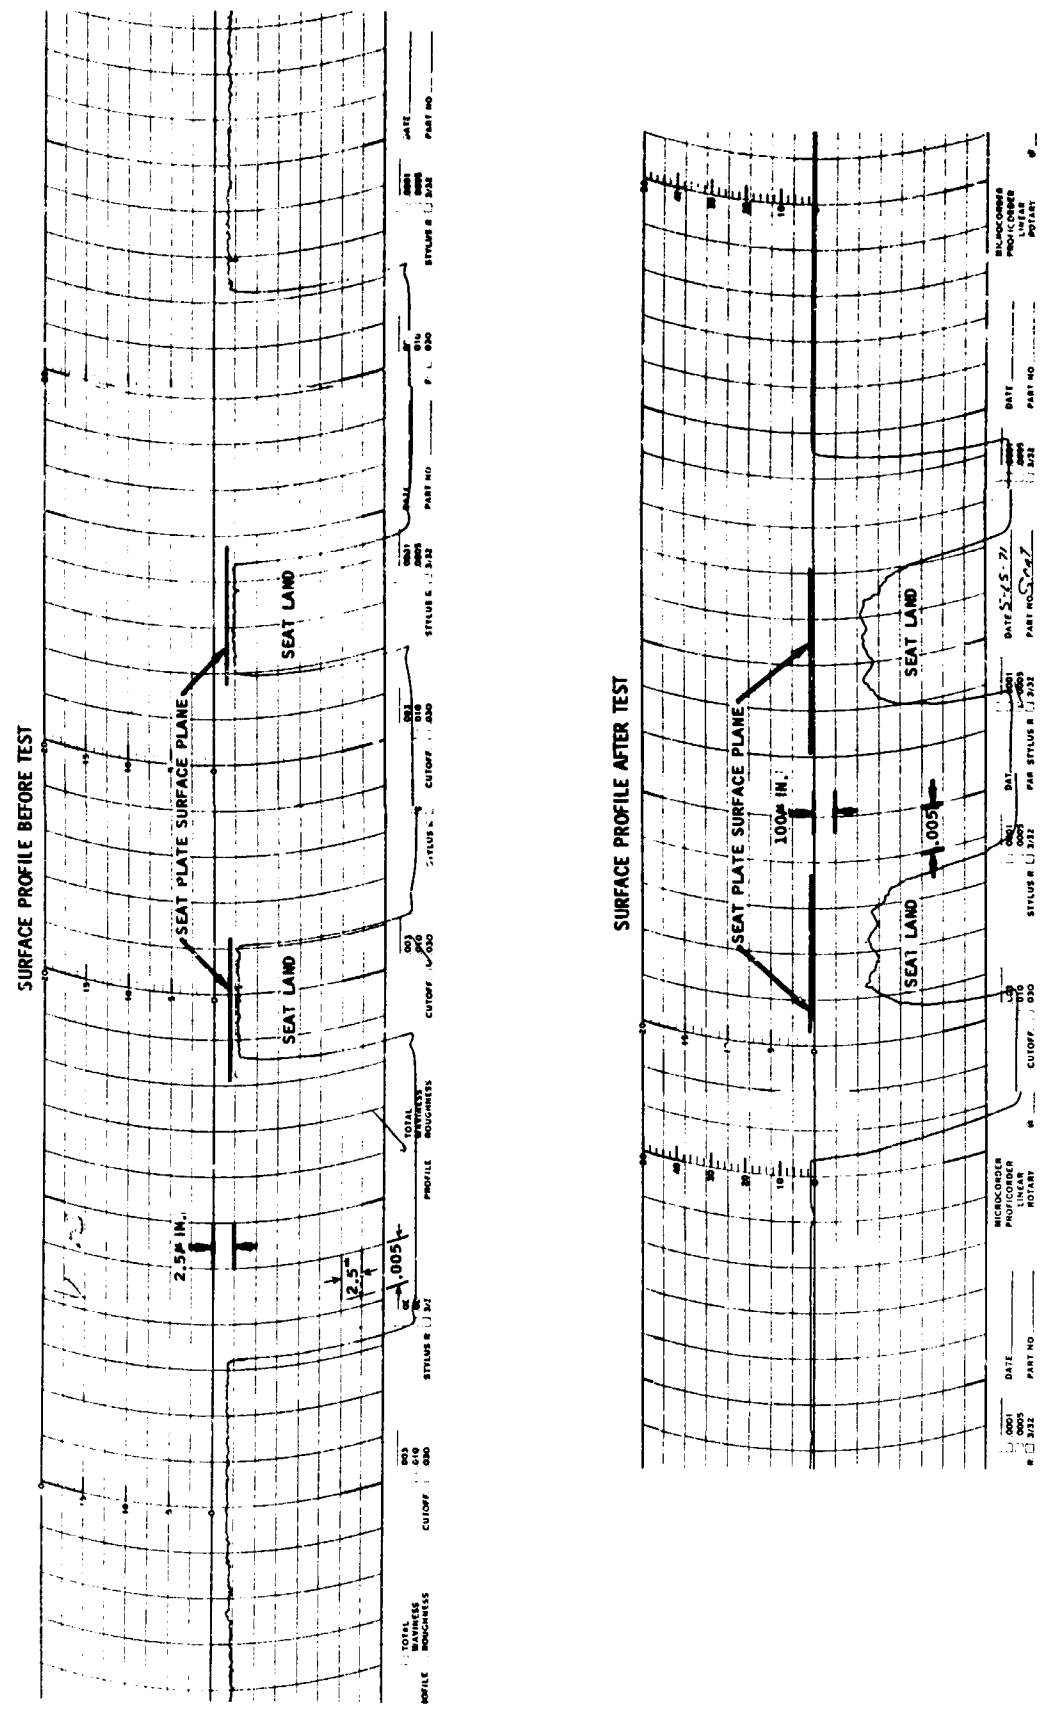
Figure 83

# WC SEAT SURFACE PROFILE BEFORE AND AFTER 100,000 CYCLE VALVE TEST - NORMAL IMPACT - CIF5

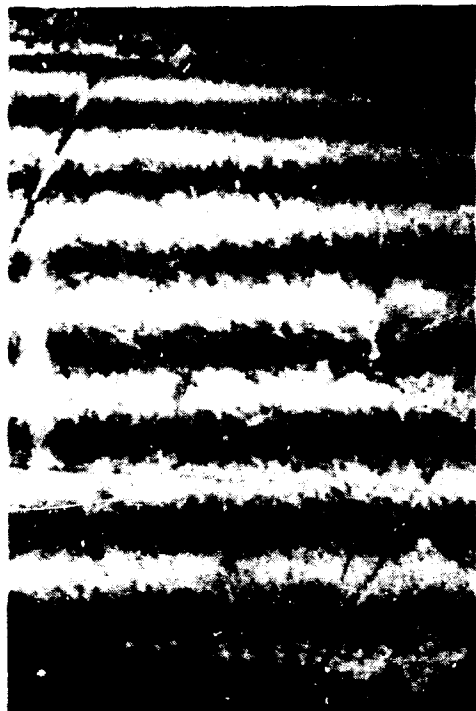
The third aluminum oxide seat and poppet was tested in the normal impact valve using  $GF_2$ . Leakage rates during the test progressively increased up to 1000 cycles and then decreased to the end of the test. Primary cause for the excessive leakage measured with the valve was discovered upon examination of the poppet and seat after the test. The seat land was found to have shattered in several areas. None of the cracks propagated completely across the seat explaining why the valve sealed to a degree. Figure 94 shows surface photographs and interferograms of the seat prior to and after the test. As with the other materials tested in the normal impact valve, there was evidence of some grooving of the seat surface. The average groove depth, however, was considerably less than the groove depth measured on the other test seats, only being 2 to 5 microinches deep. This was considerably less "wear" than seen on the other materials tested in the normal impact valve. Total erosion of the integral portion of the seat remaining was also less than that of any of the other seats tested. Figure 95 shows comparative proficorder traces made of the seat land prior to and after the test. These data indicate that the surface finish of the seat in general is still quite good even in the impact area, probably better than the surface of any of the other valve seats after testing. The poppet used for the normal impact test in gaseous fluorine was examined using the S. E. M. to evaluate the seating surface and to attempt to further define the cause of the leakage experienced. In addition to the cracks in the seat, there was considerable amount of debris found in the seat land area similar to that found on the other

Al<sub>2</sub>O<sub>3</sub> SEAT NO. 12 BEFORE LOW IMPACT VALVE  
TEST IN GF<sub>2</sub> - 210X INTERFERENCE PHOTO
