# BEHAVIOR OF EPOXY-ASPHALT AIRFIELD PAVEMENTS 1963 INSPECTIONS

A. H. Joseph

February 1965

U. S. Army Engineer Waterways Experiment Station  
CORPS OF ENGINEERS  
Vicksburg, Mississippi

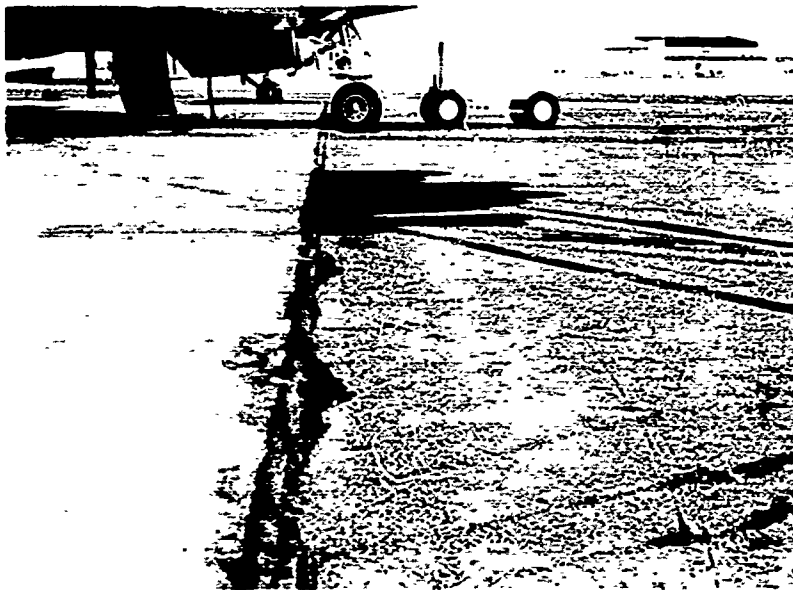
8. Condition of epoxy-asphalt pavement. Photographs 1-4 show the epoxy-asphalt pavement at Berry Field. The spillage has resulted in little or no apparent damage to the pavements. Examination of the surface did not reveal any softening. There was a small amount of shrinkage cracking in the longitudinal joints, which was most prevalent in the third joint from the south edge and the second joint from the north edge of each panel area. In spite of the spillage and the limited shrinkage cracking, the pavement as a whole was in excellent condition. The surface texture was good, and the joints were exceptionally smooth and well formed. Only time will tell whether the spilled fluids will enter the shrinkage cracks and damage the underlying asphaltic concrete. At the time of the inspection, oil appeared to be seeping into only one crack.

Photograph 1. Berry Field. Edge of overlay pavement. Note proximity of joint in original pavement

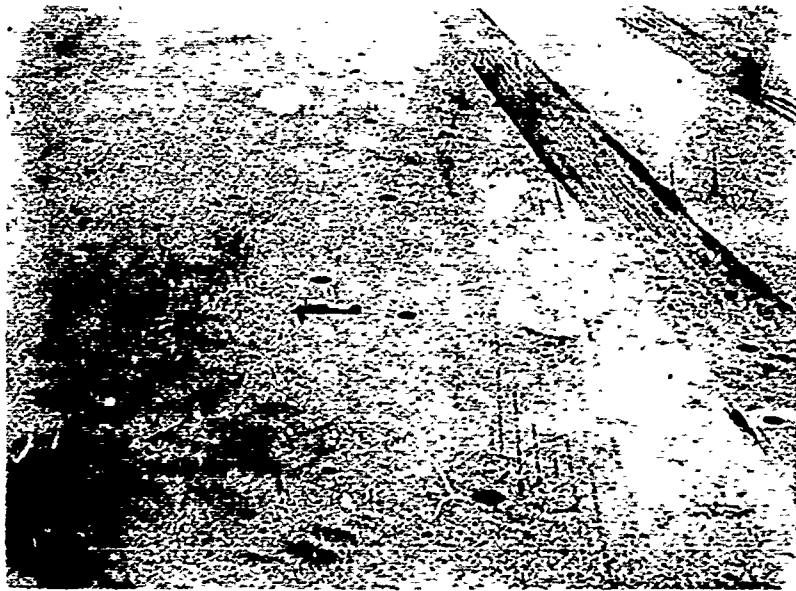
Photograph 3. Berry Field. Surface texture at longitudinal joint in epoxy-asphalt overlay

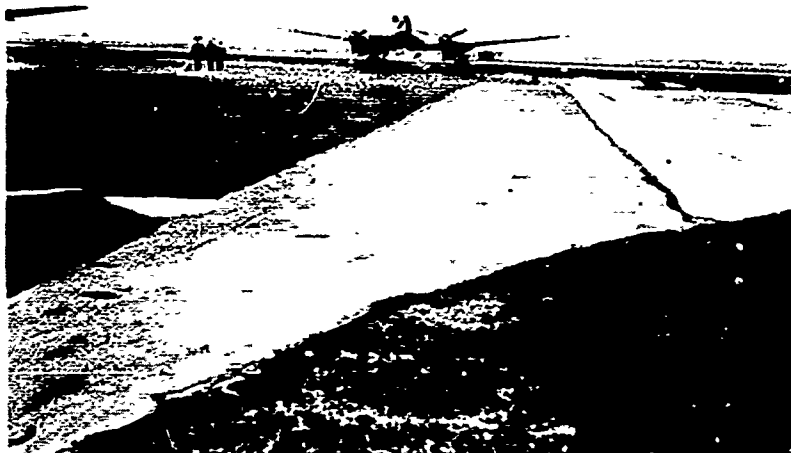
11. Condition of epoxy-asphalt pavement. Photographs 5-8 show the epoxy-asphalt pavement at Wright-Patterson AFB. In the first section, the sawed and filled joints in the strip overlying the new concrete were messy, indicating poor workmanship in filling the joints. There was no appreciable secondary cracking in this strip. In the portion overlying the tar concrete leveling course, the large expansion joints and some of the smaller contraction joints in the underlying portland cement concrete had reflected through the epoxy-asphalt overlay to the surface. The cracks ranged in width from fine hairlines to about 1/8 in.; in general, they followed the underlying joints, but in some instances meandered a few inches from straight lines, with little or no secondary cracking or raveling along the joints. In the second section, at the meet line of the taxiway and ramp, evidence of poor workmanship was manifested by rough and segregated areas. This section also had reflection cracks from the underlying concrete, but was otherwise intact.

Photograph 5. Wright-Patterson AFB. Overlay at transition from taxiway to apron

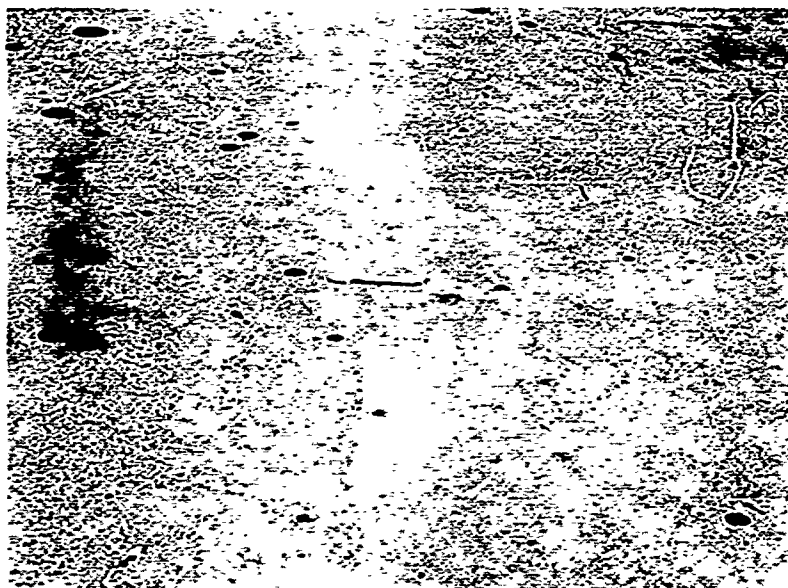
Photograph 6. Wright-Patterson AFB. Good surface texture at joint in overlay

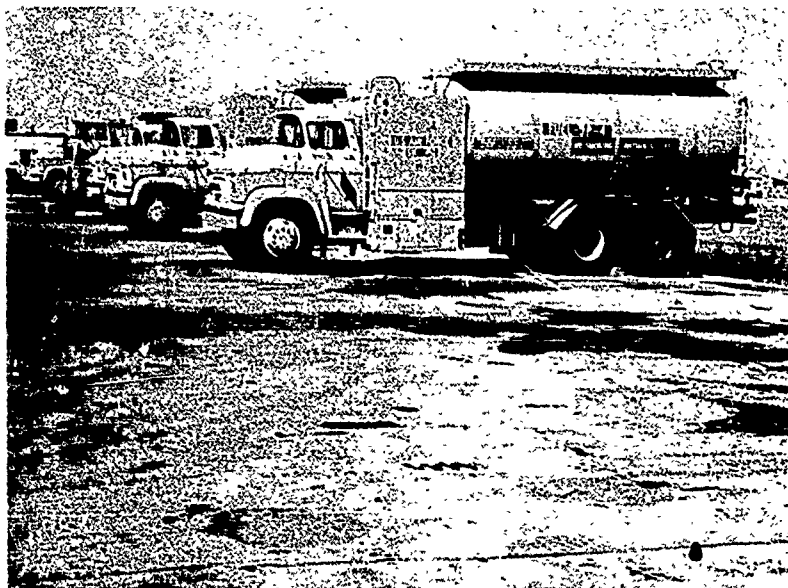
Photograph 9. Bunker Hill AFB. Overlay on flexible pavement used for parking fuel trucks. Note heavy spillage of fuel and oil

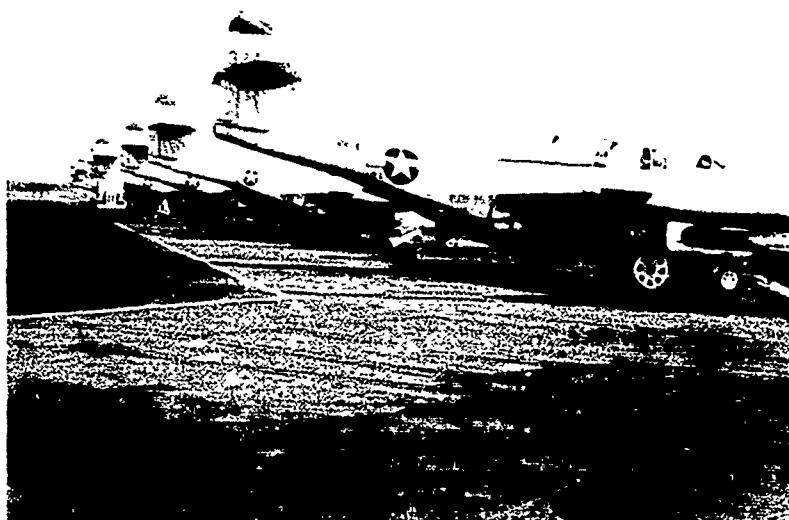
16. Usage. The pavement has been subjected to considerable parking traffic, mostly by F-89 jets with gross weights up to 44,000 lb, using 46-by 9-in. tires inflated to 200 psi (photograph 13). The pavement had also been subjected to very profuse fuel spillage (photographs 15 and 16). An area about 4 to 6 ft in diameter where hydraulic fluid had been spilled on the pavement was observed.

Photograph 13. Truax Field. Planes parked for maintenance and storage on overlay

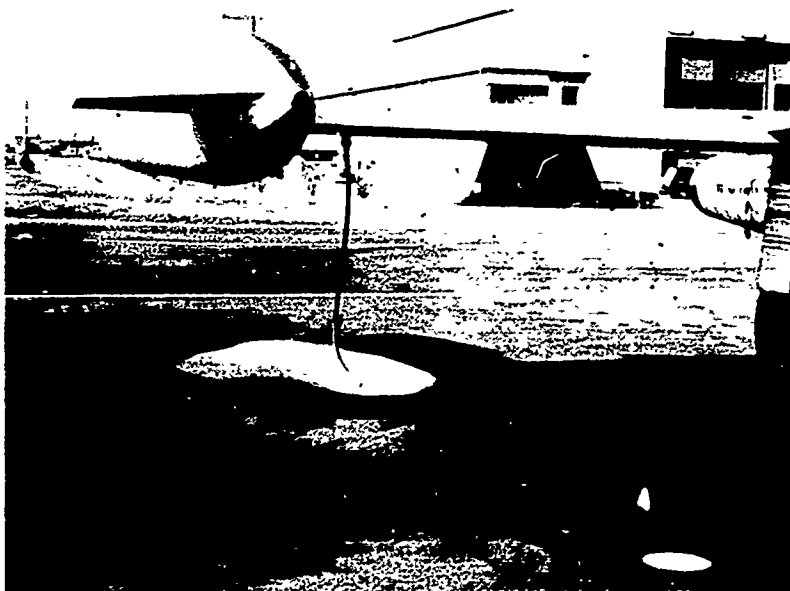
Photograph 16. Truax Field. A hose on fuel tanks  
outflow pipe as a precaution against having the fuel  
drip on and erode the pavement. Bucket not in place

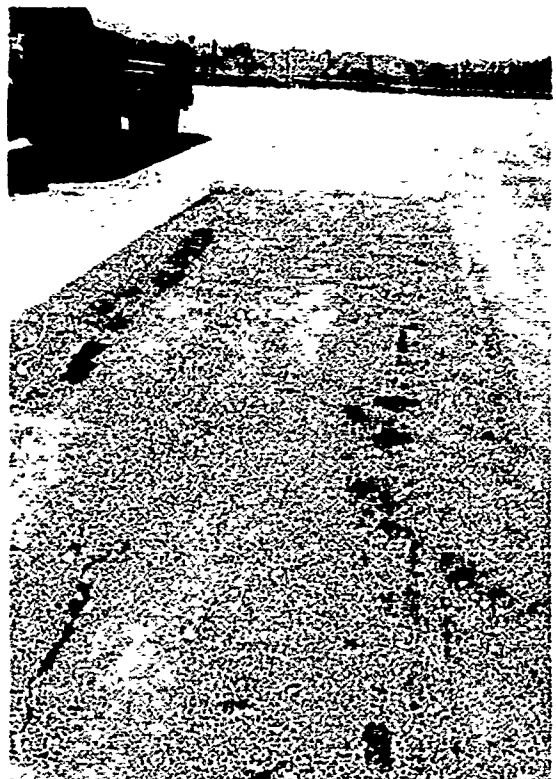
21. Condition of epoxy-asphalt pavement. In general, the epoxy asphalt showed little or no damage from the spillage where the underlying pavement was firm enough to provide support and prevent cracking of the overlay. Some areas of surface disintegration were noted, as shown in photograph 21. It appeared that such damage was caused by the heavily saturated underlying pavement. Cracking was observed in some areas. These cracks were usually parallel to the paving lanes, as shown in photograph 18. Most of the surface was smooth, but some placement irregularities had resulted in varied textures in a few areas (photograph 19).

Photograph 19. Perrin AFB. Varied textures of epoxy-asphalt pavement

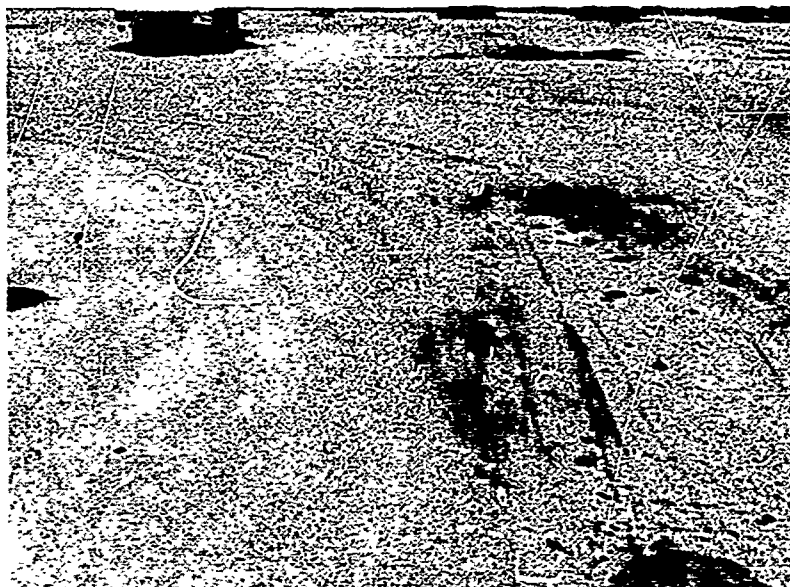
Photograph 21. Perrin AFB. Surface disintegration due to saturated underlying pavement

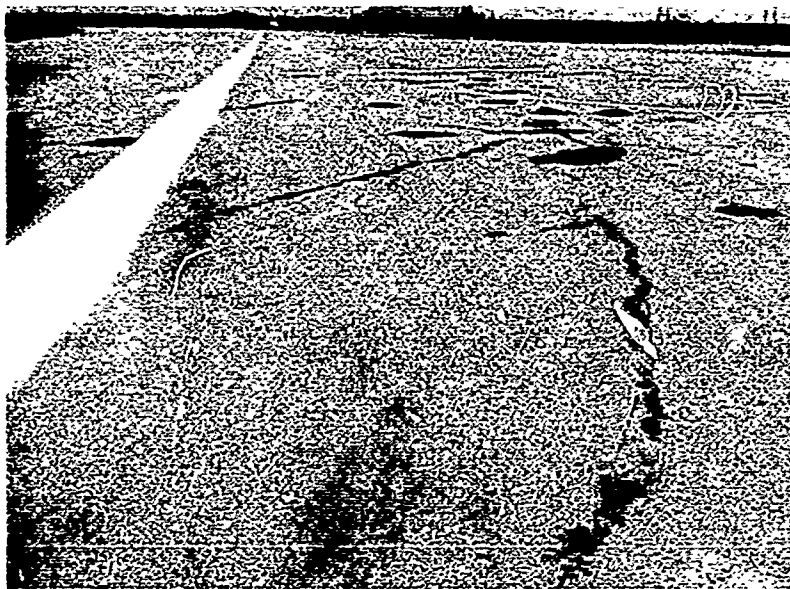
25. The 1963 inspection indicated that the condition of the overlay had changed little during the second year of service from that reported in the survey made in 1962. Areas of considerable size still existed in which no cracking had occurred, as shown in photograph 22. Sealing of cracks

Photograph 22. Davis-Monthan AFB. Area of epoxy-asphalt overlay with no cracks

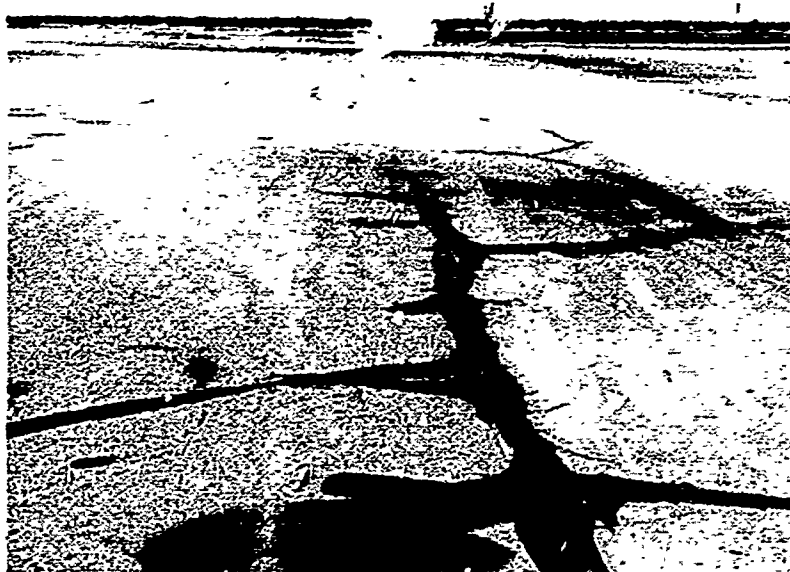
using several materials containing epoxy asphalt or straight asphalt had been unsuccessful, as shown in photograph 23. The assumption that some of the cracking was reflection is substantiated by photograph 24, which shows a crack in the shoulder paving continuing into the epoxy-asphalt overlay. Other cracks definitely appeared to be due to shrinkage, as shown in photograph 25, and there appeared to be horizontal movement in some areas where turning of aircraft occurs. This could only happen where the overlay and underlying pavement are not bonded. Reflection cracks were still the only type of cracks noticeable in the overlay over the portland cement concrete keel. No damage from jet blast or fuel spillage was found.

Photograph 23. Davis-Monthan AFB. Unsuccessful attempts to seal cracks in epoxy-asphalt pavement

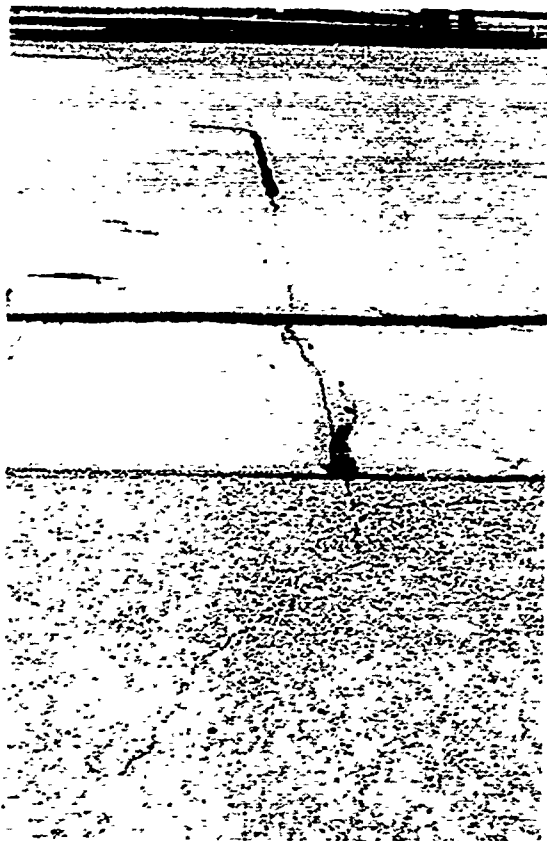
Photograph 24. Davis-Monthan  
AFB. Reflection cracking in  
shoulder pavement and epoxy-  
asphalt overlay

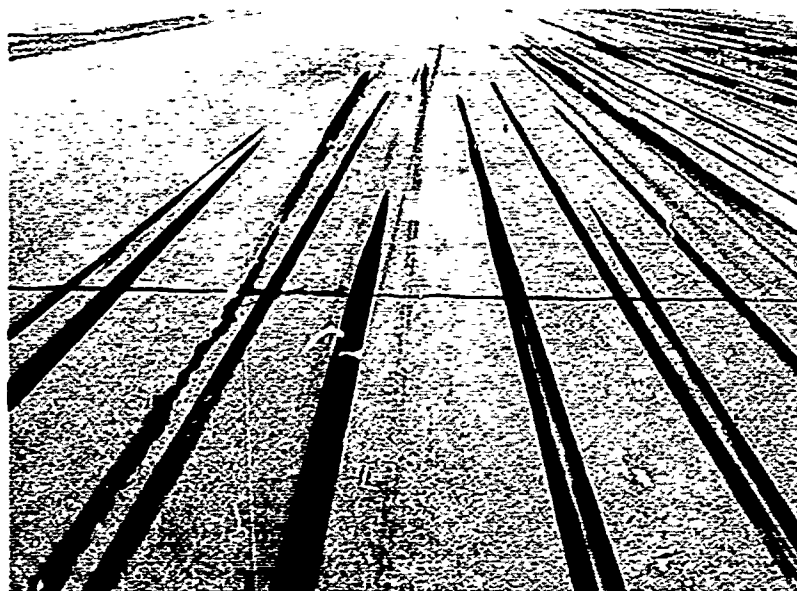
31. Condition of epoxy-asphalt pavement. Reflection cracking had occurred over the portland cement concrete joints on the northeast end of the runway. Occasional small shrinkage cracking, as can be seen in photographs 26 and 27, had also developed. Attempts at filling the cracks with an epoxy-asphalt emulsion, as seen in photograph 28, had not been successful. Reflection cracking also occurred on the southwest end of the runway, as shown in photographs 29 and 30. An area free of cracking is shown in photograph 31.

Photograph 27. George AFB. Reflection cracks which had been sealed

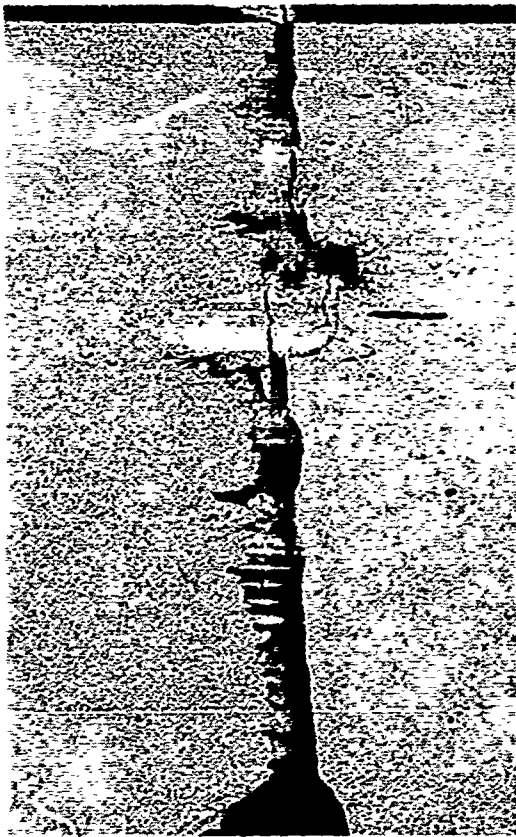
Photograph 28. George AFB. Unsuccessful attempt to fill reflection crack

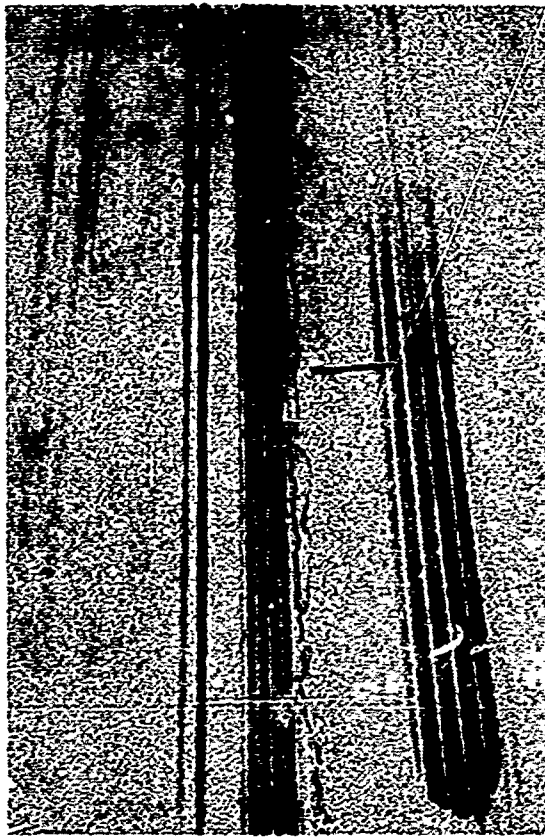
Photograph 29. George AFB. Reflection cracks on SW end of runway

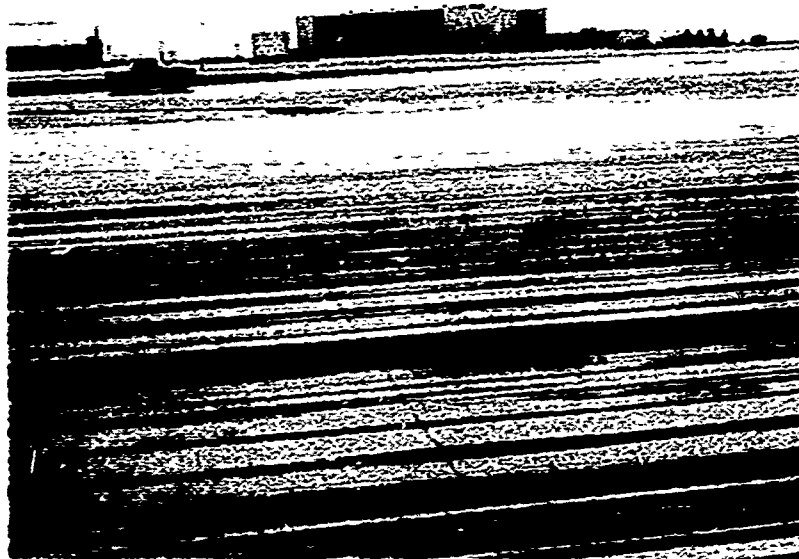
Photograph 30. George AFB. Reflection cracks on SW end of runway

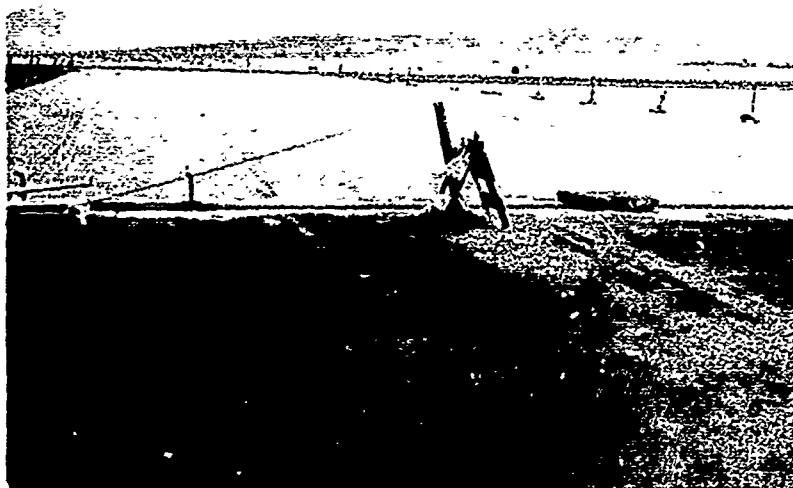
35. Condition of epoxy-asphalt pavement. There were a number of reflection cracks at joints in the old pavement and a few random cracks which appeared to be from shrinkage. The presence of these cracks was another reason that the pavement had remained closed to traffic, as the Base Civil Engineer wanted to repair them while the pavement was still clean and the cracks were free from debris which would be worked into them by traffic. The epoxy-asphalt overlay is shown in photographs 33-36.

Photograph 33. Stead AFB. General view of epoxy-asphalt overlay for helicopter pad

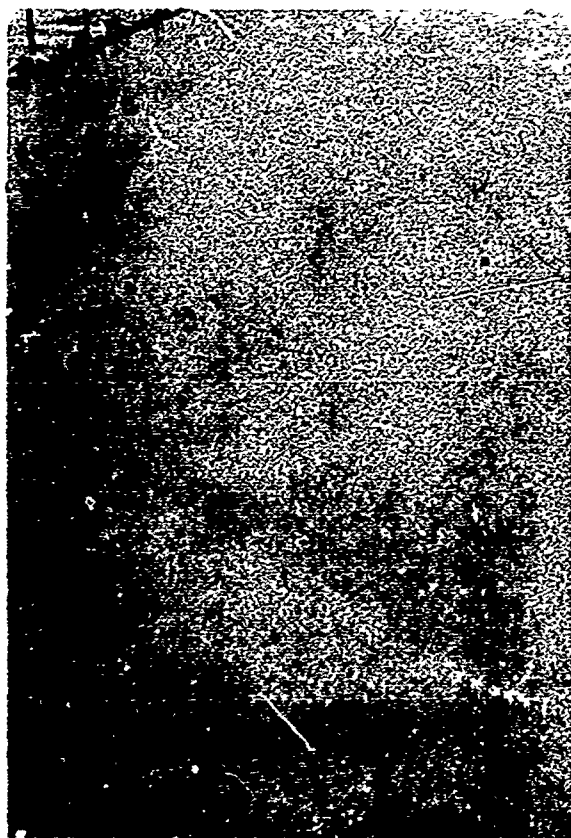
Photograph 34. Stead AFB. Area of epoxy-asphalt overlay free of cracking

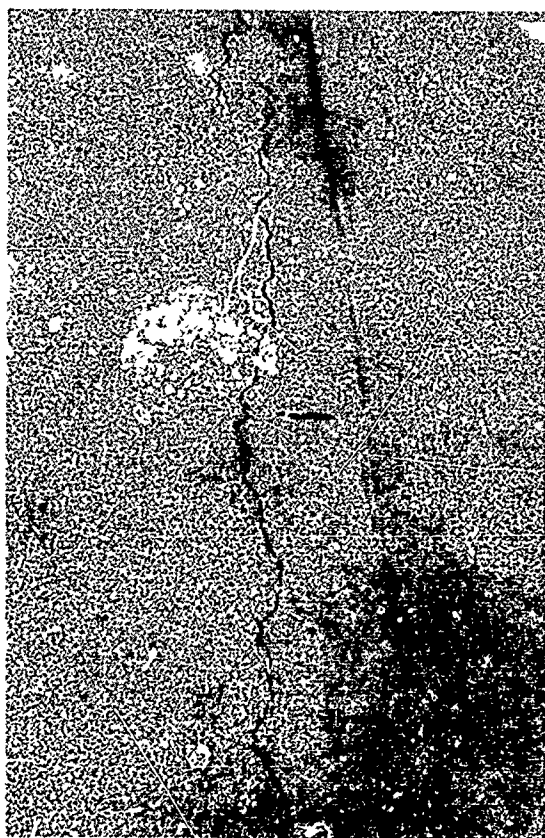
Photograph 36. Stead AFB. Random shrinkage crack in epoxy-asphalt overlay

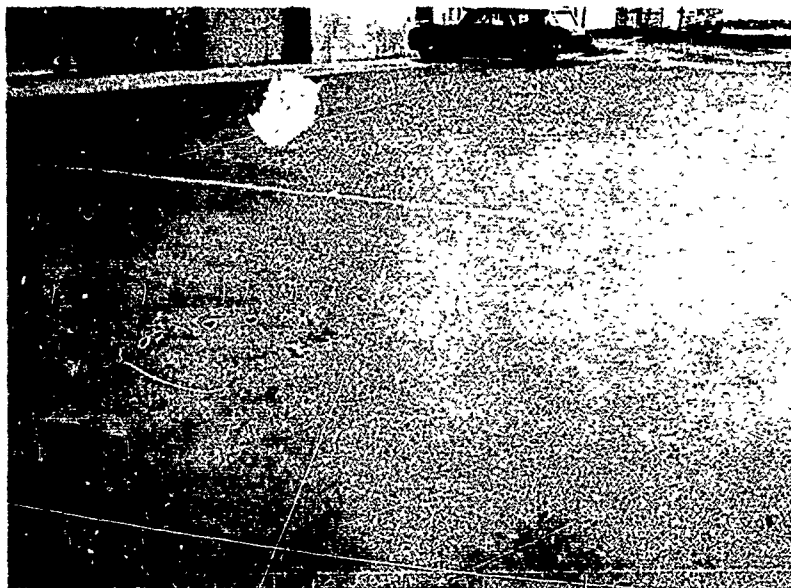
38. Condition of epoxy-asphalt pavement. In general the overlay was performing quite satisfactorily. There was no evidence of damage from solvents spilled on the pavement and the major portion of the overlay was free from any defects, as shown in photographs 37 and 38. However, there were some random shrinkage cracks, as shown in photographs 39 and 40. A shrinkage crack generally paralleling a longitudinal construction joint is shown in photograph 41.

Photograph 37. Reno ANG Field. Epoxy-asphalt overlay in satisfactory condition

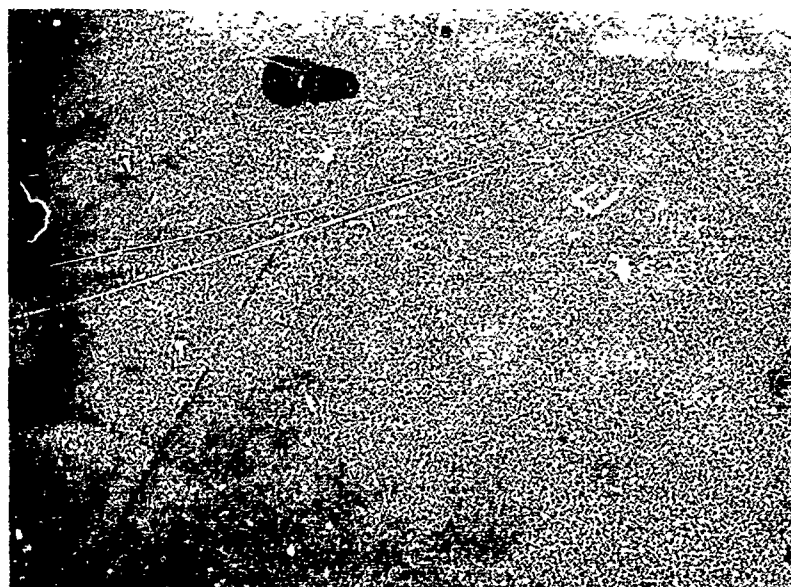
Photograph 38. Reno ANG Field. Close-up of epoxy-asphalt overlay surface

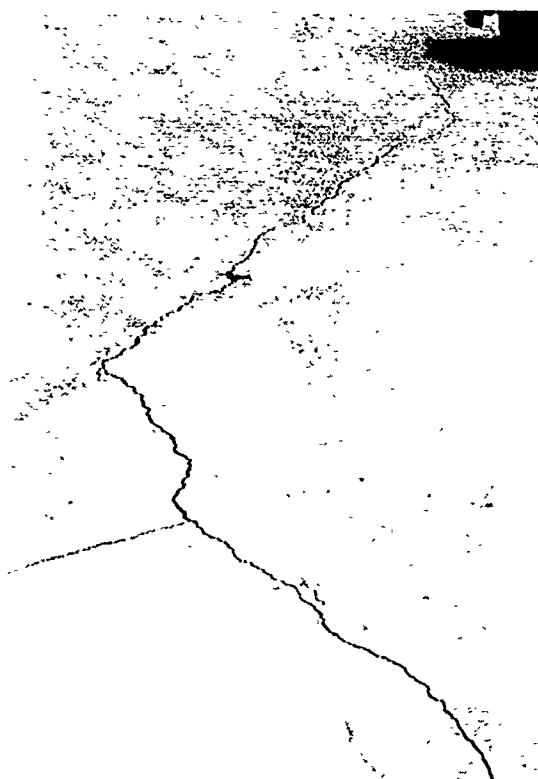
Photograph 40. Reno ANG Field.  
Close-up showing fragment of  
pavement broken out of epoxy-  
asphalt overlay

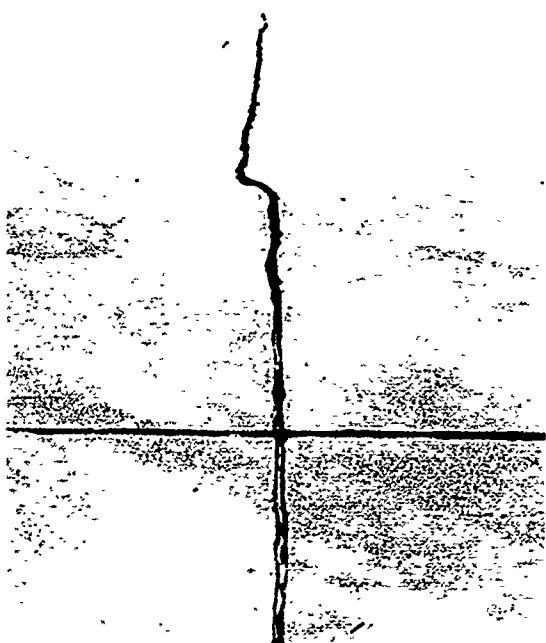
Photograph 42. Seymour Johnson AFB.  
Cracks that have been routed and  
sealed with epoxy asphalt

52. Maintenance. Some of the cracks were routed and sealed with joint-sealer material during the spring of 1963, as shown in photograph 42. Four different types of joint sealers were used, two cold-applied and two hot-applied. The hot-applied sealers were SS-164 and SS-167. Both of these sealers appeared to be properly bonded to the pavement, and the joints were sealed at the time of inspection. The cold-applied sealers (SS-170 and SS-200A) did not adhere to the epoxy asphalt, and were considered unsatisfactory. Prior to the inspection, the Shell Oil Company had sent two 5-gal cans of a rubberized-tar emulsion to Seymour Johnson AFB for experiments in sealing the reflection cracks. Several cracks were

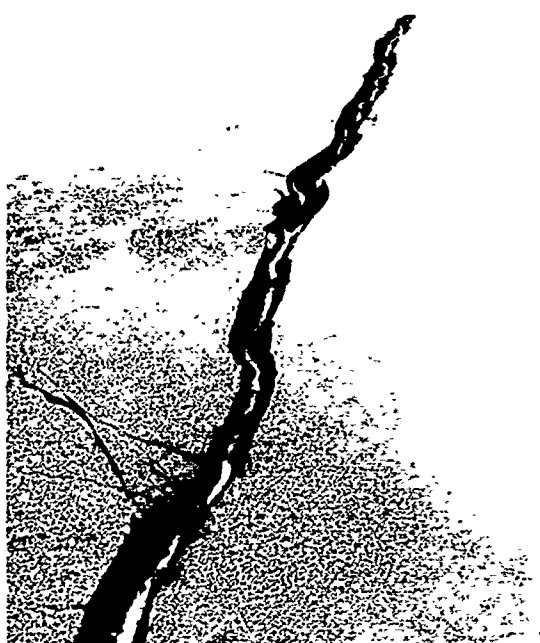
Photograph 43. Seymour Johnson AFB.  
Crack sealed with emulsion

sealed with this material during the inspection on 1 May 1963. The crack shown in the lower right of photograph 44 was sealed by squeegeeing the emulsion into the crack. The crack on the left of the photograph was sealed by diluting the emulsion with water and pouring it into the crack. The emulsion broke quite rapidly and shrunk down in the crack. The base personnel were planning to refill this crack the following day and also to do further experimenting in filling the cracks. A close-up of the emulsion squeegeed into the crack is shown in photograph 43.

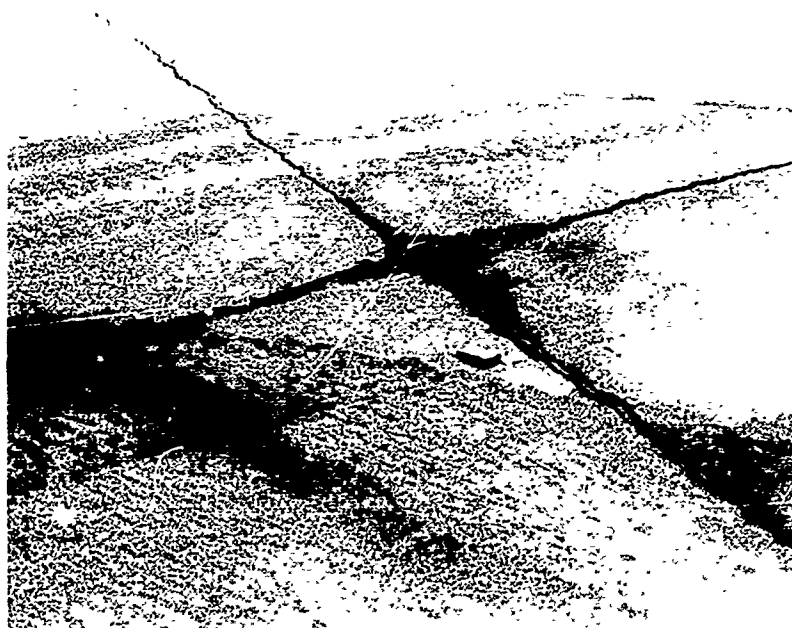
Photograph 44. Seymour Johnson AFB. Cracks in epoxy-  
asphalt pavement. Note joint-filling material in  
cracks in foreground

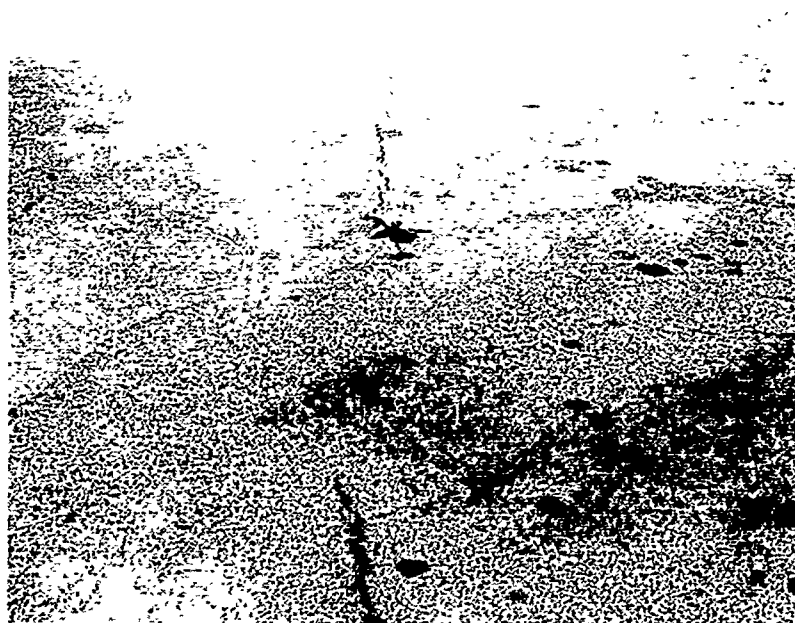
55. Condition of epoxy-asphalt pavement. The fuel spillage had stained the pavement, as shown in photograph 45, but had not caused any apparent detrimental effects. No softening or spalling of the pavement had occurred (photograph 46). Although there were some reflection cracks, the pavement was considered to be performing quite satisfactorily.

Photograph 46. Langley AFB. General view of epoxy-asphalt pavement

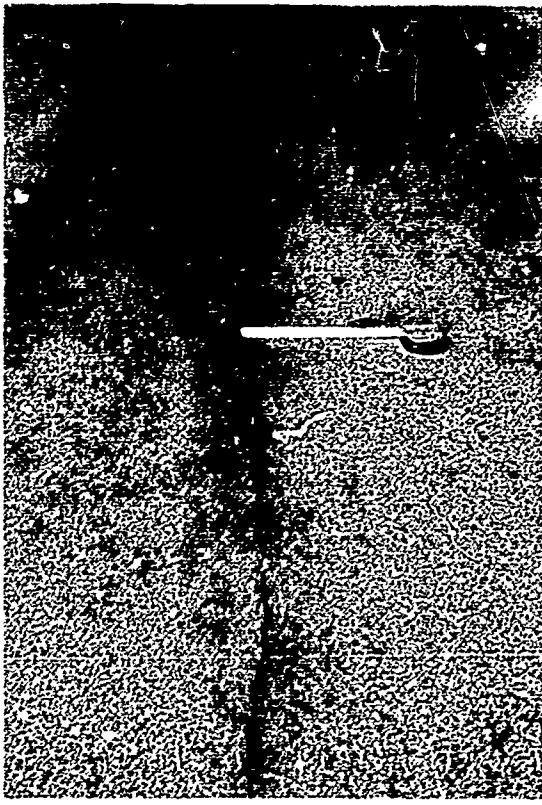
Photograph 47. Hancock Field. Crack along construction joint in epoxy-asphalt pavement

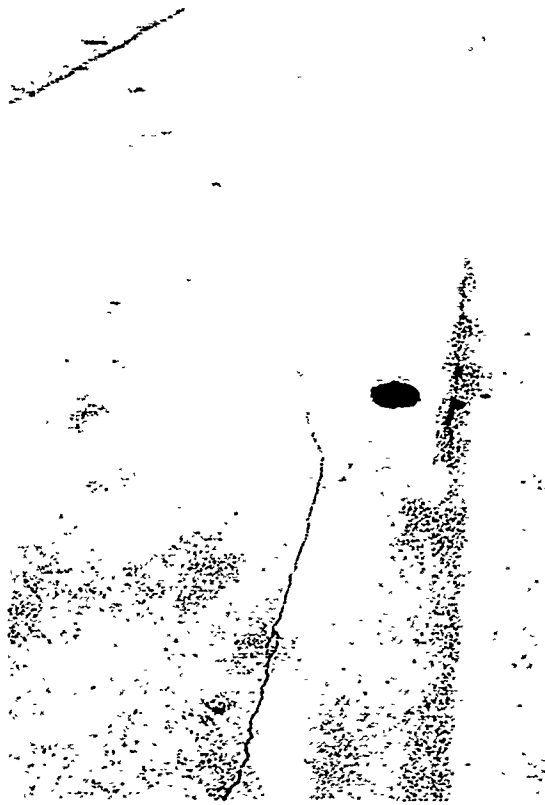
Photograph 48. Hancock Field. Random crack which parallels a construction joint

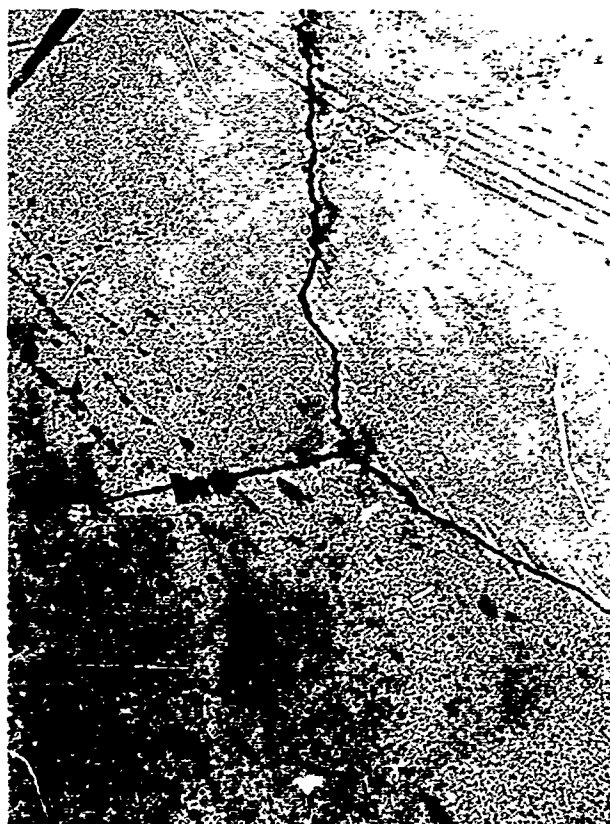
Photograph 52. Bradley Field. Random cracks beginning to spall in the epoxy-asphalt pavement

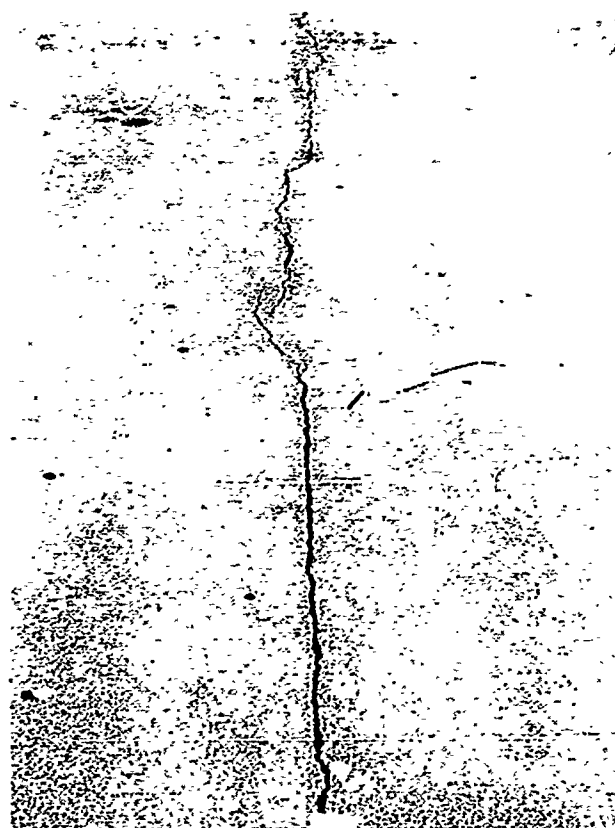
Photograph 54. Bradley Field. Open construction joints in the epoxy-asphalt pavement

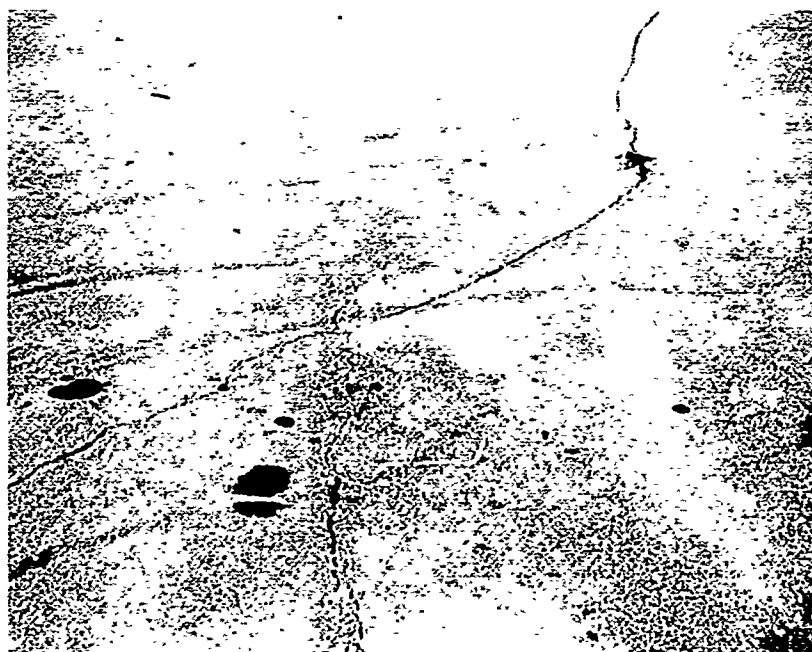
Photograph 58. Burlington Municipal Airport. Random cracks in epoxy-asphalt pavement

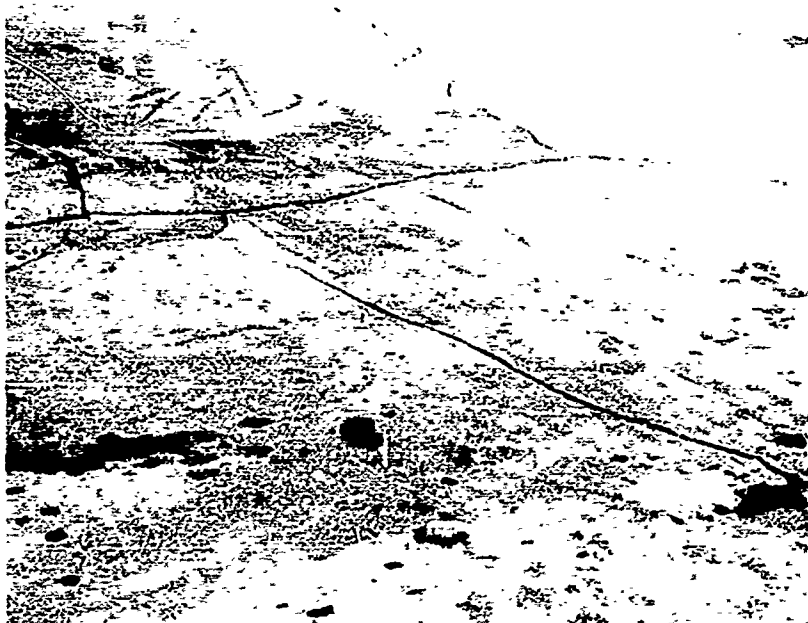
68. Condition of epoxy-asphalt pavement. The epoxy-asphalt pavement was rather severely cracked on the two pads that were available for inspection (photograph 61). Alert aircraft were parked on the other two pads and they could not be inspected. The areas inspected showed no appreciable damage from blast and, although signs of fuel stains were

Photograph 61. Loring AFB. Typical cracking on epoxy-asphalt pavement

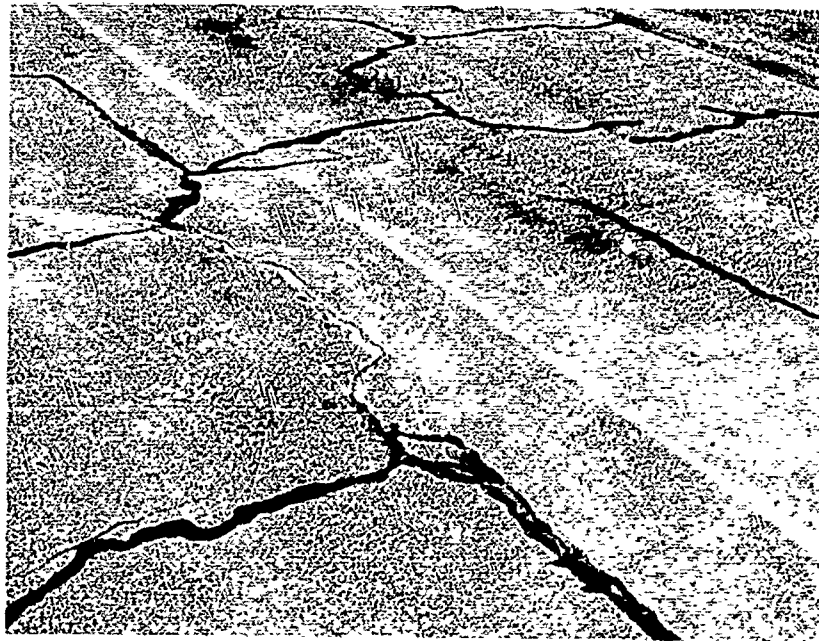
71. Condition of epoxy-asphalt pavement. The epoxy-asphalt pavement at Westchester County Airport had cracked more extensively than any other epoxy-asphalt pavement observed. It is possible that the thinness of the pavement (1/2 in. thick) and the poor construction procedures contributed to this extensive cracking. Photographs 63 and 64 show the type of cracking that has occurred.

Photograph 63. Westchester County Airport. Typical cracking in epoxy-asphalt pavement

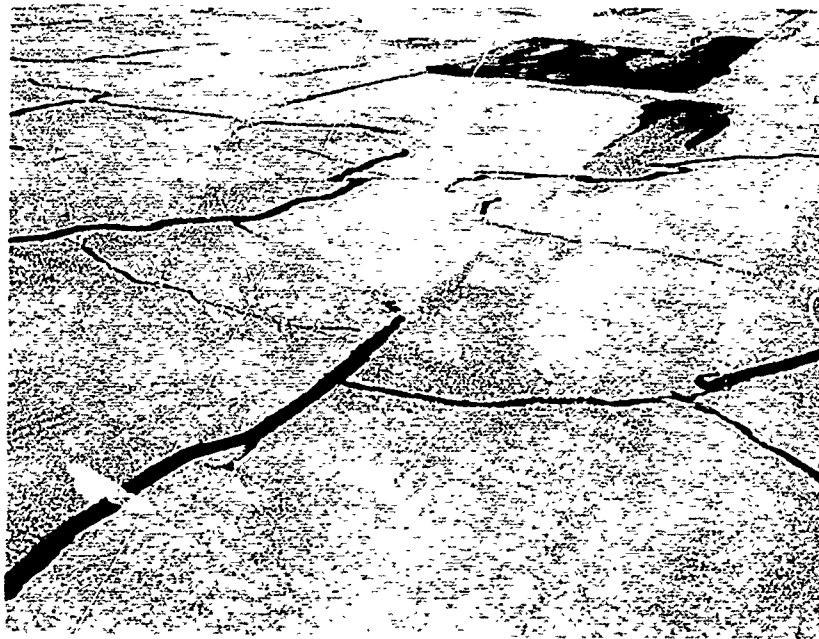
Photograph 64. Westchester County Airport. Cracking pattern on epoxy-asphalt pavements with patches in background
