MISCELLANEOUS PAPER NO. 4-759

# EVALUATION OF U. S. STEEL TYPE 4.5 AIR-DEK LANDING MAT

November 1965

**U. S. Army Engineer Waterways Experiment Station  
CORPS OF ENGINEERS  
Vicksburg, Mississippi**

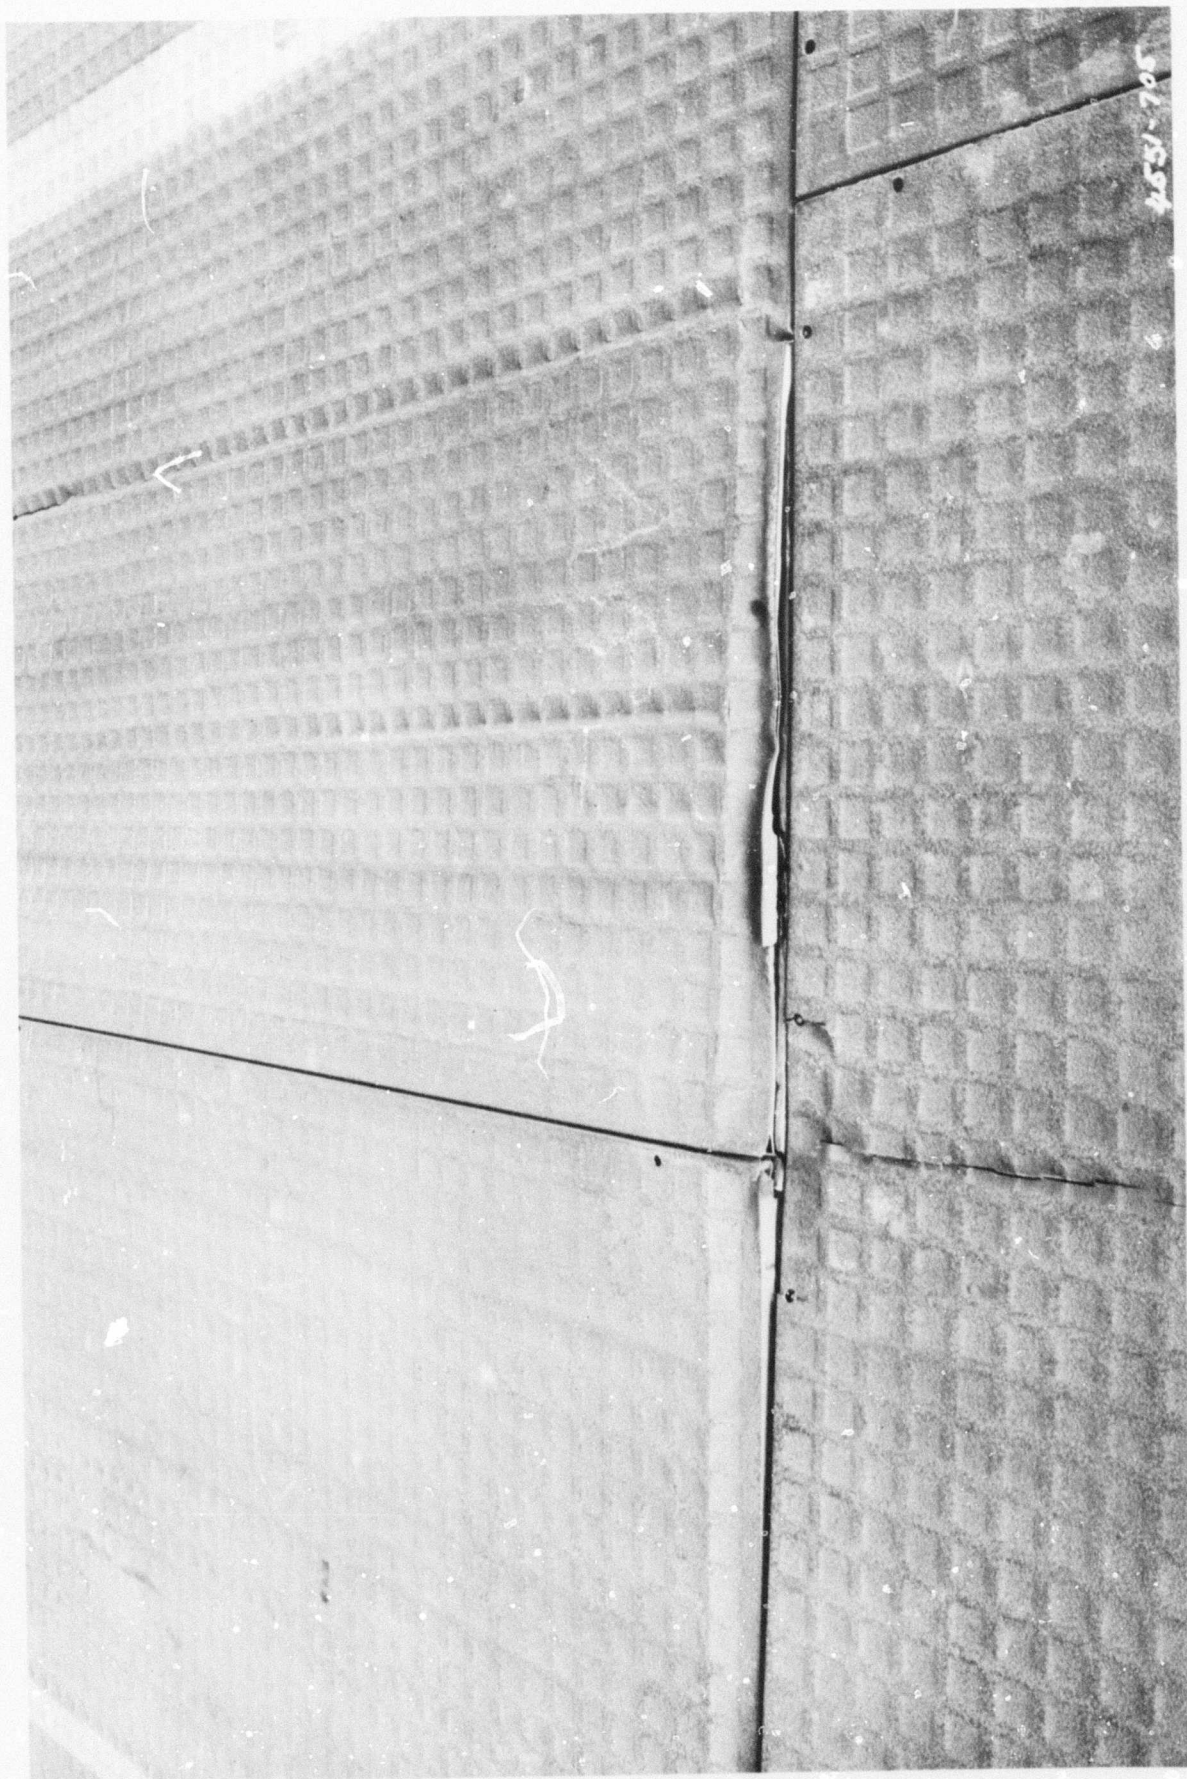
Photograph 20. General view of item 2 after 330 coverages
